Torque Fashion Ltd. (Ref No. 10924)

Shadu Para, Paragaon, Ashulia, Savar

12.MAY.2014

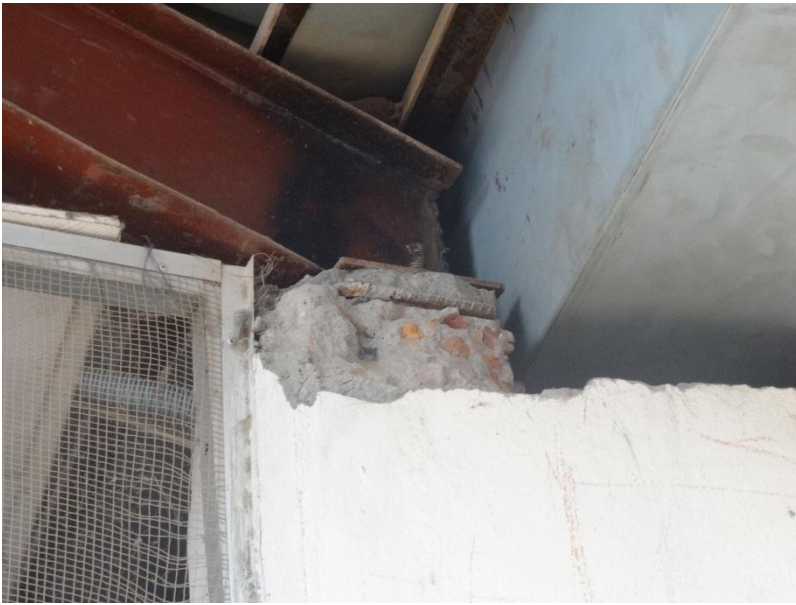
These images show examples of connections at beam ends where the resistance against uplift is questionable. It should be noted that in most locations the connections appeared appropriate, and in the under-construction Building 4 the construction methods and details seemed perfectly reasonable.

Building 1, where a connection is visible at the head of the column but cover is so small that pull-out resistance would be negligible.

ITEM 1: (Priority 2) Connection details to be further investigated for capacity against uplift.

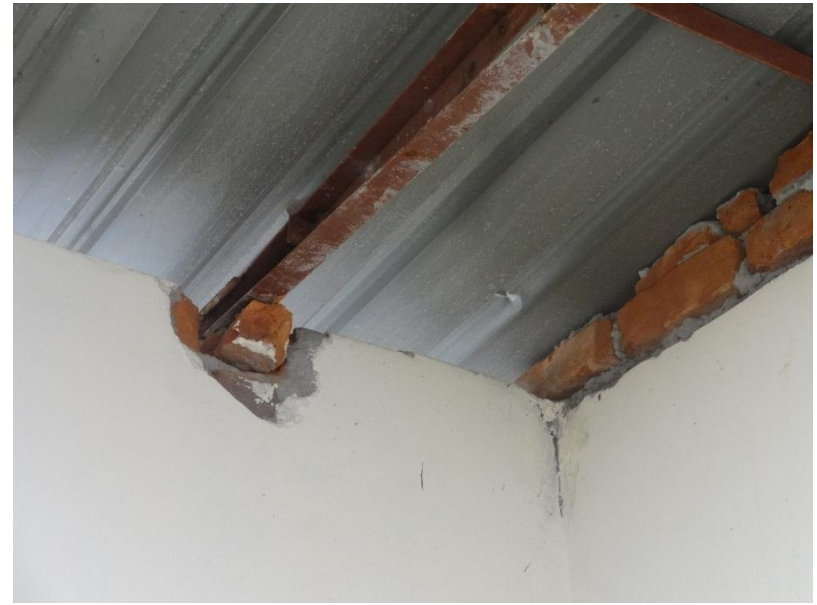
Truss-end connection in Building 6. An arbitrary attempt has been made to connect down, but the bricks are loose.

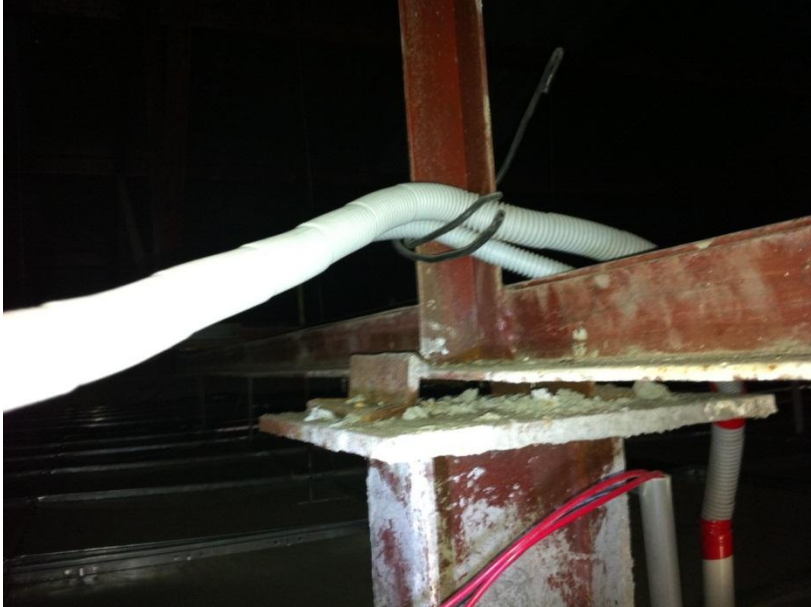
This image is from Building 3, where a roof truss is held down to the column only by a small fillet weld between it and an angle section.

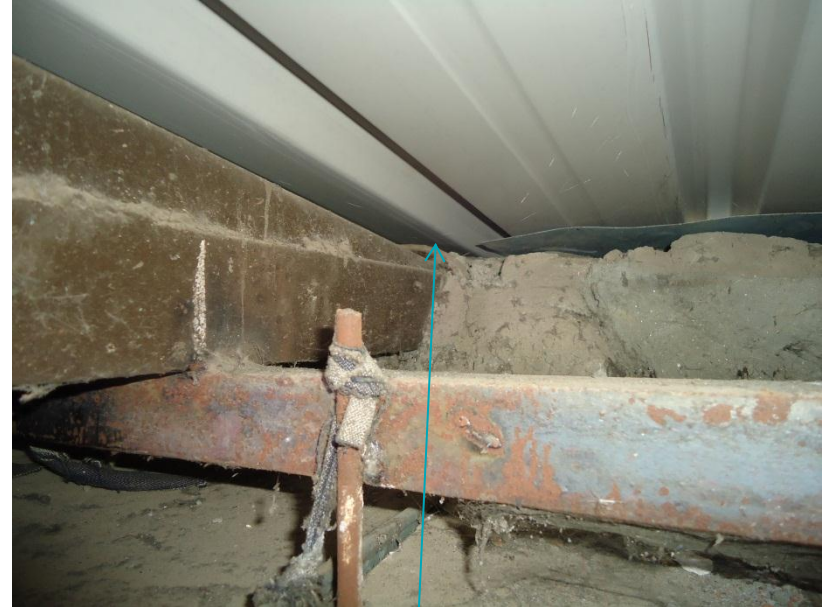
Steel rebar visible, bent over the truss end. It is unclear whether such details are present at other locations across the site. Photo taken in Building 1.

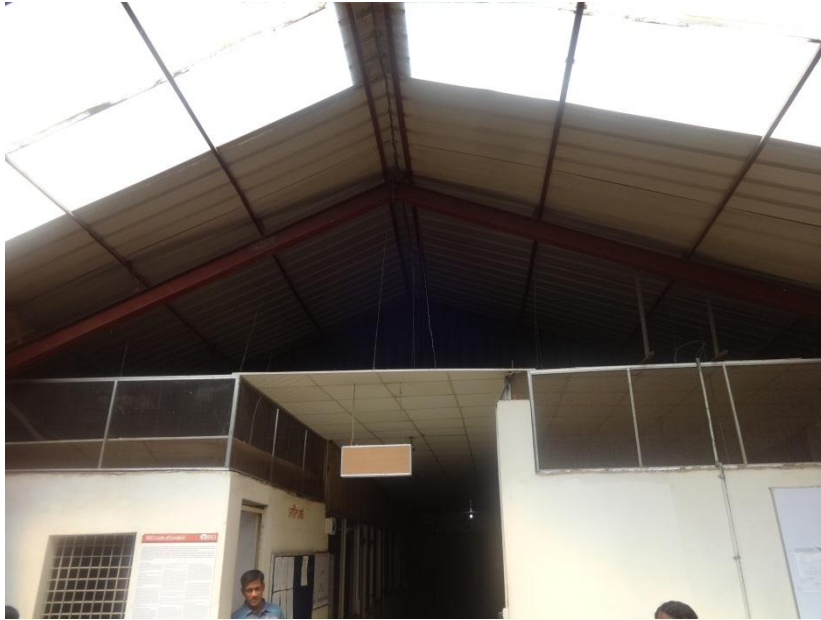
Diaphragm action and overall stability of Building 1 to be checked in more detail.

First pitch of the roof of Building 1 (Main entrance to the left), where no bracing is present and the connections between purlins and roof sheeting may not be sufficient for diaphragm action.

ITEM 2: (Priority 3) Diaphragm action and overall stability of Building 1 to be checked in more detail by Factory Engineer.

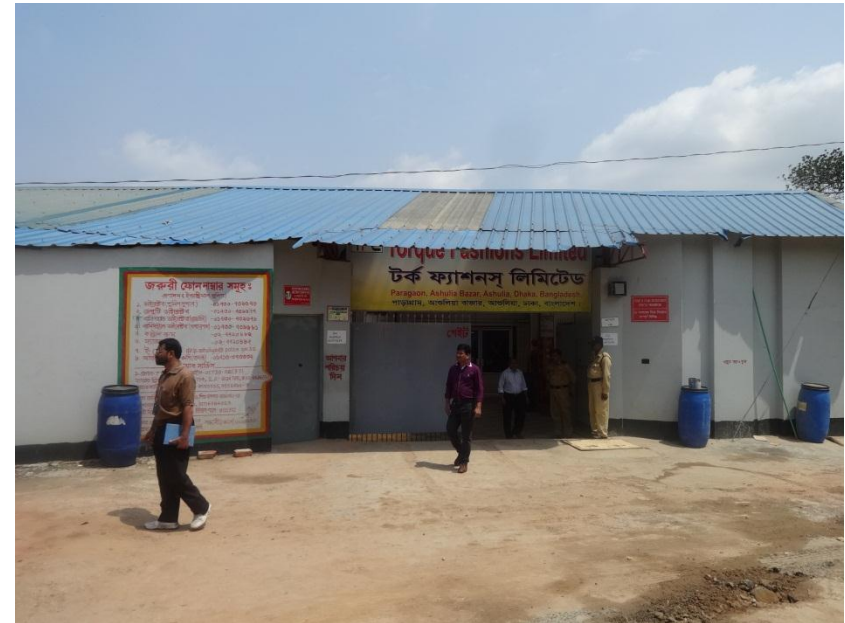
External view of Building 1, showing the lightweight roofing which may provide insufficient lateral stiffness against wind actions.

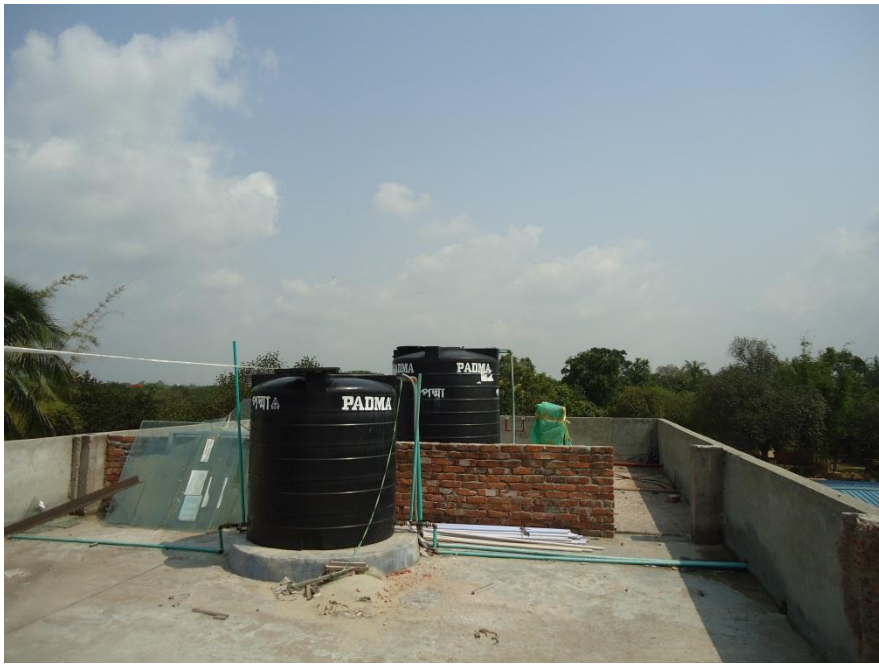
Roof level of Building 2 (the only non-steel roof on the site), with no waterproofing present.

No waterproofing was observed on the roof of the concrete building. Although no ponding or signs of water ingress were observed on site, the factory owner may wish to consider applying a waterproofing membrane.

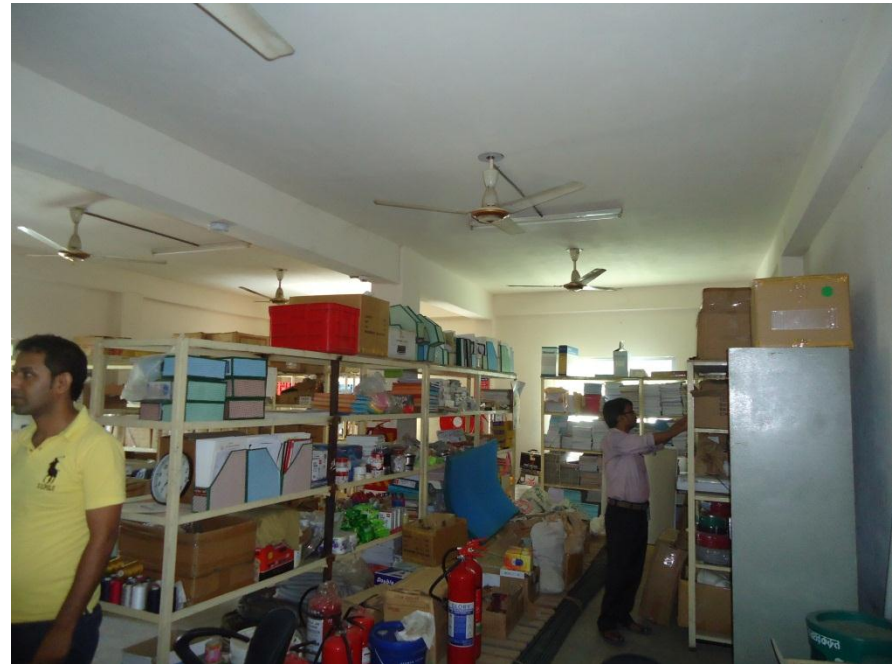
View from inside Building 2, at 1st floor level. As this image shows, no signs of water ingress were evident.
