# Pioneer Casual Wear Ltd. (9869)

Zamgora, Earpur Union, Savar.

14.MAY.2014

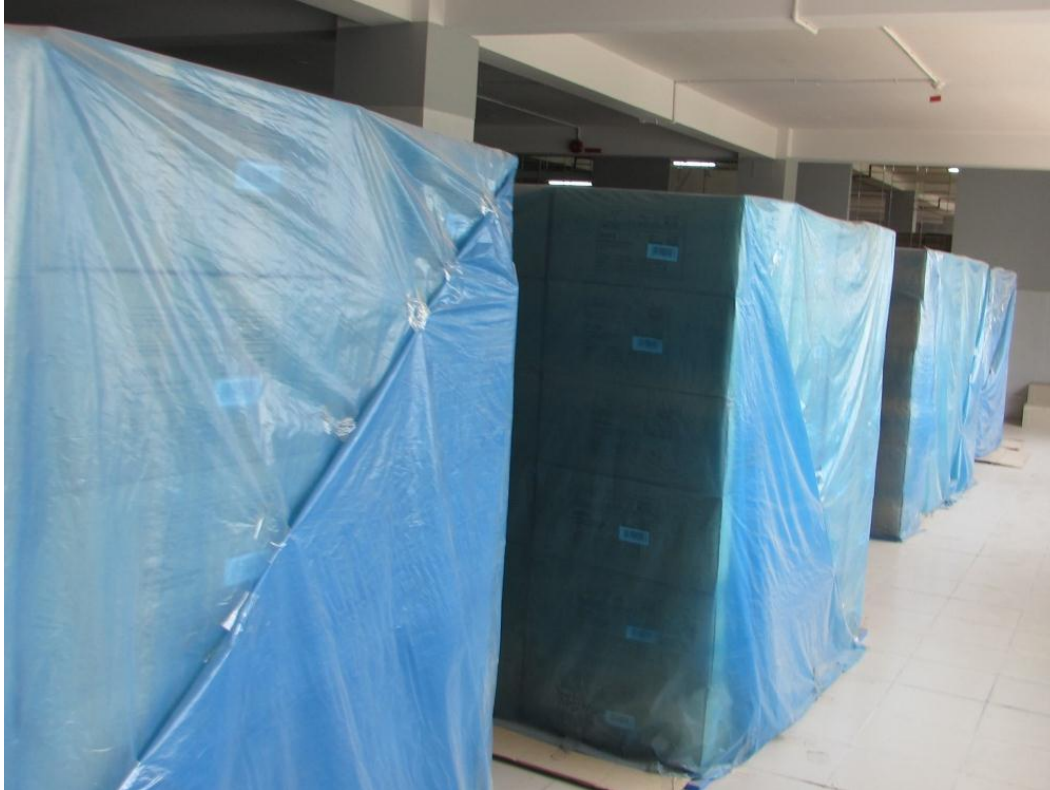
## 1<sup>st</sup> Priority 1 Concern

The storage of boxes in level 4 is higher than the design loading 2.5 kPa. Each box of fabric is estimated to be approximately 10.5kg with the dimension 0.55x0.38m and 6 layers, so the live load for this area is 3.01 kPa which is higher than the design loading 2.5 kPa.

Although the live load is only marginally higher than the imposed load, the stacking of the boxes should be carefully monitored to ensure that there is no possibility of overloading should loading conditions change in future.

Item No.	Observation	Recommended Action Plan	Recommended Timeline
1	Loading intensity appears to be greater than what was designed for on level 4.	Immediately reduce stacking height of fabric bag to ensure total load does not exceed 2.5kPa.	Immediate – Now
2	Loading intensity appears to be greater than what was designed for on level 4.	Mark the maximum allowable height of fabric stacking to ensure full compliance.	6-weeks
3	The column stress checking analysis turns out to be YELLOW rating	Factory Engineer to review design, loads and columns stresses in area identified above. Verify insitu concrete stresses either by 100mm dia. cores or existing cylinder strength data.	6-weeks
4	The column stress checking analysis turns out to be YELLOW rating	Produce and actively manage a loading plan for all floor plates within the factory giving consideration to floor capacity and column capacity.	6-months
5	Cracking appear on the Ground floor beams and slabs in Block A.	The cracks need to be investigated to see the width and depth of crack, available reinforcement, and determine remedial measures if any.	6-months

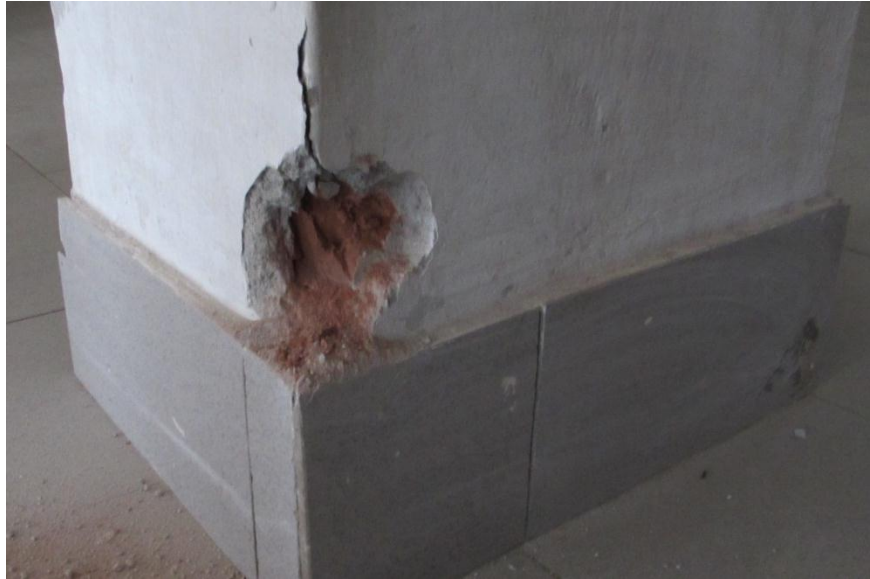
## 1<sup>st</sup> Priority 2 Concern

Based on the load rundown analysis of the building, the current building operates well within structural limits. However, the column stress checking analysis turns out to be YELLOW status, which means that all floor loadings must be carefully monitored.

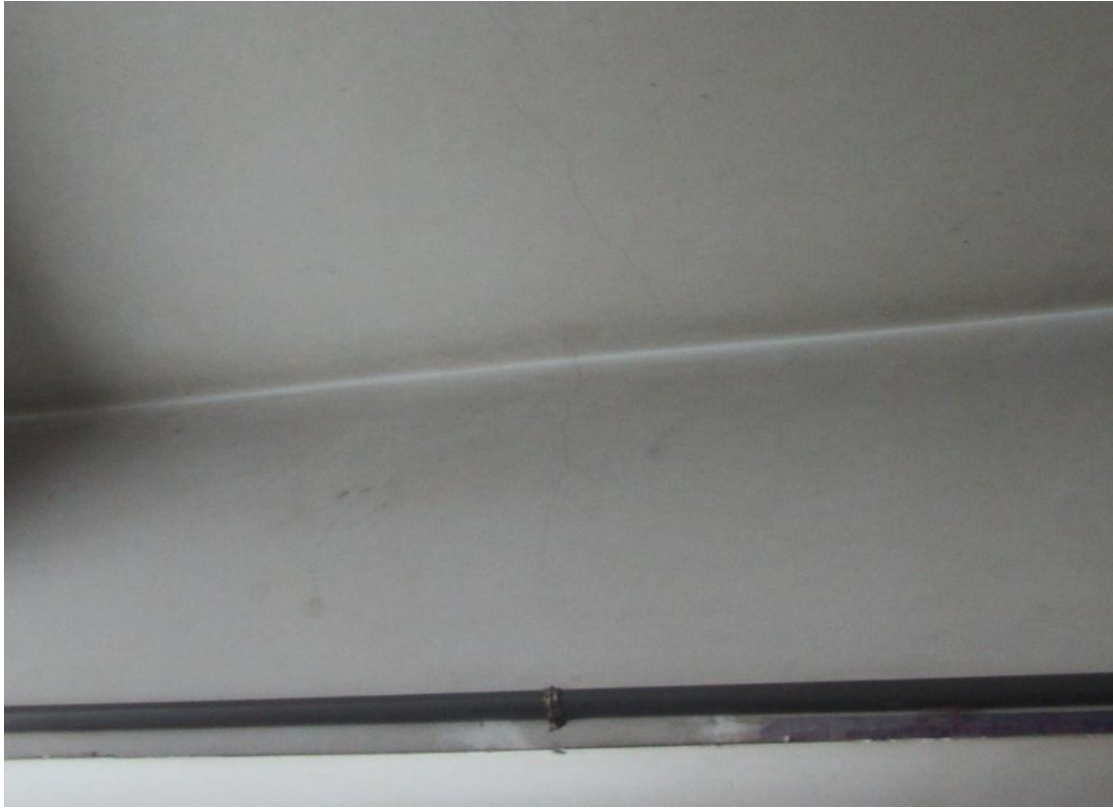
## 1<sup>st</sup> Priority 3 Concern

There are a lot of cracks appearing on the Ground Floor beams and slabs in Block A. The cracks occur at the mid-span of beam and slab. The cracks need to be investigated to determine the width and depth to find the appropriate remedial solution for the crack.

In the meantime, the loading on the Ground Floor slab should be carefully monitored to ensure no overloading occurs

We require that these items be investigated in a Detailed Engineering Assessment

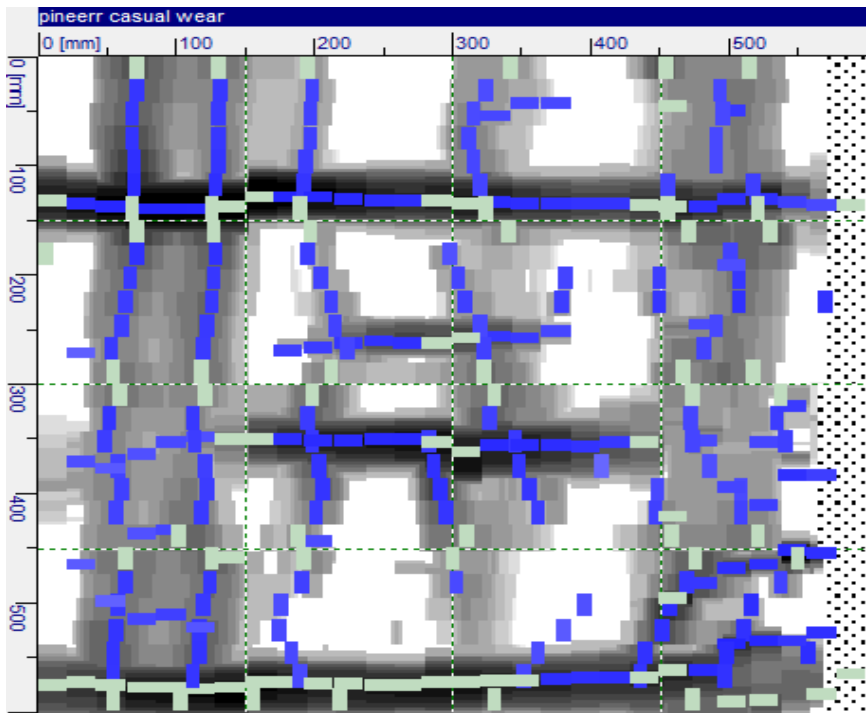
## 2<sup>nd</sup> Priority 3 Concern

The ferroskan shows that the number of rebars in column C3 does not match with the structural drawings. It appears that the number of bars is less.

A Detailed Engineering Assessment should be carried out to find out the actual as-built condition of the columns and the structural calculations checked for sufficient structural capacity

6	The ferros scanner shows the number of bars in column C3 to be less than what was provided in the structural drawings	The detail survey for the rebar of the column need to be carry out to confirm the exactly the number of bars in the column.	6-months
