**Newtex Design Ltd. (9514)**  
**Impress-Newtex Composite Textiles Ltd. (10256)**  
**Newtex Knit Fashion Ltd. (11724)**

Gorai, Industrial Area, Mirzapur, Tangail  
(+ 24.089332N, 90.171028E)

14.MAY.2014

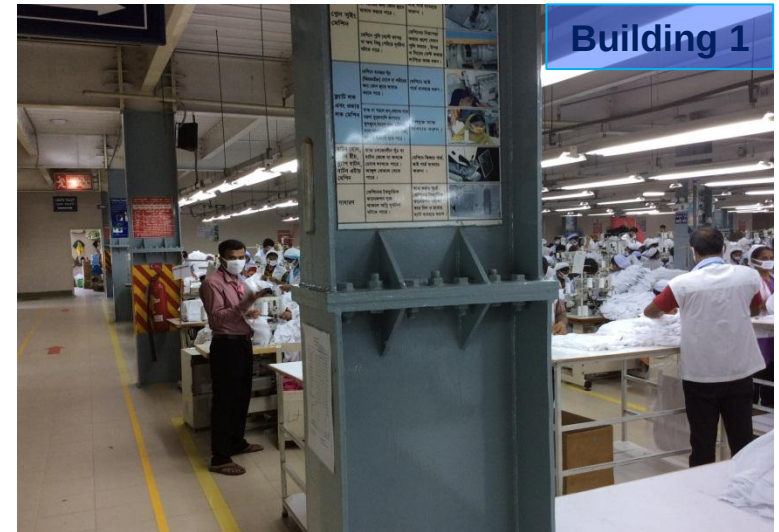
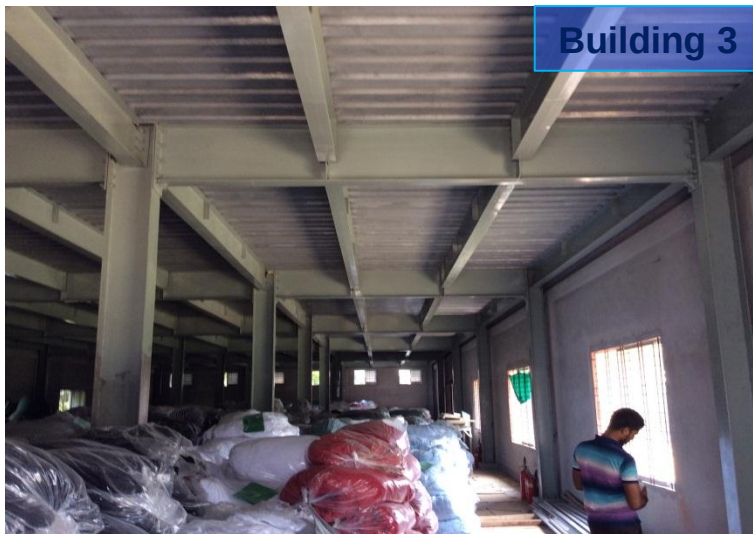
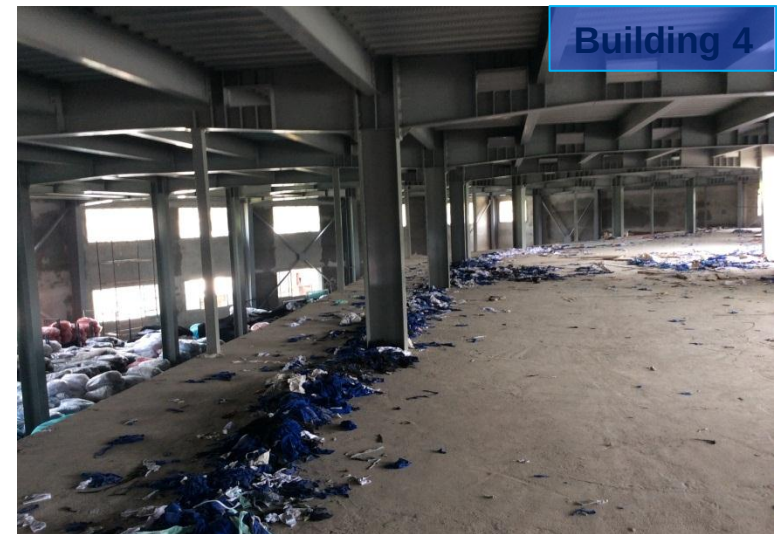
- No fireproofing for steel structure elements,
- Inconsistencies between the drawings of Building 2 and the actual as-built conditions

It is unclear whether fire proofing material is applied on structural steel elements.

| Item No. | Observation | Recommended Action Plan | Recommended Timeline |
|---|---|---|---|
| 4 | No fireproofing for steel structure elements. | Fireproofing material for structural steel element is recommended as suggested in BNBC Codes. | 6-weeks |
| 5 | No fireproofing for steel structure elements. | Maintain standard of quality control. | 6-months |

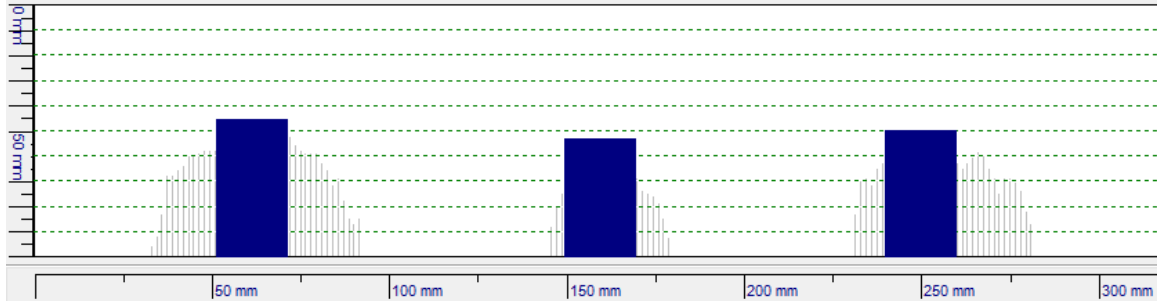
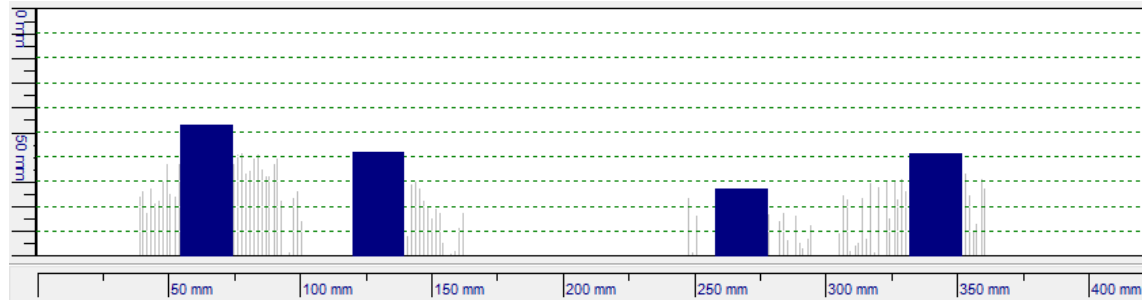
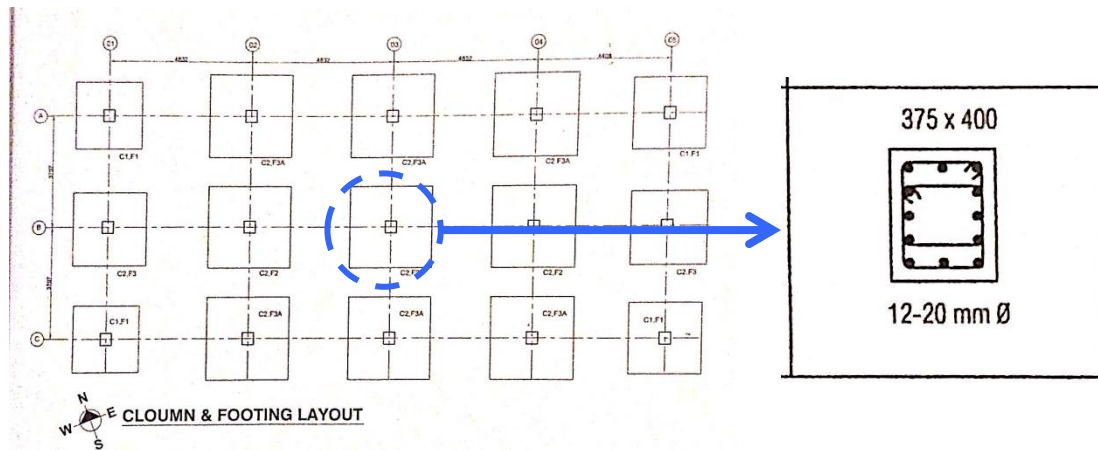
The size of column C2, as measured at the ground floor (300 x 350 mm) is smaller than what is specified in the drawings (375 x 400 mm). The no. vertical rebar measured on-site (10-Ø20 mm) is less than what is specified in the drawings (12-Ø20 mm).

From calculation check, it indicates that the FoS of interior column is 4.79.

| Item No. | Observation | Recommended Action Plan | Recommended Timeline |
|---|---|---|---|
| 6 | Inconsistencies between the drawings of Building 2 and the actual as-built conditions. | Factory Engineer to survey the actual conditions and revise the drawings.<br>Factory Engineer to review design, loads and columns stresses to confirm suitability for loads applied.<br>Produce and actively manage a loading plan for all floor plates within this area giving consideration to floor capacity and column capacity. | 6-weeks |
| 7 | Inconsistencies between the drawings of Building 2 and the actual as-built conditions. | Continue to implement load plan | 6-months |

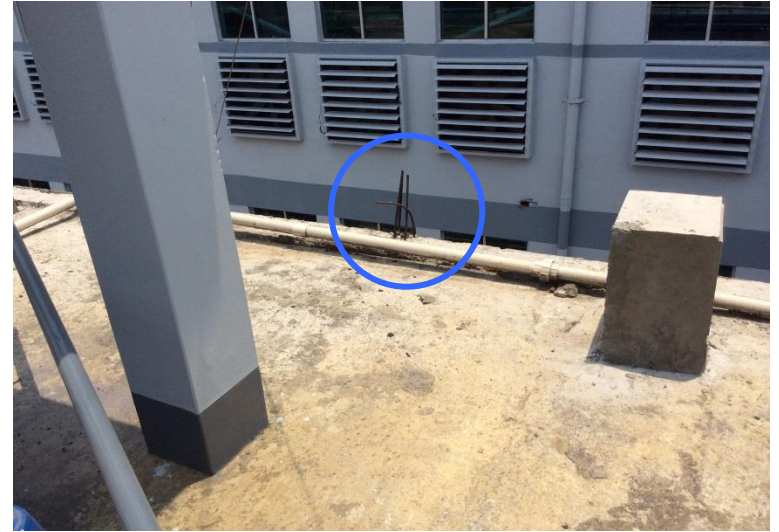
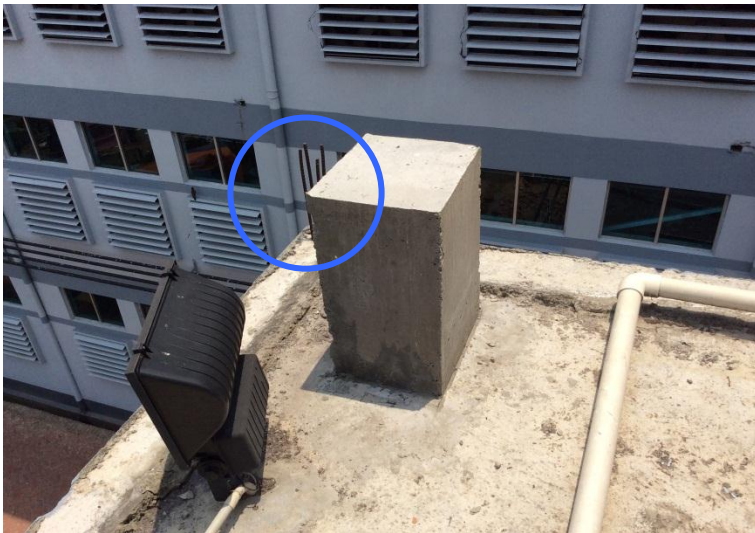
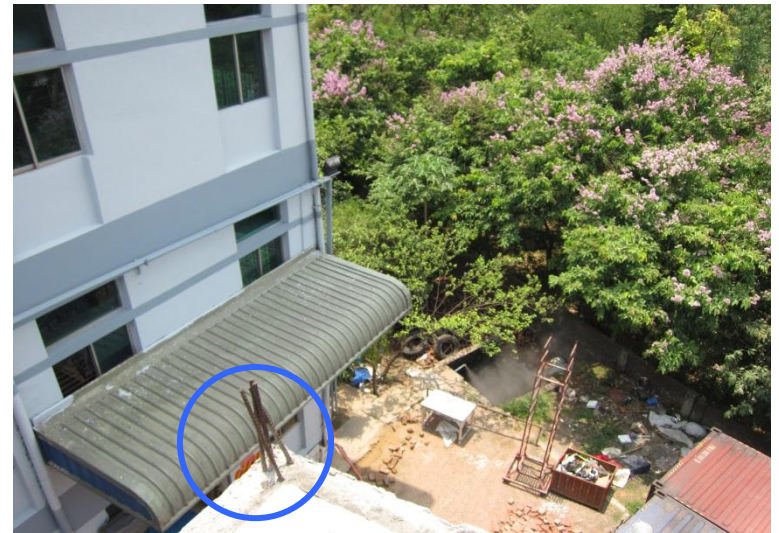
- Reinforcement left exposed at roof level of Building 2

Reinforcement is left exposed. It is unclear whether rust proof paint is applied.

| Item No. | Observation | Recommended Action Plan | Recommended Timeline |
|---|---|---|---|
| 9 | Reinforcement left exposed at roof level of Building 2. | For both durability and serviceability, rust proof paint or any appropriate methods is recommended. | 6-months |

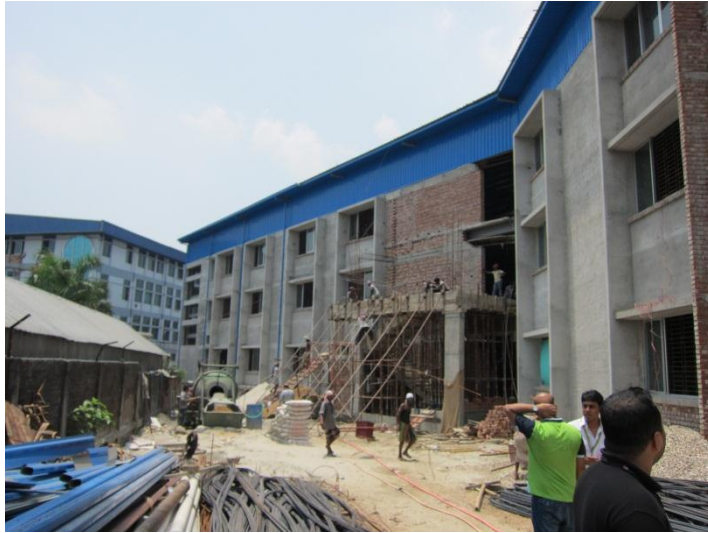
We were informed that lateral load was included in the design of Building 4 as shown in the graphic output below, submitted by .

However there are concerns on the stability system for lateral loading and seismic loading of Building 1, Building 2 and Building 3.

We require that these items be investigated in a Detail Engineering Assessment.

| Item No. | Observation | Recommended Action Plan | Recommended Timeline |
|---|---|---|---|
| 8 | Overall stability system. | Request that the Detail Engineering Assessment of the overall building to be carried out and in particular, stability and foundation aspects should be investigated in detail. | 6-weeks |

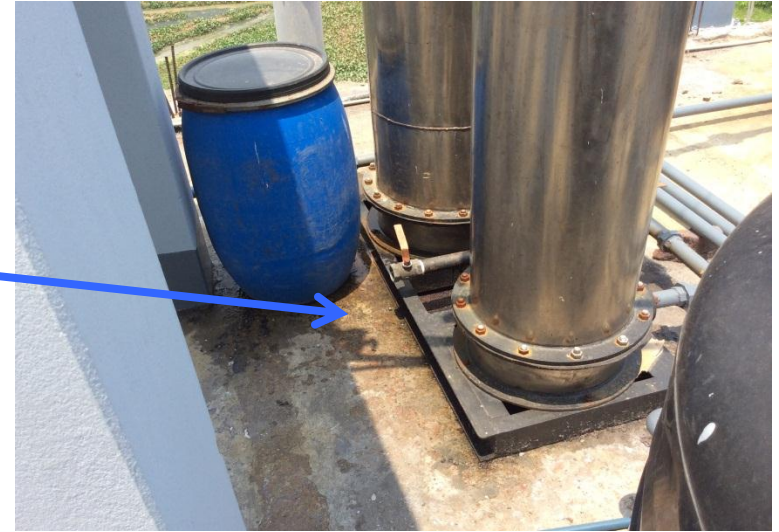
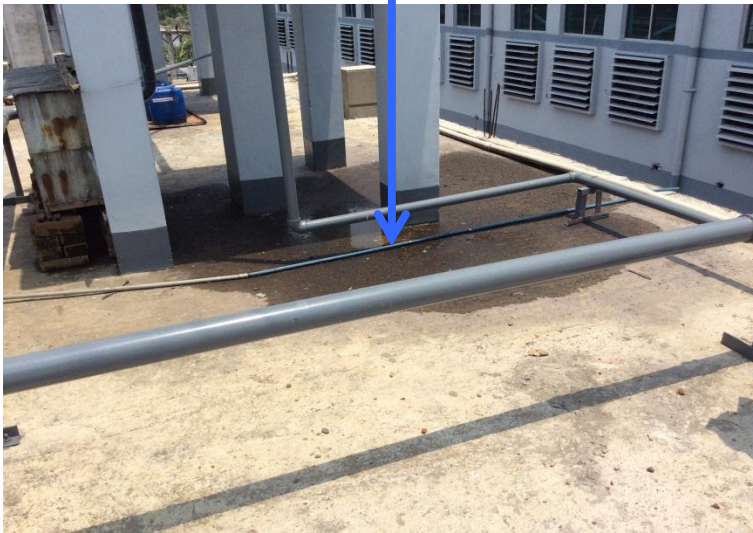
There is no water ingress found at roof level of Building 2. However water ponding has been found on the roof slab. It is also unclear whether waterproofing material is applied.

| Item No. | Observation | Recommended Action Plan | Recommended Timeline |
|---|---|---|---|
| 10 | No waterproofing material at roof level. | Engineer to inspect water damaged structure including the exterior and propose a suitable repair.<br>For both durability and serviceability, waterproofing on the roof slab is recommended. Moreover the roof slab drainage system should be investigated. | 6-months |
