# Liz Fashion Industry Ltd. (#9640)

Zamirdia (Steel Store), P.S. –Bhaluka, Mymensingh

14.MAY.2014

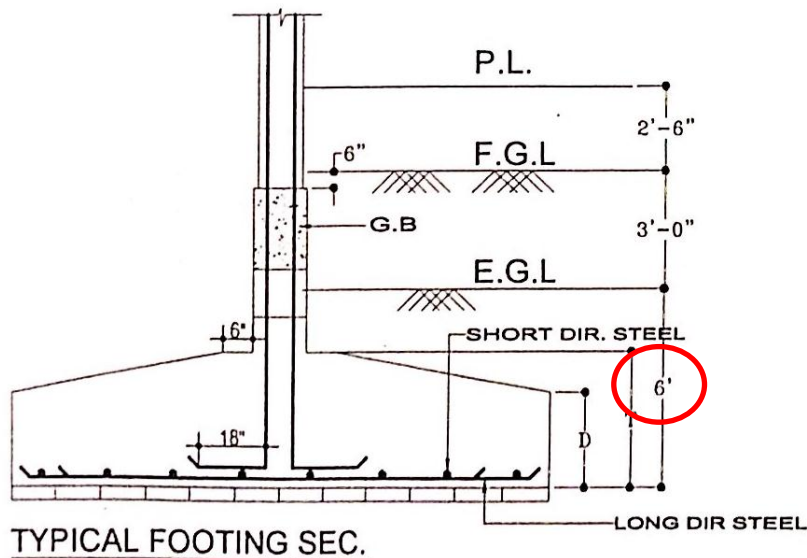
Foundation depth on structural drawings does not meet recommendations from soils report.

Foundation depth on drawing = 6'0"  
Foundation depth on soils report = 9'0"

| Item No. | Observation | Recommended Action Plan | Recommended Timeline |
|---|---|---|---|
| 1 | Foundation depth on structural drawings does not meet recommendations from soils report. | Complete a soils investigation, at the depth of the existing footings, to determine the actual bearing capacity before constructing more than 4 storeys. | 6-weeks |

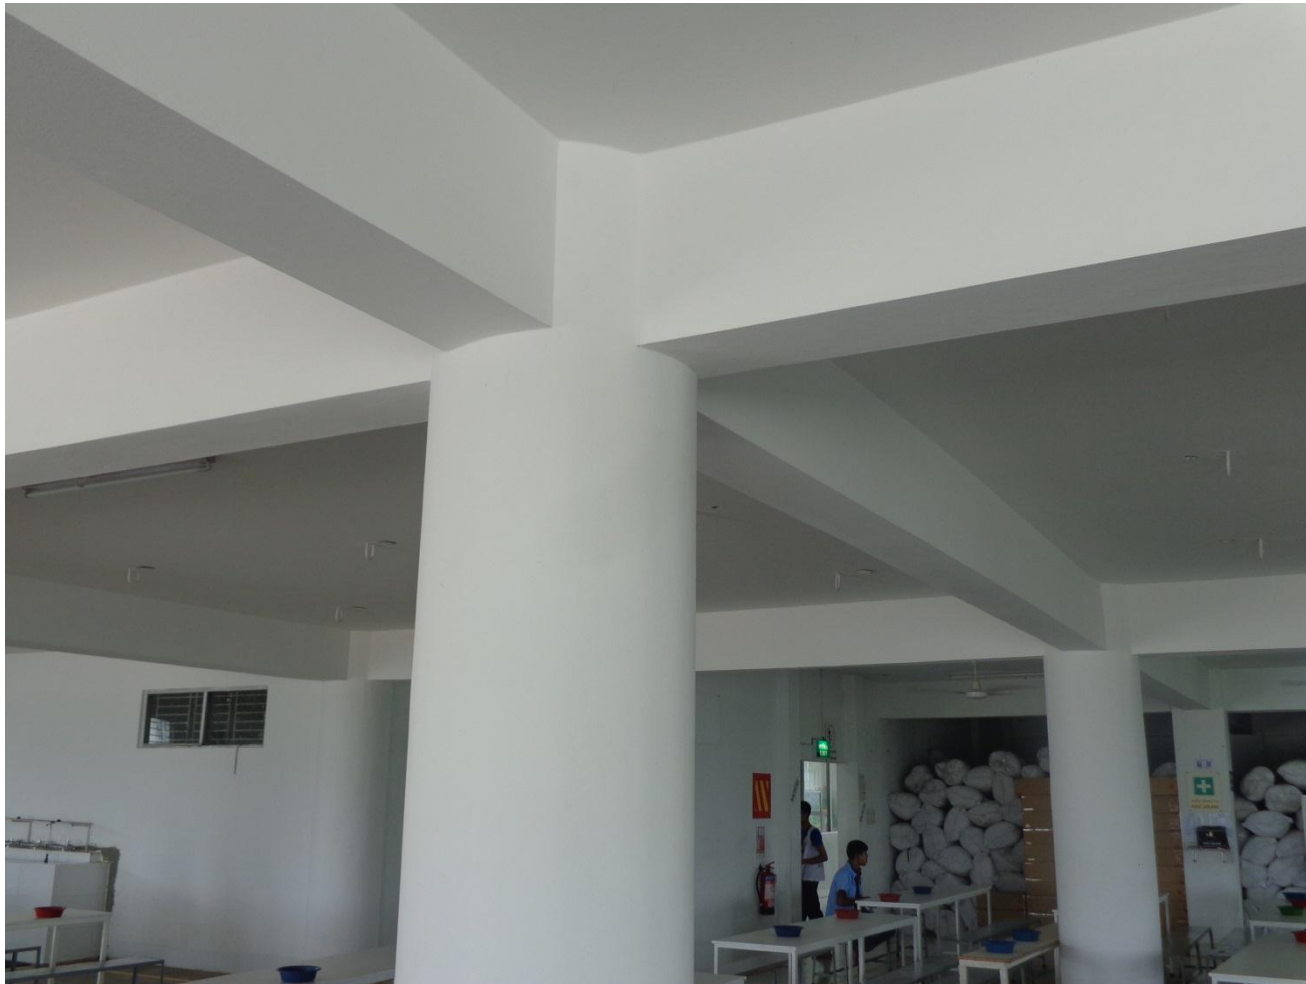
# Overall Stability System

The building did not feature any core or shear walls. Stability was achieved through sway action between beams and columns and masonry infill walls.

We require that these items be investigated in a Detail Engineering Assessment

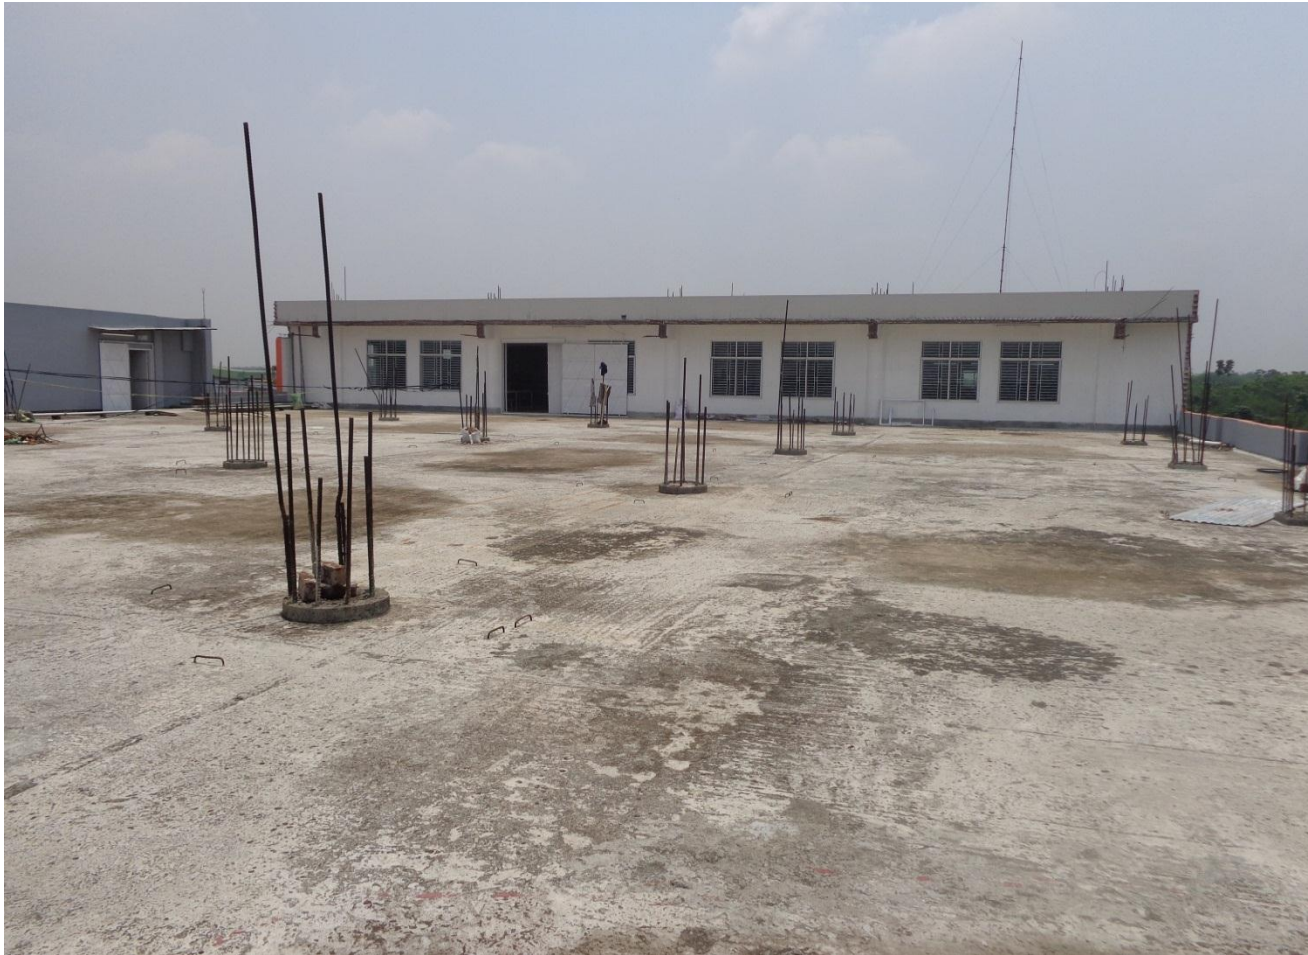
# Water Ingress at Roof Level

No waterproofing membrane was visible on the roof of the building. This means that any cracks in the surface finishes on the roof will allow water to seep into the concrete slab beneath the finishes, eventually causing corrosion of the reinforcing steel and deterioration of brick chip concrete.
