# Vintage Denim Limited (10196)

Gilarchala, Sreepur, Gazipur, Bangladesh

15.May.2014

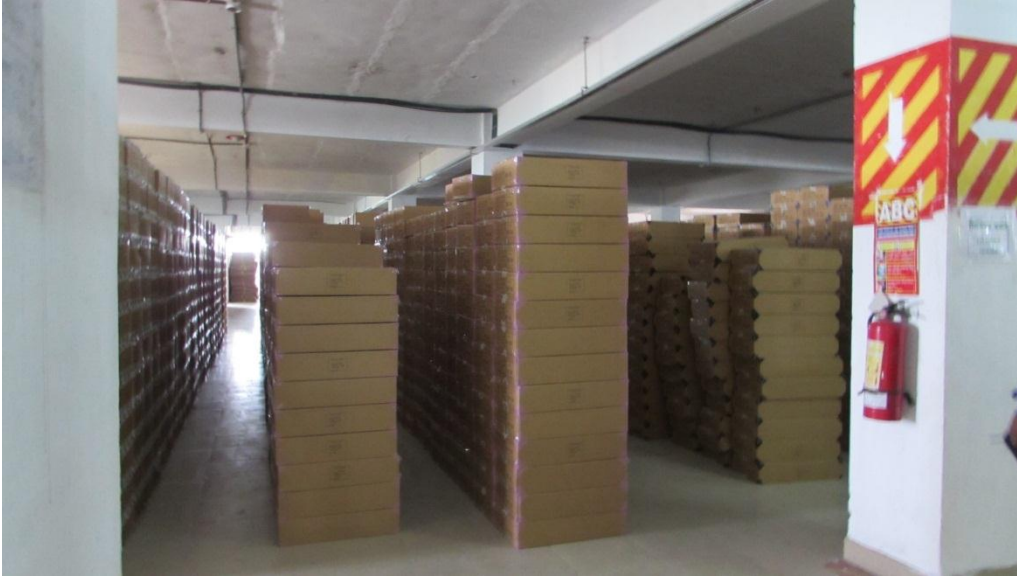
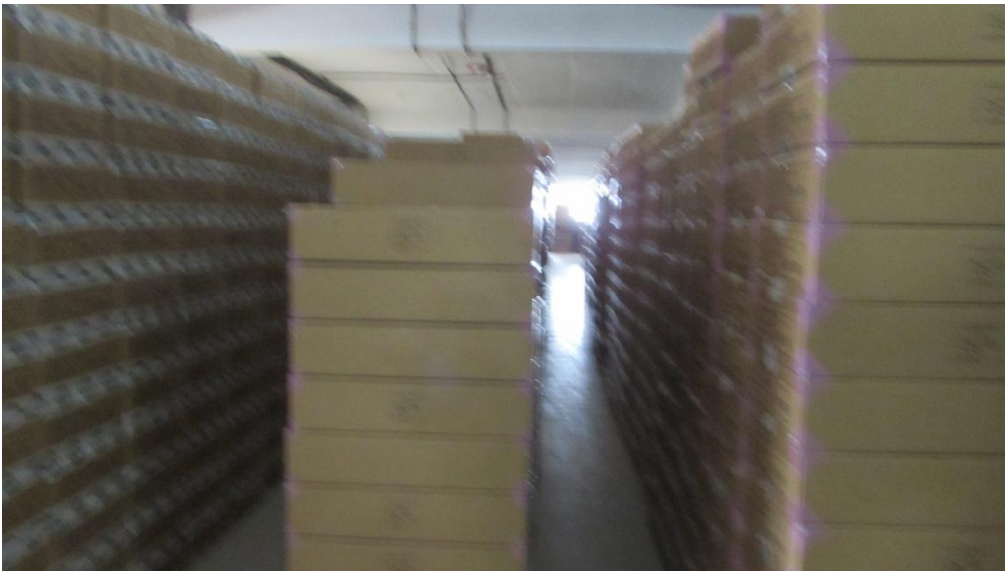
Each Box is estimated to have a maximum weight of approximately 7kg. As there are some **isolated** areas where these stacked 10 layers high, the total weight is about 70kg. (0.687kN) per stack. Although in general, the live load has not been exceeded, but if similar heavier boxes are stacked to a similar height, then it may cause overloading if not carefully controlled. The live load should ideally not exceed 3kPa.

**Potentially Slightly  
Excessive Storage Height  
on Level 3**

| Item No. | Observation | Recommended Action Plan | Recommended Timeline |
|---|---|---|---|
| 1 | Storage height of boxes in isolated locations exceeds the allowable live load limit. | Immediately reduce stacking height of box to ensure total load does not exceed 3.0kPa. | Immediate – Now |
| 2 | Storage height of boxes in isolated locations exceeds the allowable live load limit. | Mark the maximum allowable height of box stacking to ensure full compliance. | 6-weeks |

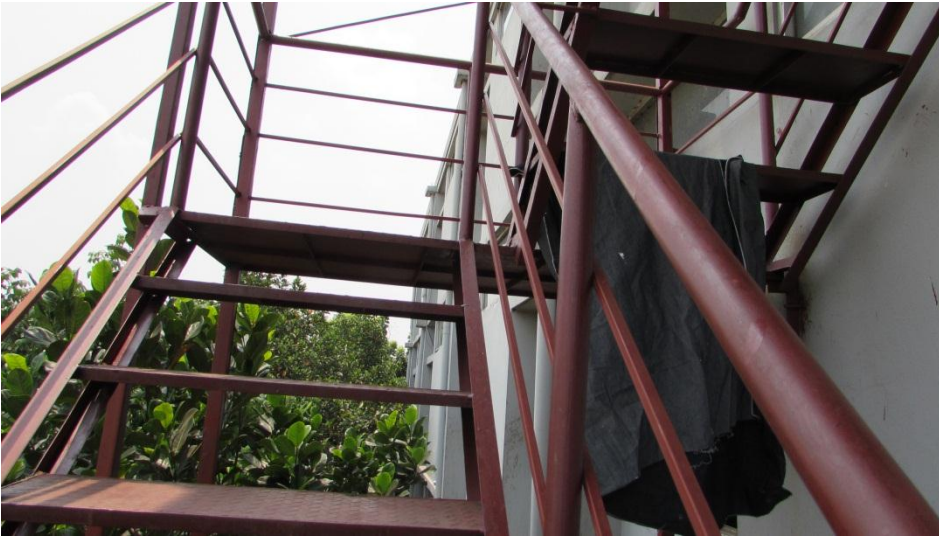
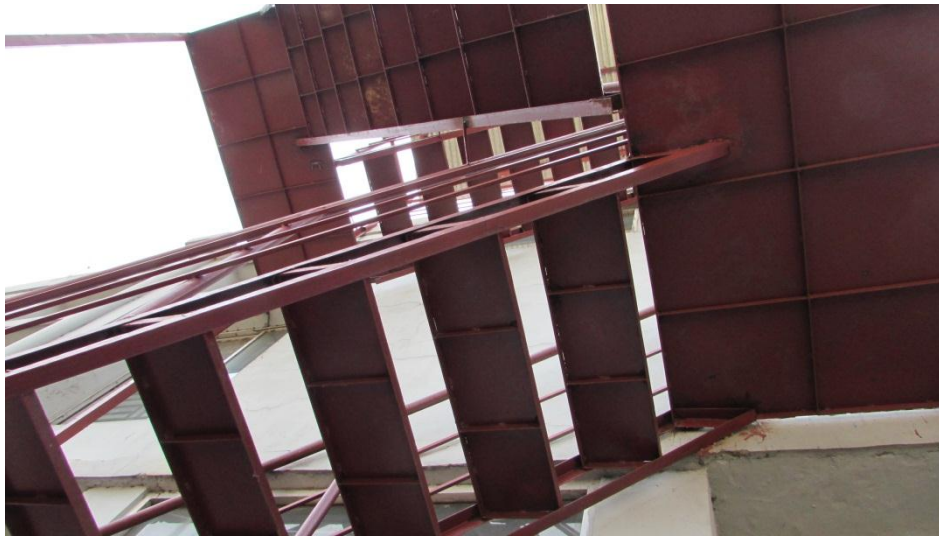
The staircase at the side of Building is meant to be a fire escape staircase. This means that there is a potential for crowds of people to use this stair in the event of emergency. However, the stair was built from very small steel members, and had not been properly galvanised, and therefore had rusted quite badly.. The structural stability of this staircase is questionable, and appears unsafe for its intended purpose

**Escape Staircase is in Poor Condition**

| Item No. | Observation | Recommended Action Plan | Recommended Timeline |
|---|---|---|---|
| 3 | Existing escape staircase at building is in very poor condition, and appears unsafe to satisfy emergency loading conditions. | Rehabilitate this staircase, using suitable corrosion-resistant materials, and designed by a Structural Engineer using exit loading as per BNBC. Based on discussion with owners, sufficient other emergency exits are available, so this stair may be closed until the repairs are made. | 6-weeks |

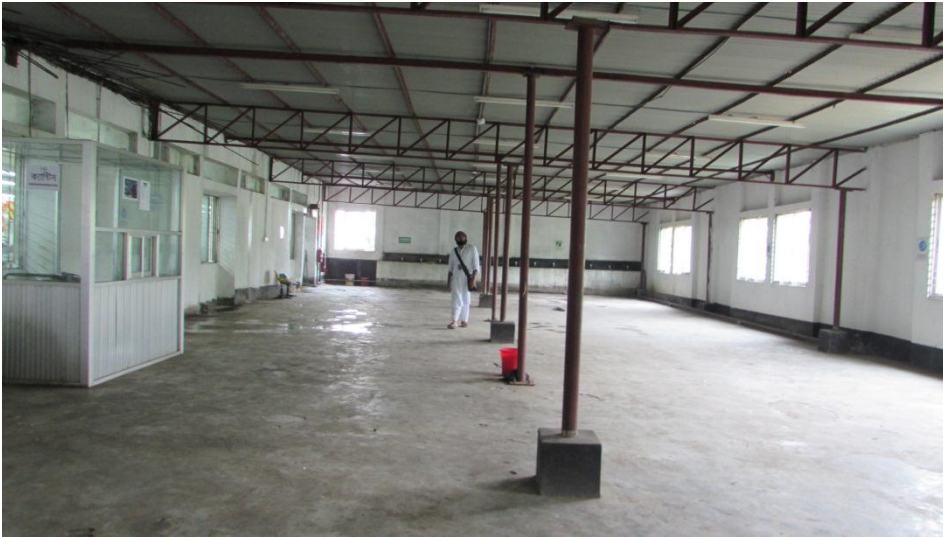
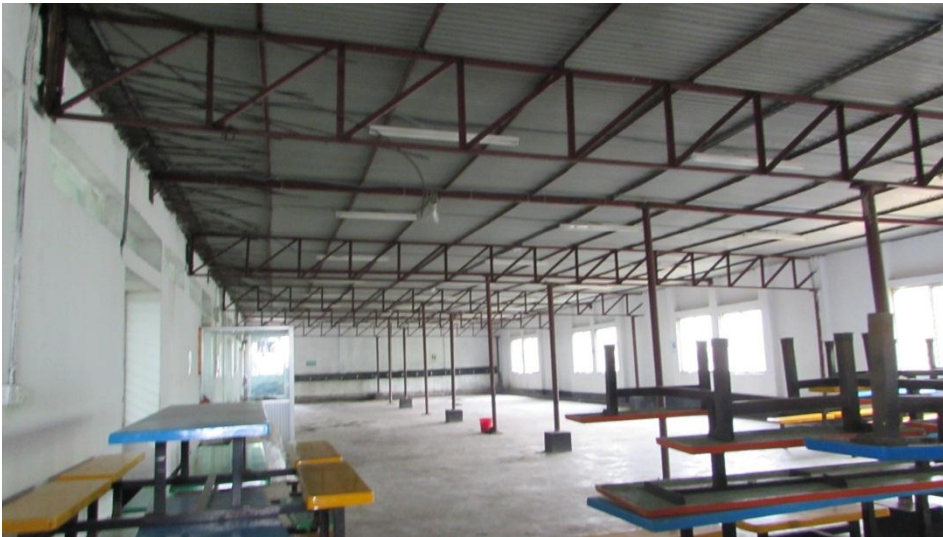
In Annex area, bracing has been omitted from the roof. No clear system to resist lateral loads (wind, seismic) as per BNBC is present.

**Bracing has been omitted from the roof in Annex area.**

| Item No. | Observation | Recommended Action Plan | Recommended Timeline |
|---|---|---|---|
| 4 | Bracing has been omitted from the roof in annex area. | Retain a Structural Engineer to perform a Detailed Engineering Assessment regarding the lateral stability of the roof structure and to design the remedial works. | 6-weeks |
| 5 | Bracing has been omitted from the roof in annex area. | Carry out the strengthening work to provide the bracing system. | 6-months |

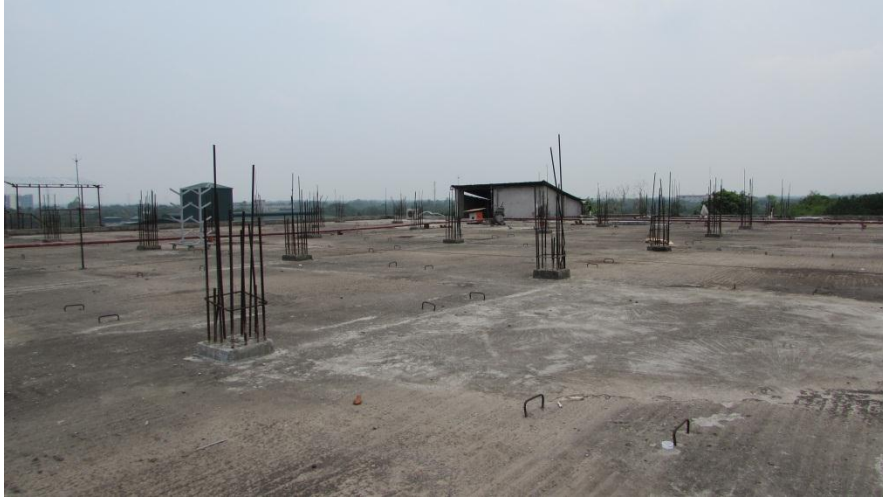
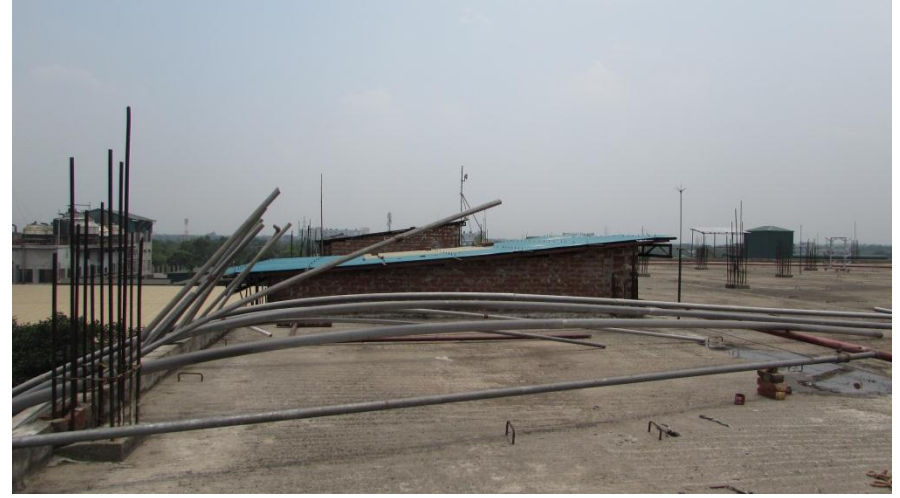
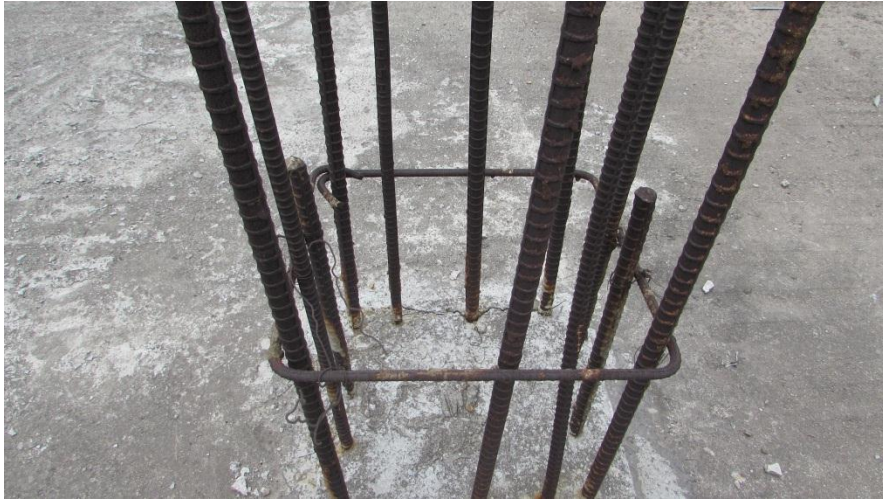
Base on discussion with owners, the plant will not build any more floors above the 4<sup>th</sup> floor . So long-term they need waterproofing for 4<sup>th</sup> floor.

**Waterproofing for 4th floor missing**

| Item No. | Observation | Recommended Action Plan | Recommended Timeline |
|---|---|---|---|
| 6 | Waterproofing for 4th floor. | Apply new proper waterproof membrane and screed on the roof floor | 6-months |
