# N.A.Z. Bangladesh Ltd. (10232)

5, Bishuya, Kuribari, Mirzapur, Gazipur, Bangladesh

15.MAY.2014

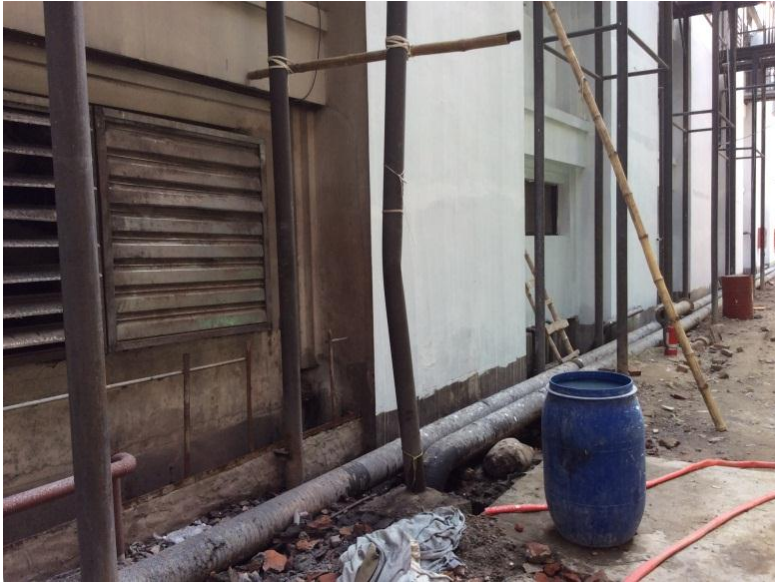
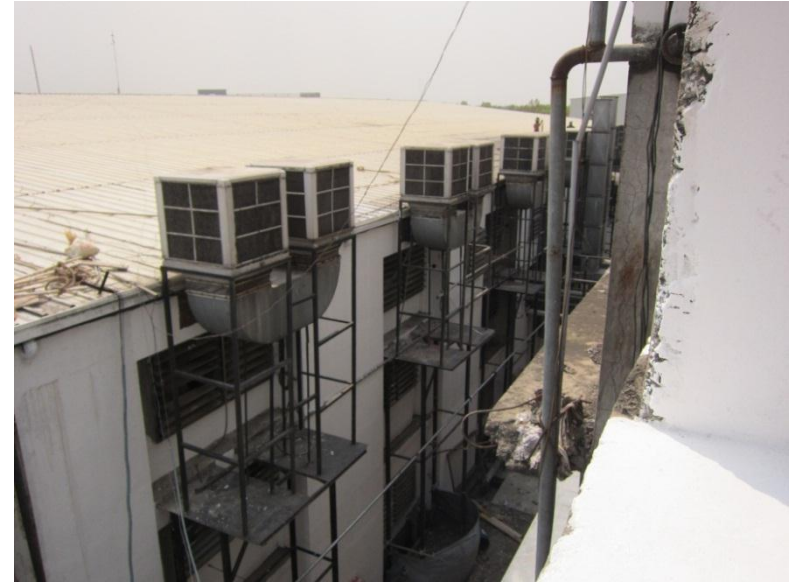
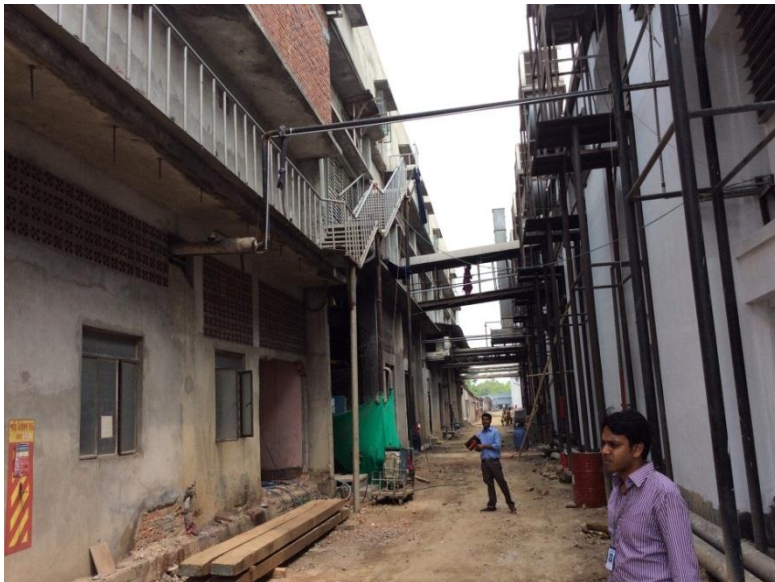
Steel column supporting the ventilation platform is buckled. The column should be replaced and a capacity check should be carried out.

| Item No. | Observation | Recommended Action Plan | Recommended Timeline |
|---|---|---|---|
| 1 | Capacity check for connecting bridge, slab supported heat exchanger, spiral staircase, customized steel racks and cantilevered beam. | Factory Engineer to review design, loads and columns stresses in area identified above.<br>A Detail Engineering Assessment of Factory to be commenced immediately in particular the stability and capacity of connecting bridge, slab supported heat exchanger, support of spiral staircase, customized steel racks and cantilevered beam. | Immediate – Now |

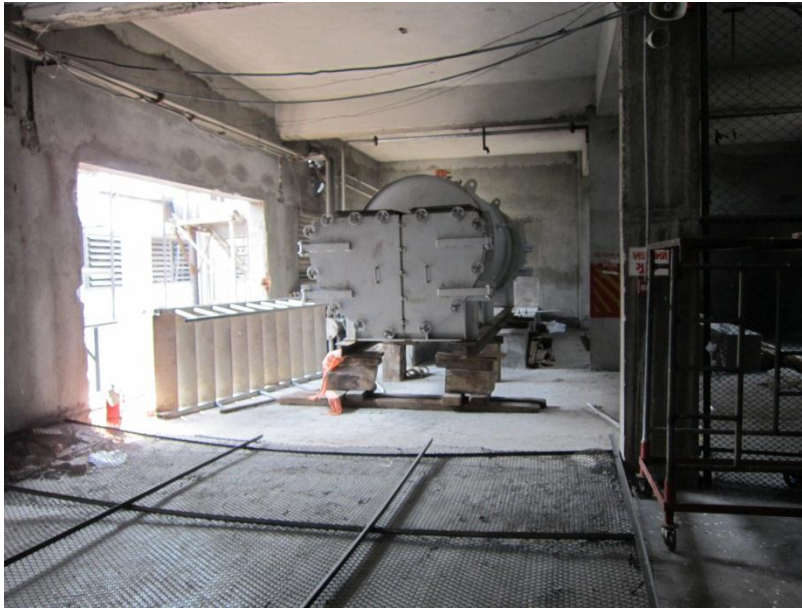
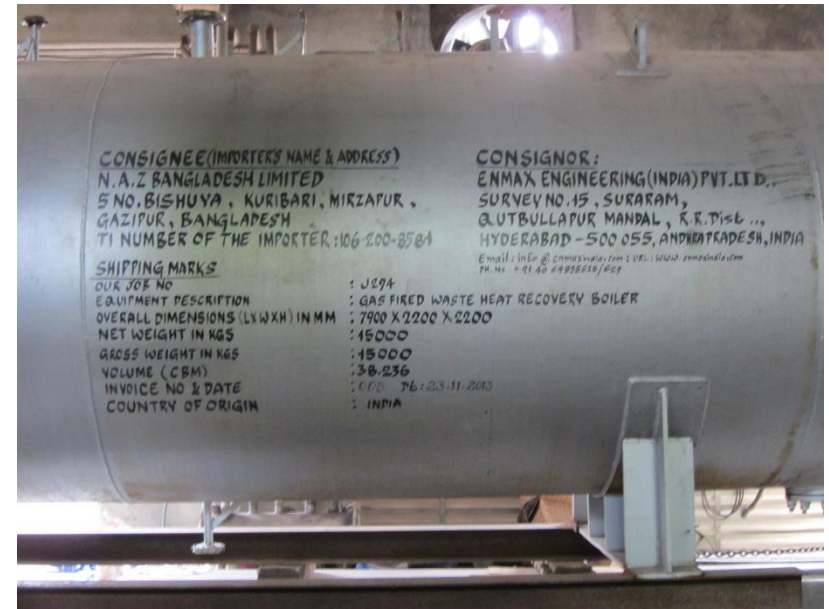
Two span of continuous 150 mm thick slab (5.50x6.50 m) is currently used for the new 15 tons heat exchanger on 1<sup>st</sup> floor of Utilities building. Capacity check should be carried out.

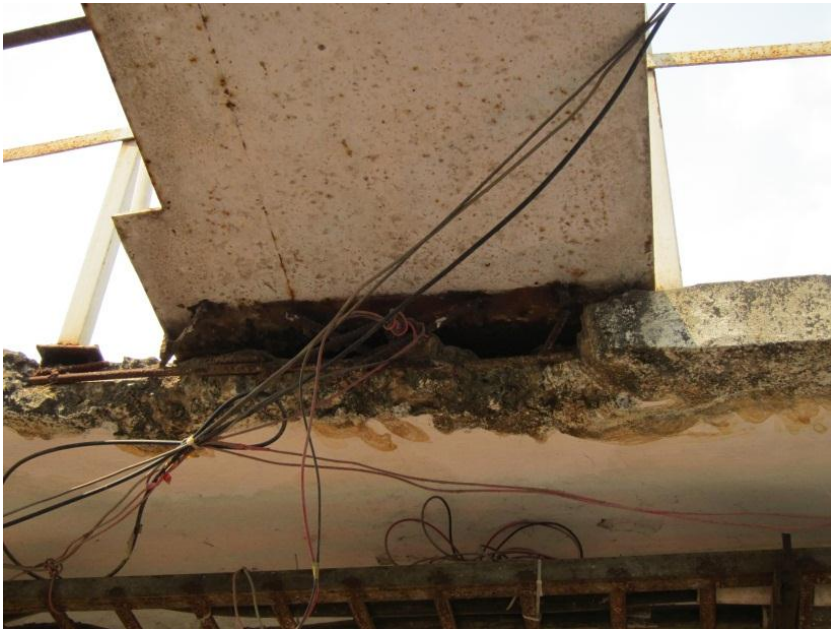
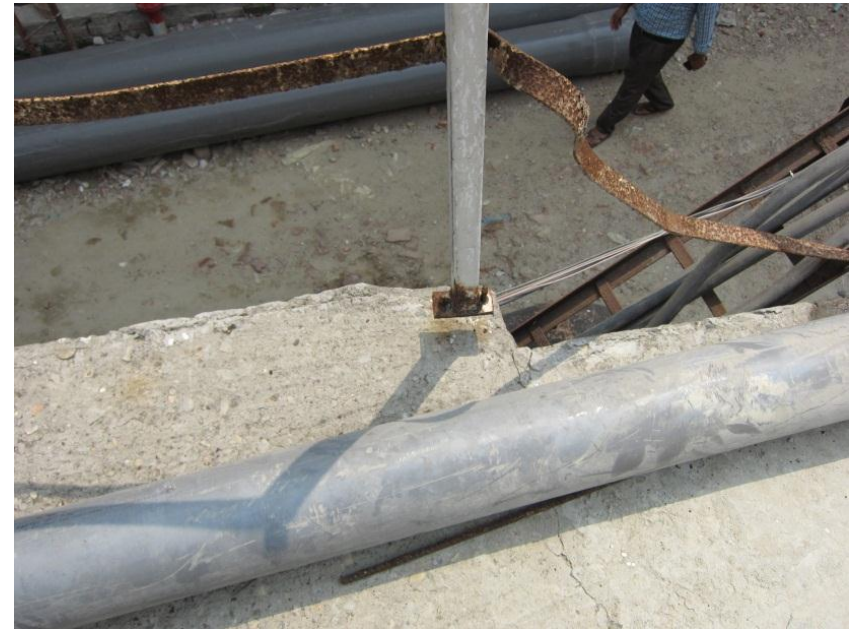
Steel connection of spiral staircase and balustrade of ETP are not attached to the reinforced concrete structure.

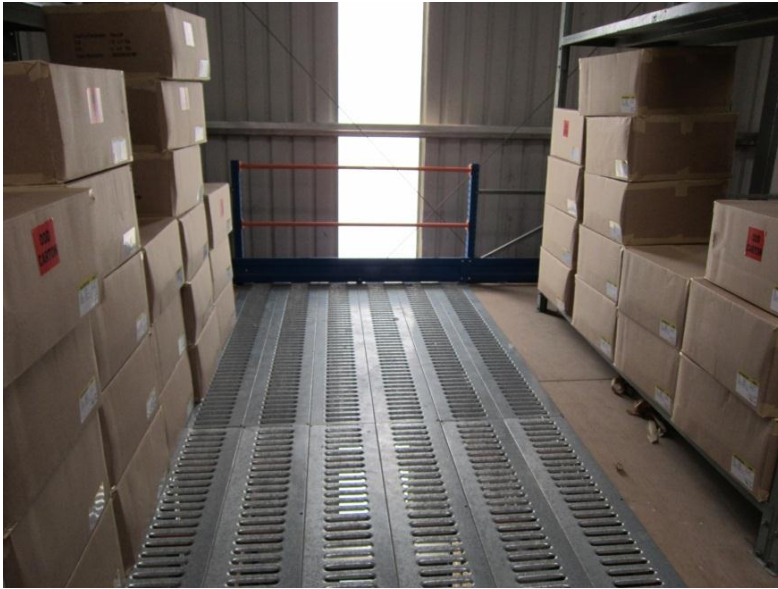
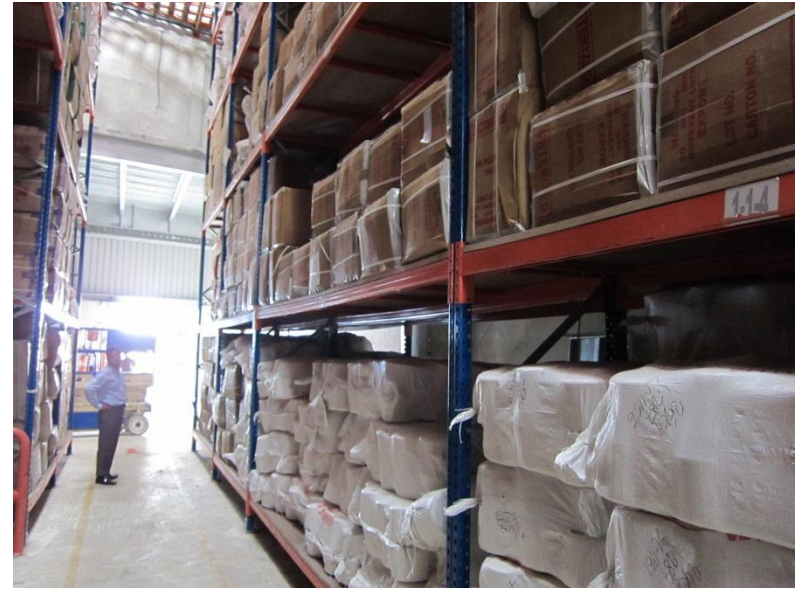
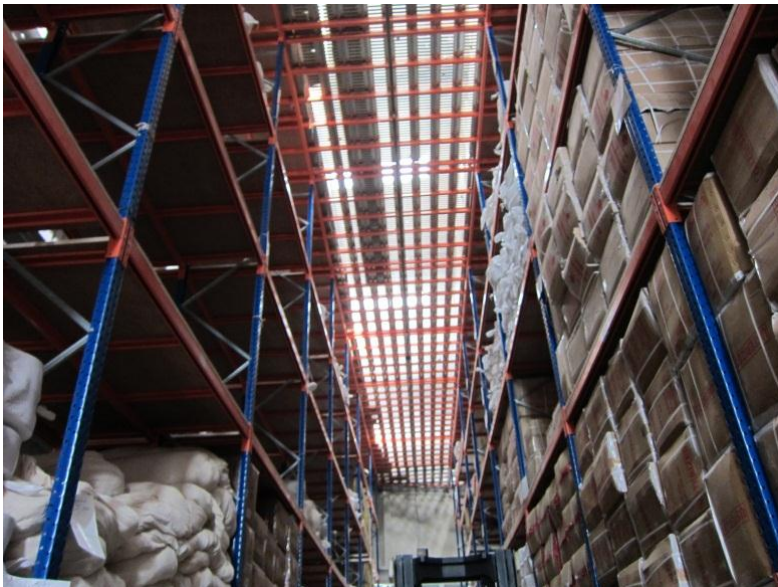
Customized steel racking system is used for storage with an upper platform over the entire area. Some horizontal frame are sagging. A capacity check should be carried out.

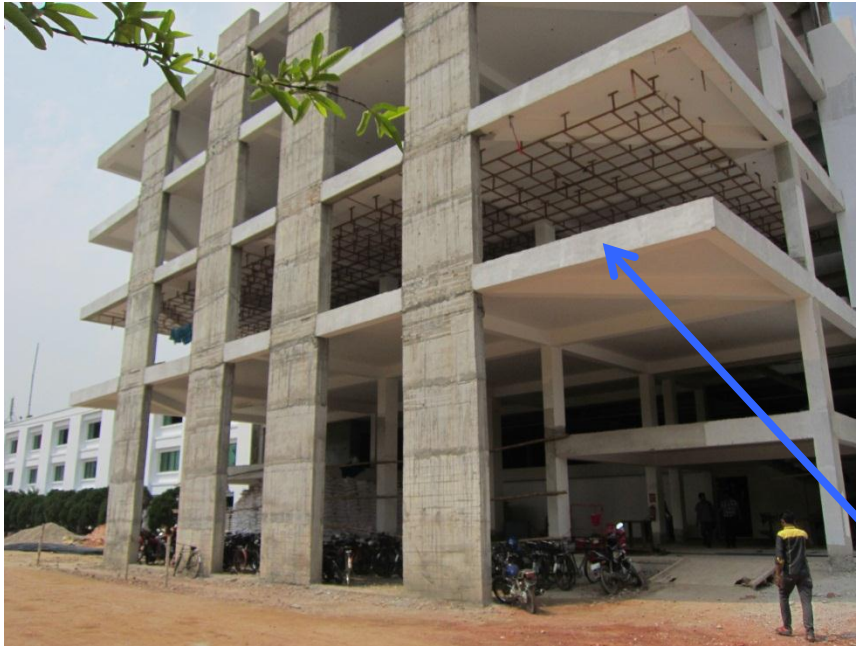
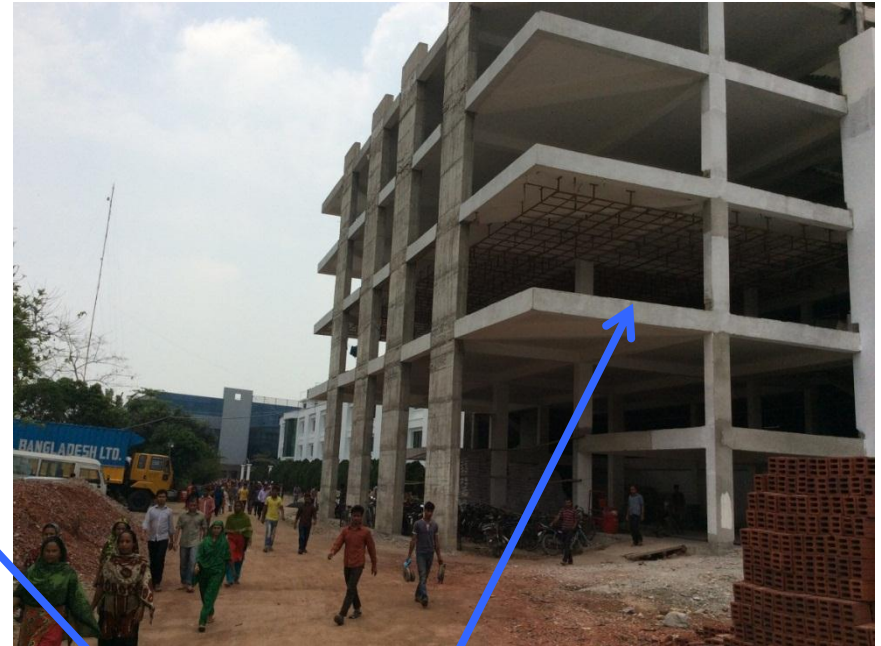
Capacity check of these beams should be carried out.

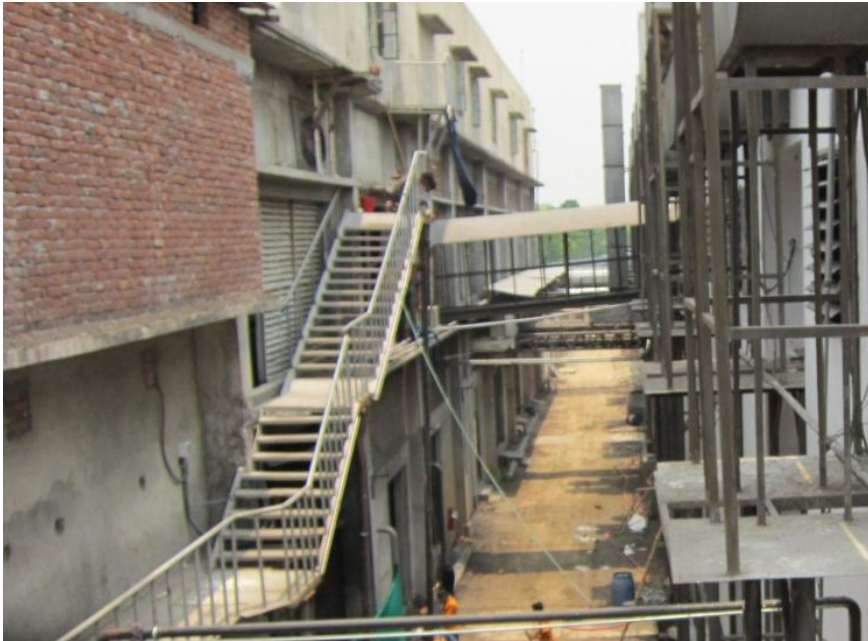
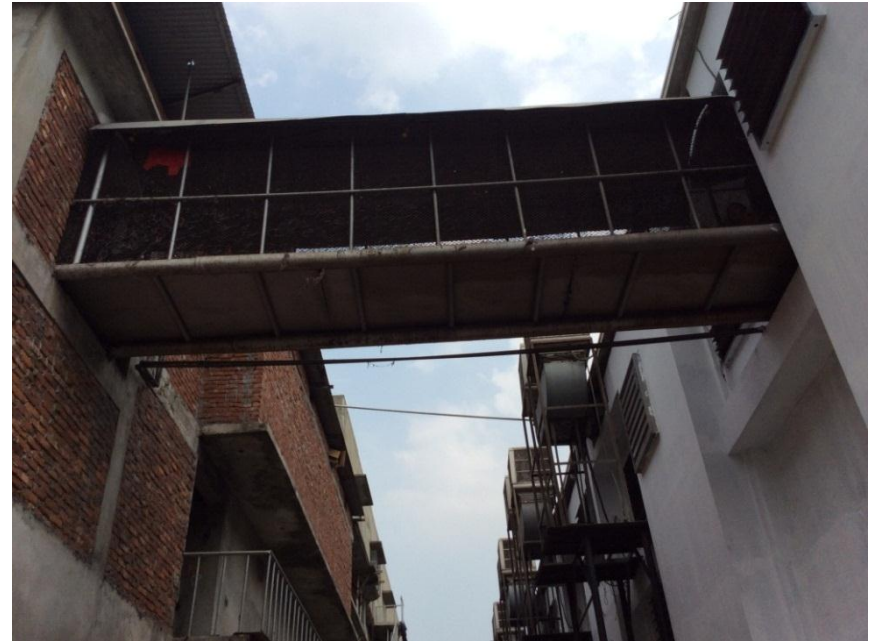
The drawings do not show any of steel staircase, ventilation platform and connecting bridge.

| Item No. | Observation | Recommended Action Plan | Recommended Timeline |
|---|---|---|---|
| 4 | Inconsistencies between drawings and actual as-built condition. | Factory Engineer to survey the actual conditions and revise the drawings.<br>Factory Engineer to review design, loads and columns stresses to confirm suitability for loads applied.<br>Produce and actively manage a loading plan for all floor plates within this area giving consideration to floor capacity and column capacity. | 6-weeks |

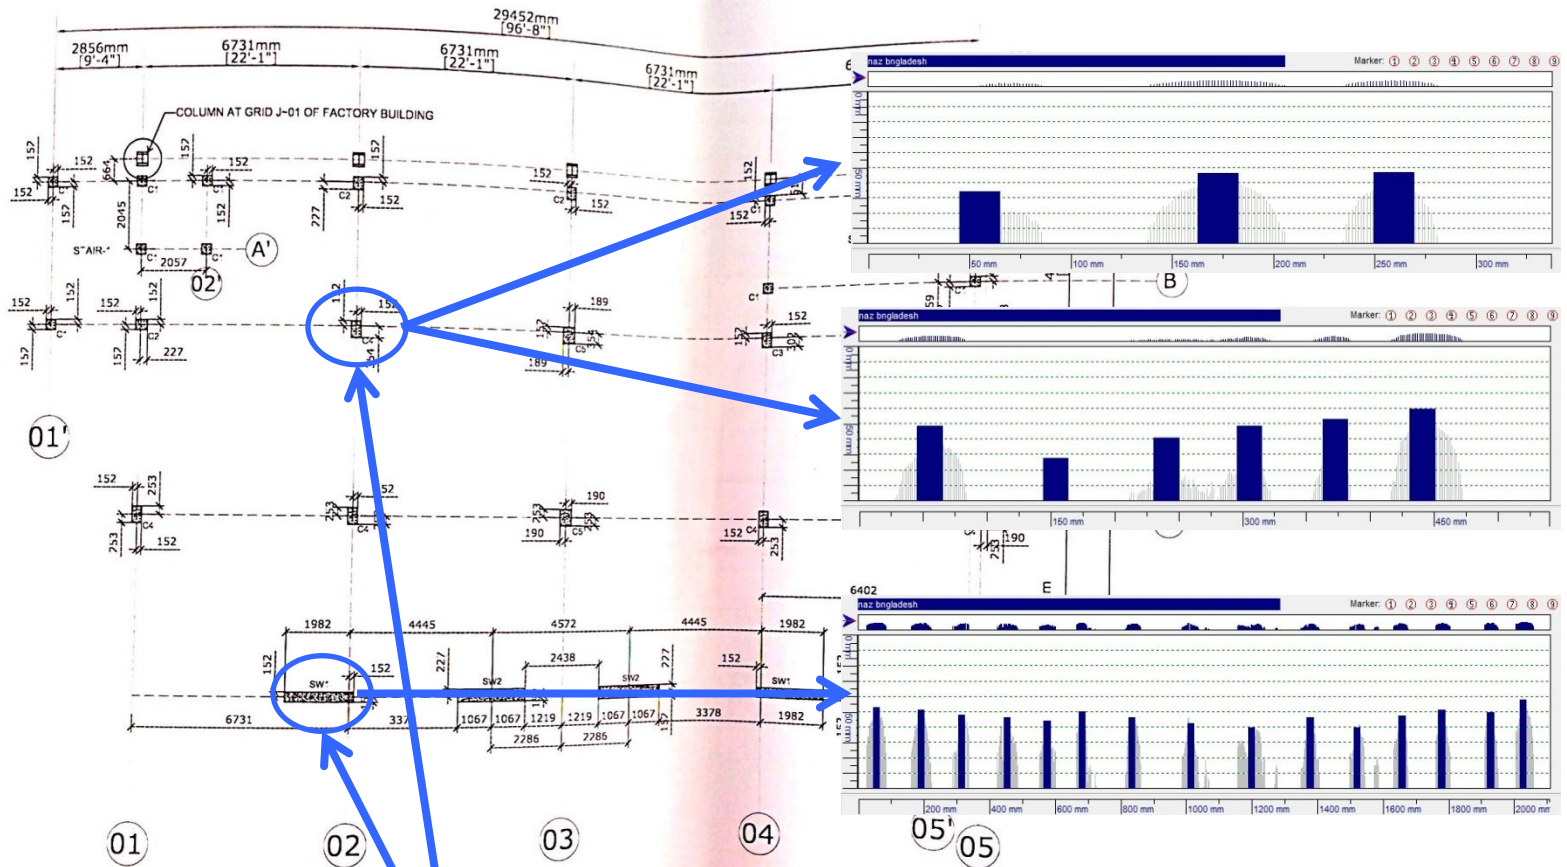
The no. of reinforcement of C4 and SW1 are less than what are shown in the drawing.

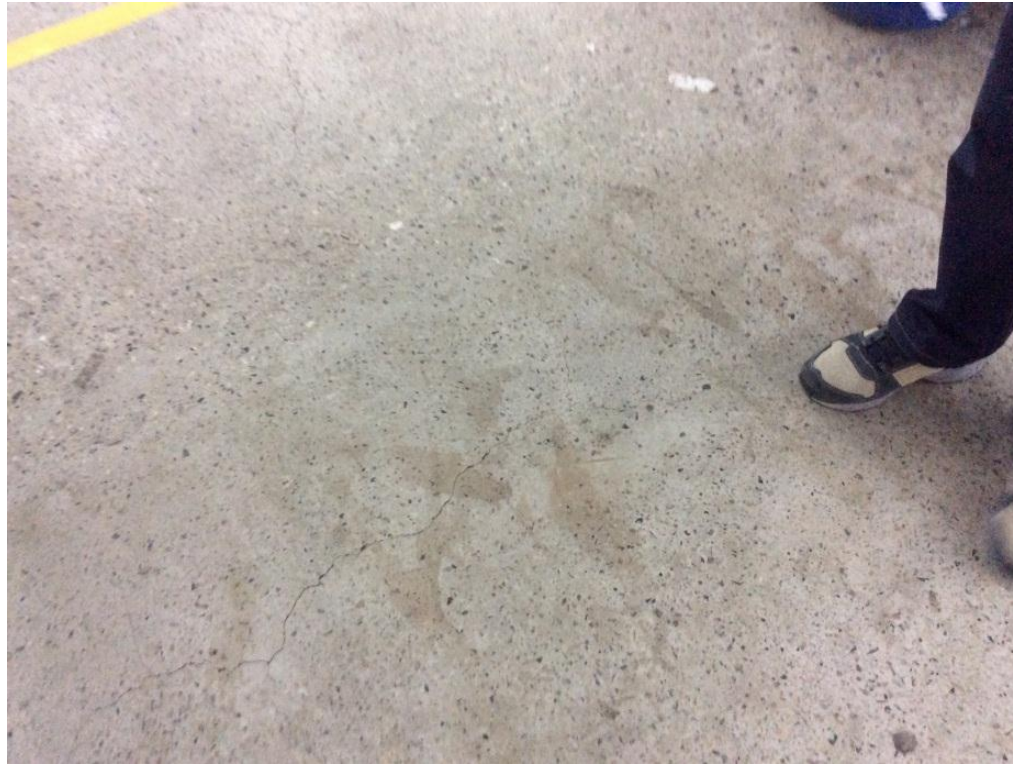
Cracks appeared on the 1<sup>st</sup> floor slab of Main building. It is unclear whether construction joint is properly established.

| Item No. | Observation | Recommended Action Plan | Recommended Timeline |
|---|---|---|---|
| 6 | Cracks appeared on floor slab. | A Detailed Engineering Assessment of this area to be carried out.<br>The distress found is recommended to be repaired. Repair by simply re-rendering is not suitable. | 6-weeks |

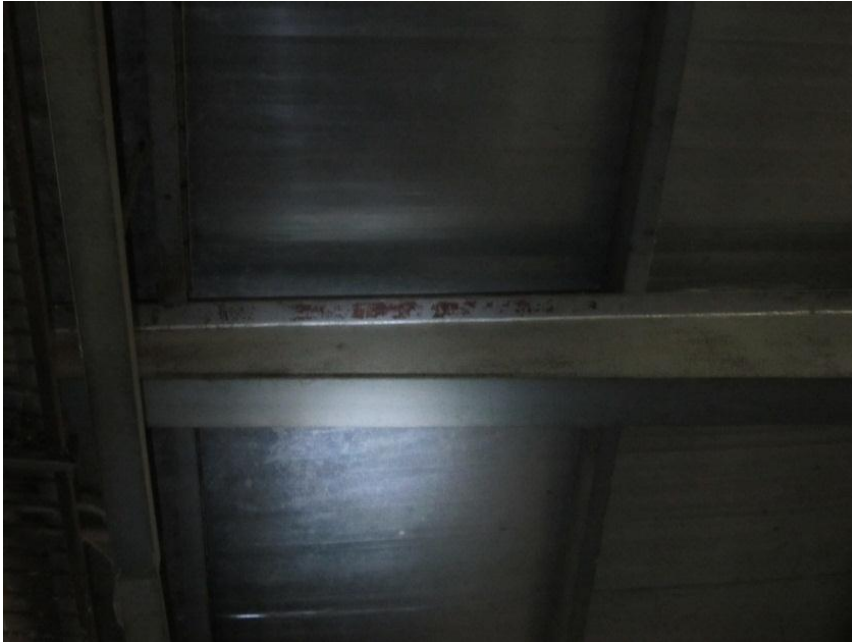
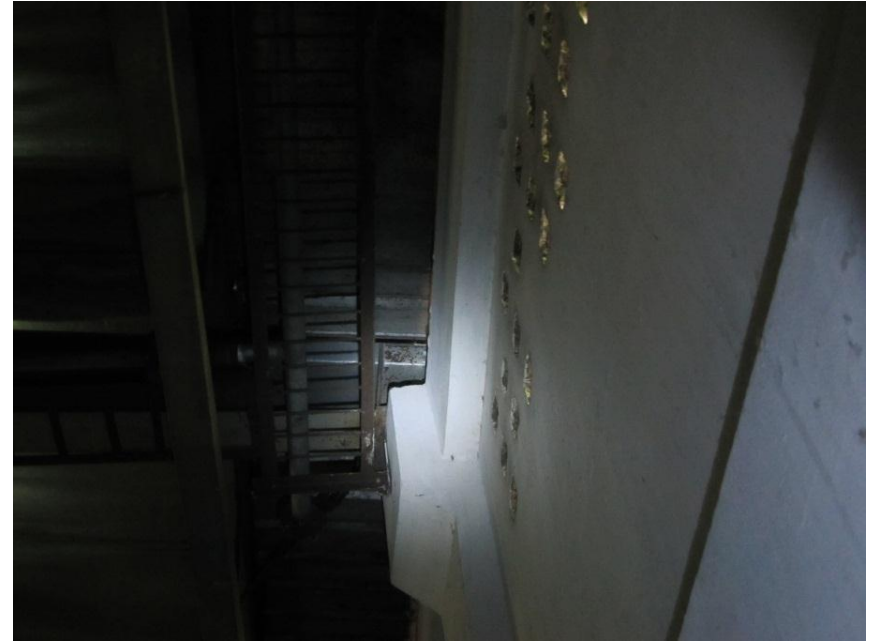
There are corrosions on steel roof frame at warehouse building. Maintenance/repair should be carried out.

| Item No. | Observation | Recommended Action Plan | Recommended Timeline |
|---|---|---|---|
| 8 | Corrosion of steel roof frame. | The distress found is to be suitably repaired and the cause rectified. Repair by simply re-rendering is not suitable. | 6-weeks |
| 9 | Corrosion of steel roof frame. | Maintain standards of quality control to ensure that all rust is removed and rust-proof paint is applied so that problems do not arise in the future. | 6-months |

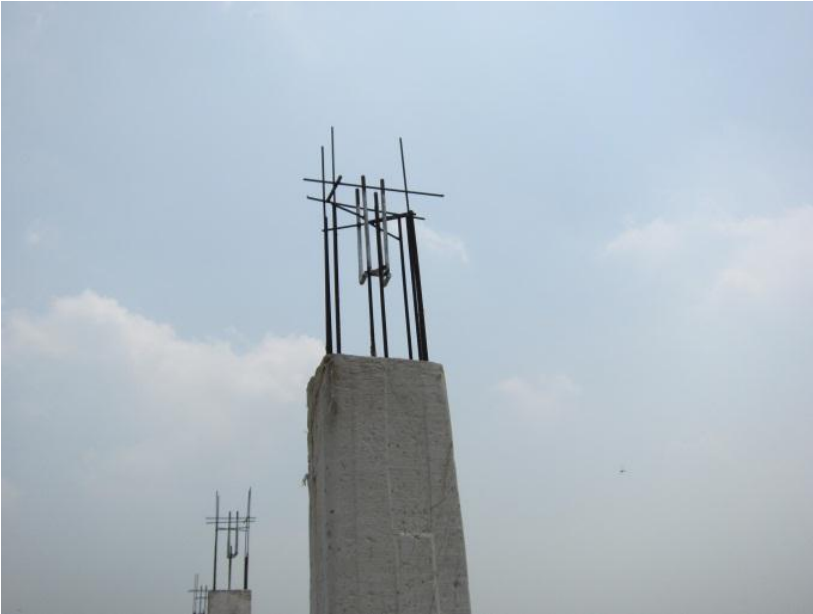
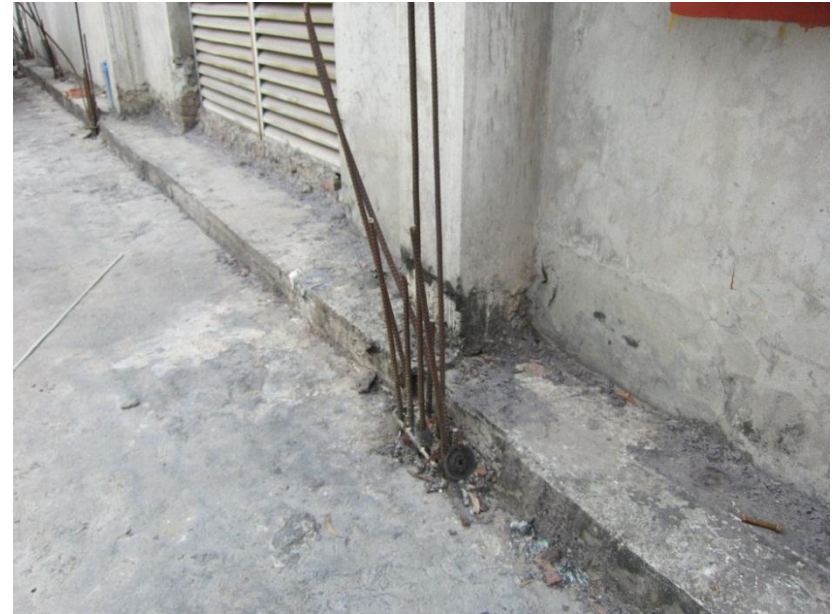
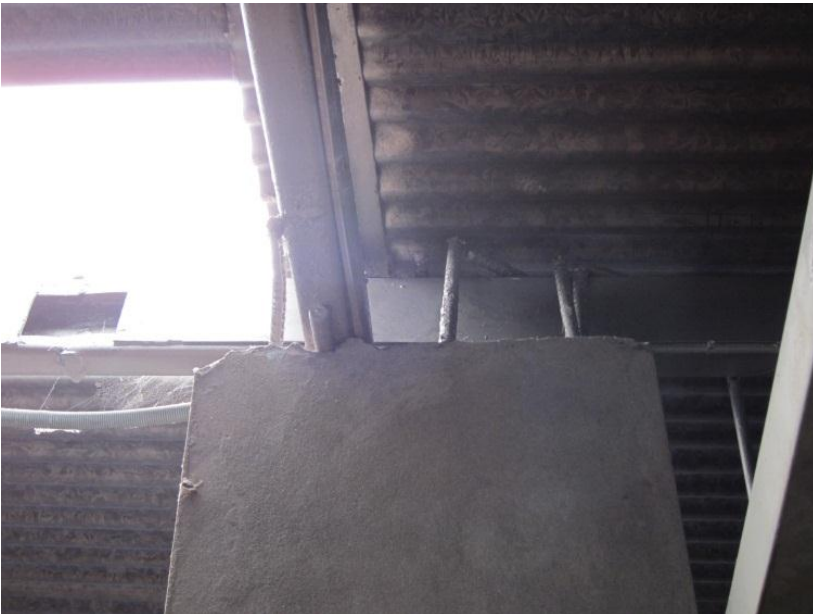
Steel reinforcement are left exposed on the top of reinforced concrete column. It is unclear whether rust-proof paint is applied.

| Item No. | Observation | Recommended Action Plan | Recommended Timeline |
|---|---|---|---|
| 11 | Reinforcement left exposed | Rust-proof paint to be applied for the exposed steel reinforcement. | 6-months |

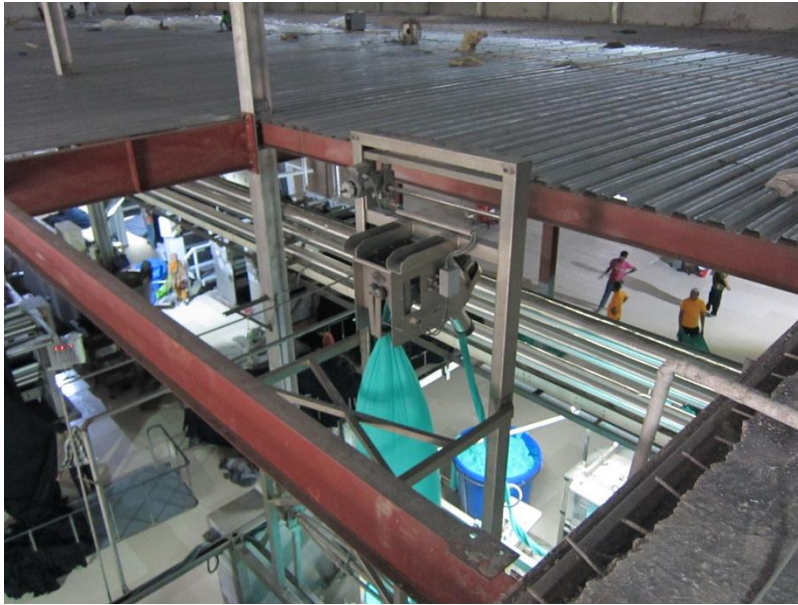
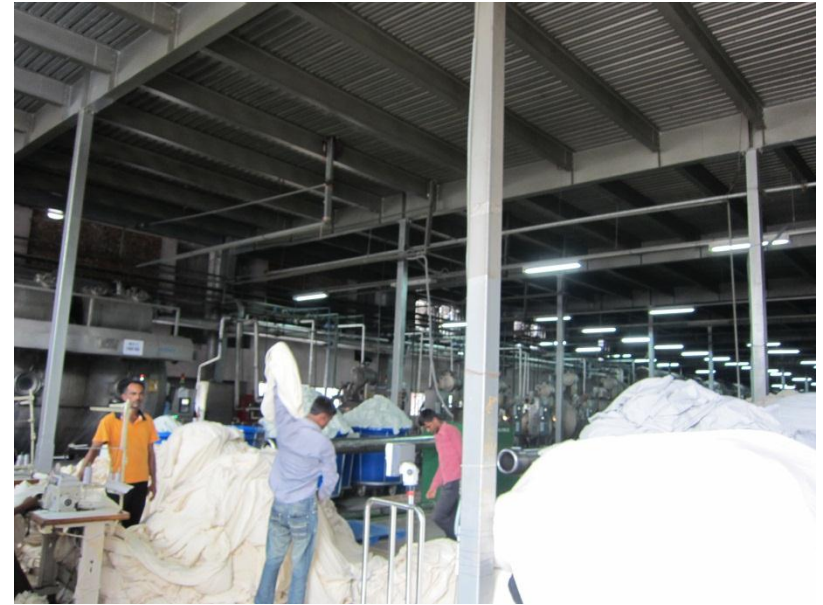
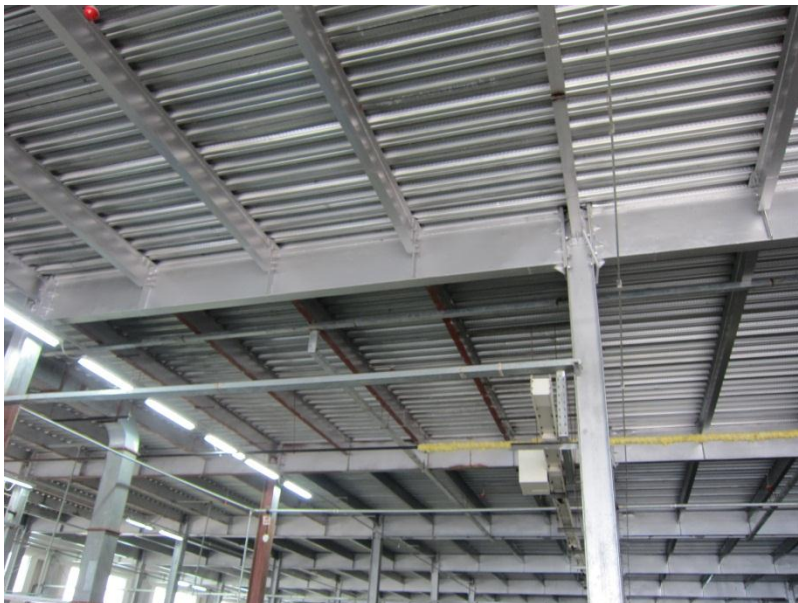
No fireproofing material is applied to the steel structure of the Main building.

| Item No. | Observation | Recommended Action Plan | Recommended Timeline |
|---|---|---|---|
| 12 | Fireproof paint for steel structure. | Fireproofing material for structural steel element needs to be applied (if required based on the provision of BNBC Codes).<br>Maintain standard of quality control. | 6-months |

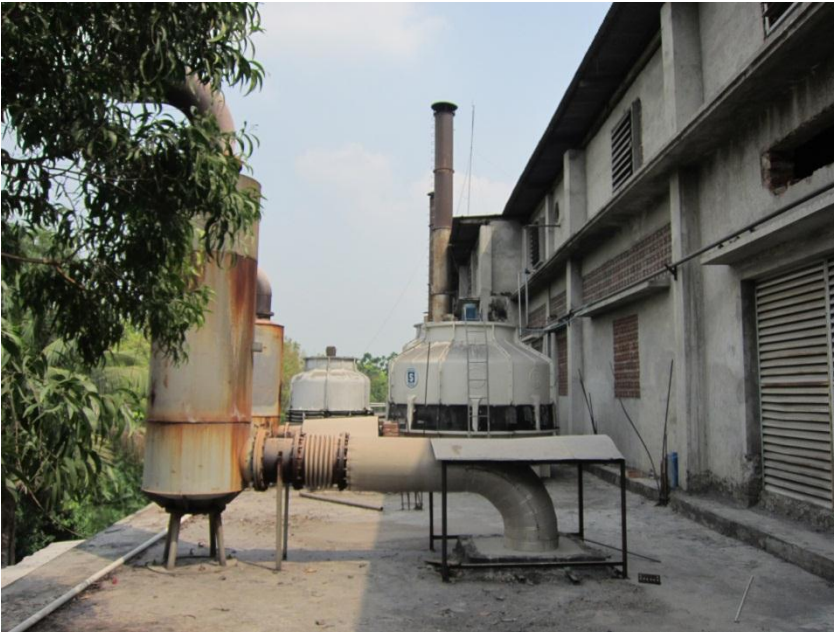
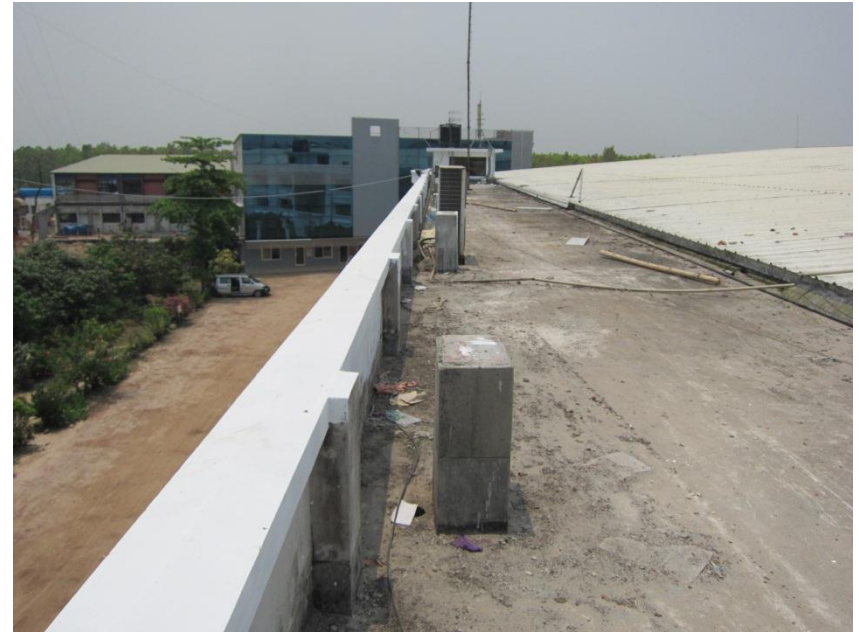
There is no distress of water ingress noted on the roof slab. But, it is unclear whether waterproofing material is applied.

| Item No. | Observation | Recommended Action Plan | Recommended Timeline |
|---|---|---|---|
| 14 | Water proofing material to be applied/maintained. | Engineer to inspect water damaged structure including the exterior and propose a suitable repair.<br>For both durability and serviceability, waterproofing on the roof slab is recommended. Moreover the roof slab drainage system should be investigated. | 6-months |

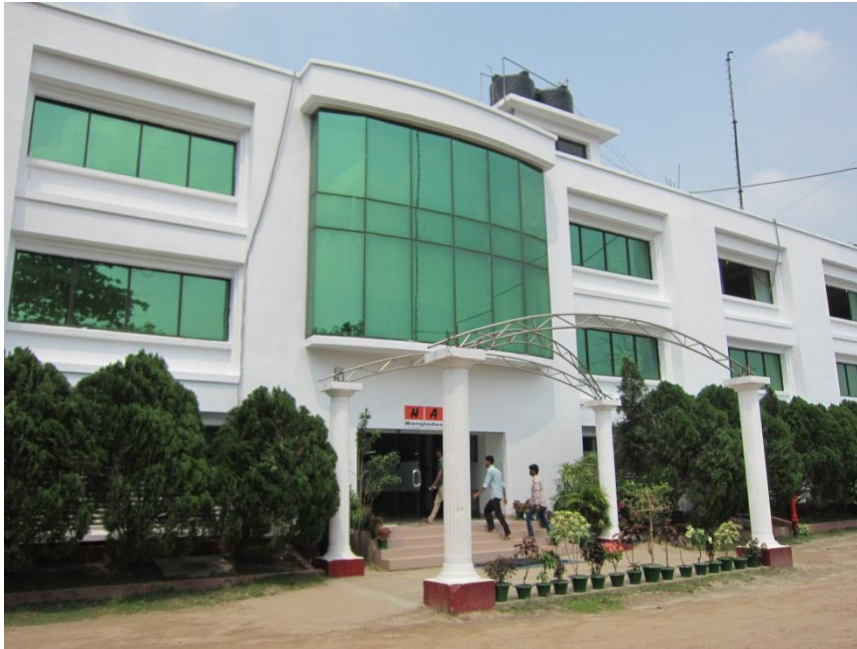
Concerns on the stability system for lateral loading, façade brickwork walls lack of moment capacity in the connections between columns and beams, especially at the joint connection of steel structure.

We require that these items be investigated in a Detail Engineering Assessment.

| Item No. | Observation | Recommended Action Plan | Recommended Timeline |
|---|---|---|---|
| 10 | Overall stability system. | Request that the Detail Engineering Assessment of the overall building to be carried out and in particular, stability and foundation aspects should be investigated in detail. | 6-weeks |

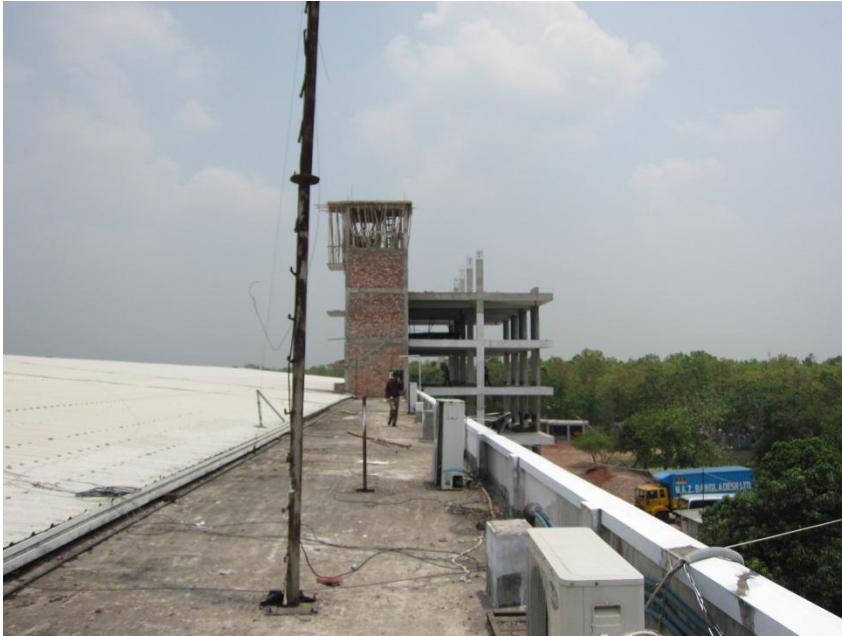
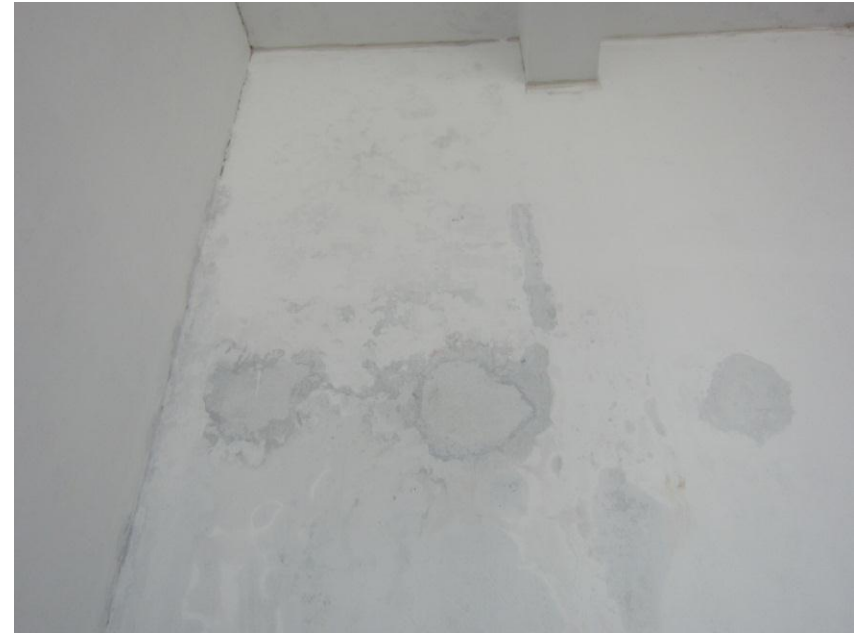
There is no distress due water ingress noted at roof top of each building. But it is still appeared on masonry wall at staircase hall of Utilities building.

| Item No. | Observation | Recommended Action Plan | Recommended Timeline |
|---|---|---|---|
| 13 | Water ingress at masonry wall. | Engineer to inspect water damaged structure and propose a suitable repair. | 6-months |
