# **FIRE SAFETY INSPECTION REPORT**

**Factory Name: Caesar Apparels Ltd - New**

**ACCORD ID: 12657**

**Date: 18th December, 2016**

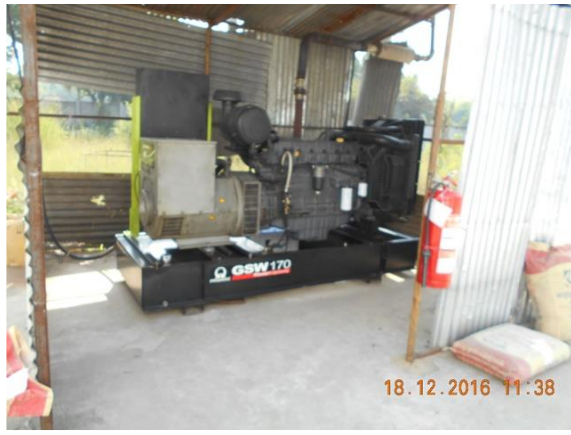
| Sl No. | Category | Findings | Required Action | Remediation Time Frame | Pictorial Evidence |
|---|---|---|---|---|---|
| 1 | Fire Rated Construction | The generator room is not separated by fire rated construction (openings, non-rated doors, penetrations) Specify location: in front of main gate of the building. | Separate the generator room by a minimum 2-hr fire-rated construction. Seal and/or protect all openings to maintain the required fire separations. Provide proper ventilation and consult a qualified engineer. | Within 3 months | 18.12.2016 11:38 |

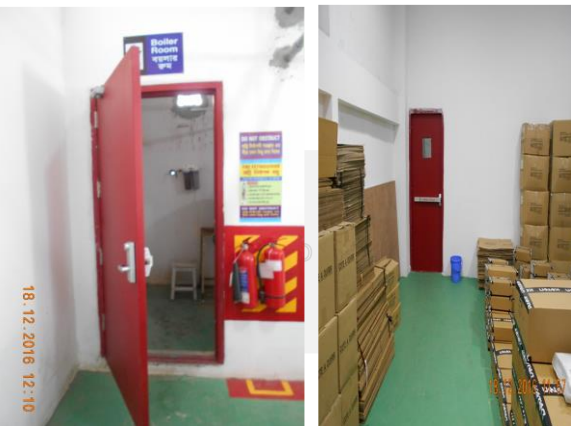
| Sl No. | Category | Findings | Required Action | Remediation Time Frame | Pictorial Evidence |
|---|---|---|---|---|---|
| 2 | Fire Rated Construction | Proper certification was not available for fire rated doors installed in the factory for storage & boiler room. | Submit proper certifications for installed fire doors to the ACCORD for verification. If not available, or certification is not approved, install new, properly certified fire rated doors in accordance with ACCORD direction. | Immediate | 18.12.2016 12:10 |

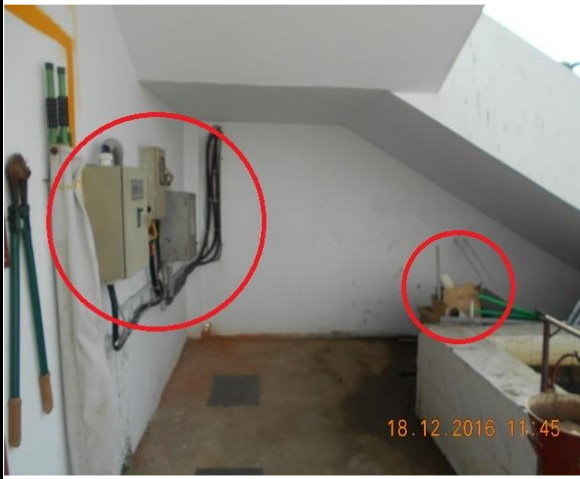
| Sl No. | Category | Findings | Required Action | Remediation Time Frame | Pictorial Evidence |
|---|---|---|---|---|---|
| 3 | Fire Rated Construction | Electrical panels were located in the exit stair enclosure. | Remove and re-locate all electrical panels from exit stair enclosures. | Within 3 months | A photograph of an exit stair enclosure. Two electrical panels are mounted on the wall, circled in red. A timestamp '18.12.2016 11:45' is visible in the bottom right corner. |

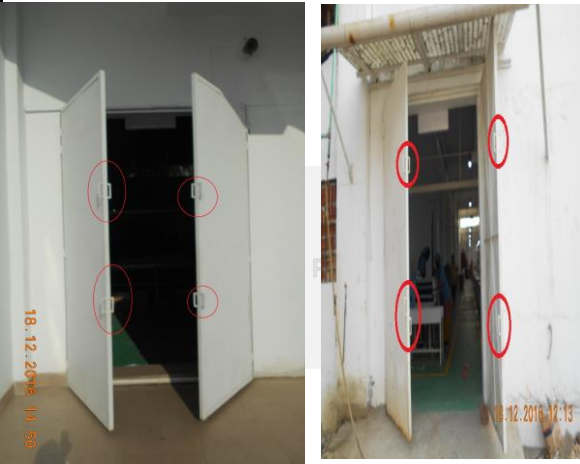
| Sl No. | Category | Findings | Required Action | Remediation Time Frame | Pictorial Evidence |
|---|---|---|---|---|---|
| 4 | Egress | Egress doors and gates with locking features are provided at building exits, exit stairs, along egress routes and exit discharge on all floors. All doors and gates were open and unlocked during inspection. | Remove locking features from all egress doors and gates. If locks are required for security reasons, utilize special door locking features complying with ACCORD standard 6.8.2. | Immediate | Two photographs showing egress doors. The left photo shows two white doors with locking features circled in red. The right photo shows a doorway with locking features circled in red. Both photos have timestamps: '18.12.2016 11:50' and '18.12.2016 12:13' respectively. |

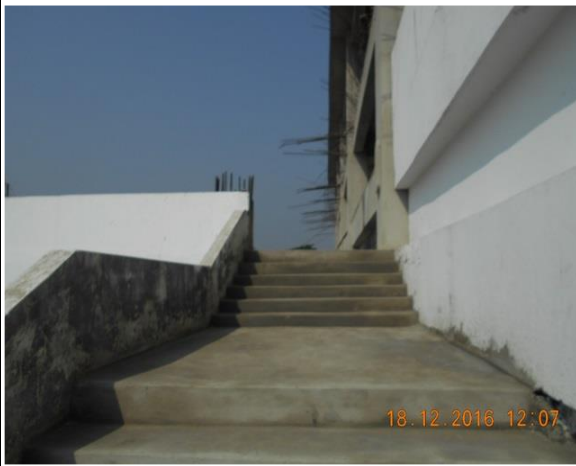
| Sl No. | Category | Findings | Required Action | Remediation Time Frame | Pictorial Evidence |
|---|---|---|---|---|---|
| 5 | Egress | Handrails are not provided on both sides of the exit stair on all floors. | Provide handrails on both sides of the exit stair. New handrails shall have a minimum height of 865 mm (34 in.) and a maximum height of 965 mm (38 in.) as measured from the leading edge of the tread. Intermediate handrails shall be provided when the stair width exceeds 2.2 m (87 in.) . | Within 3 months | |

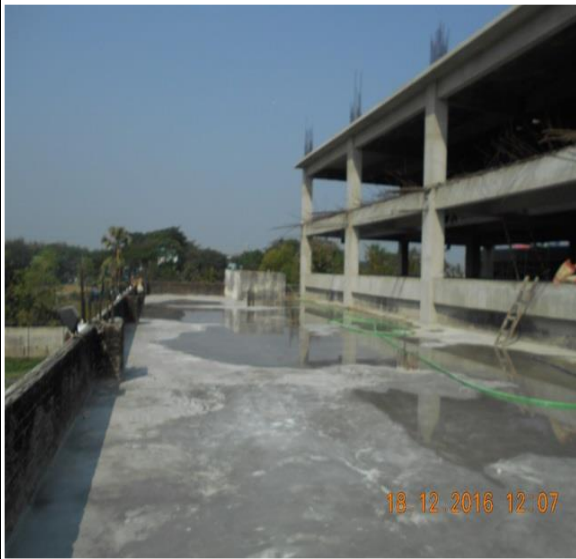
| Sl No. | Category | Findings | Required Action | Remediation Time Frame | Pictorial Evidence |
|---|---|---|---|---|---|
| 6 | Roof | Parapets or guards are not provided in occupied roof.<br>OR<br>Parapets or guards are provided in occupied roof which is less than 1067mm (42 inch.).<br>Parapets or guards are not provided in occupied roof.<br>OR<br>Parapets or guards are provided in occupied roof which is less than 1067mm (42 inch.). | Provide parapets or guards with a minimum height of 1067mm (42 inch.). | Within 3 months | |

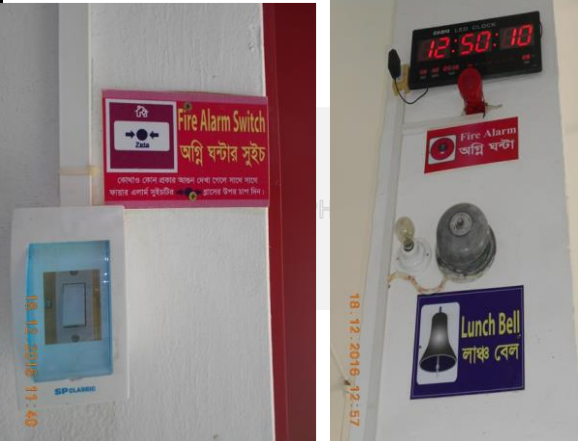
| Sl No. | Category | Findings | Required Action | Remediation Time Frame | Pictorial Evidence |
|---|---|---|---|---|---|
| 8 | Fire Detection & Protection | The fire alarm system is antiquated, not a listed system and does not provide alarm and notification features consistent with acceptable standards. | Replace the fire alarm system with a new, listed automatic fire alarm system in accordance with NFPA 72 and ACCORD standards. | Design within 4 months, install within 9 months | |

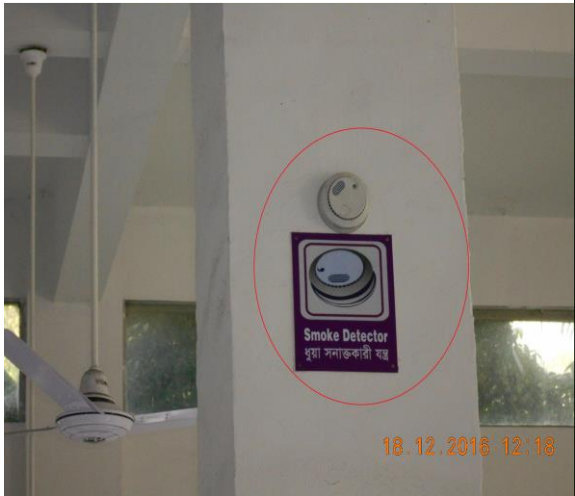
| Sl No. | Category | Findings | Required Action | Remediation Time Frame | Pictorial Evidence |
|---|---|---|---|---|---|
| 10 | Fire Detection & Protection | The building is equipped with single-station smoke alarms. Smoke alarm activation sounds only a local alarm and does not provide automatic fire alarm notification of occupants. | Remove single-station smoke alarms. Provide automatic smoke detection throughout the building, tied into the fire alarm system, in accordance with NFPA 72 and ACCORD standards. | Within 9 months | |
