FIRE SAFETY INSPECTION REPORT

Century Apparels Ltd - Unit 2

ACCORD ID: 12654

Fire Safety Inspection Report

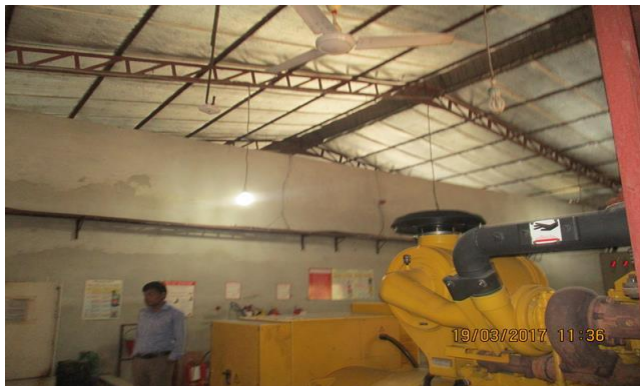
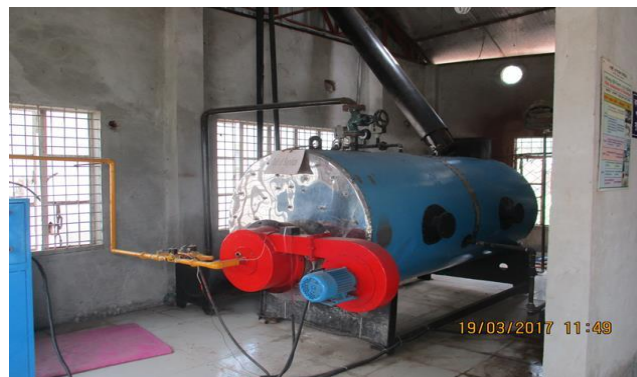
Sl No.	Category	Findings	Required Action	Remediation Time Frame
F-1	Fire Rated Construction	Production area is not separated from adjacent utility facilities (Boiler, Generator & sub-station) at Shed-01 & Shed-02.	Separate the Generator & Sub-station facilities from production area by 2-hr. fire rated construction & boiler room by 1-hr. fire rated construction. Seal all penetrations and openings (door, window etc.) should be protected by 1.5-hr fire rated materials to maintain the fire separation for generator & sub-station room & 0.75 hr. fire rated materials to maintain the fire separation for boiler room if required. All exhaust systems shall discharge to the exterior of the building in a safe location.	Within 3 months

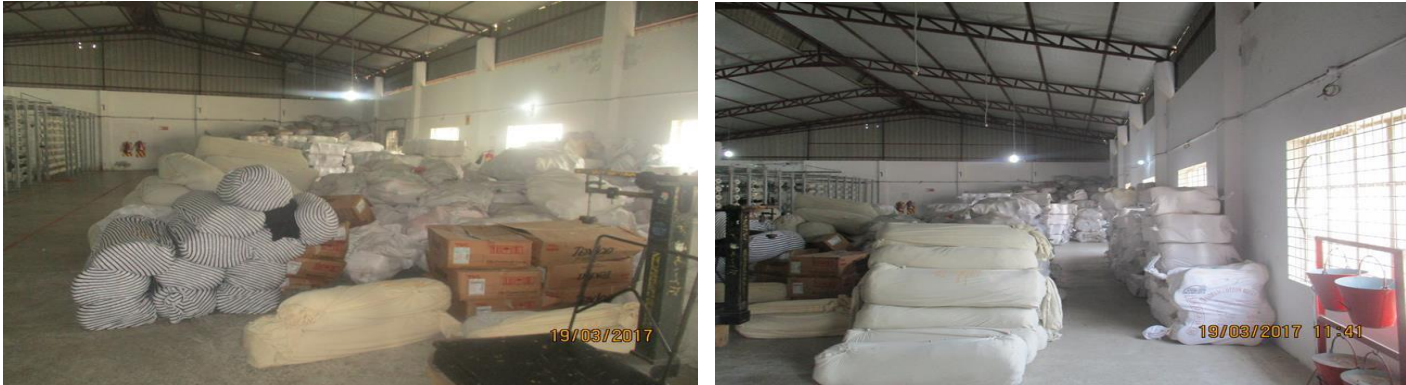
SI No.	Category	Findings	Required Action	Remediation Time Frame
F-2	Fire Rated Construction	Areas used for in-process storage of combustible materials are open to surrounding production area at North side of Shed-01.	<p>Provide defined storage areas and limit the storage arrangement as follows:-</p> <ol style="list-style-type: none"> 1. General Condition: Maximum height of 2.4m and maximum area of 23m². Separate areas of unenclosed combustible storage by a minimum clear distance of 3m. 2. If sprinkler protected: maximum height of 3.66m and maximum area of 93m². Separate areas of unenclosed combustible storage by a minimum clear distance of 3m. or 3. Enclose the storage area from the surrounding occupancy with a minimum 1 hour construction. 	Within 1 month

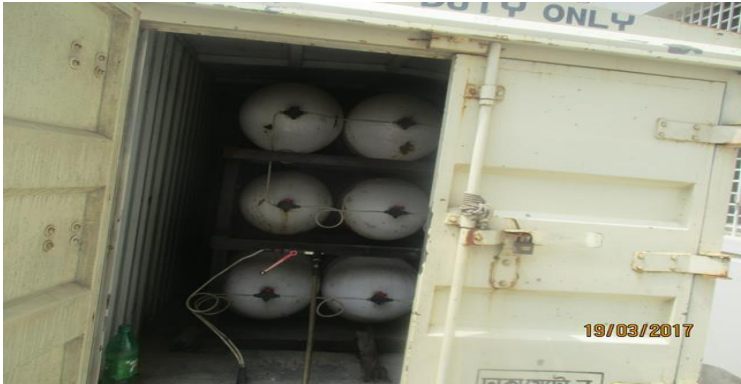
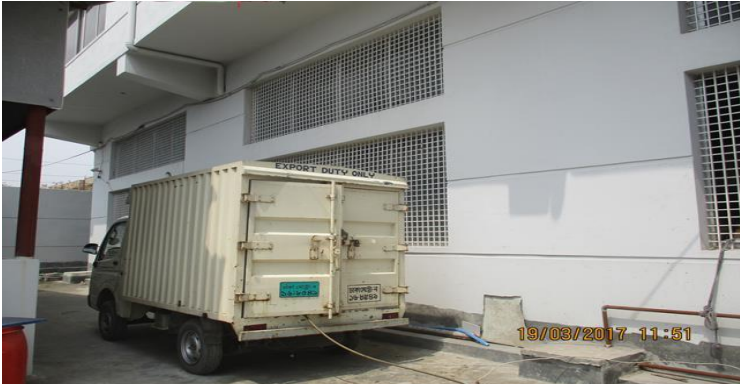
F-3	Fire Rated Construction	CNG cylinders storage area is not separated by fire-rated construction & was open to exit discharge path of Shed-04 (Dining Shed).	Separate the CNG Cylinder storage by providing a dedicated storage facilities with 2-hr fire rated construction. Seal all penetrations and protect the openings to maintain the required fire separations.	Within 1 month

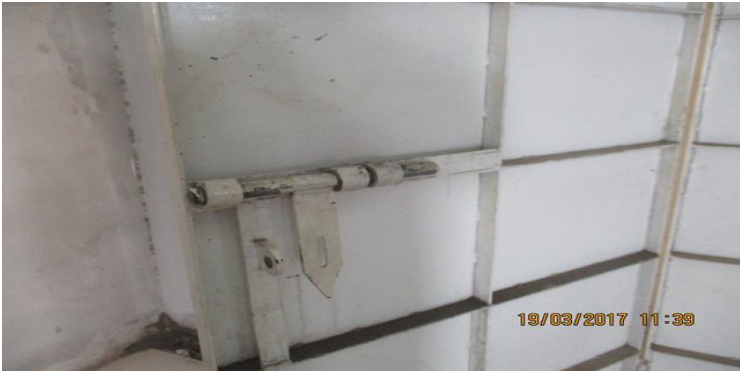
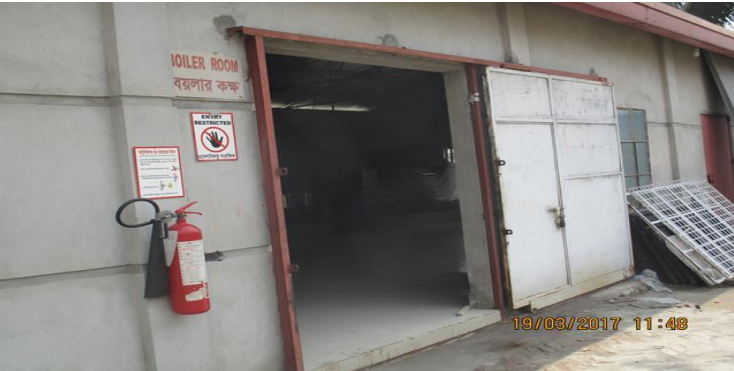
F-4	Means of Egress	Doors along means of egress are provided with non compliant locking system at Shed-01 & Shed-02	<ol style="list-style-type: none"> 1. Remove all non compliant locking features from egress doors. 2. If locks are required for security reasons, utilize special door locking features complying with NFPA 101. 3. Doors may be locked where the latch and lock are disengaged with one motion where the occupant load does not exceed 49 persons. 4. Doors may be provided with locking hardware from the ingress side provided that a panic bar is installed on any door with an occupant load exceeding 49 persons. 	Immediate

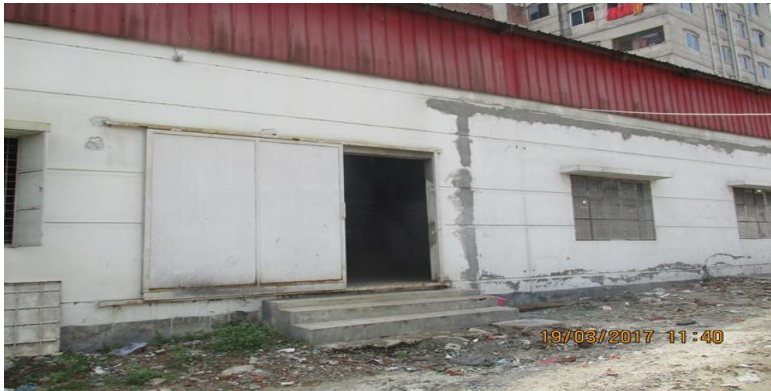
SI No.	Category	Findings	Required Action	Remediation Time Frame
F-5	Means of Egress	Sliding doors have provided along means of egress at Shed-01 & Shed-02.	<p>Replace all sliding type doors by the side-hinged swinging type doors.</p> <p>If locks are required for security reasons, utilize special door locking features complying with NFPA 101.</p>	Immediate

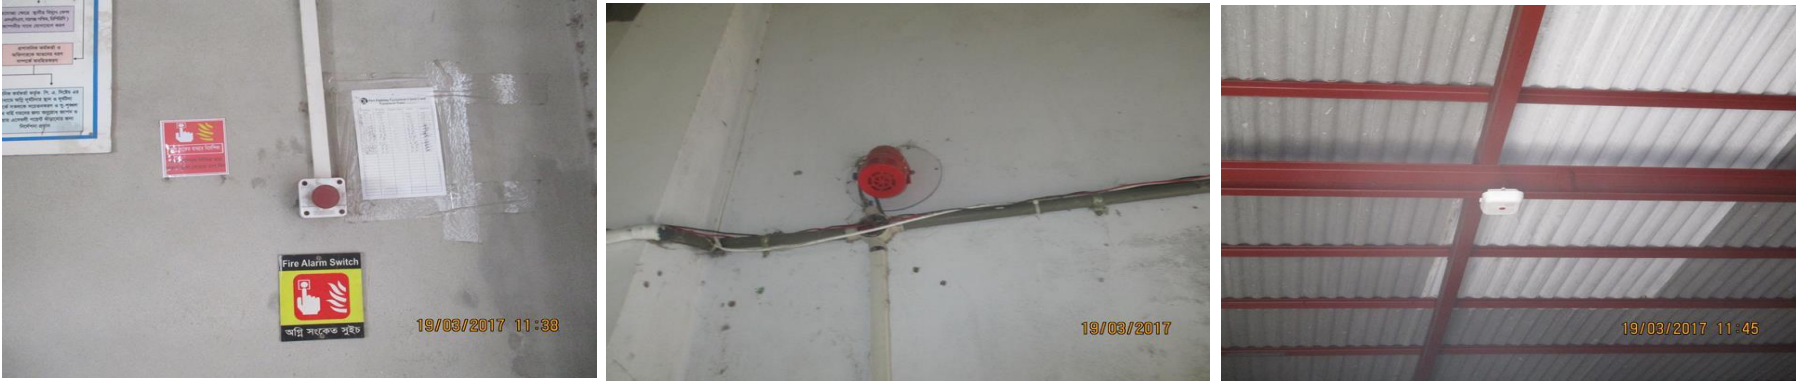
SI No.	Category	Findings	Required Action	Remediation Time Frame
F-7	Fire Detection and Alarm System	The fire detection system is antiquated, not a listed system, and does not provide alarm and notification features consistent with acceptable standards.	Replace the fire detection system with a new, listed addressable fire detection system in accordance with NFPA 72.	Design within 3 months, Install within 6 months
