# **FIRE SAFETY INSPECTION REPORT**

**East Coast Knitwear Pvt. Ltd.**

**ACCORD ID: 12453**

**Inspected By: Nusrat Hossain Trisha, Md. Sajadul Islam Shuvo  
Date: 01 November, 2016**

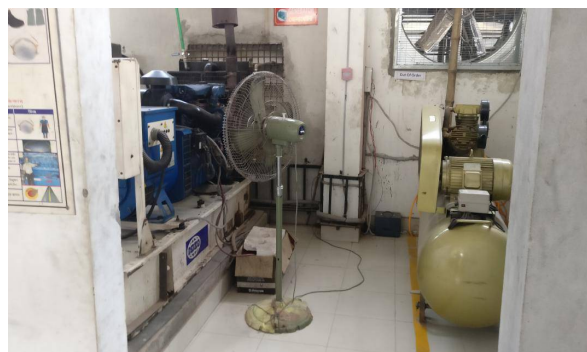
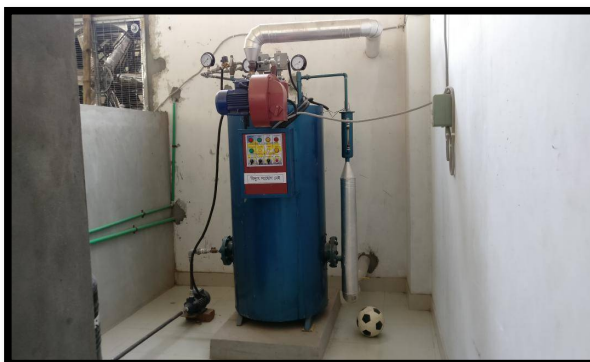
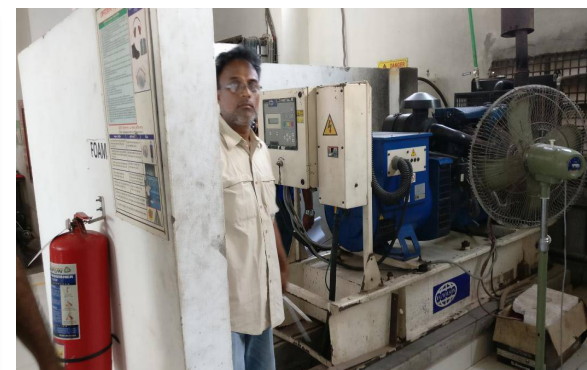
| Sl No. | Category | Findings | Required Action | Remediation Time Frame |
|---|---|---|---|---|
| F-1 | Fire Rated Construction | Generator/ compressor/ boiler room is not properly separated by fire rated construction with other occupancies/ areas in ground floor NW side. | Generator/ compressor/ boiler room shall be separated from other occupancies by a minimum 2-hr fire rated construction (wall, floor, slab etc.). Seal all penetrations and openings (door, window etc.) shall be protected by 1.5-hr fire rated materials to maintain the fire separation if required. All exhaust systems shall discharge to the exterior of the building in a safe location.<br>Or<br>Relocate these to exterior of the building and maintain a minimum 3m (10 ft.) spatial separation distance from the building. | Within 3 months |

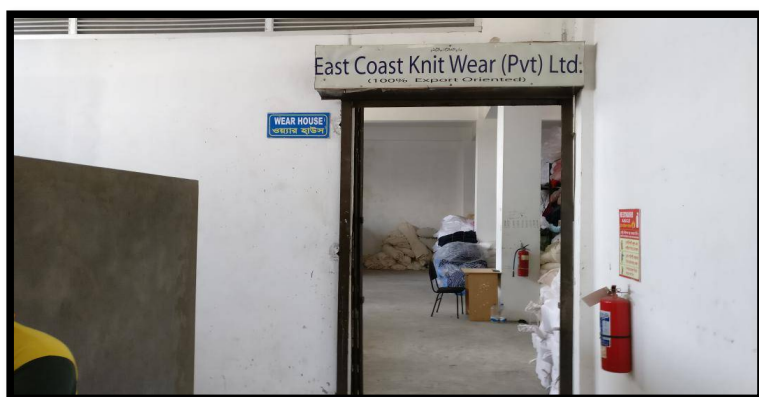
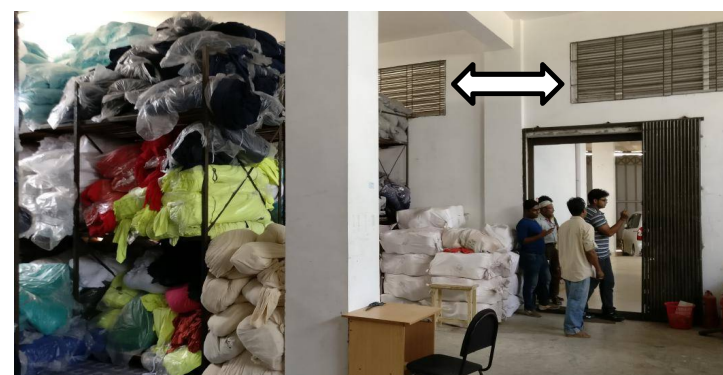
| F-2 | Fire Rated Construction | Rooms used for storage of combustible materials are not separated from the surrounding occupancy/ areas in the ground floor east side. | Rooms used for storage of combustible materials shall be separated from the surrounding occupancy with a minimum 1 hour construction. | Within 3 months |

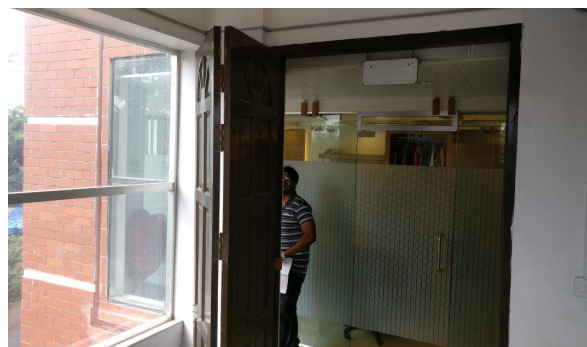
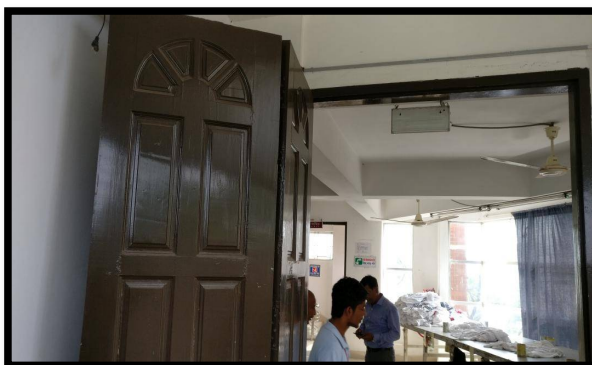
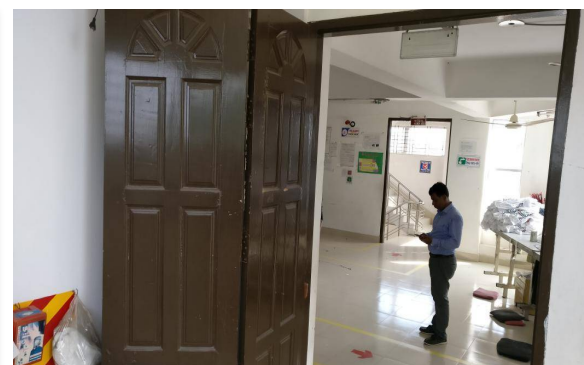
| F-3 | Fire Rated Construction | The exit stairs are not separated from [work areas, other spaces] on each floor by fire-rated construction. | Stairs shall be enclosed with a minimum 2-hr fire-rated construction. Seal all unprotected openings and provide minimum 1.5-hr fire rated doors to separate the exit stairs from work areas and other building spaces on all floor levels. Ensure that the fire doors are self-closing, positive latching and that they are provided with fire exit (panic) hardware where serving production floors. | Within 3 months |

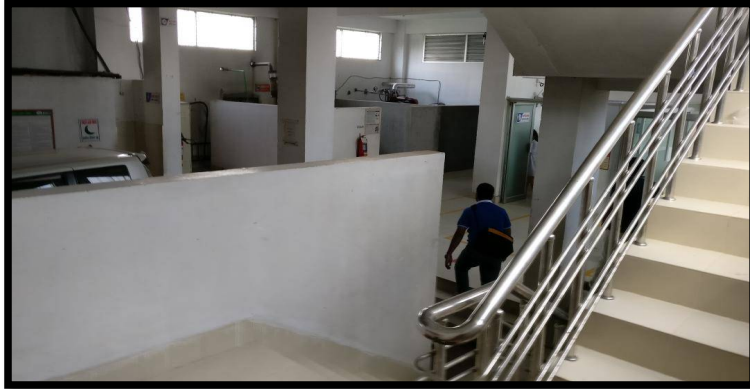
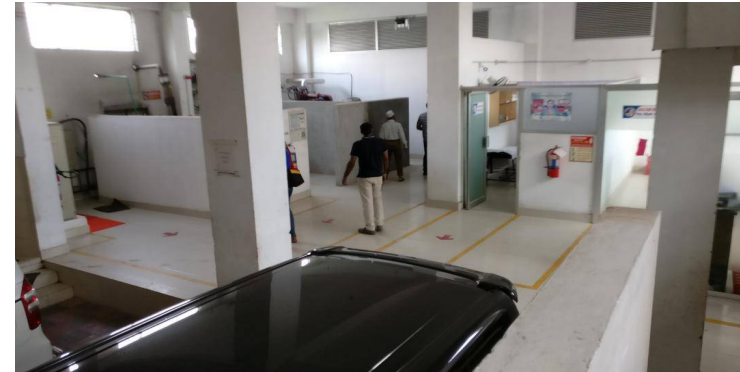
| F-4 | Fire Rated Construction | Exit stair is discharging the occupants inside the building in ground floor. | <p>1. Modify stair to discharge directly outside.</p> <p>Or</p> <p>2. Provide 2-hr fire-rated exit passageway leading directly outside (vestibules to separate any storage areas).</p> <p>Or</p> <p>3. Provide sprinkler protection for discharge floor in accordance with NFPA 13.</p> | Within 6 months |

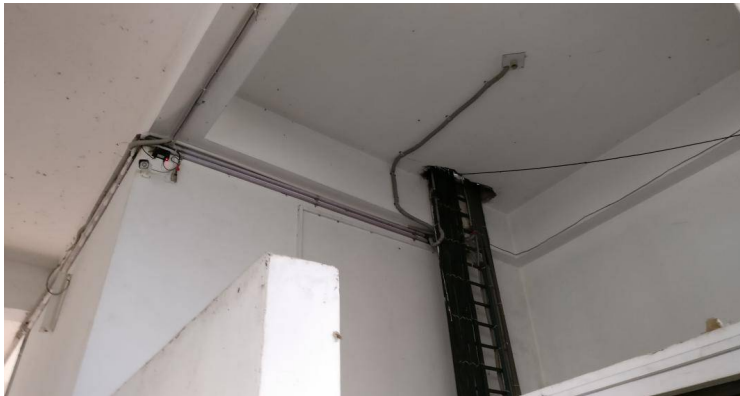
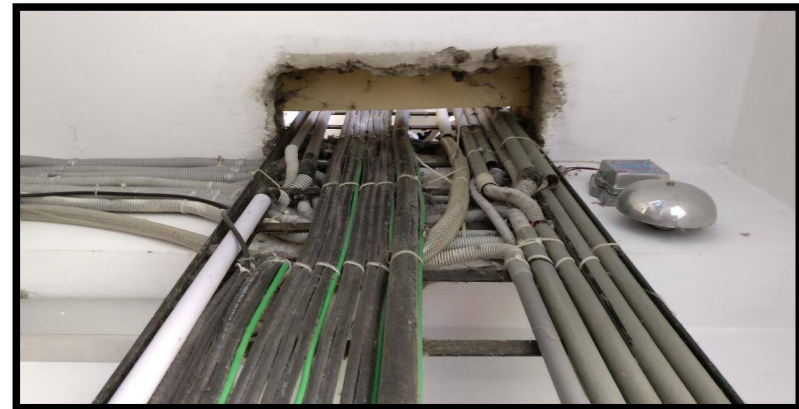
| F-5 | Fire Rated Construction | Penetrations through floor/ceiling assemblies are found unsealed.<br>(Location: Electrical riser at NW side of the building) | Seal all penetrations and openings in floor/ceiling (full thickness of the floor/ceiling) assemblies by fire rated materials to maintain the fire resistance rating.<br>Provide a minimum 2-hr fire rated shaft to separate the utility risers from each floor. | Within 3 months |

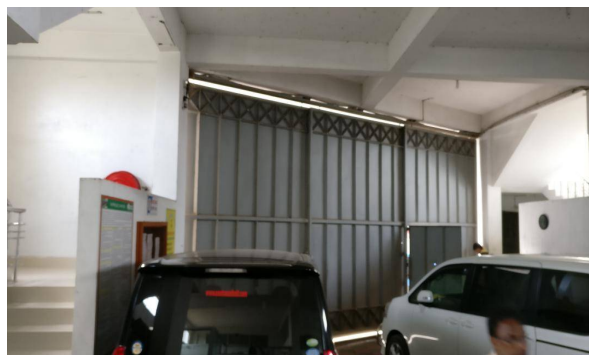
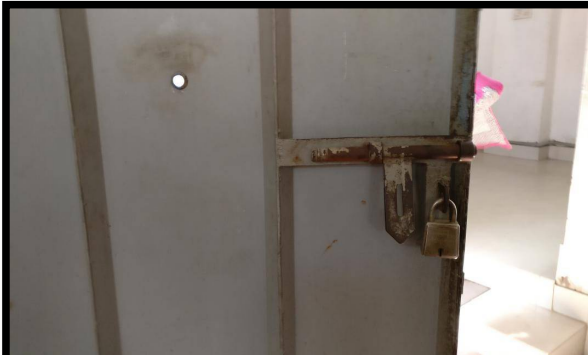
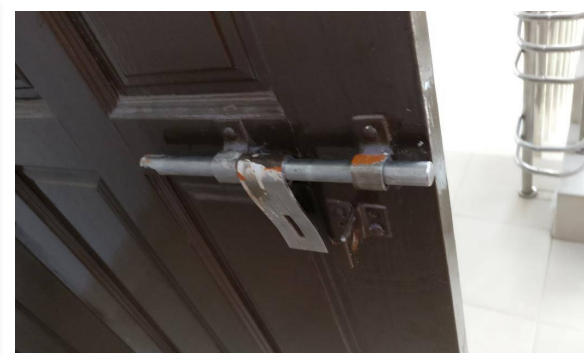
| F-7 | Egress | Doors along means of egress are provided with non compliant locking system in all floors including ground. | <ol style="list-style-type: none"> <li>1. Remove all non compliant locking features from egress doors.</li> <li>2. If locks are required for security reasons, utilize special door locking features complying with NFPA 101.</li> </ol> | Immediate |

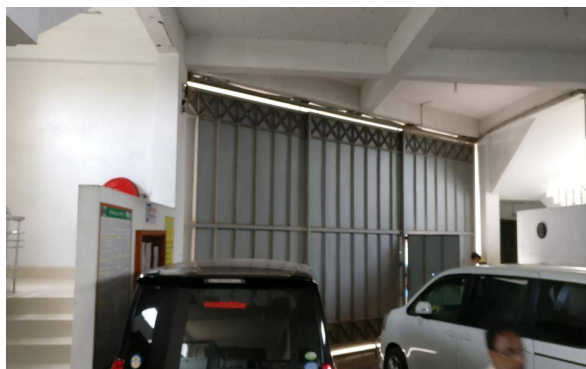
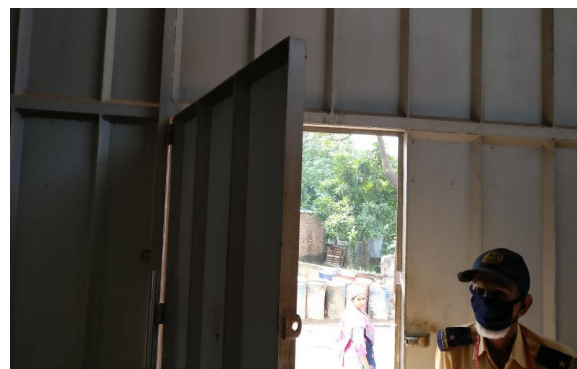
| F-8 | Egress | Egress door serving 50 or more occupants but does not swing in the direction of egress travel in ground floor. | Modify swing direction of egress doors to the direction of egress travel. Doors serving an occupant load of more than 50 shall swing in the direction (out-ward) of egress travel. | Within 1 month |

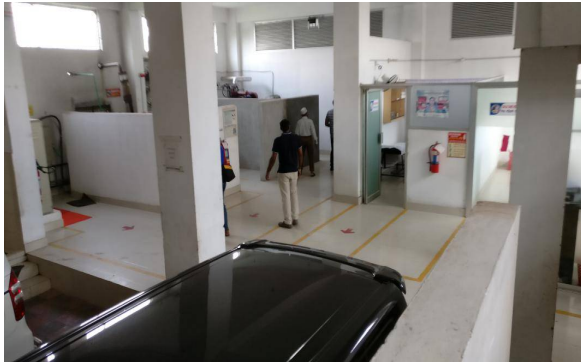
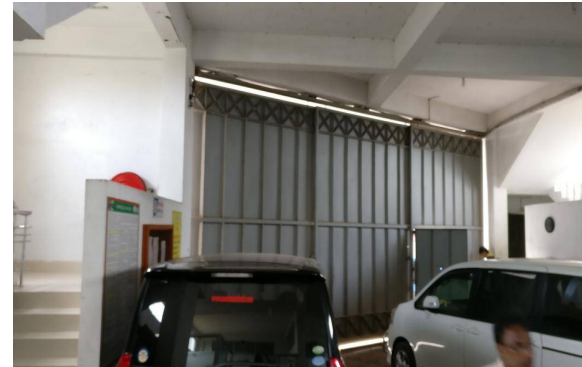
| F-9 | Egress | A single means of exit has been provided for ground floor. | Provide additional exit at ground floor (which needs to be remotely located from the existing exit) | Immediate |

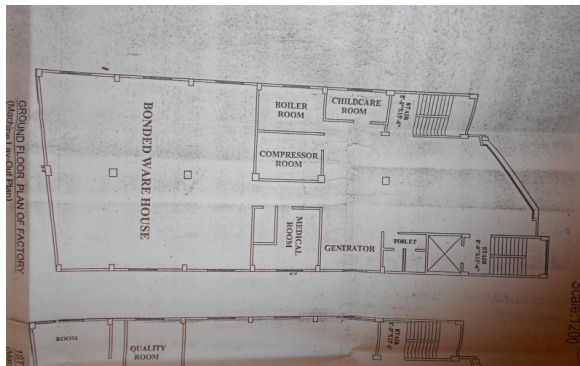
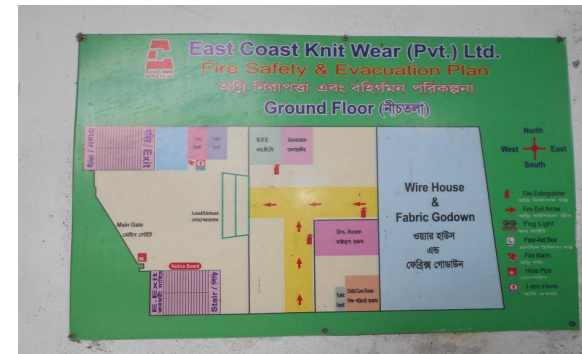
| F-10 | Egress | The exits are not remotely located from each other such that a single fire event could compromise both exits. Location: All floors | Specify appropriate upgrade based on conditions:<br>-Modify exit arrangement.<br>-Provide additional exit(s). | Within 6 months |

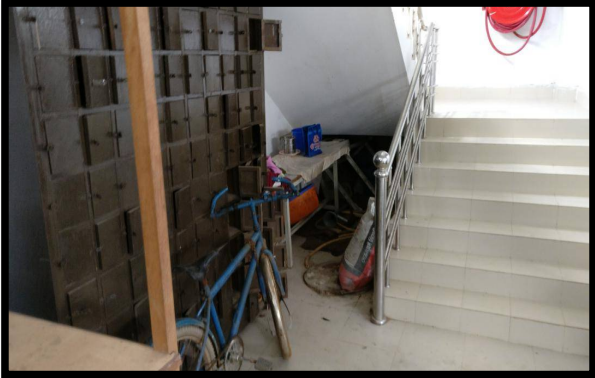
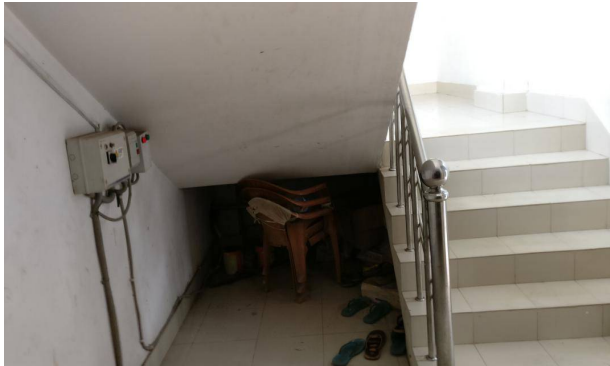
| F-12 | Egress | Storage was located in the exit stair. (Ground floor) | Remove all storage from exit stairs. | Immediate |

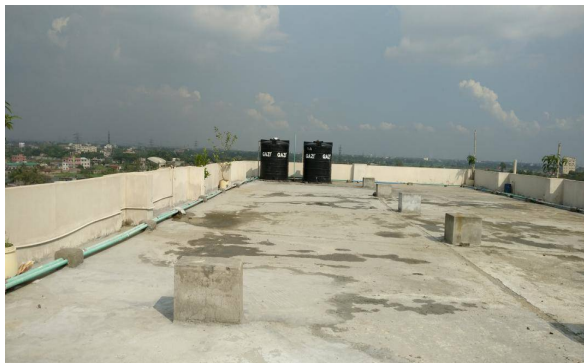
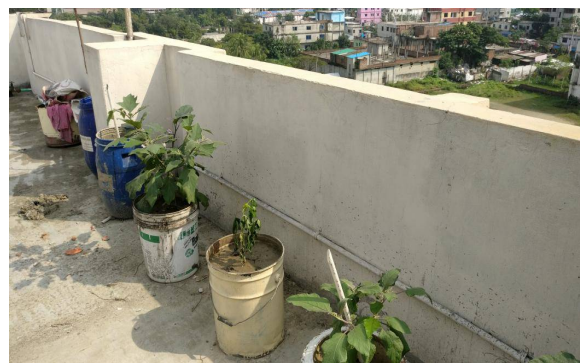
| F-13 | Egress | Parapets or guards in the occupiable roof are less than 42 inches. | Provide parapets or guards with a minimum height of 1067mm (42 inch.). | Within 3 months |

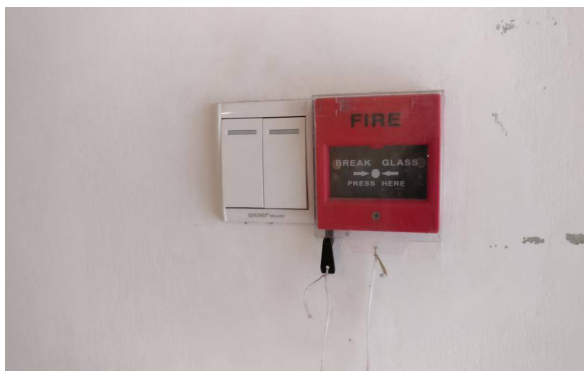
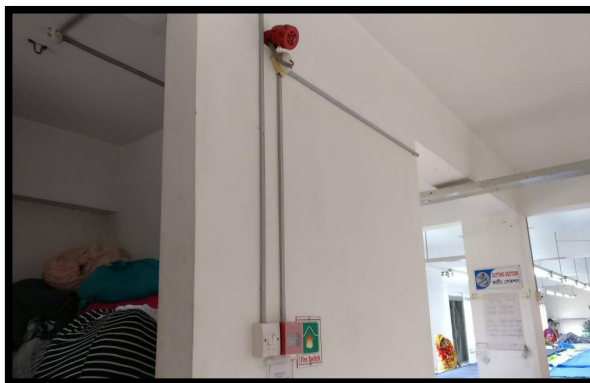
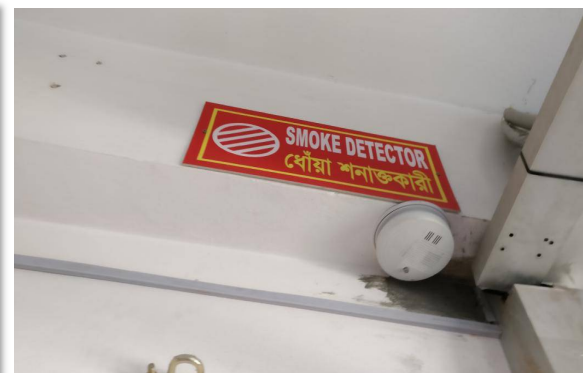
| F-14 | Fire Alarm & Detection System | The existing fire alarm system is not a listed system and does not provide automatic alarm and notification features consistent with acceptable standards. | Replace the fire alarm system with a new, listed addressable fire alarm system in accordance with NFPA 72. | Design within 4 month;<br>Install within 9 months |

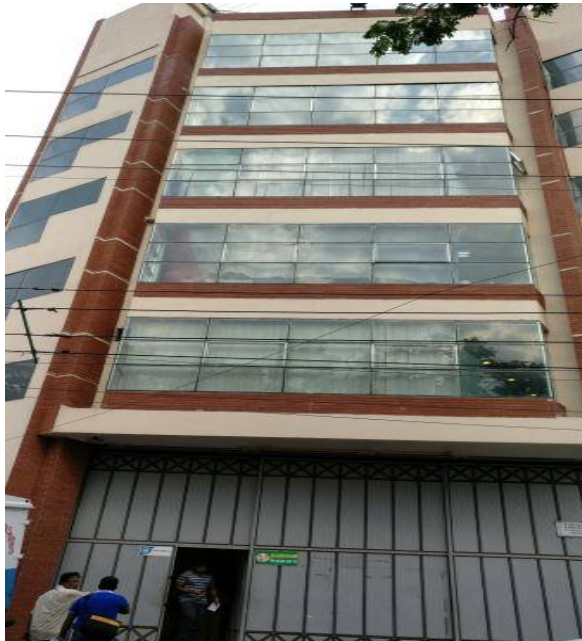
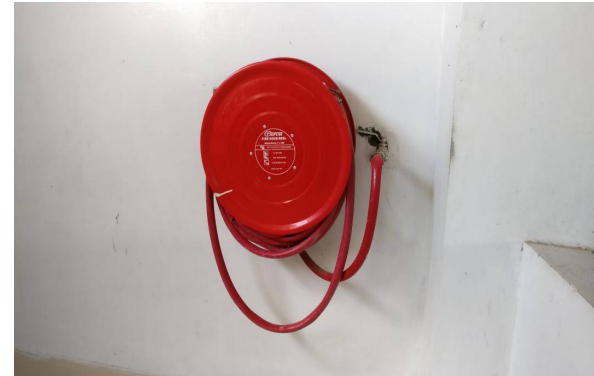
| F-16 | Fire Protection System | The existing factory building with an occupiable floor greater than 10 m (33 ft) above the finished grade is not protected with an approved standpipe system. | Install a new class III standpipe system & fire department connection in accordance with NFPA 14. | Design within 4 month;<br>Install within 9 months |

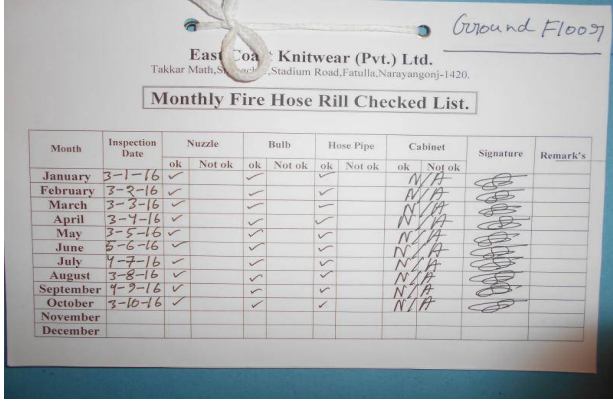
| F-17 | Fire Protection System | Inspection, testing, and maintenance of the standpipe system is not in accordance with NFPA 25. | Inspect, test and maintain the standpipe system and keep written records on-site, in accordance with NFPA 25. | Within 3 months |

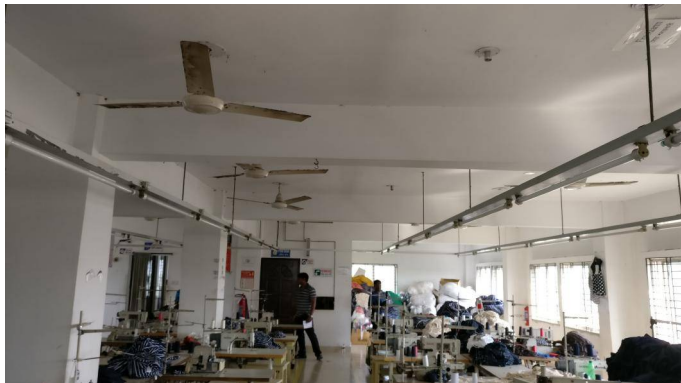
| F-18 | Egress Lighting | Based on the number and location of emergency lights observed, adequate illumination levels are not anticipated along egress routes. Location: All floors | Test the emergency lighting system on each floor and provide additional emergency fixtures to provide adequate illumination along the means of egress. Provide a minimum illumination of 10 lux at the floor level within exit stairs and exit discharge paths and minimum 2.5 lux along exit access aisles. | Within 3 months |

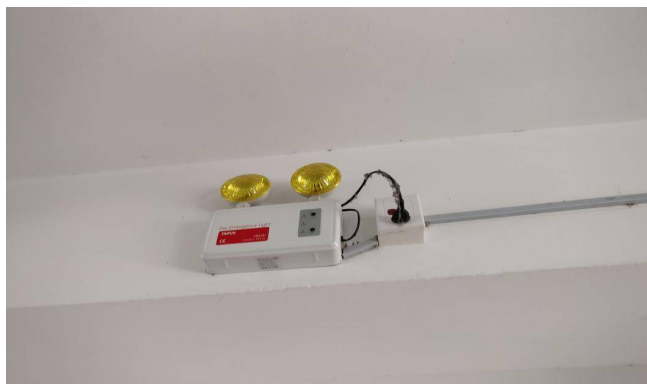
| F-19 | Egress Lighting | Manual on-off switch is provided for [emergency lighting / exit signage] units. | Remove manual on/off switches from emergency lighting / exit signage units to prevent them from being switched off. | Within 3 months |

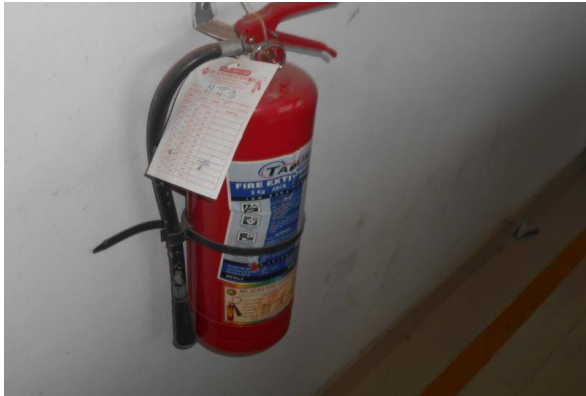
| F-21 | Fire Extinguishers<br>ITM | Inspection, testing and maintenance of portable fire extinguishers is not in accordance with NFPA 10. | Inspect, test and maintain the portable fire extinguishers and keep written records onsite, in accordance with NFPA 10 and ACCORD standards. | Within 3 months |
