FIRE SAFETY INSPECTION REPORT

**EXECUTIVE HI-FASHIONS LTD.
HOUSE #23 (FLAT #A-1), ROAD #04 BLOCK-F, BANANI,
1213, GAZIPUR**

March 4, 2014

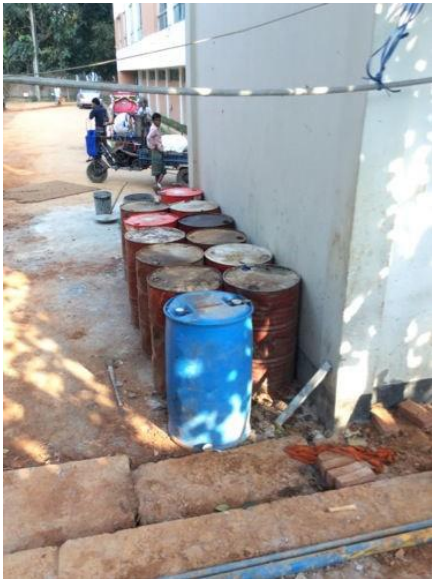
No	Category	Finding	Recommendation	Remediation Timeframe
F-1	Fire Rated Construction	The diesel fuel storage barrels next to the transformer room are not separated by fire-rated construction.	<p>Separate the flammable liquid by a minimum 2-hr fire-rated construction. Seal and/or protected all openings to maintain the required fire separations.</p> <p>Alternately, relocate the diesel fuel barrels to a location at least 30 ft. from all occupiable spaces.</p>	Within 3 months

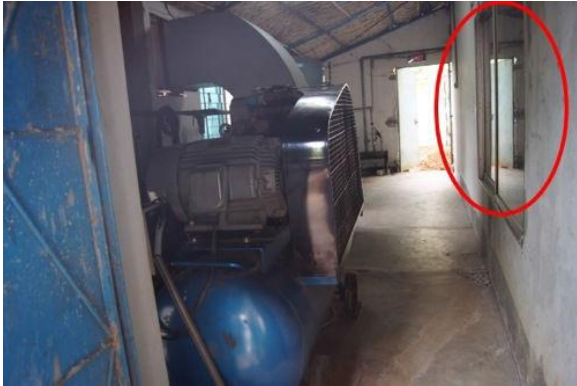
F-2	Fire Rated Construction	The boiler room connected to the west side of the building is not separated by fire-rated construction due to openings, the non fire-resistant roof, penetrations, and non-rated doors.	Separate the boiler room by a minimum 2-hr fire-rated construction. Seal and/or protected all openings to maintain the required fire separations	Within 3 months
-----	-------------------------	---	--	-----------------

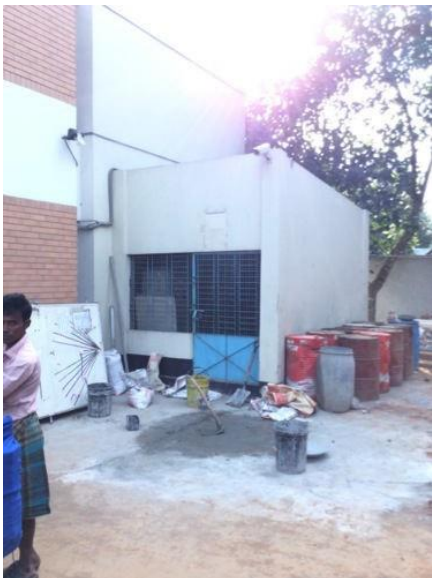
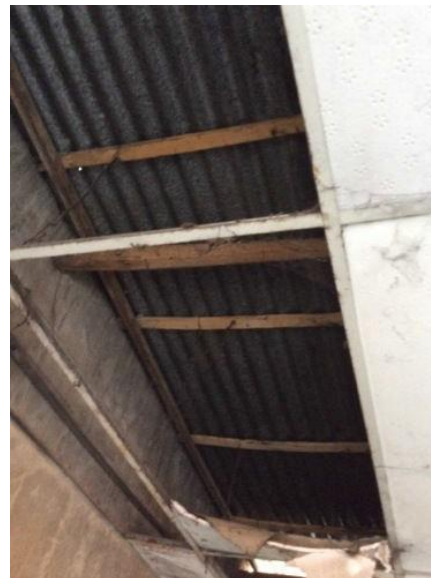
F-3	Fire Rated Construction	The transformer room is not separated by fire-rated construction due to openings, the non-fire resistant roof, penetrations, and non-rated doors.	Separate the transformer room by a minimum 2-hr fire-rated construction. Seal and/or protected all openings to maintain the required fire separations	Within 3 months
-----	-------------------------	---	---	-----------------

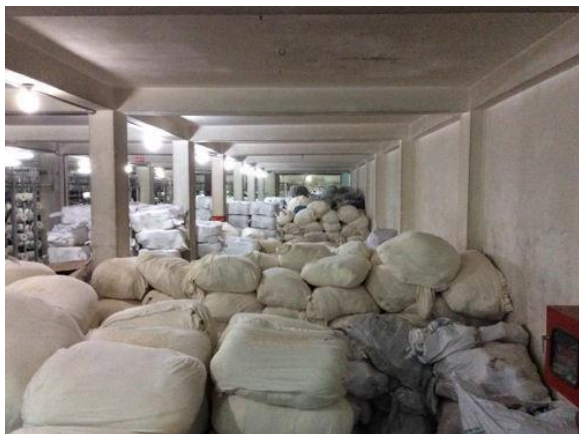
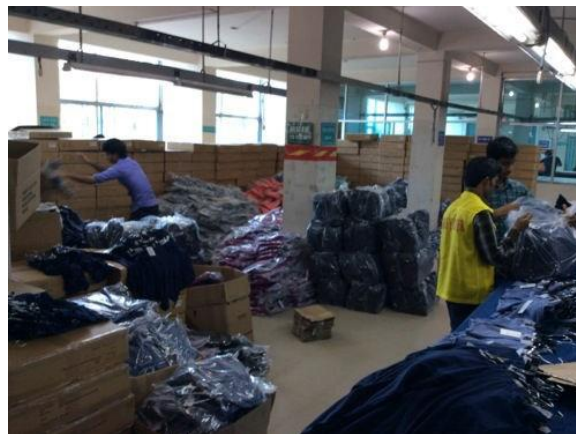
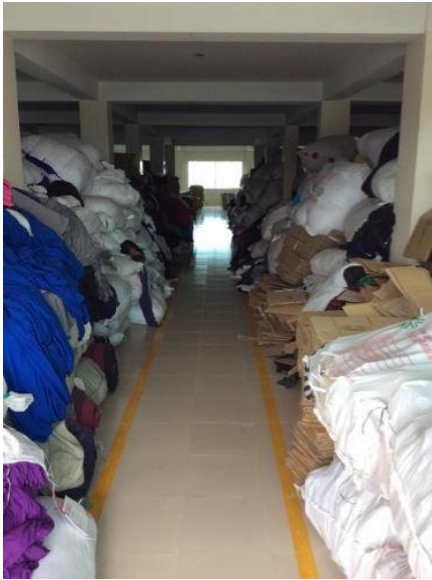
F-4	Fire Rated Construction	Areas used for combustible storage on the factory floor on the ground, first and fifth floors are not separated by fire-rated construction.	<p>Provide dedicated storage rooms separated by minimum 1-hr fire-rated construction.</p> <p>Where separate storage rooms are not feasible, provide defined storage areas and limit the storage arrangement as follows:</p> <ul style="list-style-type: none"> -Maximum height of 2.4m and maximum area of 23m² -If sprinkler protected: maximum height of 3.66m and maximum area of 93m² <p>Separate areas of unenclosed combustible storage by a minimum clear distance of 3m.</p>	Within 3 months
-----	-------------------------	---	--	-----------------

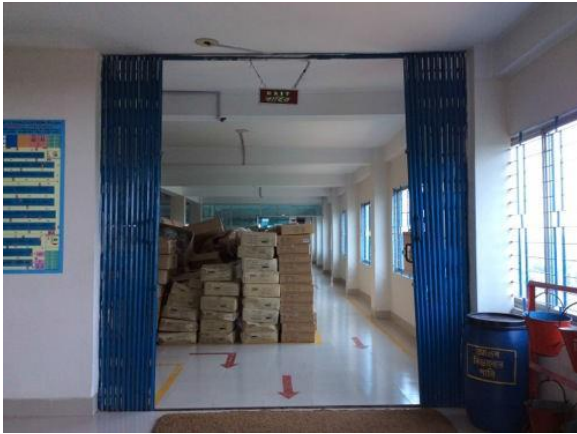
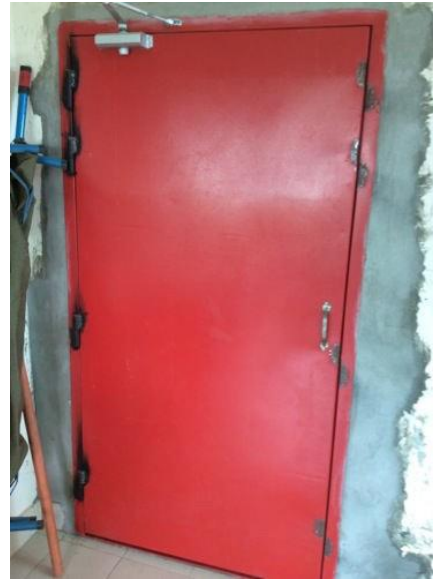
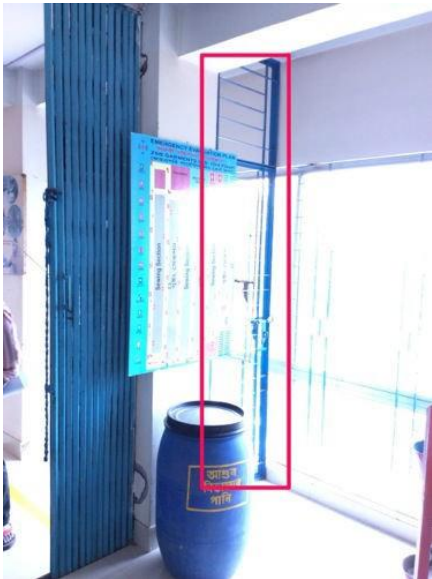
F-5	Fire Rated Construction	The exit stairs are not separated from work areas and other spaces on each floor by fire-rated construction.	Provide minimum 1.5-hr fire rated doors and seal all unprotected openings to separate the exit stairs from work areas and other building spaces on all floor levels. Ensure that the fire doors are self-closing and positive latching and that they are provided with fire exit (panic) hardware where serving production floors. If fire doors are required to be held open for functional reasons, provide automatic-closing devices tied to the fire alarm system.	Within 3 months
-----	-------------------------	--	---	-----------------

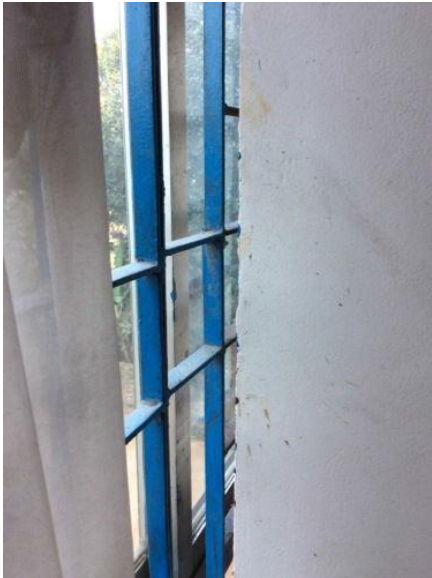
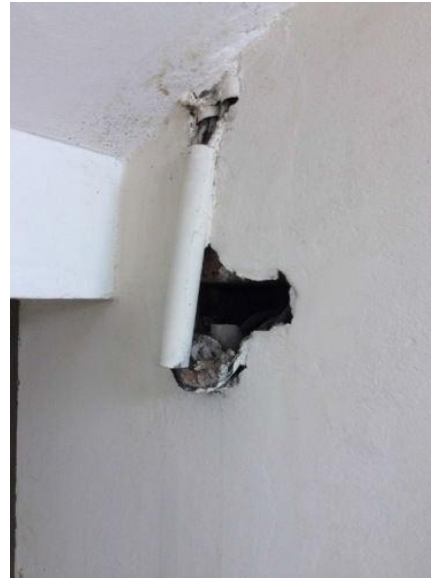
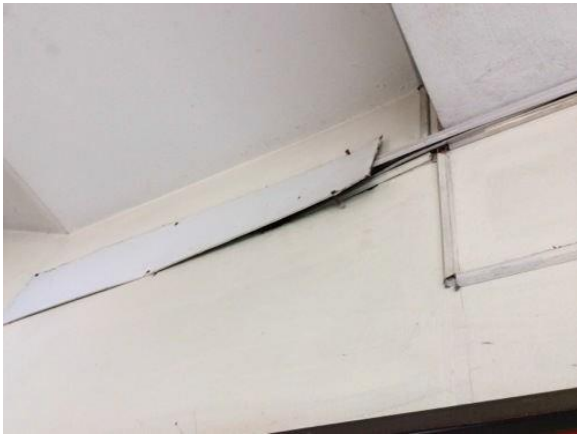
F-6	Fire Rated Construction	Unsealed penetrations and openings are located in exit stair enclosures.	Seal all penetrations and openings in exit stair enclosure walls to maintain the fire separation.	Within 3 months
-----	-------------------------	--	---	-----------------

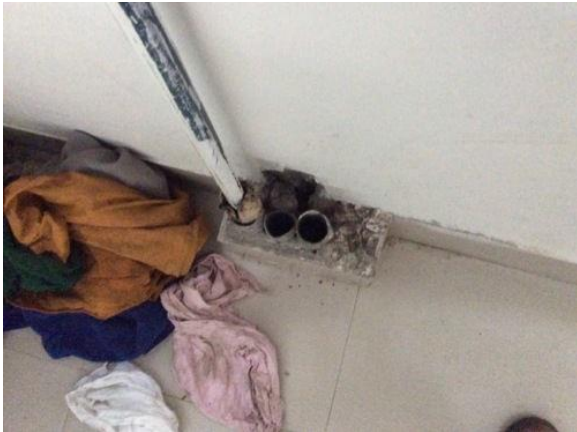
F-7	Fire Rated Construction	Unsealed penetrations and openings are located in the fire-rated floor/ceiling assemblies on the fifth floor.	Provide a minimum 2-hr fire-rated shaft to separate the utility risers from each floor level.	Within 3 months
			Seal all penetrations and openings in floor/ceiling assemblies to maintain the fire separation.

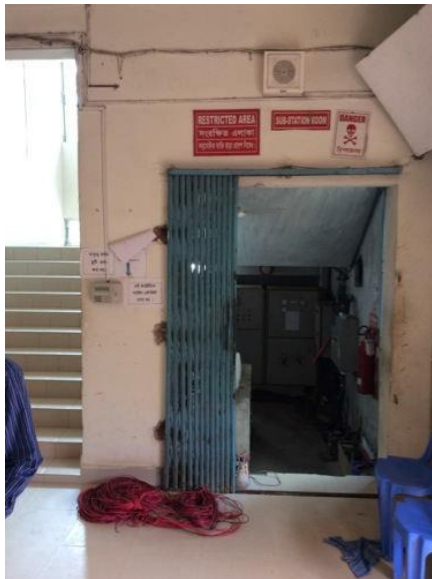
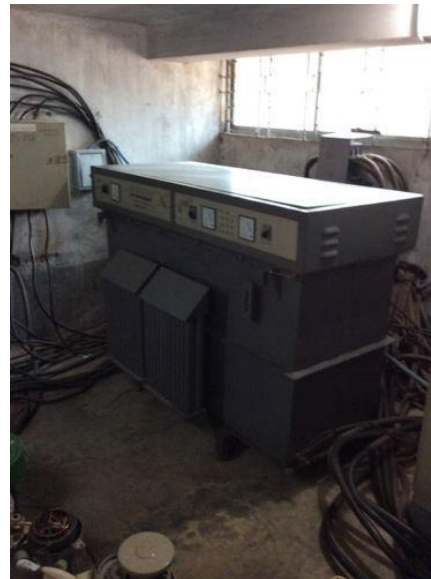
F-8	Fire Rated Construction	The sub station room at the west stairwell discharge is not separated by fire-rated construction due to non-rated doors.	Separate the sub station room by a minimum 2-hr fire-rated construction. Seal and/or protected all openings to maintain the required fire separations	Within 3 months
-----	-------------------------	--	---	-----------------

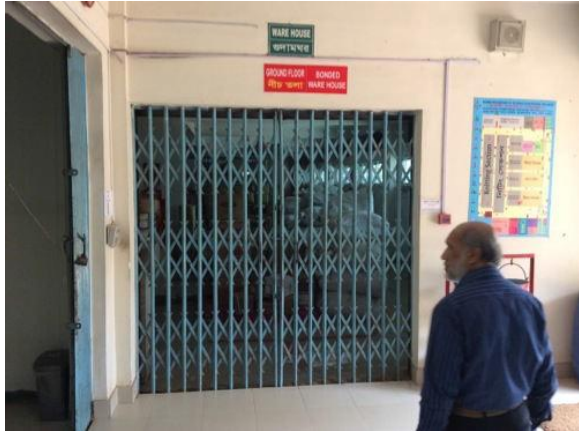
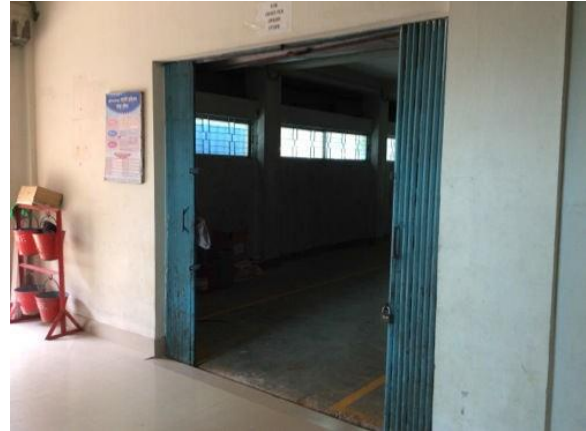
F-9	Fire Rated Construction	The ground floor bonded warehouse is not separated by fire-rated construction and discharges to an exit enclosure.	Provide 2-hr fire rated vestibule with 1.5-hr. fire rated door at each entrance discharging to the stairwells. Provide 1-hr. door from vestibule to bonded warehouse.	Within 3 months
-----	-------------------------	--	---	-----------------

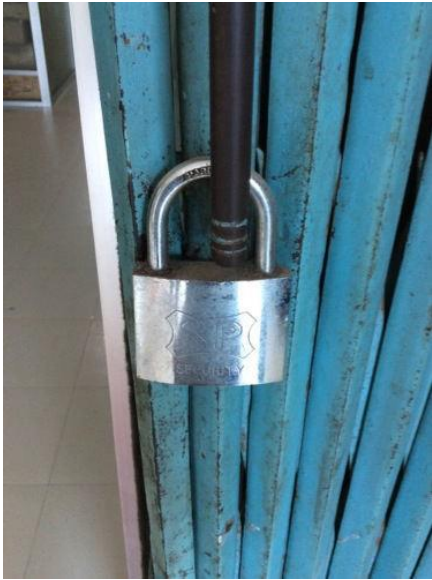
F-10	Egress	Egress gates with locking features are provided at building exits, exit stairs, and along egress routes in various locations throughout the building. All gates were open and unlocked during the inspection.	Remove locking features from all egress gates. If locks are required for security reasons, utilize special door locking features complying with NFPA 101.	Immediate
------	--------	---	--	-----------

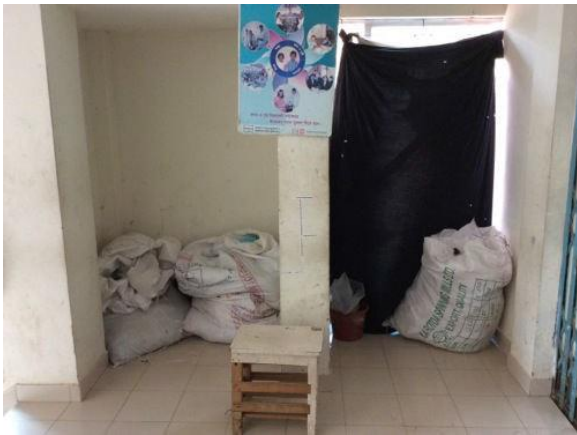
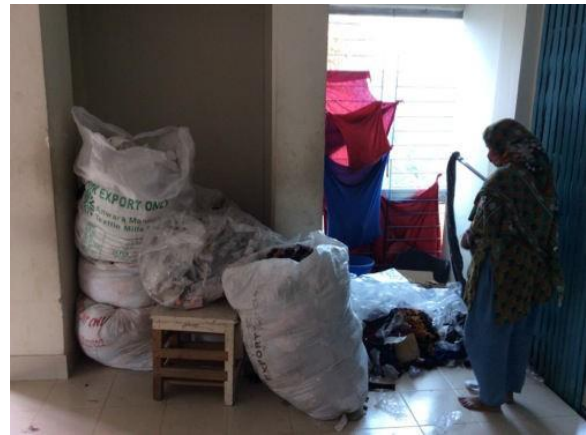
F-11	Egress	Storage was located in the west exit stair in various locations.	Remove all storage from exit stairs and egress paths.	Immediate
------	--------	--	---	-----------

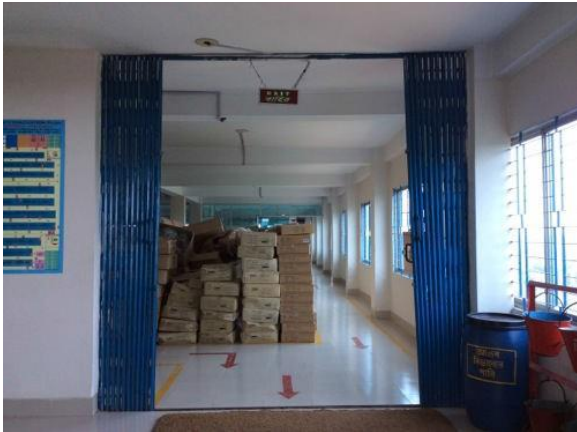
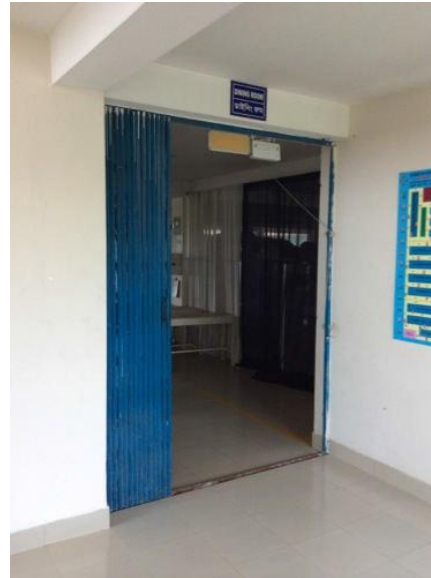
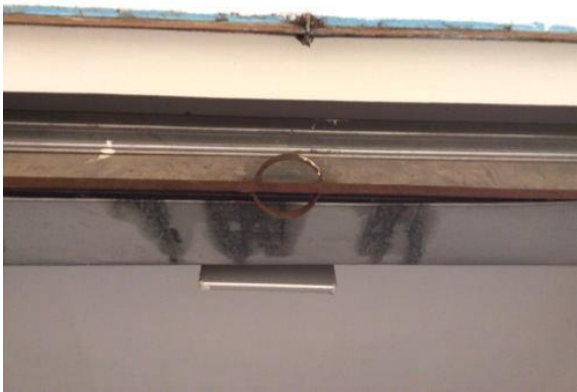
F-12	Egress	Collapsible gates are provided at building exits, exit stairs, and along egress routes at various locations throughout the building.	Replace all gates along the means of egress with side-hinged, swinging egress doors. If locks are required for security reasons, utilize special door locking features complying with NFPA 101.	Within 1 month
------	--------	--	--	----------------

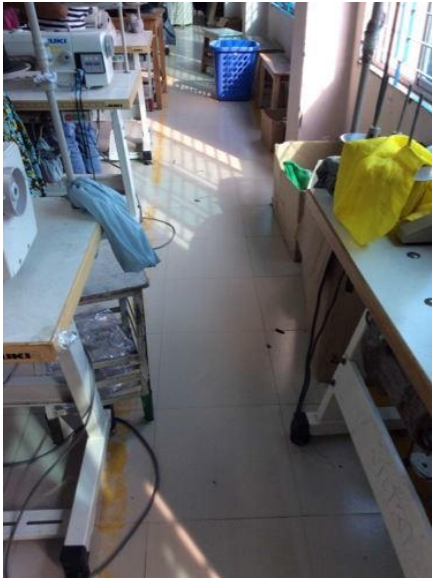
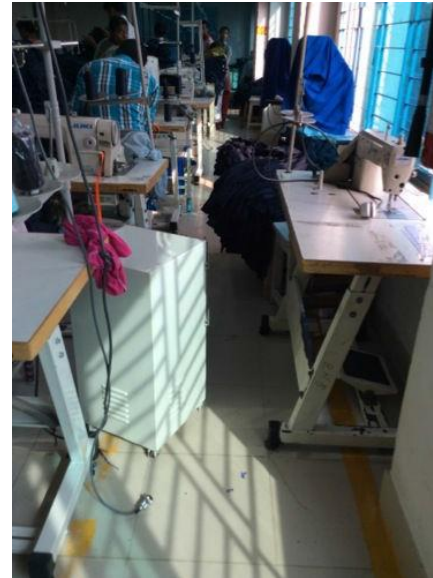
F-13	Egress	The width of egress aisles on the third floor is less than 36-in.	Provide minimum aisle widths of 36-in.	Within 3 months
------	--------	---	--	-----------------

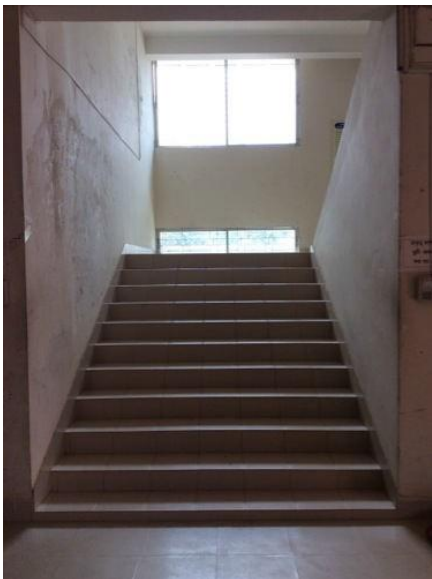
F-14	Egress	Handrails are not provided at the bottom of the west exit stair.	Provide handrails on at least one side of exit stair.	Within 3 months
------	--------	--	---	-----------------

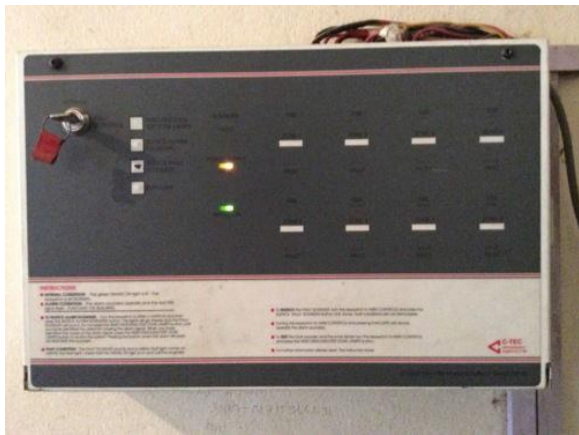
F-16	Fire Protection Inspection, testing, and maintenance records for the fire alarm system were not available.	Inspect, test and maintain the fire alarm system, and keep written records on-site, in accordance with NFPA 72.	Within 3 months
F-17	Fire Protection When initially observed, the fire alarm panel was alerting in three (3) zones.	Ensure that the fire alarm panel and all interconnected devices are installed correctly in accordance with NFPA 72 and that all electrical circuits are functional.	Within 3 months

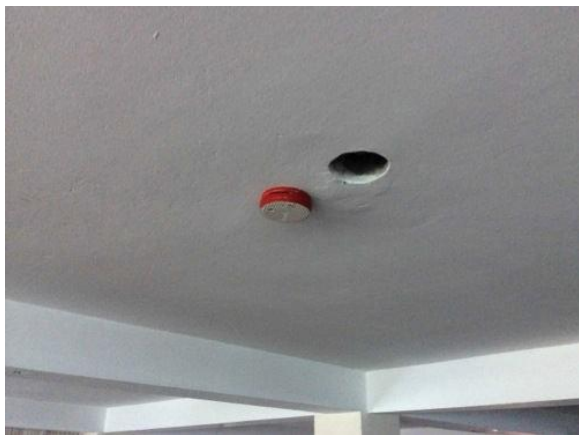
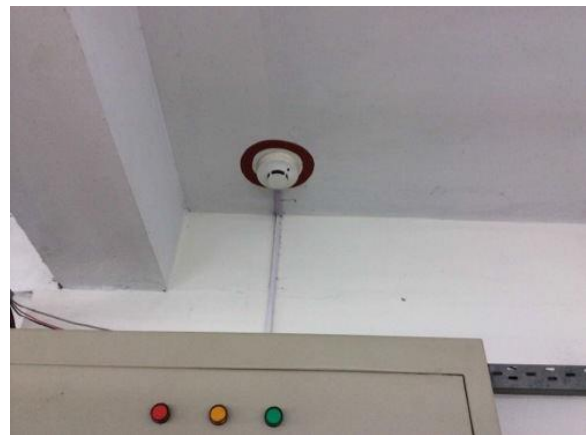
F-18	Fire Protection	<p>The building is equipped with single-station smoke alarms. Smoke alarm activation sounds only a local alarm and does not provide automatic fire alarm notification of occupants.</p>	<p>Replace the single-station smoke alarms with automatic smoke detectors tied into the fire alarm system. Configure the fire alarm system to initiate occupant notification upon activation of any two smoke detectors in addition to the manual fire alarm stations.</p>	Within 6 months
		<p>Reportedly the building owner is in the process of having new smoke detectors, that will be tied into the fire panel, installed in the entire building. Currently the first, second, and fifth floors have only one smoke detector tied to the fire alarm on the west side of the floor plate.</p>	<p>In regards to ceiling configuration, install the smoke detectors in accordance with NFPA 72.</p>

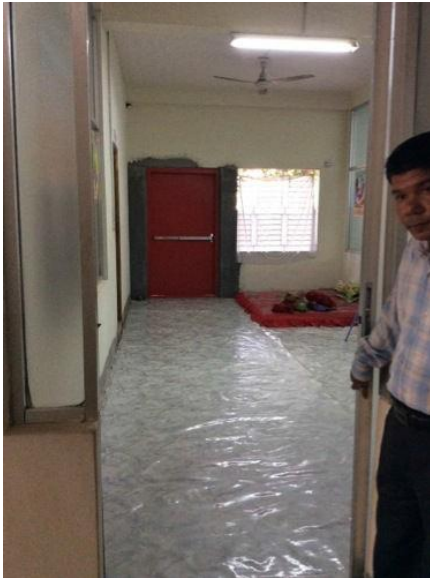
F-19	Egress Lighting	<p>Exit sign not provided at the ground floor exit to the child care room.</p>	<p>Provide exit signs above all exits to the exterior and all doors to the exit stairs.</p>	Within 1 month
------	-----------------	--	---	----------------

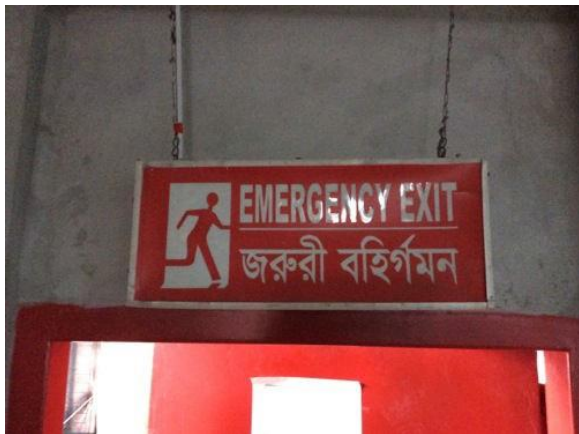
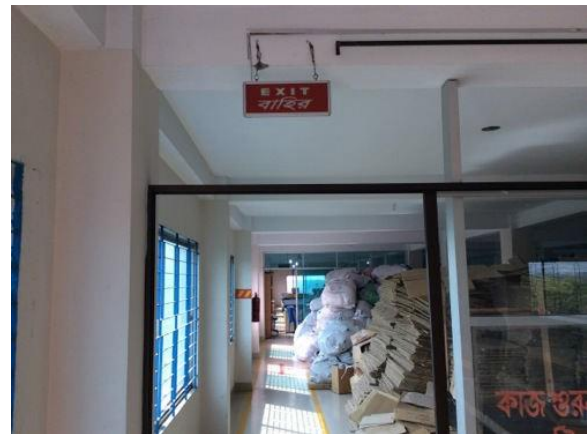
F-20	Egress Lighting	Exit signage not illuminated on the ground, first, and fifth floors and in the generator room due to burned out bulbs.	Regularly inspect all exit signage and replace/install lights as needed to illuminate signs.	Within 1 month
------	-----------------	--	--	----------------

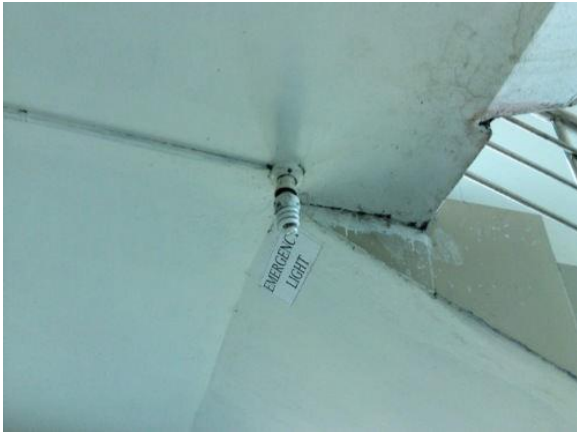
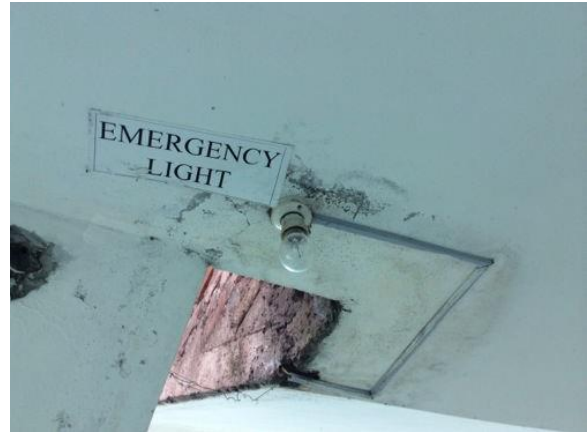
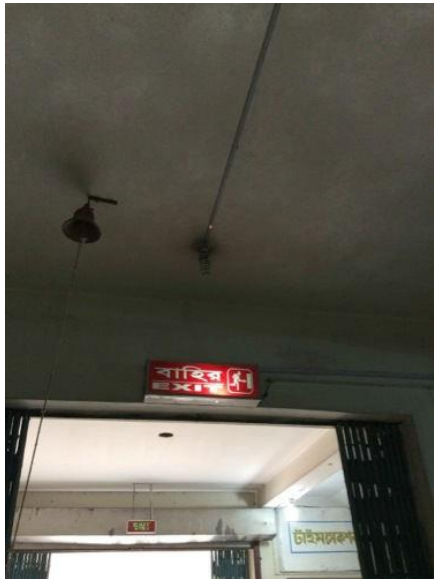
F-21	Egress Lighting	Emergency lighting was not functional in various locations throughout the factory because the bulbs were burned out.	Regularly test the emergency lighting system on each floor and replace/repair lights as needed.	Within 1 month
------	-----------------	--	---	----------------

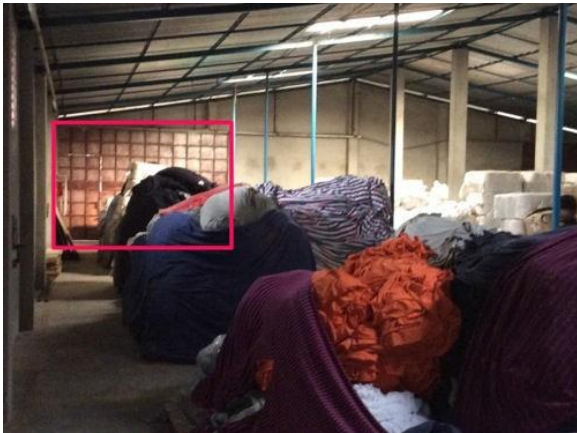
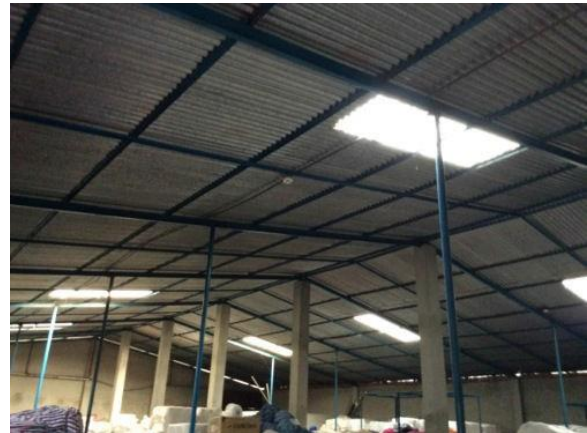
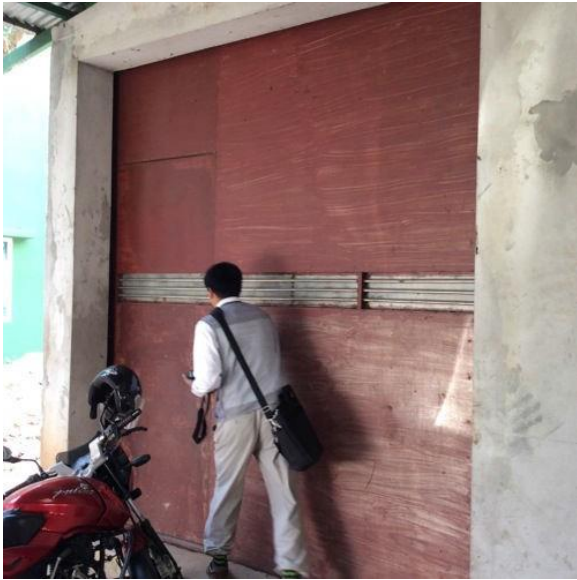
No	Category	Finding	Recommendation	Remediation Timeframe
F-1	Fire Rated Construction	The Yarn Godown, an area used for combustible storage, is not separated by fire-rated construction (non fire-rated doors and tin roof construction).	Provide the dedicated storage room separation by minimum 1-hr fire-rated construction.	Within 3 months

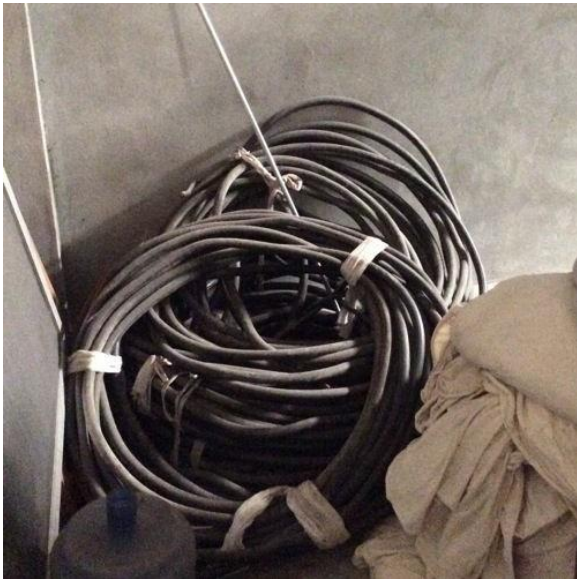
F-2	Egress	Storage was located in the egress path of the Yarn Godown.	Keep egress paths and stairs clear of storage.	Immediate
-----	--------	--	--	-----------

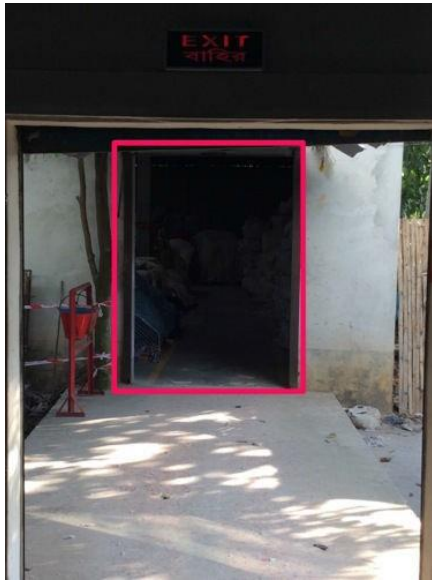
F-4	Egress	A sliding door was provided at the building exit of the Yarn Godown.	Replace all sliding doors along the means of egress with side-hinged, swinging egress doors.	Within 1 month
			If locks are required for security reasons, utilize special door locking features complying with NFPA 101.
