# Farkantex Limited (10515)

Plot # 1 & 2, Sector # 5/A, CEPZ, Chittagong

17.MAY.2014

**ACCORD**  
on Fire and Building Safety in Bangladesh

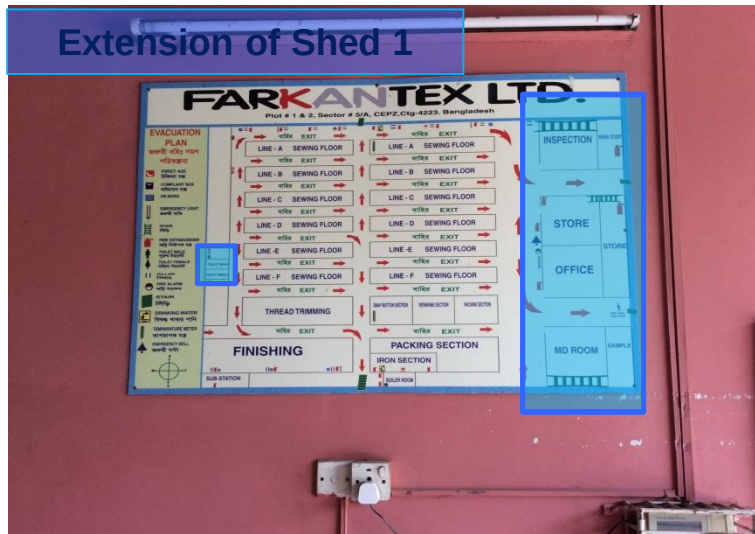
### Extension of Shed 1

There are no structural drawings of Shed 1's extension, Shed 2, Shed 3 and Shed 4.

| Item No. | Observation | Recommended Action Plan | Recommended Timeline |
|---|---|---|---|
| 1 | Incomplete structural drawing of Shed 1's extension, Shed 2, Shed 3 and Shed 4. | Factory Engineer to survey the actual conditions and create the drawings for these items.<br>Factory Engineer to review design, loads and columns stresses to confirm suitability for loads applied. | 6-weeks |
| 2 | Incomplete structural drawing of Shed 1's extension, Shed 2, Shed 3 and Shed 4. | Produce and actively manage a loading plan for all floor plates within this area giving consideration to floor capacity and column capacity. | 6-months |

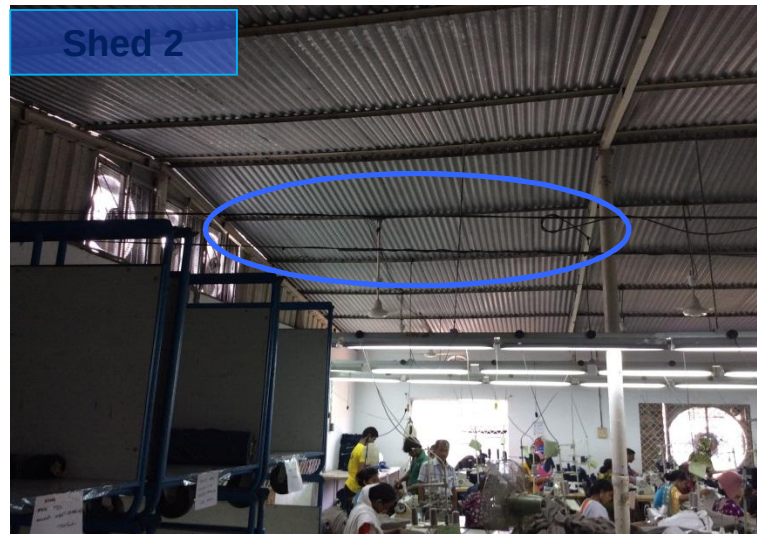
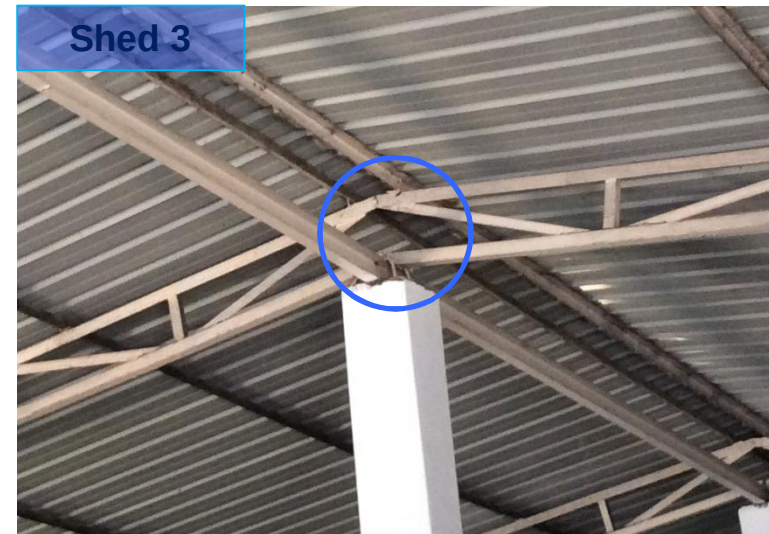
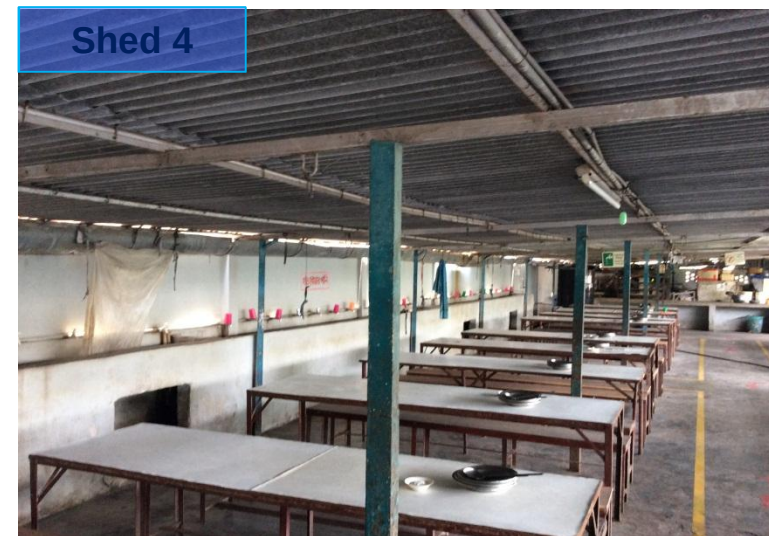
There are concerns on the roof structure elements of Shed 2 (steel purlin seems sagged), Shed 3 (no vertical steel element provided) and Shed 4 (purlin and rafter). Capacity and stability check of these items should be carried out.

| Item No. | Observation | Recommended Action Plan | Recommended Timeline |
|---|---|---|---|
| 3 | Capacity and stability check for Shed 2's roof, Shed 3 and Shed 4. | Factory Engineer to review design, loads and related elements in area identified above to confirm capacity and stability for these items. | 6-weeks |

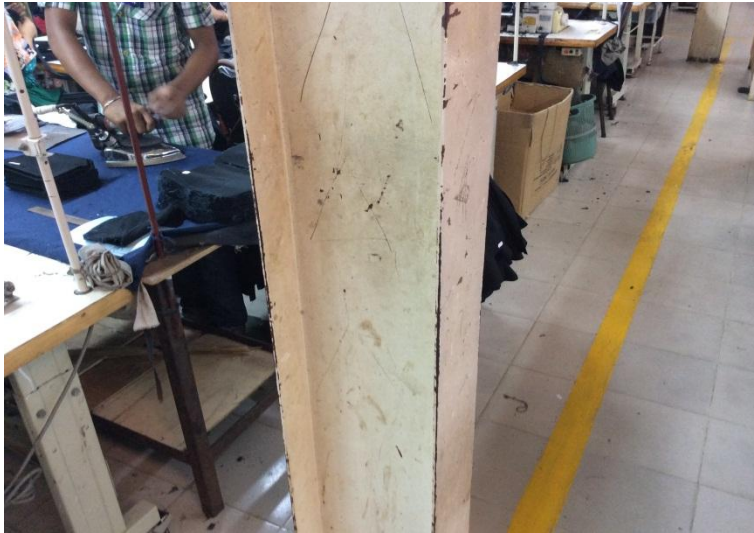
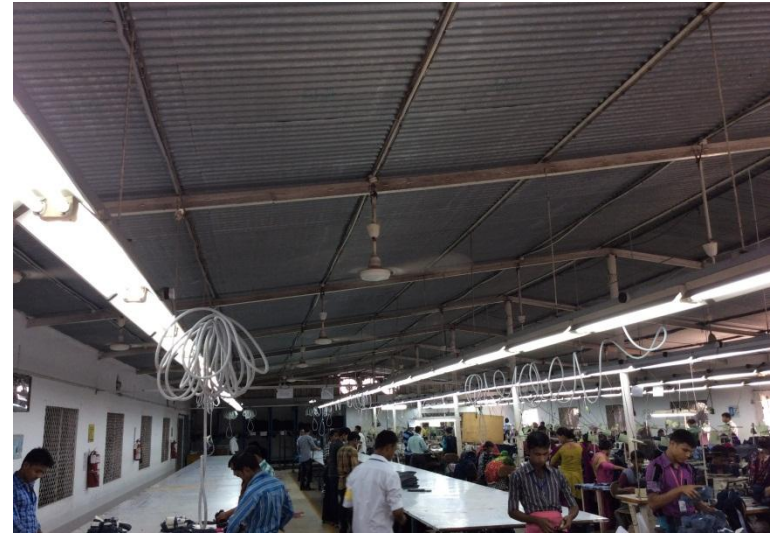
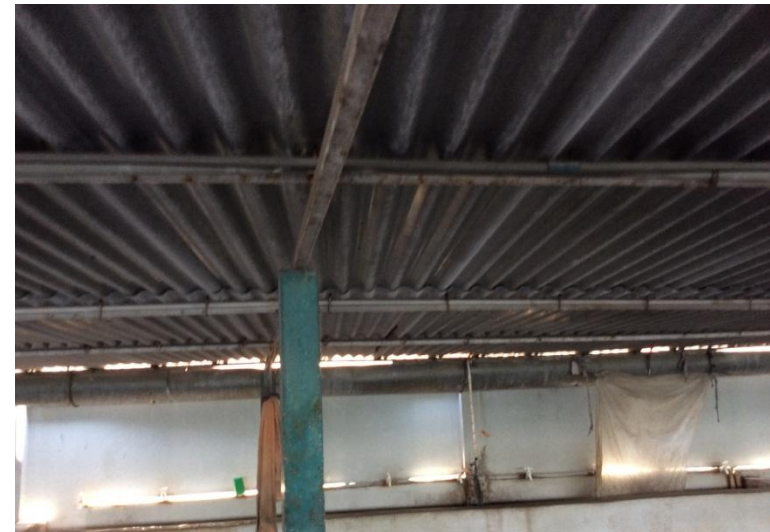
No fire proofing material is applied to the Structural steel elements. It is unclear whether this would be required by BNBC.

| Item No. | Observation | Recommended Action Plan | Recommended Timeline |
|---|---|---|---|
| 7 | No fireproofing for steel structure elements (if required). | Fireproofing material for structural steel element is recommended as suggested in BNBC Codes. Maintain standard of quality control. | 6-months |

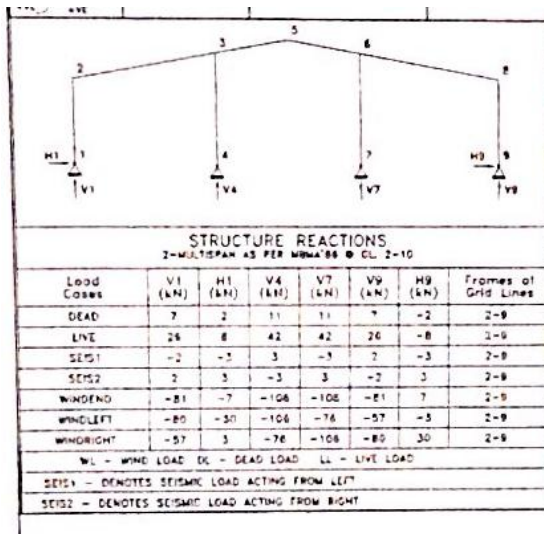
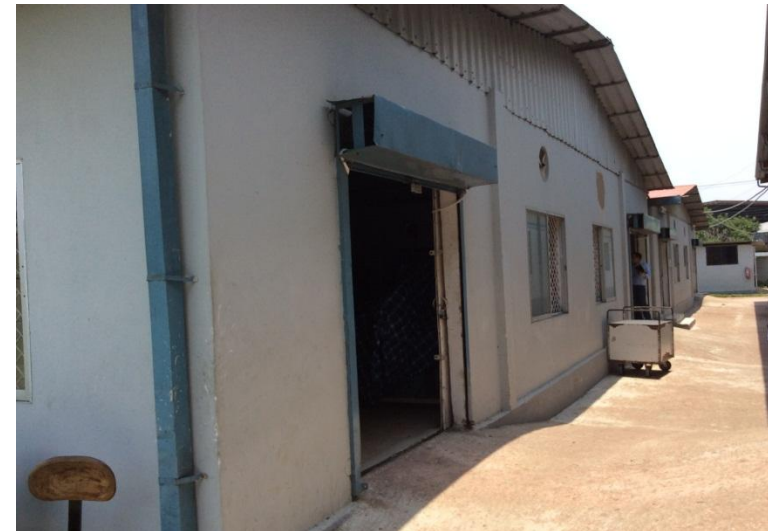
We were informed that lateral load was included in the design of Shed 1.

However there are concerns on the stability system for wind/seismic lateral loading as well as uplift due to wind for Shed 2, Shed 3 and Shed 4. These structures lack moment capacity in the connections between columns and beams.

We require that these items be investigated in a Detail Engineering Assessment.

| Item No. | Observation | Recommended Action Plan | Recommended Timeline |
|---|---|---|---|
| 4 | Overall stability system. | Request that the Detail Engineering Assessment of the overall building to be carried out and in particular, stability and foundation aspects should be investigated in detail. | 6-weeks |

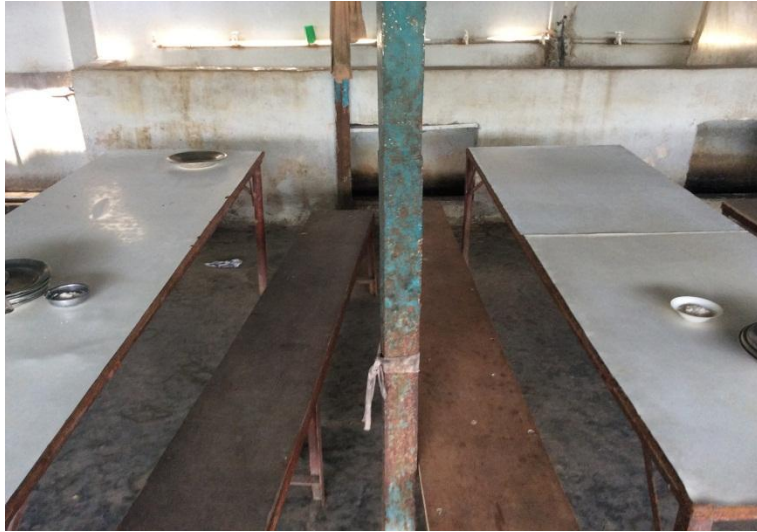
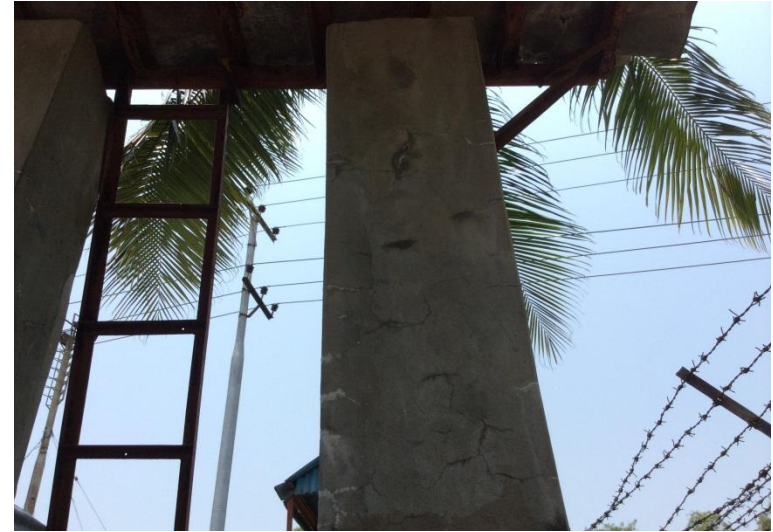
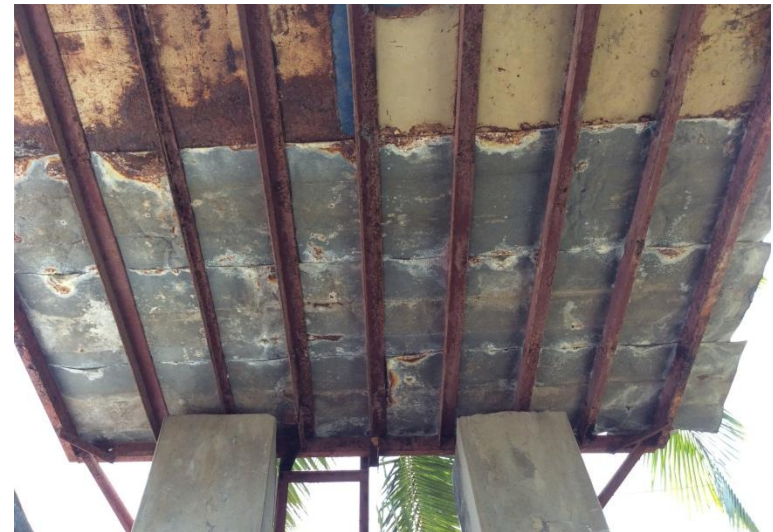
There are distresses due to water ingress noted on both steel structure elements and RC structure elements especially at over head water tank.

| Item No. | Observation | Recommended Action Plan | Recommended Timeline |
|---|---|---|---|
| 5 | Distress due to water ingress. | Factory Engineer to inspect water damaged structures and repair with a suitable method. | 6-weeks |
| 6 | Distress due to water ingress. | For both durability and serviceability, rustproofing is recommended. Maintain standard of quality control. | 6-months |
