# Islam Garments Ltd.

Zirabo, Ashulia, Savar, Dhaka.

16 April 2015

# Observations

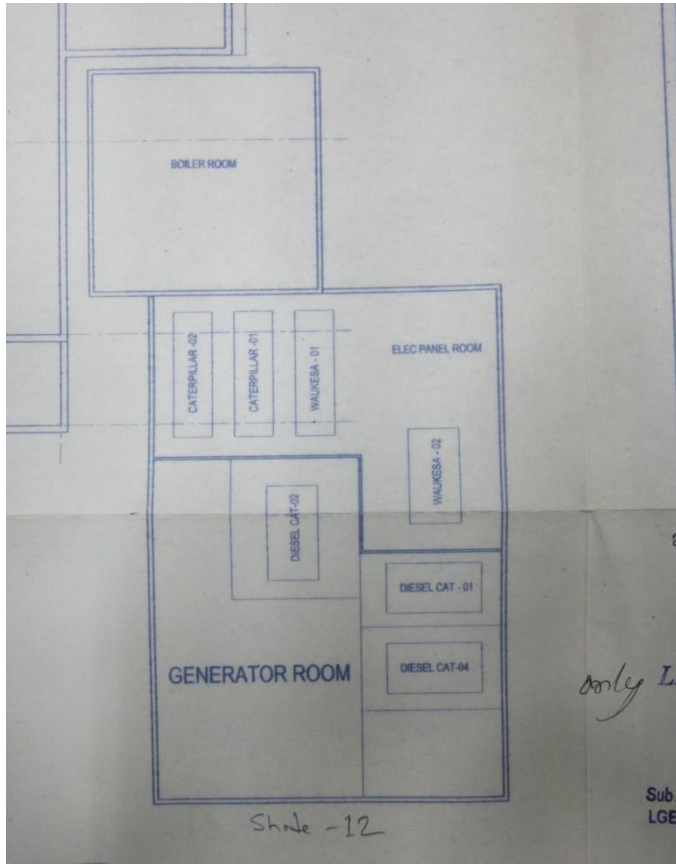
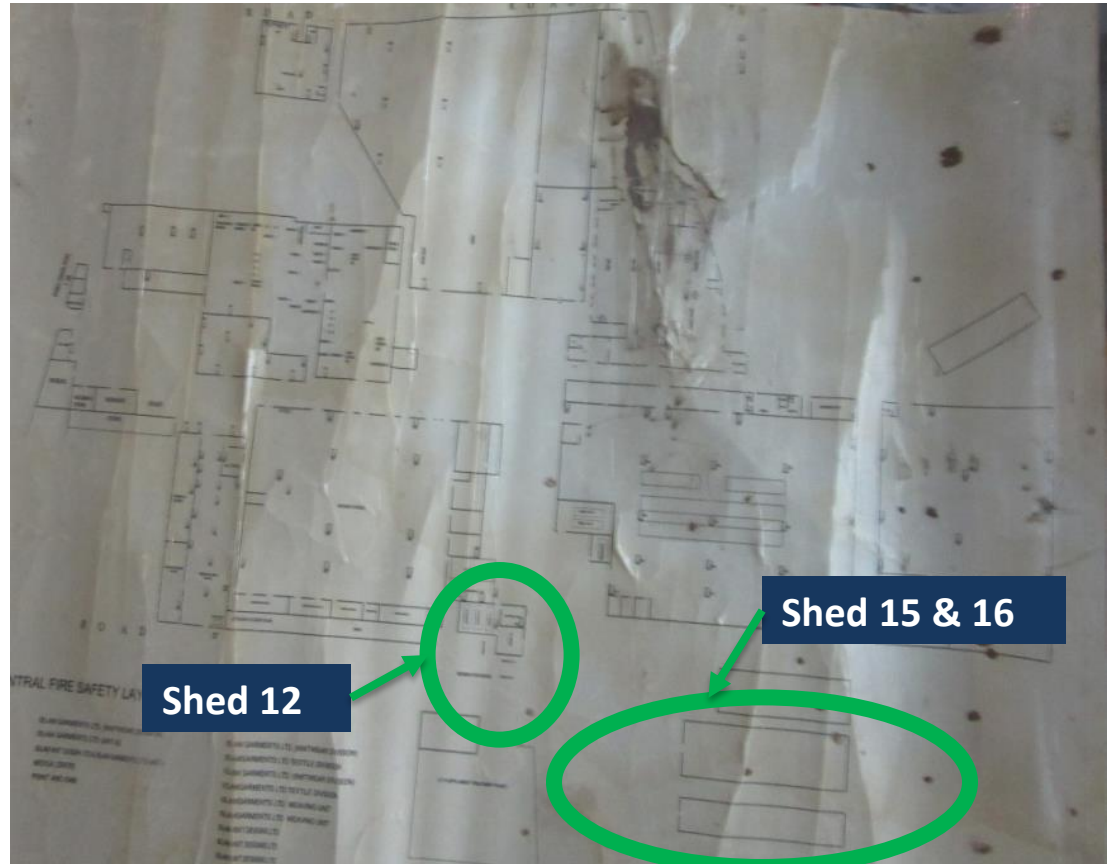
# **Absence of relevant technical documentation**

No relevant structural and/or architectural documents were available. For survey purposes industrial permit drawings were used without indication of any proper measurements or technical information.

| Item No. | Observation | Recommended Action Plan | Recommended Timeline |
|---|---|---|---|
| 1 | Absence of relevant technical documentations | Building Engineer to survey as constructed buildings. As-built drawings to be prepared showing the correct as constructed layouts, reinforcement in the main structural elements and precisions on the roof structures with the connection to the load bearing elements. | 6-months |

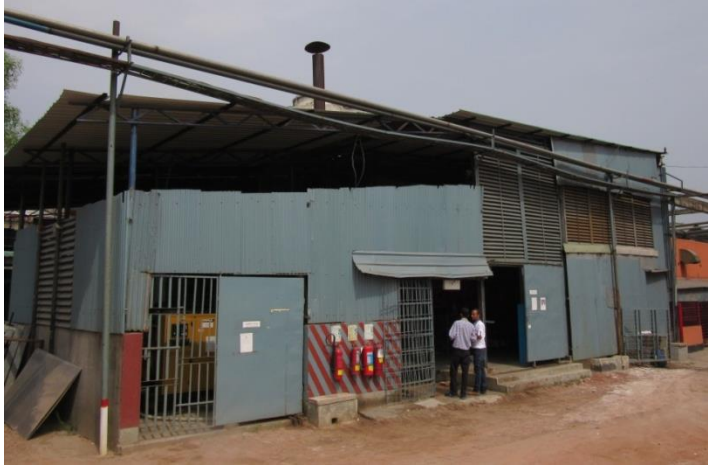
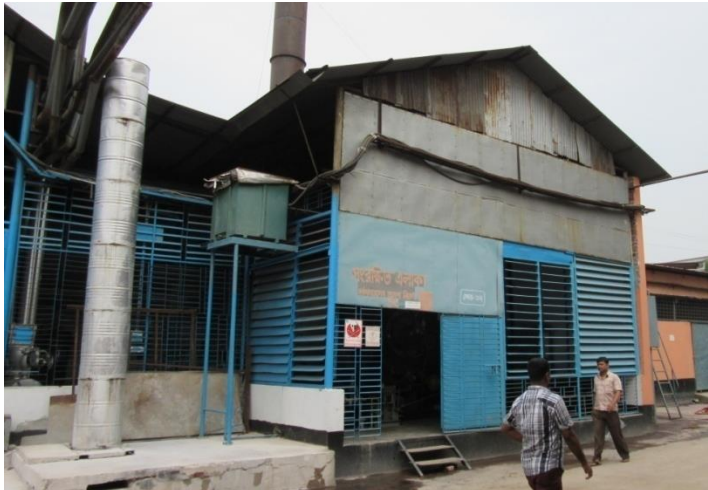
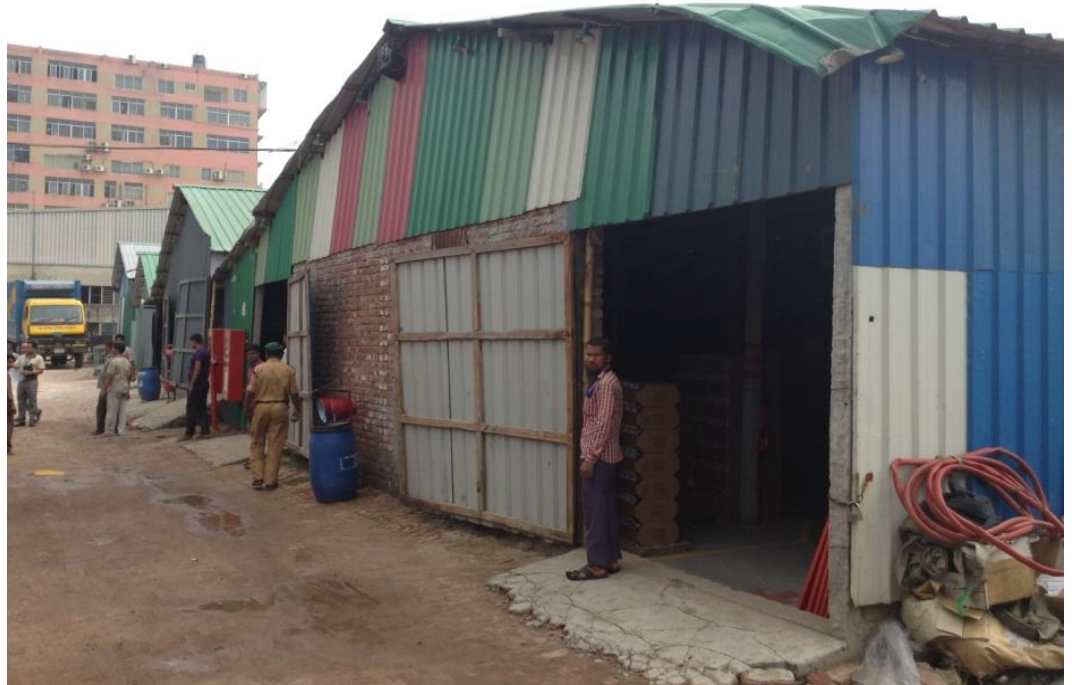
# **Apparently non engineered sheds with no apparent lateral stability system**

**Apparently non engineered sheds with non apparent lateral stability system.**

| Item No. | Observation | Recommended Action Plan | Recommended Timeline |
|---|---|---|---|
| 2 | Apparently non-engineered sheds with no-apparent lateral stability system | As part of the preparation of the As-built documentation the Building Engineer to investigate the code adequacy of the load bearing structure and the lateral stability of the sheds. | 6-months |
| 3 | Apparently non-engineered sheds with no-apparent lateral stability system | Building engineer to verify the code adequacy of the connections and the transfer of horizontal and vertical loads from the roof to the vertical load bearing structural elements and then to the foundations, | 6-months |
| 4 | Apparently non-engineered sheds with no-apparent lateral stability system | If necessary remedial works to be defined. | 6-months |
| 5 | Apparently non-engineered sheds with no-apparent lateral stability system | Make any structural alterations as advised by Building Engineer. | 6-months |

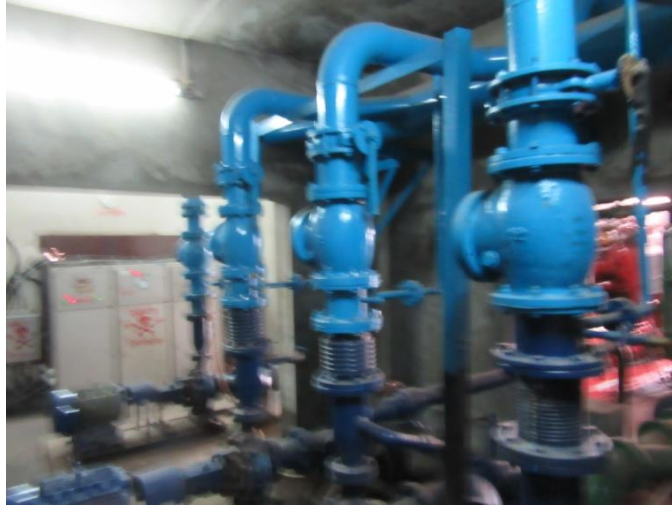
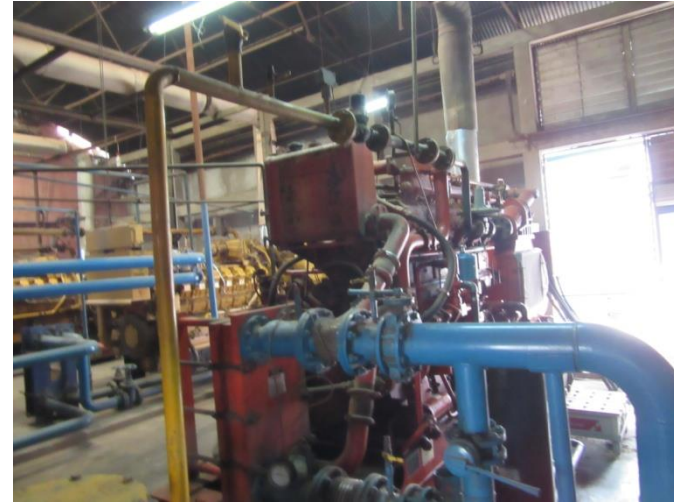
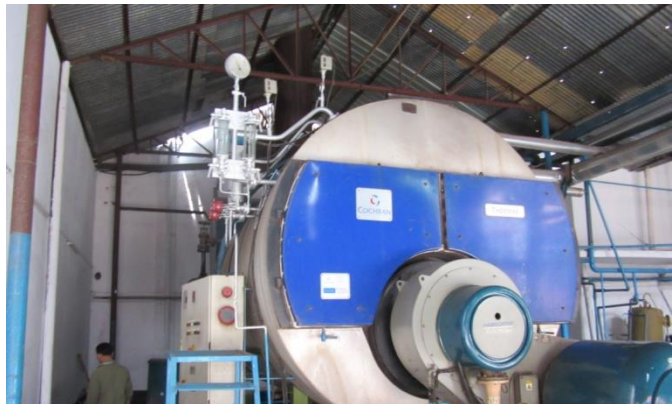
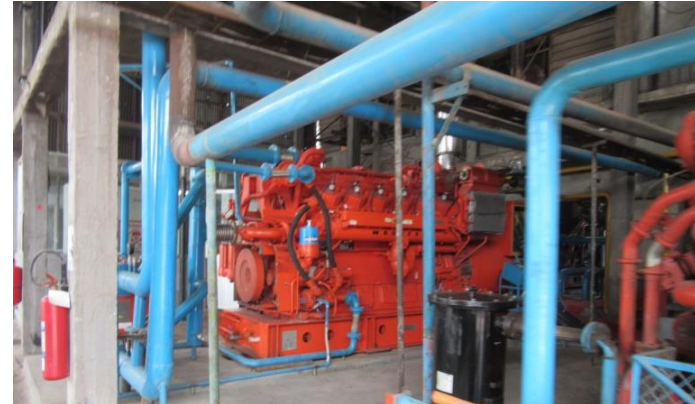
# **Excessive working condition (Heat, Vibration)**

**Excessive heat and vibrations from boiler and generator were observed. High temperature steam is evacuated directly on the surface of structural elements.**

| Item No. | Observation | Recommended Action Plan | Recommended Timeline |
|---|---|---|---|
| 6 | Excessive working conditions (heat, vibration, steam) | Building engineer to prescribe measures for protection of the structure of the shed from vibration, heat and steam direct impact. | 6-months |
| 7 | Excessive working conditions (heat, vibration, steam) | Make any structural alterations as advised by Building Engineer | 6-months |

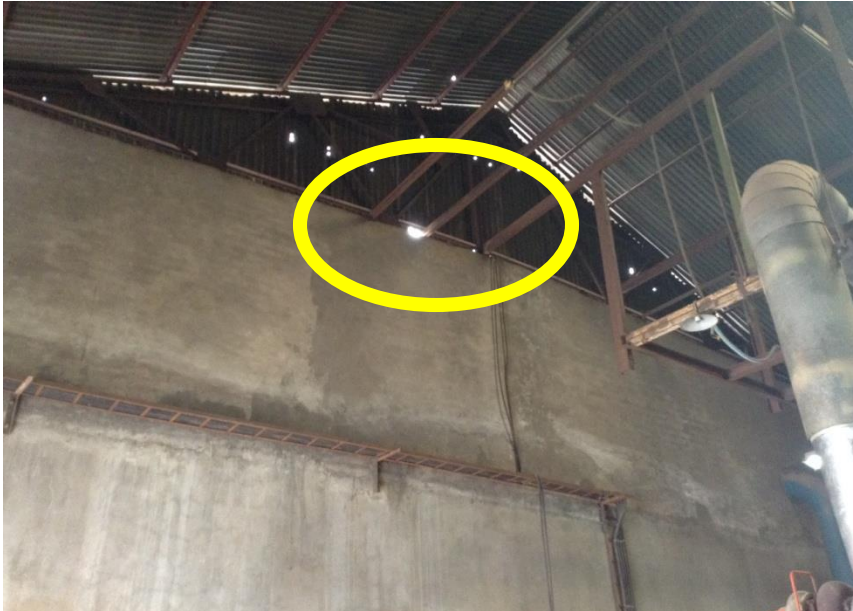
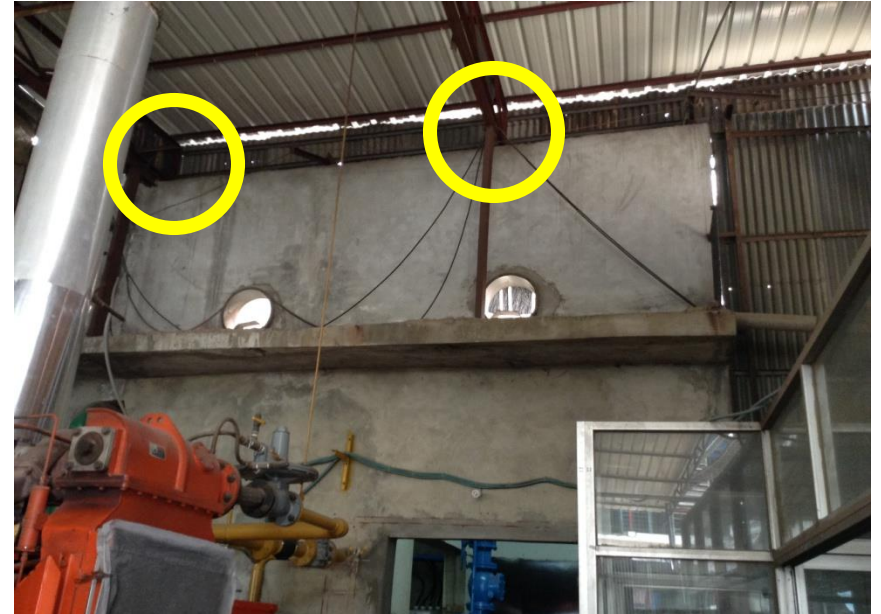
# **Apparently non-engineered connection between brick wall and steel structure**

**No drawings with connection details were found on site. The connections seem non-engineered**

| Item No. | Observation | Recommended Action Plan | Recommended Timeline |
|---|---|---|---|
| 8 | Apparently non-engineered connection between brick wall and steel structure | As part of the preparation of the As-built documentation the Building Engineer to investigate the connection between the steel shed roof and the brick walls. The parameters of the these connections and the eventual existence of concrete elements to be defined precisely. | |
| 9 | Apparently non-engineered connection between brick wall and steel structure | Building engineer to verify the code adequacy of the connections and the transfer of horizontal and vertical loads from the roof to the vertical load bearing structural elements. | 6-months |
| 10 | Apparently non-engineered connection between brick wall and steel structure | Make any structural alterations as advised by Building Engineer | 6-months |

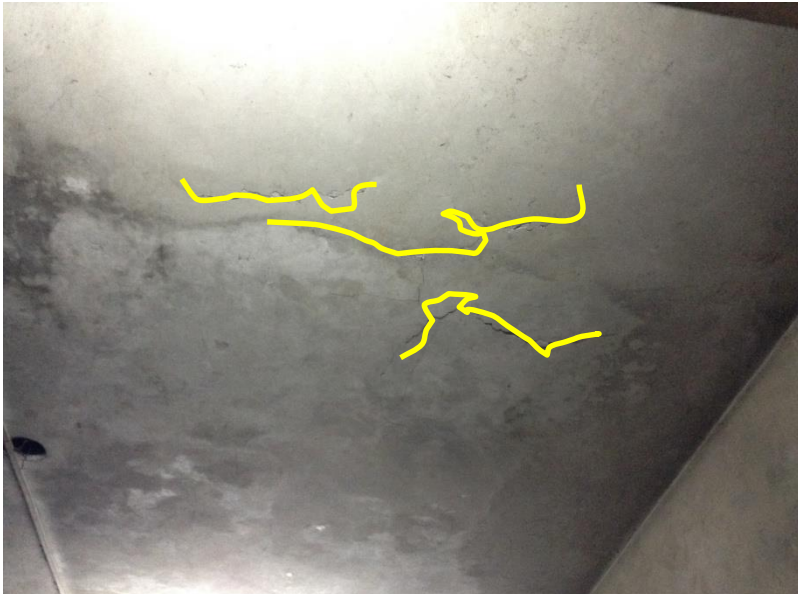
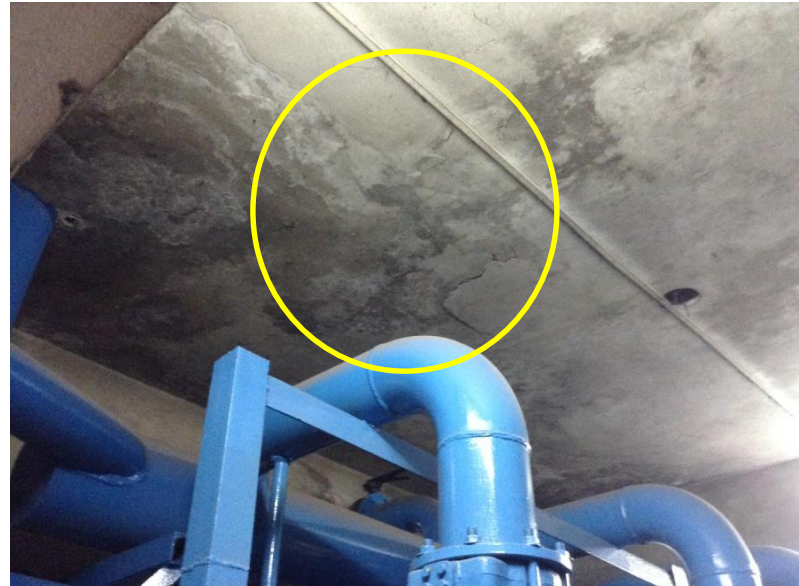
# Hair line cracking

Few hairline cracks were observed on the ceiling slab

| Item No. | Observation | Recommended Action Plan | Recommended Timeline |
|---|---|---|---|
| 11 | Hair line cracking | As part of the preparation of the As-built documentation the Building Engineer to investigate the reason for appearance of the hairline cracking | 6-months |
| 12 | Hair line cracking | Carry out any remedial structural works arising from investigation. | 6-months |

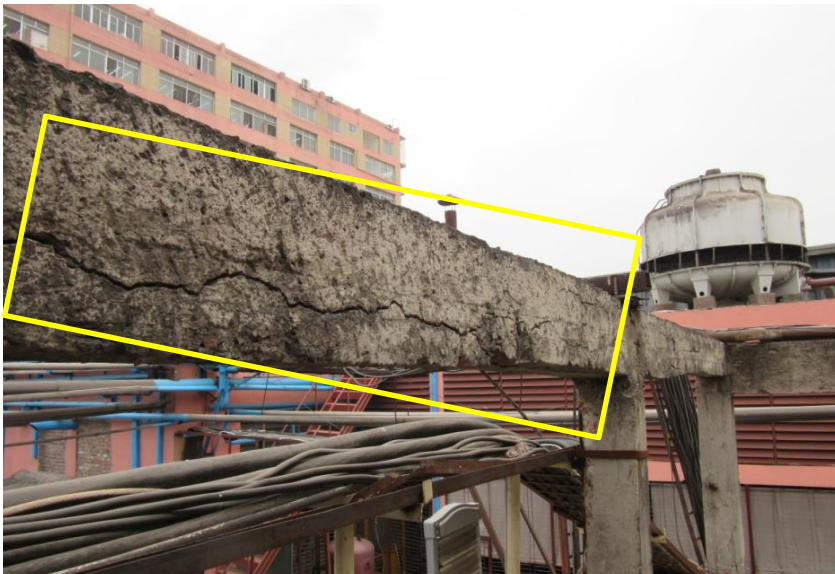
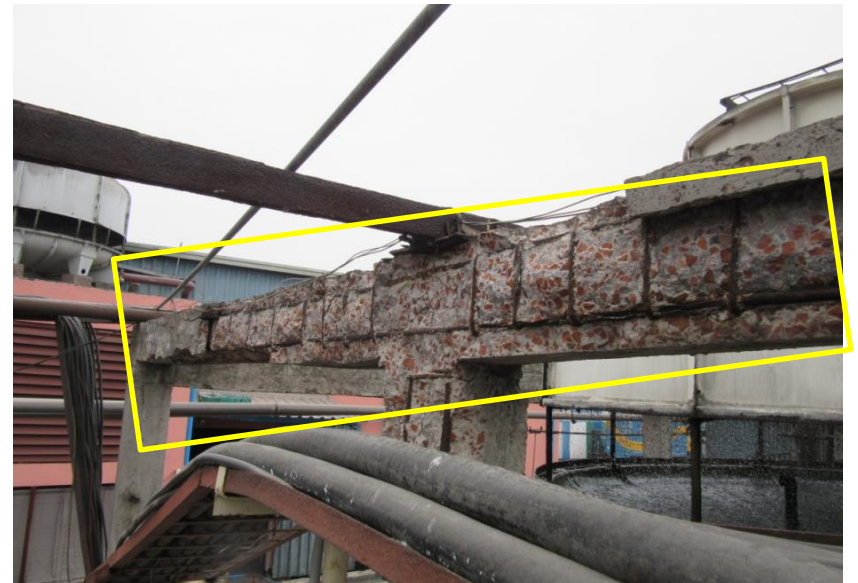
# **Falling hazard of deteriorated elements (cracked columns and beam on roof)**

**Some non loadbearing RC elements situated on the roof are in non-service condition which could present a falling hazard**

| Item No. | Observation | Recommended Action Plan | Recommended Timeline |
|---|---|---|---|
| 13 | Falling hazard of deteriorated elements (cracked columns and beam on roof) | Building engineer to prescribe measures to eliminate the existing risk of falling hazard either by removal of the cracked elements or by strengthening of this elements. | 6-months |
| 14 | Falling hazard of deteriorated elements (cracked columns and beam on roof) | Make any work alterations as advised by Building Engineer | 6-months |

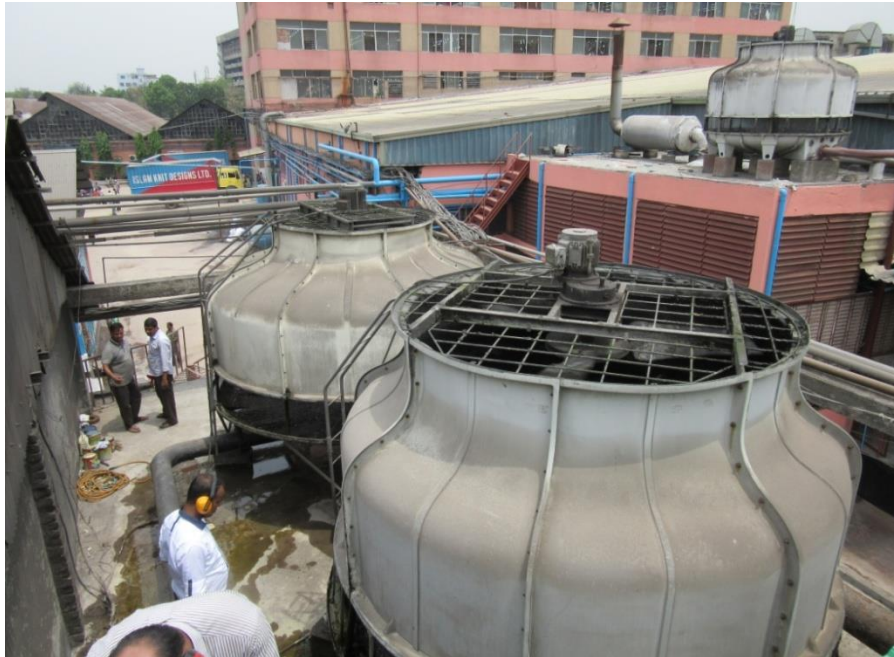
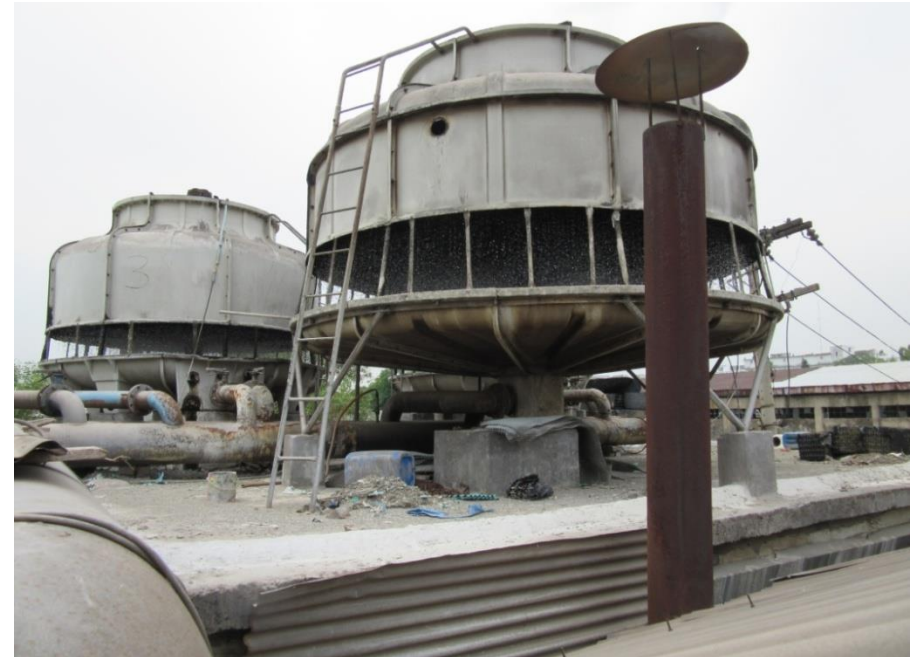
# Heavy loading on roof

Large water coolers for boiler use were placed in a close proximity on roof

| Item No. | Observation | Recommended Action Plan | Recommended Timeline |
|---|---|---|---|
| 15 | Heavy loading on roof | As part of the preparation of the As-built documentation, Building Engineer to confirm design loading of slabs. | 6-months |
| 16 | Heavy loading on roof | Produce a loading plan and actively manage the floor loading for all floor plates giving consideration to floor capacity and column capacity. | 6-months |
| 17 | Heavy loading on roof | Continue to implement the load management plan | 6-months |

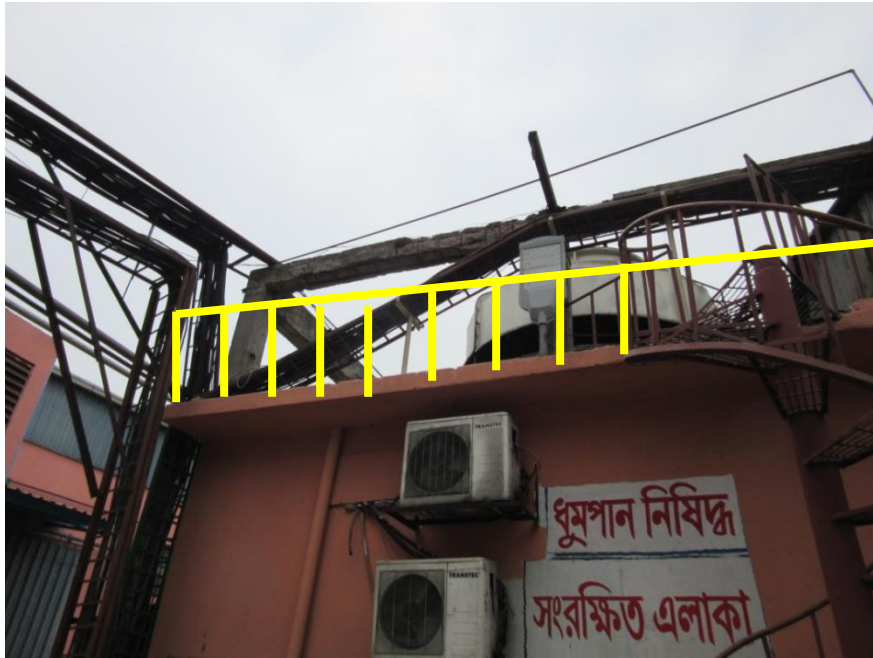
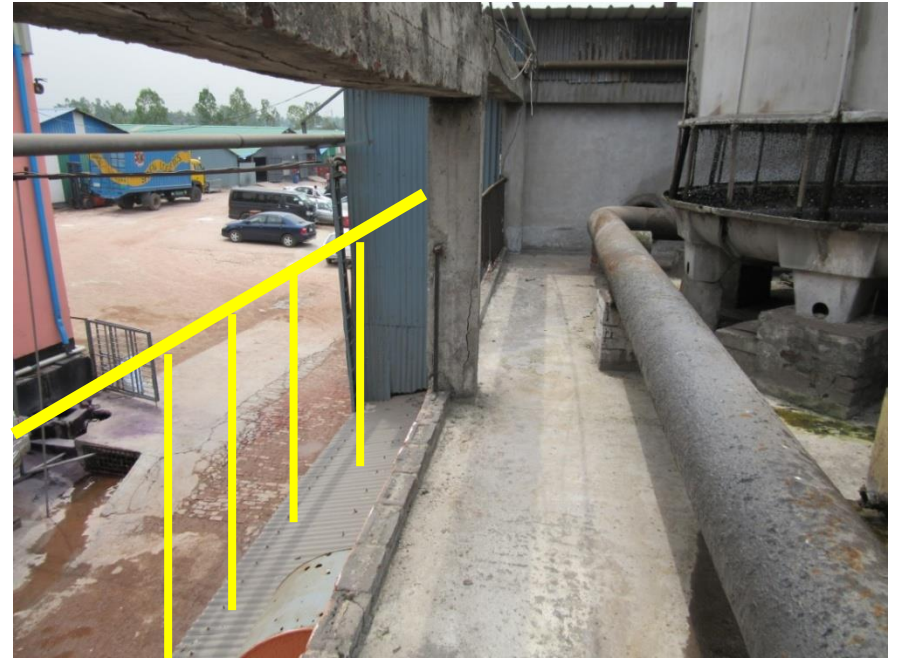
# **Lack of edge protection on roof**

Lack of edge protection may cause falling hazard

| Item No. | Observation | Recommended Action Plan | Recommended Timeline |
|---|---|---|---|
| 18 | Lack of edge protection on the roof | Secure appointed areas of hazards and provide an appropriate fall protection. | 6-months |
| 19 | Lack of edge protection on the roof | Monitor fall protection over time and insure their maintenance. | 6-months |

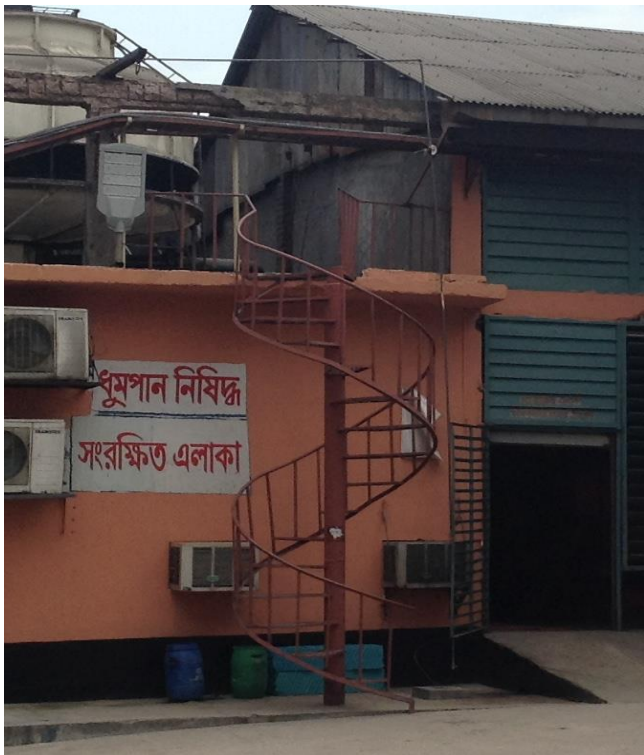
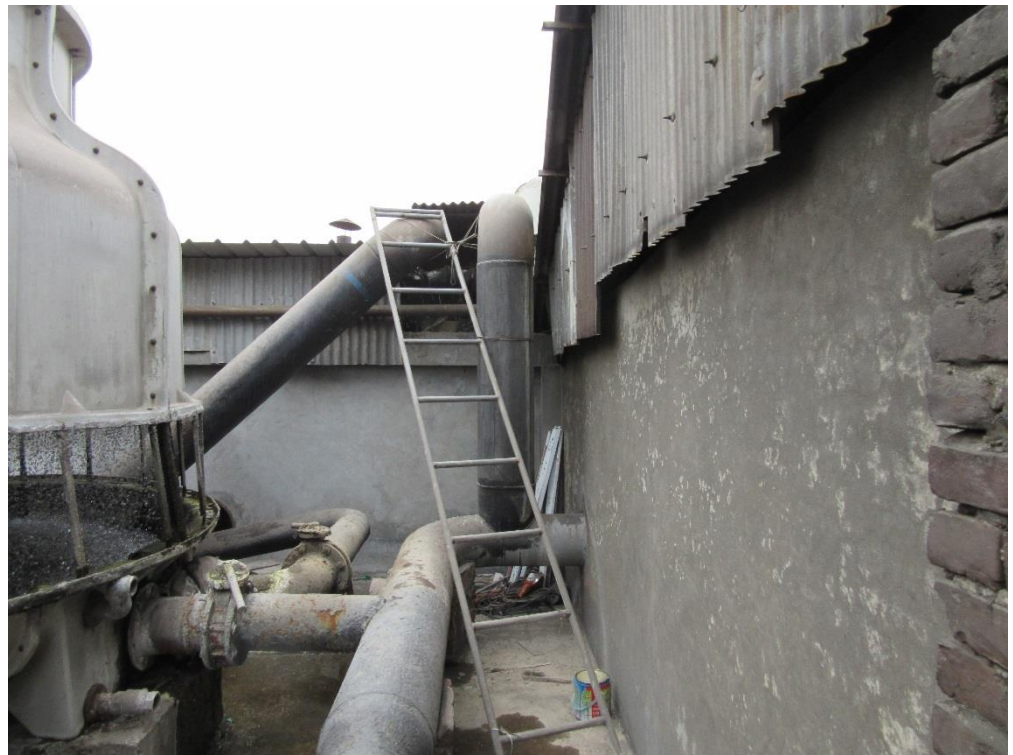
# Apparently non engineered stair

Steel stairs appear to be non engineered.

| Item No. | Observation | Recommended Action Plan | Recommended Timeline |
|---|---|---|---|
| 20 | Apparently non-engineered stairs | As part of the preparation of the As-built documentation Building Engineer to survey and investigate the steel stairs | 6-months |
| 21 | Apparently non-engineered stairs | Adequacy for code vertical and horizontal loads to be ensured. | 6-months |
| 22 | Apparently non-engineered stairs | Complete any structural alterations as advised by Building Engineer. | 6-months |
