# JFK Fashion Ltd.

Mowsayed, Uttarkhan, Uttara  
(23.898021N, 90.437810E)

13<sup>th</sup> March 2017

# Observations

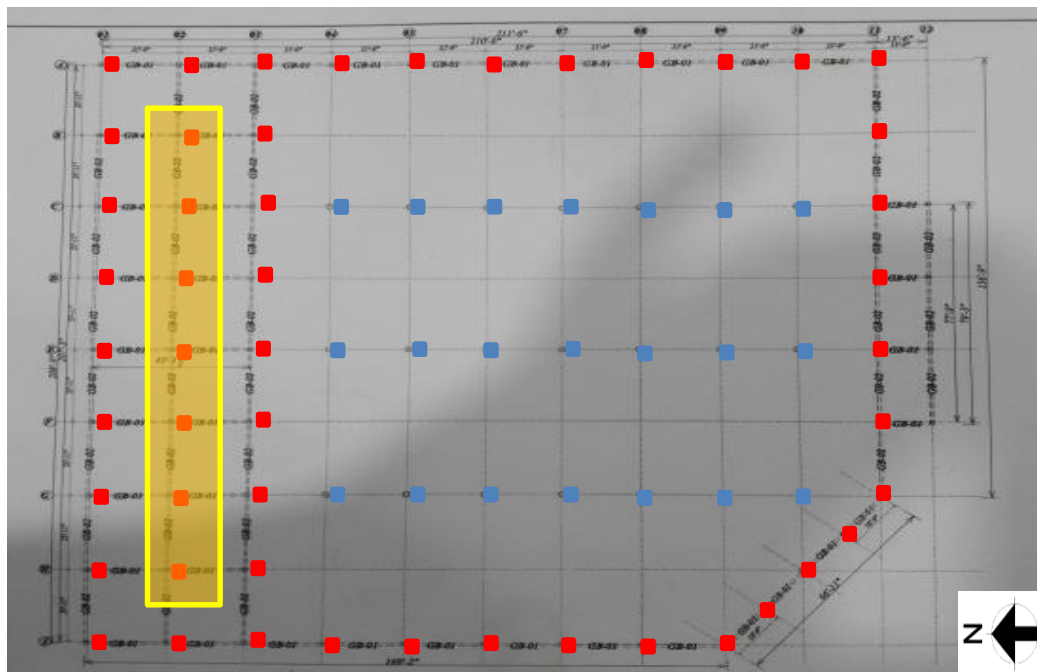
Column Layout

Cursory calculations indicate that all internal columns are highly stressed at ground floor. Building Engineer to review design, loads and columns stresses.

The reinforcement quantities recorded at Ground Floor level using the Ferro scanner coincided with the values provided in the Column Schedule. Brick aggregate was observed on-site. No loading plan was provided for the building.

| Item No. | Observation | Recommended Action Plan | Recommended Timeline |
|---|---|---|---|
| 1 | High Stress in Column | Factory Engineer to review design, loads and columns stresses in area identified above. | Immediate - Now |
| 2 | High Stress in Column | Verify insitu concrete stresses either by 100mm dia. cores or existing cylinder strength data for [the identified columns] or [100mm dia. cores from 4 columns] | Immediate - Now |
| 3 | High Stress in Column | A Detail Engineering Assessment of Factory to be commenced, see attached Scope. | Immediate - Now |
| 4 | High Stress in Column | Produce and actively manage a loading plan for all floor plates within the factory giving consideration to floor capacity and column capacity. | 6-weeks |

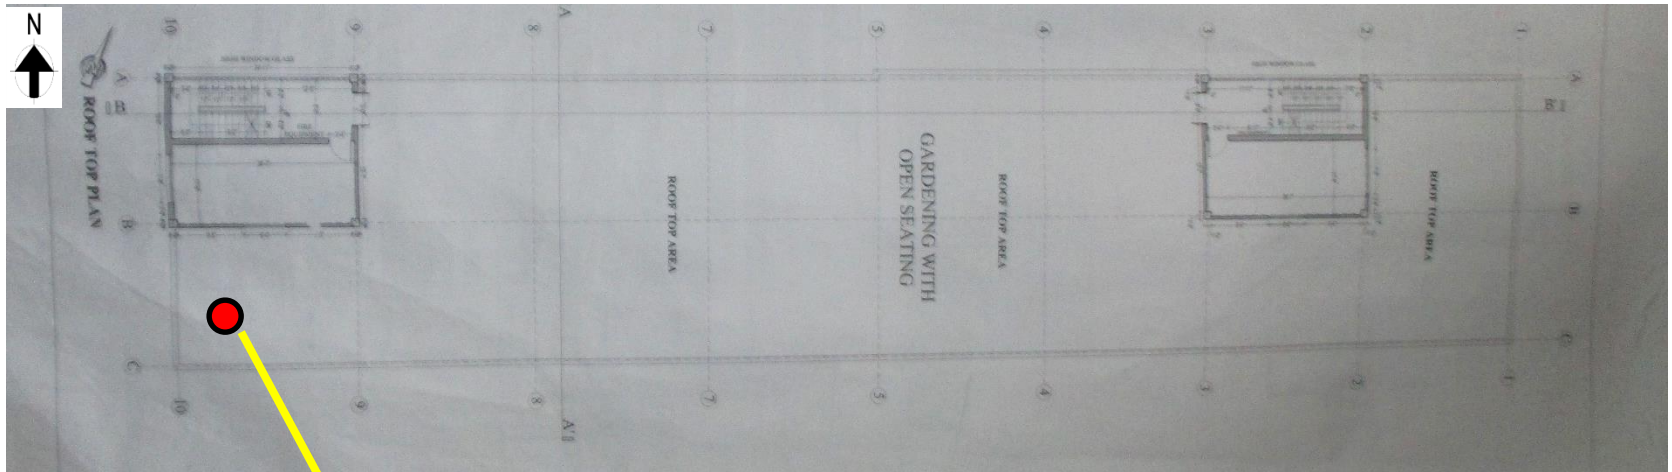
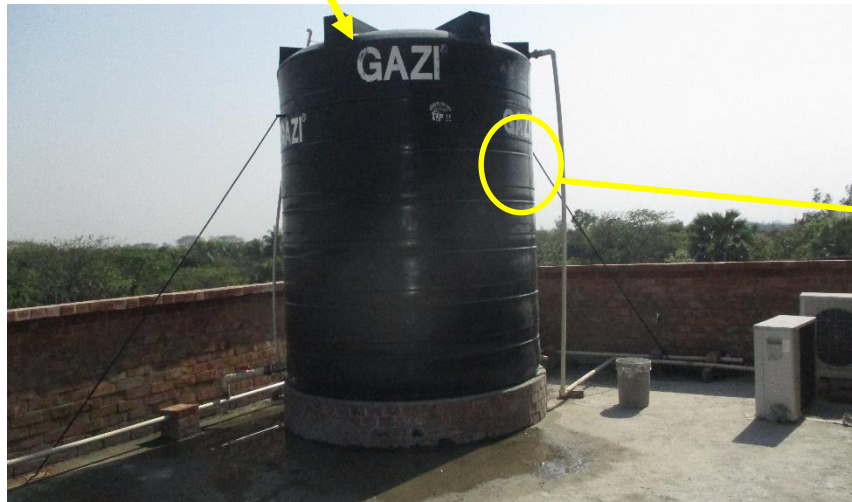
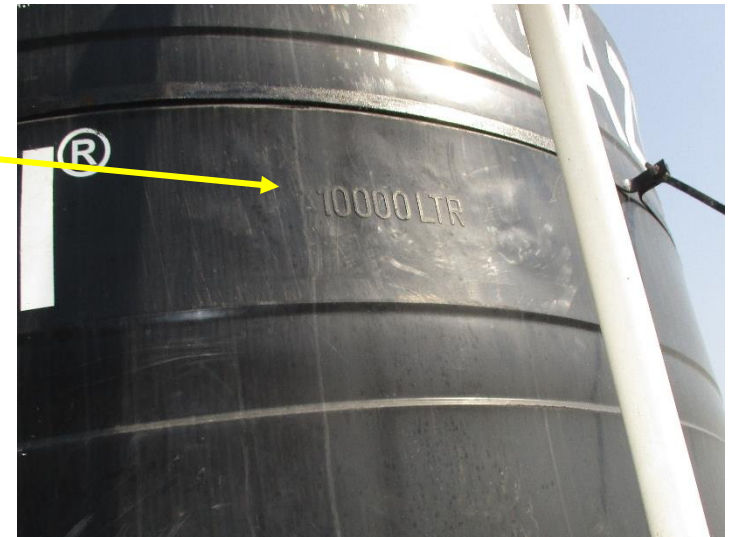
A 10000 liters capacity Over head plastic water tank was found at west side of roof. Factory engineer is required to check the adequacy of slab and beam .

| Item No. | Observation | Recommended Action Plan | Recommended Timeline |
|---|---|---|---|
| 8 | Heavy water tank on roof | Provide calculations showing the structural adequacy of slab. | 6-weeks |
| 9 | Heavy water tank on roof | Verify that supporting structures have adequate capacity to support heavy loading such as plastic water tank. | 6-weeks |
| 10 | Heavy water tank on roof | Remedial works to be carried out if required. | 6-months |

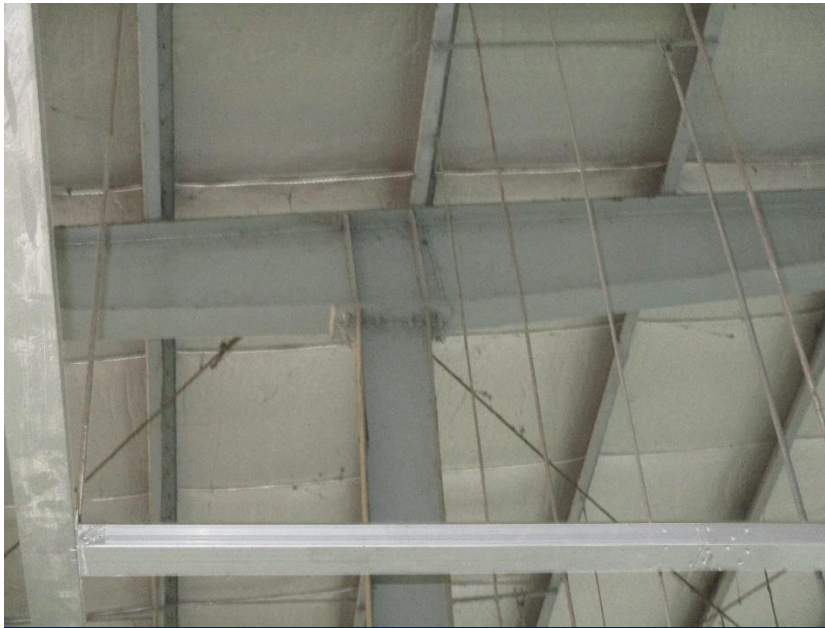
Beam column connection

Structural drawings for steel structural of main production building was missing in the time of inspection. Member size, connection details, bracing layout nothing was available.

| Item No. | Observation | Recommended Action Plan | Recommended Timeline |
|---|---|---|---|
| 11 | Lack of Structural drawing for steel structure | Engage an Engineer to produce an “as constructed” drawings which reflect the actual site dimensions with complete structural information's. | 6-weeks |

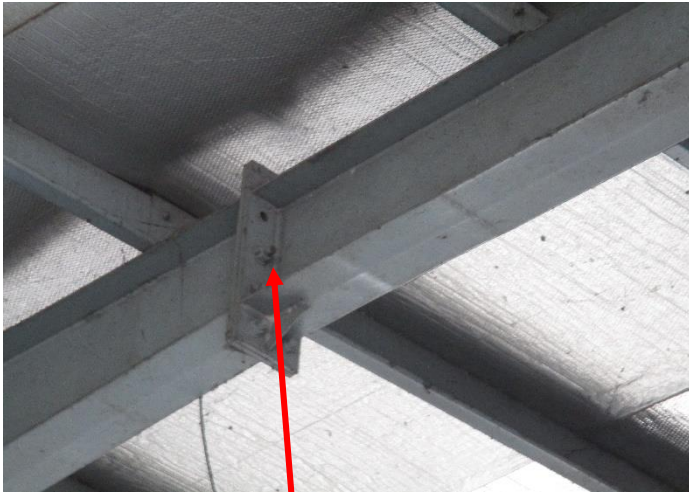
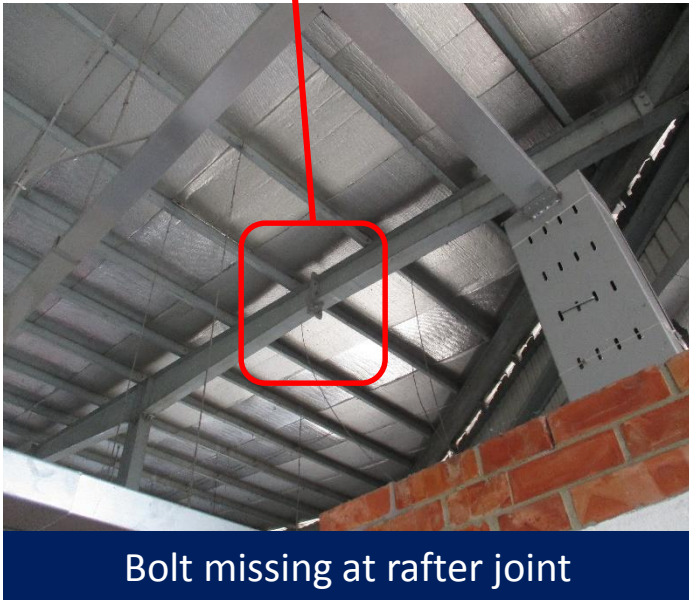
Bolt missing at rafter joint

| Item No. | Observation | Recommended Action Plan | Recommended Timeline |
|---|---|---|---|
| 12 | Bolt missing at rafter connection & Roof Bracing not continuous to end | Install missing bolt and bracing as per bracing layout. | 6-weeks |

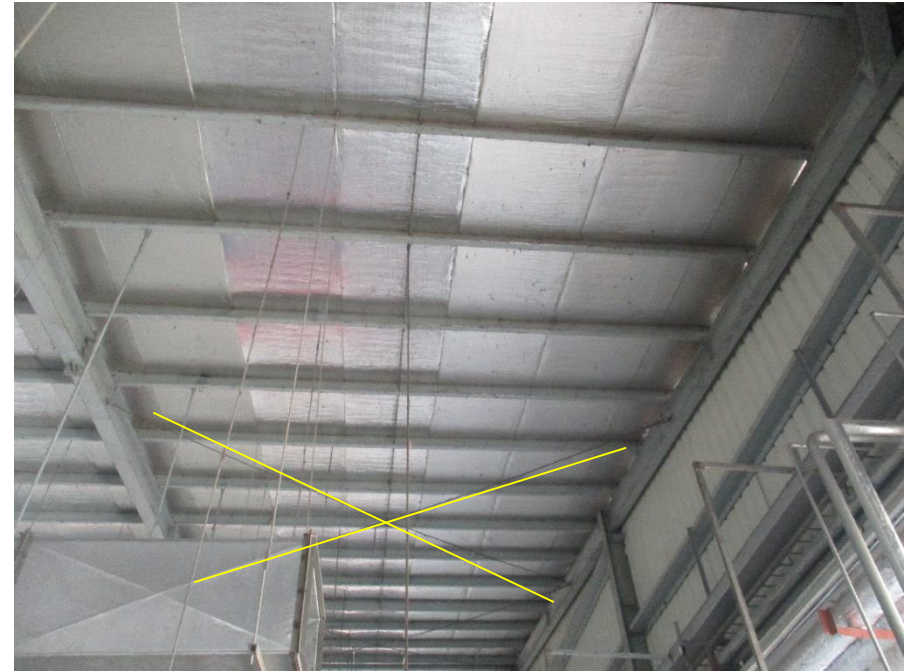
At south roof bracing does not continuous to end. Bracings are shown yellow in picture.

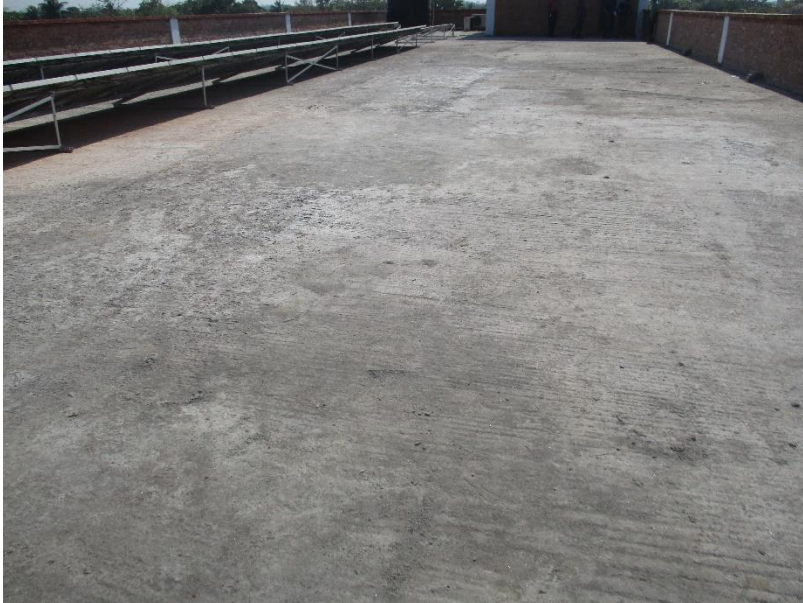
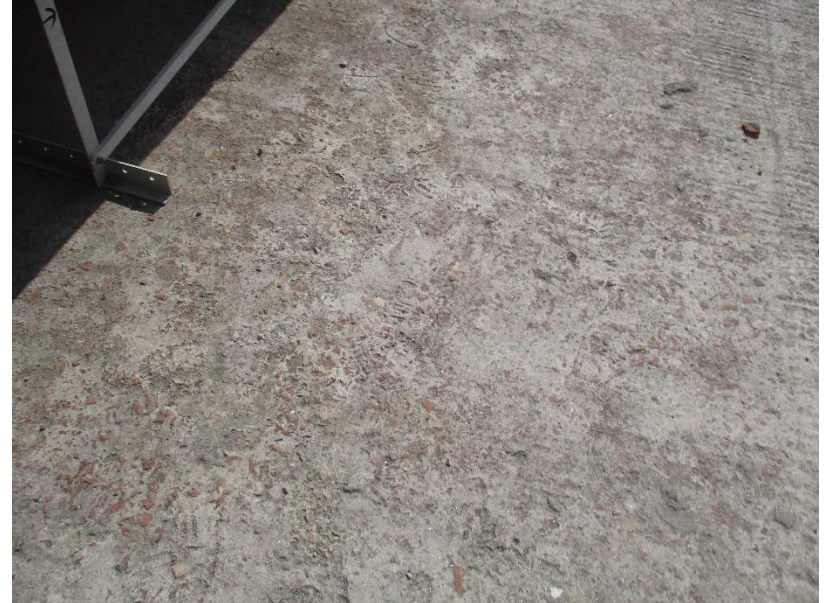
No water proofing was observed at roof and aggregates were expose to air in some areas.

| Item No. | Observation | Recommended Action Plan | Recommended Timeline |
|---|---|---|---|
| 13 | No water proofing at roof | Waterproofing on the roof slab is to be applied | 6-weeks |

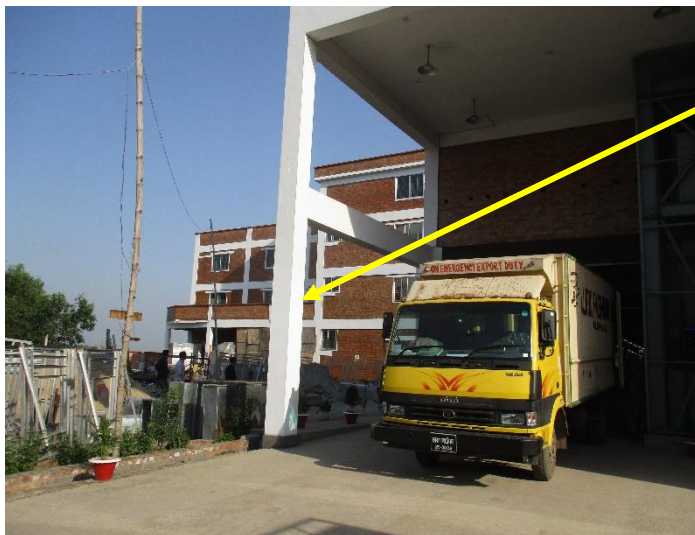
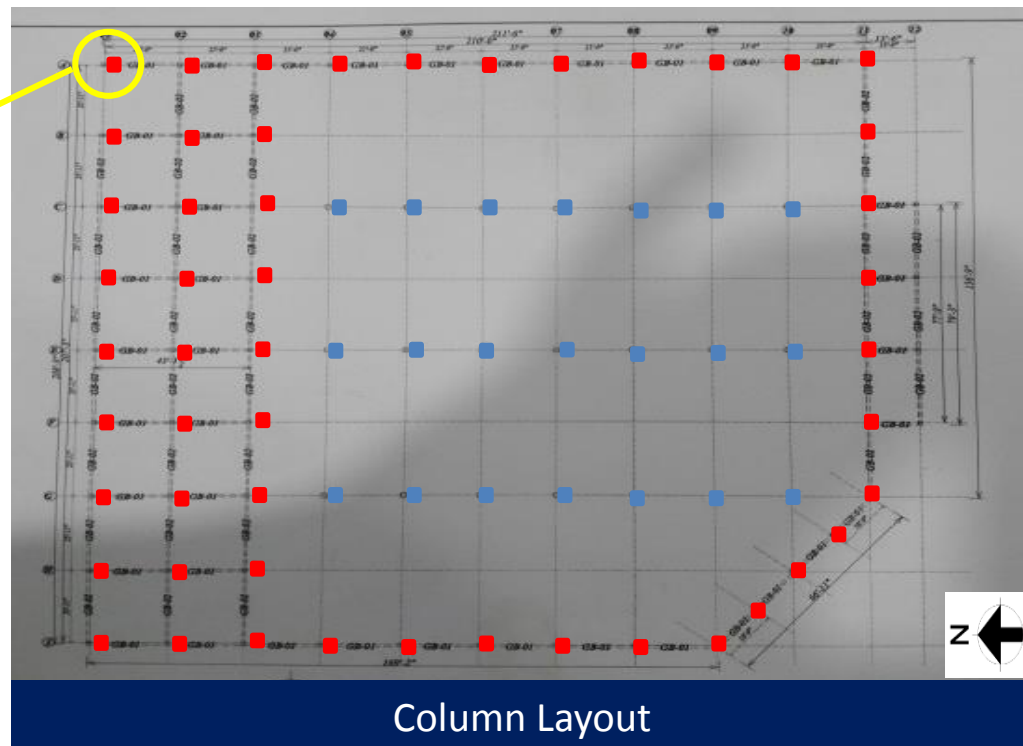
Impact protection not provided to columns at loading –unloading area. Columns are susceptible to impact loading from vehicles.

| Item No. | Observation | Recommended Action Plan | Recommended Timeline |
|---|---|---|---|
| 14 | Columns susceptible to vehicle impact | Install a barrier to prevent vehicle impact in column | 6-weeks |

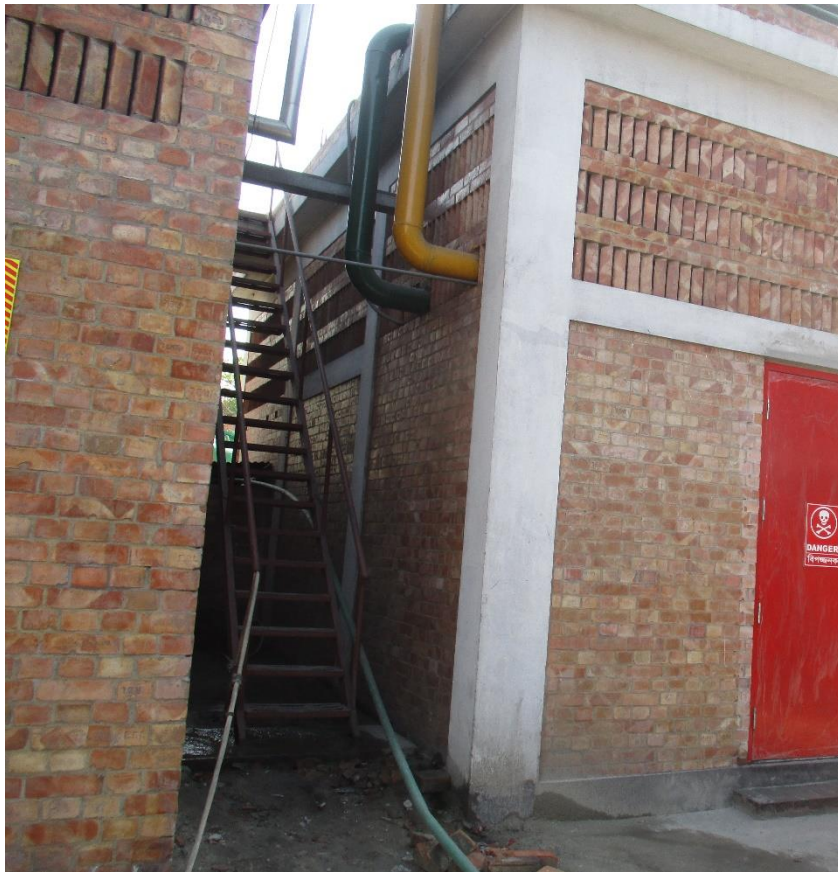
External steel stair between Boiler & Chiller room

The member of stairs and the connection to the building appears to be poor. Building Engineer to carry out a design check on the suitability of the steel exit stair with particular emphasis on member adequacy and connections, and to carry out the necessary remedial works.

| Item No. | Observation | Recommended Action Plan | Recommended Timeline |
|---|---|---|---|
| 15 | Non-engineered external steel Stair | Engage Building Engineer to check load bearing capacity of external escape stair and to ensure adequate stability and connections are provided. | 6-weeks |
