# Lida Textile & Dyeing Limited (Extended Buildings)

Holding 100/2, Block B, Shaheed Mosharaf Hossain Road, Purbo chandora, Shofipur, Kaliakoir, Gazipur  
(24.036580N, 90.271251E)  
28<sup>th</sup> March 2017

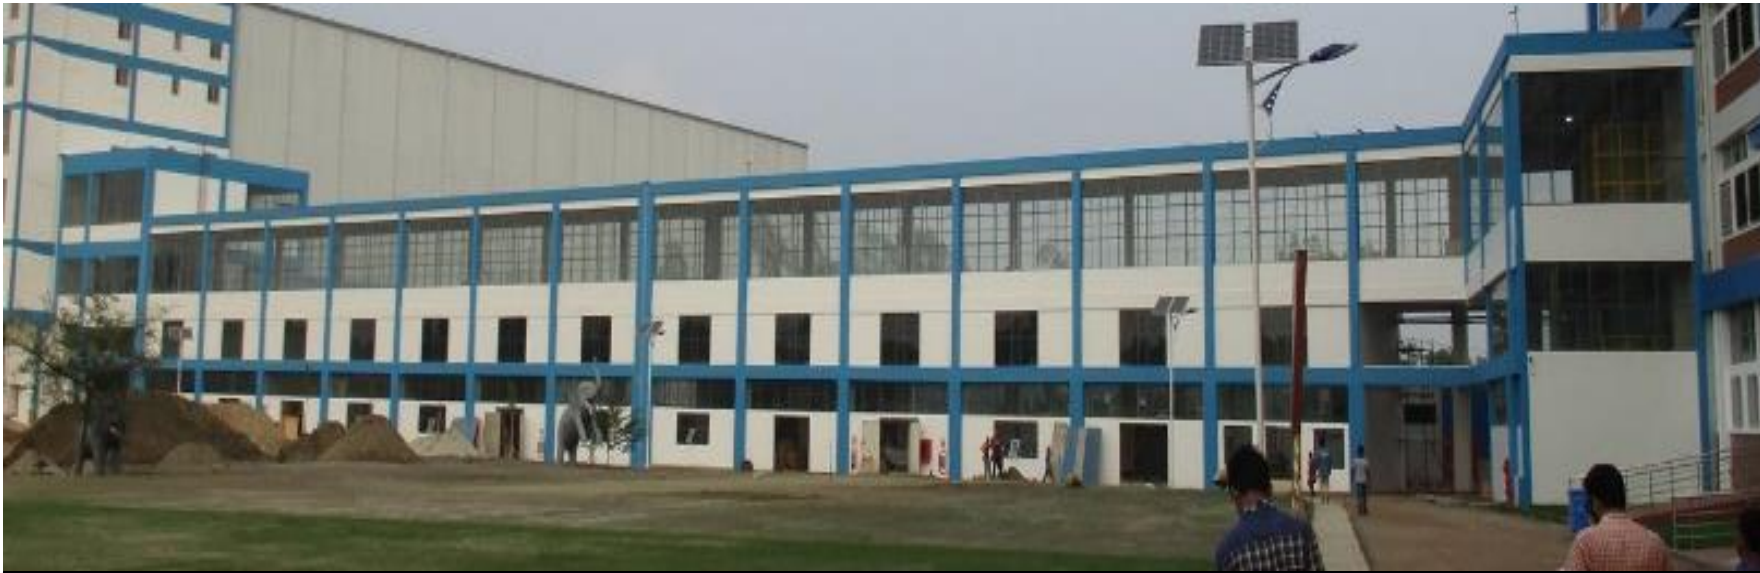
# Insufficient as-built drawing for conveyer belt building

As-built was not available for the conveyer belt building

| Item No. | Observation | Recommended Action Plan | Recommended Timeline |
|---|---|---|---|
| 1 | Insufficient as-built drawing for conveyer belt building | Engage a Building Engineer to survey the structure and update a full set of “as-constructed” drawings. | 6-weeks |

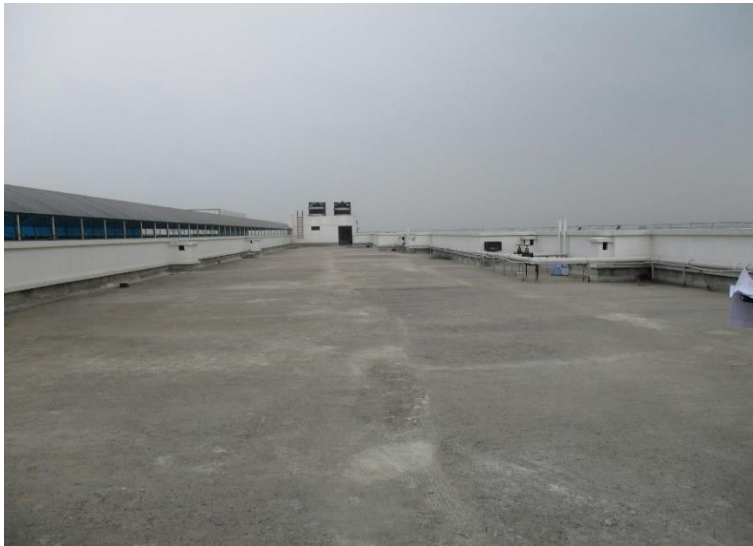
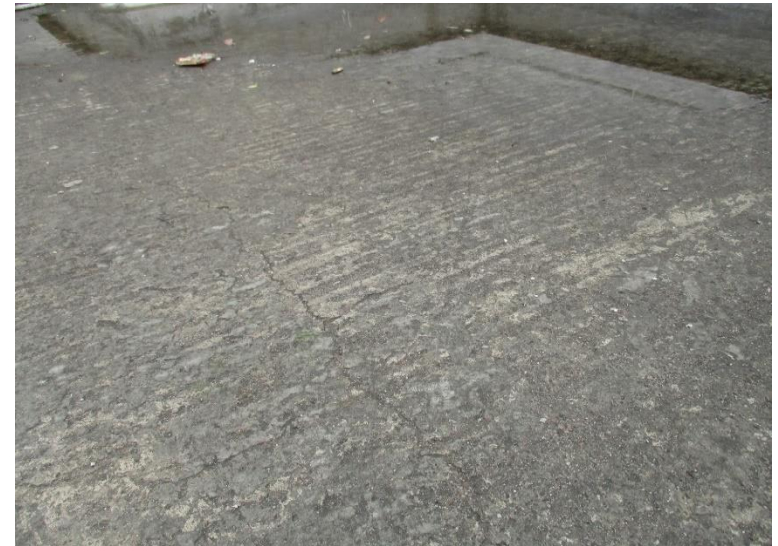
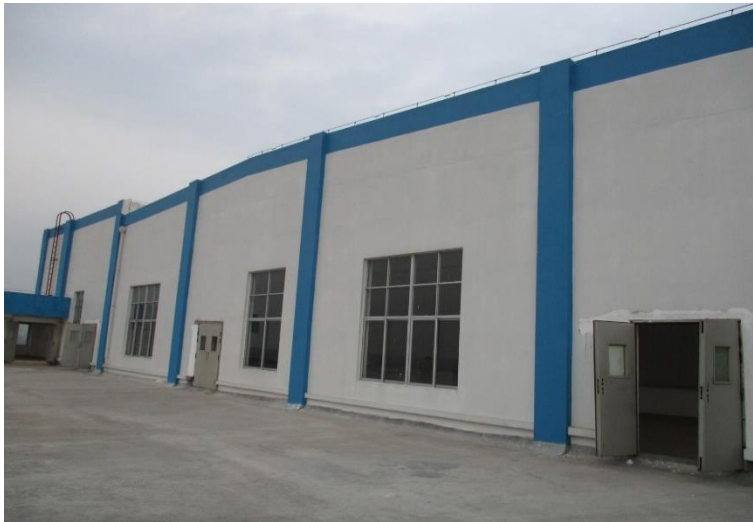
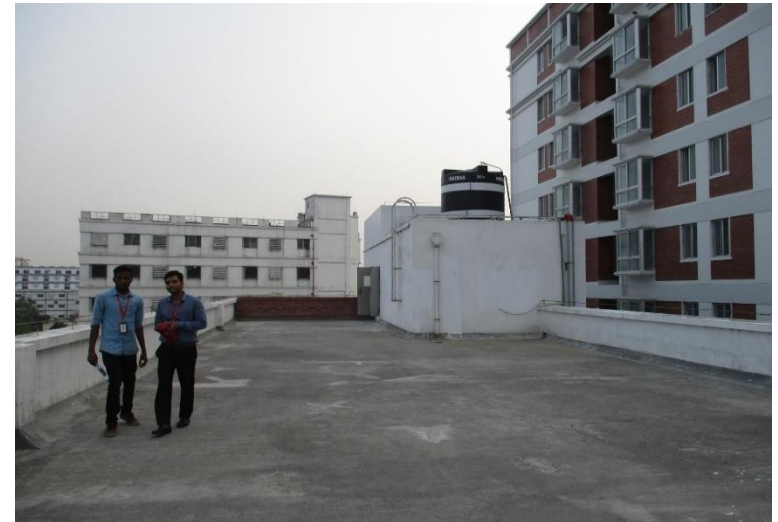
**Lack of water proofing membrane on roof for  
all buildings**

Water proofing membrane was not observed on the roof for all RC building. Some micro cracks were observed on the roof slab which may allow the water into the slab concrete.

| Item No. | Observation | Recommended Action Plan | Recommended Timeline |
|---|---|---|---|
| 2 | Lack of water proofing membrane on roof for all buildings | Building Engineer to develop the drainage system on roof and apply water proofing membrane to resist the water ingress into the slab. | 6-months |

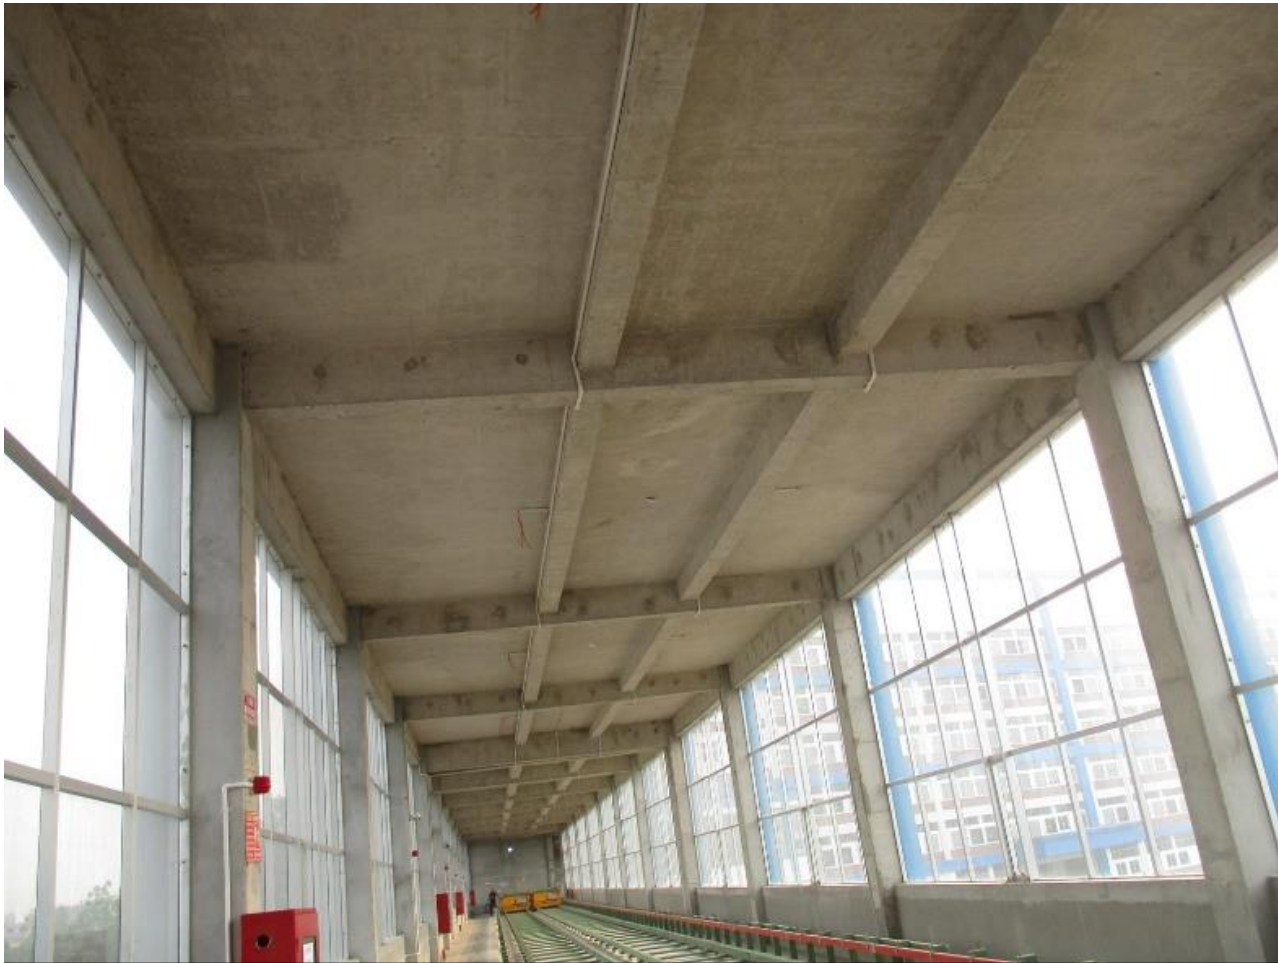
# Lateral stability of conveyer belt building

The frame of this 2 storey building comprised with a single bay which may critical for the lateral loading from transverse direction. Factory engineer to check the stability of the building for lateral loading.

| Item No. | Observation | Recommended Action Plan | Recommended Timeline |
|---|---|---|---|
| 3 | Lateral stability of conveyer belt building | Building Engineer to check the stability system against lateral loading. | 6-weeks |
| 4 | Lateral stability of conveyer belt building | Implement the remedial works suggested by the engineer | 6-months |

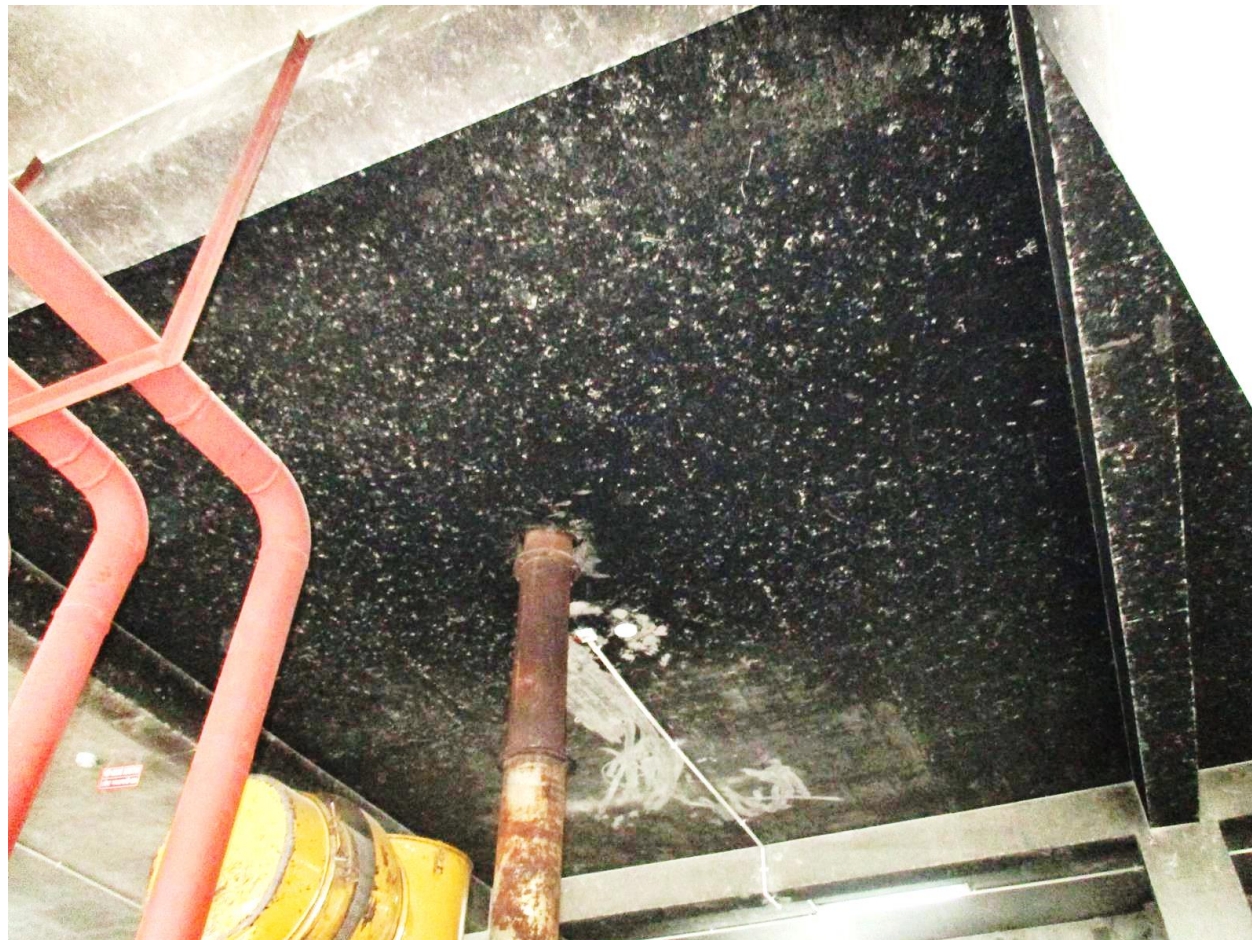
# Carbonation effect on the soffit of slab for utility building

Carbonation was observed in the soffit of slab

| Item No. | Observation | Recommended Action Plan | Recommended Timeline |
|---|---|---|---|
| 5 | Carbonation effect on soffit of slab for utility building | Building engineer to check the effect of carbonation and suggest any suitable repair method if required. | 6-months |
