# **FIRE SAFETY INSPECTION REPORT**

## **SHAMRIN TEXTILE LTD.**

**62, Kathgora, Amtola, Ashulia, Dhaka**

August 25, 2014

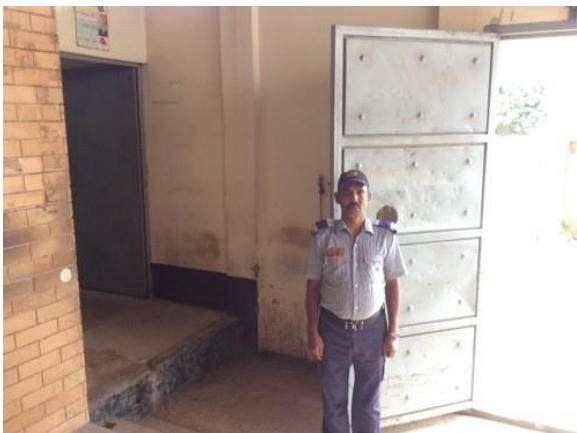
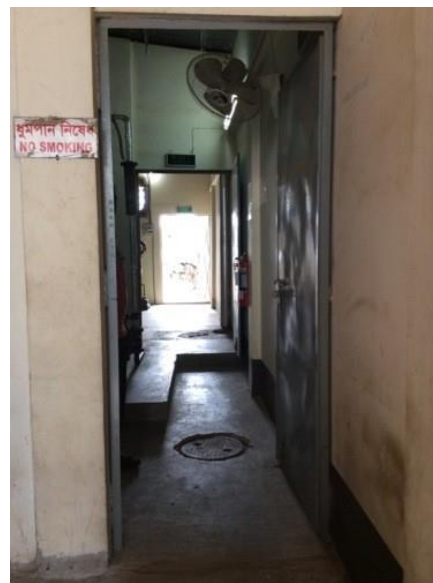
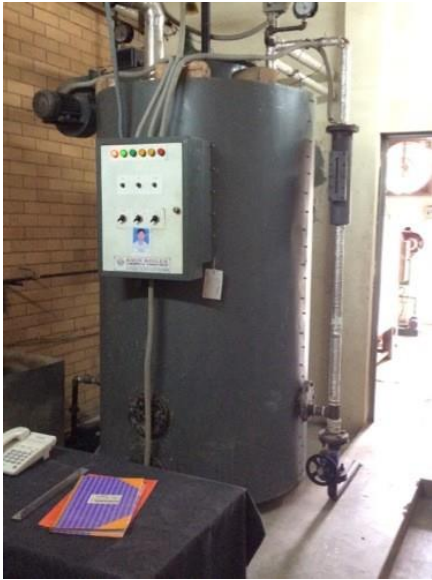
No.	Category	Finding	Recommendation	Remediation Timeframe
F-1	Fire Rated Construction	<p>The boiler room is not separated by fire-rated construction due to non-rated doors and penetrations.</p> <p>One of the boiler room doors was adjacent to the exit discharge of the southwest exit stair.</p>	<p>Separate the boiler room by a minimum 2-hr fire-rated construction. Seal and/or protected all openings to maintain the required fire separations.</p> <p>If the maximum travel distance to an exit is 25 ft., the boiler room door adjacent to the exit discharge of the southwest exit stair can be sealed and a single exit on the south side of the boiler room can be provided. If not, fire-rated doors are required at all boiler room entrances.</p>	Within 3 months

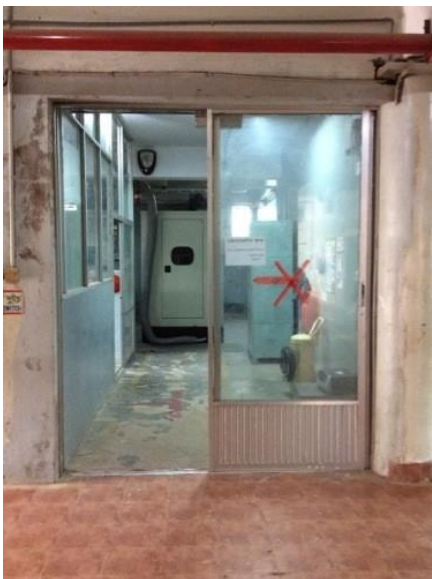
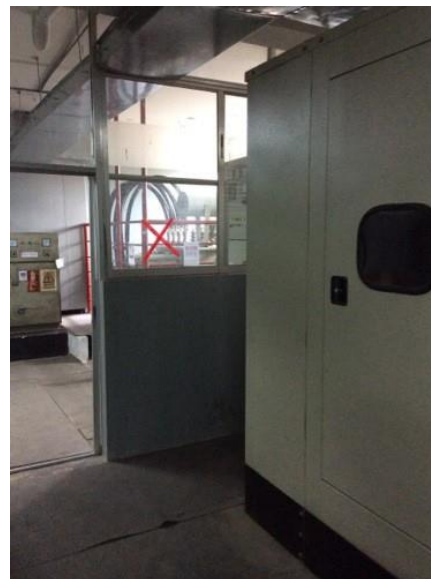
F-2	Fire Rated Construction	The generator and transformer room is not separated by fire-rated construction due to non-rated doors and penetrations.  The generators are not separated from the transformer.	Separate the generator and transformer room by a minimum 2-hr fire-rated construction. Seal and/or protected all openings to maintain the required fire separations.  Separate the generators from the transformer by 2-hr fire-rated construction.	Within 3 months
-----	-------------------------	---	---	-----------------

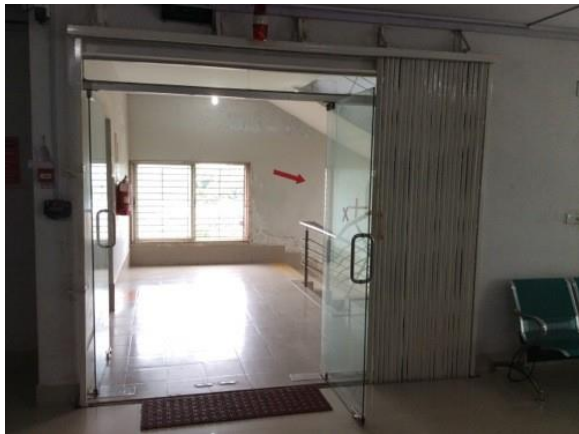
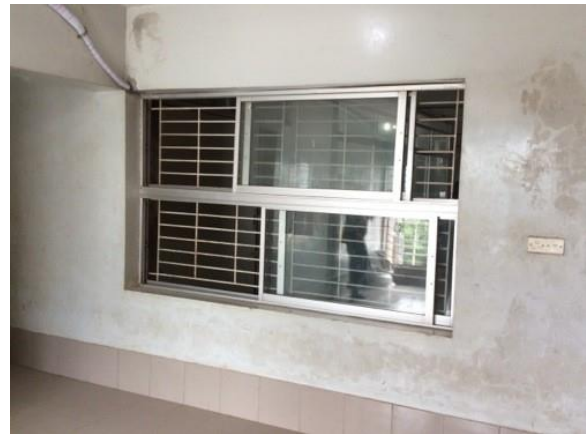
F-3	Fire Rated Construction	The exit stairs are not separated from work areas and other spaces on each floor by fire-rated construction.	Provide minimum 1.5-hr fire rated doors and seal all unprotected openings to separate the exit stairs from work areas and other building spaces on all floor levels. Ensure that the fire doors are self-closing and positive latching and that they are provided with fire exit (panic) hardware where serving production floors.  If fire doors are required to be held open for functional reasons, provide automatic-closing devices tied to the fire alarm system.	Within 3 months
-----	-------------------------	--	---	-----------------

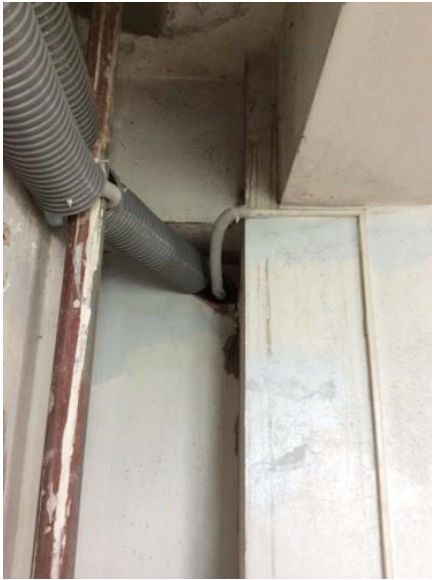
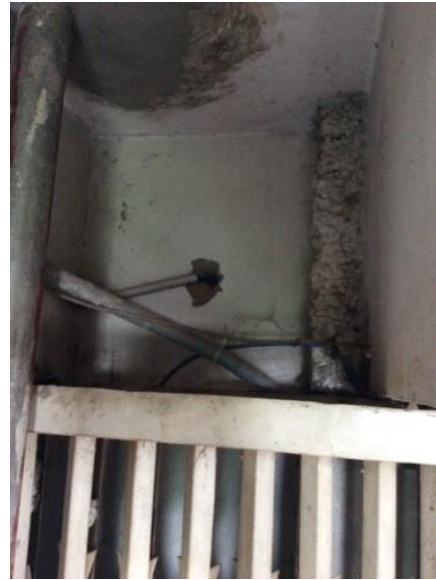
F-4	Fire Rated Construction	Unsealed penetrations and openings are located in the northwest exit stair enclosure on every floor.	Provide a minimum 2-hr fire-rated shaft to separate the electrical penetrations to the exit stairs from the factory floors.	Within 3 months
-----	-------------------------	--	---	-----------------

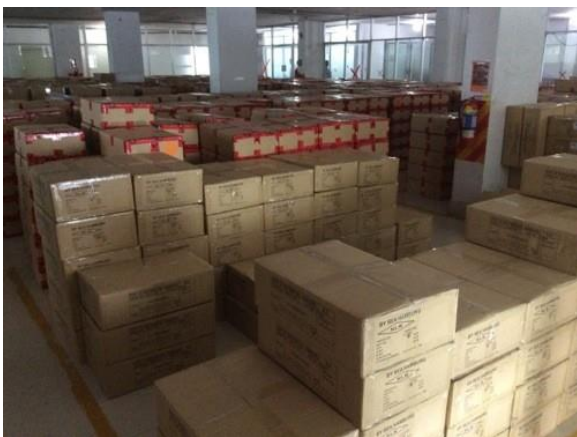
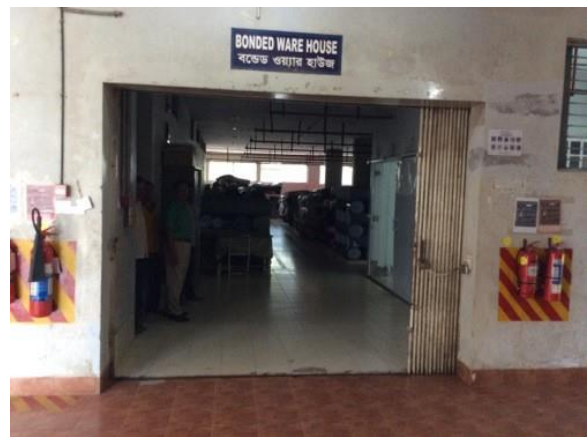
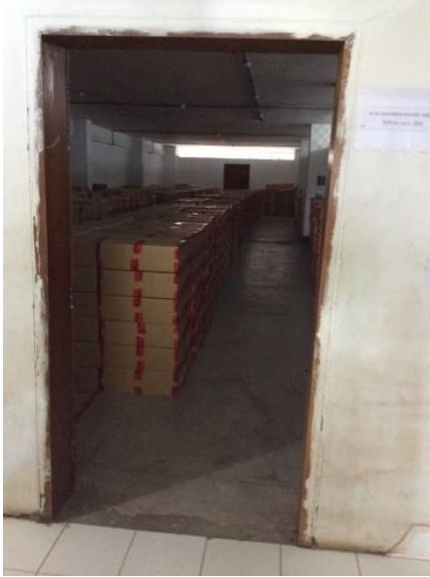
F-5	Fire Rated Construction	Rooms used for combustible storage are not separated by fire-rated construction. Specifically, the building had dedicated storage rooms on the ground (accessory store, fabric store) and fourth (two (2) finished goods areas) floors.	Provide dedicated storage rooms separated by minimum 1-hr fire-rated construction.	Within 3 months
-----	-------------------------	---	--	-----------------

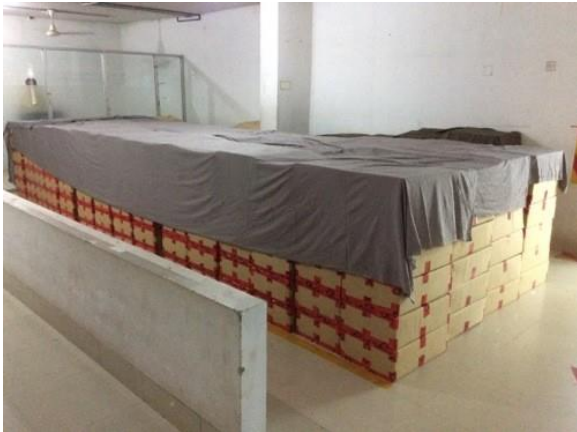
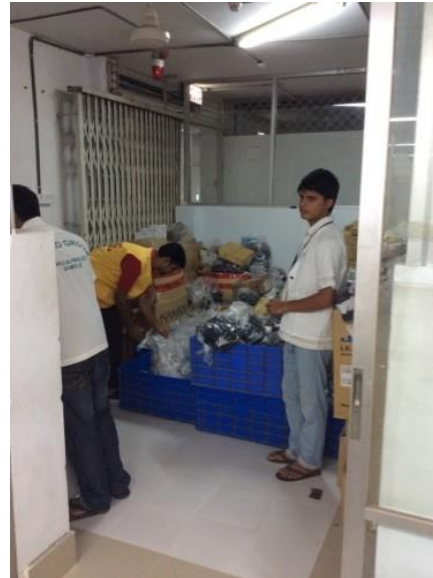
F-6	Fire Rated Construction	Areas used for combustible storage, open to the factory floor, were not separated by fire-rated construction. Specifically, storage was open to the factory floor on the fourth floor.	Provide dedicated storage rooms separated by minimum 1-hr fire-rated construction.  Where separate storage rooms are not feasible, provide defined storage areas and limit the storage arrangement as follows: -Maximum height of 2.4m and maximum area of 23m <sup>2</sup> -If sprinkler protected: maximum height of 3.66m and maximum area of 93m <sup>2</sup>  Separate areas of unenclosed combustible storage by a minimum clear distance of 3m.	Within 3 months
-----	-------------------------	--	--	-----------------

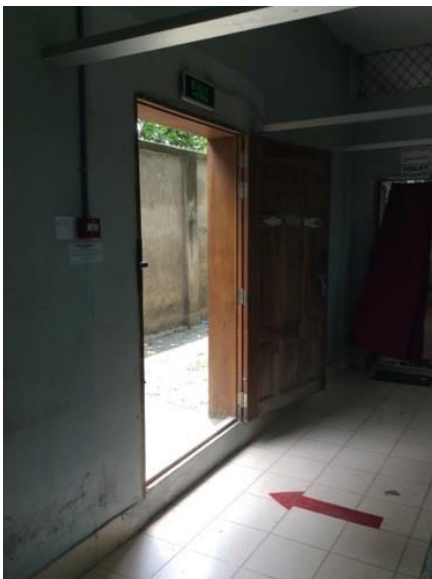
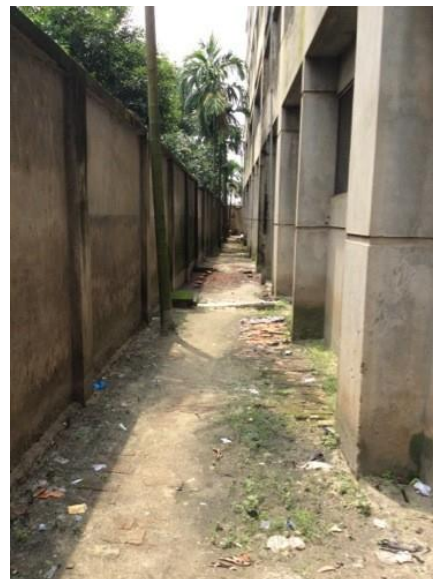
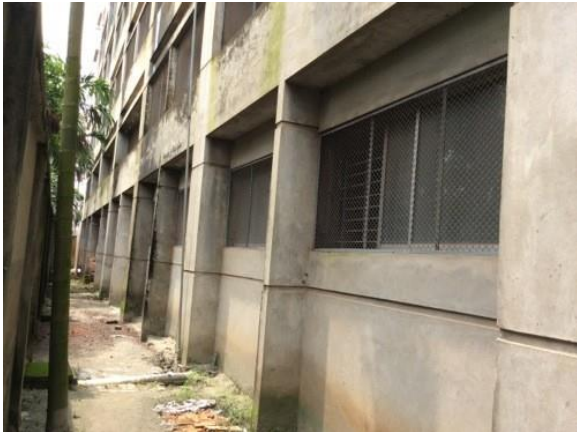
F-7	Fire Rated Construction	The exit discharge path serving the ground floor, cutting section building exit is less than 10 ft. wide and is not separated from the building interior.	Seal all penetrations and openings to the interior of the building along the discharge path, up to a height of 10 ft., to provide a minimum 1-hr fire separation.  Alternatively, provide a second remote discharge path to a public way.	Within 6 months
-----	-------------------------	---	---	-----------------

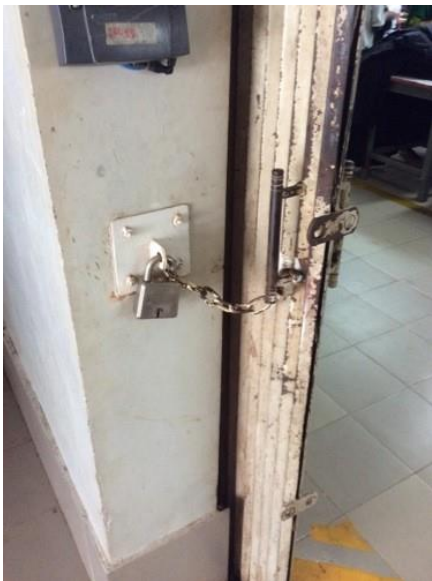
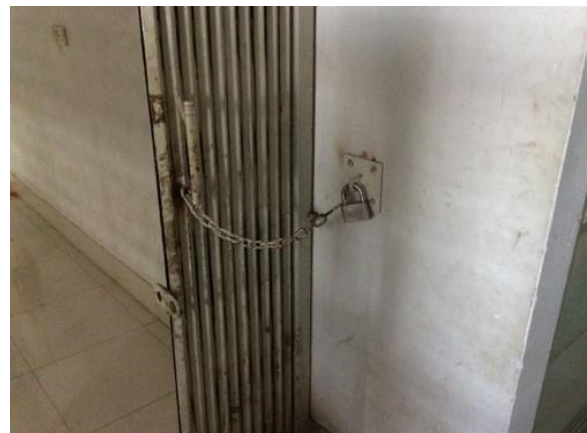
F-8	Egress	Egress doors and gates with locking features are provided at building exits, exit stairs, along egress routes and at exit discharge. All gates and doors were open and unlocked during the inspection.	Remove locking features from all egress doors and gates.  If locks are required for security reasons, utilize special door locking features complying with NFPA 101.	Immediate
-----	--------	--	--	-----------

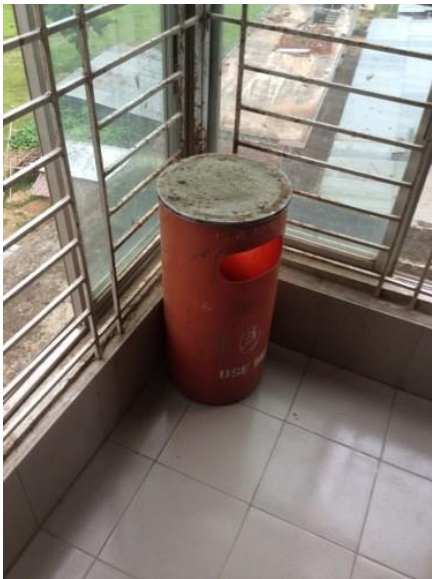
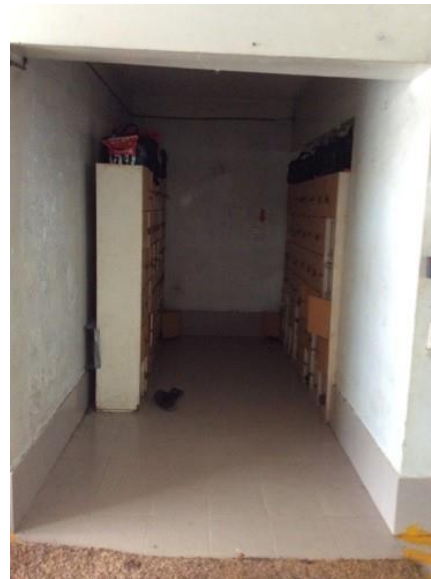
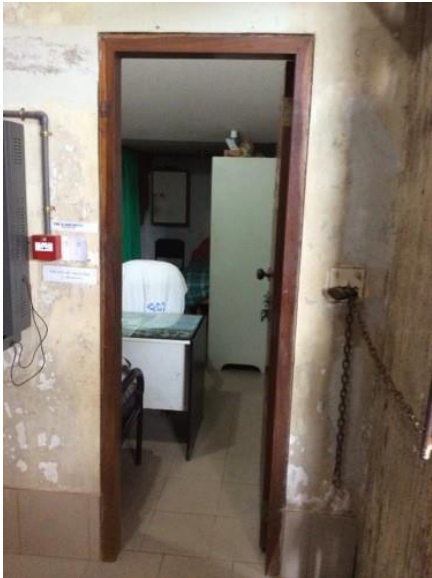
F-9	Egress	<p>Storage was located in each exit stair. Specifically, trash bins were located throughout all exit stairs, the southwest exit stair had storage racks at the main floor landings from the ground to third floor and a security room on the ground floor, and the northwest exit stair had a washroom on the ground floor.</p>	<p>Remove all storage from exit stairs and egress paths.</p>	<p>Immediate</p>
-----	--------	---	--	------------------

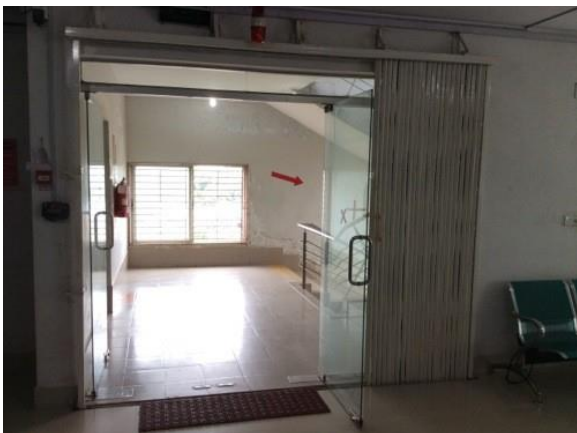
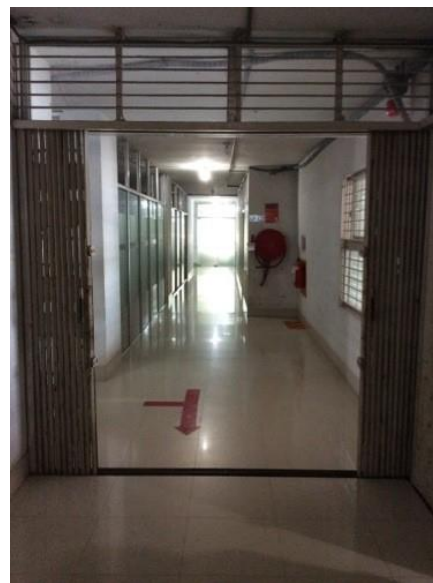
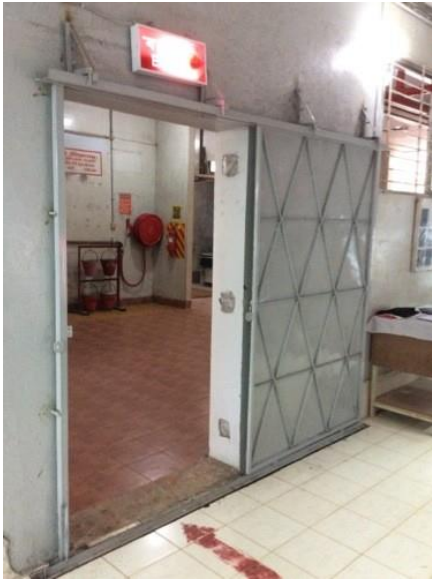
F-10 Egress

Collapsible gates and sliding doors are provided at building exits, exit stairs, along egress routes and at exit discharge.

Replace all gates and sliding doors along the means of egress with side-hinged, swinging egress doors.

If locks are required for security reasons, utilize special door locking features complying with NFPA 101.

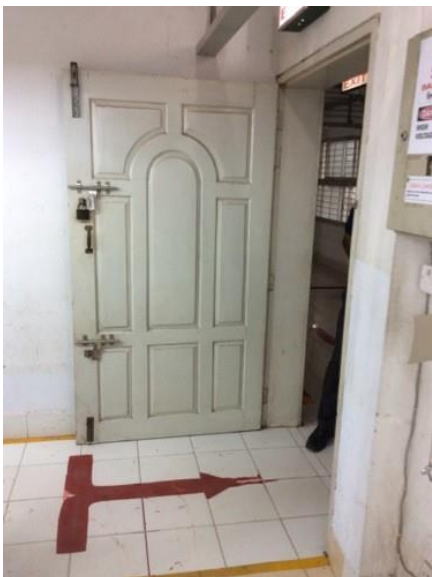
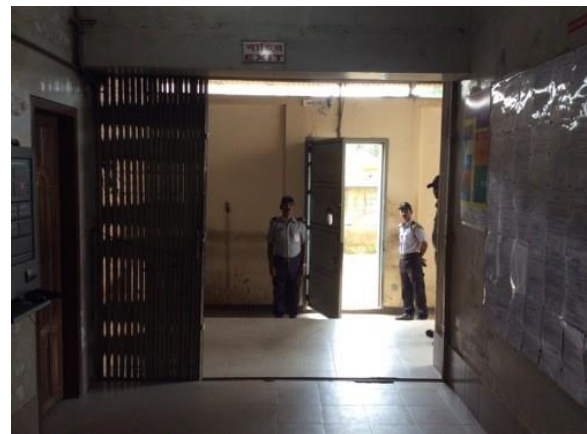
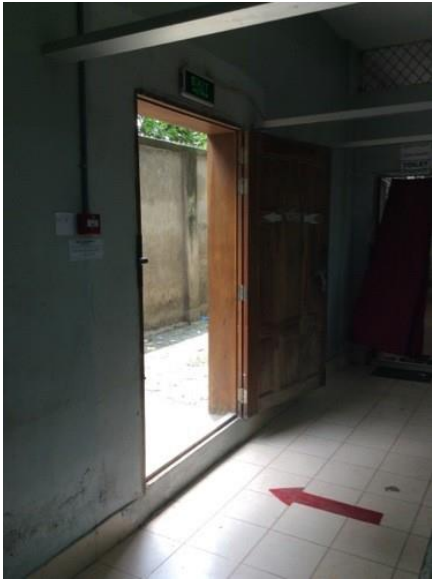
F-11 Egress

The two (2) egress doors from the ground floor cutting section, the egress doors after exit discharge from the southwest and northwest exit stairs and the two (2) egress doors from the fourth floor sample section did not swing in the direction of egress.

Modify the egress door to swing in the direction of egress travel.

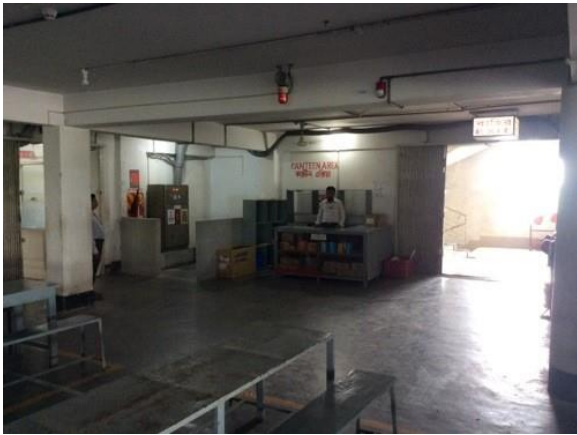
F-12 Egress

The exits from the fourth floor dining area are not remotely located from each other such that a single fire event could compromise both exits.

Provide additional, remote exit.

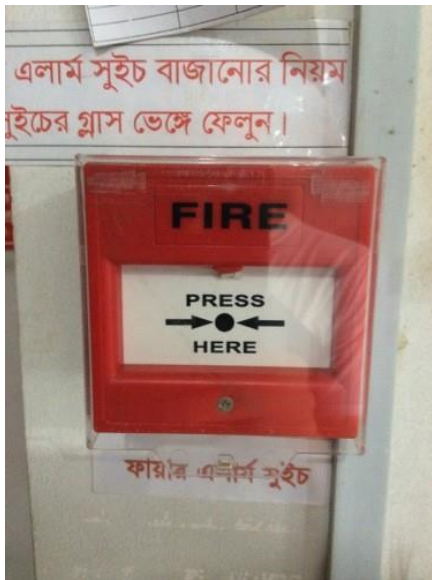
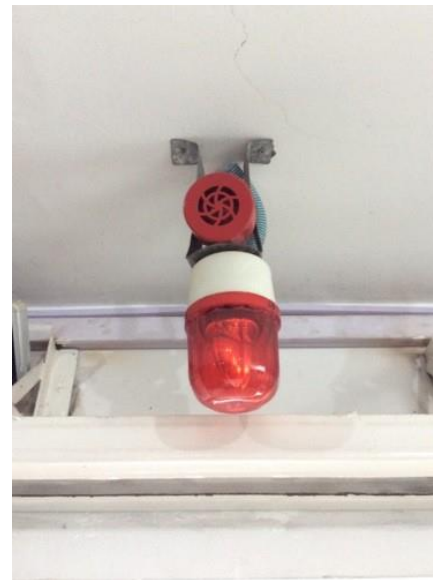
F-13	Fire Protection	When tested during the inspection, the new addressable fire alarm system did not alarm immediately when tested (took several minutes).	Test the addressable fire alarm system for functionality and ensure that all components function properly. Repair any non functioning components or electrical connections as needed.	Within 1 month
F-14	Fire Protection	The older fire alarm system is antiquated, not a listed system, and does not provide alarm and notification features consistent with acceptable standards.	Remove the old fire alarm system.	Within 3 months

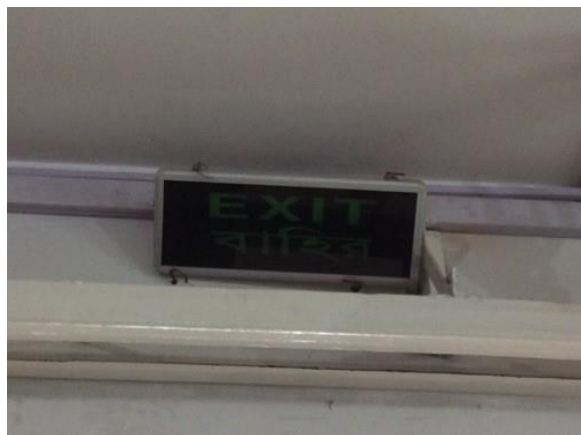
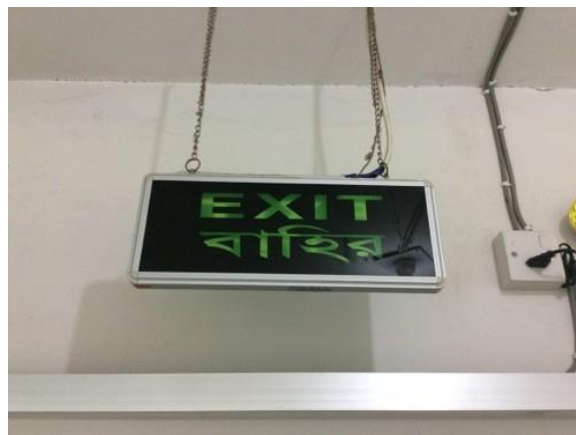
F-17	Fire Protection	No records of inspection, testing, and maintenance of the automatic sprinkler system were provided at the time of the inspection.	Inspect, test and maintain the automatic sprinkler system, and keep written records on-site, in accordance with NFPA 25.	Within 3 months
F-18	Egress Lighting	Not all exit signs were in working order (burned out, broken, etc.). Specifically, the exit sign to the fourth floor exit stair and the two (2) exit signs from the fourth floor sample section were not light.	Regularly inspect all exit signage and replace/install lights as needed to illuminate signs.	Within 1 month
