# INITIAL STRUCTURAL INTEGRITY ASSESSMENT REPORT (SIAR)

Factory Name: **Tex Tech Co. Ltd.**  
Address: **Safwan Tower, Sharifpur, Khanpara, Gazipur Gazipur  
Dhaka Bangladesh**  
Assessor: **BD Technologies**  
Date: **03 Jan 2015**

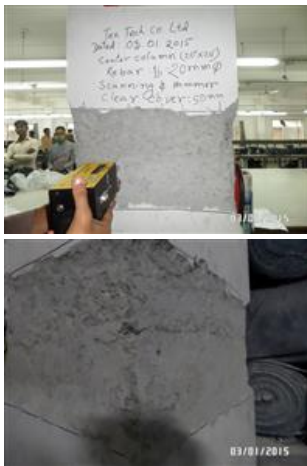
| Question: | Are the available FoS for the columns adequate based on Preliminary calculation? | |
| Description: | <p>FoS calculations are based on a concrete compressive strength of 2,370 psi (Alliance Standard minimum for Stone Chips) for main factory buildings and 2045 psi (minimum for MCAC) for ancillary building. Nondestructive compressive strength (rebound hammer) testing was conducted as part of this assessment. Reinforcement configuration was verified via ferro-scanning.</p> <p>Main factory building 1 FoS results, 42 psf live load (current 4-story configuration): Central Column - 3.61; Corner Column - 3.02; Edge Column - 2.99. Main factory building 2 FoS results, 42 psf live load (current 4-story configuration): Central Column - 4.16; Corner Column - 4.59; Edge Column - 3.18. Main factory building 1 FoS results, 42 psf live load (approved 7-story configuration): Central Column - 2.07; Corner Column - 1.73; Edge Column - 1.71. Main factory building 2 FoS results, 42 psf live load (approved 7-story configuration): Central Column - 2.38; Corner Column - 2.62; Edge Column - 1.82. Ancillary building FoS results, 42 psf live load: Central Column - 5.52; Corner Column - 3.10; Edge Column - 3.68. As several of the main building FoS results fall below 1.86, the main buildings should not be vertically extended any further prior to additional investigation into their load-bearing capacity by a qualified structural engineer.</p> | |

| Suggested Plan of Action: | Prior to any further vertical extension of the main buildings, conduct destructive core testing under the guidance of a qualified structural engineer to validate the in-situ concrete compressive strength of structural elements. | |

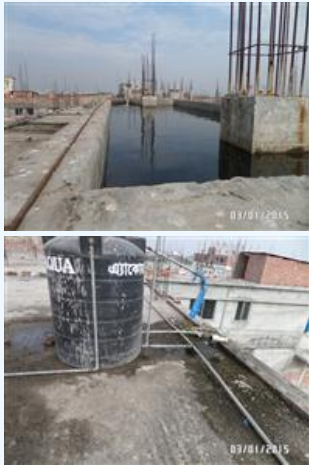
| Question: | Can documentation be provided that the building is compliant with the requirements for wind loading and storm surge loadings as detailed in BNBC Part 6 Section 1.5.3? | |
| Description: | No credible documentation is available to indicate the building is compliant with the requirements for wind loading and storm surge loadings as detailed in BNBC Part 6 Section 1.5.3. | |

| Suggested Plan of Action: | Engage a qualified structural engineer to confirm satisfactory structural performance of the buildings under wind and storm surge loadings.. | |

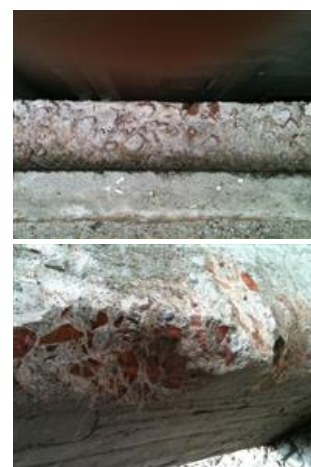
| Question: | The exterior façade is free of cracking. | |
| Description: | There was a crack in exterior façade. | |

| Suggested Plan of Action: | Have a qualified structural engineer provide further analysis of the identified cracks to determine the appropriate course of corrective action. | |
