# Organic Jeans Ltd. (9867)

Fouzderhat, Sagarika Road, Chittagong

18.MAY.2014

# Identified Priority 1 Concerns

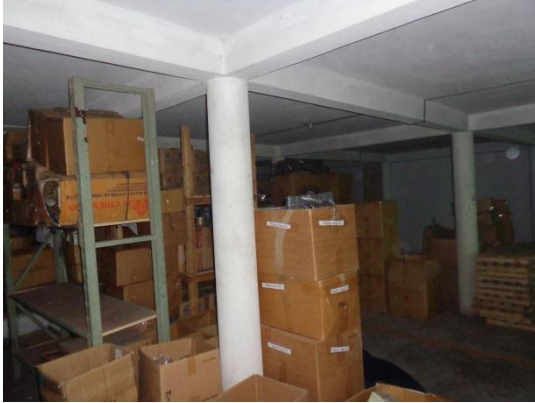
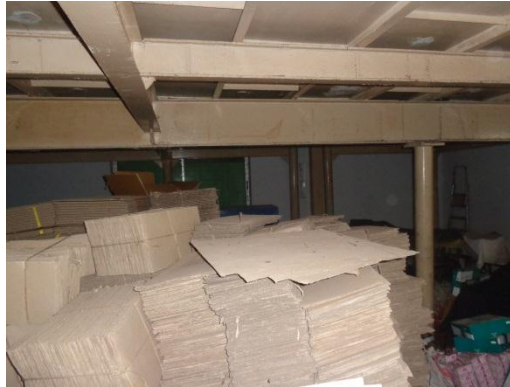
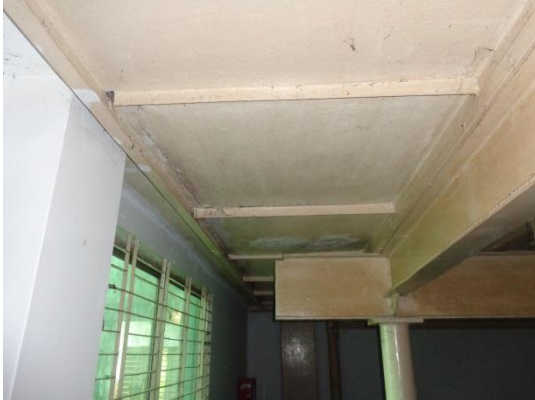
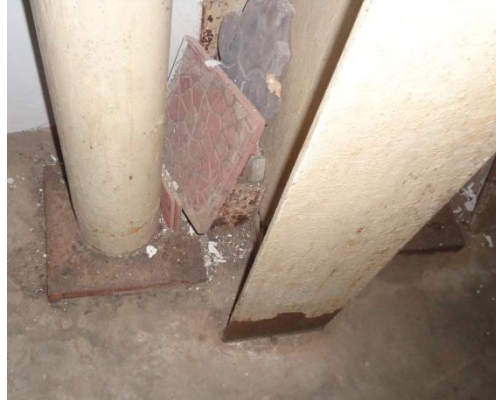
## 1<sup>st</sup> Priority 1 Concern

The following was observed for the steel and concrete mezzanine on the ground floor of the main building:

- Column position seemed inaccurate
- cantilevered steel deck slab with no support, crooked columns, columns with no anchor bolts, and columns bearing directly on the slab on grade.

In addition, the structural drawings made available were not complete or accurate.

**ITEM 1:** (Priority 1) Several dubious steel details for the mezzanine were observed such as:

- wrongly positioned columns
- cantilevered steel deck slab with no support
- crooked columns
- columns with no anchor bolts
- columns bearing directly on the slab on grade.

| Item No. | Observation | Recommended Action Plan | Recommended Timeline |
|---|---|---|---|
| 1 | Several dubious steel details for the mezzanine were observed | Do not increase loading on mezzanine.<br>Detailed Engineering Assessment is required for the mezzanine (both concrete and steel) to determine design and construction adequacy. | 6-weeks |
| 2 | Several dubious steel details for the mezzanine were observed | Implement any recommendations from DEA. | 6-weeks |

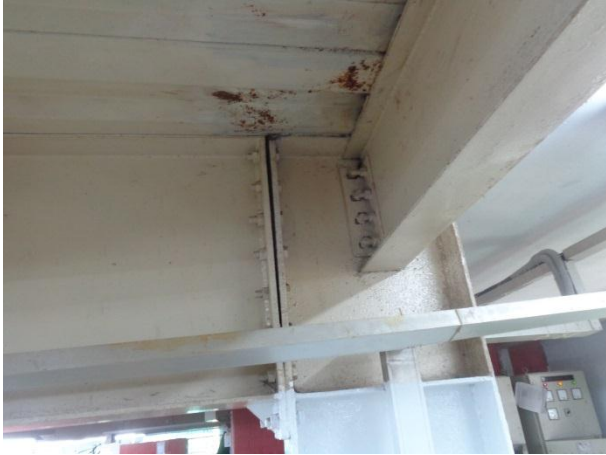
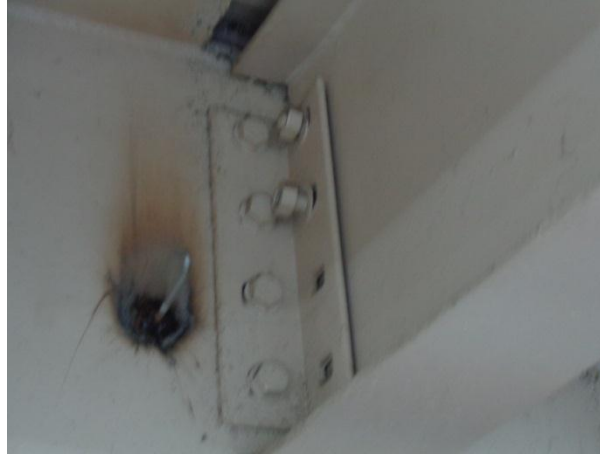
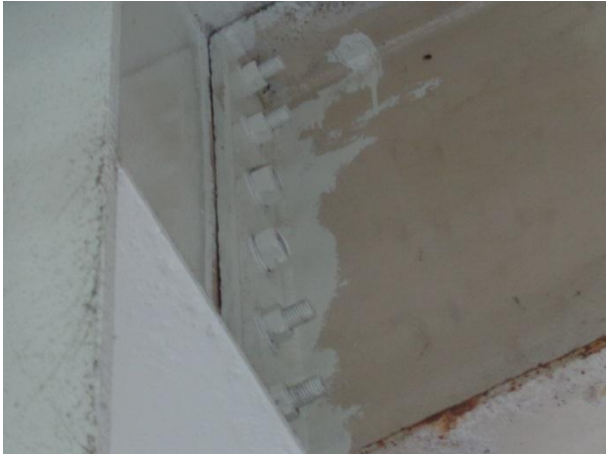
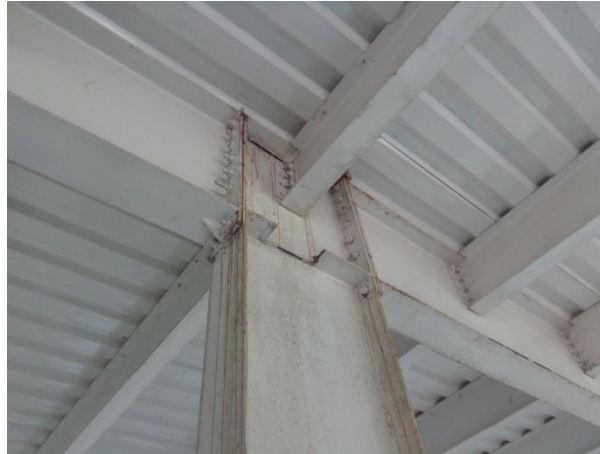
## 2<sup>nd</sup> Priority 1 Concern

The following steel erection deficiencies were observed for the steel connections of the main building:

- missing bolts
- missing nuts
- short bolts
- gaps between connection plates
- cut stiffener plates

**ITEM 2:** (Priority 1) Steel erection deficiencies were observed for the steel connections of the main building.

| Item No. | Observation | Recommended Action Plan | Recommended Timeline |
|---|---|---|---|
| 3 | Steel erection deficiencies were observed for the steel connections of the main building | A Detailed Engineering Assessment is required to determine extent of steel erection deficiencies and to provide correction recommendations. | 6-weeks |
| 4 | Steel erection deficiencies were observed for the steel connections of the main building | Carry out corrective measures as recommended in DEA. | 6-months |

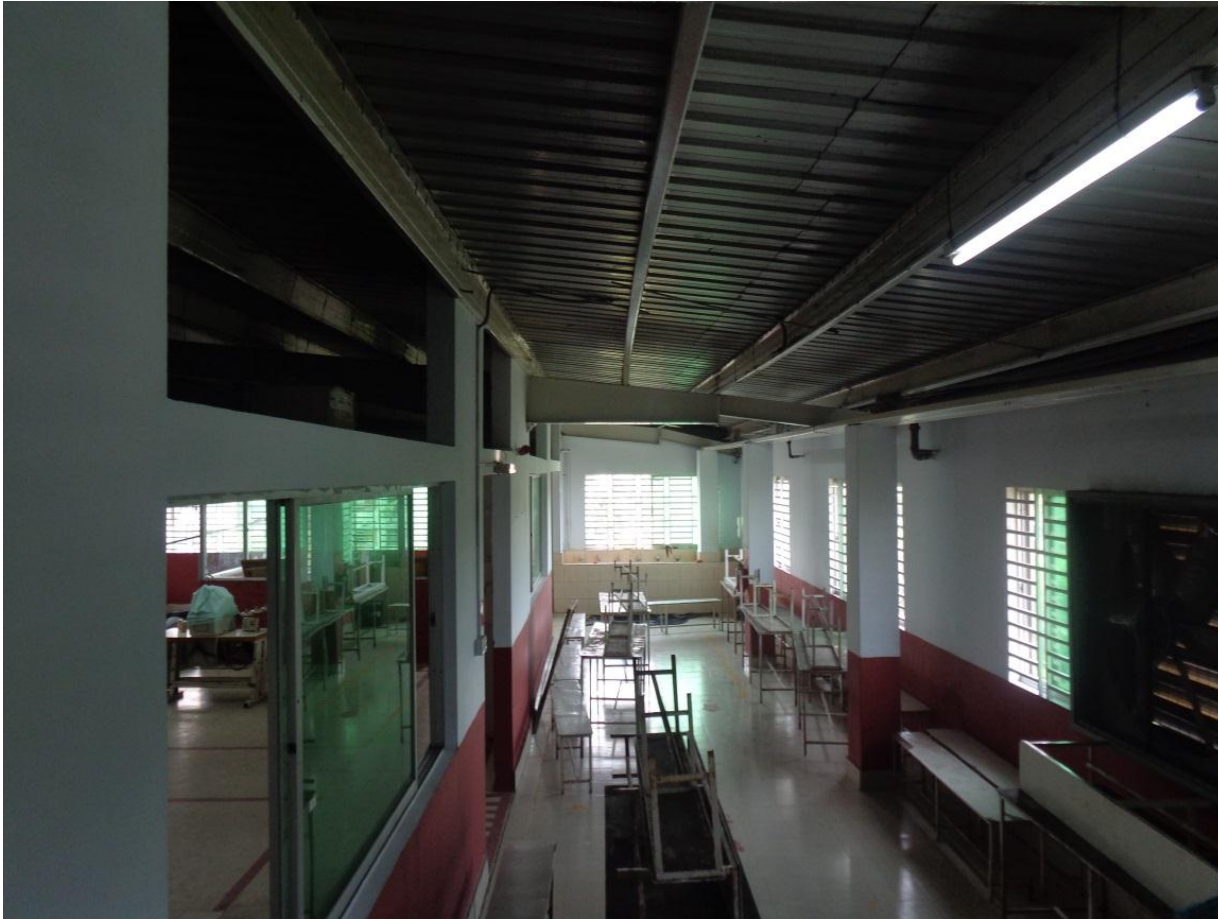
Main Building

No structural drawings were made available for the concrete building extension on the West side of the main building the generator building, and the WTP shed.

**ITEM 3:** (Priority 2) No structural drawings were made available for the mezzanine, the concrete building extension on the West side of the main building, the generator building, and the WTP shed.

| Item No. | Observation | Recommended Action Plan | Recommended Timeline |
|---|---|---|---|
| 5 | No structural drawings were made available for the mezzanine, , the concrete building extension on the West side of the main building, the generator building, and the WTP shed. | Structural Engineer to complete engineering assessment and provide as-built drawings for the above mentioned buildings. | 6-weeks |

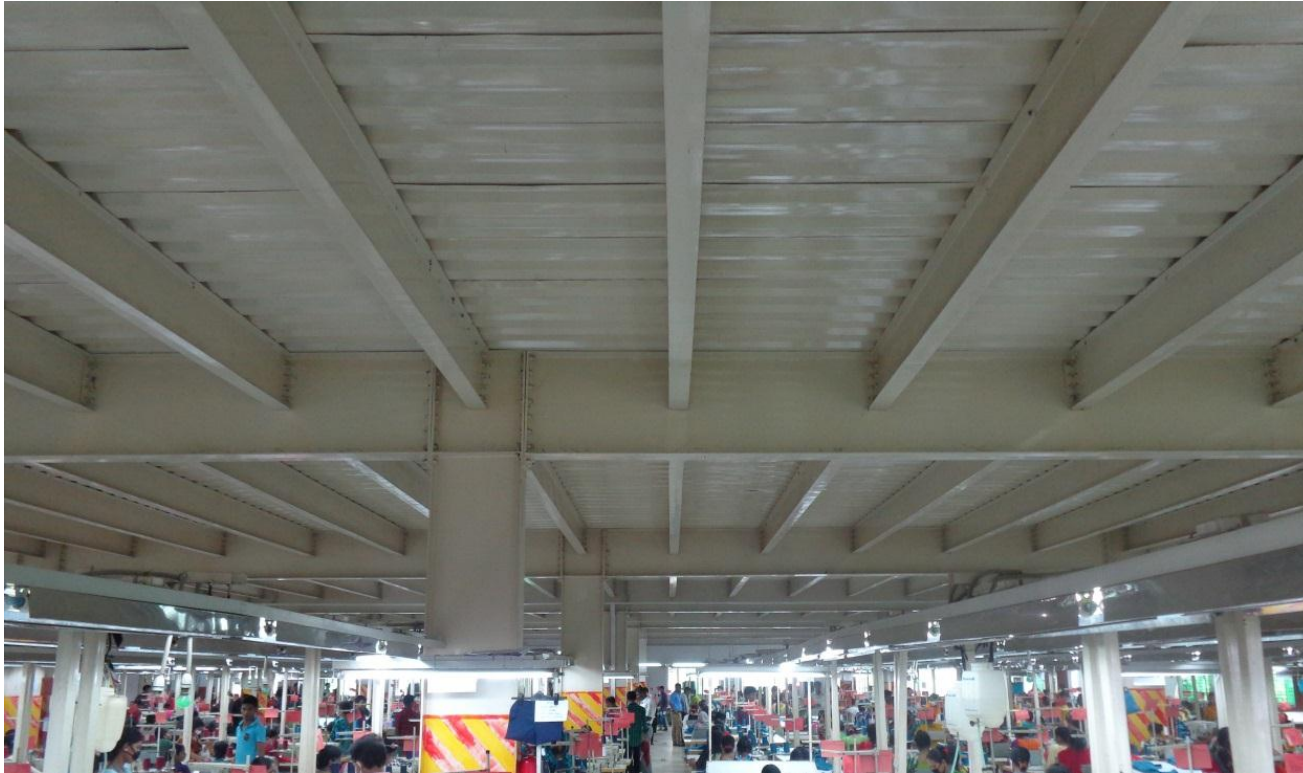
Main Building

No lateral resisting elements (cross-bracing, moment frame, etc.) were observed in the North-South direction. Moment frame was observed in the East-West direction.

**ITEM 4:** (Priority 2) No lateral resisting elements (cross-bracing, moment frame, etc.) were observed in the North-South direction.

| Item No. | Observation | Recommended Action Plan | Recommended Timeline |
|---|---|---|---|
| 6 | No lateral resisting elements (cross-bracing, moment frame, etc.) were observed in the North-South direction. | A Detailed Engineering Assessment is required to determine adequacy of lateral resistance in both directions. | 6-weeks |
| 7 | No lateral resisting elements (cross-bracing, moment frame, etc.) were observed in the North-South direction. | Implement any recommendations from DEA. | 6-months |

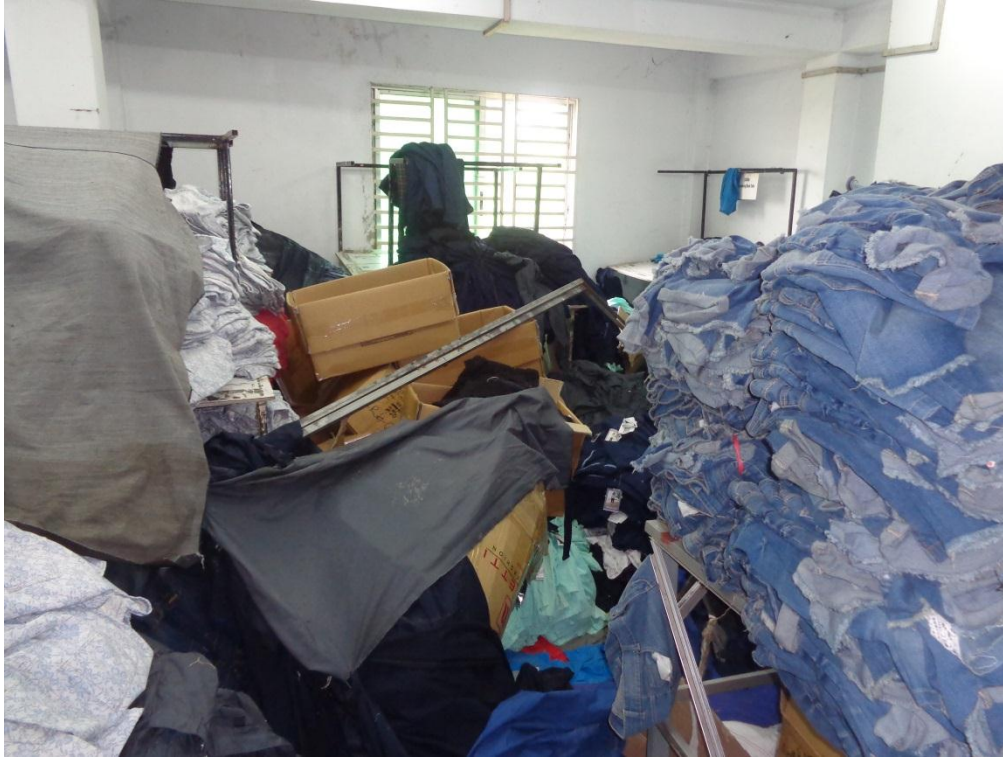
Security Building

Storage was observed on the 1<sup>st</sup> floor of the security building. In addition, no loading plans were made available.

**ITEM 5:** (Priority 2) No loading plans were made available. In addition, storage was observed on the 1<sup>st</sup> floor of the security building.

| Item No. | Observation | Recommended Action Plan | Recommended Timeline |
|---|---|---|---|
| 8 | No loading plans were made available. In addition, storage was observed on the 1st floor of the security building. | Structural Engineer to assess load bearing capacity of each floor of the main building and provide loading plans. | 6-weeks |
| 9 | No loading plans were made available. In addition, storage was observed on the 1st floor of the security building. | Post and manage loading plans on each floor. | 6-months |

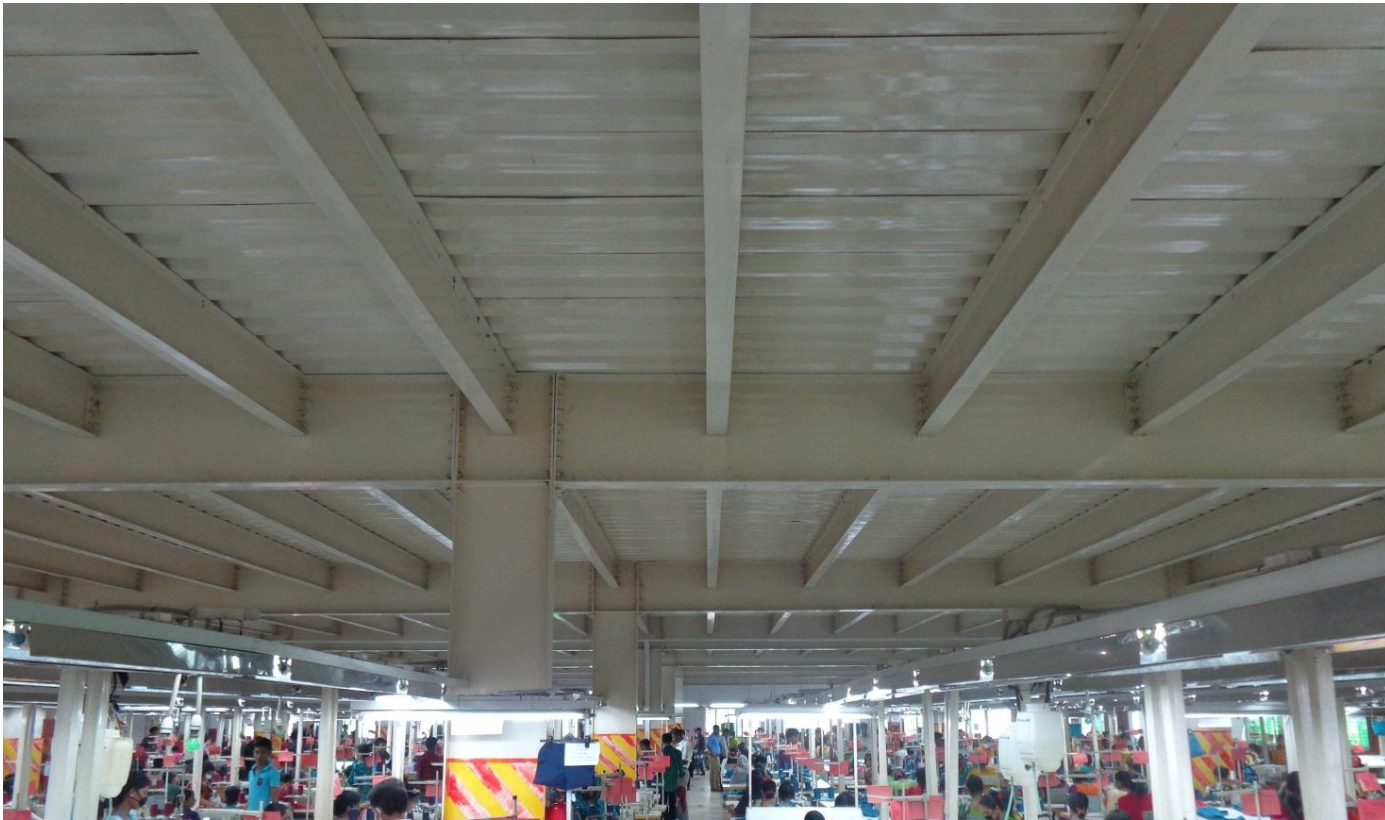
The building did not feature any core or shear walls. All the steel Moment Resisting Frames were oriented in the same direction, resulting in no clear lateral load resisting systems in the other direction.

We require that these items be investigated in a Detail Engineering Assessment

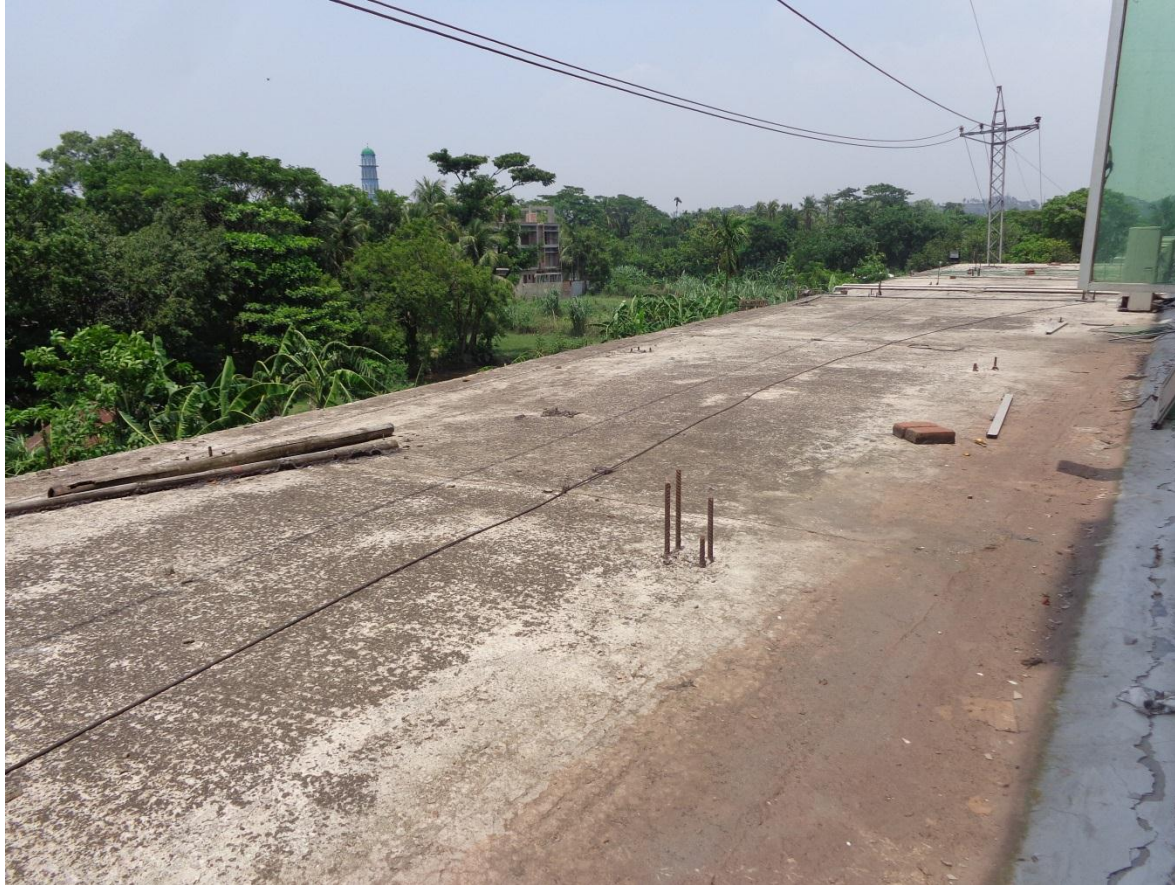
No waterproofing membrane was visible on the roof of the Security Building. This means that any cracks in the surface finishes on the roof will allow water to seep into the concrete slab beneath the finishes, and cause corrosion of the reinforcing steel.
