# Section Seven Limited (9216)

Plot #21-24 (Part), Sector-3, Road-4, South Haliashahar, CEPZ, Chittagong  
(+ 22.287786N, 91.775024E)

19.MAY.2014

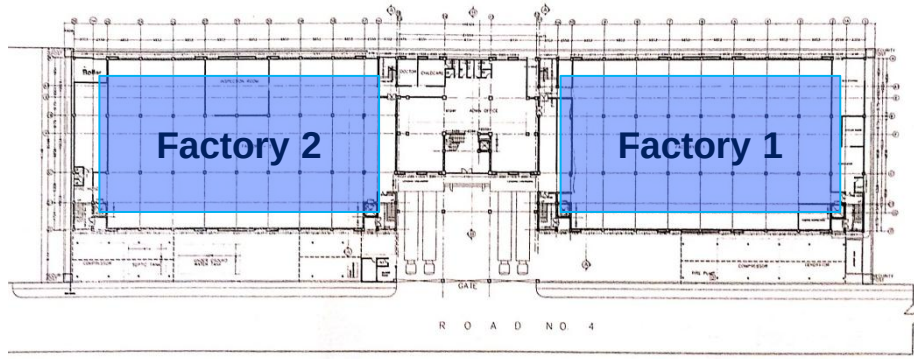
From the drawings, it was appeared to be one pile of each column, where the size equals to 600 mm in diameter and 15 m long, supporting the interior column in area between grid line 1A-10A/A1-C1 of Factory 1 and the area between grid line 16A-25A/A1-C1 of Factory 2. The tributary area is 10.03 m x 5.85 m of 4 storeys with an exclusion of ground floor which is informed to be slab on ground).

From the calculation, the factor of safety (FoS) appears to be **1.38** (Allowable pile capacity 784.8 kN; received from SI report x 2.50 divided by unfactored column load 1426 kN).

| Item No. | Observation | Recommended Action Plan | Recommended Timeline |
|---|---|---|---|
| 1 | Capacity check for piled foundation of Factory 1 and Factory 2. | <p>Factory Engineer to review design, loads and substructure to confirm capacity and suitability for loads applied.</p> <p>Investigate foundation in areas above by excavation and verify pile length by parallel seismic pile testing.</p> <p>Geotechnical investigation in situ and in laboratory.</p> <p>A Detail Engineering Assessment to be commenced.</p> <p>Until this concern is resolved, the loads in the factory, at all floors, must not be increased past the present levels.</p> | Immediate – Now |
| 2 | Capacity check for piled foundation of Factory 1 and Factory 2. | <p>Produce and actively manage a loading plan for all floor plates within this area giving consideration to floor capacity and column capacity.</p> <p>Detail Engineering Assessment to be completed.</p> | 6-weeks |
| 3 | Capacity check for piled foundation of Factory 1 and Factory 2. | Continue to implement load plan | 6-months |

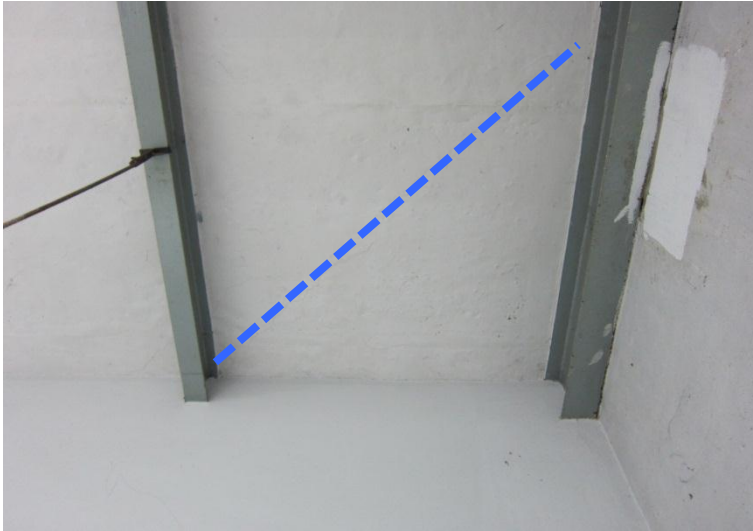
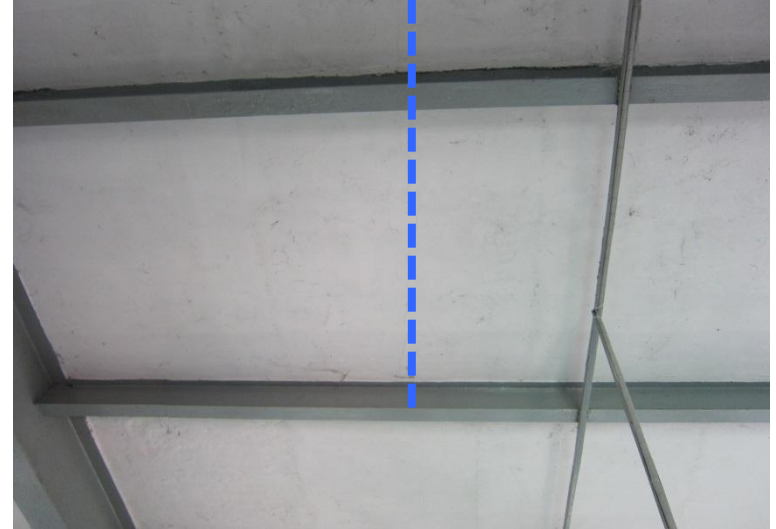
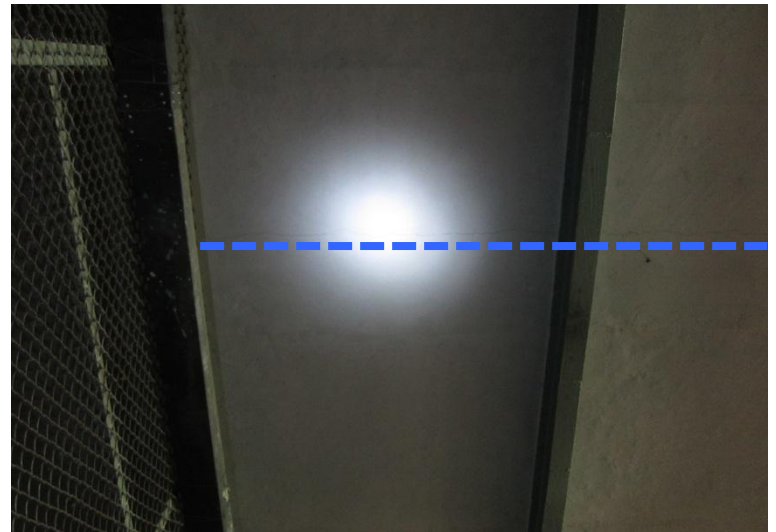
These cracks are found underside slab's soffit. Some of them appeared to be the same cracks pattern on the top and underside of slab's soffit. It is not clear whether these cracks are structural cracks. We require that these items be investigated in a Detail Engineering Assessment.

| Item No. | Observation | Recommended Action Plan | Recommended Timeline |
|---|---|---|---|
| 4 | Cracks appeared on floor slab. | <p>The Factory Engineer to investigate the cause of cracks by appropriate methods.</p> <p>The distress found is to be suitably rectified and then repaired.</p> | 6-weeks |
| 5 | Cracks appeared on floor slab. | <p>Create loading plans for each floor level.</p> <p>Maintain standards of quality control to ensure that loading plan is correctly followed so that problems do not arise in the future.</p> <p>Maintain and enforce the loading plans.</p> | 6-months |

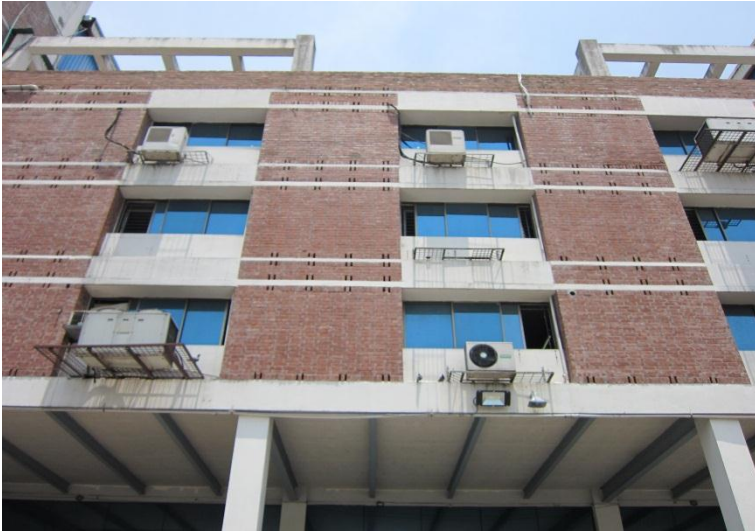
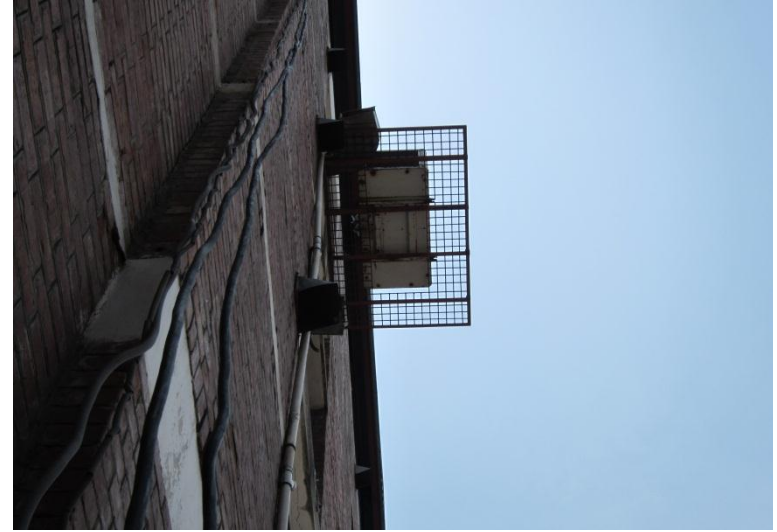
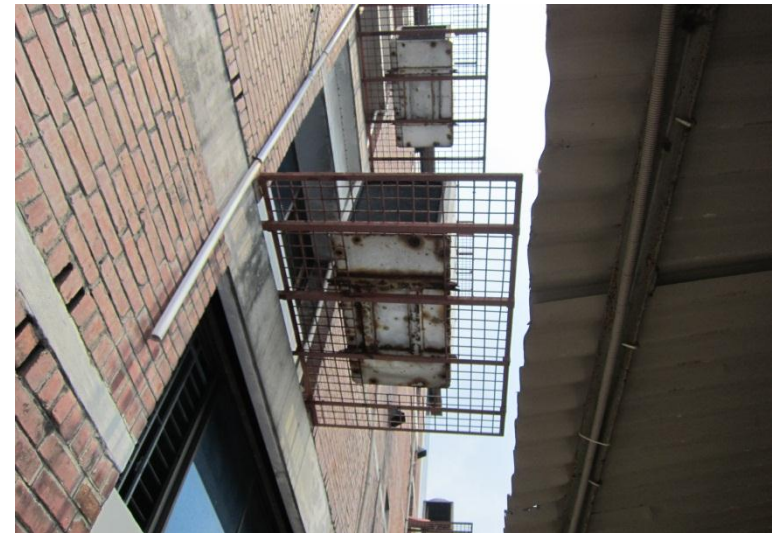
There are concerns on the cantilevered grating supporting AC compressor. Capacity and stability check of these items and related elements should be carried out.

| Item No. | Observation | Recommended Action Plan | Recommended Timeline |
|---|---|---|---|
| 6 | Capacity and stability check for cantilevered grating supporting AC compressor. | Factory Engineer to review design, loads and related elements in area identified above to confirm capacity and stability for these items. | 6-weeks |

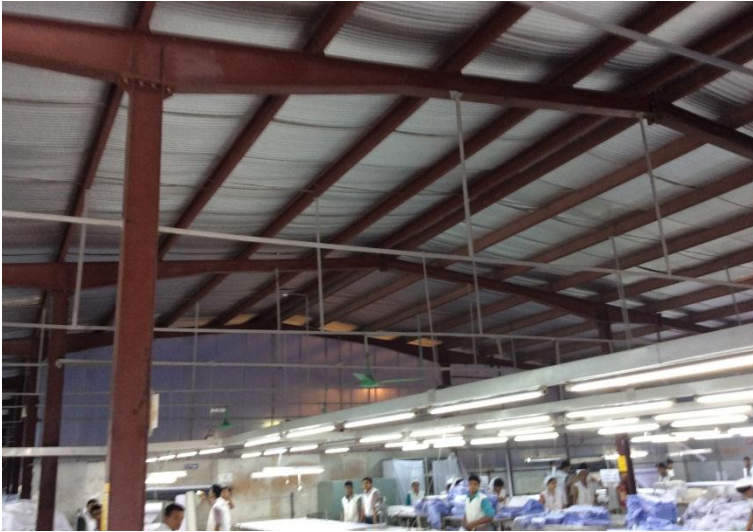
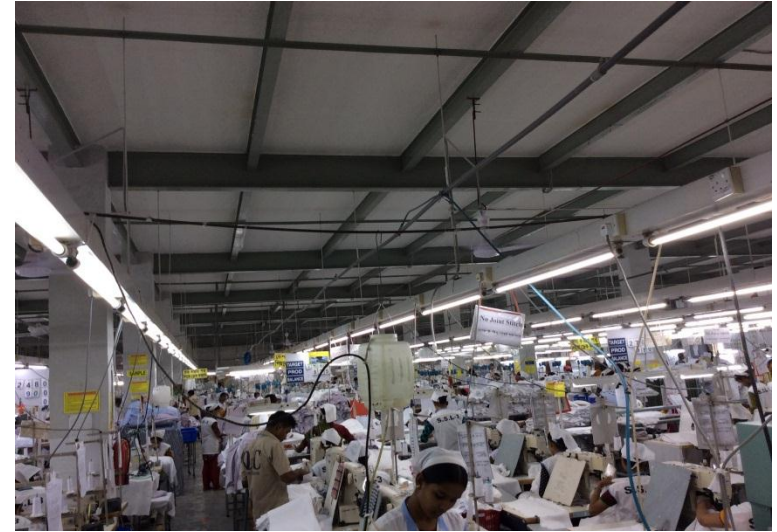
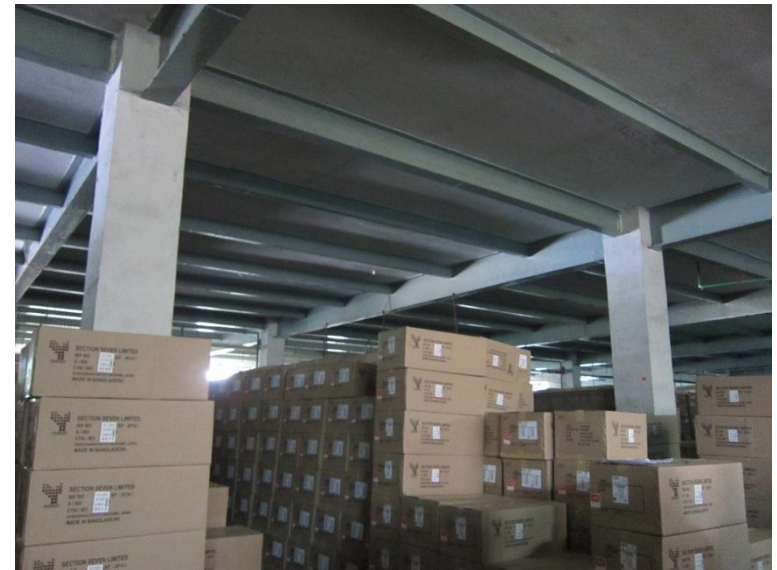
No fireproofing material is applied to the structural steel elements. It is unclear whether it is required by BNBC.

| Item No. | Observation | Recommended Action Plan | Recommended Timeline |
|---|---|---|---|
| 7 | No fireproofing for steel structure elements (if required). | Fireproofing material for structural steel element is recommended as suggested in BNBC Codes. | 6-weeks |
| 8 | No fireproofing for steel structure elements (if required). | Maintain standard of quality control. | 6-months |

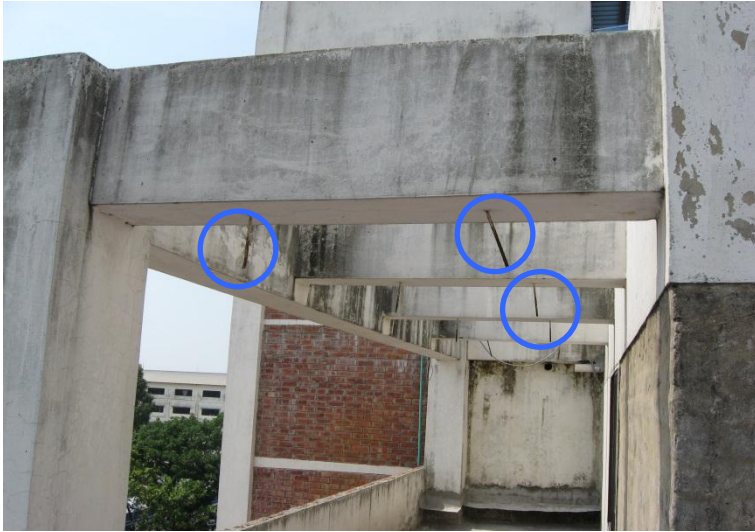
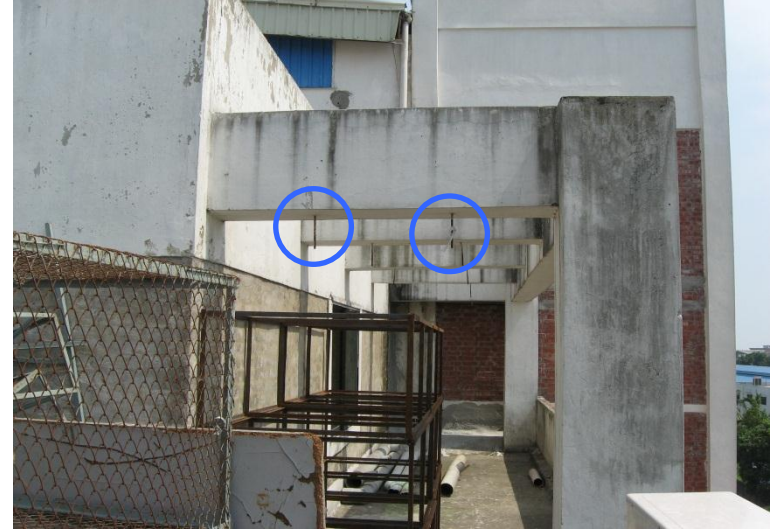
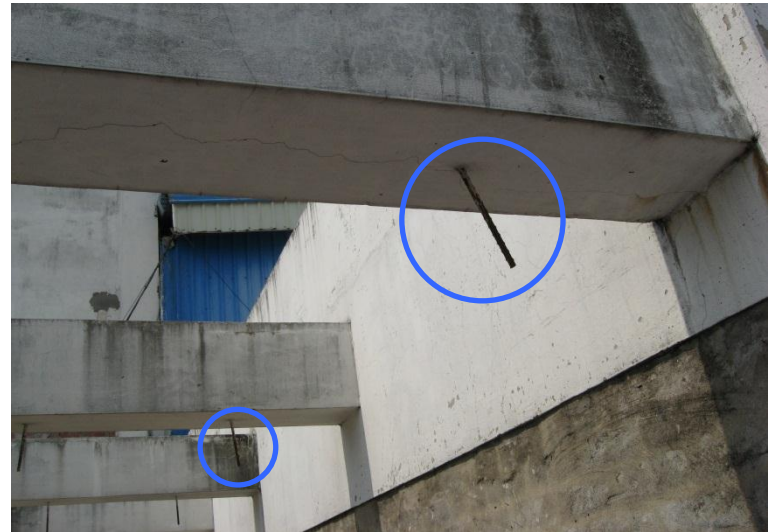
Reinforcement are left exposed. No rust-proof paint is applied.

| Item No. | Observation | Recommended Action Plan | Recommended Timeline |
|---|---|---|---|
| 12 | Reinforcement left exposed at top level of Office. | For both durability and serviceability, rust proof paint or any appropriate methods is recommended. | 6-months |

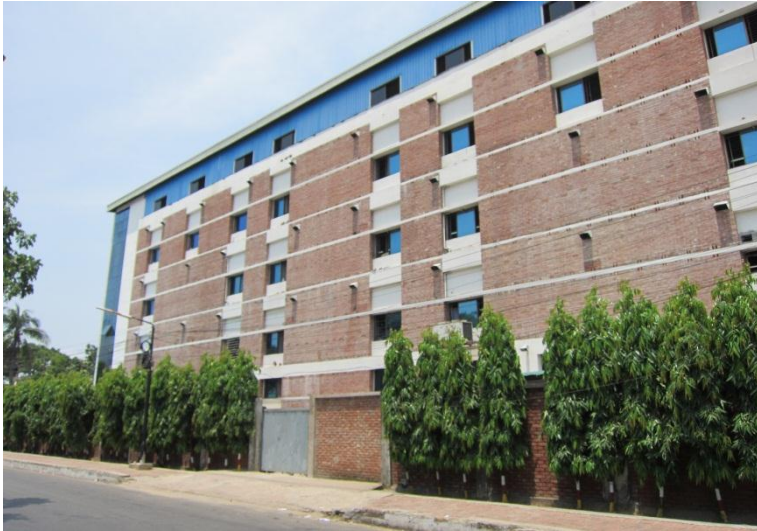
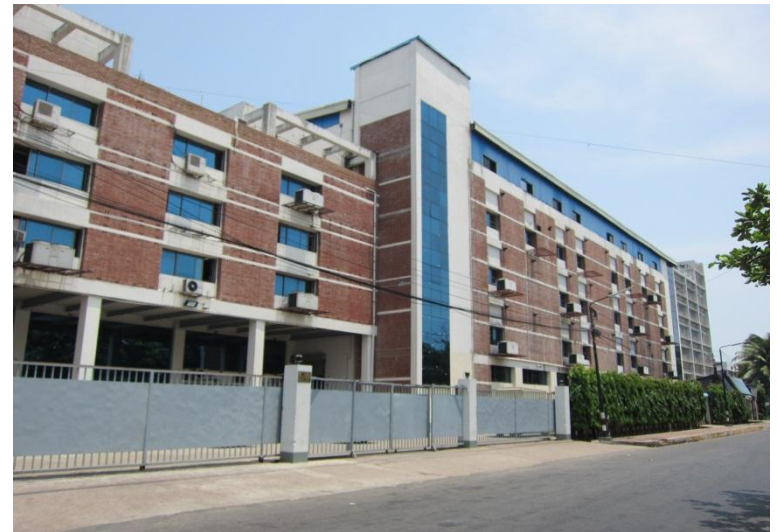
Concerns on the stability system for wind loading and seismic loading. Façade brickwork walls lack of moment capacity in the connections between columns and beams. There are no bracings installed for steel portal frame to support the roof. Furthermore as seen in the photo below the building may present a Weak Storey deficiency as per BNBC.

We require that these items be investigated in a Detail Engineering Assessment.

| Item No. | Observation | Recommended Action Plan | Recommended Timeline |
|---|---|---|---|
| 9 | Overall stability system. | Request that the Detail Engineering Assessment of the overall building to be carried out and in particular, stability and foundation aspects should be investigated in detail. | 6-weeks |

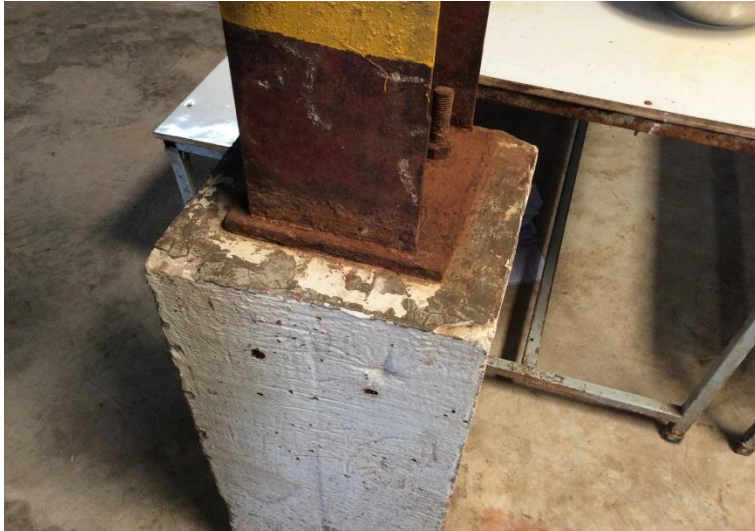
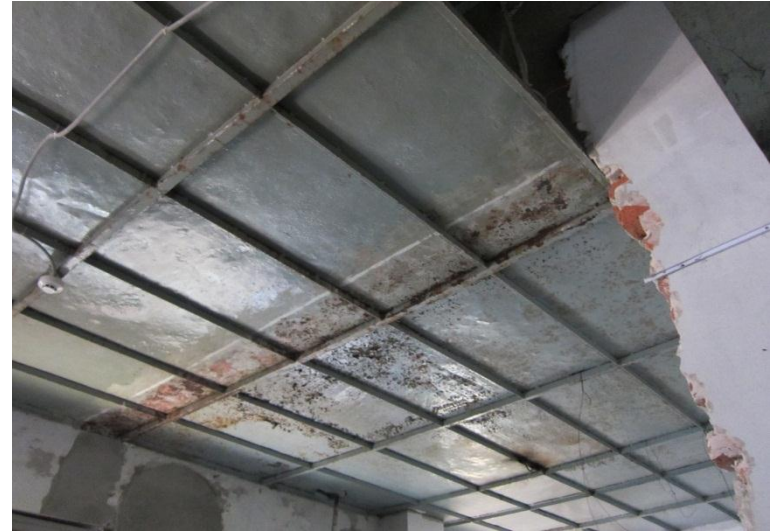
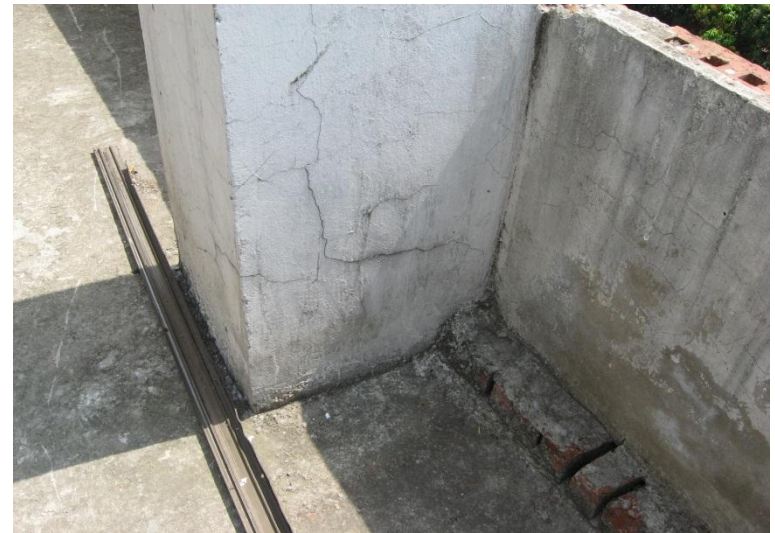
We observed distress due to water ingress on steel and RC structure elements at various locations.

| Item No. | Observation | Recommended Action Plan | Recommended Timeline |
|---|---|---|---|
| 10 | Distress due to water ingress. | Factory Engineer to inspect water damaged structures and repair with a suitable method. | 6-weeks |
| 11 | Distress due to water ingress. | For both durability and serviceability, rustproofing is recommended. Waterproofing on the roof slab is recommended. Moreover the slab drainage system should be investigated. Maintain standard of quality control. | 6-months |
