# Suji Fashions Ltd. Shyms Fashions Ltd.

(Present Location) Plot No.P-04, Mohora (Noxious) CDA Industrial Area, Chittagong.  
(22.394087, 91.861443)  
8<sup>th</sup> March 2017

# Observations

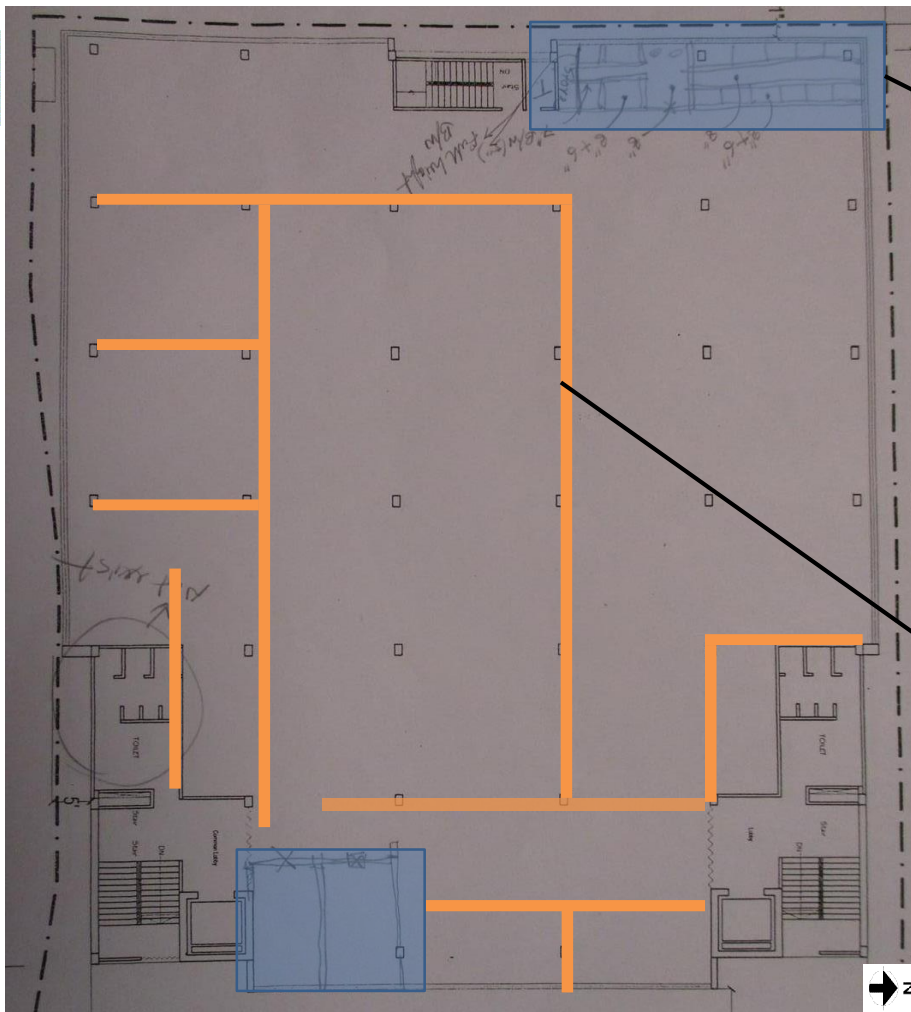
Floor layout plan

Internal partition wall of the factory building does not match with provided as-built drawings.

| Item No. | Observation | Recommended Action Plan | Recommended Timeline |
|---|---|---|---|
| 1 | Discrepancies between provided drawings and as-built conditions | Building Engineer is required to survey the structure and update the architectural and structural drawings to the "as-constructed" status. | 6-weeks |

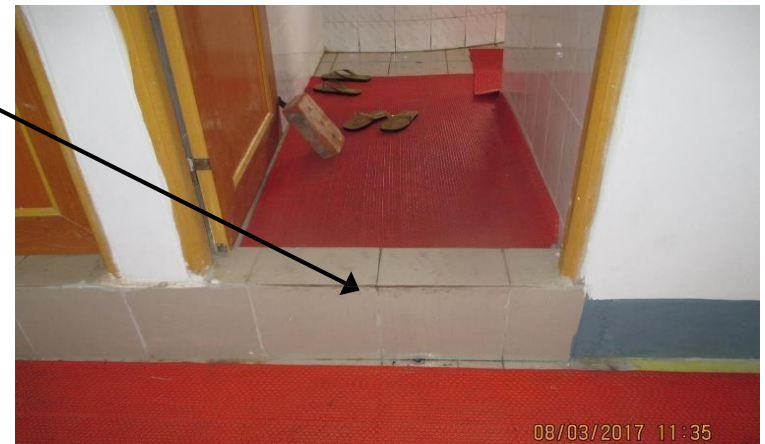
Additional toilets with 200mm ~ 350mm floor built up on 2<sup>nd</sup> & 3<sup>rd</sup> floor

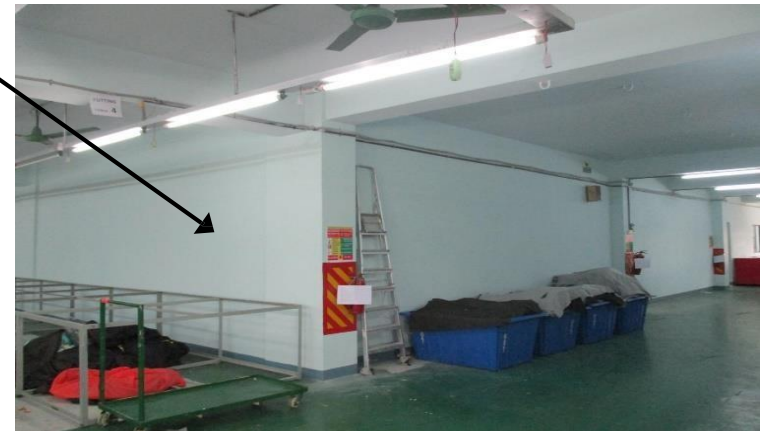
Full height brick walls on 1<sup>st</sup> floor

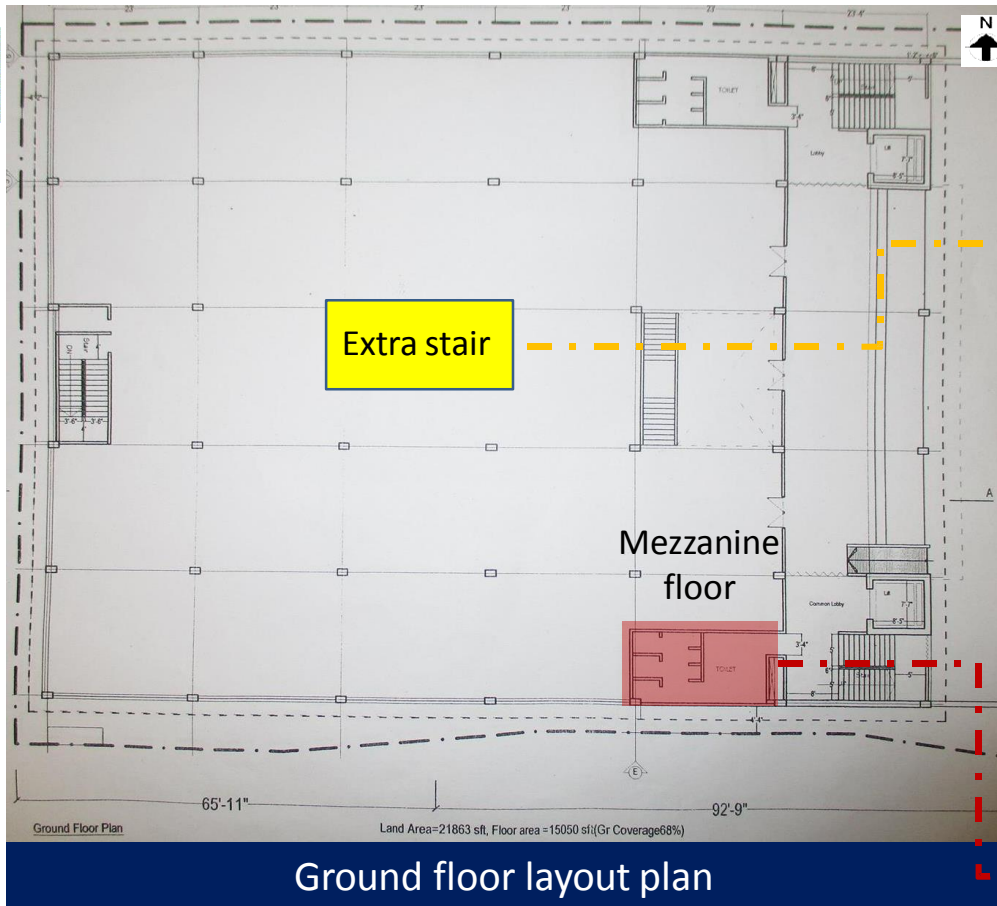
Ground floor layout plan

A undocumented mezzanine floor is found beside stair core at south east corner and a additional stair was observed at mid of the factory building which is in ground floor only.

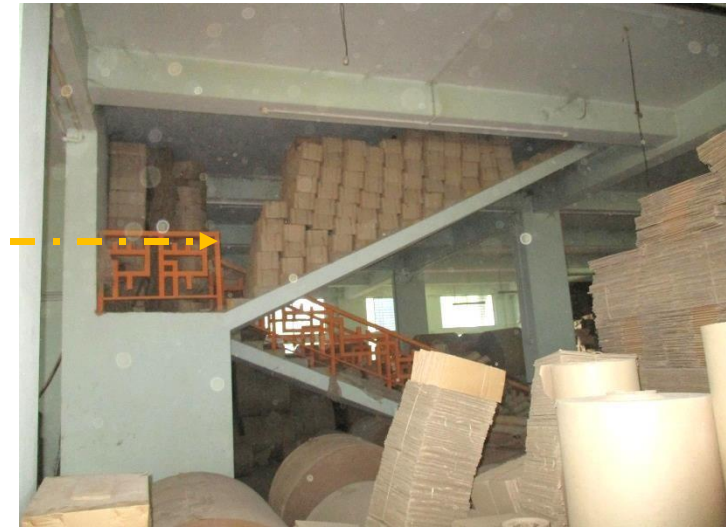
The stair not shown in drawings.

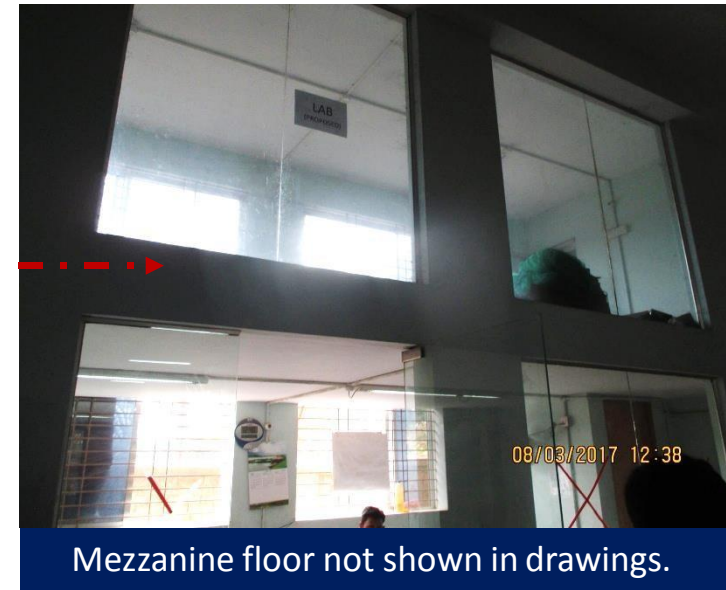
Mezzanine floor not shown in drawings.

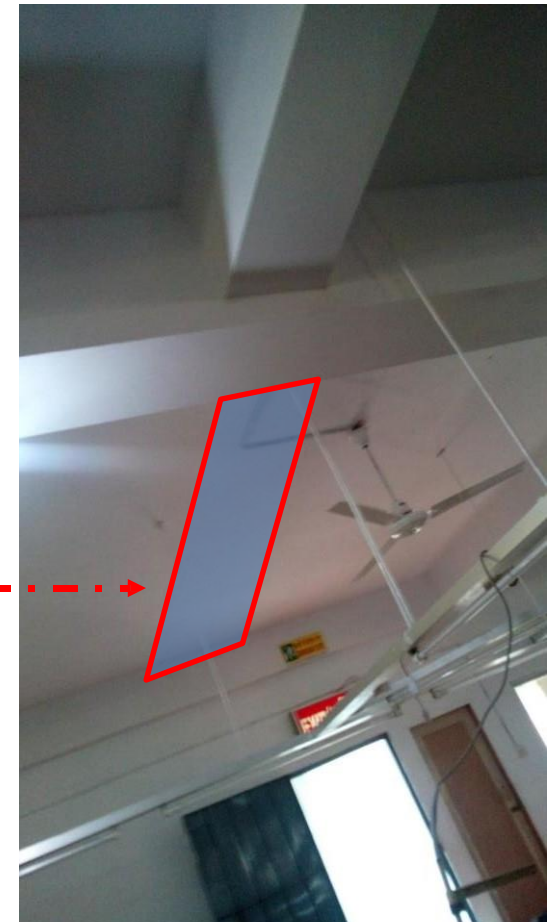
Beam missing on 2nd floor

A sub-beam is missing from at 2<sup>nd</sup> floor of factory building. Factory engineer to survey the whole structure and produce a set of as built drawings considering as-constructed condition.

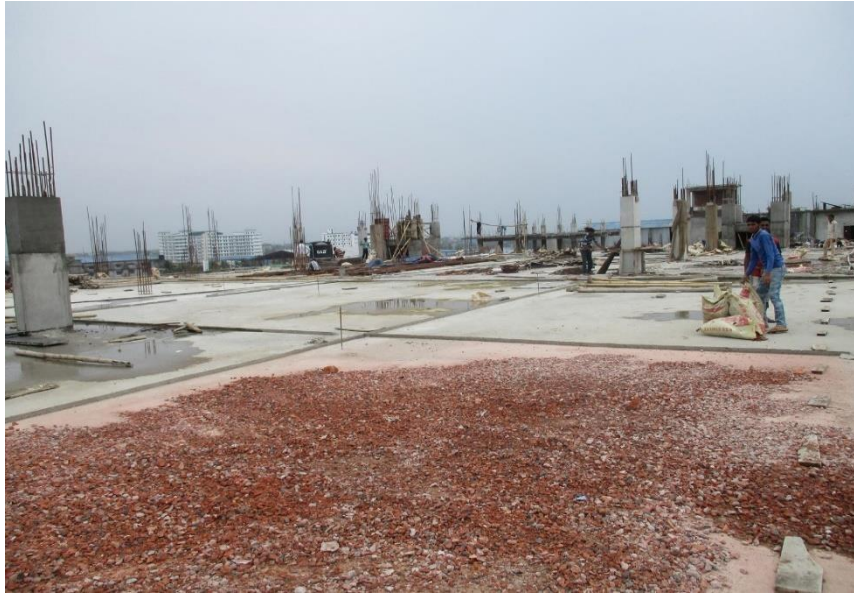
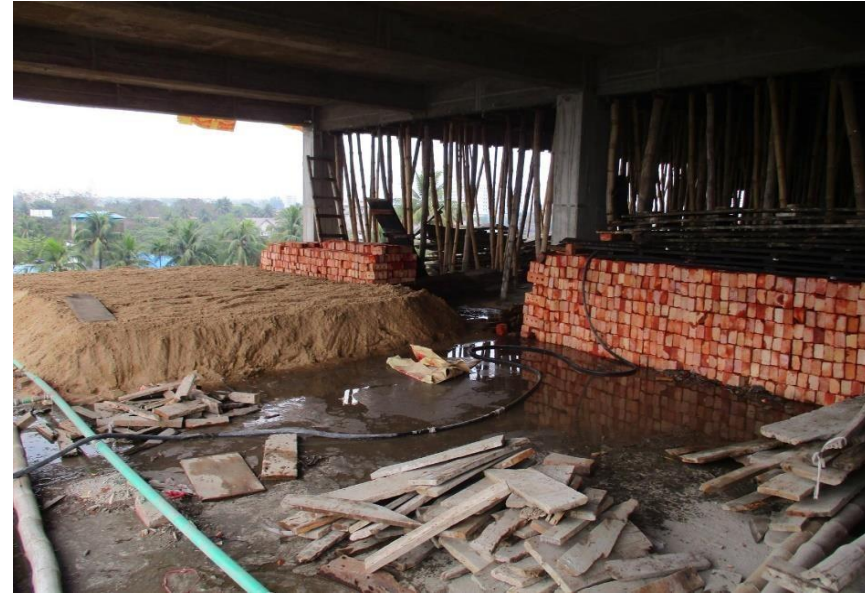
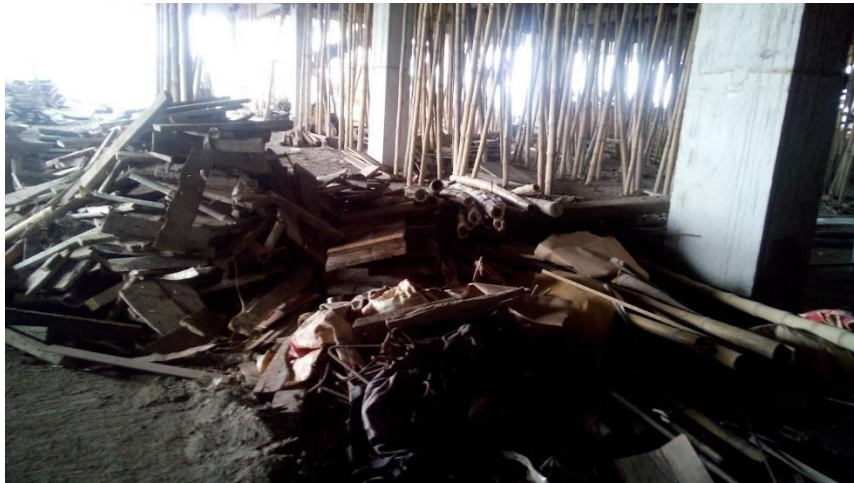
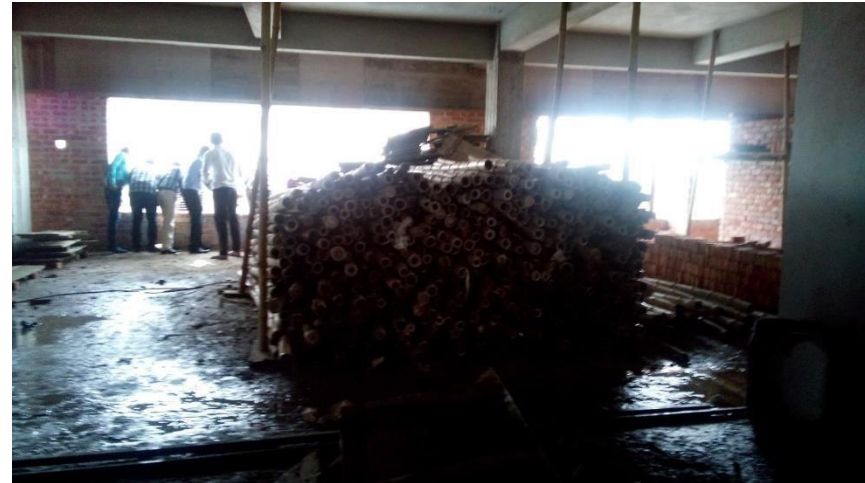
# Construction material and debris on 4<sup>th</sup> floor and roof

Construction material and debris was observed on 4<sup>th</sup> floor and roof. All construction material and debris must be removed from 4<sup>th</sup> floor and roof.

| Item No. | Observation | Recommended Action Plan | Recommended Timeline |
|---|---|---|---|
| 2 | Construction material and debris on 4th floor and roof | Remove the construction material and debris from 4th floor and roof | Immediate - Now |
| 3 | Construction material and debris on 4th floor and roof | Implement the prepared load plan | 6-weeks |

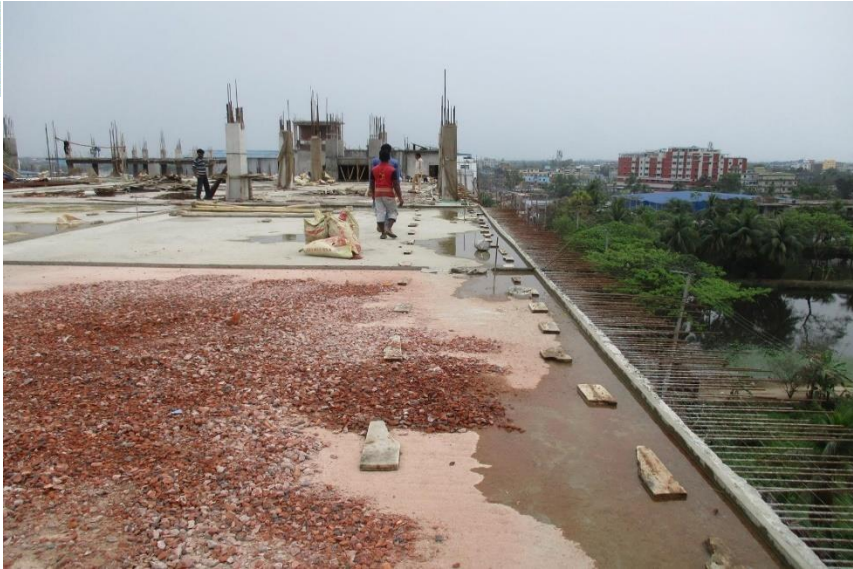
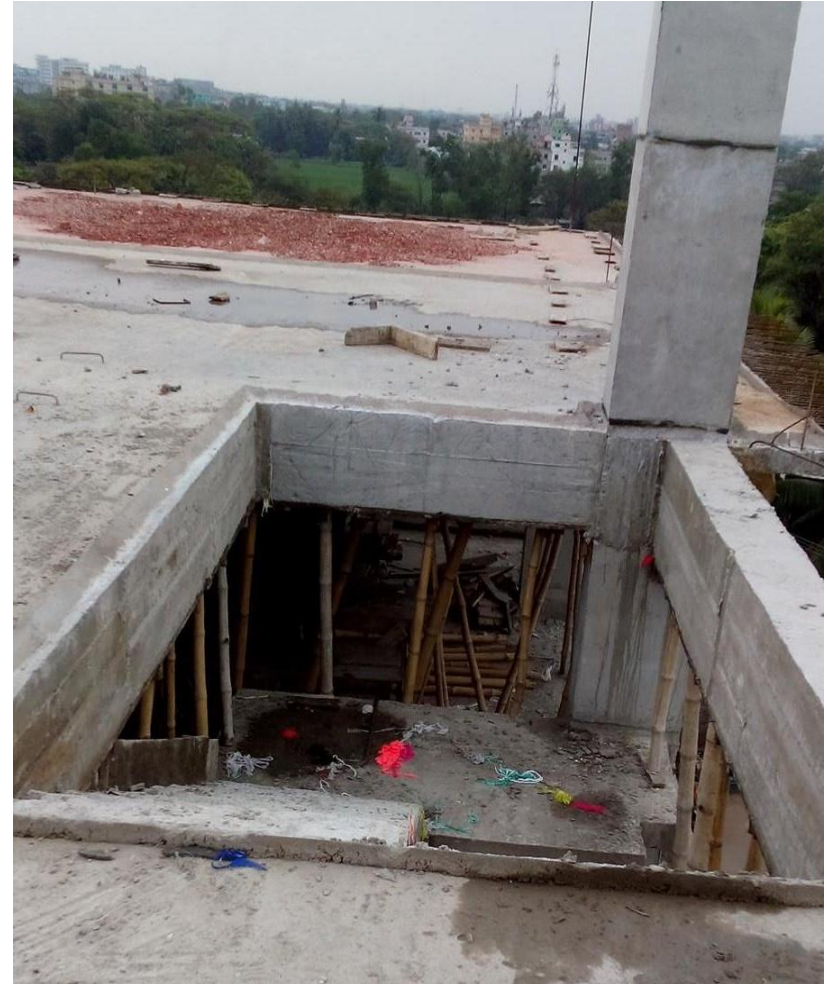
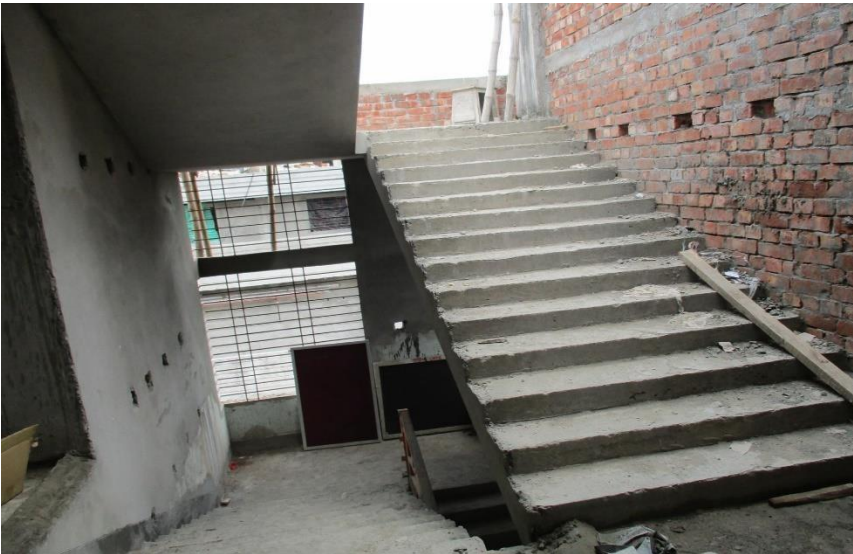
# Falling Hazard on roof and stair

No edge protection system was observed on roof and stair. Factory engineer to provided proper edge protection system or railing to avoid falling hazard.

| Item No. | Observation | Recommended Action Plan | Recommended Timeline |
|---|---|---|---|
| 4 | Falling Hazard on roof and stair | Provide parapet wall on the roof and railing along the stair case | Immediate - Now |

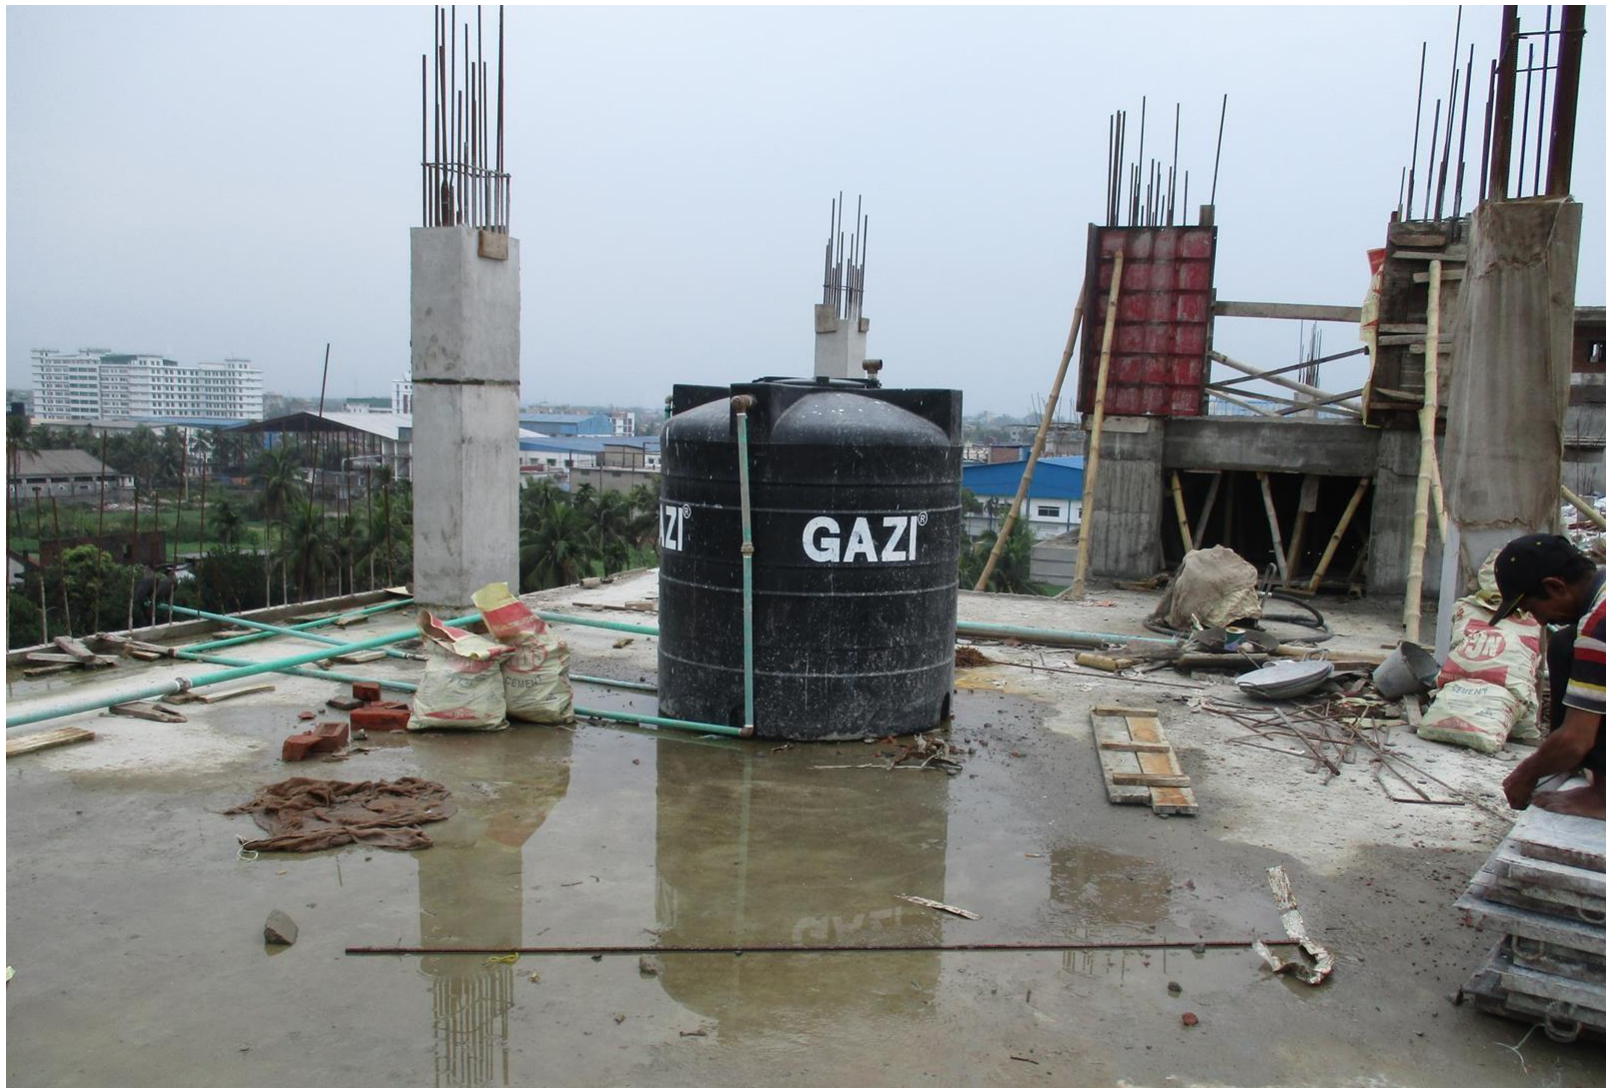
## **Lack of water proofing membrane on roof**

Water ponding was observed on the roof of production building. Proper drainage system and water proofing membrane need to apply on roof to resist water ingress into the slab.

| Item No. | Observation | Recommended Action Plan | Recommended Timeline |
|---|---|---|---|
| 5 | Lack of water proofing membrane on roof | Building engineer to develop proper drainage system and apply water proofing membrane on the roof to avoid water intrusion in roof slab. | 6-months |

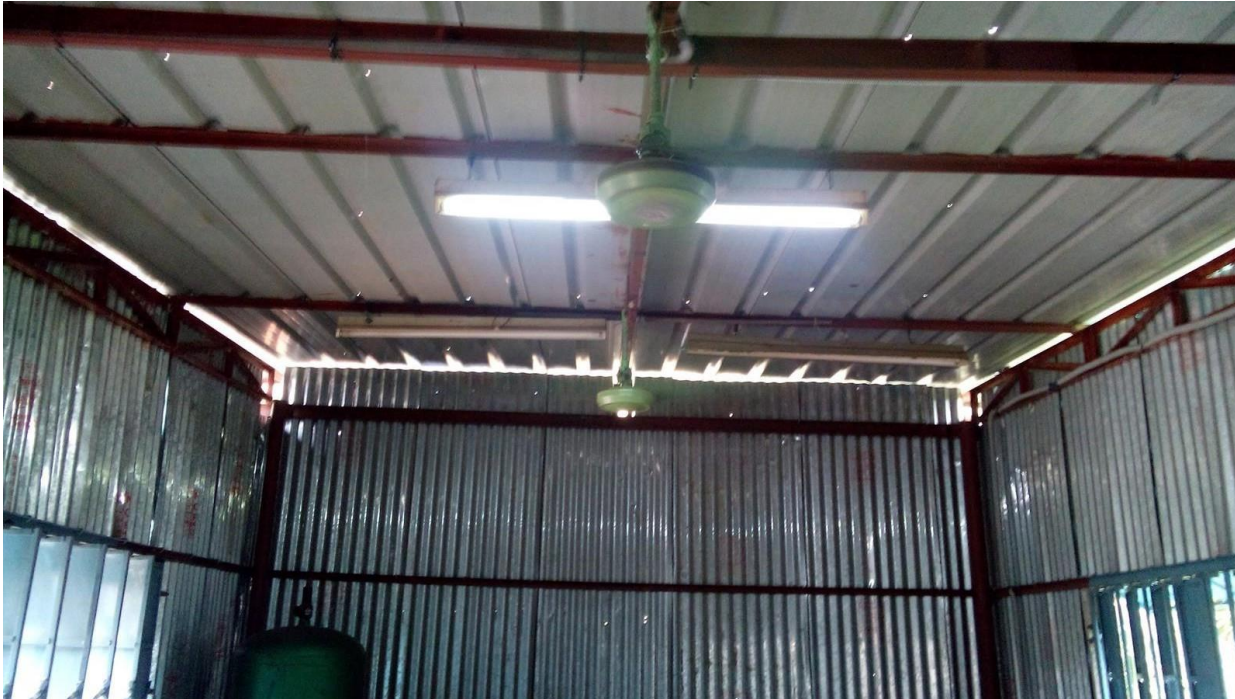
Lightweight steel truss supported roof cladding

The connections between the truss and pipe post are apparently non-engineered. Factory engineer to check the adequacy of the connections and the stability against wind loading.

| Item No. | Observation | Recommended Action Plan | Recommended Timeline |
|---|---|---|---|
| 6 | Apparently non engineered steel roof | Factory engineer to be checked the connections and adequacy of the steel structure against wind loading. | 6-weeks |
| 7 | Apparently non engineered steel roof | Carry out repair works if required | 6-months |

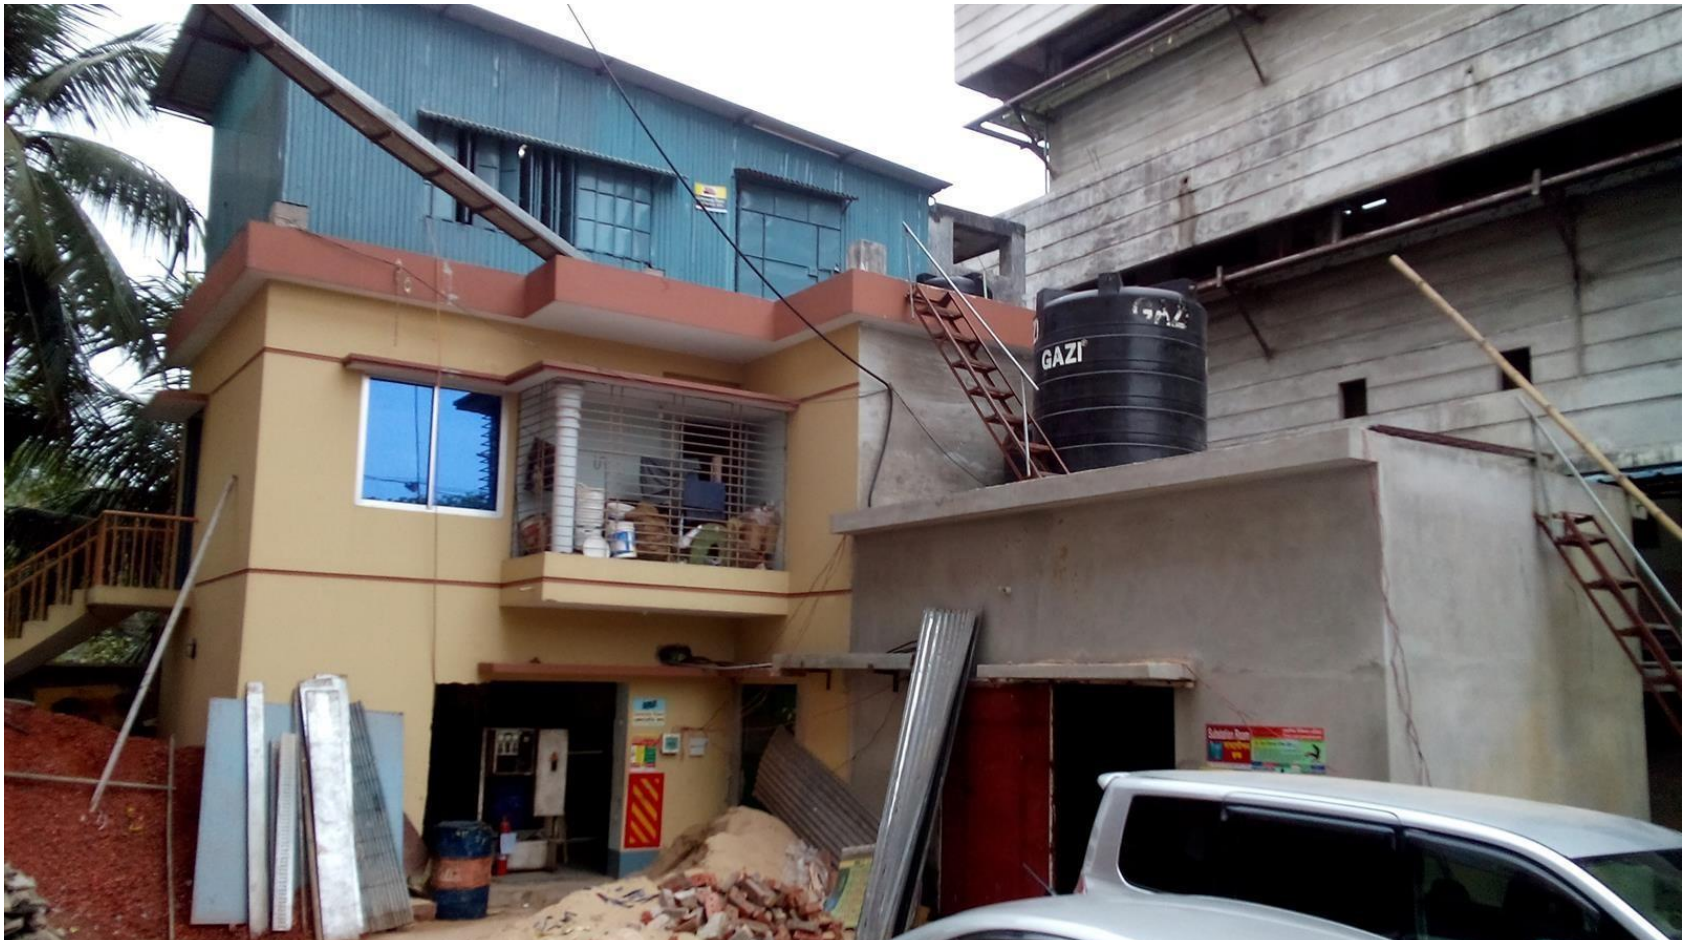
# **Lack of as-built drawing of utility building**

No drawing/document was available for the utility building

Factory engineer to prepare the as-built drawings to the as-constructed condition.

| Item No. | Observation | Recommended Action Plan | Recommended Timeline |
|---|---|---|---|
| 8 | Lack as-built drawings of utility building | Building Engineer is required to prepare the as-built architectural and structural drawings for the utility building. | 6-weeks |

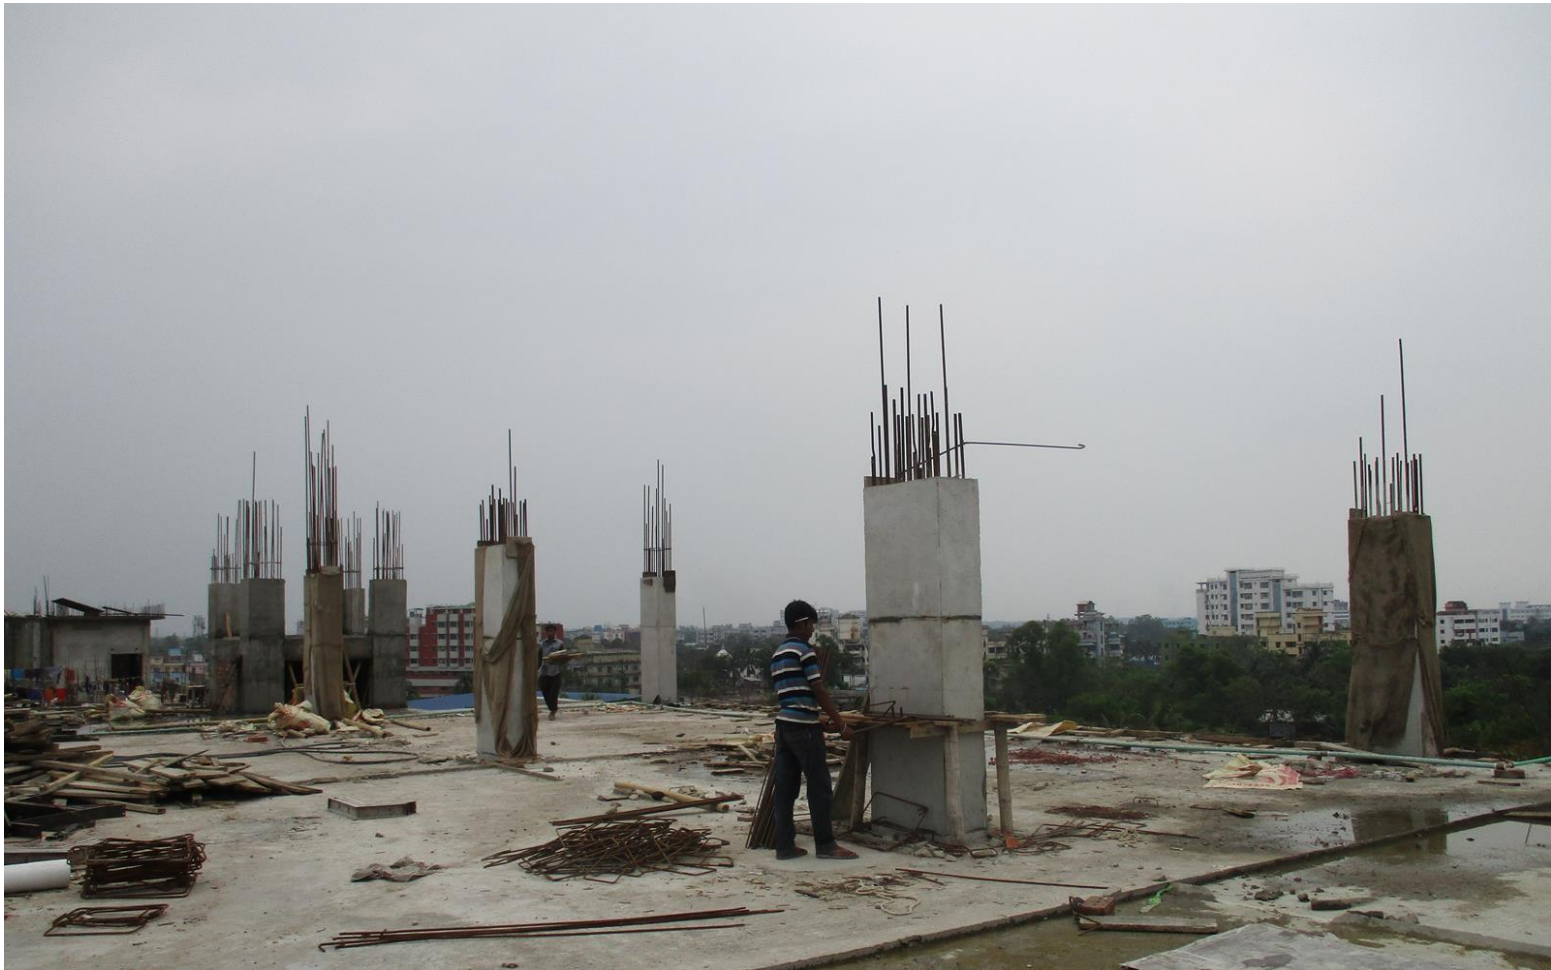
**Future extension to be carried out.**

According to the cursory calculation, if the extension work has been done then the column stress will exceed the normal design limit. Factory engineer is required to carried out a Detail Engineering Assessment considering BNBC provision prior to any extention work.

| Item No. | Observation | Recommended Action Plan | Recommended Timeline |
|---|---|---|---|
| 9 | Future extension to be carried out. | Factory engineer to carried out a Detail Engineering Assessment (DEA) prior to commencement of further construction above 5 storey factory building. | 6-months |
