# Tokio mode Limited (10350)

98/173 Choydana, National University, Gazipur, Bangladesh

20.May.2014

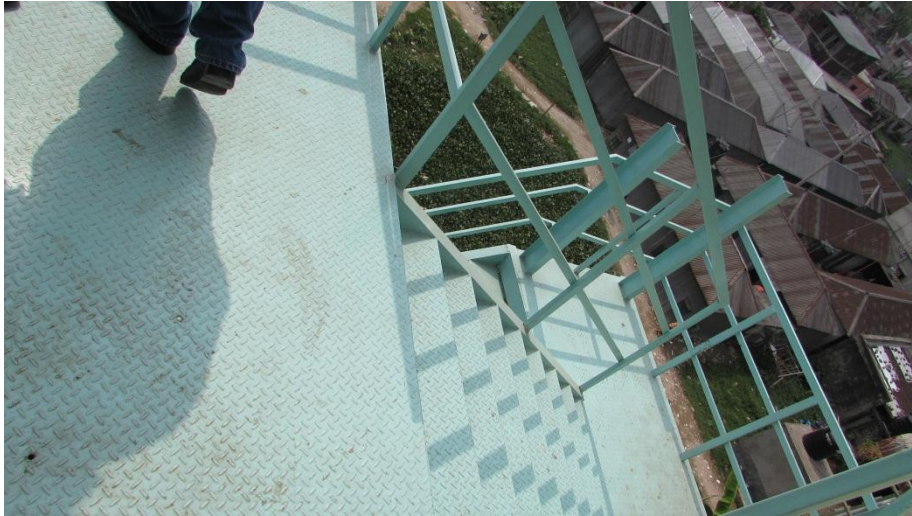
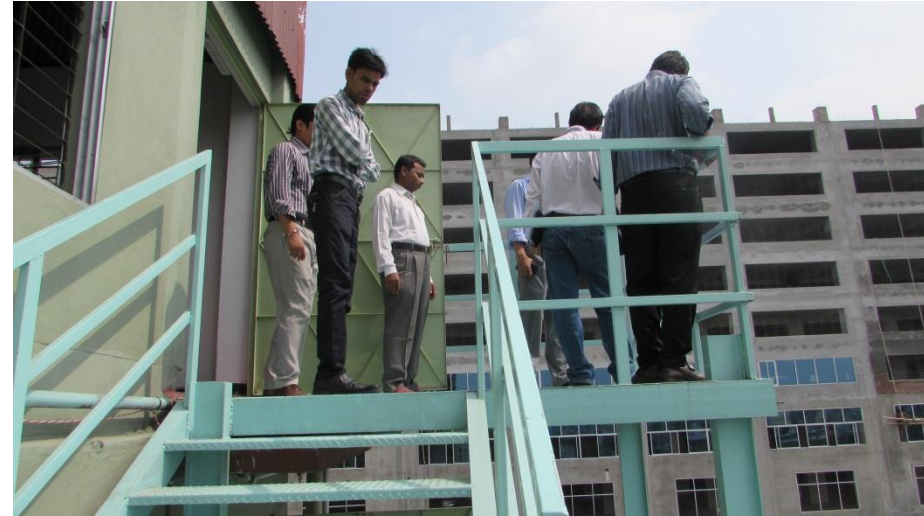
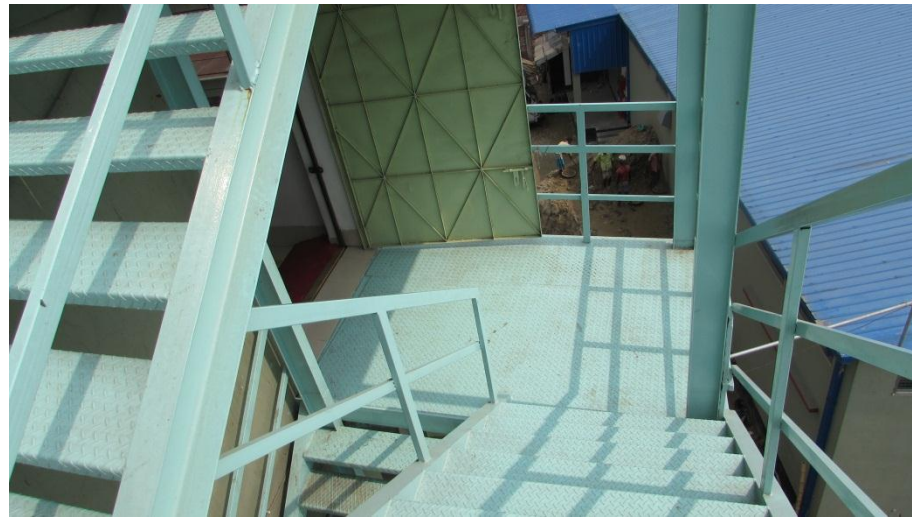
The staircase at the side of Building is meant to be a fire escape. This means that there is a potential for crowds of people to use this stair in the event of emergency. However, the stair was built from very small steel members. The structural stability of this staircase is questionable, and it appears not to comply to BNBC load requirements for exits. Furthermore the staircase wasn't shown on any of the structural drawings.

**Escape Staircase construction isn't strong**

| Item No. | Observation | Recommended Action Plan | Recommended Timeline |
|---|---|---|---|
| 1 | Escape staircase appears to be insufficient for emergency loading | Consider the renewal of this staircase, using suitable corrosion-resistant materials, and of a design suitable for emergency and panic loading. | 6-weeks |

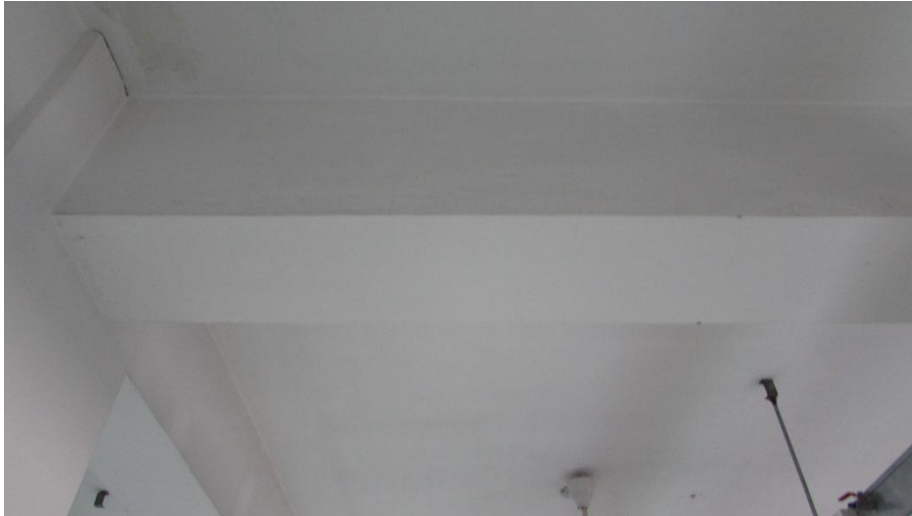
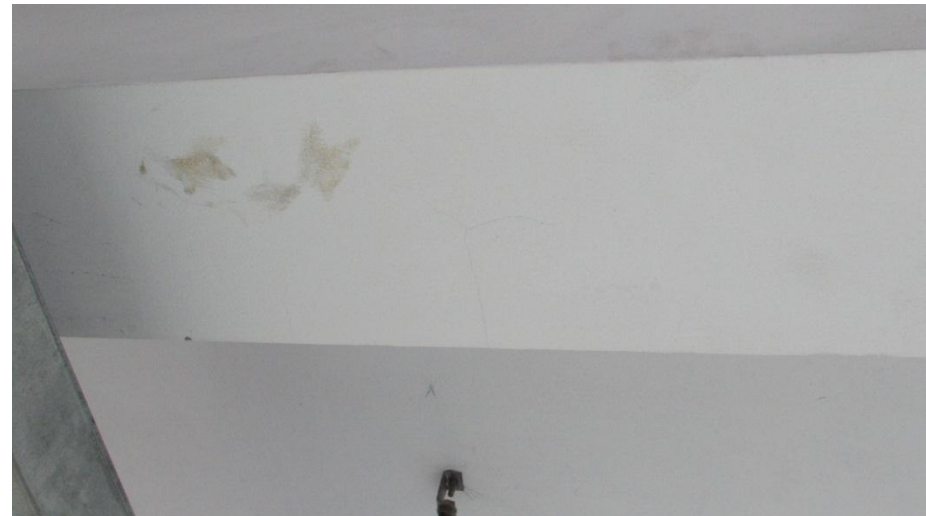
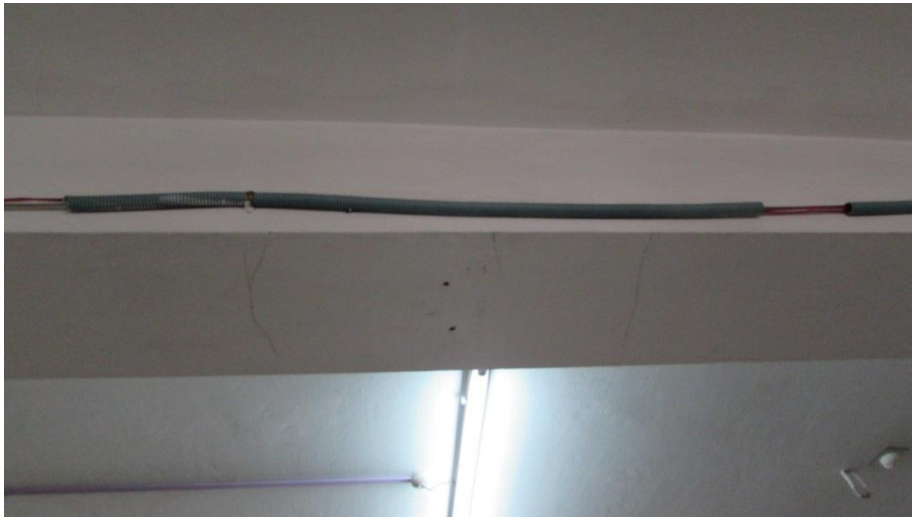
Practically every beam and slab on the roof floor had cracks observed.

Some cracks are thought to be flexural tension cracks, whilst some cracks may be shrinkage cracks

**Some Beam and Slab on roof exhibits Cracking**

| Item No. | Observation | Recommended Action Plan | Recommended Timeline |
|---|---|---|---|
| 2 | Some Beams and Slabs at the roof exhibit Cracking | Carry out full survey of all structural elements to check for cracking and remove surface finishes to expose concrete<br>Carry out repairs to the cracks in the concrete<br>Apply new proper waterproof membrane and screed on the roof floor | 6-months |

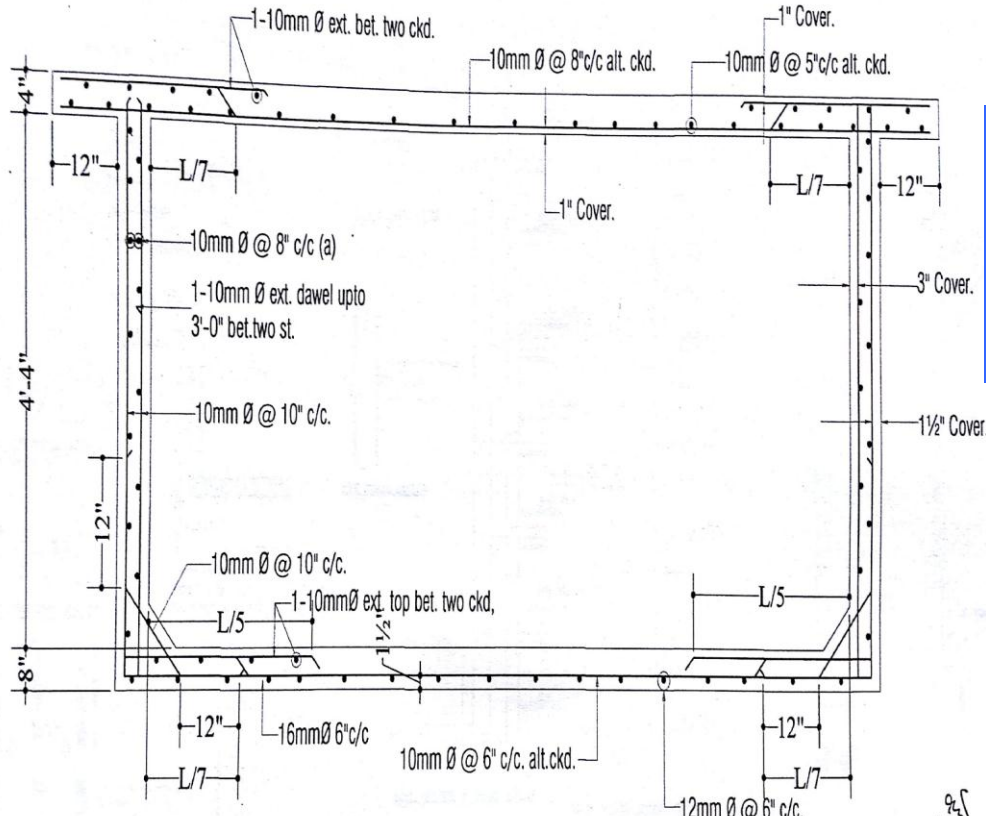
There is insufficient information regarding the water tank details.

Lack some information about Water tank details

| Item No. | Observation | Recommended Action Plan | Recommended Timeline |
|---|---|---|---|
| 3 | Water tank doesn't have enough structural information on the drawings | The building engineer to prepare accurate structural and architectural records for the building, reflecting accurately the as-built condition. | 6-months |

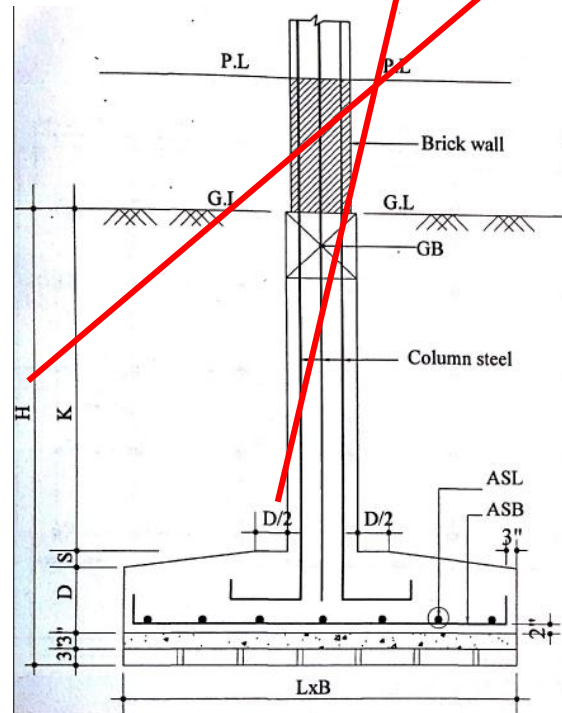
Not enough information in table on foundation detail:

- H
- D2

Lack some information about foundations

| Item No. | Observation | Recommended Action Plan | Recommended Timeline |
|---|---|---|---|
| 4 | The foundation drawing lacks some detail | The building engineer to prepare accurate structural and architectural records for the building, reflecting accurately the as-built condition. | 6-months |
