# INITIAL STRUCTURAL INTEGRITY ASSESSMENT REPORT (SIAR)

Factory Name: **Pearl Garments Co. Ltd.**  
Address: **Palash Bari, Nabinagar, Savar Savar Dhaka  
Bangladesh**  
Assessor: **Bureau Veritas**  
Date: **19 Jun 2014**

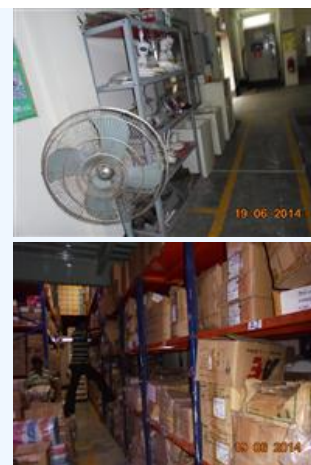
| Description: | Previously, above the 4th floor there was an approved steel shed structure. After the detailed assessment, the assessment report recommended that the steel shed structure can be replaced by RCC beam-slab floor system. (the renovation has been completed) |
