# Stitchtone Apparels Ltd. (9884)

18/19, Strand Road, Champa Tower

20.MAY.2014

# Identified Priority 1 Concerns

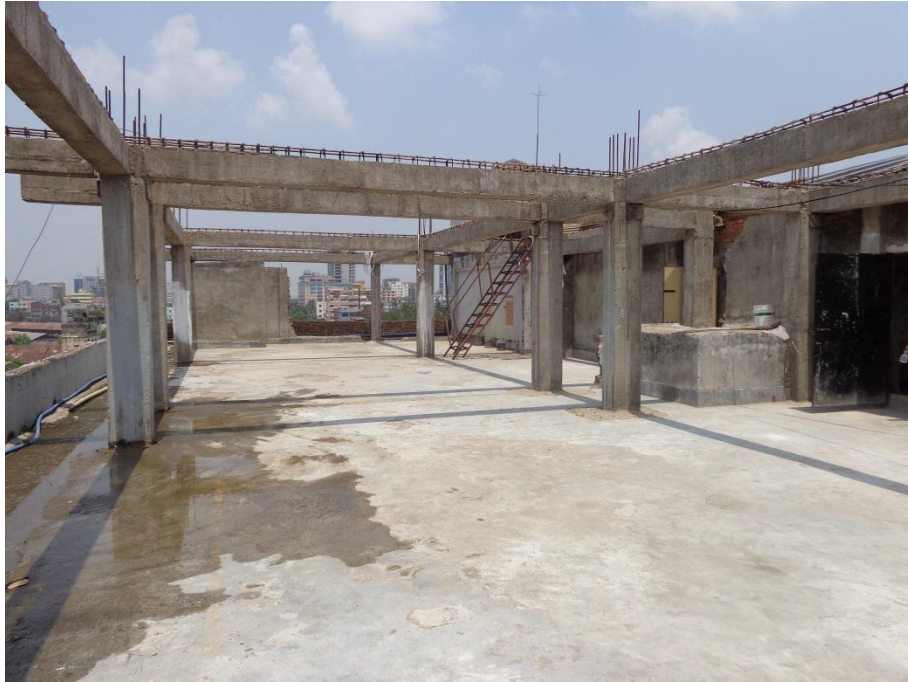
5<sup>th</sup> floor roof slab

The columns are overstressed due to additional live loading and steel roof on roof slab (5th floor).

| Item No. | Observation | Recommended Action Plan | Recommended Timeline |
|---|---|---|---|
| 1 | The columns are overstressed due to additional live loading and steel roof on roof slab (5th floor). | Do not increase the loading and follow posted loading plans.<br>A Detail Engineering Assessment of Factory to be commenced, see attached Scope. | immediate – now |
| 2 | The columns are overstressed due to additional live loading and steel roof on roof slab (5th floor). | Complete the Detailed Engineering Assessment for the load bearing capacity of concrete columns.<br>Verify concrete strength by 100mm dia. Cores – see DEA scope. | 6-weeks |
| 3 | The columns are overstressed due to additional live loading and steel roof on roof slab (5th floor). | Implement recommendations from DEA. | 6-months |

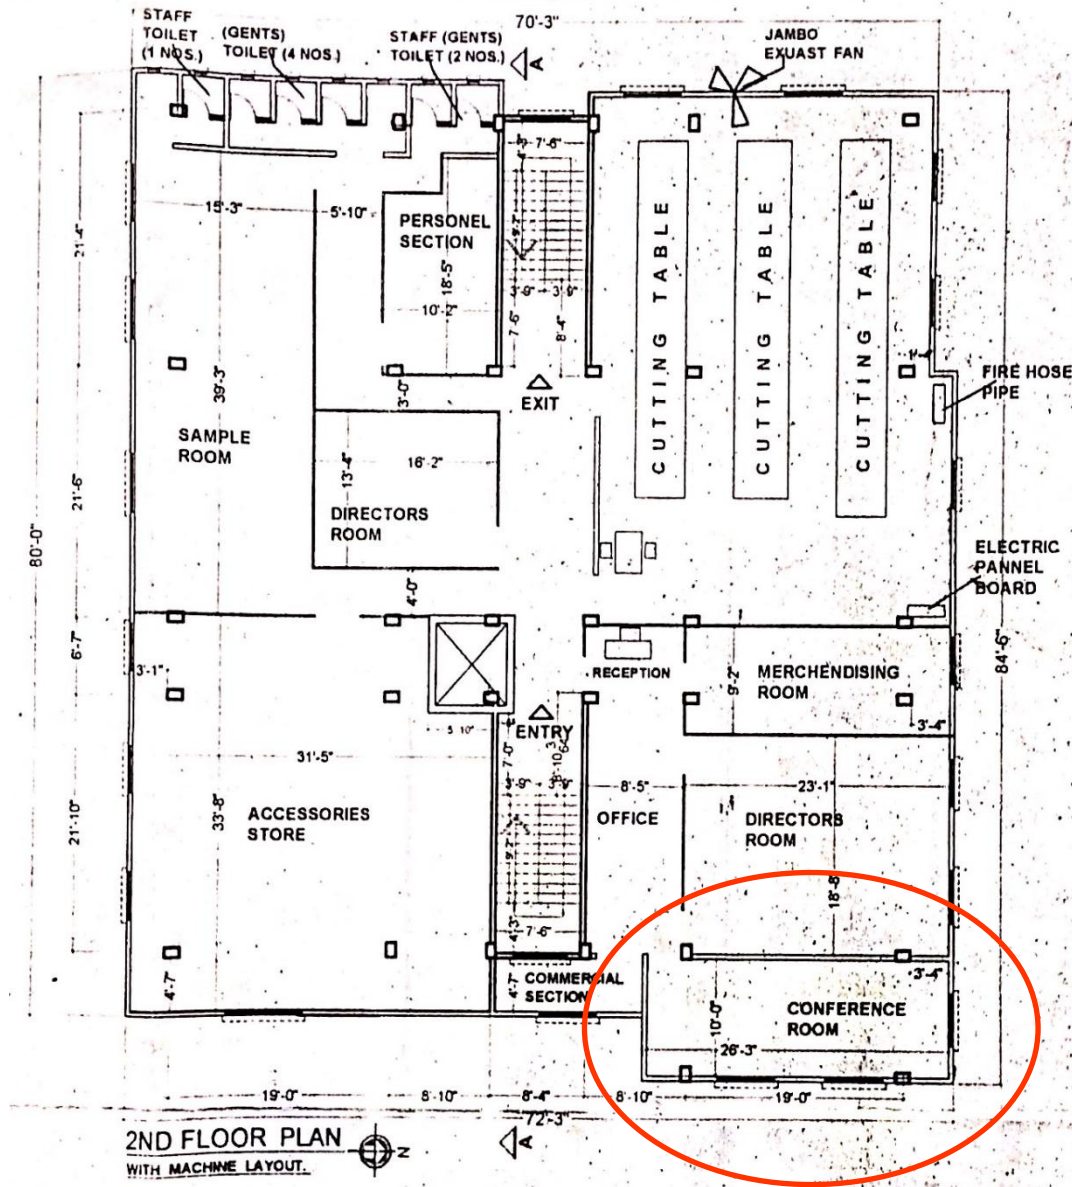
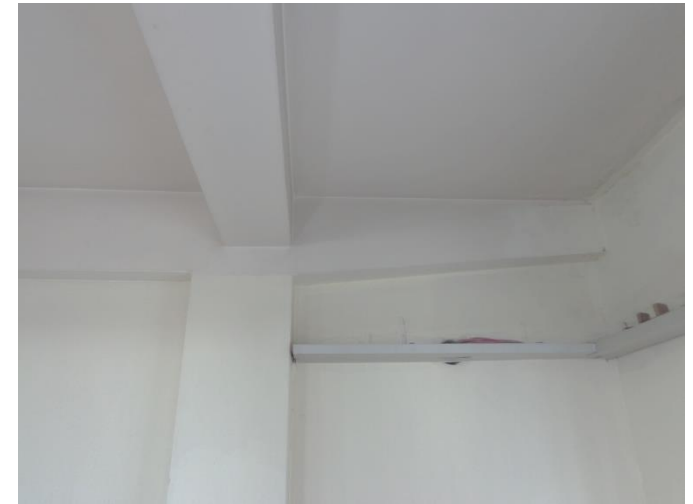
Structural drawings do not match as built conditions and are incomplete:

- extra bay (extension) on East side not shown
- grid spacing not accurate
- Cantilevered slabs not shown
- steel roof at the 5th floor

| Item No. | Observation | Recommended Action Plan | Recommended Timeline |
|---|---|---|---|
| 4 | Structural drawings do not match as built conditions and are incomplete. | Structural Engineer responsible for design to revise drawings to match existing condition.<br>Detailed Engineering Assessment is required for extension, cantilevered slab, and steel roof. | 6-weeks |
| 5 | Structural drawings do not match as built conditions and are incomplete. | Implement recommendations from DEA | 6-months |

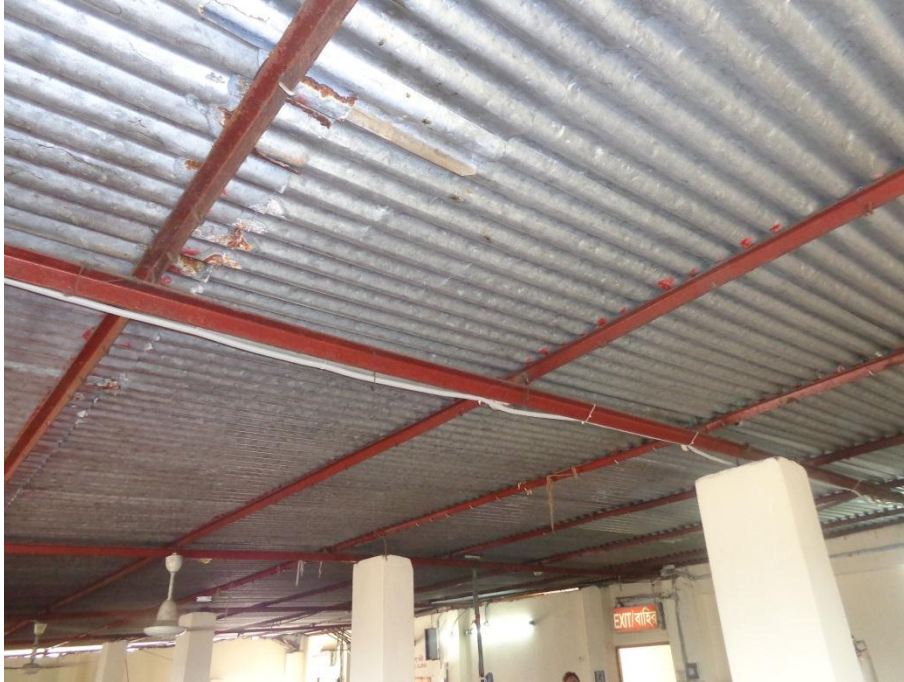
Steel roof on roof slab

Poor steel detailing, especially of deck to purlins and of structure to columns, was observed for steel roof on 5th floor slab and canopy at front entrance.

| Item No. | Observation | Recommended Action Plan | Recommended Timeline |
|---|---|---|---|
| 6 | Poor steel detailing for steel roof on 5th floor slab and canopy at front entrance. | Detailed Engineering Assessment is required for steel detailing of roof and canopy. | 6-weeks |
| 7 | Poor steel detailing for steel roof on 5th floor slab and canopy at front entrance. | Implement recommendations from DEA | 6-months |

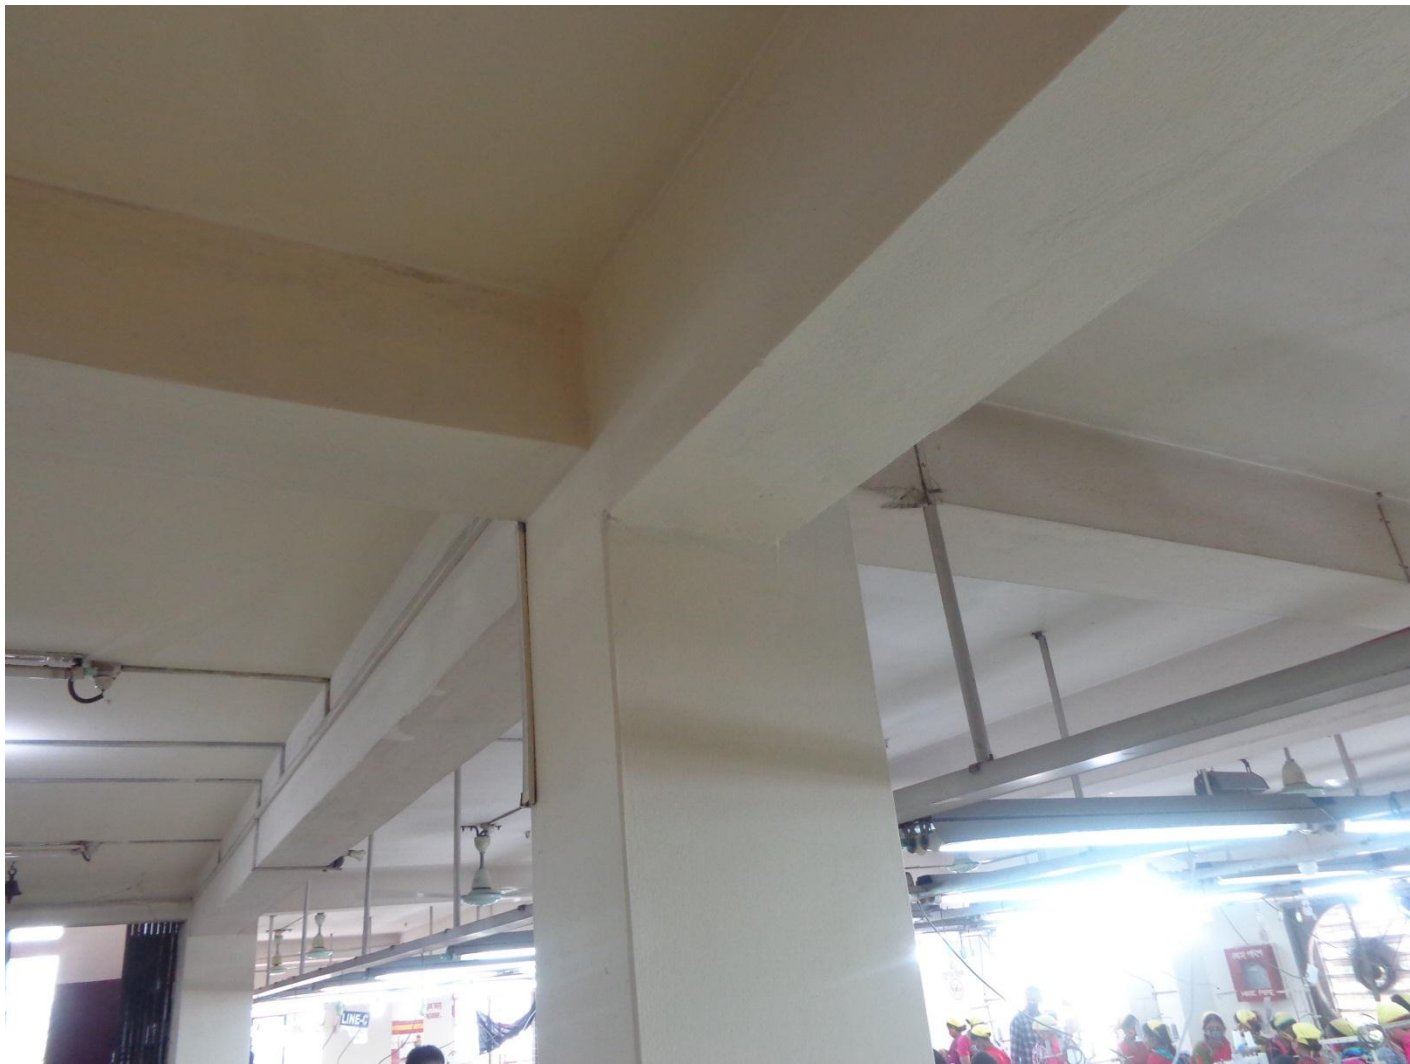
The building did not feature any core or shear walls. Stability was achieved through sway action between beams and columns and masonry infill walls.

We require that these items be investigated in a Detail Engineering Assessment

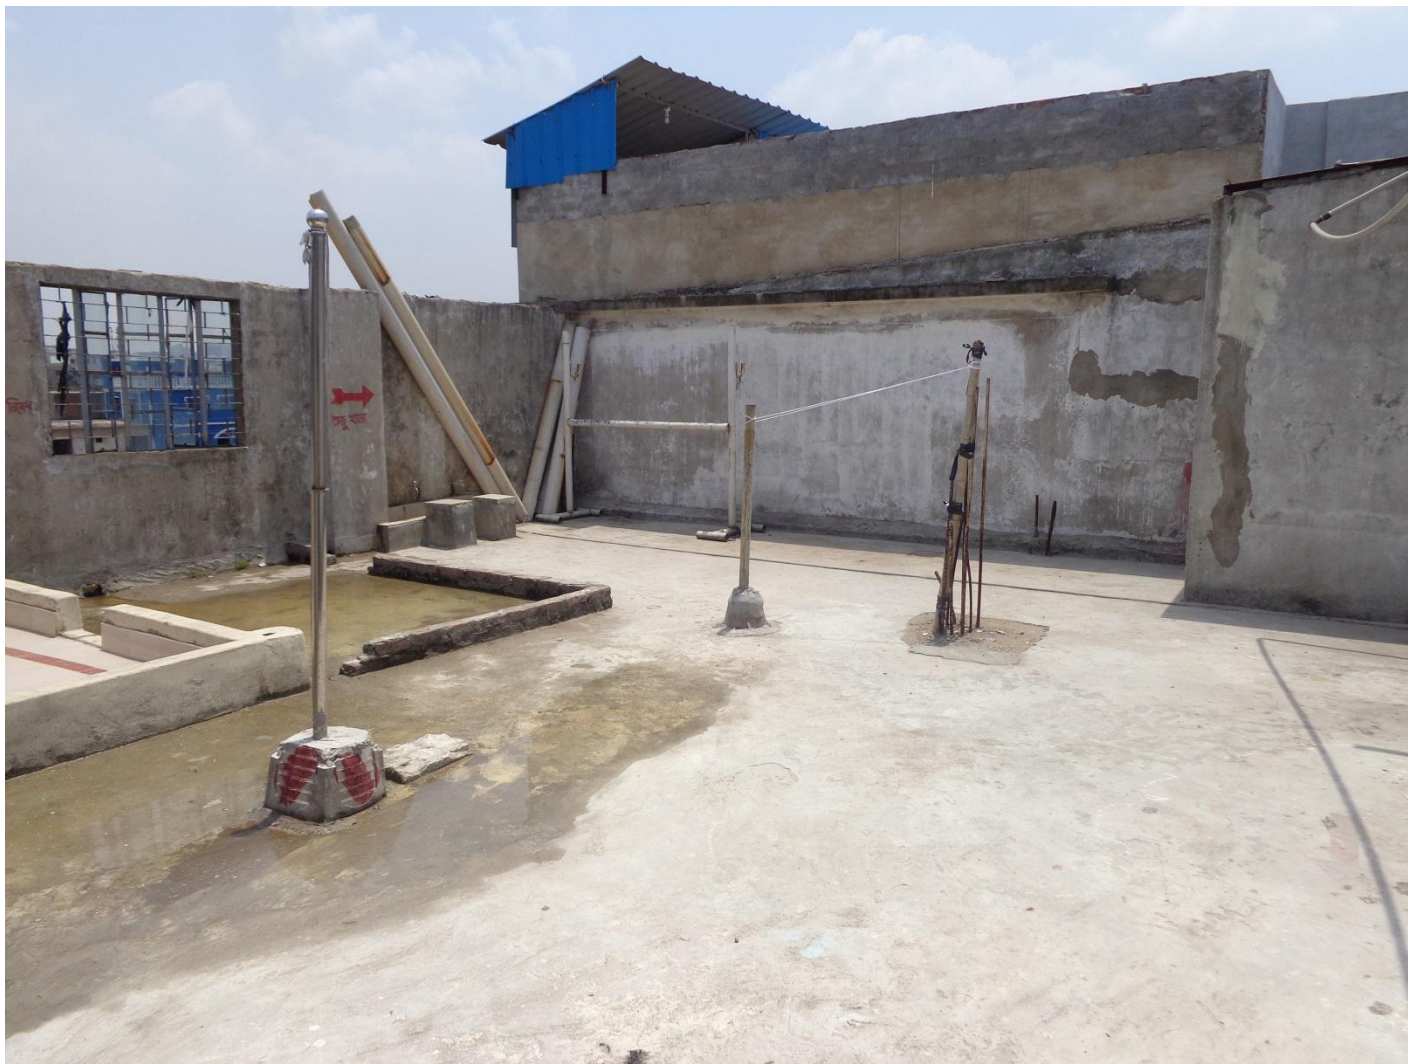
No waterproofing membrane was visible on the roof of the building. This means that any cracks in the surface finishes on the roof will allow water to seep into the concrete slab beneath the finishes, and cause corrosion of the reinforcing steel.
