# MAS Intimates Bangladesh Pvt. Ltd. (9550)

FSFB #1, Karnaphuli Export Processing Zone, North Patenga, Chittagong

20.MAY.2014

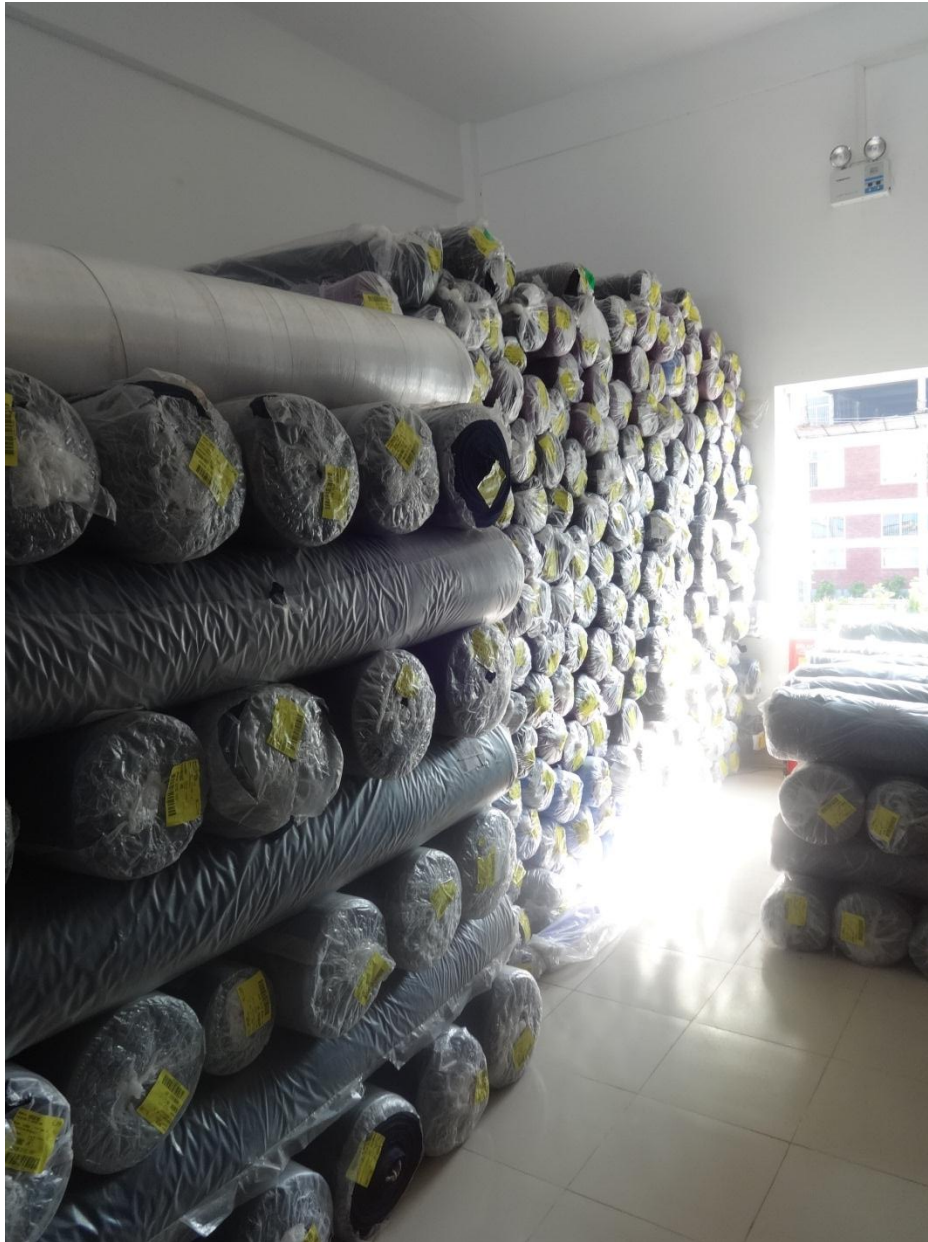
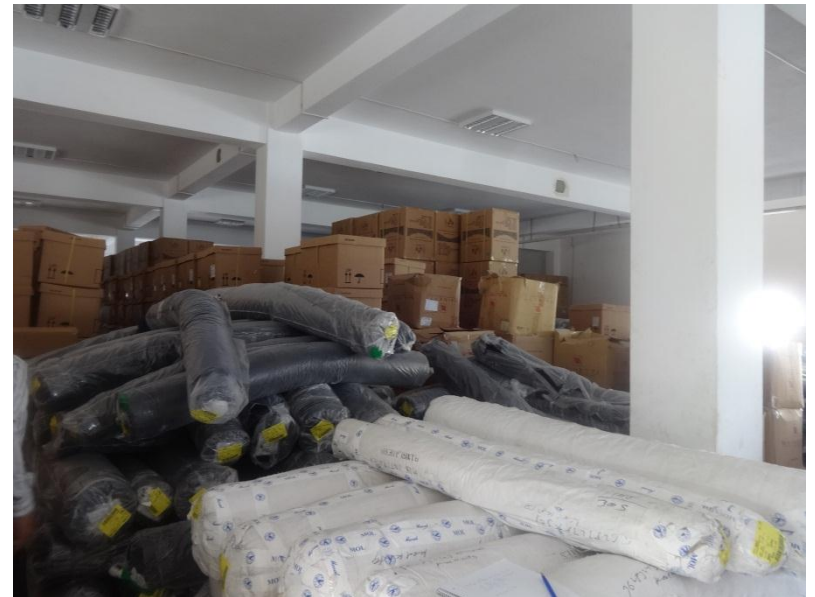
Storage loading on the first floor of the two-storey office building considerably exceeds design load and should be reduced.

To the left is the most heavily loaded area of the building identified, with a quick calculation establishing around 6kN/m<sup>2</sup> area load. Below is another image on the same floor, demonstrating the uncontrolled loading present.

35kg per roll, ÷ (1.65m x 0.275m plan area), x 8 rolls high, = 617kg/m<sup>2</sup>

| Item No. | Observation | Recommended Action Plan | Recommended Timeline |
|---|---|---|---|
| 1 | Excessive storage on first floor of office building, to be reduced. | Stacking of rolls of fabric to be immediately reduced to a maximum of 4 rolls in height. | Immediate – Now |
| 2 | Excessive storage on first floor of office building, to be reduced. | Factory Engineer to produce a loading plan, with maximum storage heights being established, to ensure that 3kN/m <sup>2</sup> is not exceeded. | 6-weeks |
| 3 | Excessive storage on first floor of office building, to be reduced. | Loading plan to be adhered to, with factory managers and supervisors to ensure compliance. | 6-months |

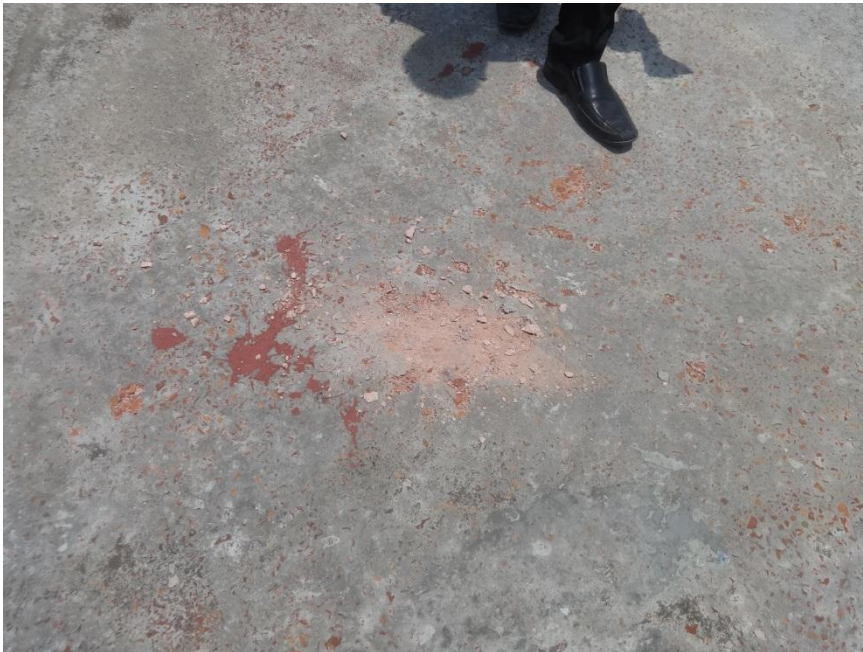
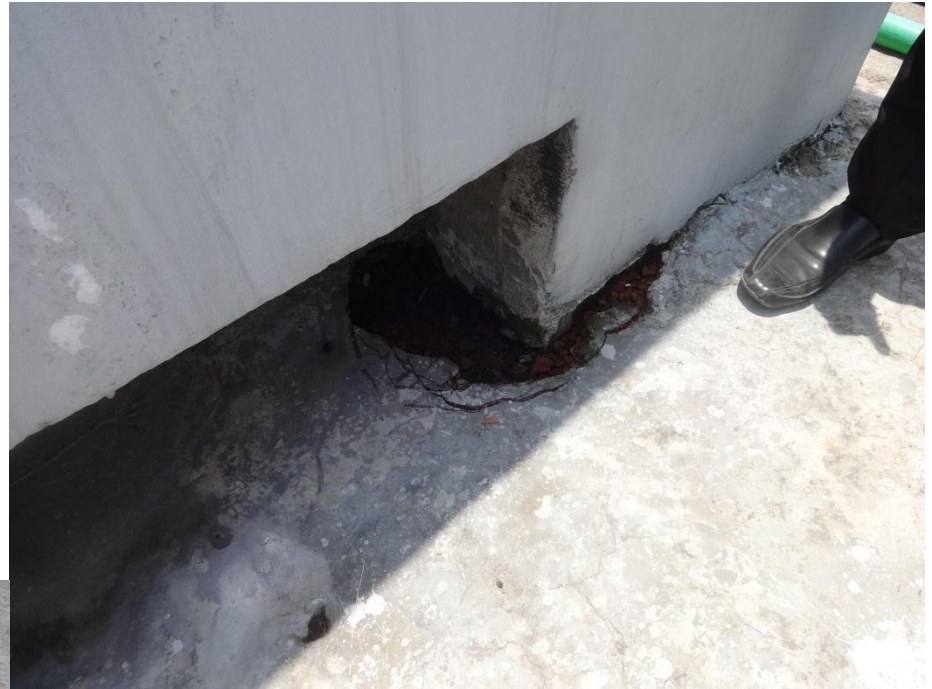
Below is a characteristic flat area of the roof, where the surfacing course is clearly worn away and brittle, exposing the aggregate beneath.

Above is the roof build-up around the legs of the rooftop water tank, where the build-up is at its thickest and the deterioration is most evident.

It is evident in these areas that the build-up on top of the roof slab is just loose brick aggregate, with a very thin screed on top. In principle the build-up is ok, allowing runoff of water from the roof, but it must be repaired and covered to ensure that water cannot penetrate through it, and into the structural slab.

| Item No. | Observation | Recommended Action Plan | Recommended Timeline |
|---|---|---|---|
| 4 | Roof build-up on the main factory building has deteriorated to allow water ingress, and should be repaired. | Existing build up to be locally repaired/replaced where deteriorated, to ensure and constant and even slope towards the perimeter of the building.<br>Total thickness of the build-up should not be increased from its existing level. | 6-weeks |
| 5 | Roof build-up on the main factory building has deteriorated to allow water ingress, and should be repaired. | Apply a waterproof coating or membrane to ensure that water cannot infiltrate the build-up.<br>Monitor condition of the roof and carry out regular maintenance wherever necessary. | 6-months |

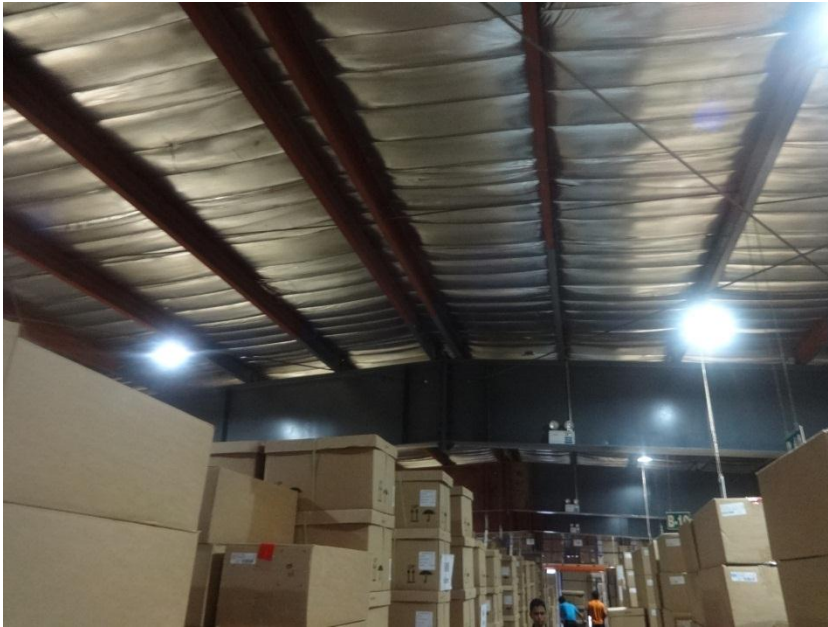
A report by CUET has previously been carried out, but this gives only a generalised statement regarding lateral stability.

The image above shows the portal frame providing stability for the warehouse in one direction. In the other direction, concrete columns support steel columns above, and no system of bracing or lateral restraint was evident.

| Item No. | Observation | Recommended Action Plan | Recommended Timeline |
|---|---|---|---|
| 8 | Lateral stability system of warehouse building does not seem comprehensive, and should be investigated further. | CUET Engineering Assessment should be developed to establish capacity of existing structure against normal lateral loading.<br>Suitable system of restraint to be established, if considered that existing stability system is not adequate. | 6-weeks |
| 9 | Lateral stability system of warehouse building does not seem comprehensive, and should be investigated further. | Implement and structural alterations deemed necessary by the aforementioned Engineering Assessment. | 6-months |

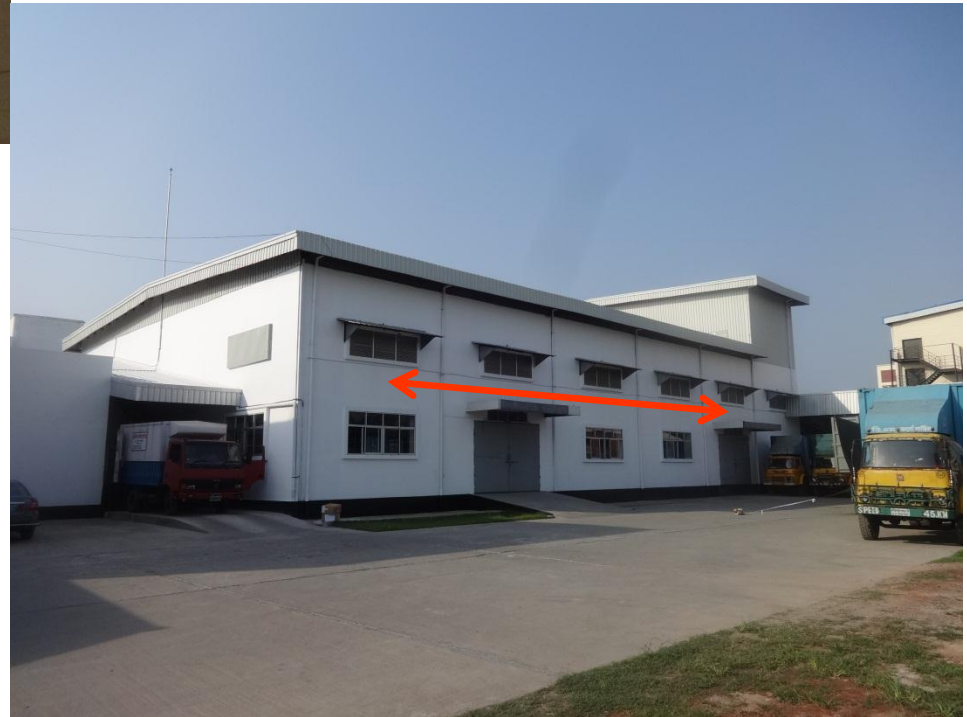
The image to the right is annotated to show the direction in which the stability system is to be established/improved.

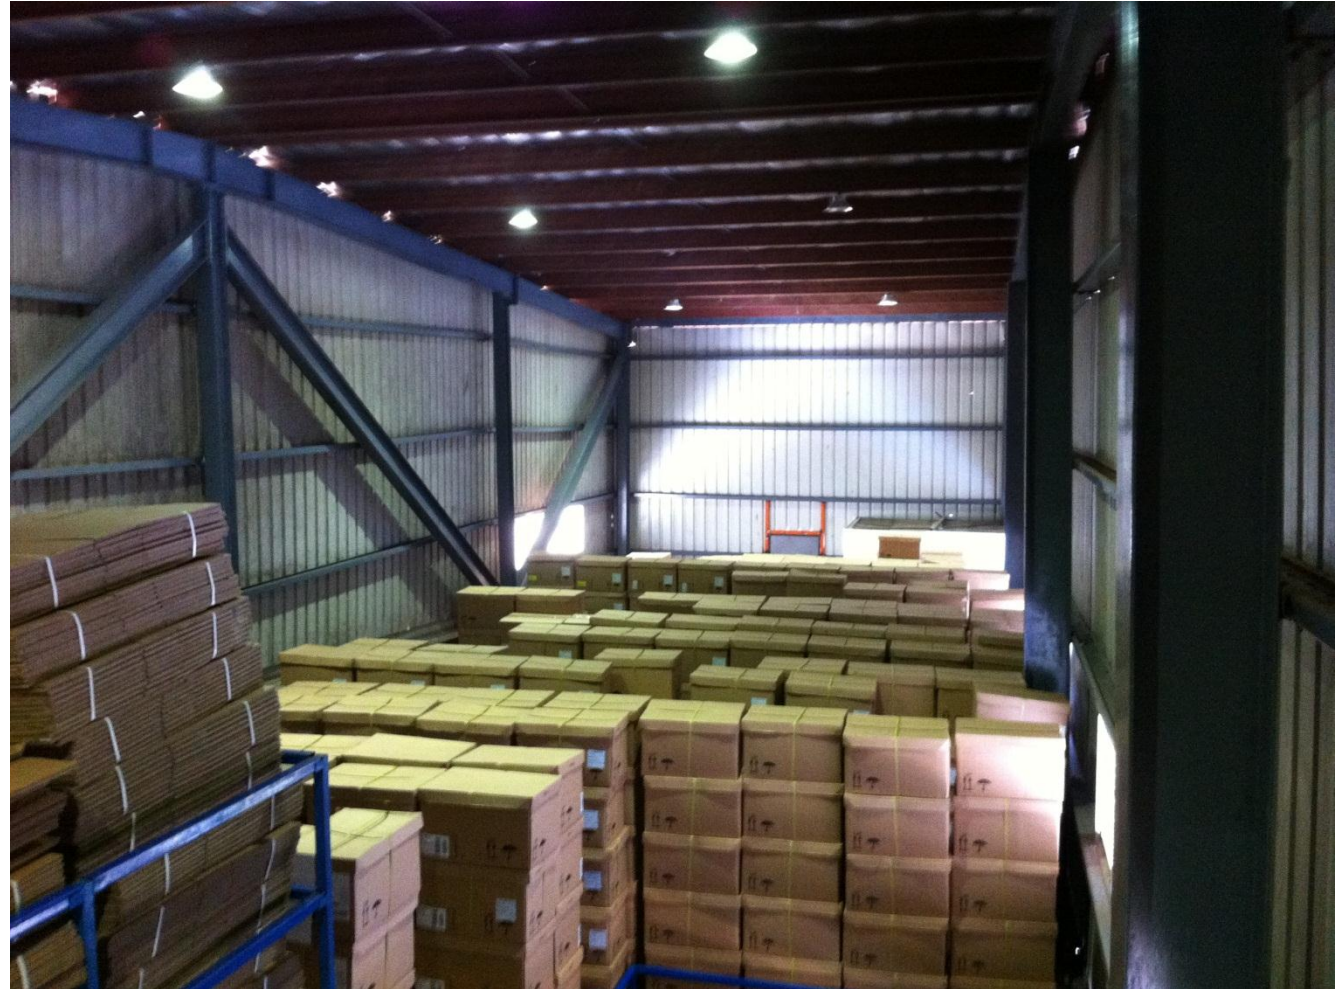
This image shows the upper portion of the warehouse building, where steel columns are present, supported by the concrete columns at lower level.

At this level in particular, the lateral stability system is not clear. The roof is quite high, yet there is no system of lateral stability in one direction and the capability of the roof for diaphragm action must also be confirmed.

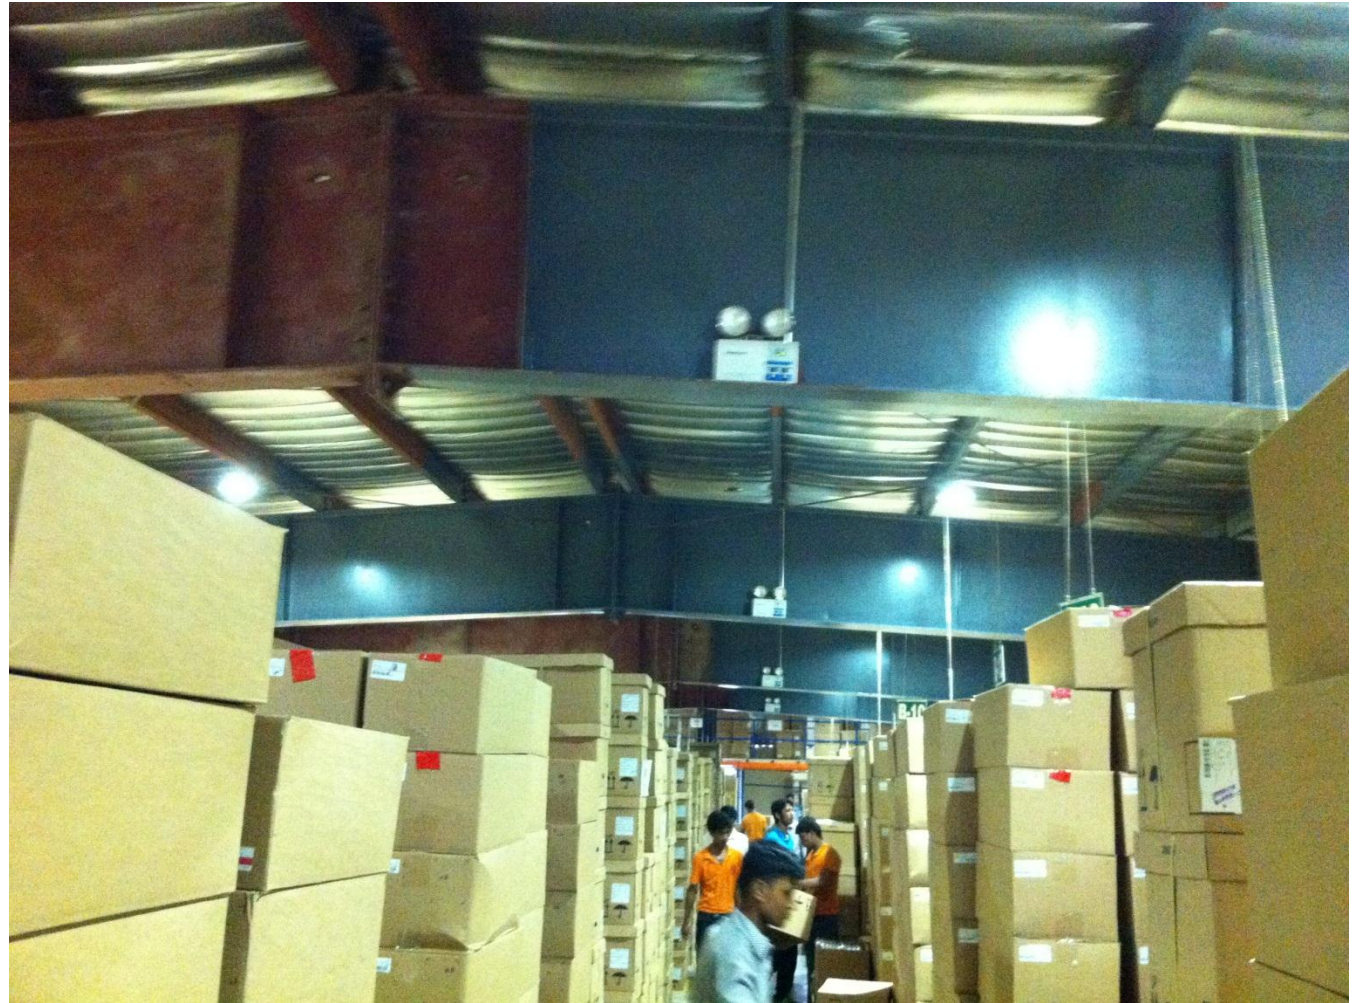
As shown in this image, there is no restraint to the bottom flange of the roof girders. It is only at rigid supports that compression is generated in this flange under normal gravity loading, however in a wind uplift loading condition, significant portions of the bottom flange are in compression, and should be suitably restrained against lateral torsional buckling.

| Item No. | Observation | Recommended Action Plan | Recommended Timeline |
|---|---|---|---|
| 6 | Warehouse building roof girders have no bottom flange restraint. | Factory Engineer to design appropriate positioning and spacing of bottom flange restraint. | 6-weeks |
| 7 | Warehouse building roof girders have no bottom flange restraint. | Bottom flange restraint to be implemented, under the supervision of capable Engineer to ensure suitable installation to ensure full restraint is established. | 6-months |

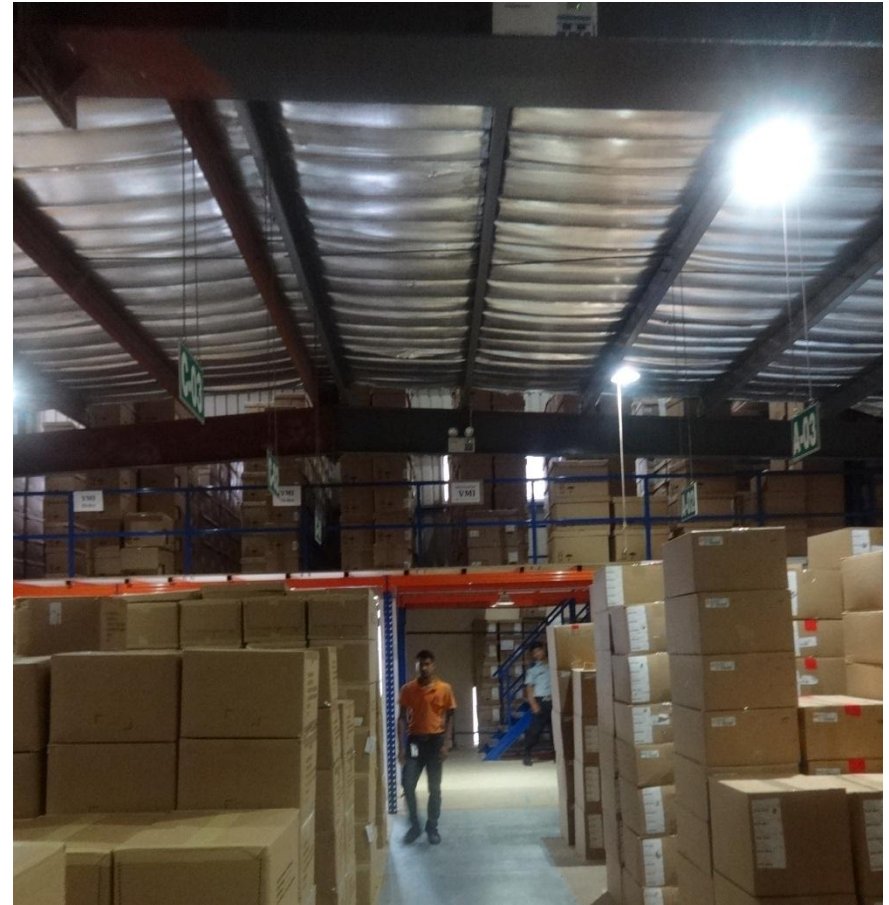
To the left is the leg of a 3<sup>rd</sup> mezzanine-level column, which is actually supported directly from the mezzanine level below. Most of these legs are over the joist-lines below, but this is not always the case.

| Item No. | Observation | Recommended Action Plan | Recommended Timeline |
|---|---|---|---|
| 10 | Mezzanines in the warehouse building are very lightweight construction, and in some cases are supported on top of one another. Further assessment required. | Mezzanine manufacturer's advice to be sought, concerning the capacity of the existing structure.<br>Particular consideration to be given to existing floor deck capacity, and appropriateness of supporting one mezzanine off another. | 6-weeks |
| 11 | Mezzanines in the warehouse building are very lightweight construction, and in some cases are supported on top of one another. Further assessment required. | Implement any structural changes deemed necessary by the mezzanine manufacturer. | 6-months |

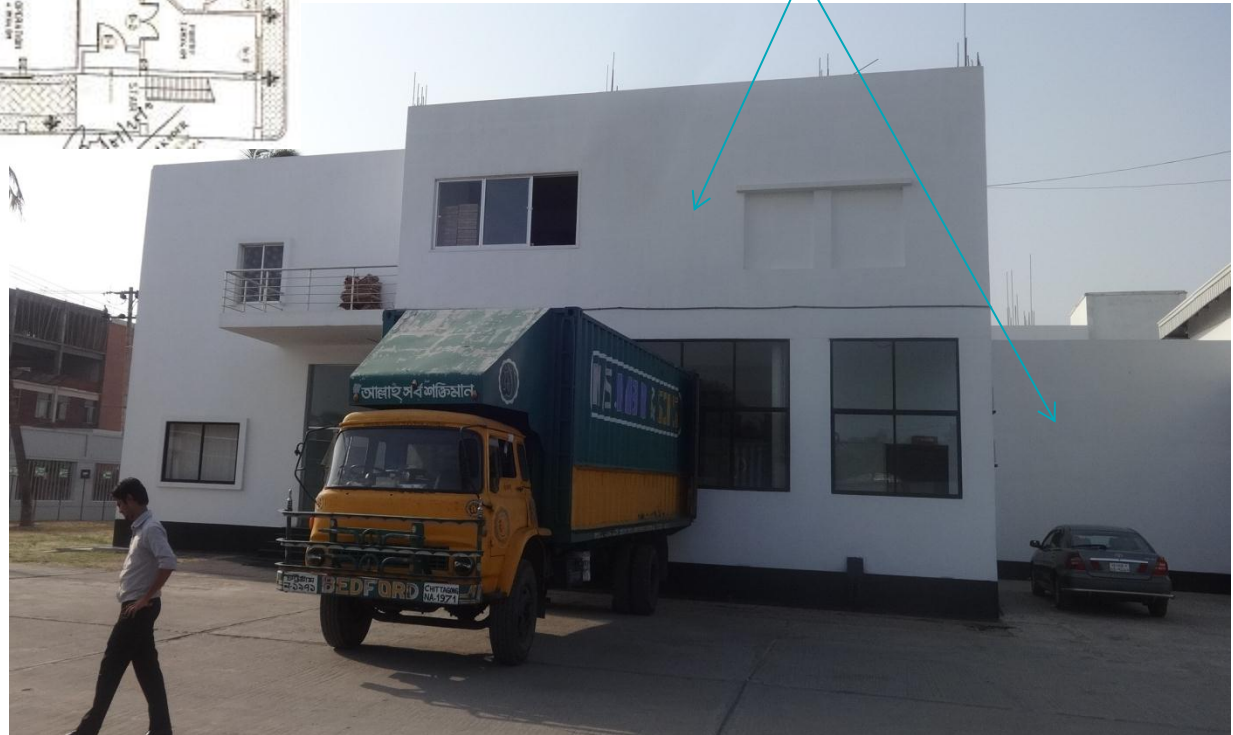
To the left is the architectural plan of the office building, showing a rectangular plan layout with a porch and an external stair. Below is the South elevation, indicated on the drawing to the left, which shows extensions both to the South and East.

Existing areas not indicated on drawing.

In addition to the overall layout inaccuracies indicated here, the internal column layout observed did not match the drawing above, with some beam spans being almost double what is indicated on the drawings.

| Item No. | Observation | Recommended Action Plan | Recommended Timeline |
|---|---|---|---|
| 14 | Inadequate or incorrect drawings of office building and warehouse. Site conditions to be surveyed and drawings to be amended. | Existing layout and construction to be surveyed in the office building and warehouse. | 6-weeks |
| 15 | Inadequate or incorrect drawings of office building and warehouse. Site conditions to be surveyed and drawings to be amended. | Following the aforementioned survey, architectural and structural 'as-built' drawings to be produced. | 6-months |

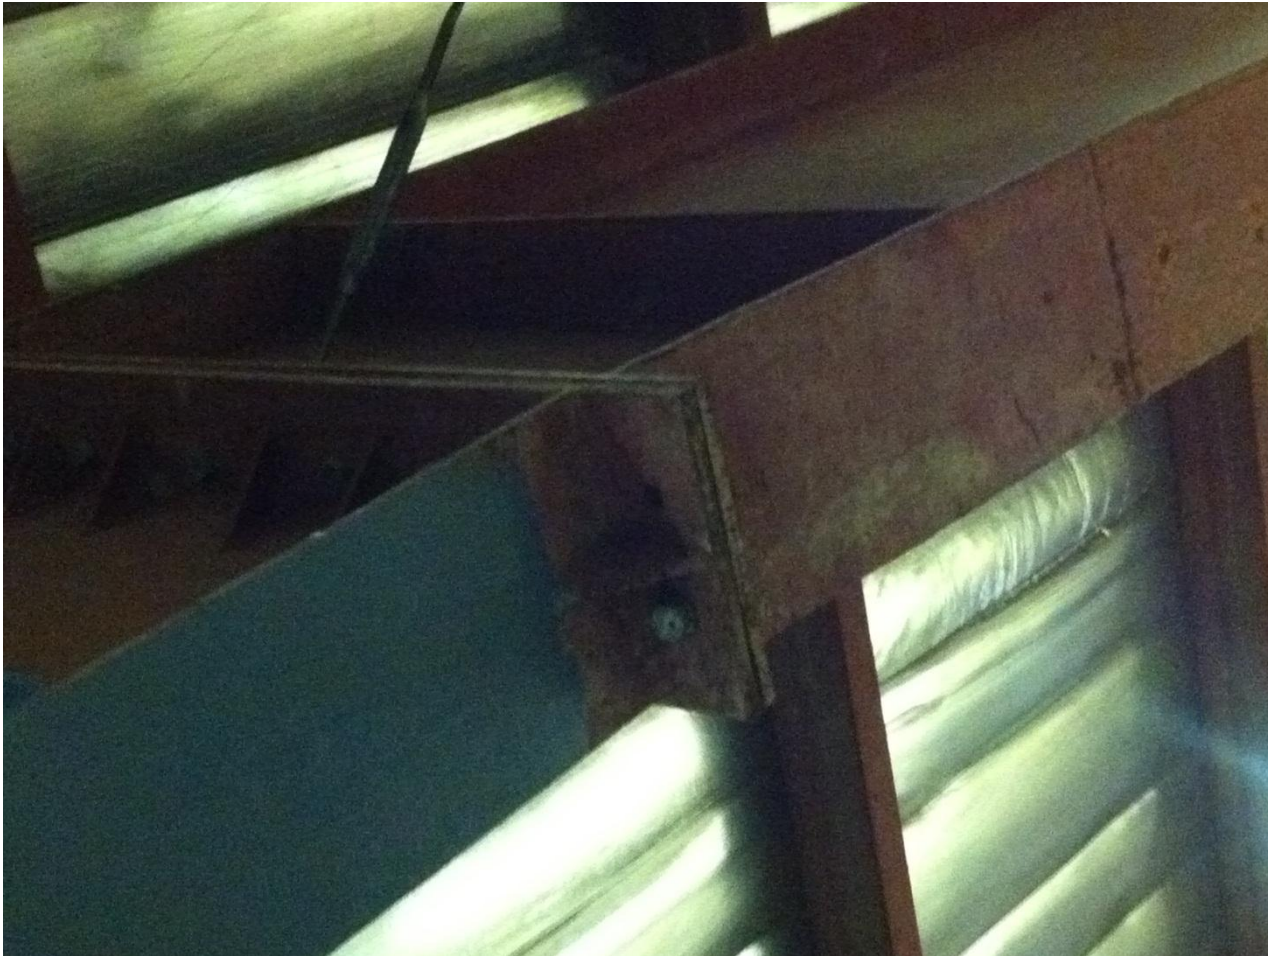
This image shows a connection between primary roof members in the warehouse building. As can clearly be seen, a bolt is missing and should be replaced.

It is important that the warehouse building is carefully inspected to ensure that any other locations where such omissions have taken place are rectified.

| Item No. | Observation | Recommended Action Plan | Recommended Timeline |
|---|---|---|---|
| 12 | Some connection bolts were missing from the warehouse roof structure. | Warehouse to be thoroughly surveyed to establish all locations of missing bolts at connections or other fixing points. | 6-weeks |
| 13 | Some connection bolts were missing from the warehouse roof structure. | Bolts to be reinstated, using a size and grade of bolt consistent with the original design.<br>If connection design is not available, Factory Engineer to advise on specification. | 6-months |

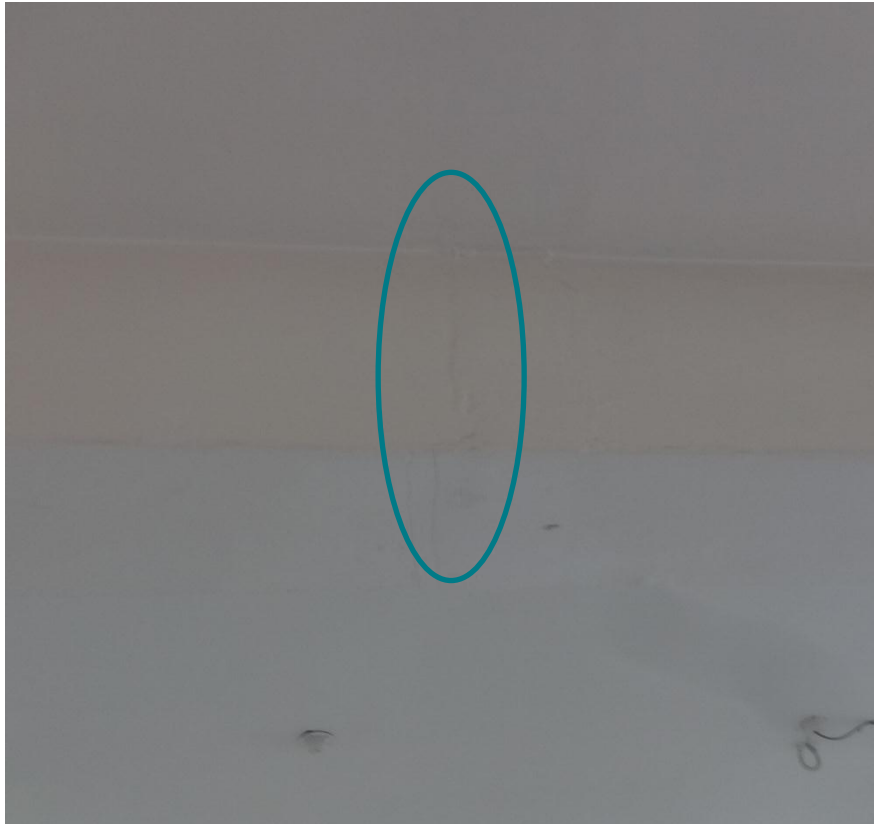
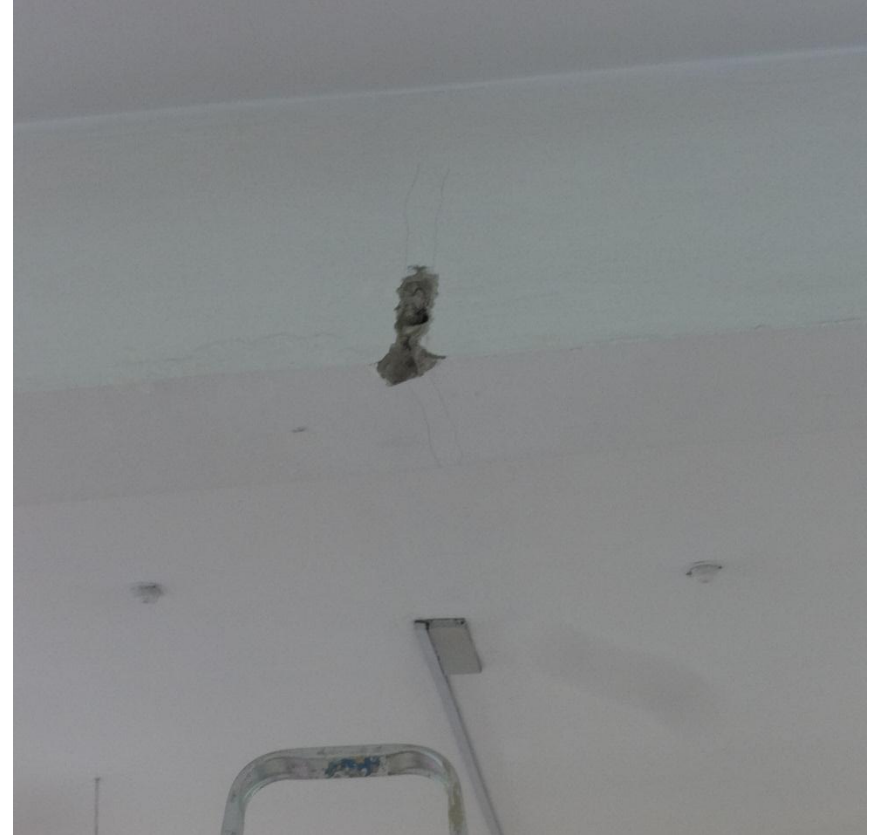
Below is a hairline crack through the mid-span of an internal floor beam, as was observed in several locations around the building. The image to the right shows where the plaster was carefully removed over the crack, revealing poorly laid concrete.

Several cracked beams were scanned on site, and a level of reinforcement which seemed to correspond to the structural drawings was established.

| Item No. | Observation | Recommended Action Plan | Recommended Timeline |
|---|---|---|---|
| 16 | Hairline cracks on several internal downstand beams evident. Any progression to be monitored by the factory. | Cracking of beams to be monitored by in-house factory staff.<br>If any progression or opening-up is observed, structural engineer to be immediately contacted for further assessment. | 6-months |

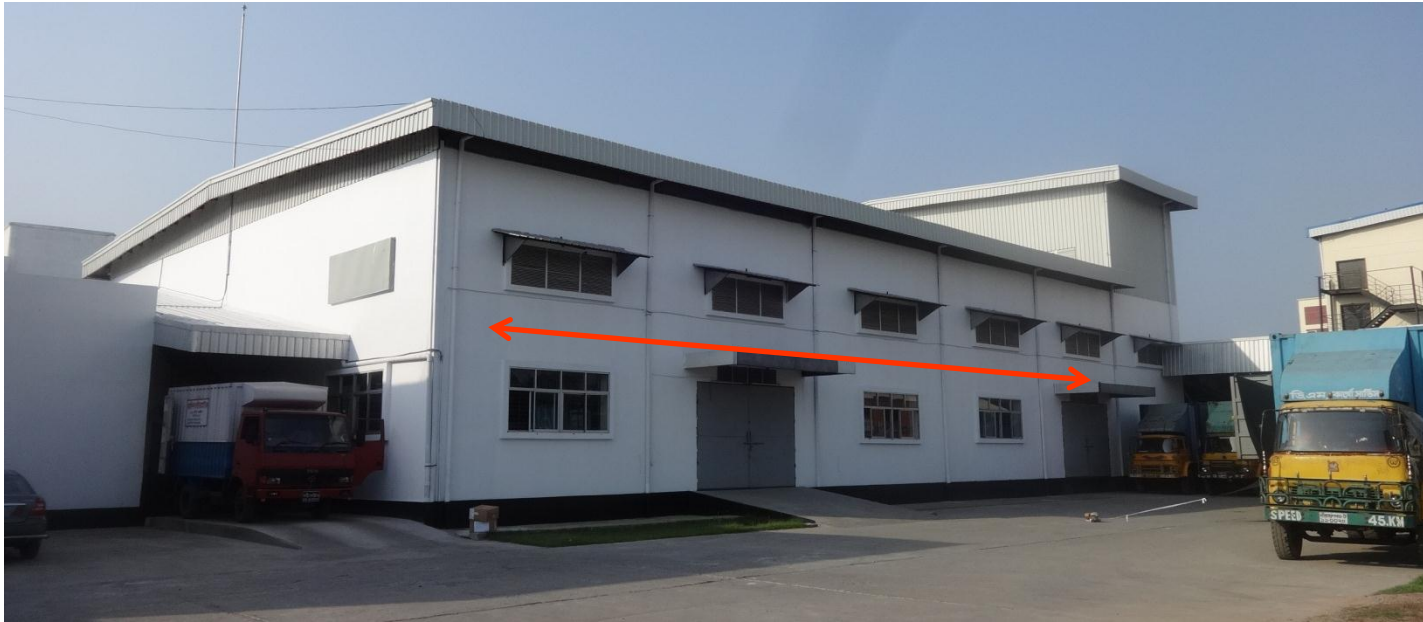
The concrete-framed main factory building and office building gain their stability through rigid beam-column connections (left) and masonry infill walls. However the warehouse building has no evident system of lateral stability in the direction shown on the image below. As mentioned previously, a CUET report has been carried out, but it gives very little consideration to the lateral stability of the warehouse.

It is recommended that the CUET report be updated to include thorough lateral stability analysis of the warehouse and the office, as was done for the factory building.

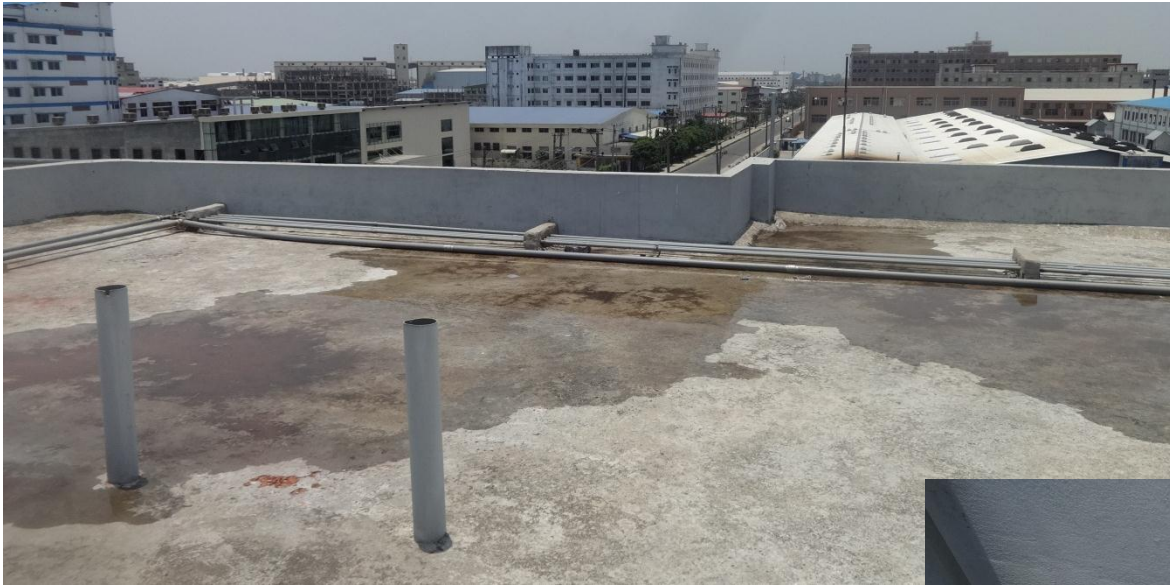
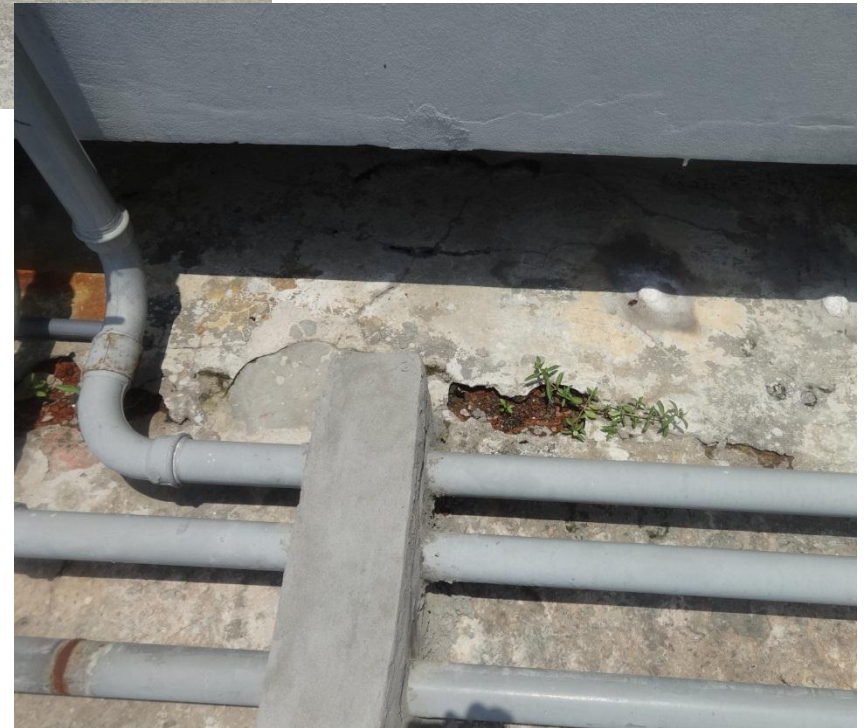
An attempt has been made to prevent ponding by creating a sloped build-up at roof level. As can be seen above, this has not always been successful, while in many locations the surfacing on the build-up has deteriorated to an extent where water can easily penetrate (right).

The build-up should be repaired, and a suitable waterproof coating applied, to ensure that water cannot penetrate the structural roof slab.
