# Visual Knitwears Limited (9466)

295, Shafi Complex, Hatazari Road, Jalalabad, Chittagong

21.MAY.2014

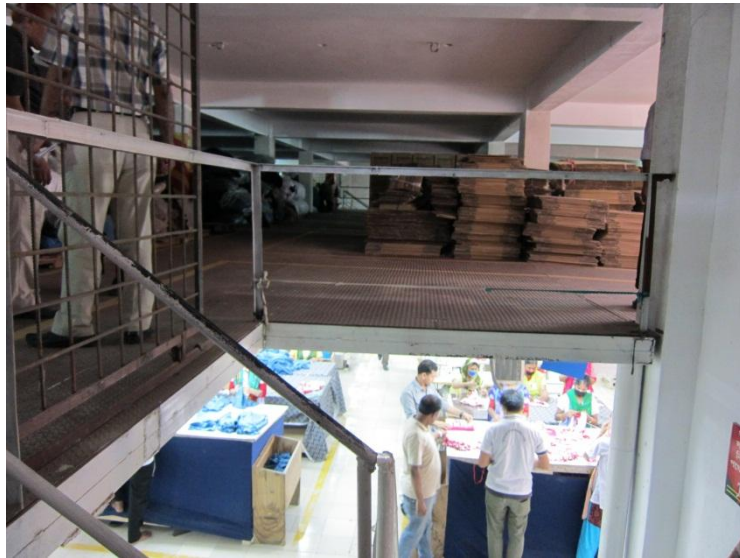
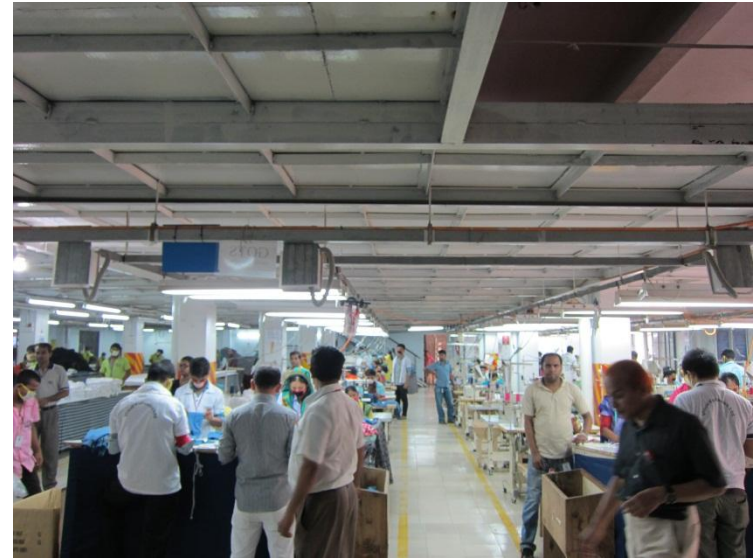
## 1<sup>st</sup> Priority 1 Concern

Some of steel joist beam supported steel checkered plate are sagging. Main steel beam connected to steel column are used to transfer the load carrying onto ground slab. Capacity check should be carried out.

| Item No. | Observation | Recommended Action Plan | Recommended Timeline |
|---|---|---|---|
| 1 | Capacity check for steel mezzanine floor. | Factory Engineer to review design, loads and columns stresses in area identified above.<br>A Detail Engineering Assessment of Factory to be commenced immediately in particular the stability and capacity of steel mezzanine floor. | Immediate – Now |
| 2 | Capacity check for steel mezzanine floor. | Produce and actively manage a loading plan for all floor plates within this area giving consideration to floor capacity and column capacity.<br>Detail Engineering Assessment to be completed. | 6-weeks |
| 3 | Capacity check for steel mezzanine floor. | Continue to implement load plan | 6-months |

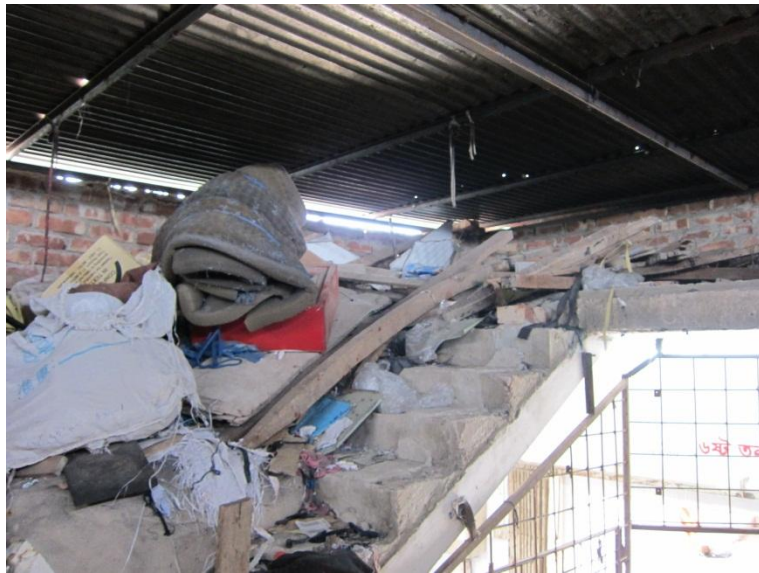
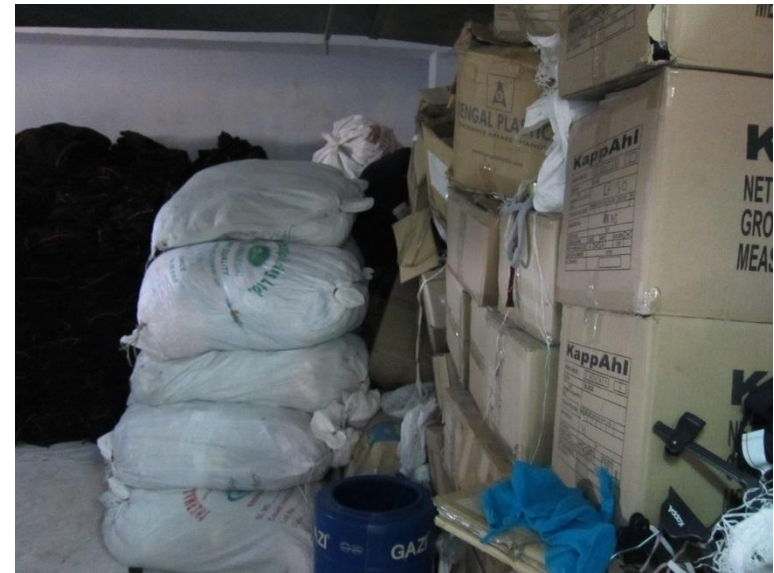
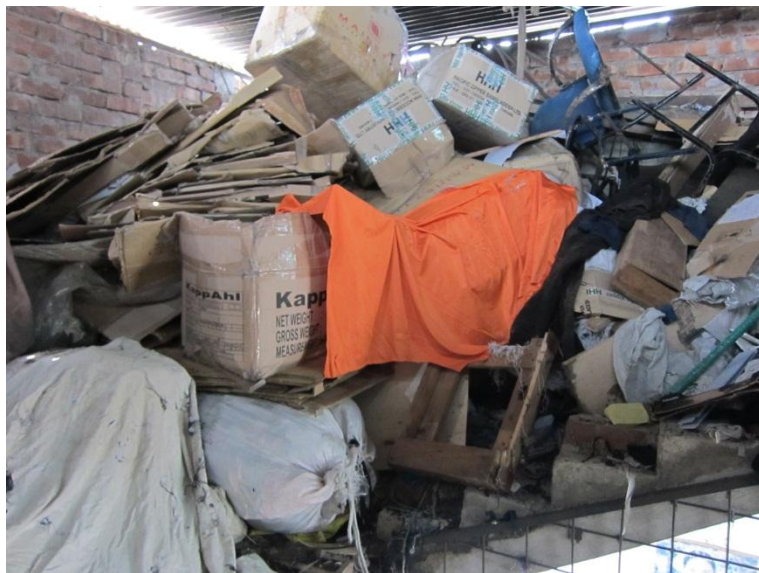
## 2<sup>nd</sup> Priority 1 Concern

Uncontrolled heavy storage loading was found at staircase on 5<sup>th</sup> floor where it was left unused, also, at the storage room on 4<sup>th</sup> floor

| Item No. | Observation | Recommended Action Plan | Recommended Timeline |
|---|---|---|---|
| 4 | Uncontrolled heavy storage loading area. | Reduce stacking height to ensure total load does not exceed 2 kPa.<br>Factory Engineer to review design, loads, columns stresses and shear stresses in area identified above.<br>Factory Engineer to state the maximum weight that is allowed per square meter. Suggest that state the value on notice boards in this area. | Immediate – Now |
| 5 | Uncontrolled heavy storage loading area. | Adopt some sort of signage/staff guidance to ensure that the maximum weight of storage is not exceeded. (Loading Plans). | 6-weeks |
| 6 | Uncontrolled heavy storage loading area. | Maintain standards of quality control to ensure that storage procedures are correctly followed so that overloading problems do not arise in the future.<br>Implement Loading Plan. | 6-months |

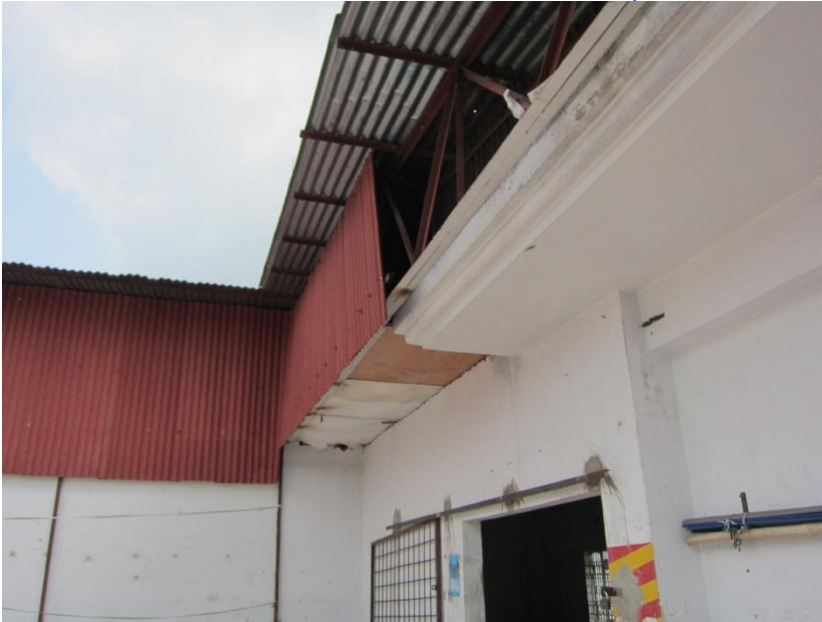
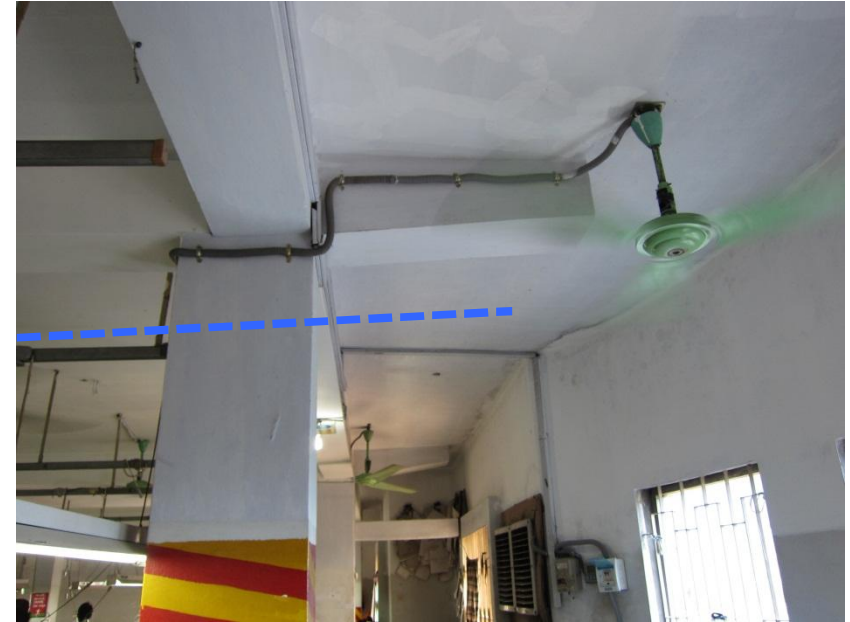
## 1<sup>st</sup> Priority 2 Concern

The extension of roof was carried out for dining area which was not shown in the drawings. Cantilevered beam on every floor was constructed instead of cantilevered slab. Capacity check should be carried out.

| Item No. | Observation | Recommended Action Plan | Recommended Timeline |
|---|---|---|---|
| 7 | Inconsistency between drawings and actual as-built condition of the building . | Factory Engineer to survey the actual conditions and revise the drawings.<br>Factory Engineer to review design, loads and columns stresses to confirm suitability for loads applied.<br>Produce and actively manage a loading plan for all floor plates within this area giving consideration to floor capacity and column capacity. | 6-weeks |
| 8 | Inconsistency between drawings and actual as-built condition of the building . | Continue to implement load plan | 6-months |

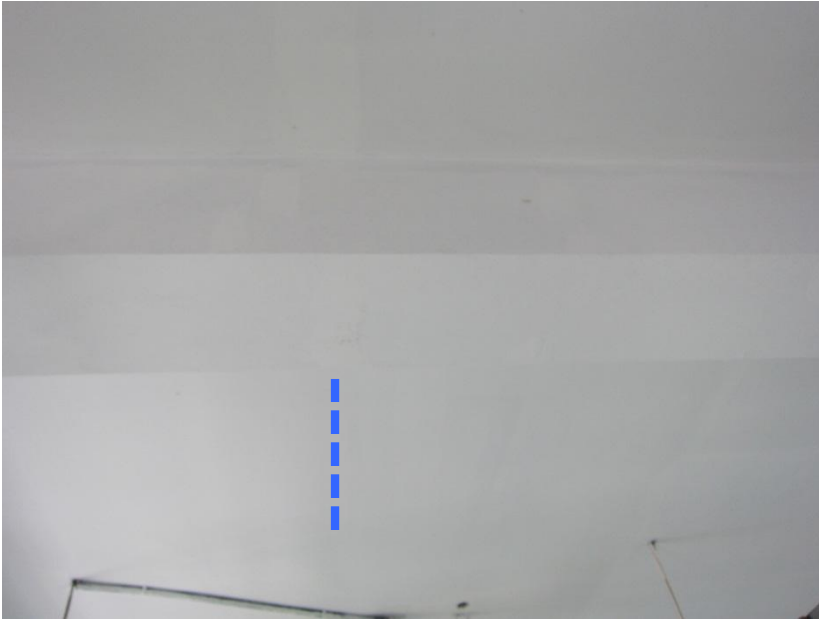
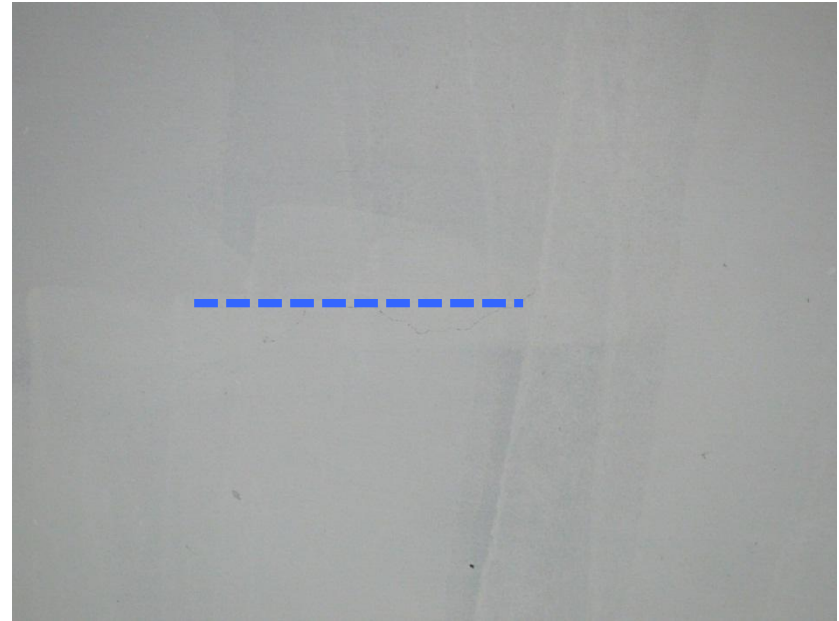
## 2<sup>nd</sup> Priority 2 Concern

Cracks appeared underside floor slab and beam. It is not clear whether these cracks are structural cracks. We require that these items be investigated in a Detail Engineering Assessment.

| Item No. | Observation | Recommended Action Plan | Recommended Timeline |
|---|---|---|---|
| 9 | Crack appeared underside floor slab and beam | The Factory Engineer to investigate the cause of cracks by appropriate methods.<br>The distress found is to be suitably rectified and then repaired. | 6-weeks |
| 10 | Crack appeared underside floor slab and beam | Create loading plans for each floor level.<br>Maintain standards of quality control to ensure that loading plan is correctly followed so that problems do not arise in the future.<br>Maintain and enforce the loading plans. | 6-months |

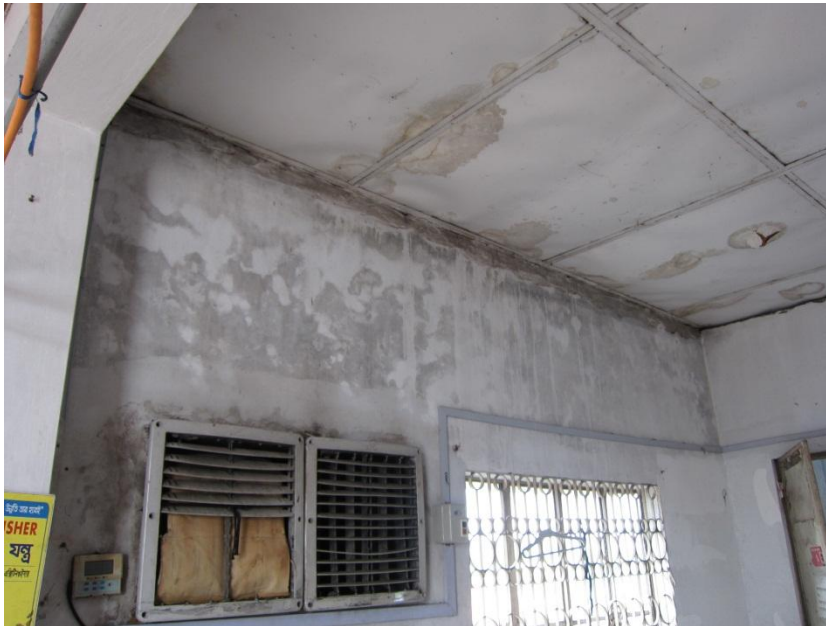
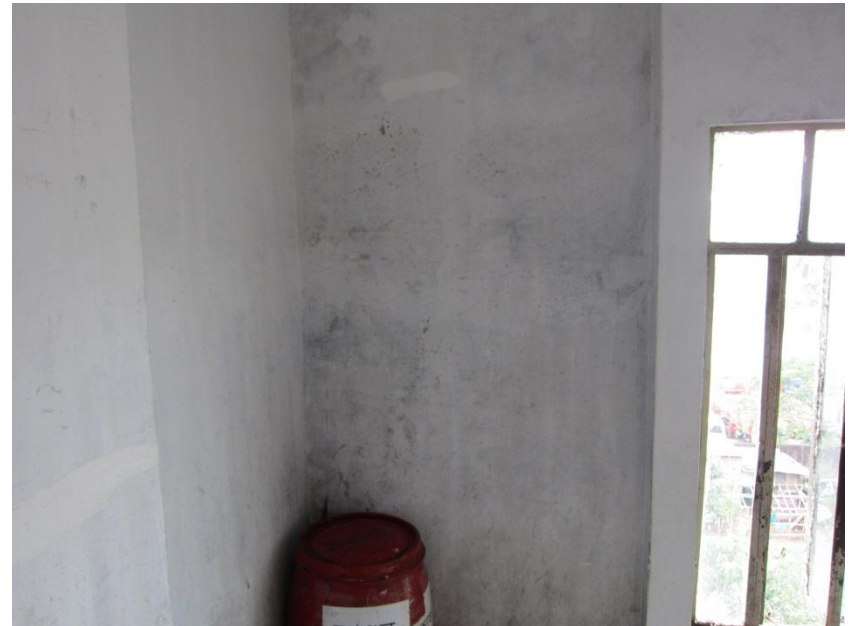
## 1<sup>st</sup> Priority 3 Concern

There are distresses due to water ingress noted at dining room on 5<sup>th</sup> floor.

| Item No. | Observation | Recommended Action Plan | Recommended Timeline |
|---|---|---|---|
| 12 | Distress due to water ingress | For both durability and serviceability, waterproofing material is recommended.<br>Maintain standard of quality control. | 6-months |

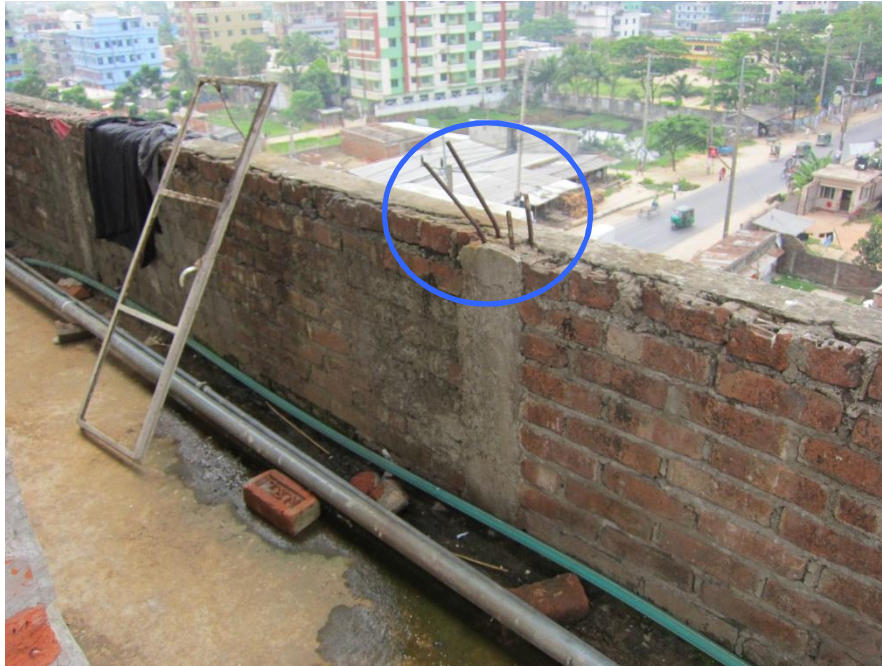
## 2<sup>nd</sup> Priority 3 Concern

Reinforcement are left exposed. No rust-proof paint is applied.

| Item No. | Observation | Recommended Action Plan | Recommended Timeline |
|---|---|---|---|
| 13 | Reinforcement left exposed at top level of Office | For both durability and serviceability, rust proof paint or any appropriate methods is recommended. | 6-months |

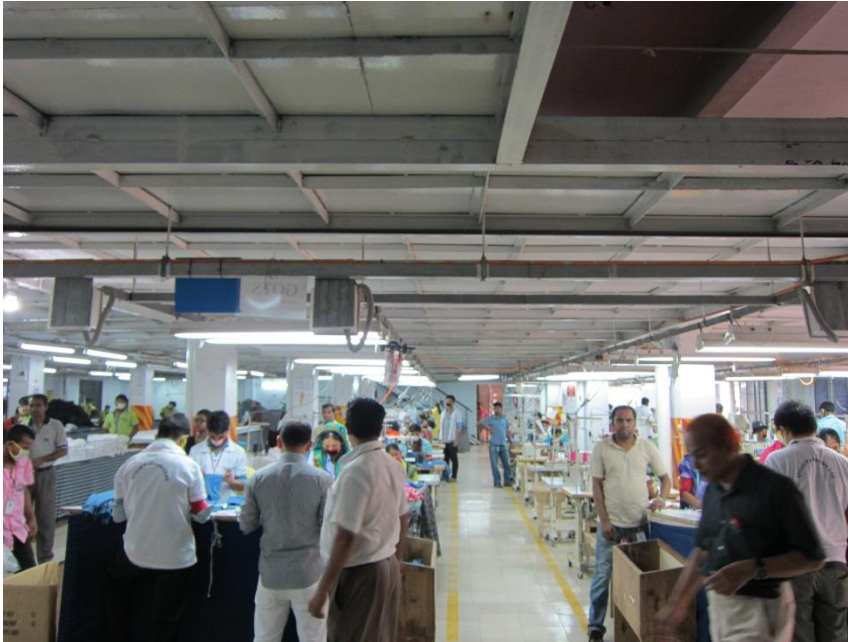
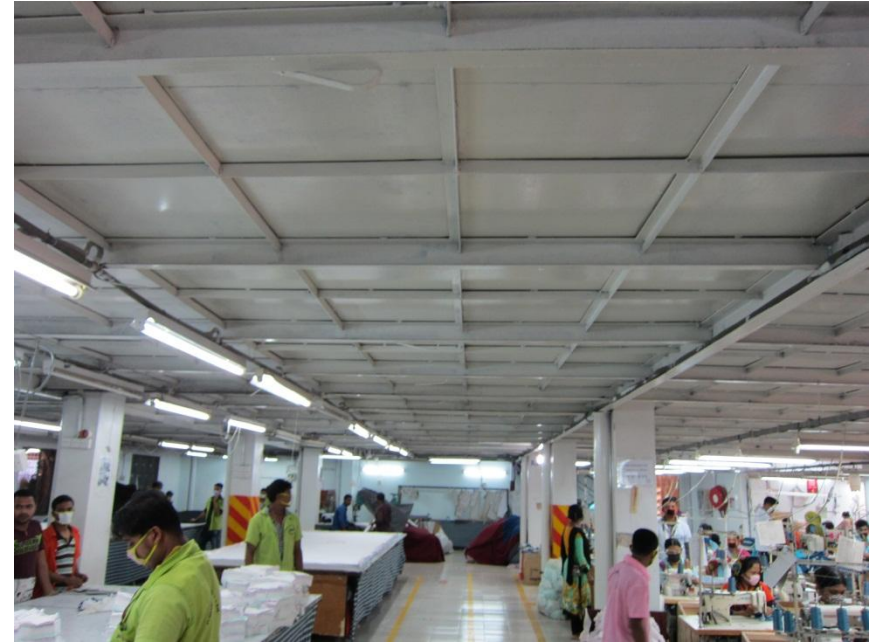
### 3<sup>rd</sup> Priority 3 Concern

No fireproofing material is applied to the structural steel elements of mezzanine floor. It is unclear whether it is required by BNBC.

| Item No. | Observation | Recommended Action Plan | Recommended Timeline |
|---|---|---|---|
| 14 | No fireproofing material applied for steel structure | Fireproofing material for structural steel element needs to be applied (if required based on the provision of BNBC).<br>Maintain standard of quality control. | 6-months |

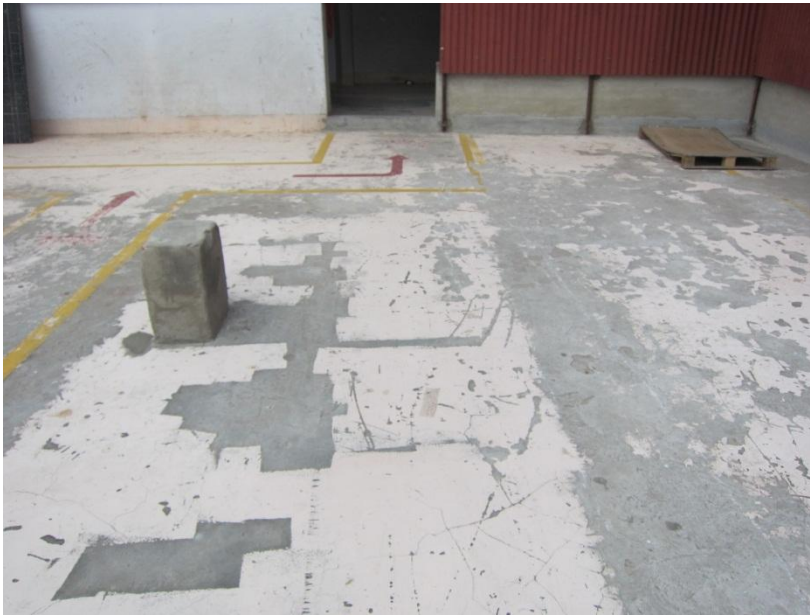
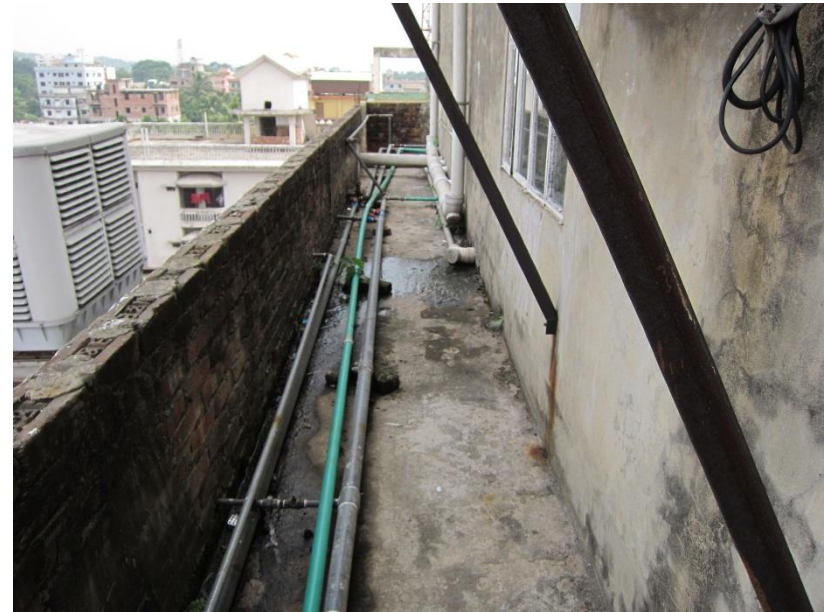
#### 4<sup>th</sup> Priority 3 Concern

It is unclear whether waterproofing material is applied at roof level.

| Item No. | Observation | Recommended Action Plan | Recommended Timeline |
|---|---|---|---|
| 15 | No waterproofing material applied at roof level. | Engineer to inspect water damaged structure including the exterior and propose a suitable repair.<br>For both durability and serviceability, waterproofing on the roof slab is recommended. Moreover the roof slab drainage system should be investigated. | 6-months |

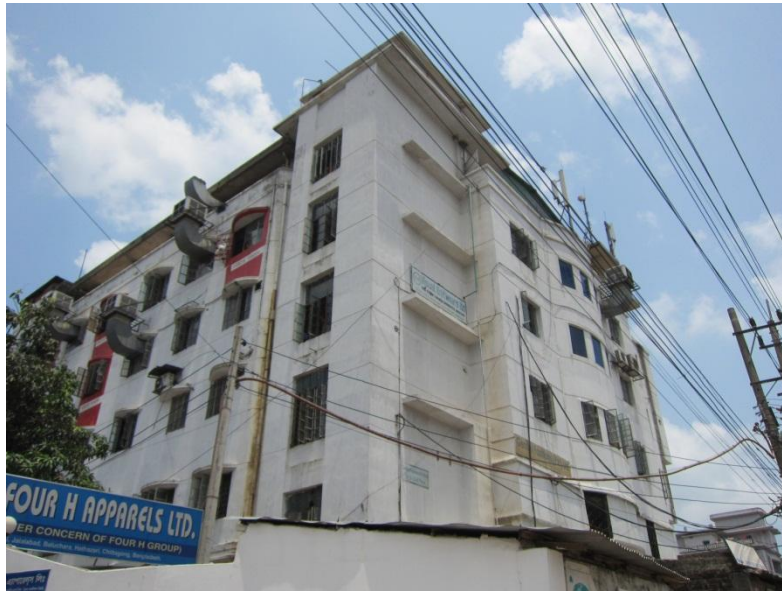
# Overall Stability System

The building does not feature any core or shear walls. Stability is achieved through sway action between beams and columns and masonry infill walls.

We require that these items be investigated in a Detail Engineering Assessment.

| Item No. | Observation | Recommended Action Plan | Recommended Timeline |
|---|---|---|---|
| 11 | Overall stability system. | Request that the Detail Engineering Assessment of the overall building to be carried out and in particular, stability and foundation aspects should be investigated in detail. | 6-weeks |

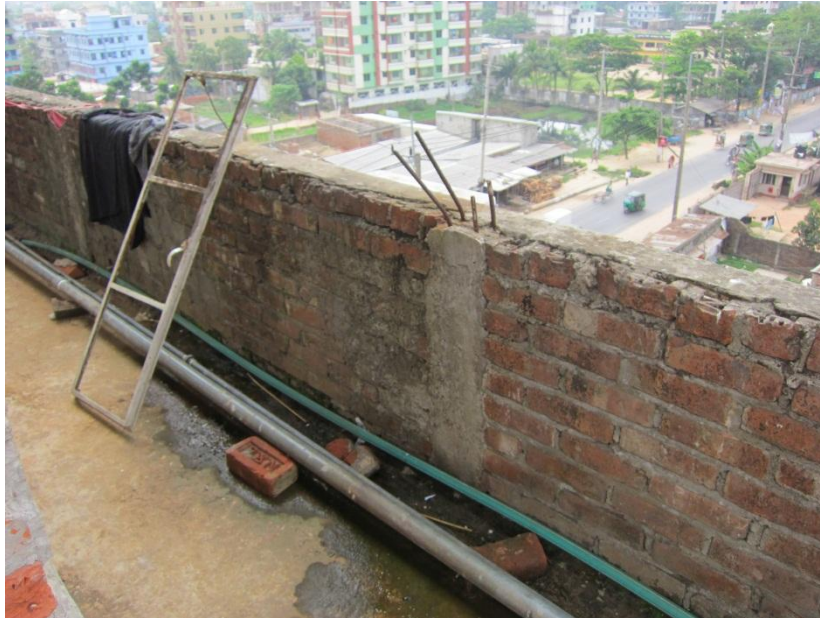
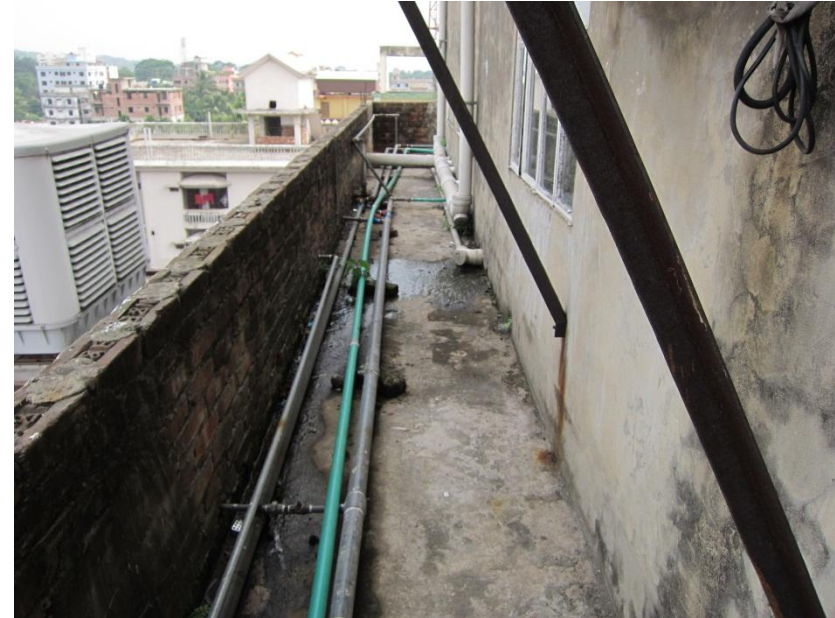
## Water Ingress at Roof Level

There is no distress due to water ingress noted at roof level except water ponding.
