# **Arafat Fashion Garments Ltd. (10495)**

## **J.K. Shirt & Fabric Ltd. (10506)**

3118/1, Noyahat road, Panchlaish, Chittagong

21.MAY.2014

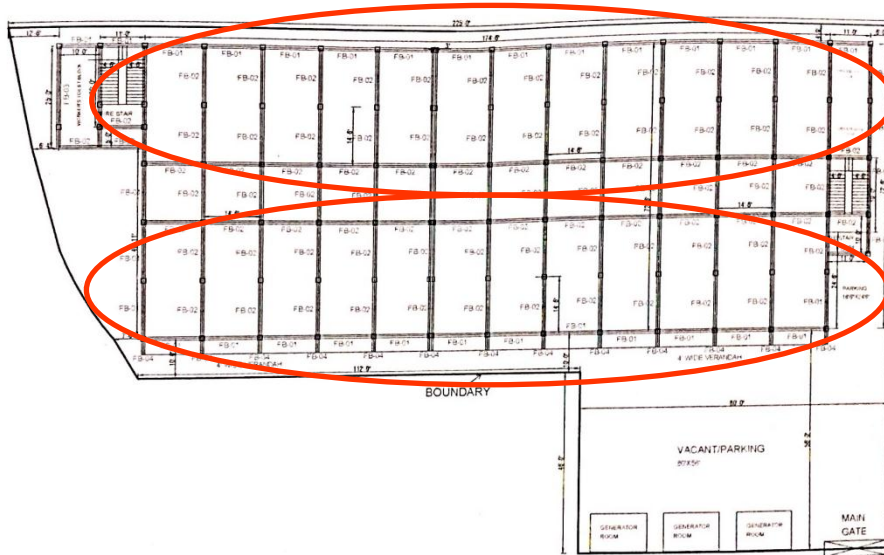
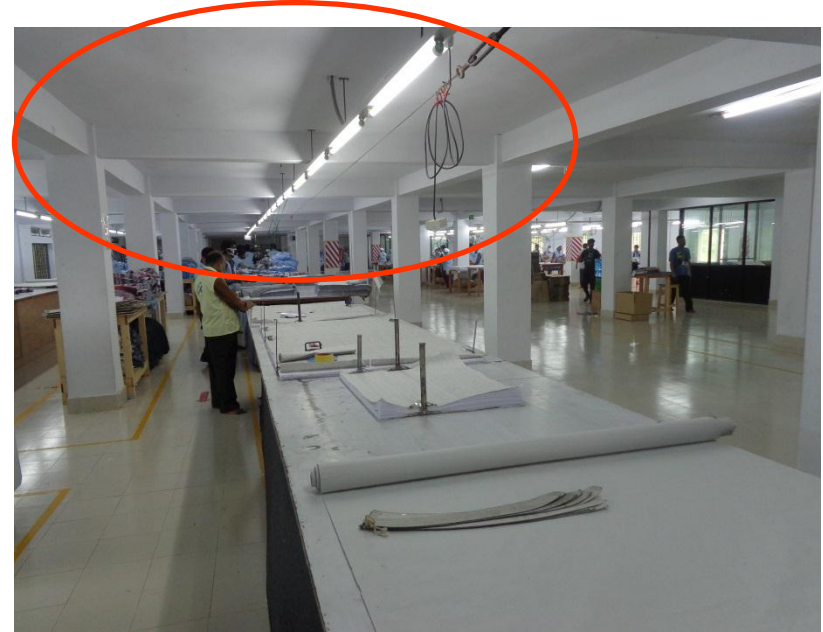
## 1<sup>st</sup> Priority 2 Concern

Structural drawings do not match existing conditions:

- Beam layout on the 1<sup>st</sup> and 3<sup>rd</sup> floor
- Grid layout

**ITEM 1:** (Priority 2) Structural drawings do not match existing conditions.

| Item No. | Observation | Recommended Action Plan | Recommended Timeline |
|---|---|---|---|
| 1 | Structural drawings do not match existing conditions. | Structural Engineer responsible for the design to review existing conditions and revise structural drawings.<br>Structural Engineer to assess additional construction and changes to design. | 6-weeks |
| 2 | Structural drawings do not match existing conditions. | Implement any recommendations from structural assessment. | 6-months |

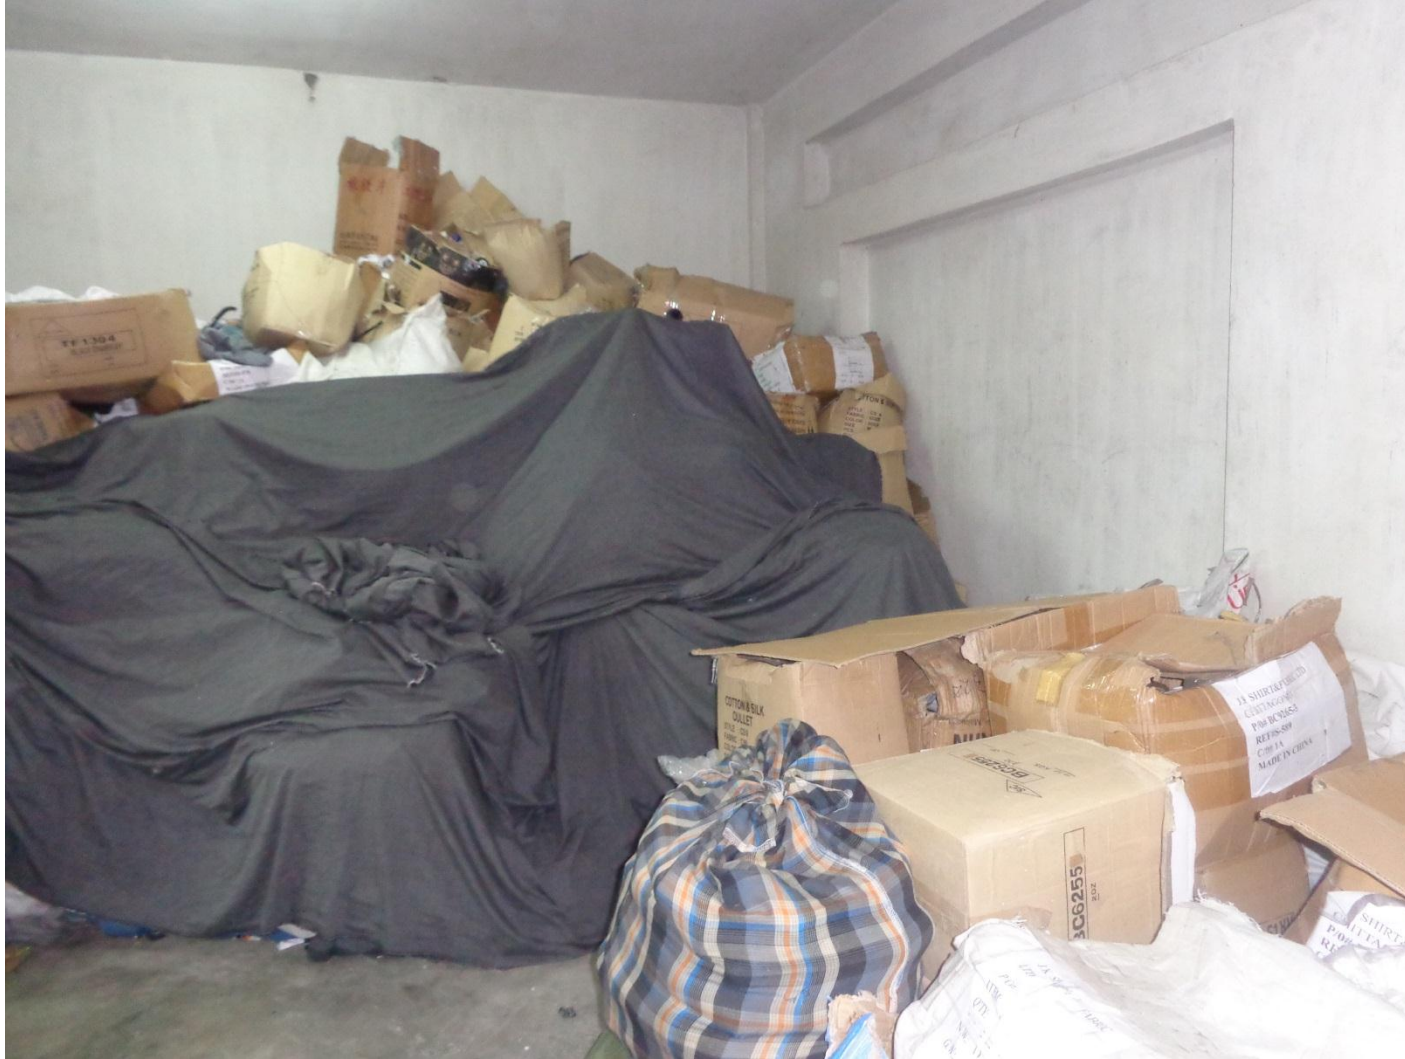
## 2<sup>nd</sup> Priority 2 Concern

No loading plans were made available and storage loading was observed on the 1st floor.

**ITEM 2:** (Priority 2) No loading plans were made available and storage loading was observed on the 1st floor.

| Item No. | Observation | Recommended Action Plan | Recommended Timeline |
|---|---|---|---|
| 3 | No loading plans were made available and storage loading was observed on the 1st floor. | Structural Engineer to determine load carrying capacity of each floor and produce loading plans. | 6-weeks |
| 4 | No loading plans were made available and storage loading was observed on the 1st floor. | Post loading plans on each floor and manage loading. | 6-months |

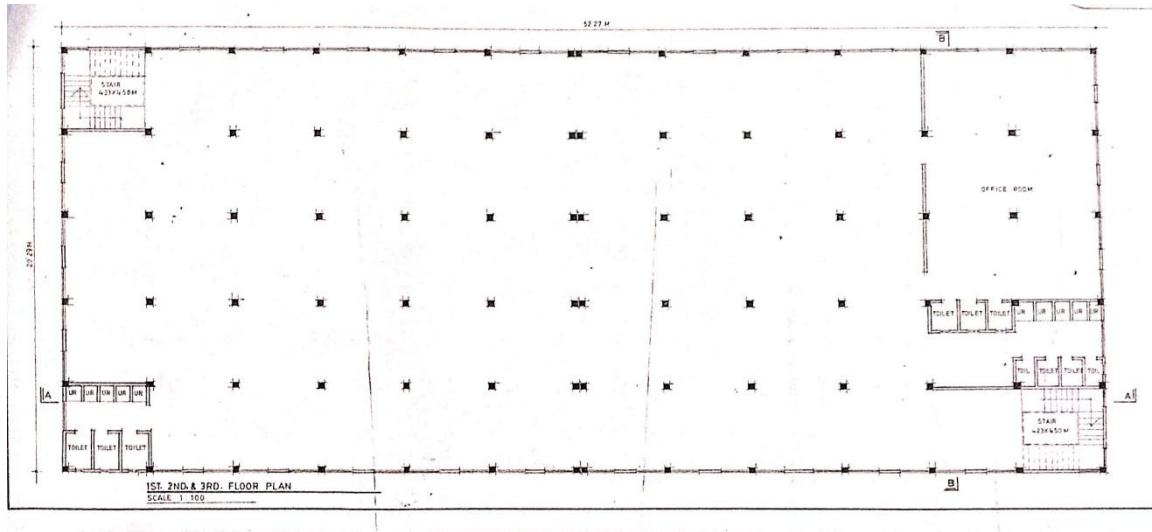
Architectural Drawings used for Permit

Permit drawings do not match structural drawings or as built conditions.

**ITEM 3:** (Priority 3) Permit drawings do not match structural drawings or as built conditions.

| Item No. | Observation | Recommended Action Plan | Recommended Timeline |
|---|---|---|---|
| 5 | Permit drawings do not match structural drawings or as built conditions. | Revise Architectural drawings based on as-built conditions and re-apply for permit approval. | 6-months |

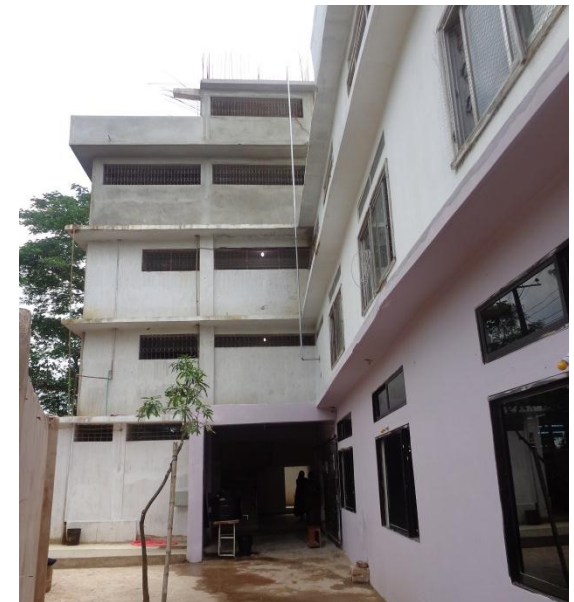
Additional stairwell bays were constructed on both sides of building (see below).

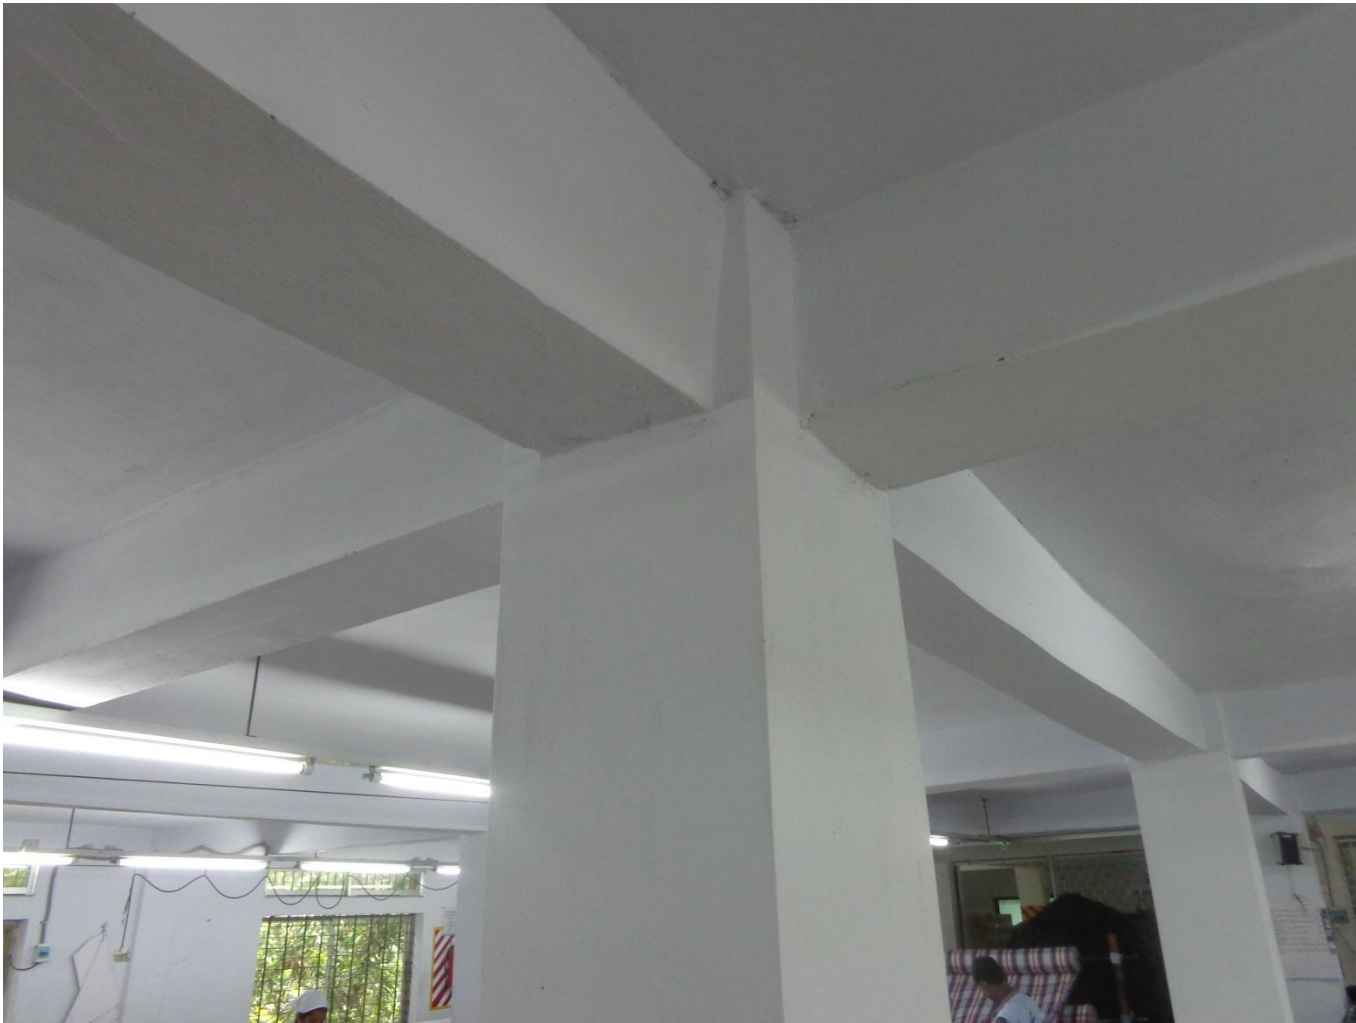
# Overall Stability System

The building did not feature any core or shear walls. Stability was achieved through sway action between beams and columns and masonry infill walls.

We require that these items be investigated in a Detail Engineering Assessment

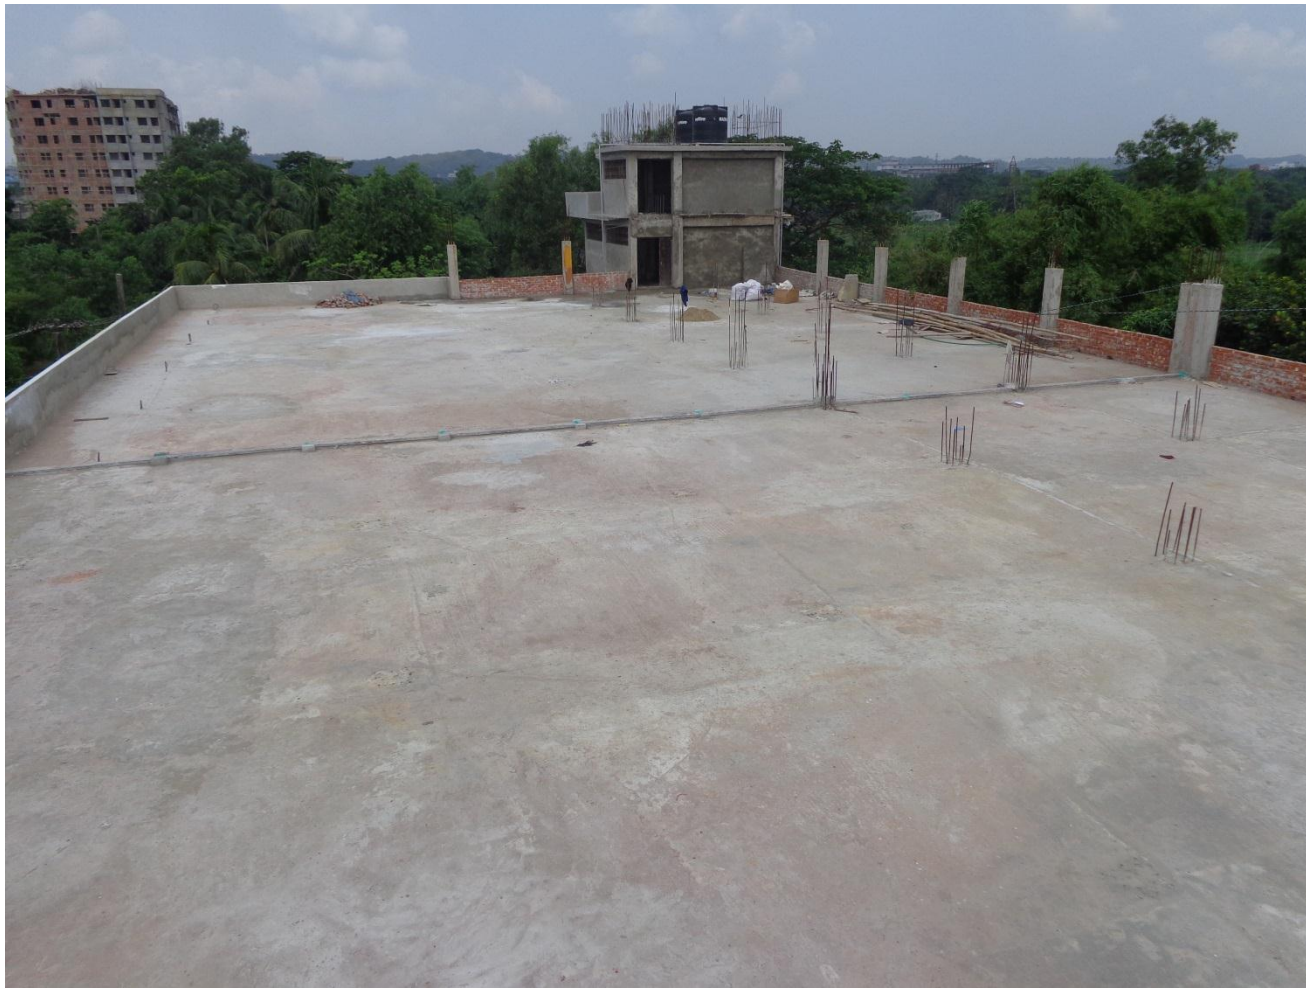
# Water Ingress at Roof Level

No waterproofing membrane was visible on the roof of the building. This means that any cracks in the surface finishes on the roof will allow water to seep into the concrete slab beneath the finishes, and cause corrosion of the reinforcing steel.
