# Mozart Knit Ltd (9722)

Bashaid, Ashulia, Savar, Dhaka

24.05.2014

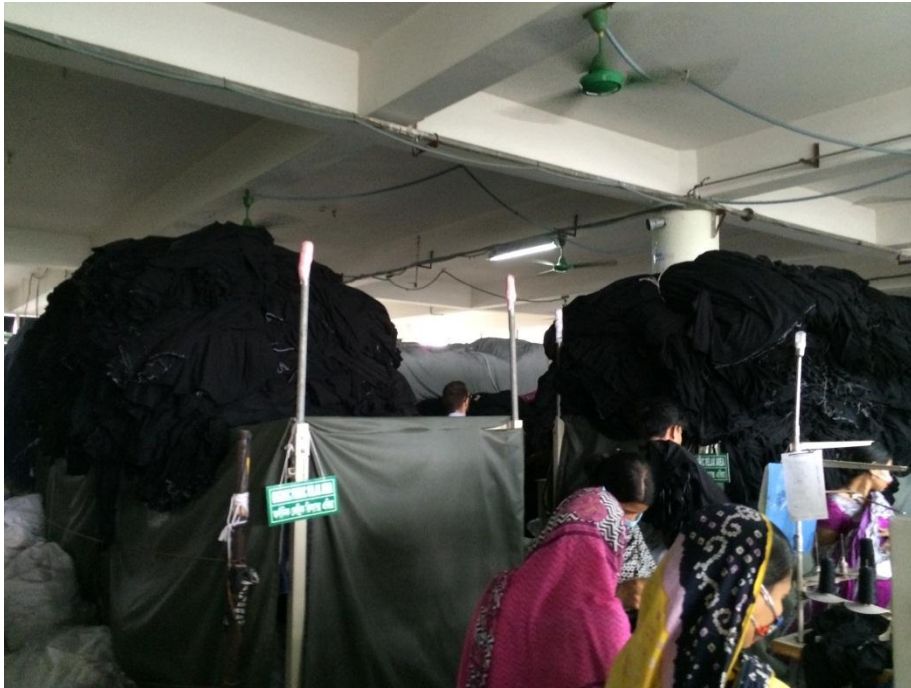
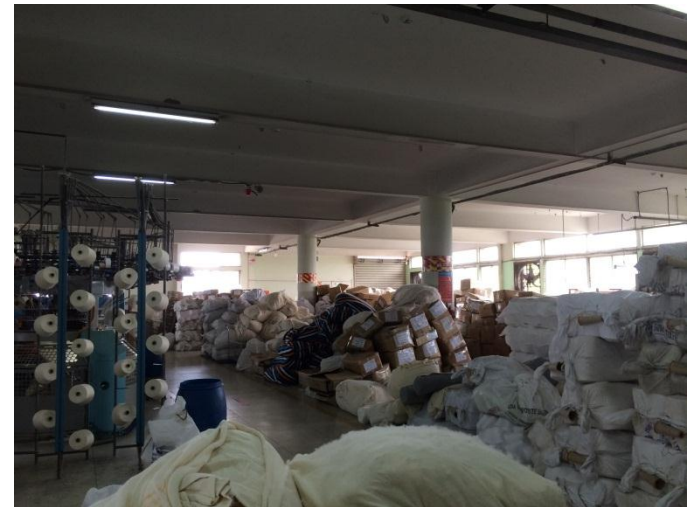
## 1<sup>st</sup> Priority 1 Concern

Garment Building – Heavy loading

During our survey, we noted very heavy loading at certain level. Considering the thickness of the slab and to the size of the columns and beams, the loading should be reduced immediately to a maximum load of 3.0kPa.

| Item No. | Observation | Recommended Action Plan | Recommended Timeline |
|---|---|---|---|
| 1 | Garment Building – Heavy loading | Carry out a Detailed Engineering Assessment on all the floors.<br>Reduce all floor loading down to 3.0kPa. | Immediate - Now |
| 2 | Garment Building – Heavy loading | Verify in situ concrete stresses either by existing cylinder strength data or 100mm dia. cores from 4 columns and slabs. | 6-weeks |
| 3 | Garment Building – Heavy loading | Create and actively manage loading plans for all floors by establishing some signage to prevent mismanagement of loading the slab. | 6-months |

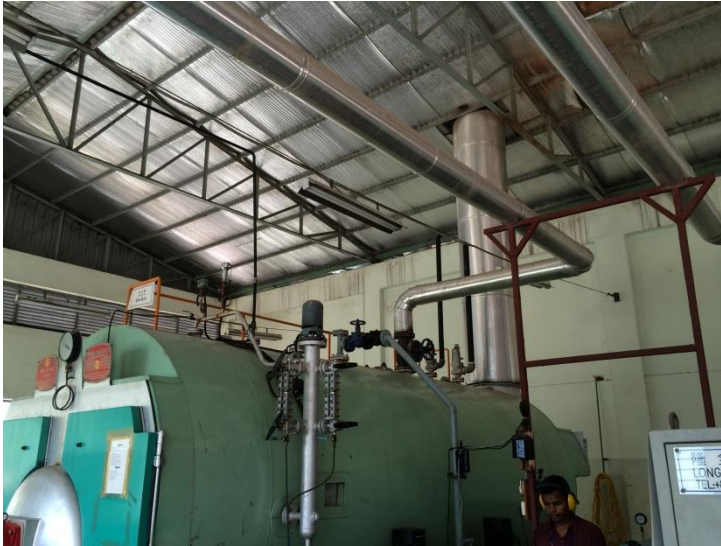
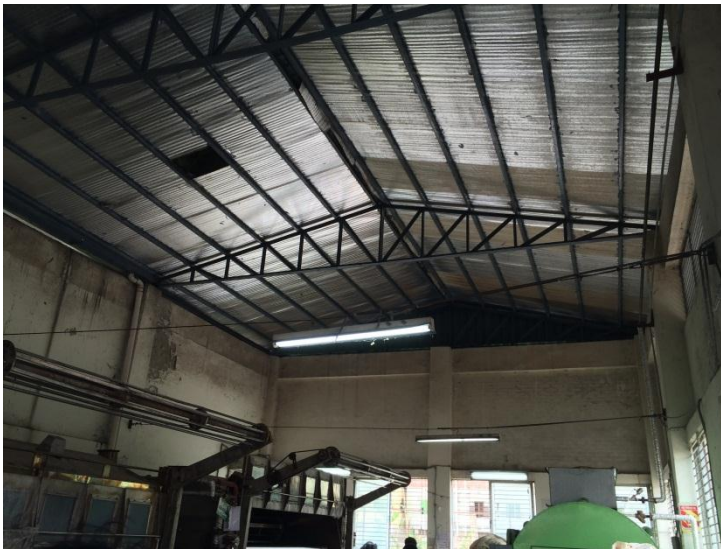
## 1<sup>st</sup> Priority 2 Concern

Power house shed, Dyeing shed, Boiler shed, Sample dyeing shed and Godown shed – Truss extremities seem to lack bearing and uplift capacities.

At the Power house shed, Dyeing shed, Boiler shed, Sample dyeing shed and Godown shed all the bearings of the steel truss at the concrete beams must be verified for the uplift of the roof. Also, at minimum one of the extremity of (shoe) of the steel truss had been modified, for the passage of the gutter or other reason. A design check of all of the structural steel of these sheds must be included in the Detailed Engineering Assessment.

| Item No. | Observation | Recommended Action Plan | Recommended Timeline |
|---|---|---|---|
| 4 | Power house Shed, Dyeing Shed, Boiler Shed, Sample dyeing Shed and Godown Shed – Truss extremities seem to lack bearing and uplift capacities. | Carry out a Detailed Engineering Assessment on all the connexions of the trusses to the bearing and also the uplift capacities of these roofs. | Immediate - Now |
| 5 | Power house Shed, Dyeing Shed, Boiler Shed, Sample dyeing Shed and Godown Shed – Truss extremities seem to lack bearing and uplift capacities. | Carry out any remedial works deemed necessary by assessment. | 6-weeks |

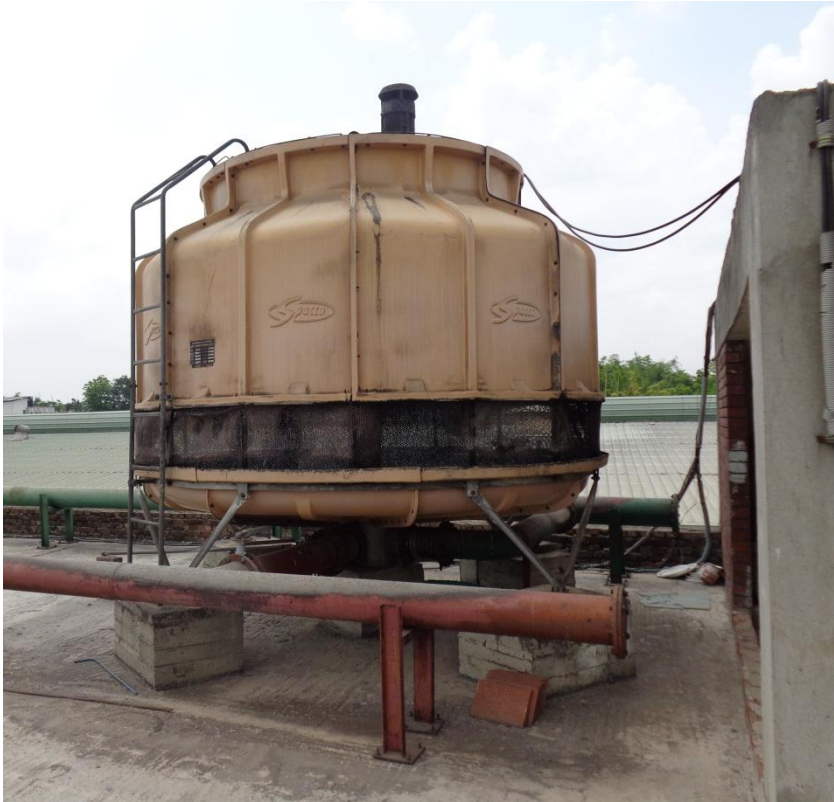
## 2<sup>nd</sup> Priority 2 Concern

Power house – Water cooling towers on 125mm slab.

At the roof of the Power House, 2 water cooling towers sits on a 125mm thick slab. Usually these equipments take a seat directly on a beam system.

We require a Detailed Engineering Assessment of the building to investigate these discrepancies.

| Item No. | Observation | Recommended Action Plan | Recommended Timeline |
|---|---|---|---|
| 8 | Power House Shed– Water cooling towers on 125mm slab. | Carry out a Detailed Engineering Assessment on the capacity of the 125mm slab to receive the water cooling tower. If necessary furnish the solution to remediate to this situation. | Immediate - Now |
| 9 | Power House Shed– Water cooling towers on 125mm slab. | If it is necessary, carry out and complete any remedial works recommended. | 6-weeks |

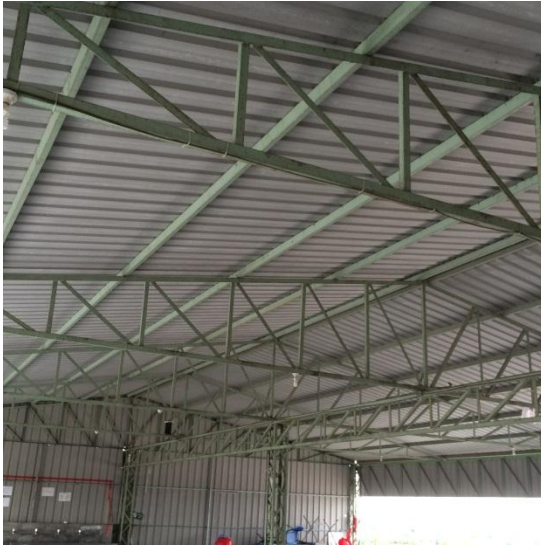
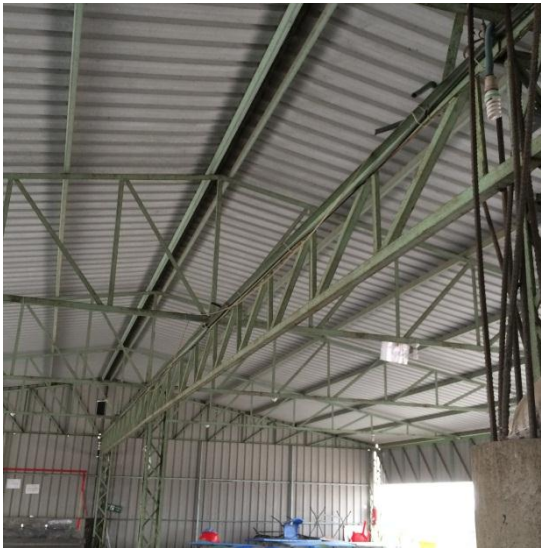
### 3<sup>rd</sup> Priority 2 Concern

Garment Building – Steel roof shed.

At the roof's shed of the Garment Building, all the structural steel including steel columns and RC columns, steel trusses, joists, perkins and deck must be verified for their entity and also for the wind uplift of the roof. A design check of all of the structural steel of this shed must be included in the Detailed Engineering Assessment.

| Item No. | Observation | Recommended Action Plan | Recommended Timeline |
|---|---|---|---|
| 6 | Garment Building – Steel roof shed | Carry out a Detailed Engineering Assessment of all the structural steel of the roof's shed and evaluate their capacities to resist uplift and lateral forces due to high winds. | Immediate - Now |
| 7 | Garment Building – Steel roof shed | If it is necessary, carry out and complete any remedial works recommended. | 6-weeks |

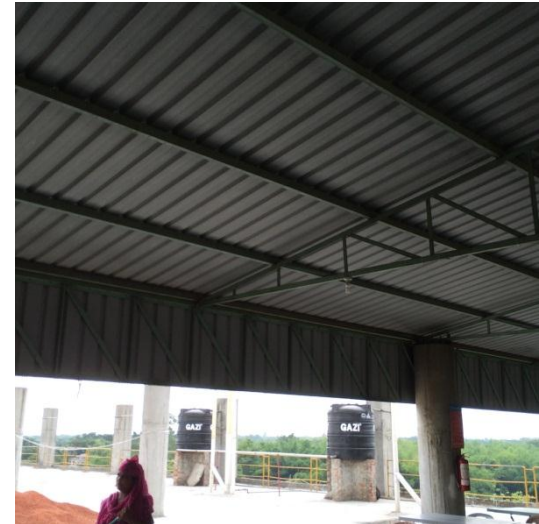
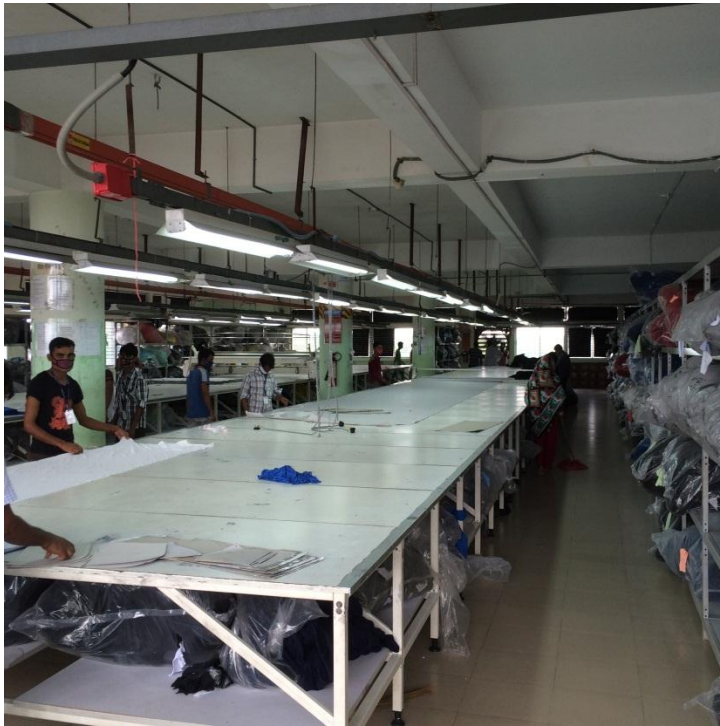
#### 4<sup>th</sup> Priority 2 Concern

Garment Building - Overall stability.

We believe that the intent of the original structural design was to use the main grid line beams to provide some form of lateral stability via moment frame action.

However, in this factory there's RC building completely and RC Building with steel roof. But for the Dyeing shed, the roof is made of structural steel with a support at the mid span with steel columns. There's no bracing in the grid line of the columns.

| Item No. | Observation | Recommended Action Plan | Recommended Timeline |
|---|---|---|---|
| 10 | Garment Building - Overall stability. | Carry out an Engineering Assessment on the building to verify that it is stable under lateral loading. | 6-weeks |
| 11 | Garment Building - Overall stability. | Carry out all recommendations of the Engineering Assessment. | 6-months |

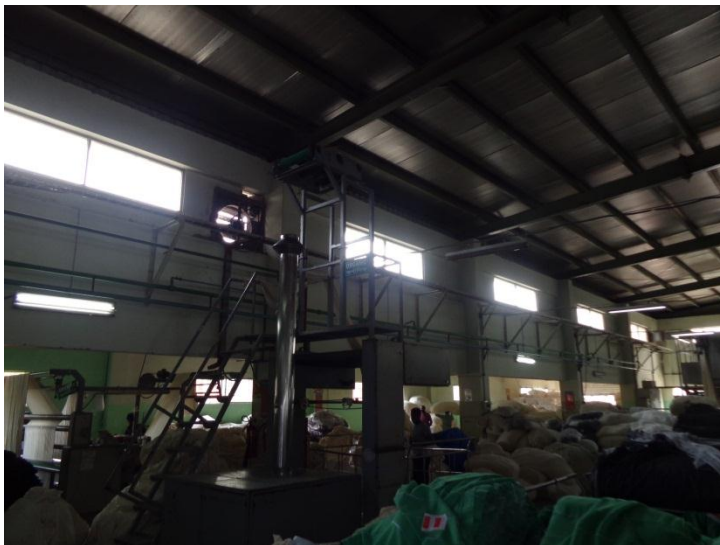
For this last, we require that the lateral support system is investigated as part of a Detailed Engineering Assessment.

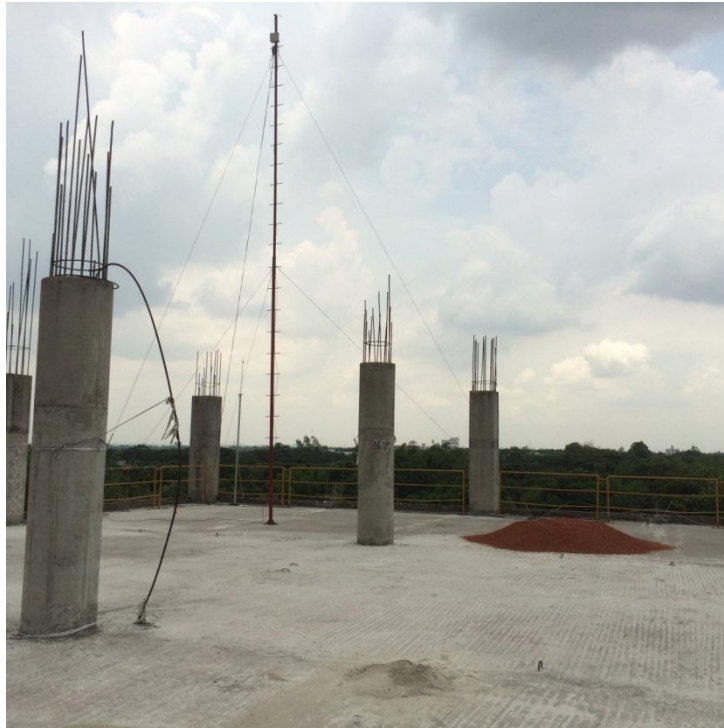
At the concrete roof of the Garment Building, the Dormitory Building and the Power House, no waterproofing membrane was visible on the roof. This means that any cracks in the surface will allow water to seep into the concrete slab and cause long-term soaking of the slab.

The Factory Building has reinforcement steel bars extended above the top of the column. This will allow rainwater to seep into the concrete column and cause long-term soaking in these. The reinforcement should be removed and new waterproofing should be applied to the entire column.

| Item No. | Observation | Recommended Action Plan | Recommended Timeline |
|---|---|---|---|
| 12 | Garment Building - Water ingress and exposed rebar. | Factory engineer has to verify the status of degradation of the water ingress in the columns and furnish the solution for the waterproofing of the columns. | 6-weeks |
| 13 | Garment Building - Water ingress and exposed rebar. | Carry out all recommendations for the remedial works from the Factory Engineer. | 6-months |
