# Paddock's Jeans Ltd. (#10026)

Plot – 59 & 60, DEPZ, Ganakbari, Savar

24.MAY.2014

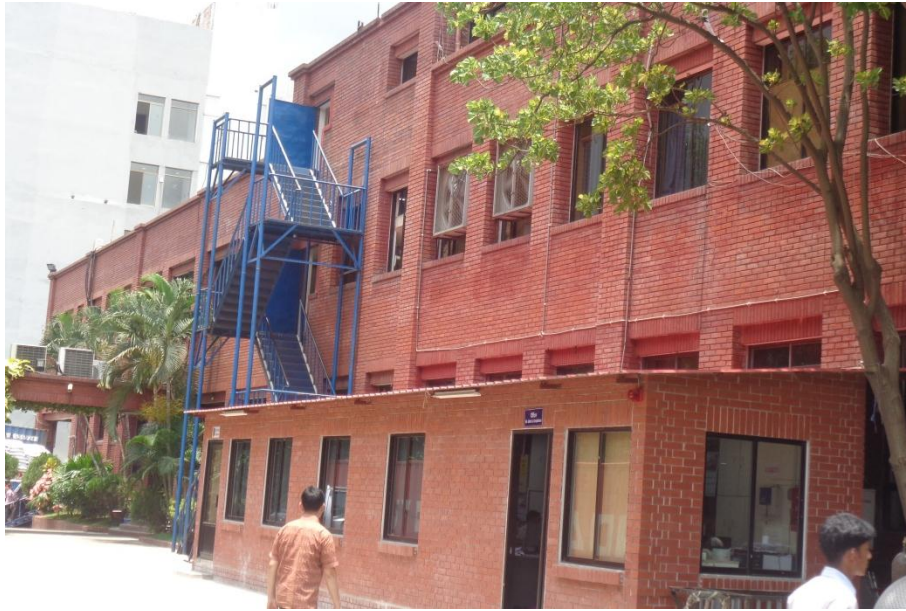
Main 3-storey building & adjacent staircase

Complete structural drawings were not made available for the following buildings:

| Item No. | Observation | Recommended Action Plan | Recommended Timeline |
|---|---|---|---|
| 1 | Complete structural drawings were not made available for the following buildings:<br><ul style="list-style-type: none"> <li>- Main 3-storey building</li> <li>- 2-storey concrete extension</li> <li>- Two 1-storey steel extensions</li> <li>- Steel canopy at front entrance</li> <li>- Steel staircases adjacent to main 3-storey building</li> <li>- Ancillary buildings (day care, security building, sheds)</li> </ul> | Structural Engineer to review existing conditions and provide as-built drawings. | 6-weeks |

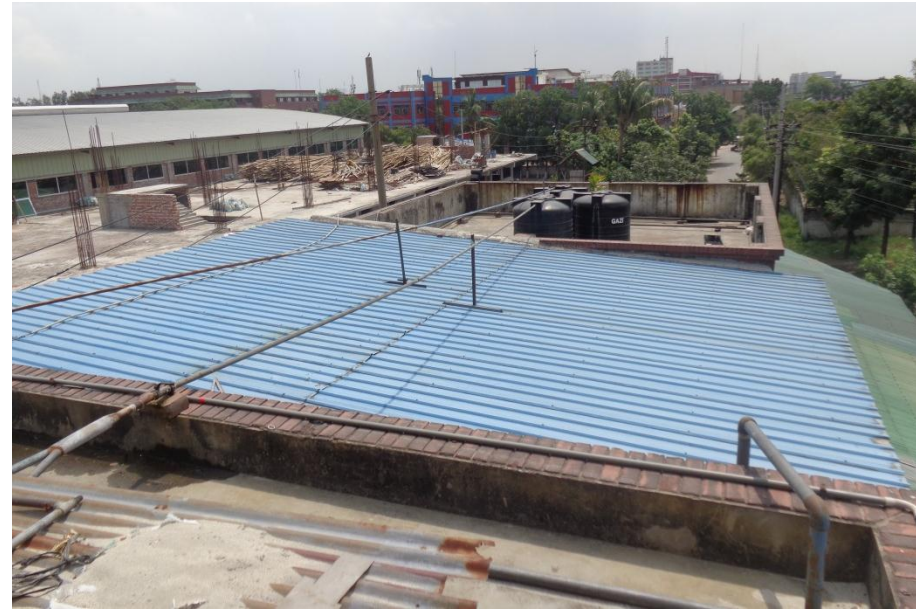
2-storey concrete extension

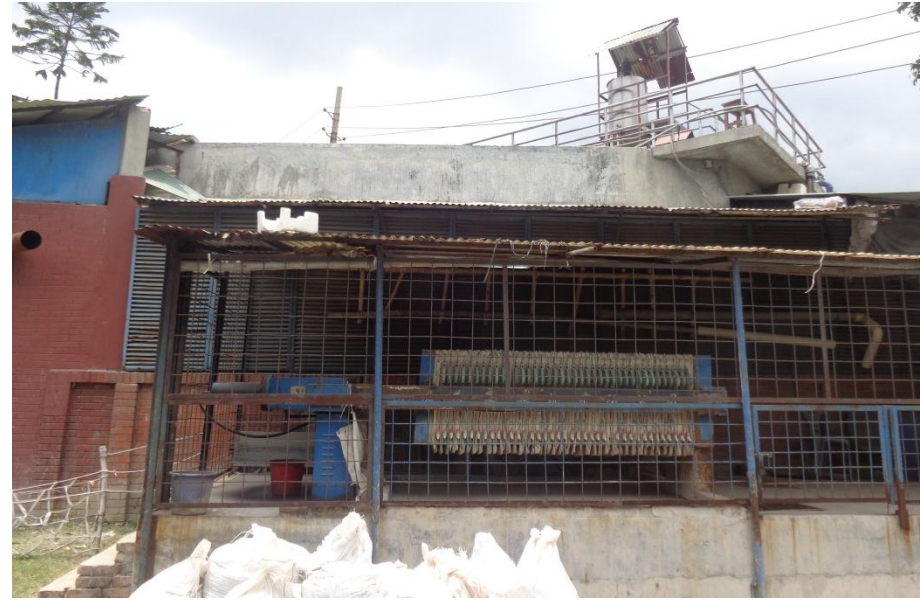
Poor corrugated steel and purlin detailing at ancillary sheds

Poor steel detailing was observed for the following structures:

| Item No. | Observation | Recommended Action Plan | Recommended Timeline |
|---|---|---|---|
| 2 | Poor steel detailing was observed for the following structures:<br><ul style="list-style-type: none"> <li>- Steel roof of main 3-storey building</li> <li>- Steel roof portion of 2-storey concrete extension</li> <li>- The two steel roof extensions</li> <li>- Steel canopy at front entrance</li> <li>- Ancillary sheds</li> </ul> | A Detailed Engineering Assessment is required for the above mentioned structures. | 6-weeks |
| 3 | Poor steel detailing was observed for the following structures:<br><ul style="list-style-type: none"> <li>- Steel roof of main 3-storey building</li> <li>- Steel roof portion of 2-storey concrete extension</li> <li>- The two steel roof extensions</li> <li>- Steel canopy at front entrance</li> <li>- Ancillary sheds</li> </ul> | Implement any recommendations from DEA. | 6-months |

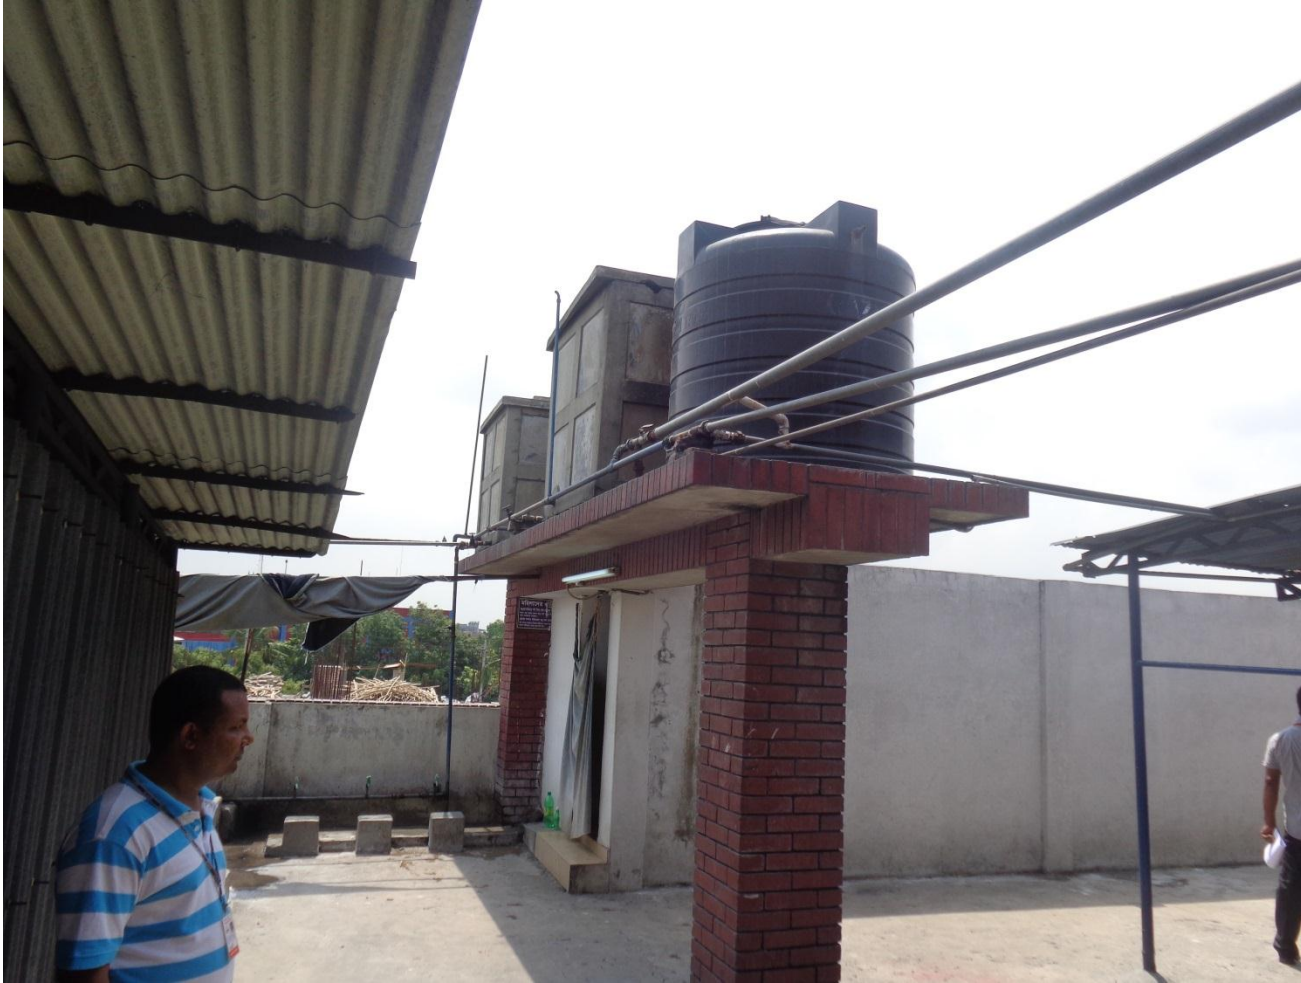
Water tanks on roof of main 3-storey building appear unstable. The simple 1 beam – 2 column structure supporting water tanks has no lateral resisting system.

| Item No. | Observation | Recommended Action Plan | Recommended Timeline |
|---|---|---|---|
| 4 | Water tanks on roof of main 3-storey building appear unstable. | Detailed Engineering Assessment is required for the concrete structure supporting the water tanks on the main building. | 6-weeks |
| 5 | Water tanks on roof of main 3-storey building appear unstable. | Implement any recommendations from DEA. | 6-months |

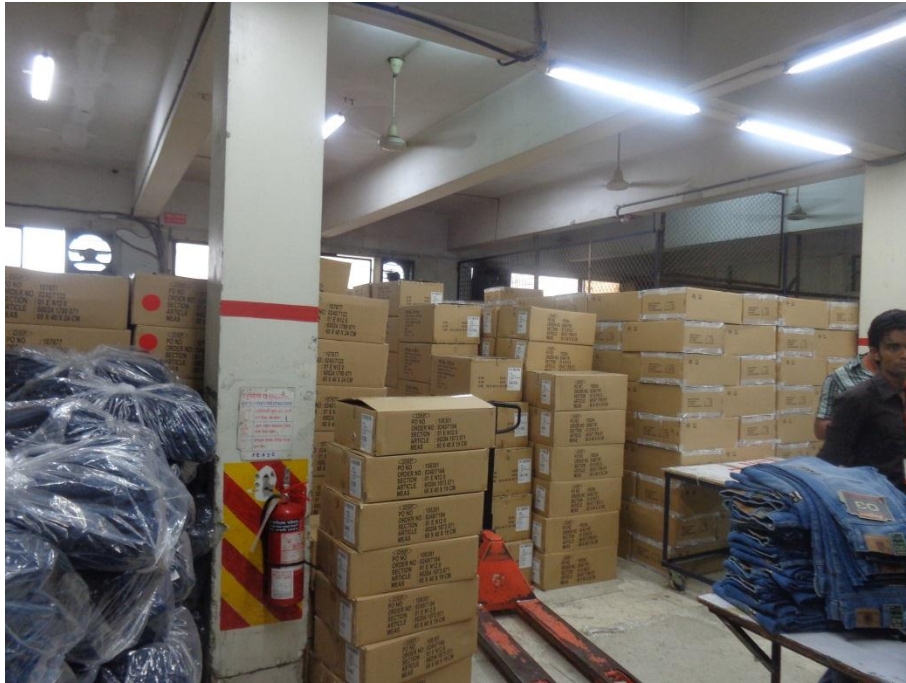
Storage Loading on 1<sup>st</sup> floor

No loading plans were made available and storage was observed on the 1<sup>st</sup> and 2<sup>nd</sup> floor of the main 3-storey building.

| Item No. | Observation | Recommended Action Plan | Recommended Timeline |
|---|---|---|---|
| 6 | No loading plans were made available and storage was observed on the 1st and 2nd floors of main 3-storey building. | Structural Engineer to determine load bearing capacity for each floor of all buildings and produce loading plans. | 6-weeks |
| 7 | No loading plans were made available and storage was observed on the 1st and 2nd floors of main 3-storey building. | Post loading plans on each floor and manage accordingly. | 6-months |

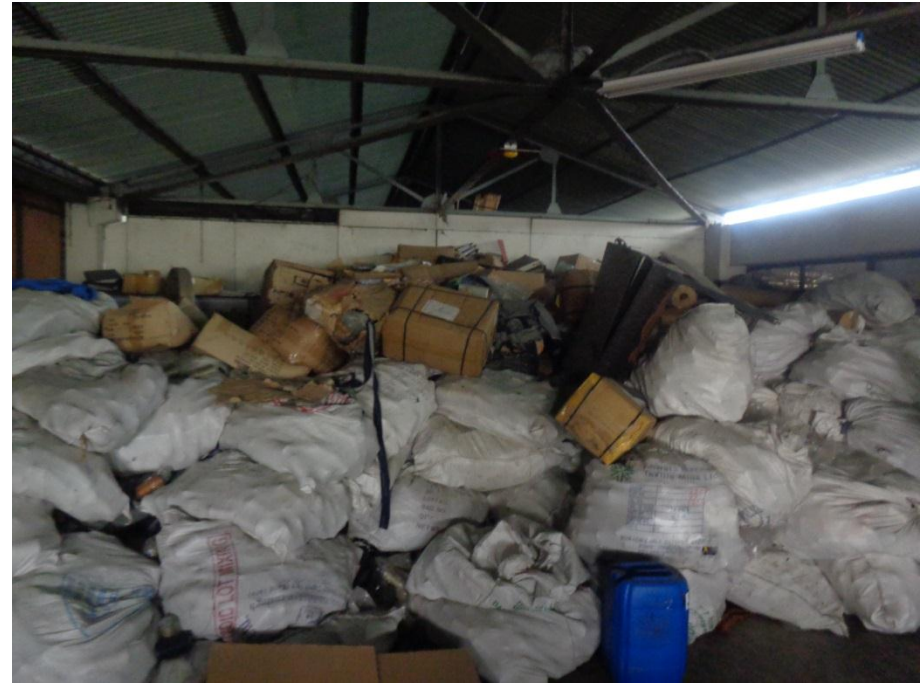
Storage Loading on 2<sup>nd</sup> floor

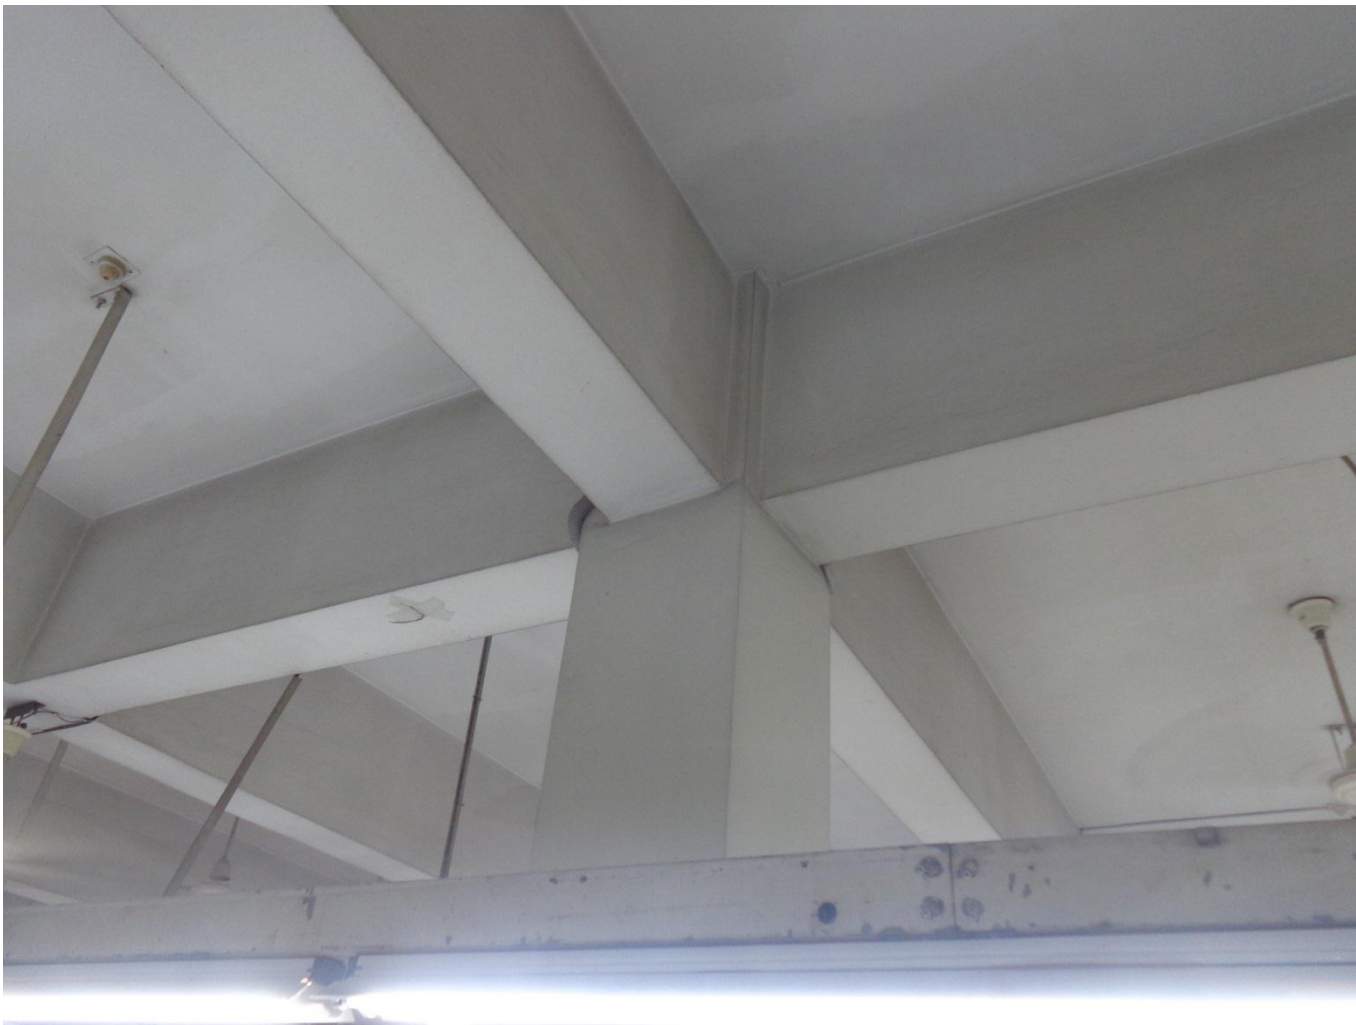
The building did not feature any core or shear walls. Stability was achieved through sway action between beams and columns and masonry infill walls.

We require that these items be investigated in a Detail Engineering Assessment

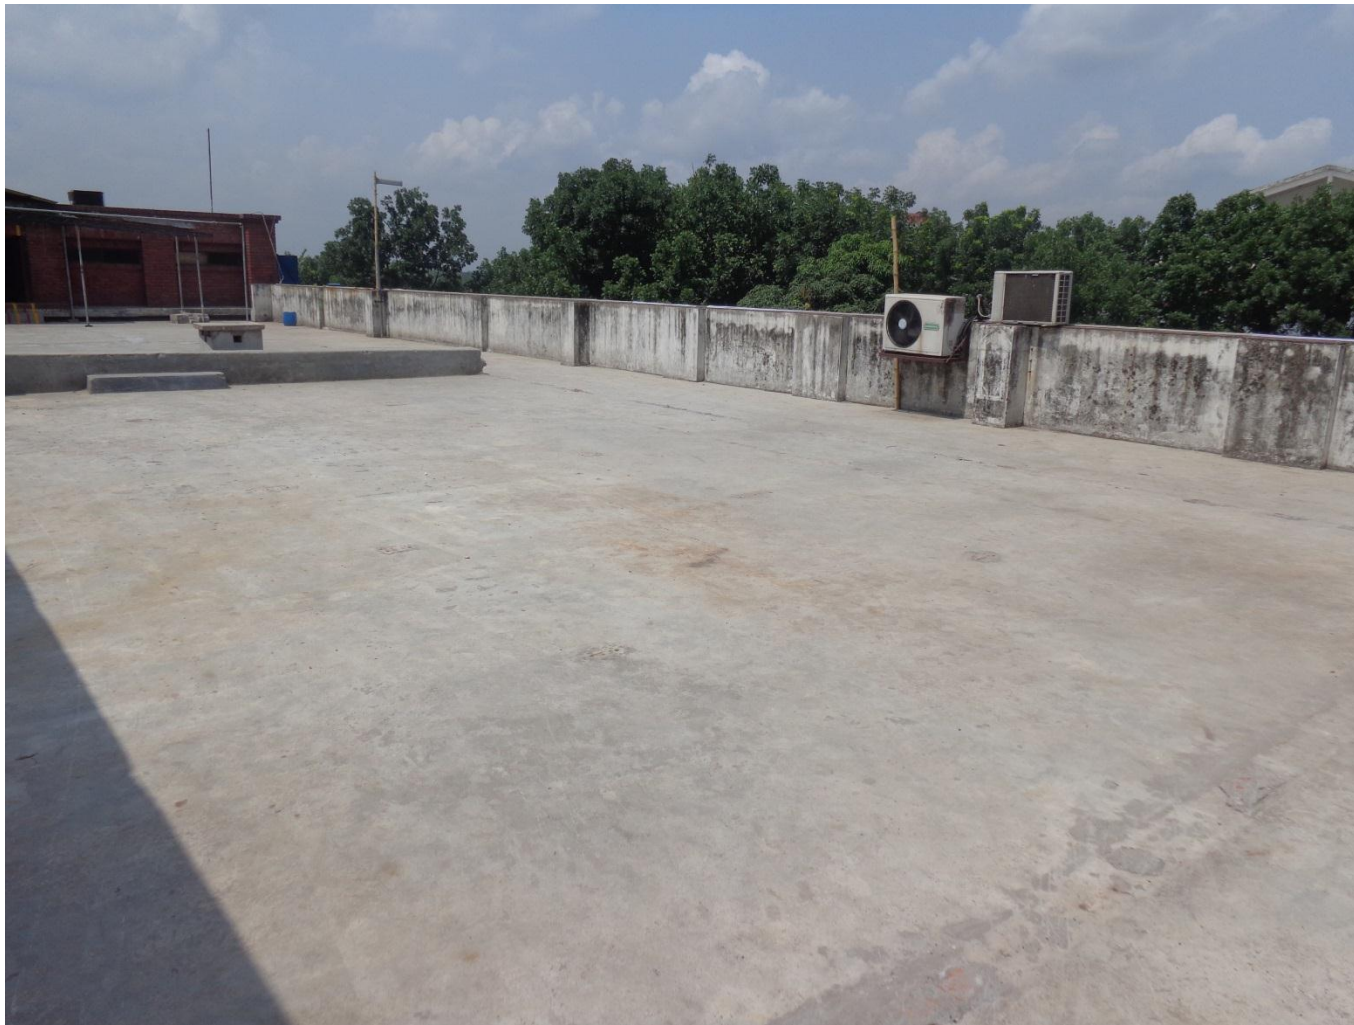
No waterproofing membrane was visible on the roof of the building. This means that any cracks in the surface finishes on the roof will allow water to seep into the concrete slab beneath the finishes, and cause corrosion of the reinforcing steel.
