# Latest Garments Ltd. (10077)

519, Chator, Chotobari, Post-DUET, Gazipur

24.MAY.2014

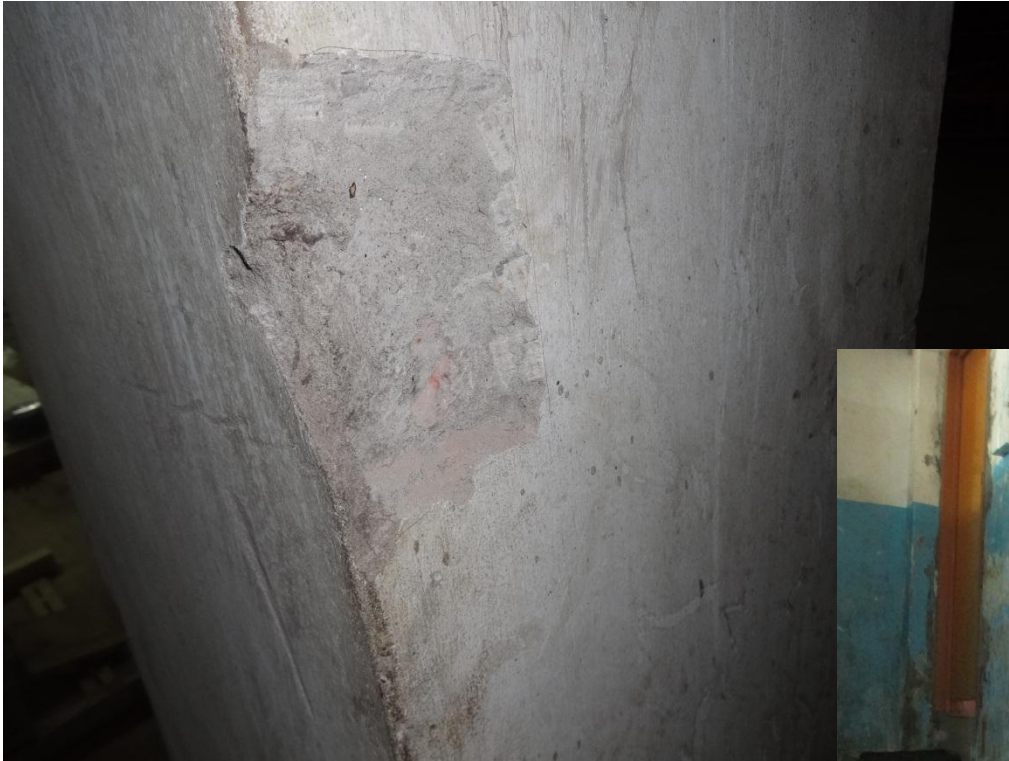
Slight over-stress in columns, established through column load run-down.

Left, the ground floor column from which the plaster was removed to establish that brick aggregate had been used. Below is the significant floor build-up under the toilet areas, which contributes significantly to the stress in the columns.

| Item No. | Observation | Recommended Action Plan | Recommended Timeline |
|---|---|---|---|
| 1 | Slight over-stress of columns, with a load run-down Factor of Safety between 1.5 and 1.86. | Factory Engineer to review design, loads and column stresses, particularly in areas where floor build-up is excessive (toilet blocks). Verify insitu concrete stresses by 100mm diameter cores from columns in this area. | 6-weeks |
| 2 | Slight over-stress of columns, with a load run-down Factor of Safety between 1.5 and 1.86. | Produce and actively manage a loading plan for all floor plates within the factory, giving consideration to floor capacity and column capacity. | 6-months |

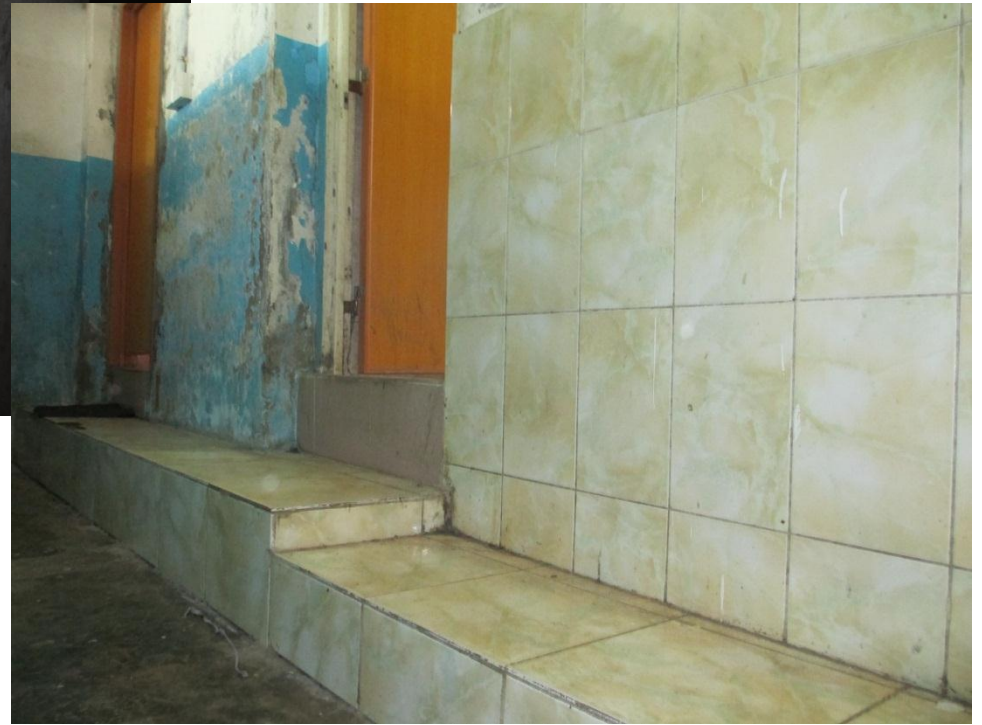
Following the scanning of a typical internal column to establish the reinforcement, and the column load run-down spreadsheet, a 'yellow' rating for the column stress was established.

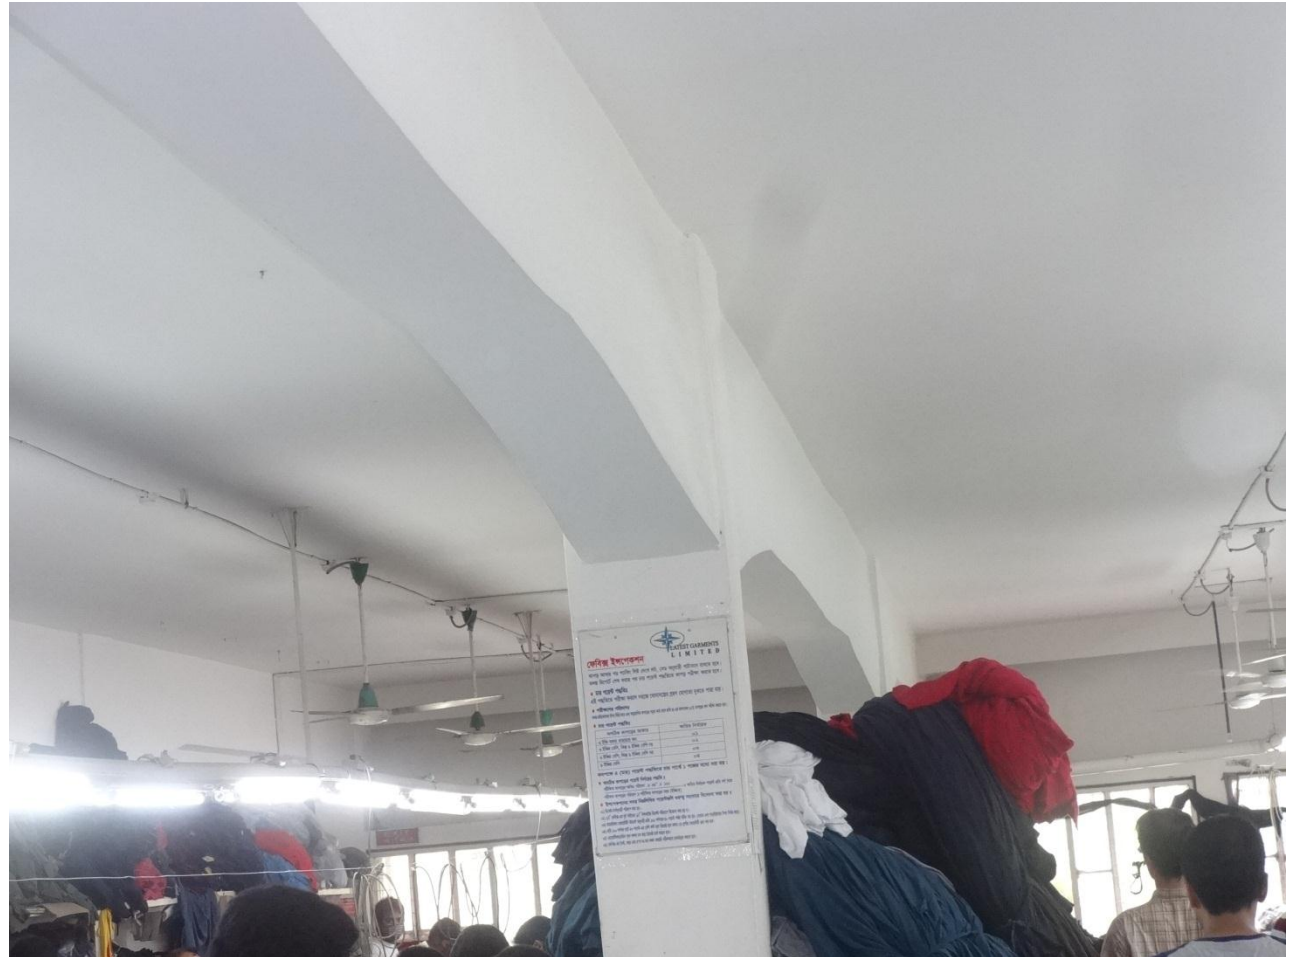
Concerns regarding the lateral stability of the building in one direction, due to the presence of down-stand beams only in one direction.

To the right is an internal image from the factory, showing very deep down-stand beams in one direction, providing stability through moment frame action. In the other direction however, no sufficient lateral stability system could be established. This should be further investigated in the form of a Detailed Engineering Assessment.

| Item No. | Observation | Recommended Action Plan | Recommended Timeline |
|---|---|---|---|
| 3 | Lateral stability system of the building is to be established, with down-stand beams only in one direction. | Detailed Engineering Assessment to be carried out, to establish suitability of existing lateral stability system.<br>Any deficiencies or necessary remedial works to be established. | 6-weeks |
| 4 | Lateral stability system of the building is to be established, with down-stand beams only in one direction. | Implement any structural alterations recommended through the DEA. | 6-months |

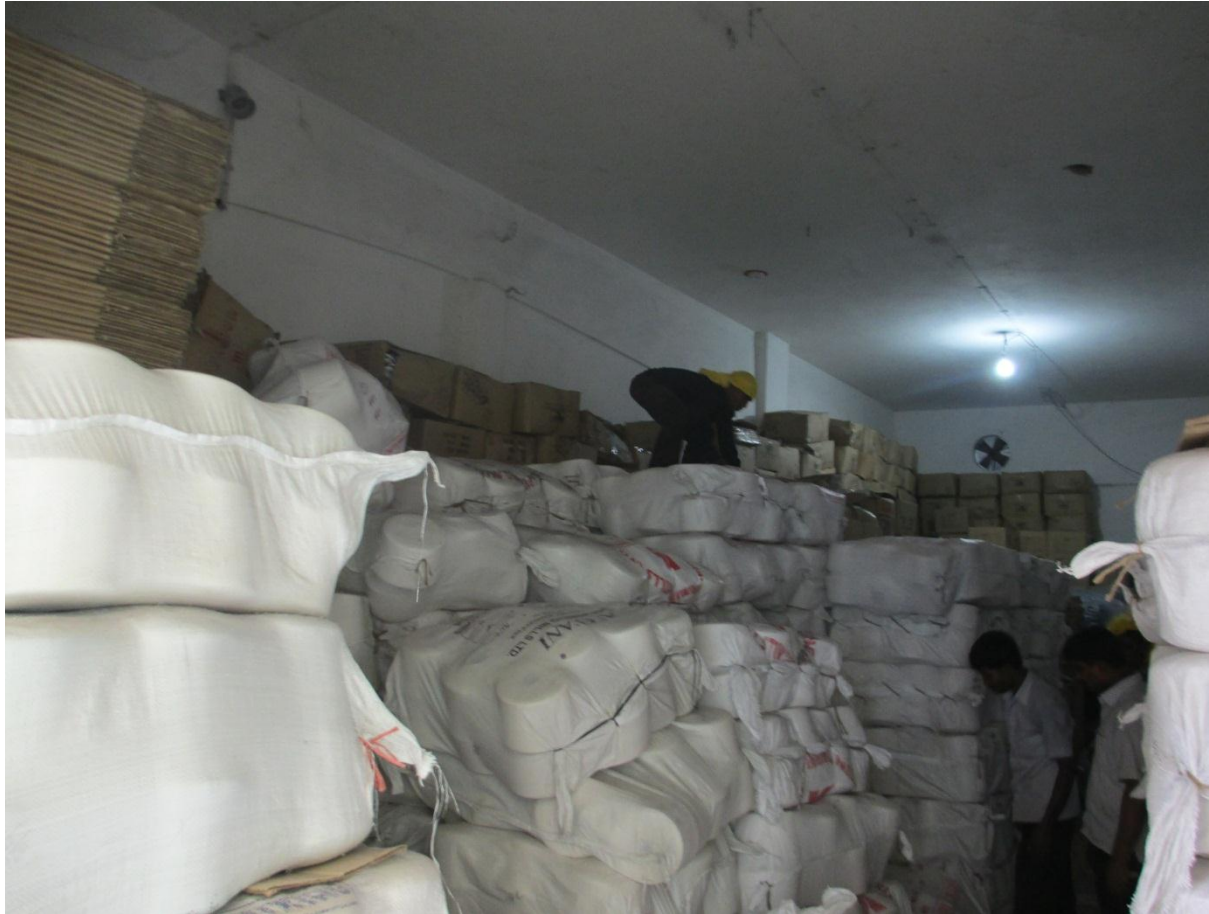
Large amounts of storage load at ground floor level, immediately adjacent to internal partition wall. This can introduce un-designed-for lateral loading on the wall.

This image shows a significant amount of uncontrolled storage at ground floor level. Although this does not cause any concerns with regard to the overall stability of the building, the stacking of this material against the internal partition wall imposes a lateral load that may not have been designed for.

This loading causes concern for the stability of this particular internal wall, and as such the loading should be controlled so as to not lean on the wall and apply any horizontal load.

| Item No. | Observation | Recommended Action Plan | Recommended Timeline |
|---|---|---|---|
| 5 | Storage at ground floor level is stacked against an internal partition wall, introducing lateral loading. | Reduce storage height to 2m, and control so that it is not leaning on the wall.<br>Loading plan to be produced, paying attention to the prevention of lateral loading. | 6-weeks |
| 6 | Storage at ground floor level is stacked against an internal partition wall, introducing lateral loading. | Suitable storage height to be established and maintained.<br>Storage to be controlled, to ensure stacks/piles are self-supporting. | 6-months |

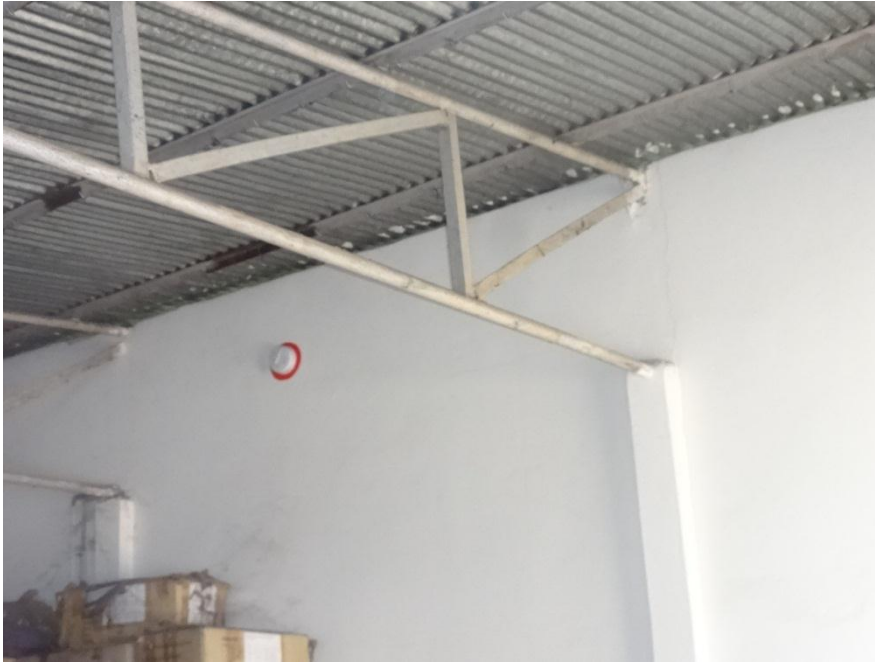
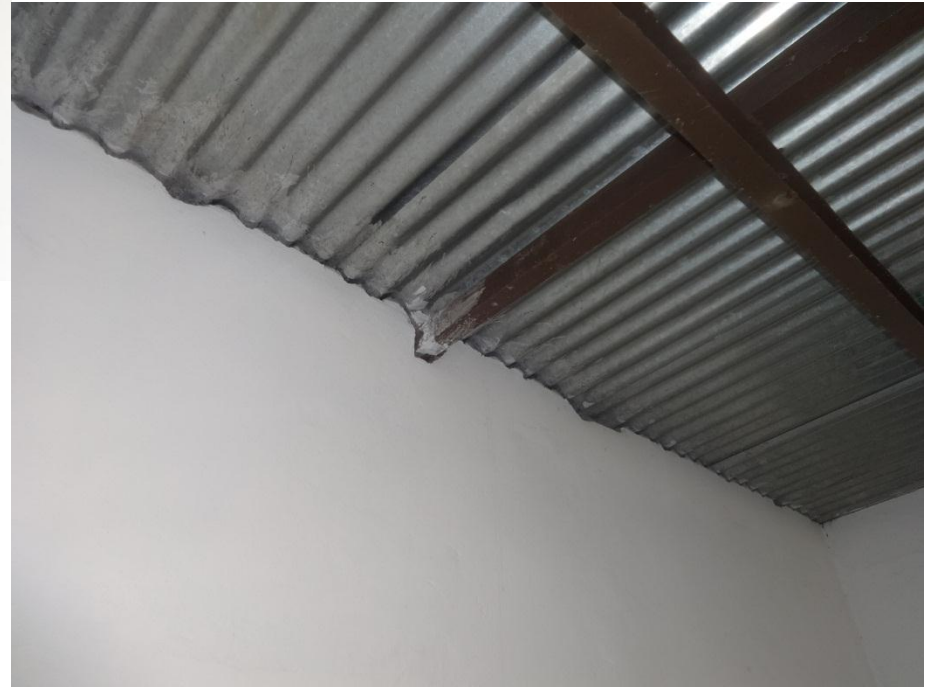
Some portions of the steel roof over 3<sup>rd</sup> floor level (built up above concrete roof level) have questionable anchorage details. Further investigation is recommended.

In some case an attempt has been made to anchor the truss or rafter down to the concrete post or brick wall supporting it, however in many cases this appeared insufficient. These details should be reviewed by the Factory Engineer and improved where necessary.

These images show anchorage details for steel roofs across the site. These are present at the roof over 3<sup>rd</sup> floor level as well as the individual buildings around the perimeter of the site.

| Item No. | Observation | Recommended Action Plan | Recommended Timeline |
|---|---|---|---|
| 7 | Anchorage of the steel roof trusses over 3rd floor level is to be checked in further detail and improved if necessary. | Factory Engineer to review suitability of anchorage details of steel roofs.<br>Any additional restraint deemed necessary to be implemented and overseen by Engineer. | 6-months |

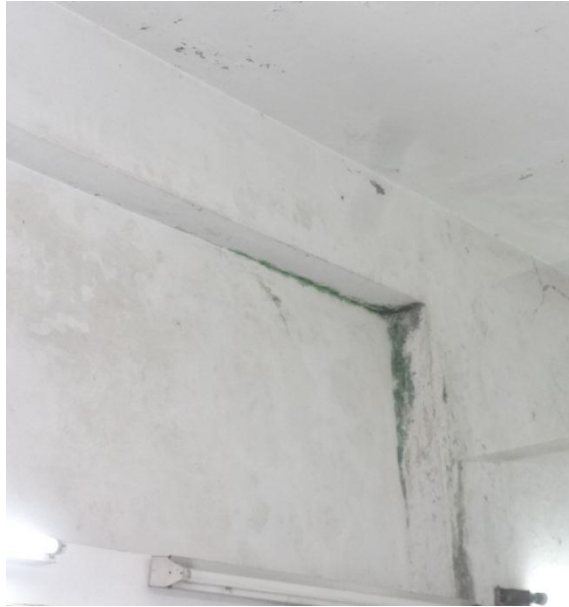
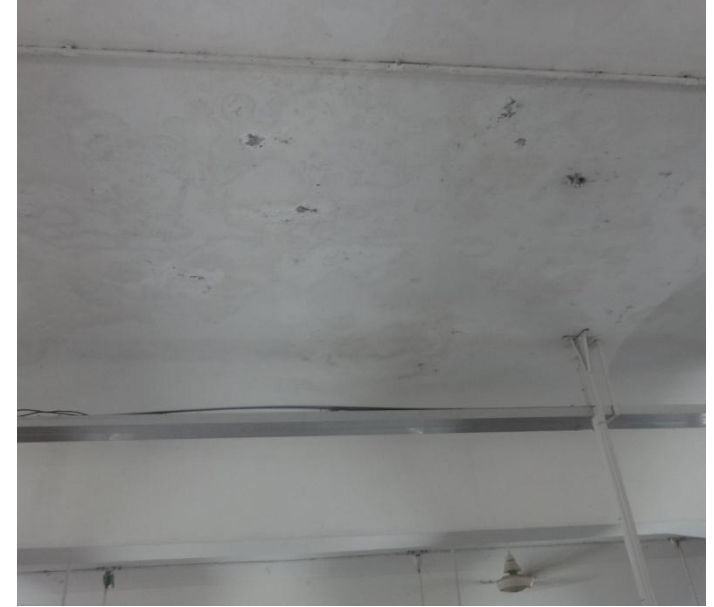
Some water ingress was visible in the soffit above 2<sup>nd</sup> floor level, immediately beneath concrete roof level. An appropriate waterproofing system is recommended.

There were numerous signs of water ingress across the soffit over 2<sup>nd</sup> floor level (the underside of the roof slab). This can cause degradation to the slab and its reinforcement if allowed to develop.

Apparently a slope is to be added to the roof. This must be done under the close supervision of a Structural Engineer, paying particular attention to the following aspects:

1. Waterproofing layer to the surface of the build-up to be sufficient to ensure water ingress into the brick build-up does not occur.
2. Build-up should not add such a load as to have any negative effect on the structural integrity of the roof or supporting structural elements.

| Item No. | Observation | Recommended Action Plan | Recommended Timeline |
|---|---|---|---|
| 8 | Signs of water ingress were evident to the soffit above 2nd floor level; the underside of the concrete roof slab. | Waterproofing layer to be applied to concrete roof.<br>If slope is to be applied, Engineer must oversee works to ensure that surfacing is sufficiently waterproof (and thick enough to avoid cracking) and that the build-up is not so thick as to cause any excess stress to roof slab or supporting columns. | 6-months |

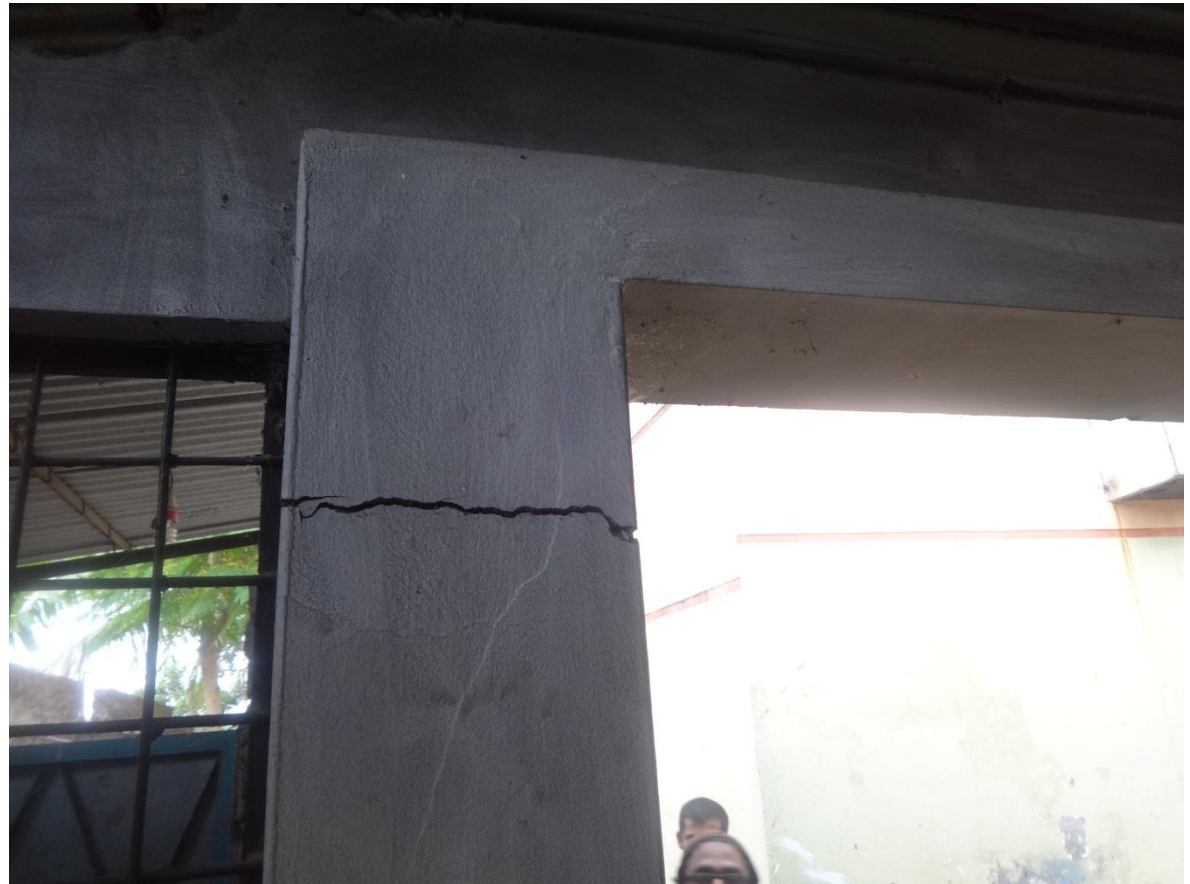
Cracked column supporting lintel in external generator room building, requires repair.

This cracked pier supports the lintel over the doorway into the generator room, located just outside the main factory building.

In a minor wind loading situation, the lintel could become unstable and cause a threat to the safety of anyone nearby. As such suitable repair works should be carried out, designed and overseen by the Factory Engineer.

| Item No. | Observation | Recommended Action Plan | Recommended Timeline |
|---|---|---|---|
| 9 | Column supporting lintel over the door into the external generator room is cracked almost through the entire cross section. | Plaster to be broken out to establish that reinforcement is present and undamaged.<br>If this is the case, local repair to be carried out.<br>If reinforcement is damaged, Factory Engineer to design and oversee removal and re-installation of reinforced concrete pier. | 6-months |

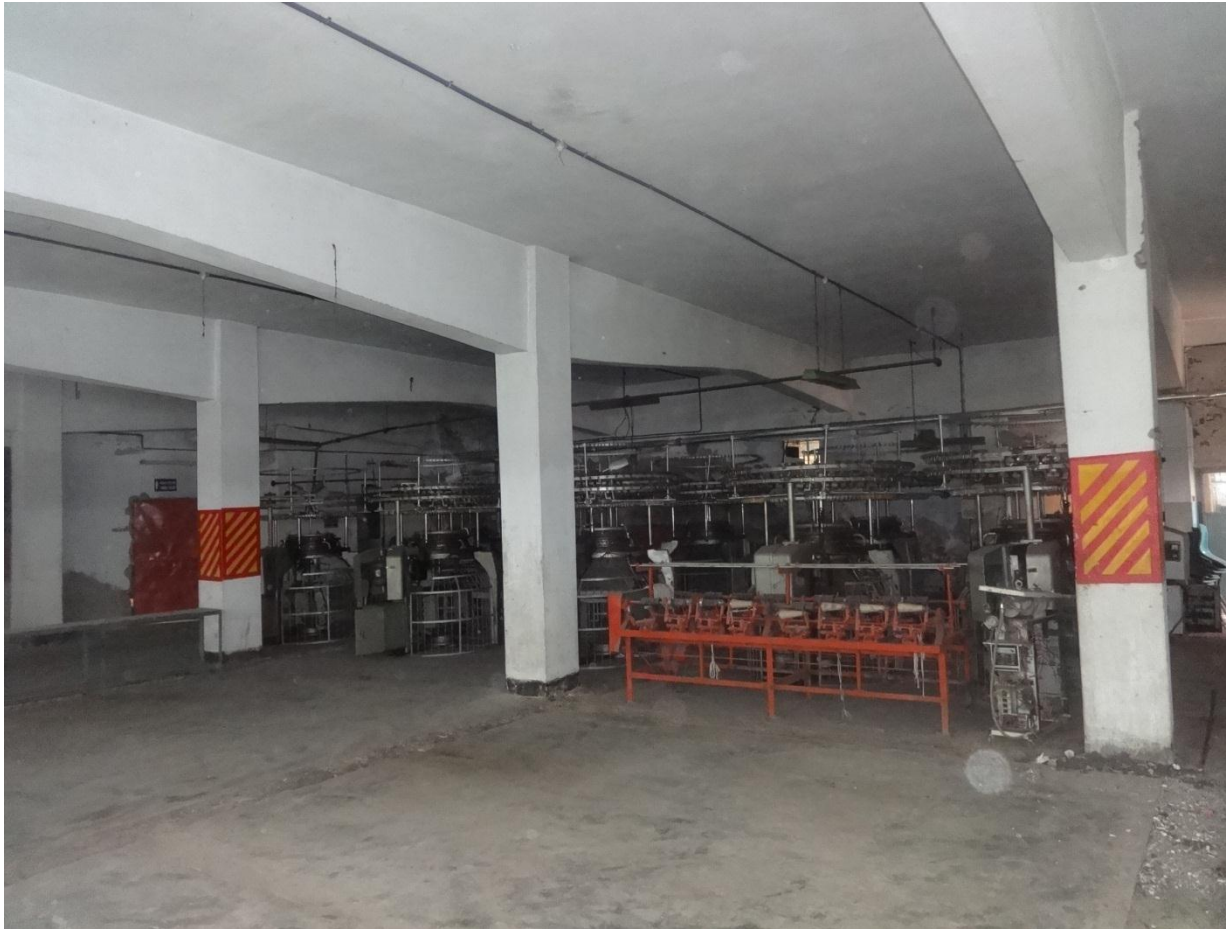
View from ground floor level, where floor-to-ceiling height is slightly greater than elsewhere.

As can be seen here, very deep concrete beams with haunches are present in one direction. This provides ample lateral stability for the building in this direction through moment frame action.

Perpendicular to these beams, however, only the rigidity of the slab provides any stability, with some small contribution from the rigid perimeter walls.

We require that these items be investigated in a Detail Engineering Assessment

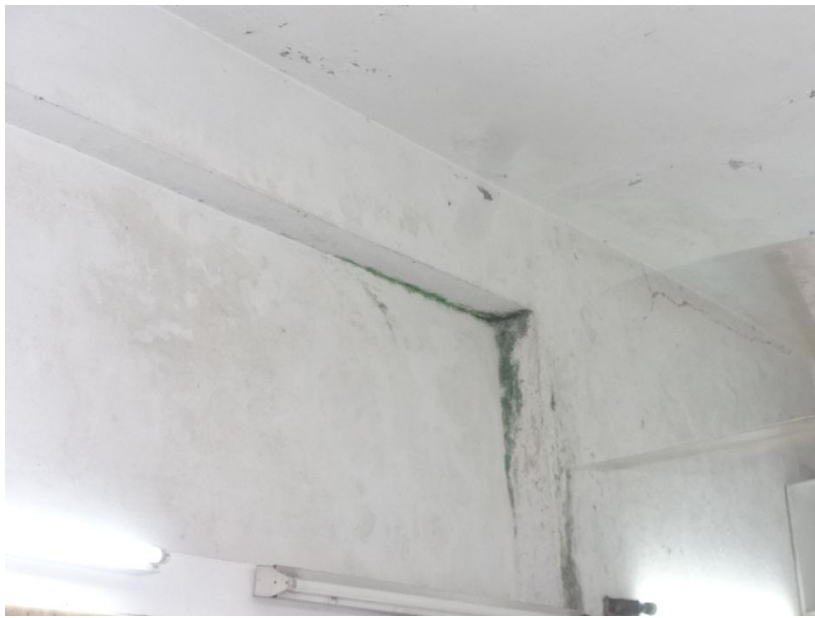
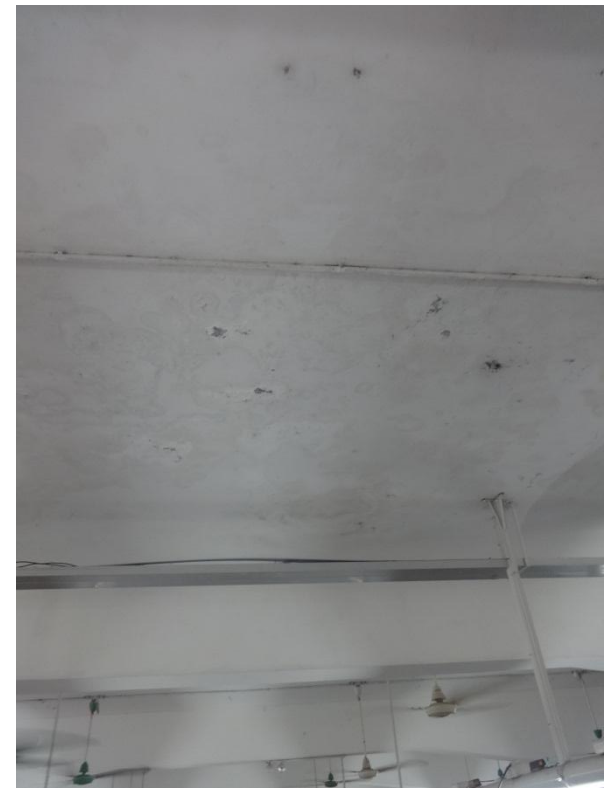
Bottom left; small signs of ponding at roof level. Left and right; evidence of water ingress on the underside of the roof slab, viewed from 2<sup>nd</sup> floor level.

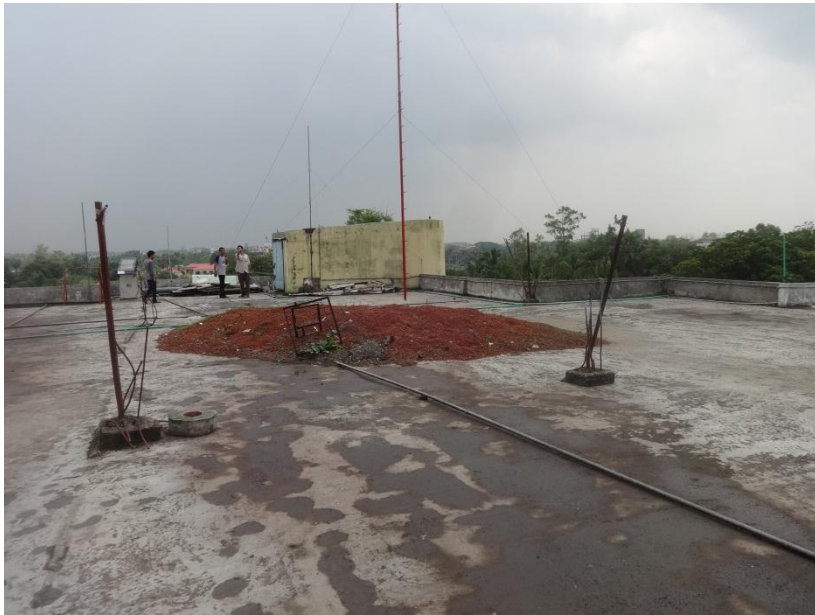
The pile of aggregate to the left is purportedly to be used to create a slope on the roof for water runoff. This should be overseen by a Structural Engineer to ensure a sufficient slope, appropriate waterproofing, and avoidance of excessive load.
