# Tasniah Fabrics Ltd. (9886)

Nayapara, Konabari, Kashimpur, Garzipur

25.MAY.2014

## Identified Priority 2 Concerns

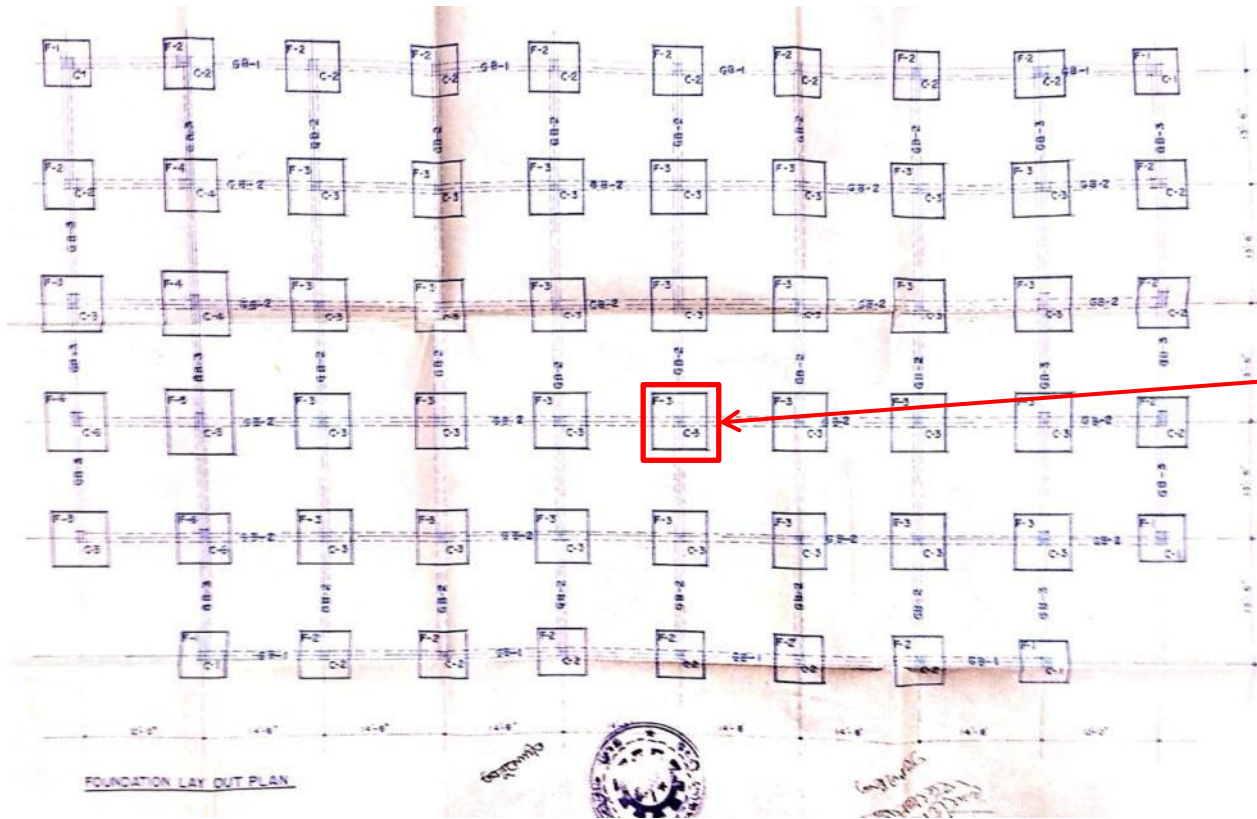
Based on the column load rundown with the agreed minimum design live load assignment, A shown column seems to be significantly insufficient in carrying the dead and live loads, giving a firm **AMBER** warning, suggesting a necessity for immediate structural analysis of the building, with the columns appearing very close to being overloaded.

| Item No. | Observation | Recommended Action Plan | Recommended Timeline |
|---|---|---|---|
| 1 | Column load run-down indicate a low factor of safety for column. | Factory engineer to review design, loads and column stresses in areas identified above.<br>Produce and actively manage a loading plan for all floor plates within the factory giving consideration to floor slab and column capacity. | 6-weeks |
| 2 | Column load run-down indicate a low factor of safety for column. | Maintain standards of quality control to ensure that loading plan is correctly followed so that overloading problems do not arise in the future. | 6-months |

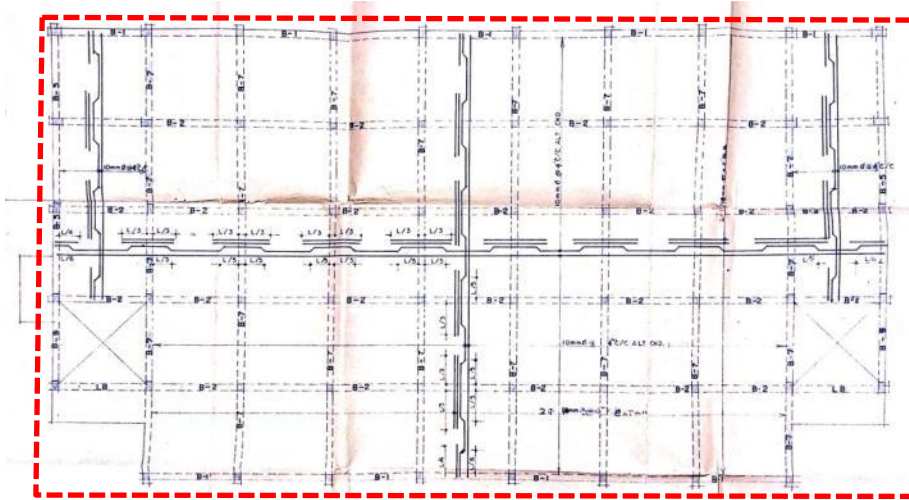
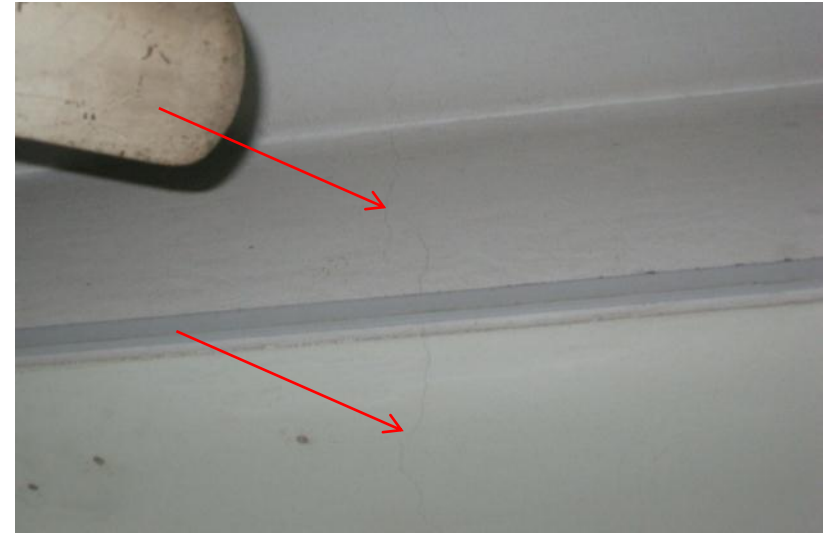
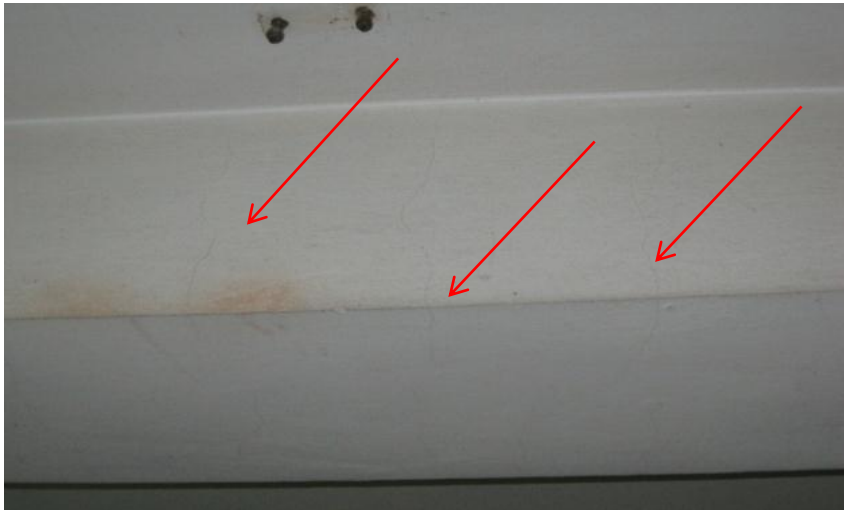
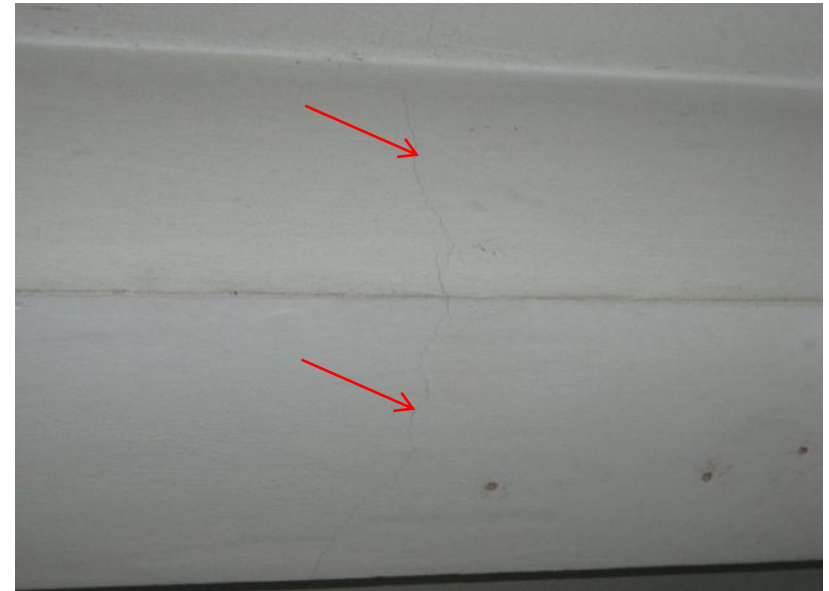
## 2<sup>nd</sup> Priority 2 Concern

Cracks appeared underside beam and slab on 2<sup>nd</sup> and 3<sup>rd</sup> floor, capacity check is required prior to repairing.

| Item No. | Observation | Recommended Action Plan | Recommended Timeline |
|---|---|---|---|
| 3 | Cracks appeared on beam and slab, capacity check is required. | A Detailed Engineering Assessment of the factory is to be carried out. The distress found is to be suitably repaired.<br>Simply plastering over is not allowed. | 6-weeks |
| 4 | Cracks appeared on beam and slab, capacity check is required. | Maintain standards of quality control to ensure that loading plan is correctly followed so that problems do not arise in the future. | 6-months |

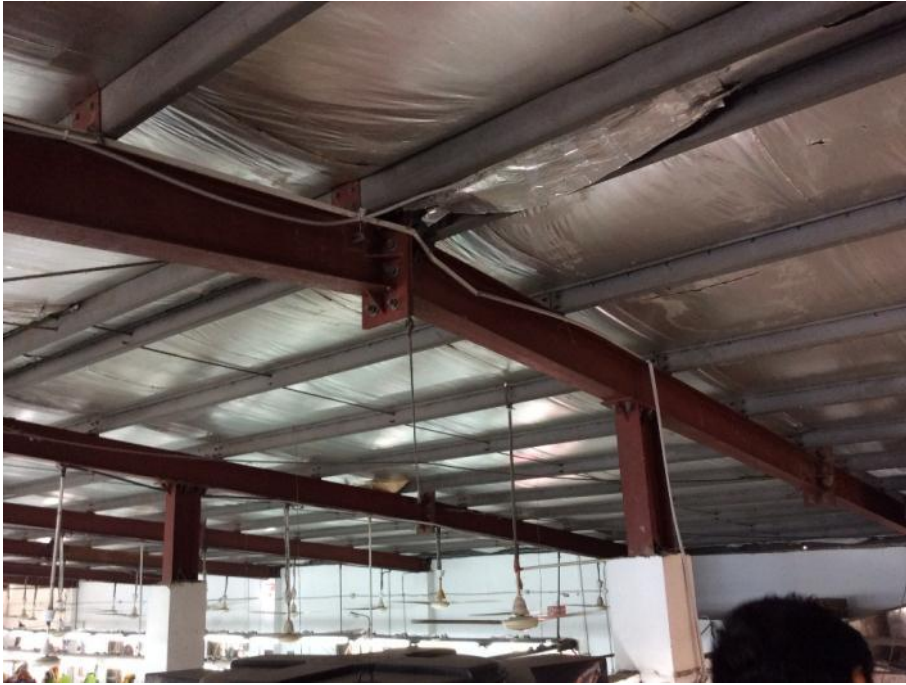
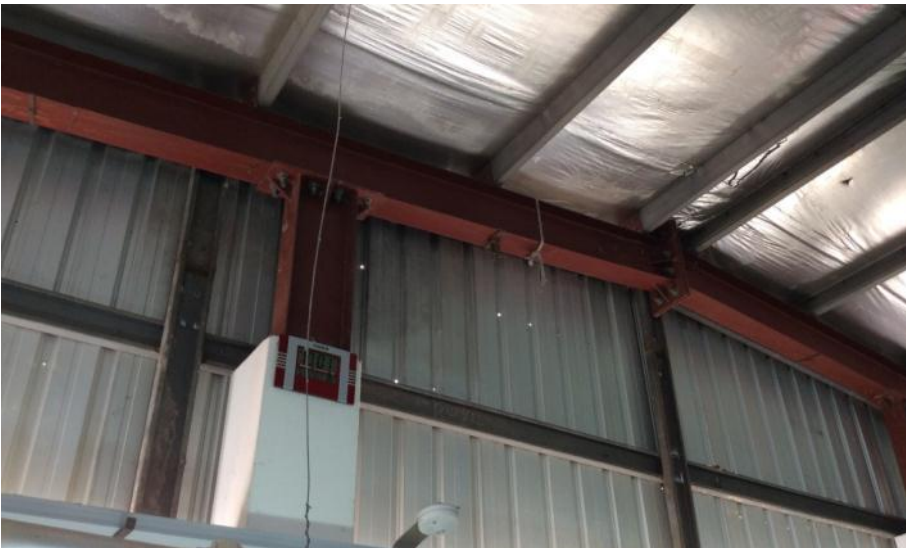
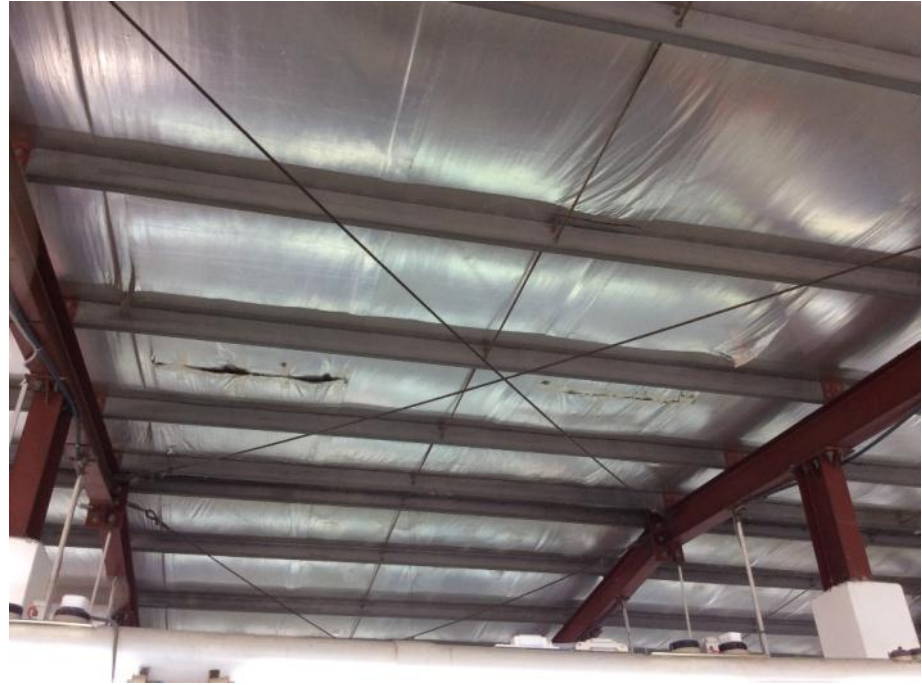
## 3<sup>rd</sup> Priority 2 Concern

There is no structural drawings provided and insufficient lateral steel bracing. Capacity check is required.

| Item No. | Observation | Recommended Action Plan | Recommended Timeline |
|---|---|---|---|
| 5 | No structural drawings for steel roof and insufficient lateral steel bracing, capacity check is required. | Factory Engineer to review design and Detailed Engineering Assessment to be completed. | 6-weeks |
| 6 | No structural drawings for steel roof and insufficient lateral steel bracing, capacity check is required. | Continue to implement load plan | 6-months |

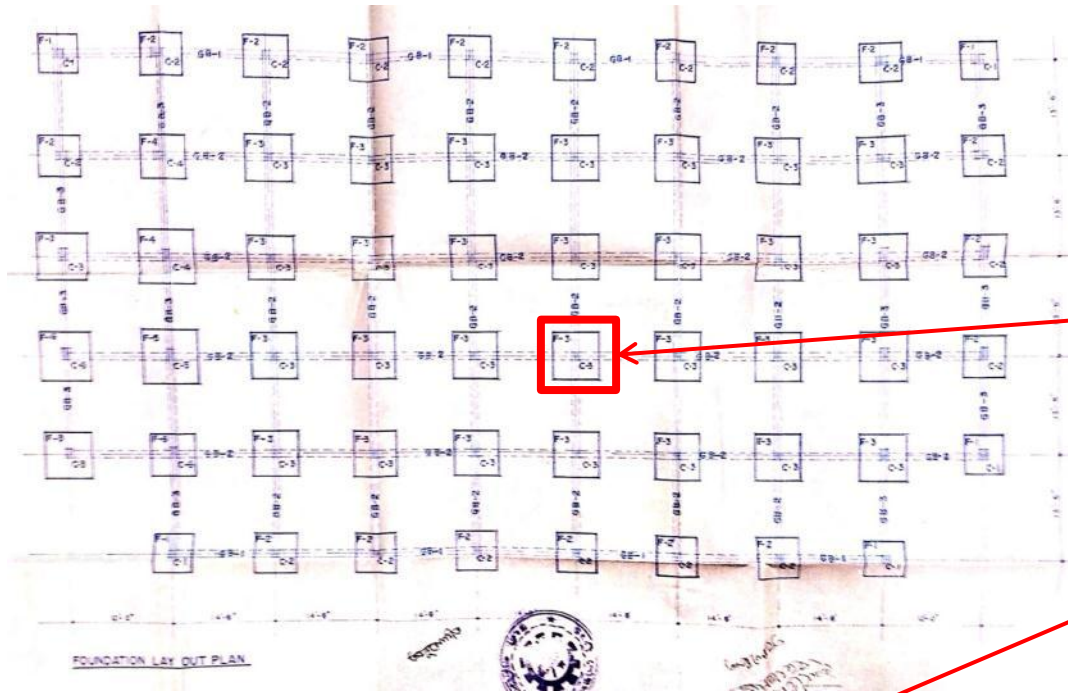
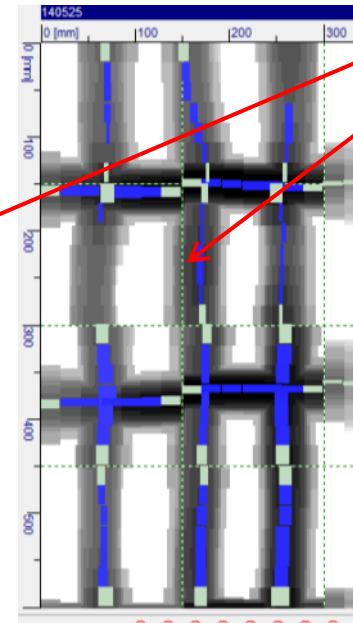
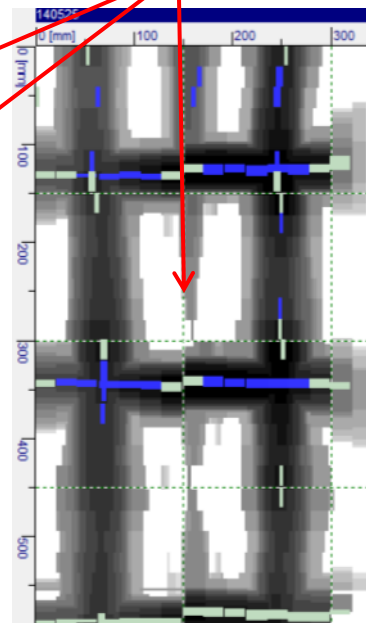
# 4<sup>th</sup> Priority 2 Concern

The number of re-bars detected appear to be fewer than those specified on the construction drawings.

Long Side: 3-16mm.

Short Side: 3-16mm.

| Item No. | Observation | Recommended Action Plan | Recommended Timeline |
|---|---|---|---|
| 7 | Existing structural system does not match the construction documentations. | Factory Engineer to review design and Detailed Engineering Assessment to be completed. | 6-weeks |
| 8 | Existing structural system does not match the construction documentations. | Continue to implement load plan | 6-months |

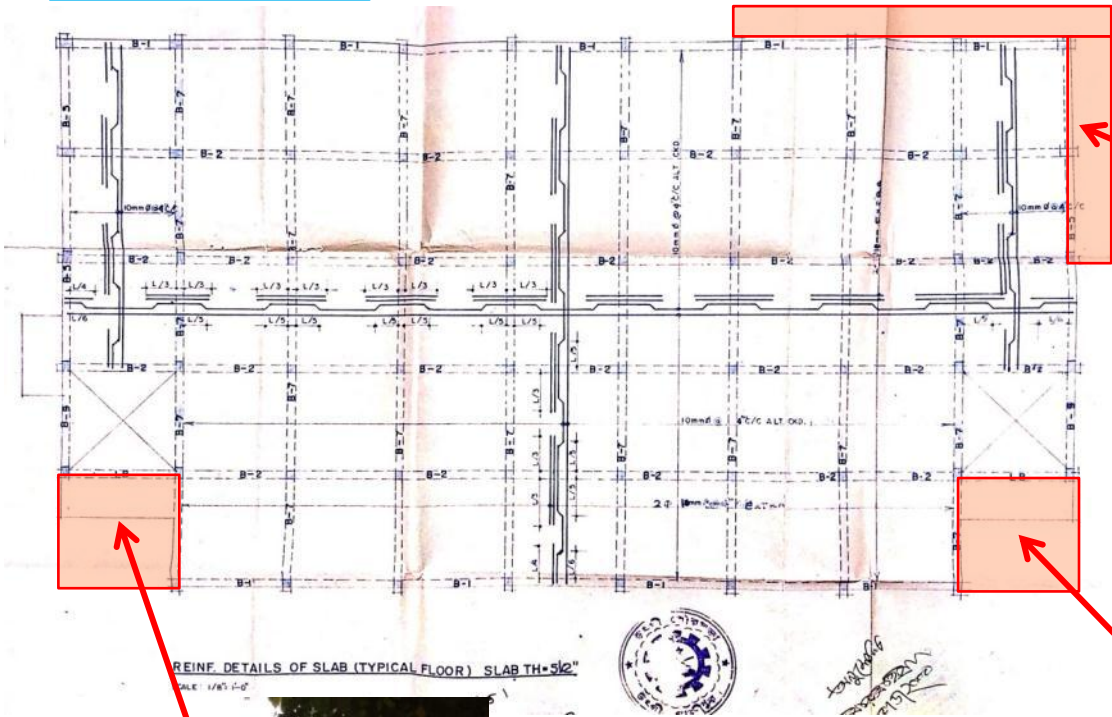
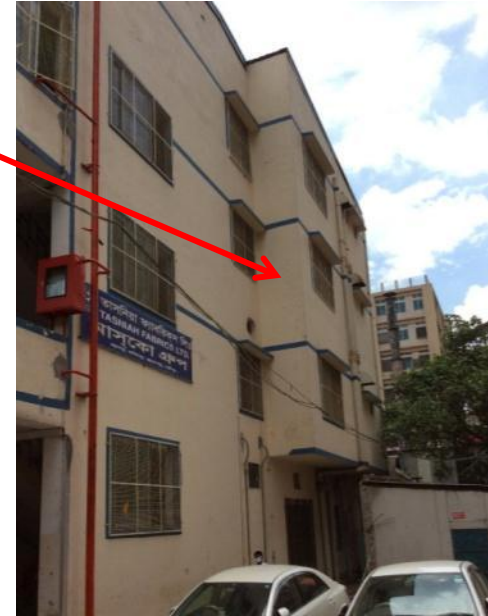
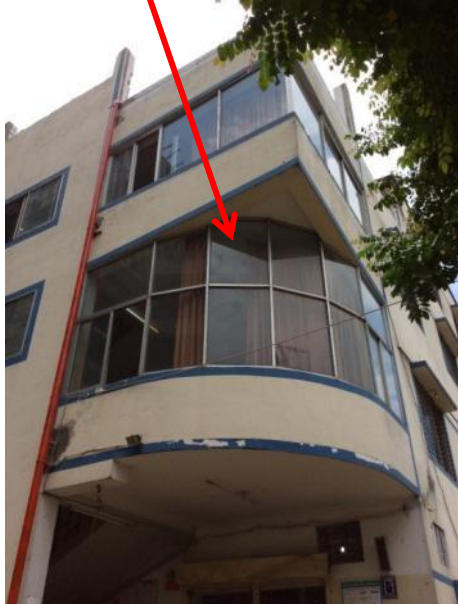
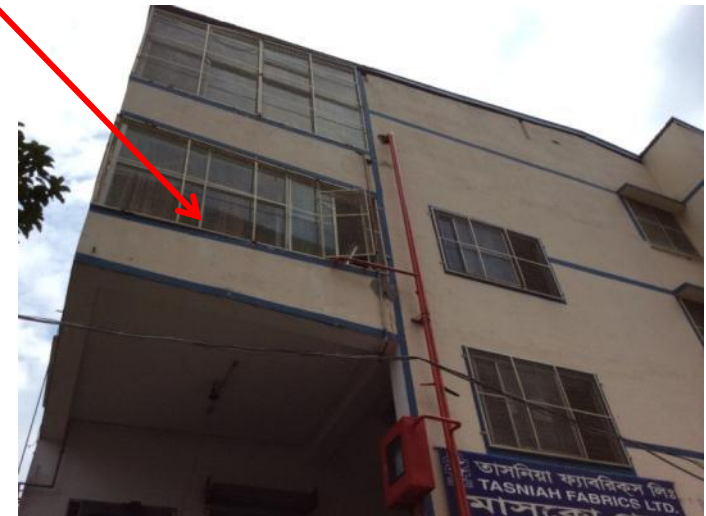
## 4<sup>th</sup> Priority 2 Concern

There are cantilevered slabs and beam on 1<sup>st</sup> to 3<sup>rd</sup> floor levels that do not appear on the structure drawings. Capacity checks are required.

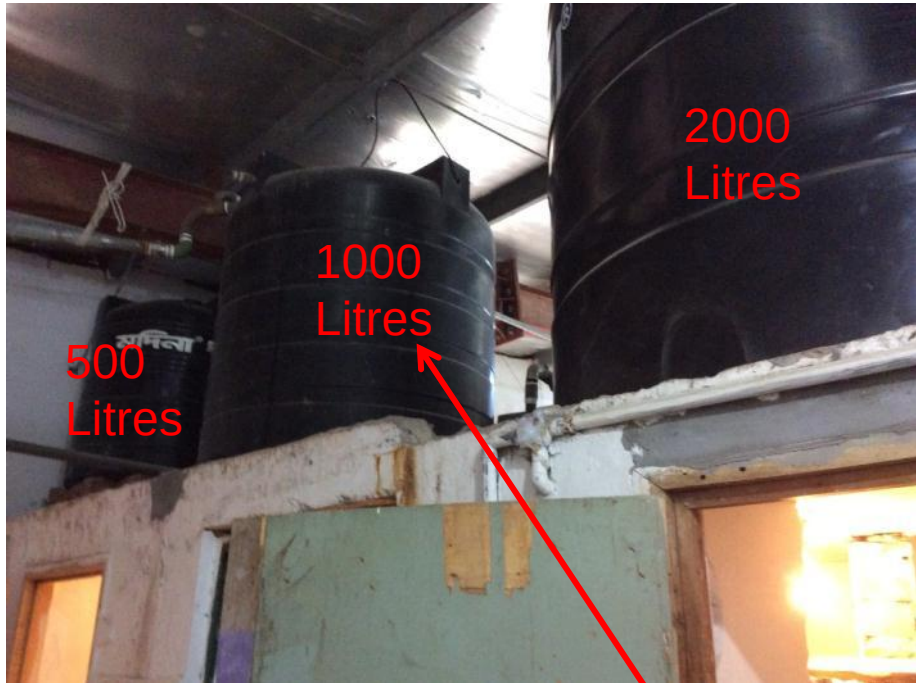
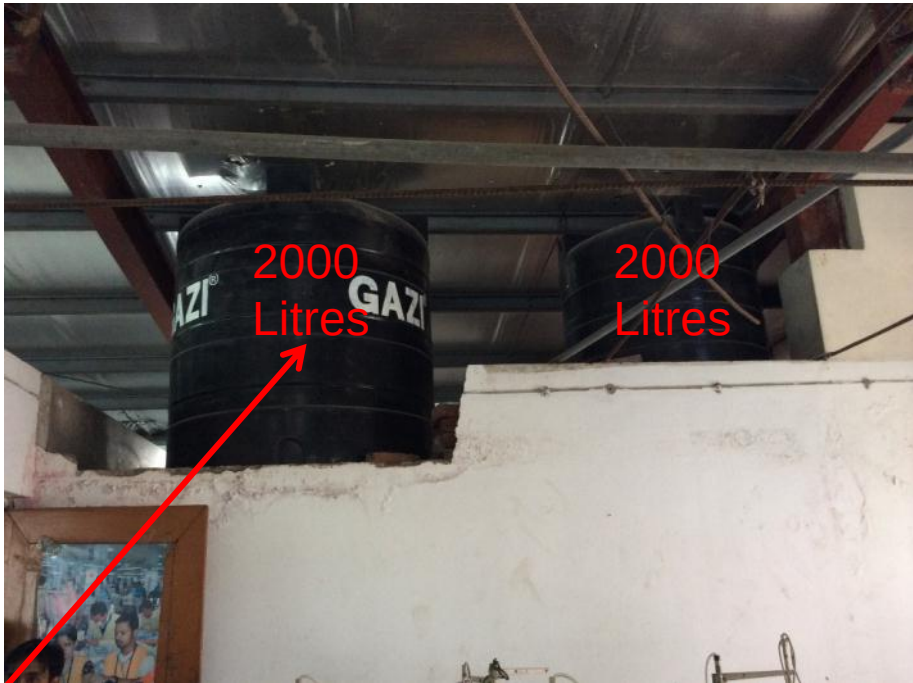
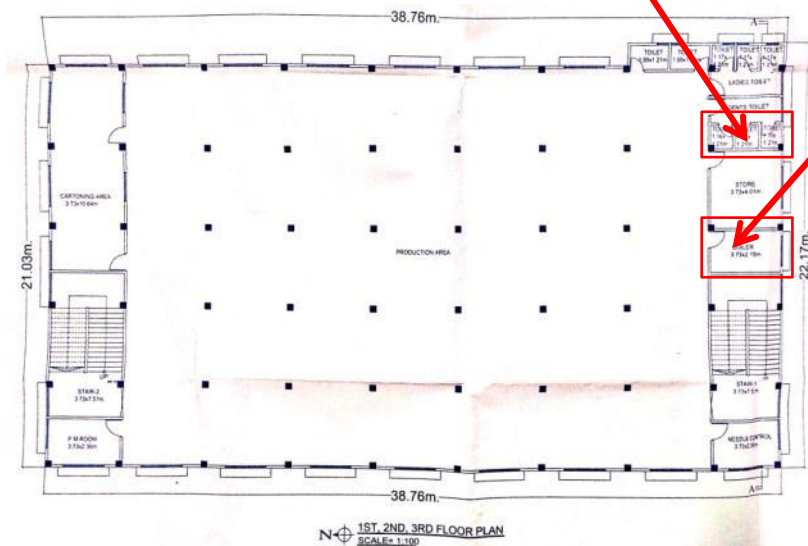
## 5<sup>th</sup> Priority 2 Concern

There are no structural support for water tank, capacity check is required.

| Item No. | Observation | Recommended Action Plan | Recommended Timeline |
|---|---|---|---|
| 9 | No structural support for water tank, capacity check is required. | Factory Engineer to review design and Detailed Engineering Assessment to be completed. | 6-weeks |
| 10 | No structural support for water tank, capacity check is required. | Continue to implement load plan | 6-months |

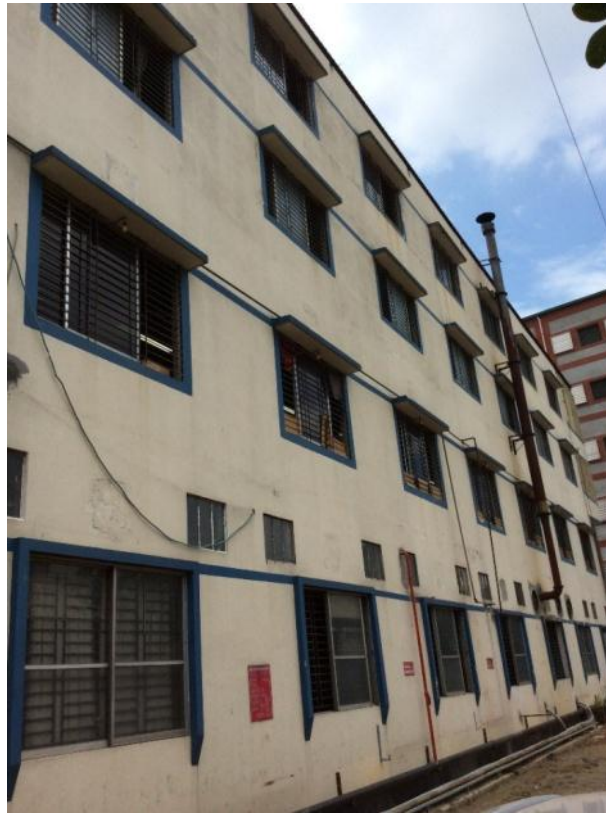
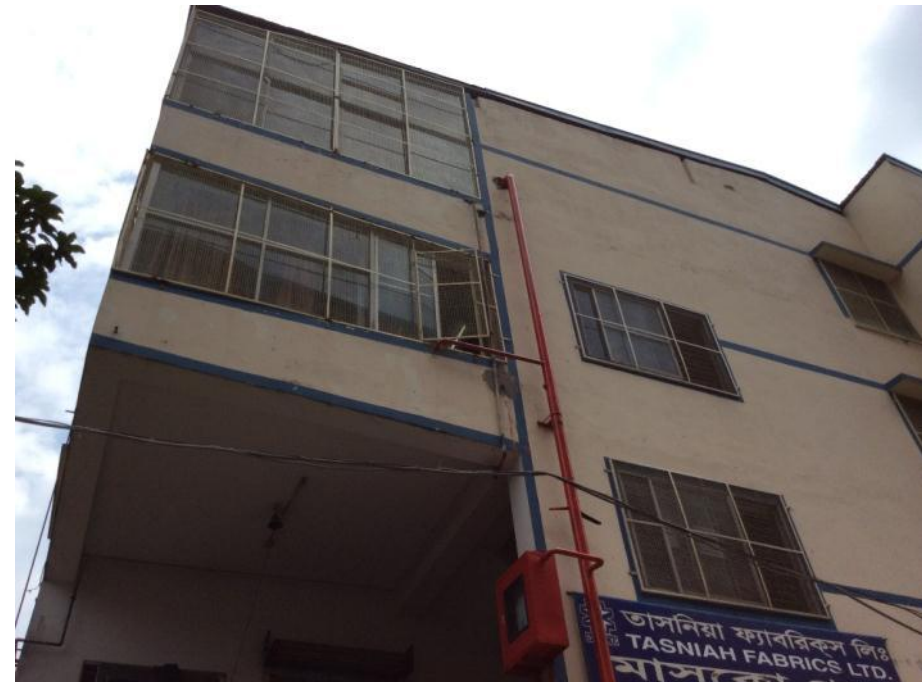
# Overall Stability System

We require that these items be investigated as part of a Detailed Engineering Assessment

Concerns on the stability system for lateral loading. Façade brickwork walls lack of moment capacity in connection between columns and beams.

| Item No. | Observation | Recommended Action Plan | Recommended Timeline |
|---|---|---|---|
| 11 | Overall stability system. | Request that the Detail Engineering Assessment of the overall building to be carried out and in particular, stability and foundation aspects should be investigated in detail. | 6-weeks |

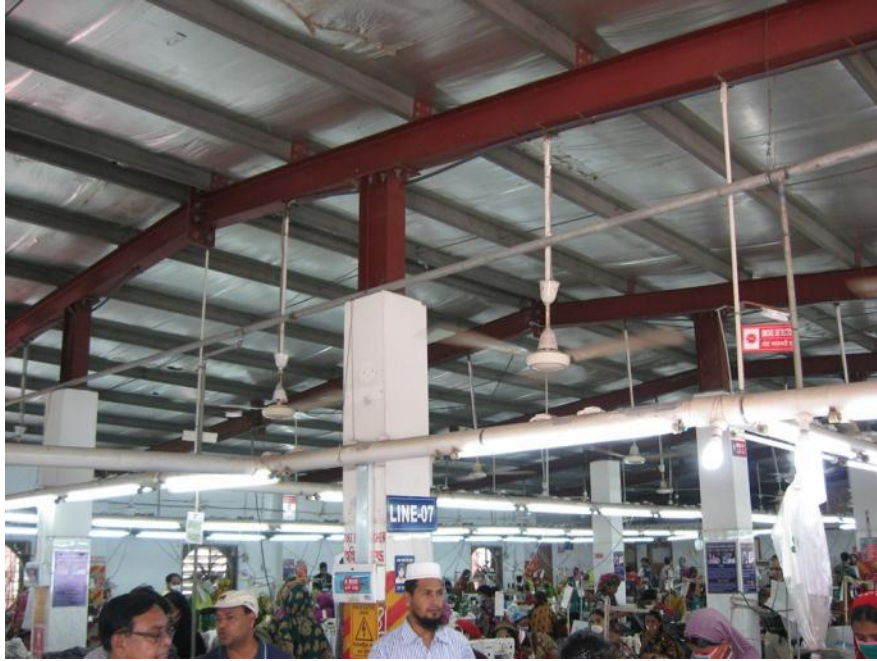
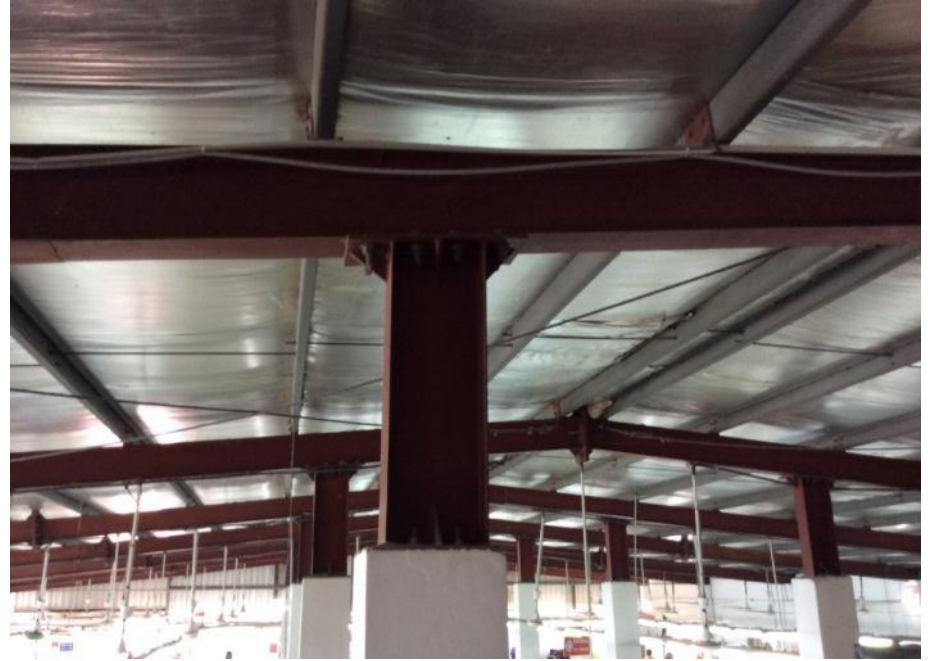
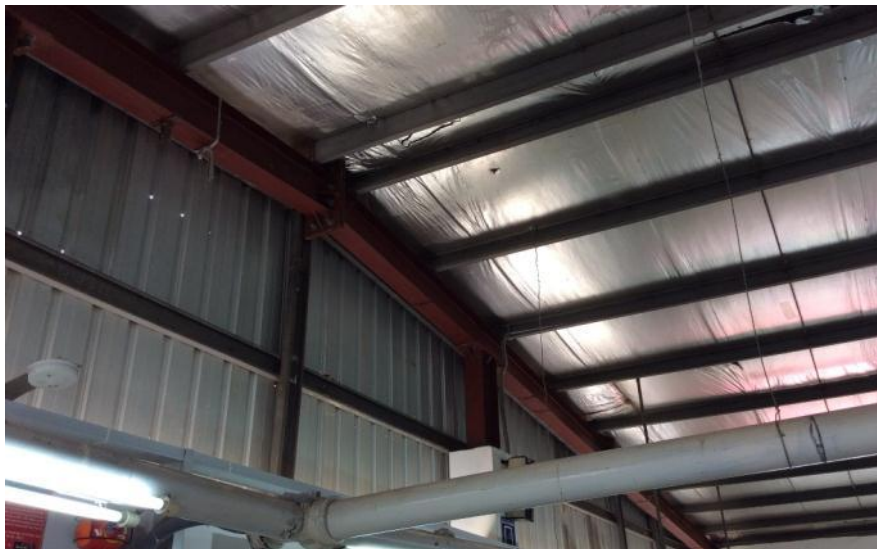
## 1<sup>st</sup> Priority 3 Concern

There are no fire proofing material applied for structural steel elements. It is unclear whether it is required by BNBC.

| Item No. | Observation | Recommended Action Plan | Recommended Timeline |
|---|---|---|---|
| 12 | No fireproofing material applied for steel structural elements (if required). | Fireproofing material for structural steel element is recommended as suggested in BNBC Codes.<br>Maintain standard of quality control. | 6-months |
