# Ibrahim Knit Garments (Pvt) (9688)

Alipara, Pathantoli, Siddhirgonj, Narayangonj

23.APRIL.2014

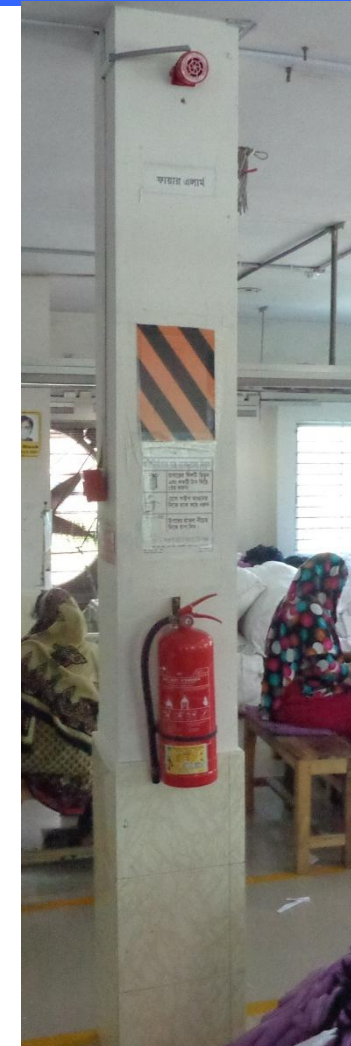
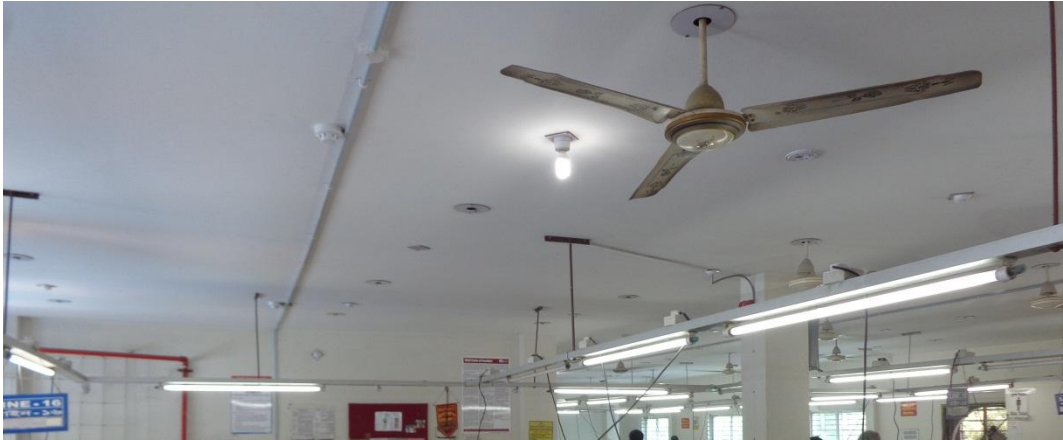
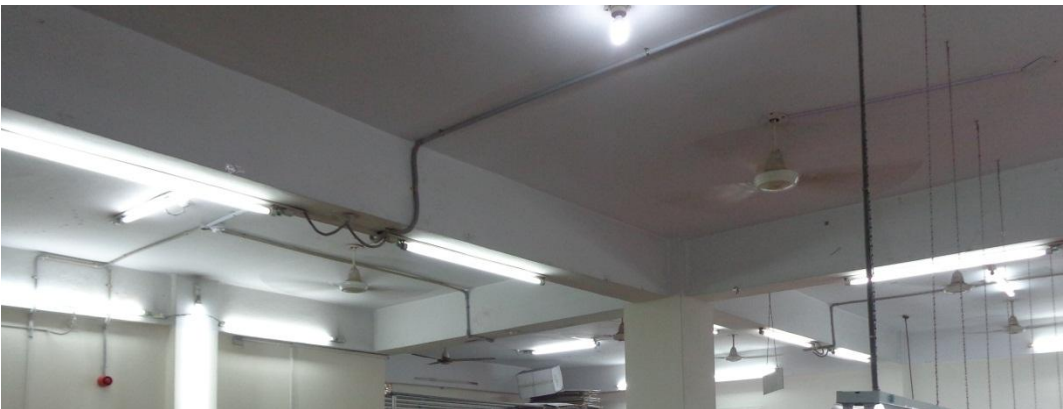
## High Column Stresses

Based upon observed column sizes, reinforcement and slab loadings, column safety factors are lower than desirable in the 6 Storey building and the northern-most of the two 5 Storey Buildings (See column schedule above).

**ITEM 1: (Priority 2) Column load run-downs indicate high column stresses within the 6 Storey building as well as the Northern-most of the two 5 Storey buildings.**

- Factory Engineer to review design, loads and column stresses in the areas identified above.

- Complete implementation of any works deemed necessary by the Engineering review.

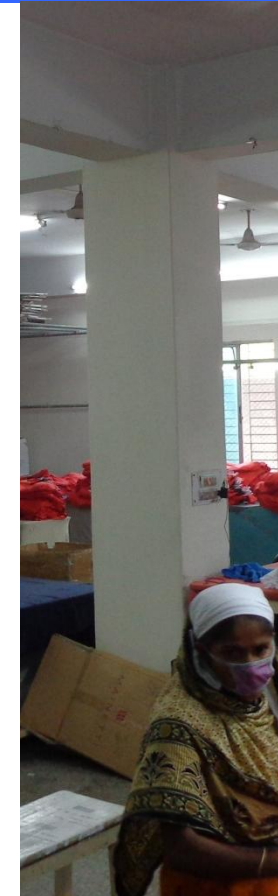
## Drawing vs. Construction Discrepancy

Structural drawings show beam/slab configurations that differ from those observed in all buildings, column sizes in the 6 Storey building differed from those shown on Structural details. Additionally, where beams were present, the beam sizes differed from the Structural drawings provided.

**ITEM 2: (Priority 2) There are discrepancies between the Structural drawings and the observed as-built construction. Notably, column sizes vary in the 6 Storey Building and the slab systems differ throughout all of the factory buildings.**

- Commence a Detailed Engineering Assessment to review the adequacy of as-built construction. Assessment to include formulation of as-built drawings and verification of reinforcing steel.
- The DEA is to include lateral stability checks for all factory buildings.

- Implement recommendations of the DEA.

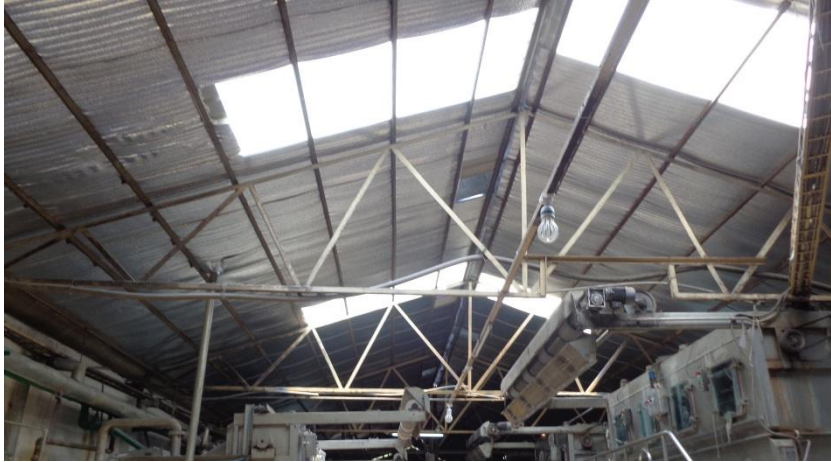
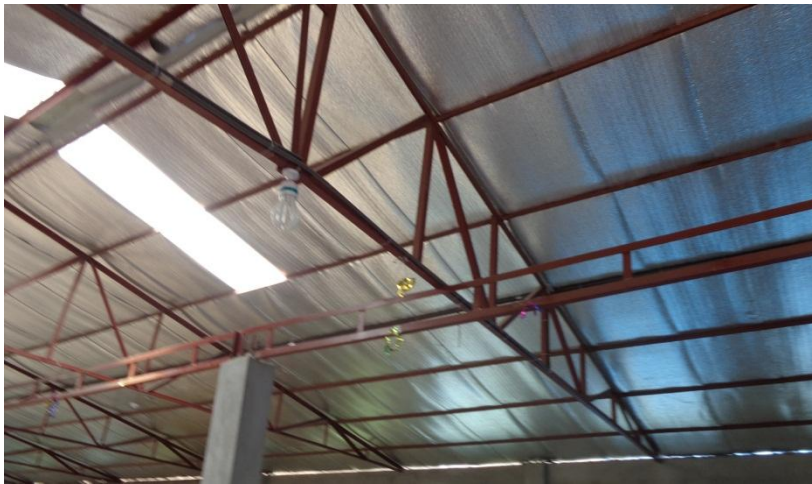
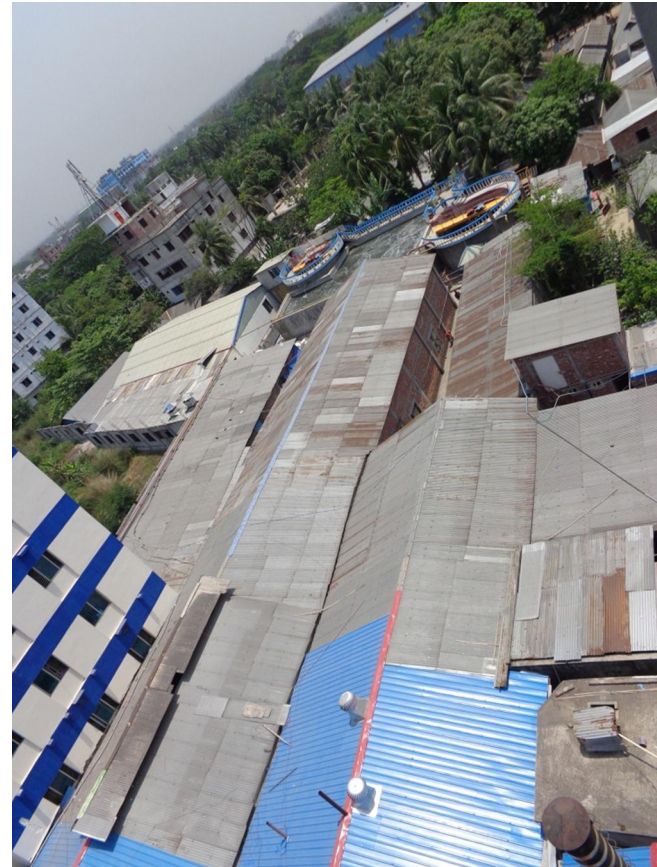
## Poorly Constructed Steel Shades

The steel sheds covered practically the entirety of the complex not already occupied by the R.C. buildings. Many of the sheds were observed to be very poorly constructed and of questionable structural integrity.

**ITEM 3: (Priority 2) The steel roof sheds covering a large portion of the factory complex grounds are poorly constructed of light steelwork framing.**

- Begin a Detailed Engineering Assessment which is to include an evaluation of the steel shed's framing.

- Complete implementation of any works deemed necessary by the DEA.

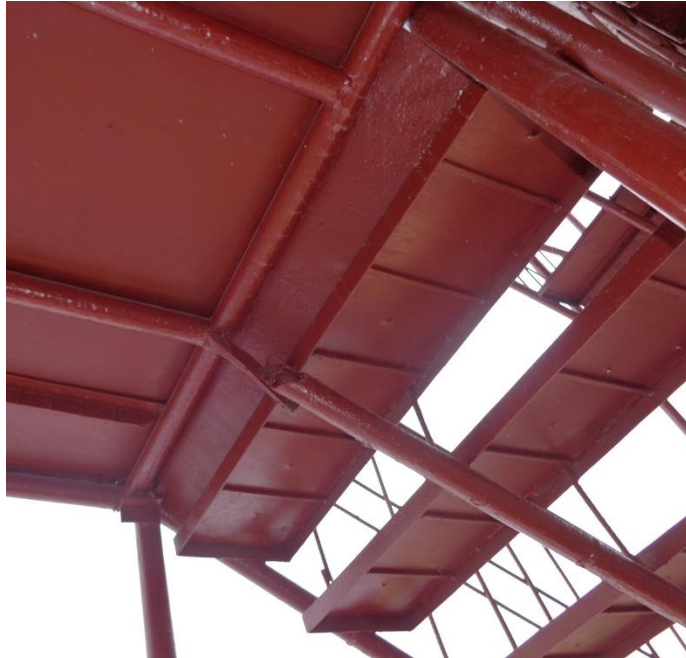
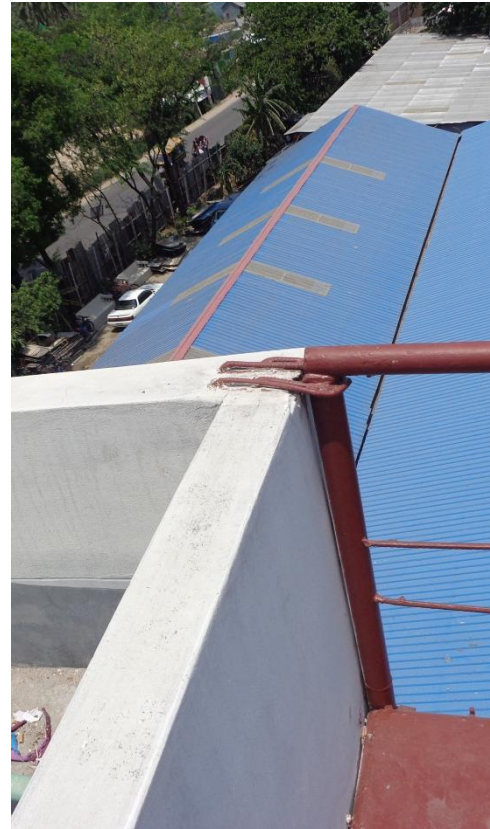
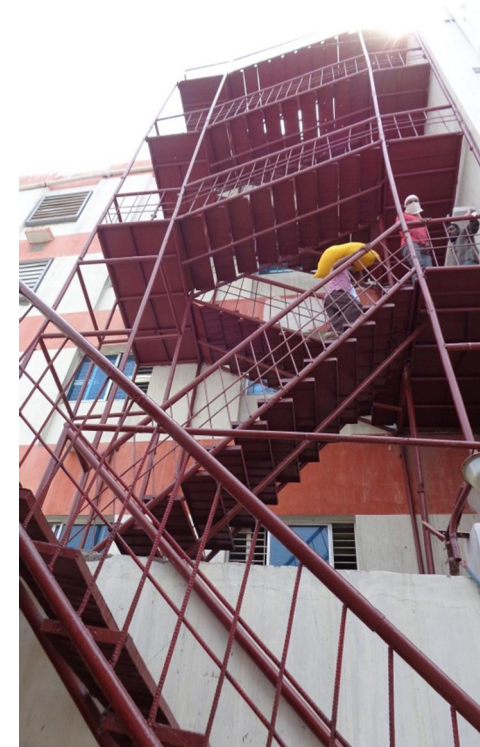
## Poorly Constructed Steel Fire Escape Stair

The steel fire escape stair at the side of the southern-most of the two 5 storey buildings was poorly constructed and it is doubtful that it would support loads imposed by a mass evacuation.

**ITEM 4: (Priority 2) The steel fire escape stair at the Southern-most of the two 5 Storey buildings is poorly constructed and of questionable structural integrity.**

- Begin a Detailed Engineering Assessment which is to include an evaluation of the steel fire escape stair at the side of the Southern-most of the two 5 Storey buildings.

- Complete implementation of any works deemed necessary by the DEA.

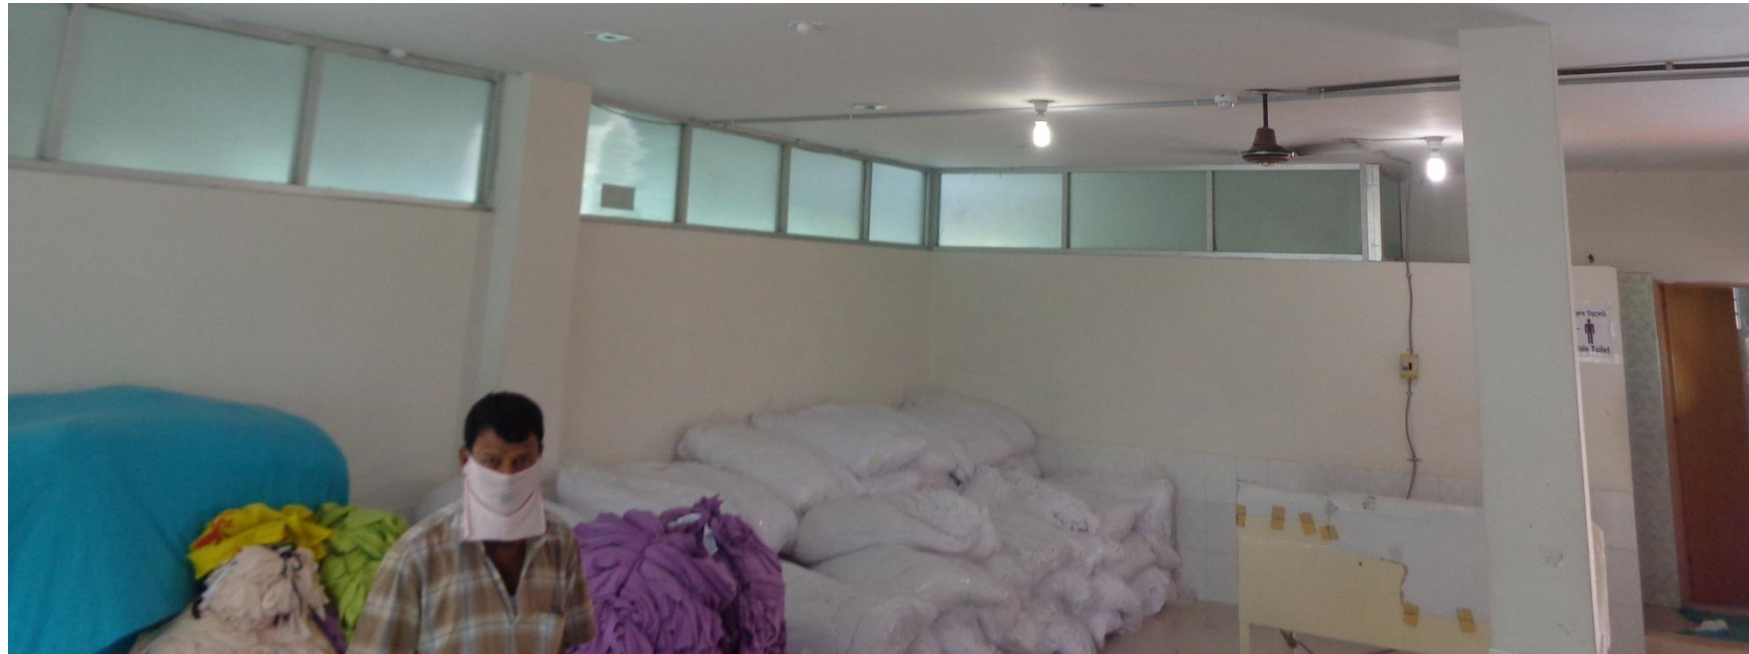
**No Loading Plan**

Very little storage was observed throughout the R.C. buildings. However, no slab loading plan was available nor were there any signs of ongoing slab load monitoring.

**ITEM 5: (Priority 3) There was no loading plan in effect, although little storage was observed within the factory buildings.**

- Begin a Detailed Engineering Assessment which shall include the development of a slab loading plan for all floor plates within the factory, taking into consideration slab, beam and column capacities.

- Implement and actively monitor the slab loading plan for all floor plates within the factory buildings.

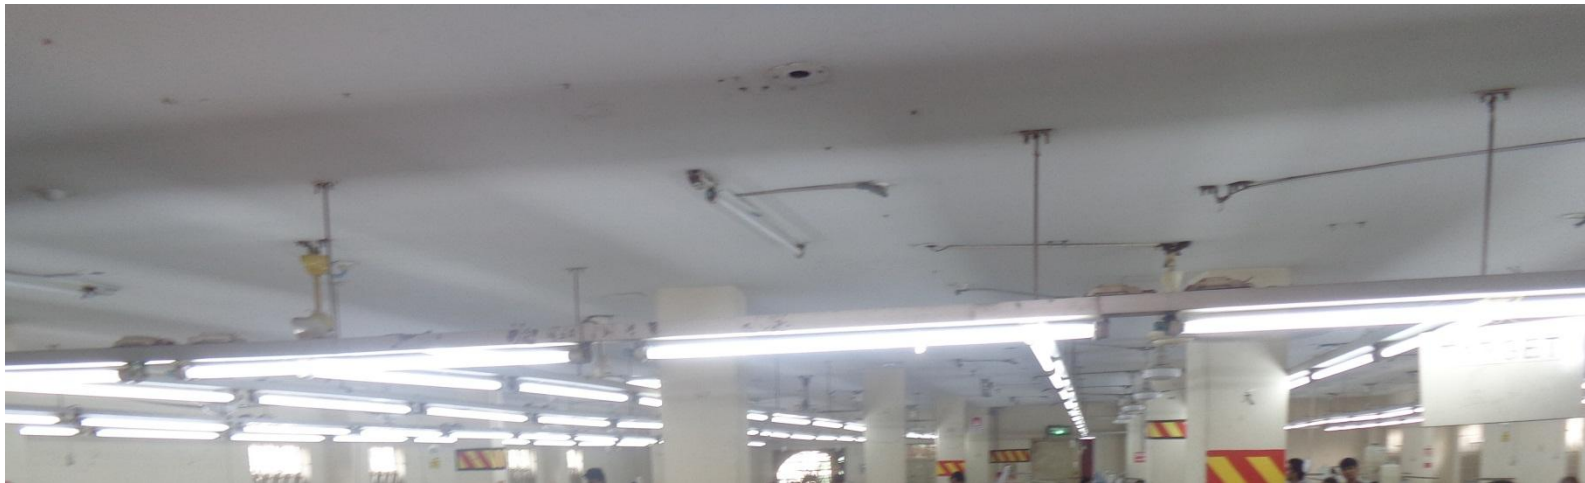
## Lateral Restraint System

All factory floors other than the 1<sup>st</sup> floor slab of the 6 Storey building were flat slab configurations. There was no apparent lateral restraint system other than brick infill walls.

We require that these items be investigated as part of a Detailed Engineering Assessment

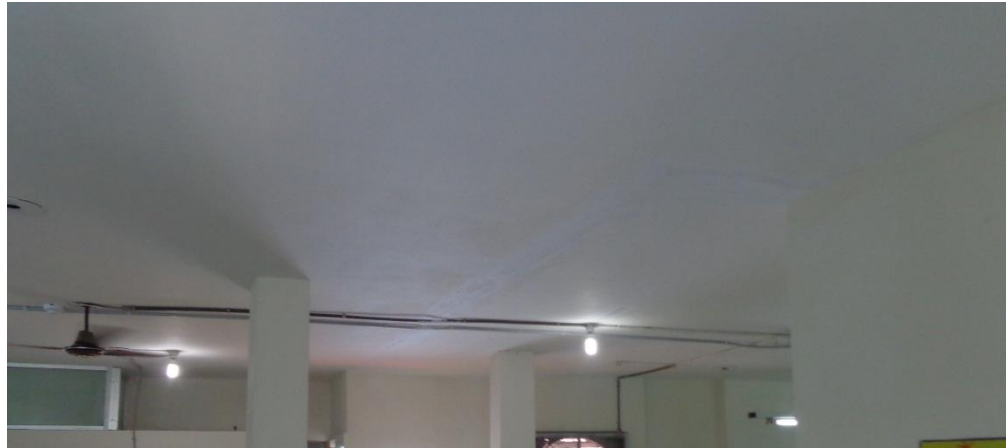
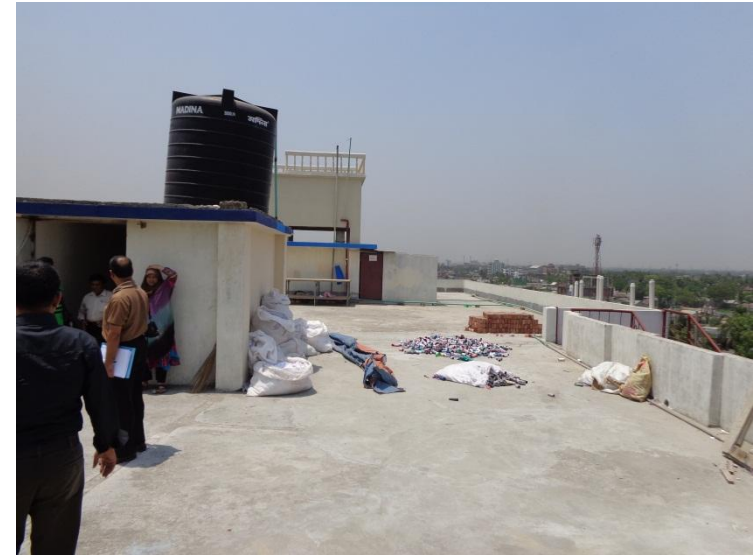
## Roof Waterproofing System

There was no real waterproofing present at the roof levels. However, no evidence of water infiltration was observed at the underside of the roof slabs.
