# Geebee Garments Industries Ltd. (11335)

DEPZ, Ganakbari, Savar  
(+ 23.951528N, 90.271568E)

26.MAY.2014

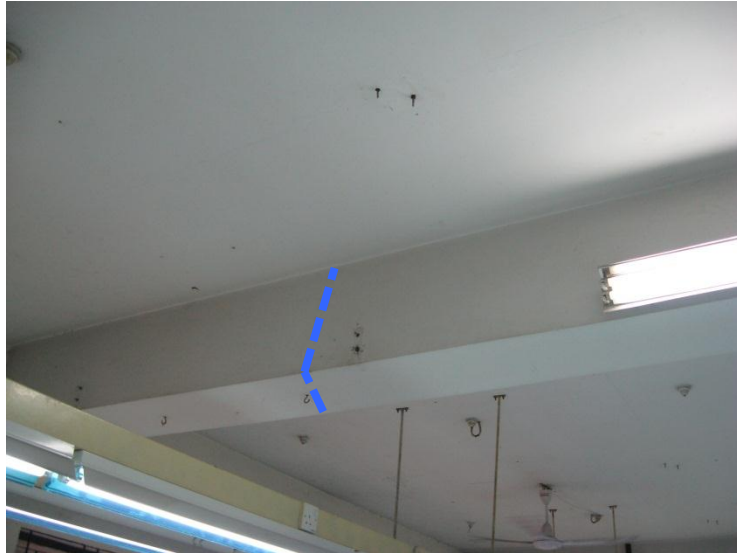
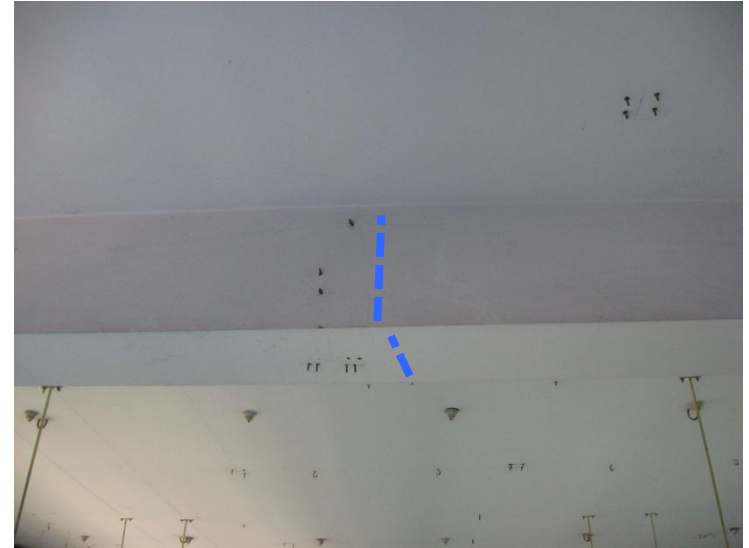
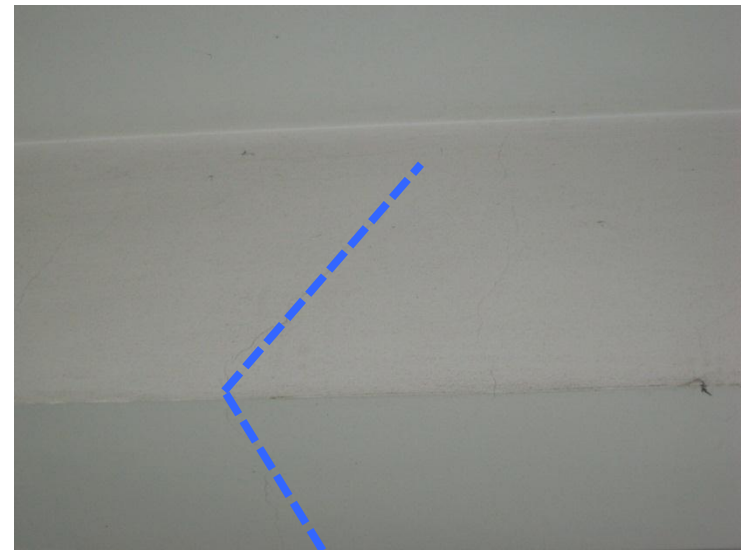
Cracks appeared underside beam on 1<sup>st</sup>, 2<sup>nd</sup> and 3<sup>rd</sup> floor. We require that these items be investigated in a Detail Engineering Assessment.

| Item No. | Observation | Recommended Action Plan | Recommended Timeline |
|---|---|---|---|
| 1 | Cracks appeared underside beam on 1st, 2nd and 3rd floor. | The Factory Engineer to investigate the cause of cracks by appropriate methods.<br>The distress found is to be suitably rectified and then repaired. | 6-weeks |
| 2 | Cracks appeared underside beam on 1st, 2nd and 3rd floor. | Create loading plans for each floor level.<br>Maintain standards of quality control to ensure that loading plan is correctly followed so that problems do not arise in the future.<br>Maintain and enforce the loading plans. | 6-months |

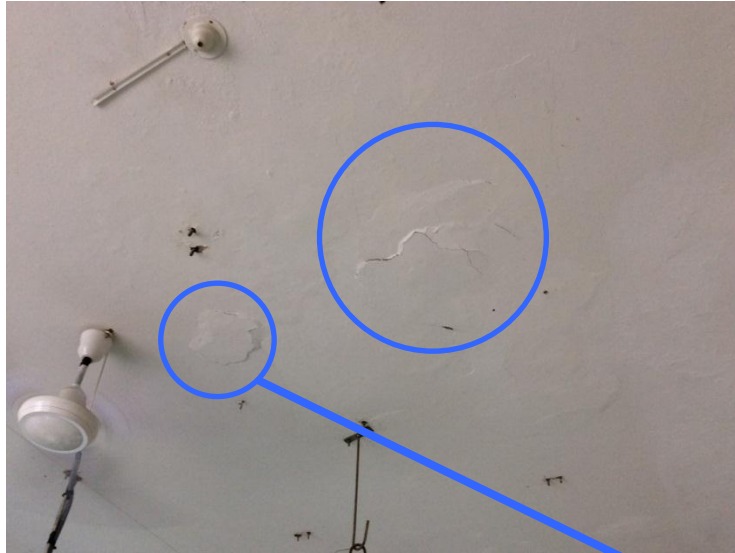
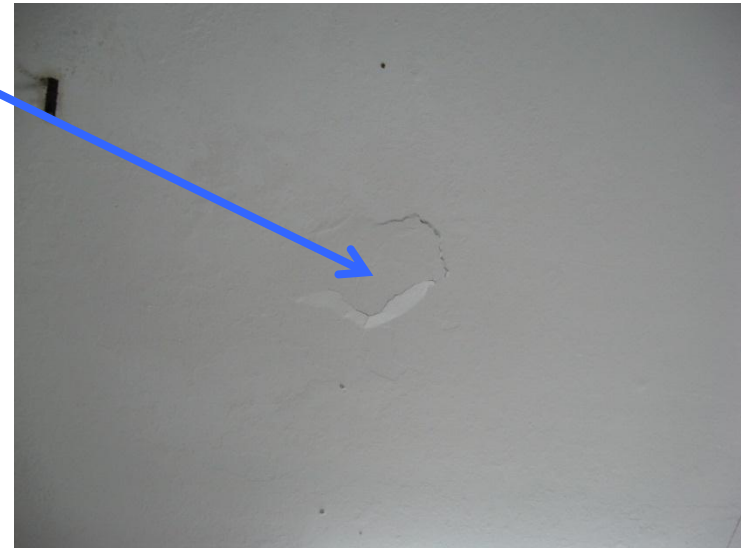
There are spalling of concrete and/or plaster found underside slab on 3<sup>rd</sup> floor slab. We require that these items be investigated in a Detail Engineering Assessment.

| Item No. | Observation | Recommended Action Plan | Recommended Timeline |
|---|---|---|---|
| 3 | Spalling of concrete and/or plaster appeared underside slab on 3rd floor. | The Factory Engineer to investigate the cause of spalling by appropriate methods.<br>The distress found is to be suitably rectified and then repaired. | 6-weeks |

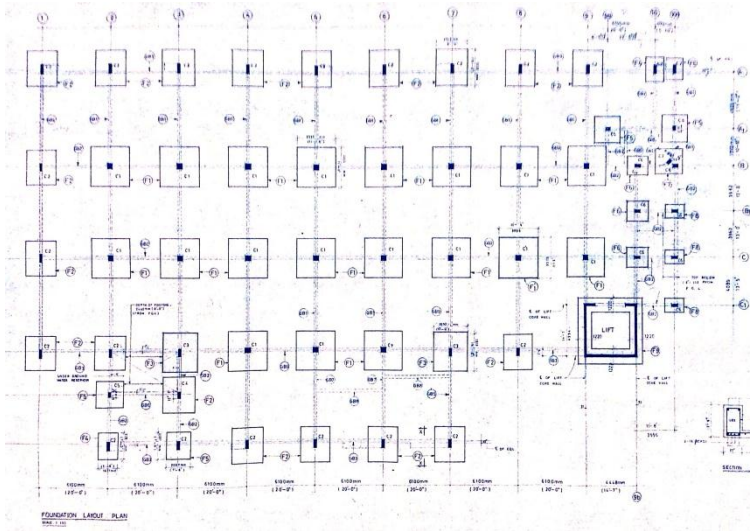
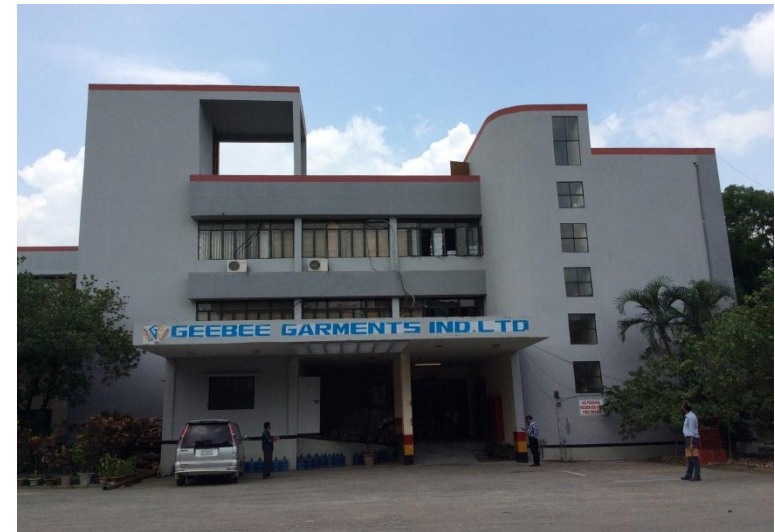
Concerns on the stability system for lateral loading. This building may be twisted under lateral loading due to unbalanced position of shear wall.

We require that these items be investigated in a Detail Engineering Assessment.

| Item No. | Observation | Recommended Action Plan | Recommended Timeline |
|---|---|---|---|
| 4 | Overall stability system. | Request that the Detail Engineering Assessment of the overall building to be carried out and in particular, stability and foundation aspects should be investigated in detail. | 6-weeks |

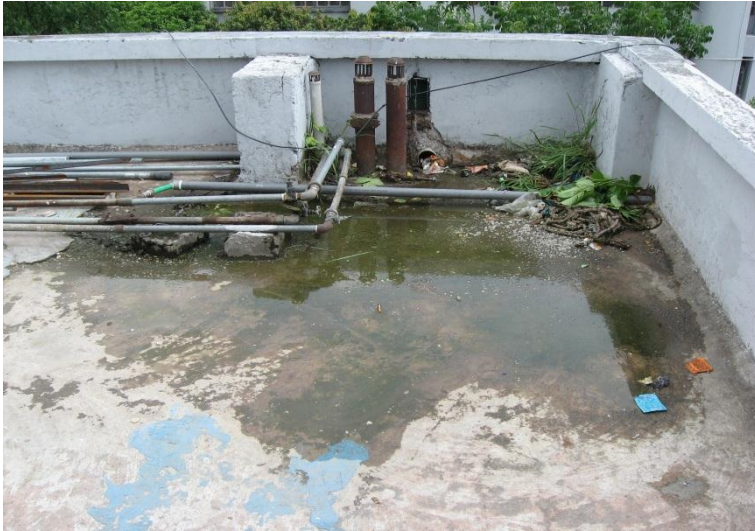
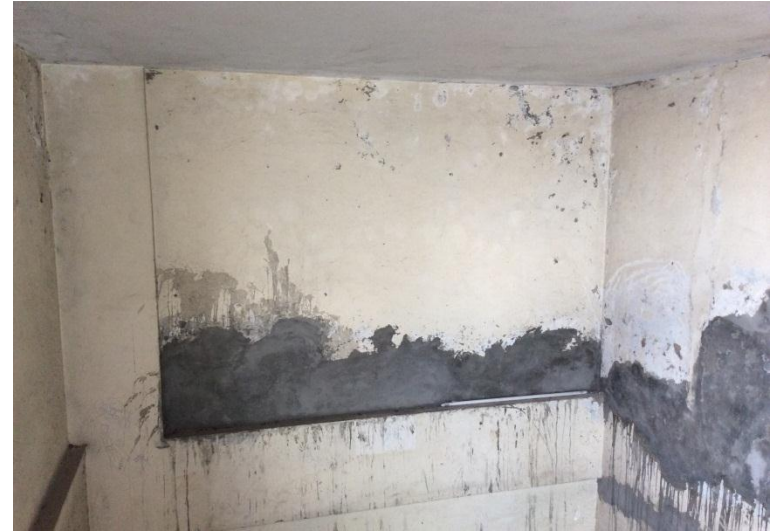
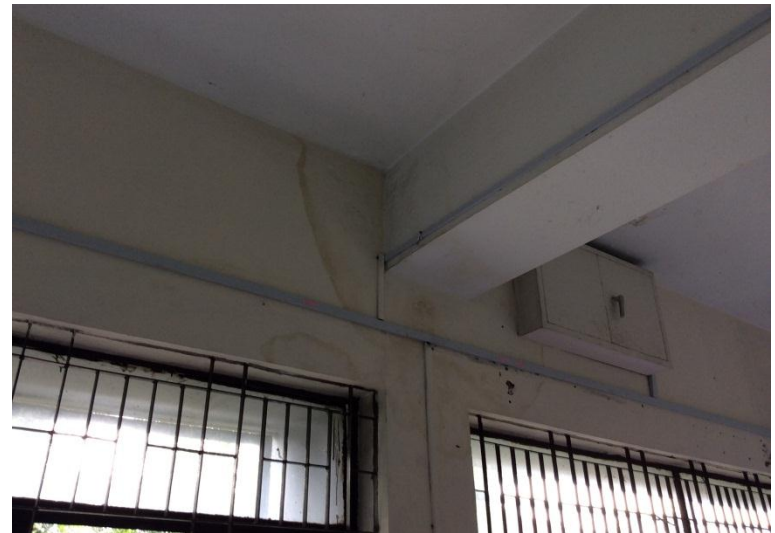
There are water ponding on the roof slab and distress due to water ingress noted on slabs, beams, columns and walls.

| Item No. | Observation | Recommended Action Plan | Recommended Timeline |
|---|---|---|---|
| 5 | Distress due to water ingress. | Factory Engineer to inspect water damaged structures and repair with a suitable method.<br>Waterproofing on the roof slab is recommended. Moreover the slab drainage system should be investigated.<br>Maintain standard of quality control. | 6-months |
