# Faiza Industries Ltd.

R.S - 425, Baimail, Konabari, P.O.- Kashem Cotton Mill, Thana- Joydebpur,, Gazipur 1346  
(24.006652, 90.337365)

15<sup>th</sup> June 2017

# Observations

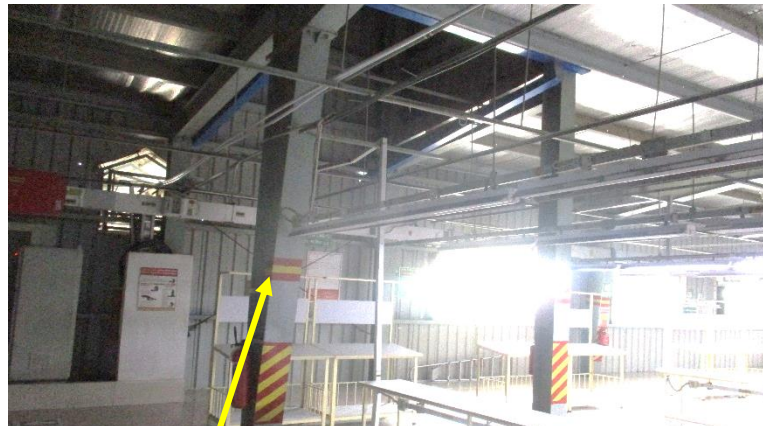
Misplaced Column

Column, main beam & sub-beam sizes were not fully matched with provided drawings. Building engineer is required to survey the as built condition and produce as built drawings.

| Item No. | Observation | Recommended Action Plan | Recommended Timeline |
|---|---|---|---|
| 1 | (Production Shed)<br>Discrepancies between drawings and on site condition | Engage an Engineer to produce an “as constructed” drawings which reflect the actual site dimensions with complete structural information. | 6-weeks |

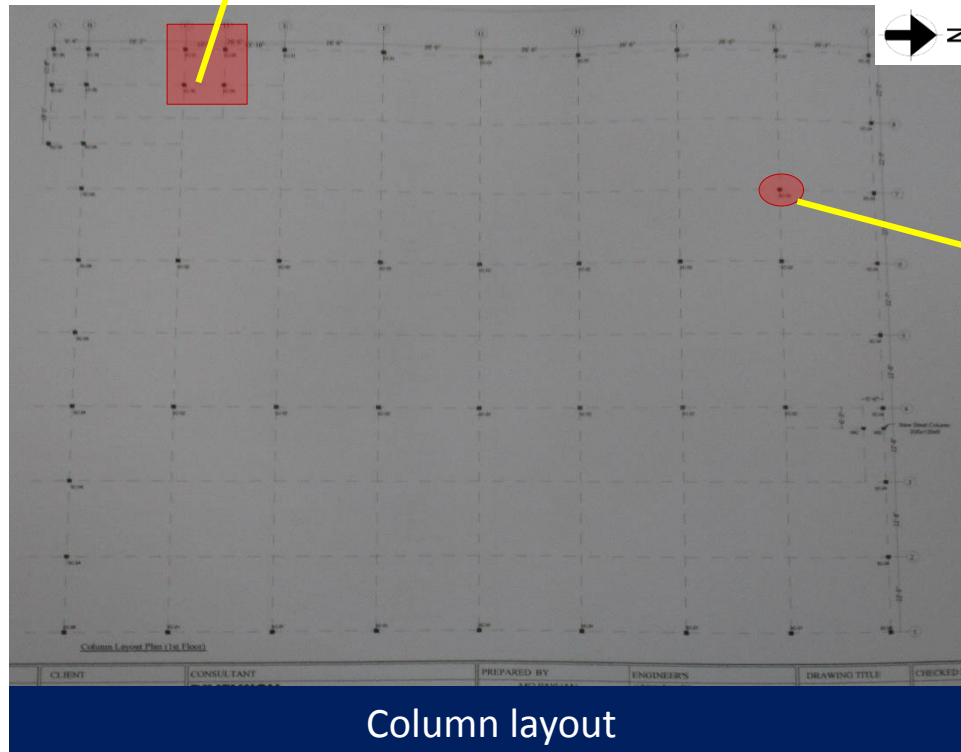
Column layout

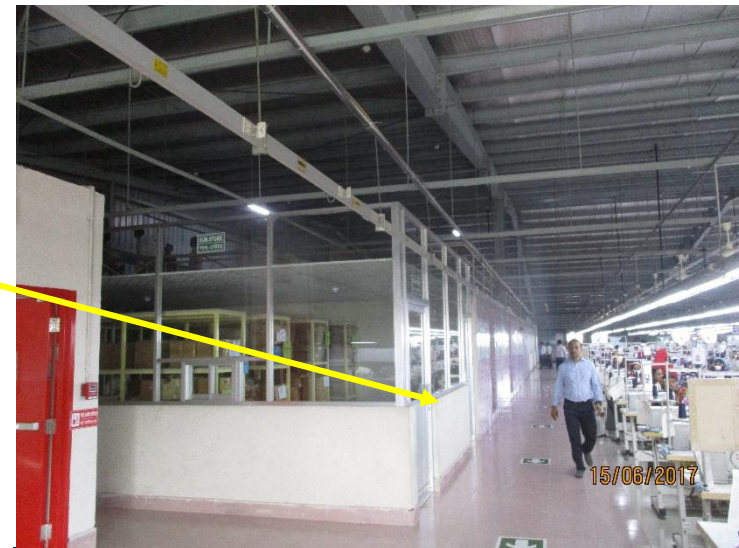
Missing Column

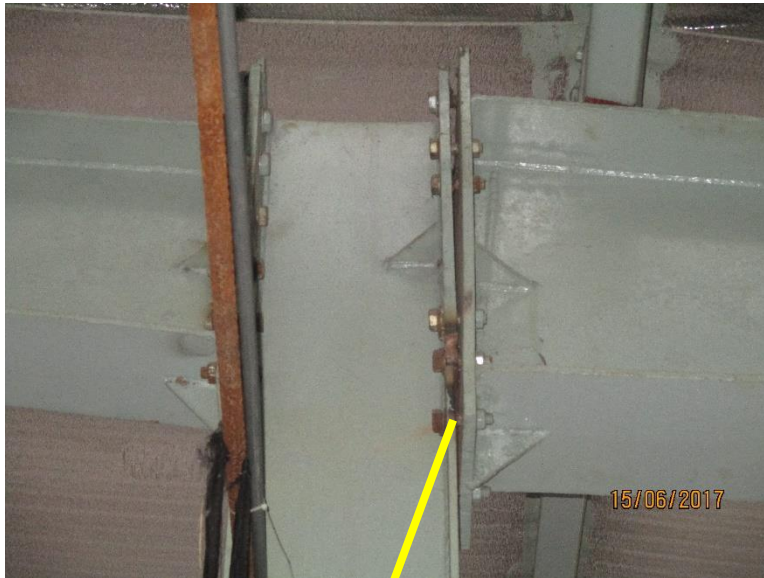
Tear on column-rafter joint

| Item No. | Observation | Recommended Action Plan | Recommended Timeline |
|---|---|---|---|
| 2 | (Production Shed)<br>Improper connection | Qualified Structural Engineer to investigate the connection of steel joint and suggest necessary remediation. | 6-weeks |
| 3 | (Production Shed)<br>Improper connection | Remedial works to be carried out. | 6-months |

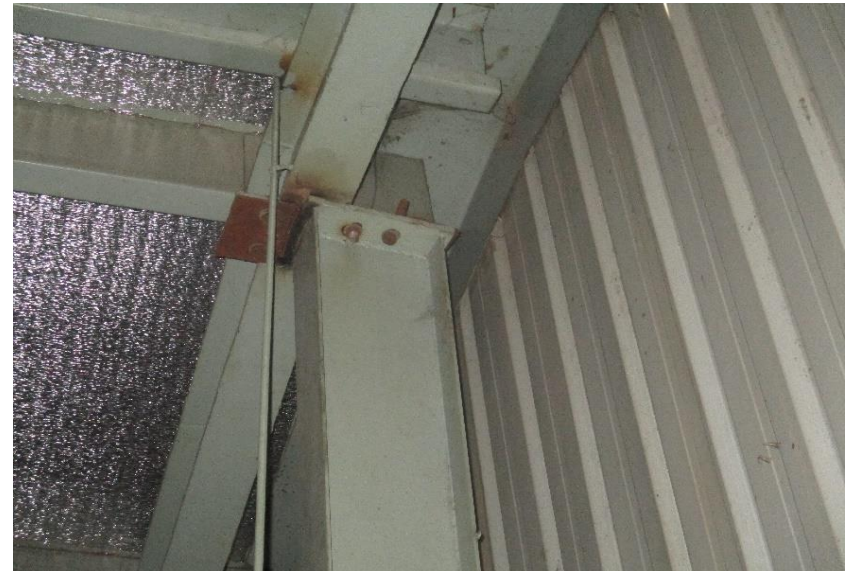
Additional steel plate added to support rafter

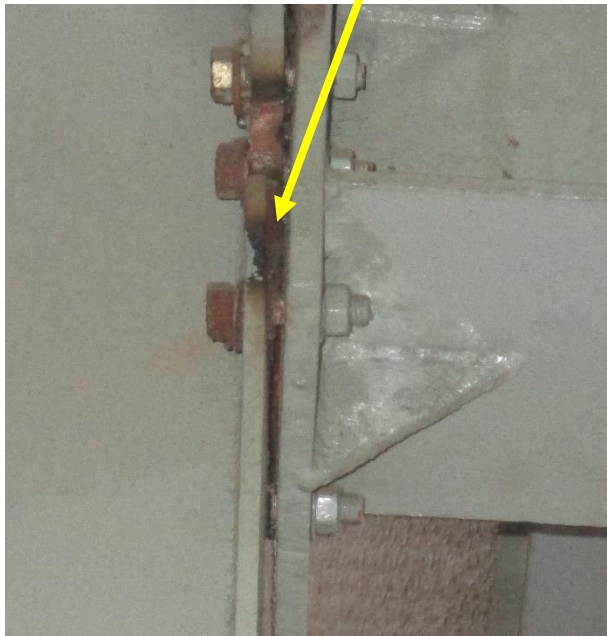
Rafter is not connected properly with column at North side of the production shed.

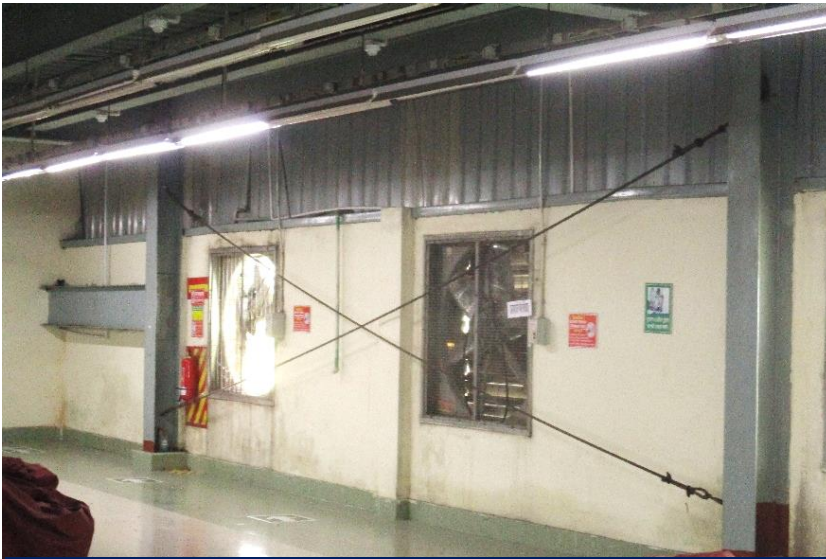
Loose wall bracing

Loose bracing were observed during inspection. Cable bracings were not properly connected with column.

| Item No. | Observation | Recommended Action Plan | Recommended Timeline |
|---|---|---|---|
| 4 | (Production Shed)<br>Loose and poor connection of bracing. | Upgrade the connection of bracings. | 6-weeks |
| 5 | (Production Shed)<br>Loose and poor connection of bracing. | Tighten loose bracings. | 6-weeks |

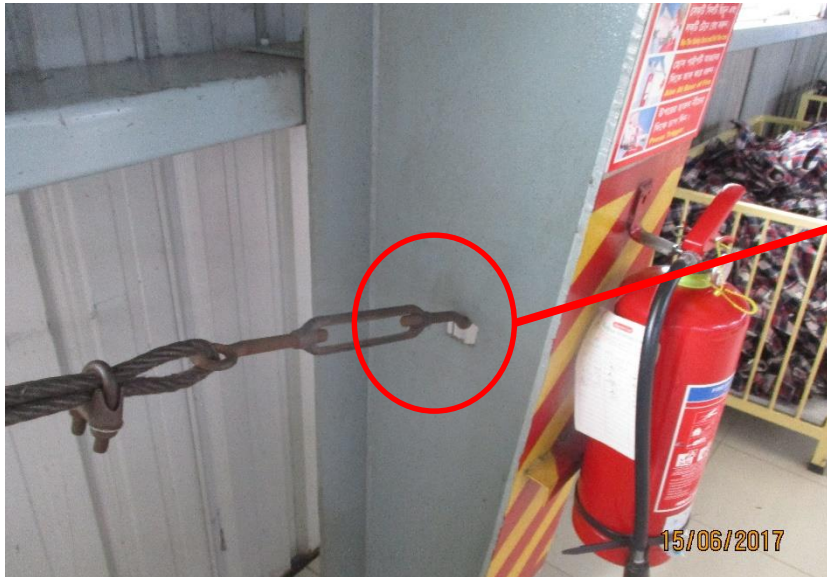
Poor bracing connection

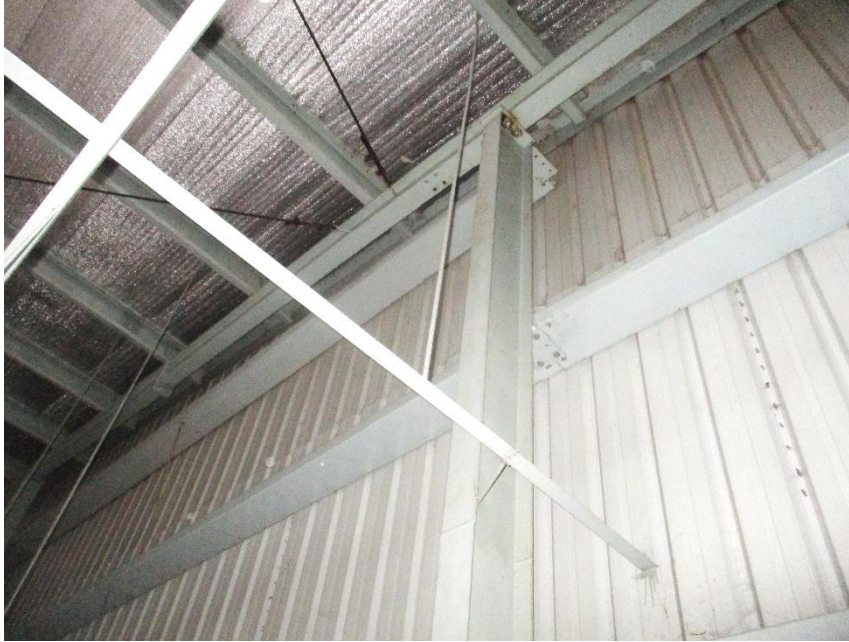
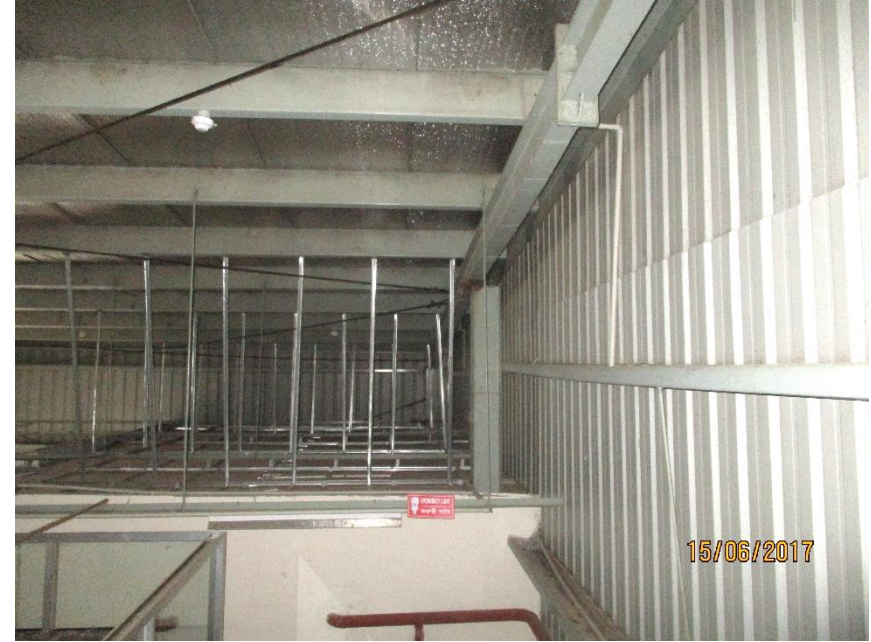
Lateral load transferring system (compression strut) was not observed on roof. Factory engineer to check the lateral stability system of the building against lateral loading.

| Item No. | Observation | Recommended Action Plan | Recommended Timeline |
|---|---|---|---|
| 6 | (Production Shed)<br>Lack of lateral load resisting system | Building engineer to check the lateral stability of the building against lateral loading. | 6-weeks |
| 7 | (Production Shed)<br>Lack of lateral load resisting system | Implement the recommendation of engineering assessment. | 6-months |

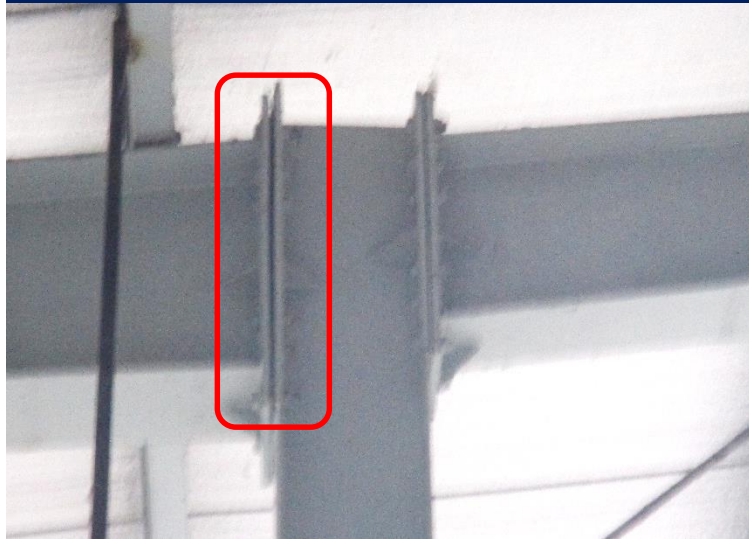
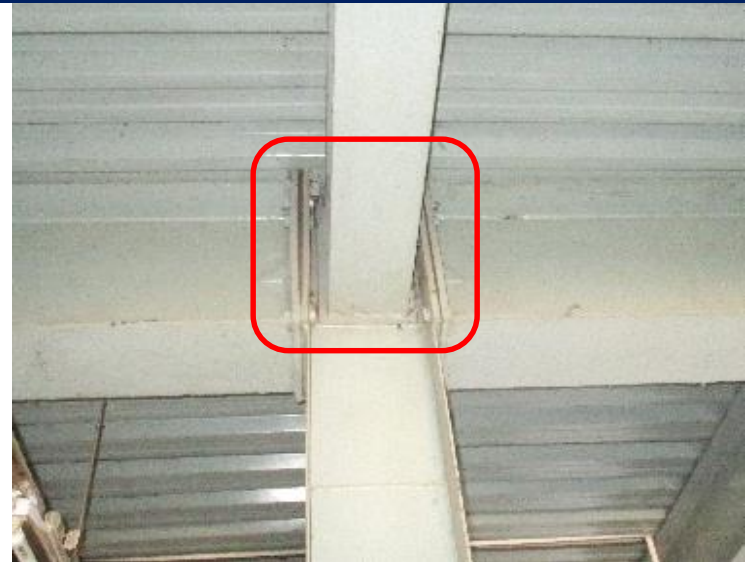
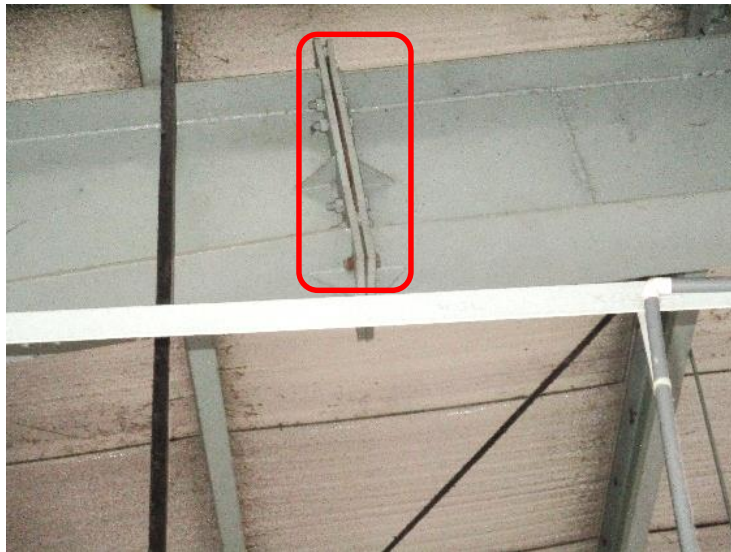
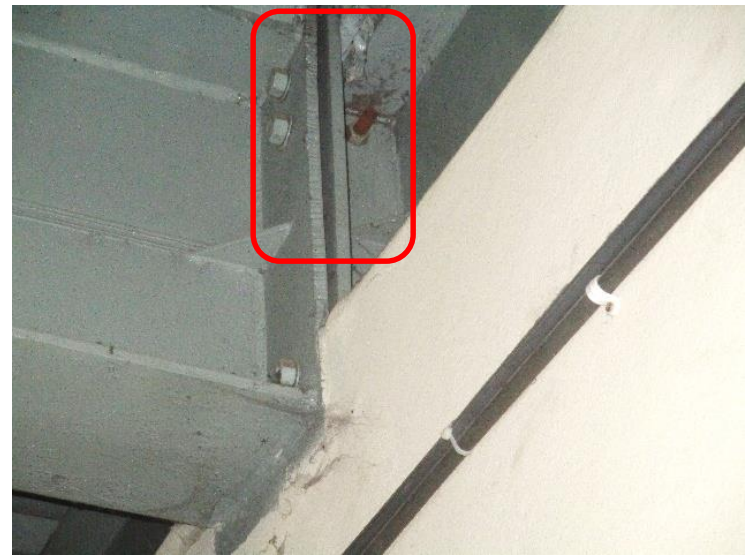
Existence of significant gap in several connection.

| Item No. | Observation | Recommended Action Plan | Recommended Timeline |
|---|---|---|---|
| 8 | (Production Shed)<br>Gap between beam-column joint | Engage an Engineer to check that the connections are adequate. | 6-weeks |
| 9 | (Production Shed)<br>Gap between beam-column joint | Carry out suitable repair works where necessary. | 6-months |

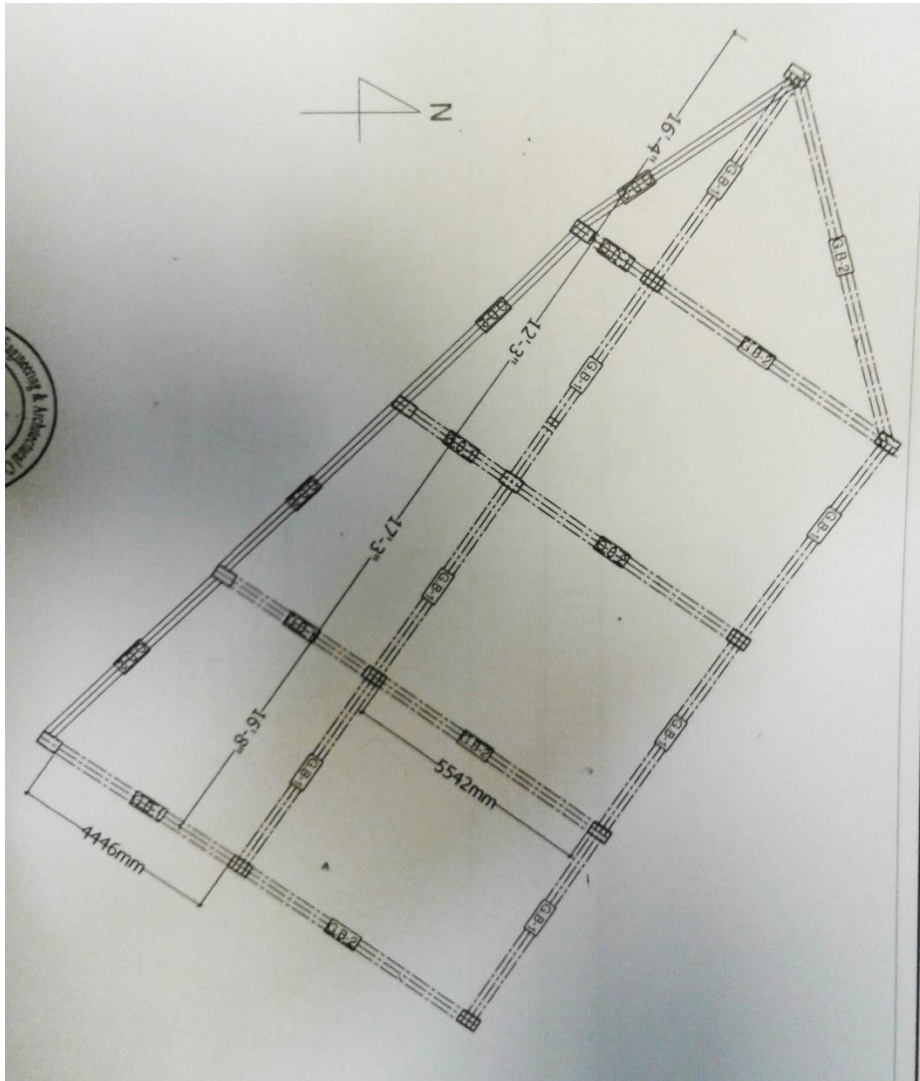
Layout plan

Grid dimension didn't fully match with provided drawing of Generator shed.

| Item No. | Observation | Recommended Action Plan | Recommended Timeline |
|---|---|---|---|
| 10 | (Utility-1)<br>Mismatch in drawings | Building Engineer to update as-built drawing according to actual condition. | 6-weeks |
