# MAS Intimates Bangladesh (Pvt.) Ltd.(Unit-03)

Plot 12-14, Sector 01, Karnaphuli EPZ, North Patenga, Chittagong

Date: 19 June 2017

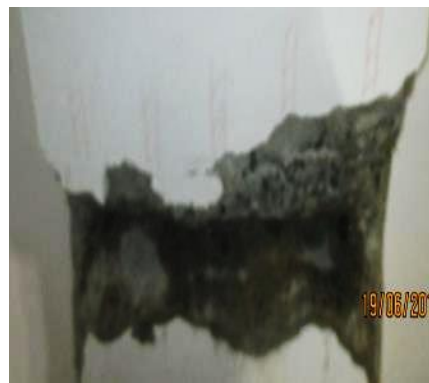
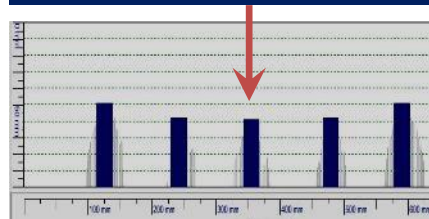
C-1: Edge Column

Number of re-bar in C-1 & C-2 columns have been found less than the number mentioned in column schedule above 2nd floor.

Mismatch found in column schedule & scan report

| Item No. | Observation | Recommended Action Plan | Recommended Timeline |
|---|---|---|---|
| 1 | Discrepancies in as-built drawings | Factory engineer is to check, collect information and produce accurate and complete as-built drawings. | 6-weeks |

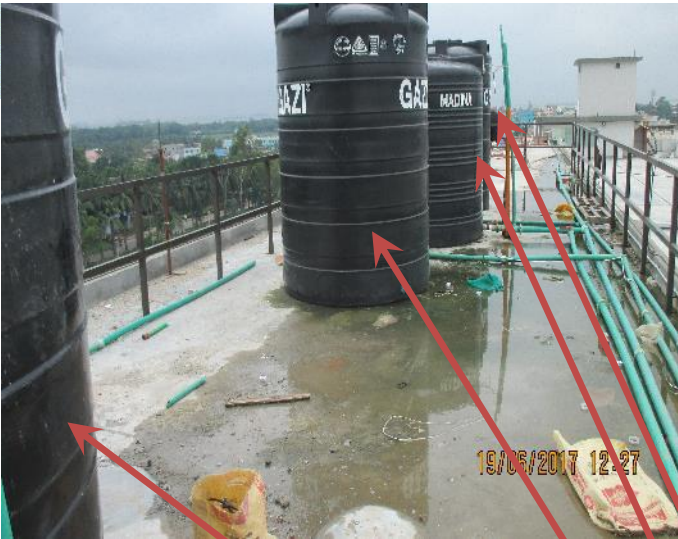
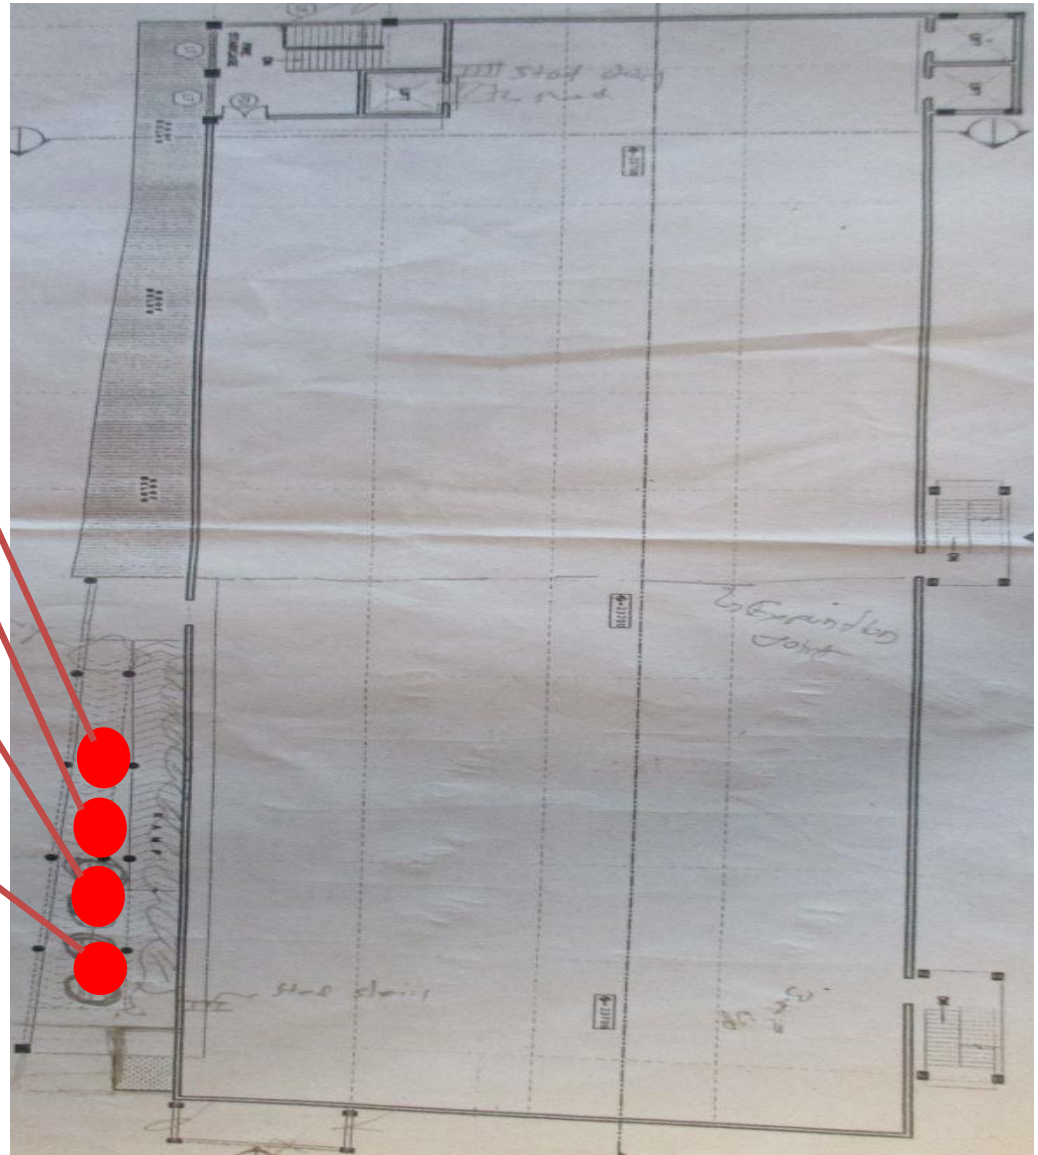
4 Number plastic water tanks on the roof top of Ramp of capacity 5000L which are not mentioned on roof top plan.

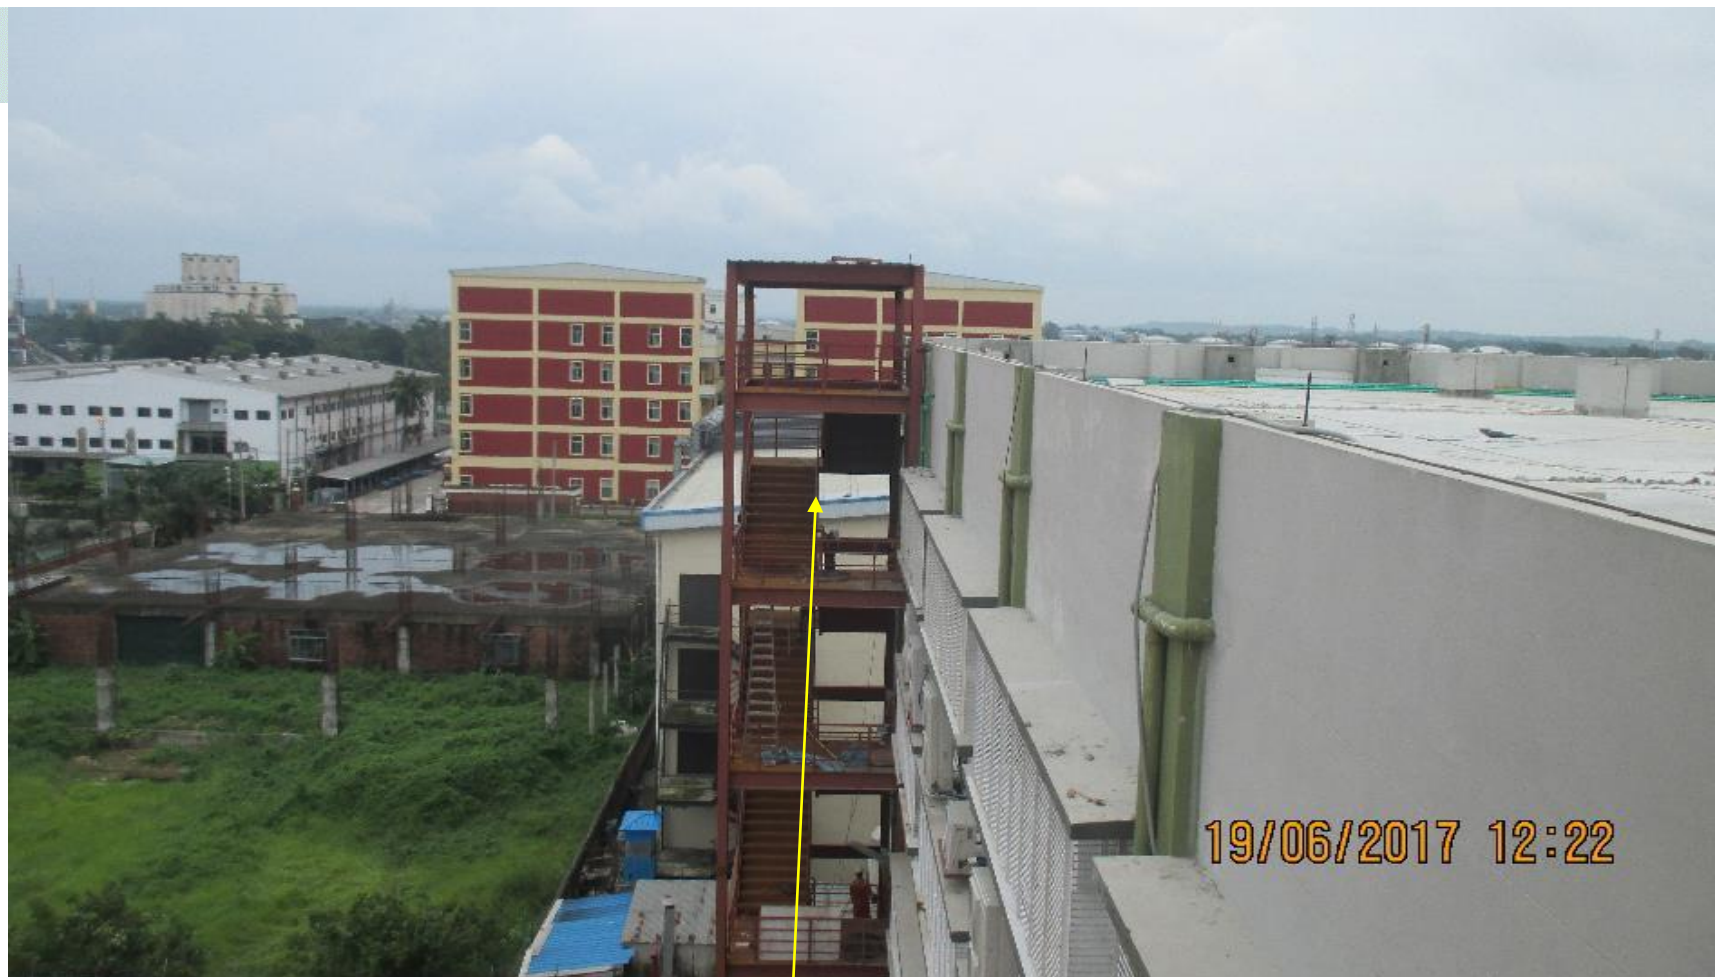
**No as built document was found for the existing steel stair in the north side of the building. Factory is required to investigate the adequacy of the steel stair.**

| Item No. | Observation | Recommended Action Plan | Recommended Timeline |
|---|---|---|---|
| 2 | Undocumented steel stair on the north side of the building | Update architectural drawing as per as built condition. | 6-weeks |
| 3 | Undocumented steel stair on the north side of the building | Factory engineer is to check the adequacy of the steel stair. | 6-weeks |
