# CA Knitwear Ltd. (Relocation)

Vill: Bhabanipur, P.O: Mahna Bhabanipur, Gazipur Sadar, Gazipur  
(24.147535, 90.422713)

20<sup>th</sup> June 2017

# Observations

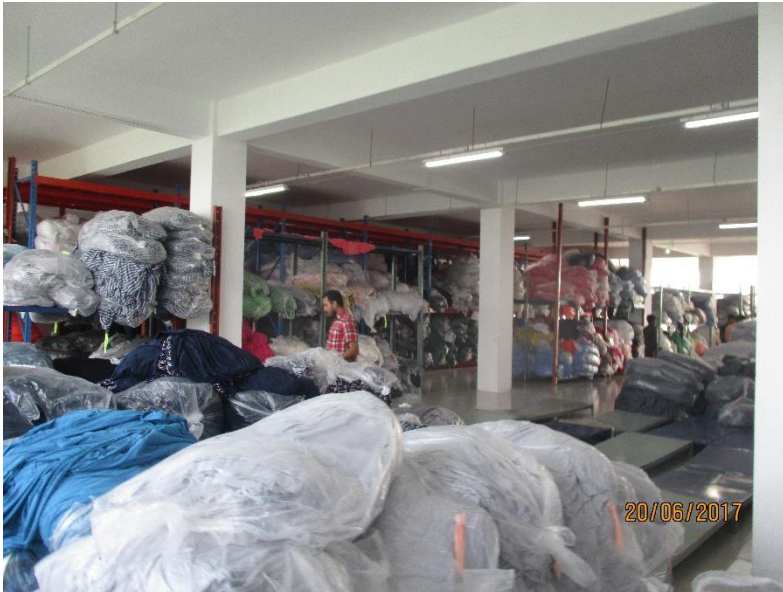
Main factory building (2<sup>nd</sup> Floor)

No load management programs were visible except post of load plan. Factory is required to implement load management program as per its floor loading capacity and Follow the load plans for all floors of the buildings and make sure that the workers understand the loading requirements.

| Item No. | Observation | Recommended Action Plan | Recommended Timeline |
|---|---|---|---|
| 1 | (Main Factory Building)<br>Implement floor load management program | Factory is required to implement load management program as per its floor loading capacity. | 6-weeks |
| 2 | (Main Factory Building)<br>Implement floor load management program | Follow the load plans for all floors of the buildings and make sure that the workers understand the loading requirements. | 6-months |

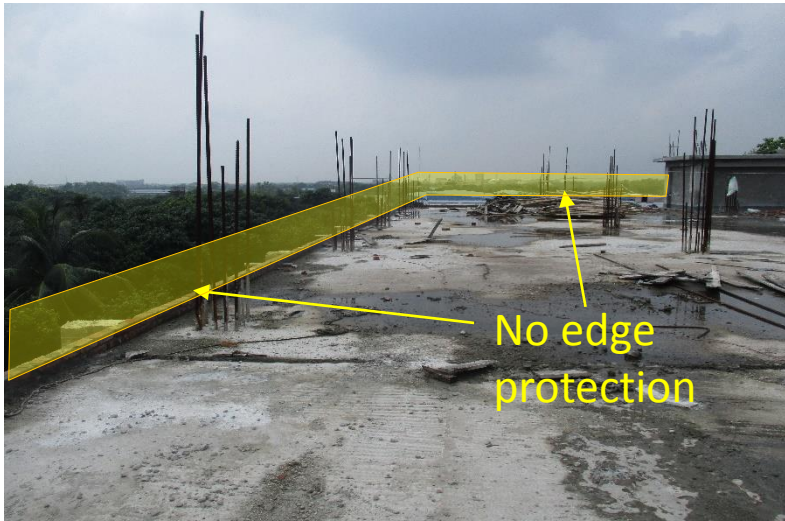
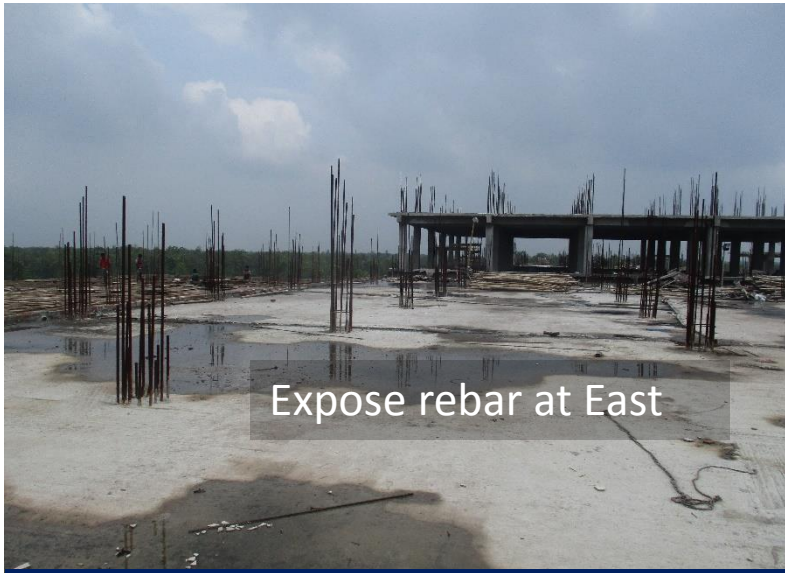
Falling hazards due to unprotected edge of under construction building. All exposed reinforcement must have adequate protection from the corrosion. Currently the exposed reinforcement is prone to corrosion.

| Item No. | Observation | Recommended Action Plan | Recommended Timeline |
|---|---|---|---|
| 3 | (Main Factory & Utility Building)<br>Falling hazards on the roof and protect reinforcement from corrosion. | Secure constructed area around the perimeter wall to exclude any possible falling hazard. | Immediate - Now |
| 4 | (Main Factory & Utility Building)<br>Falling hazards on the roof and protect reinforcement from corrosion. | All exposed reinforcement is to be protected from corrosion which may cause degradation of the concrete. | 6-weeks |

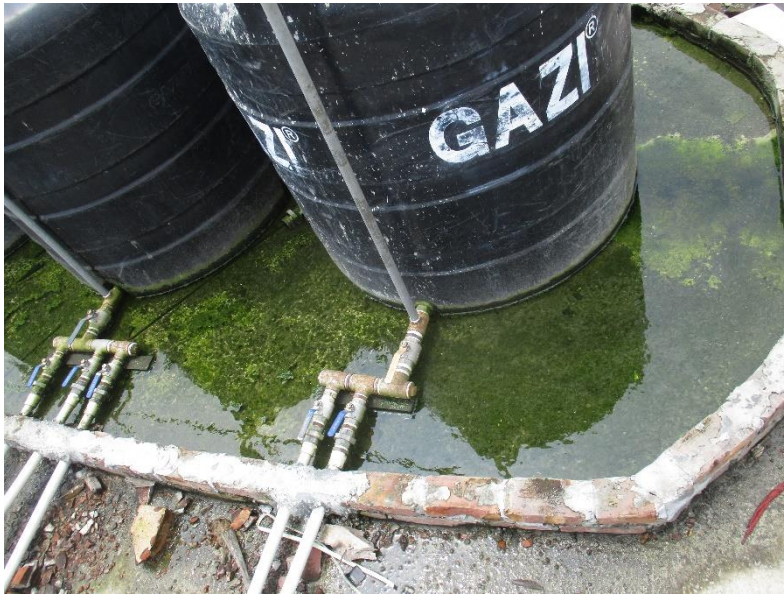
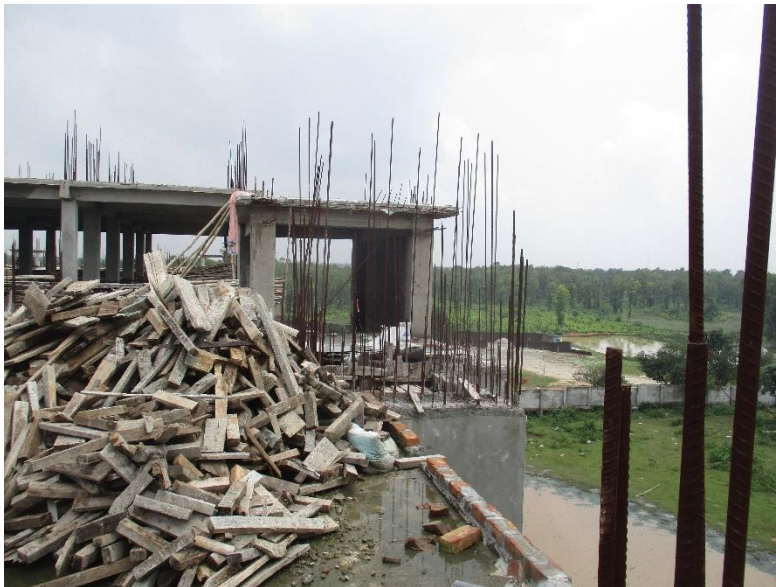
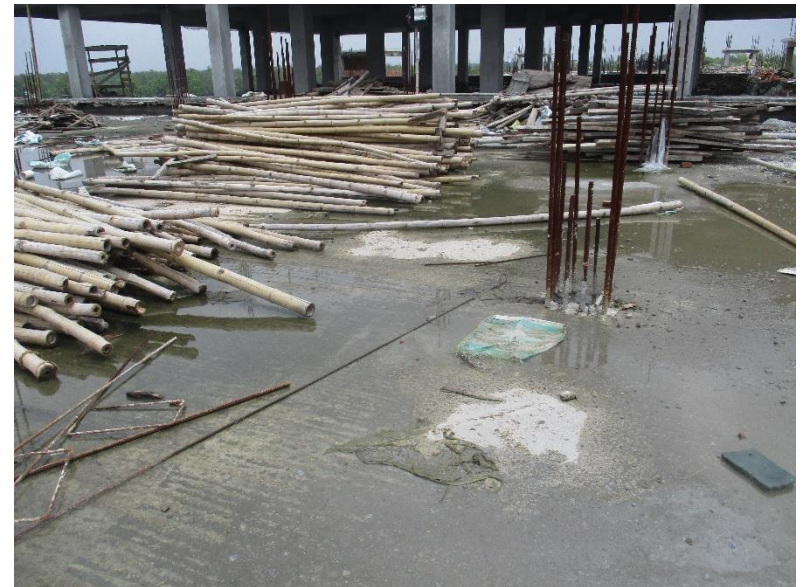
Water ponding found at current roof of the factory building. Also stacking of construction materials were found at roof.

| Item No. | Observation | Recommended Action Plan | Recommended Timeline |
|---|---|---|---|
| 5 | (Main Factory Building)<br>Water ponding and stacking of construction material on roof | For both durability and serviceability, waterproofing on the roof slab is recommended. Moreover the roof slab drainage system should be investigated. | 6-weeks |
| 6 | (Main Factory Building)<br>Water ponding and stacking of construction material on roof | Remove construction materials from roof top. | 6-weeks |

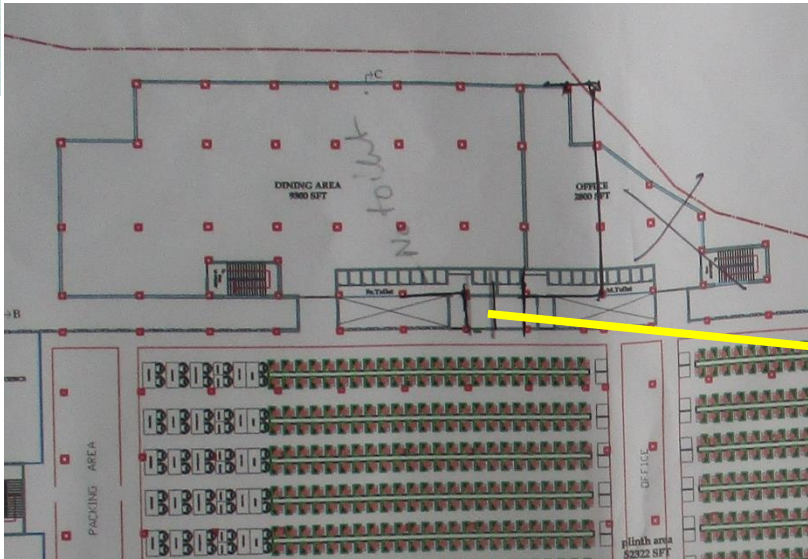
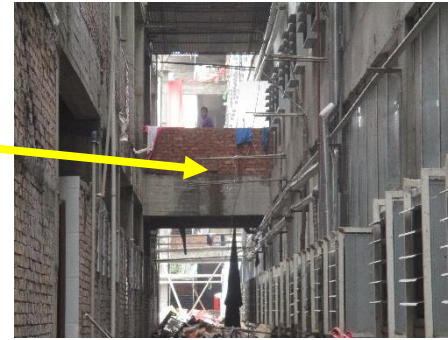
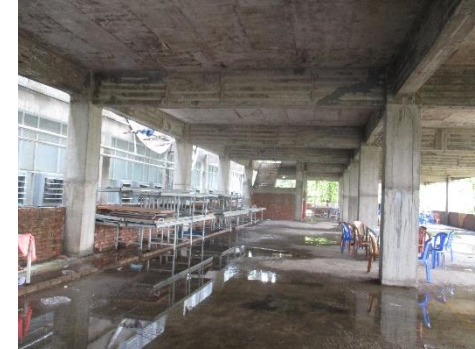
Floor Layout Plan

Architectural drawings not fully matched. Toilet partition wall and location of connection bridge not matched with drawings.

| Item No. | Observation | Recommended Action Plan | Recommended Timeline |
|---|---|---|---|
| 7 | (Utility building)<br>Discrepancies between Structural drawing and on-site condition. | Building Engineer to prepare accurate as-built structural and architectural drawing. | 6-weeks |

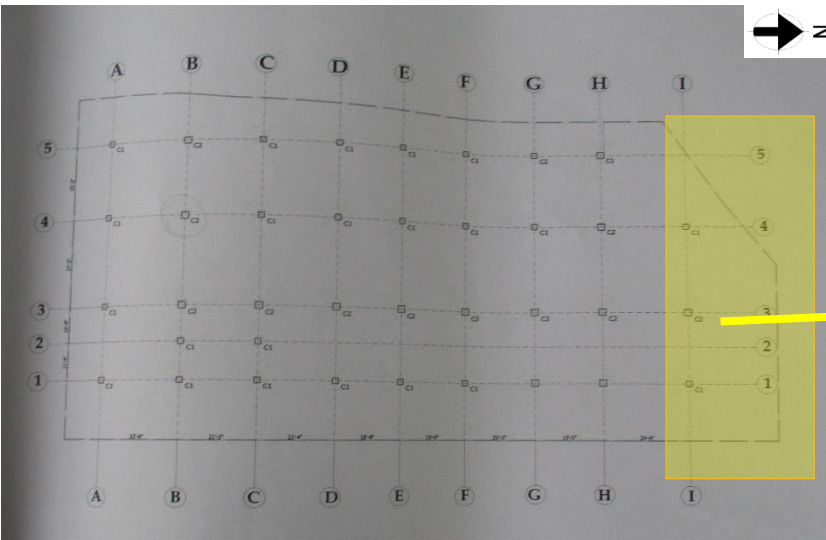
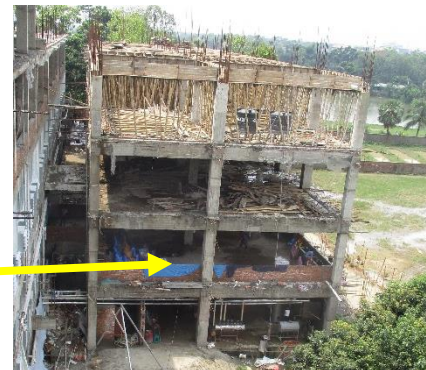
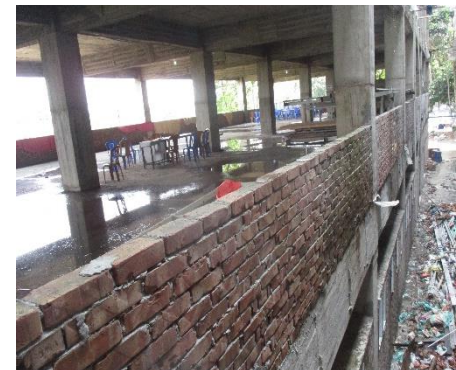
Column Layout Plan

Column & floor layout and nos. of grid do not fully matched with provided drawings.
