# Shin Shin Apparels Ltd. (9615)

27.MAY.2014

# Identified Priority 1 Concerns

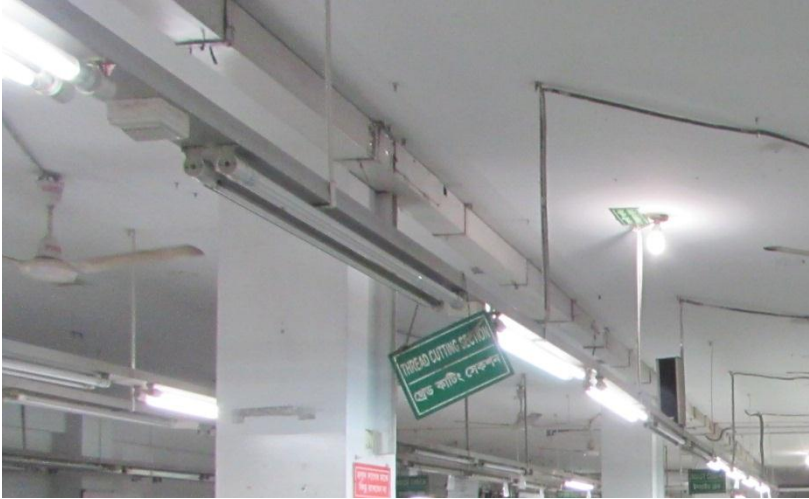
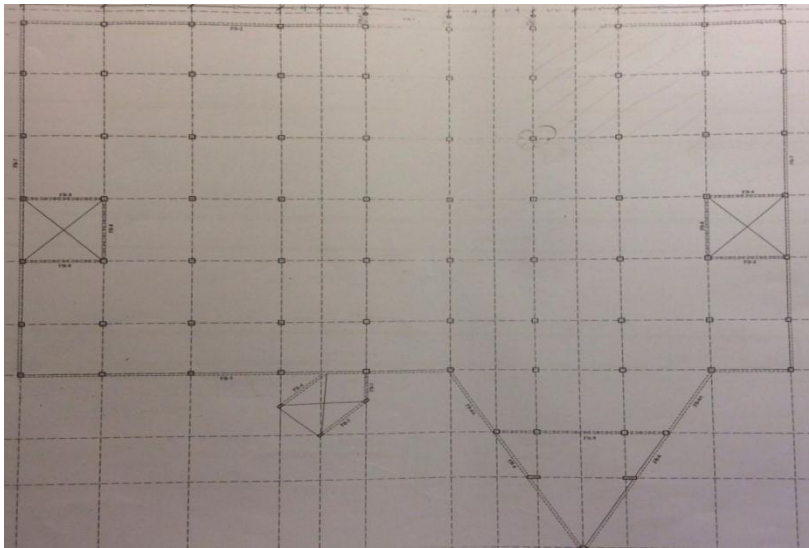
Based on the Detail Engineering Assessment report by BUET, the recommendation is using 1.5kPa (30psf) for live load for flat slab system due to the punching shear issued.

As per our calculation with the live load 1.5kPa for punching shear at the typical column, the shear stress at the first perimeter is higher than the design concrete shear stress. Based on the code, it must be increase the slab thickness or provide shear links for slab. However, the shear links have not provided as per structural drawing.

Furthermore, due to the lack of lateral stability system, the increase of un-balance moment due to lateral load need to be considered.

| Item No. | Observation | Recommended Action Plan | Recommended Timeline |
|---|---|---|---|
| 1 | 1st Priority 1 - The flat slab is not sufficient to resist the punching shear force. | Limit the average imposed load on the floor to a maximum of 1.5kPa (30 psf) | Immediate - Now |
| 2 | 1st Priority 1 - The flat slab is not sufficient to resist the punching shear force. | Carry out intrusive testing of the structure to determine the actual concrete strength, rebar strength and rebar layout. | 6-weeks |
| 3 | 1st Priority 1 - The flat slab is not sufficient to resist the punching shear force. | If necessary, carry out the strengthening work to increase the punching shear capacity.<br>Carry out the strengthening work to provide the lateral load resistance system. | 6-months |

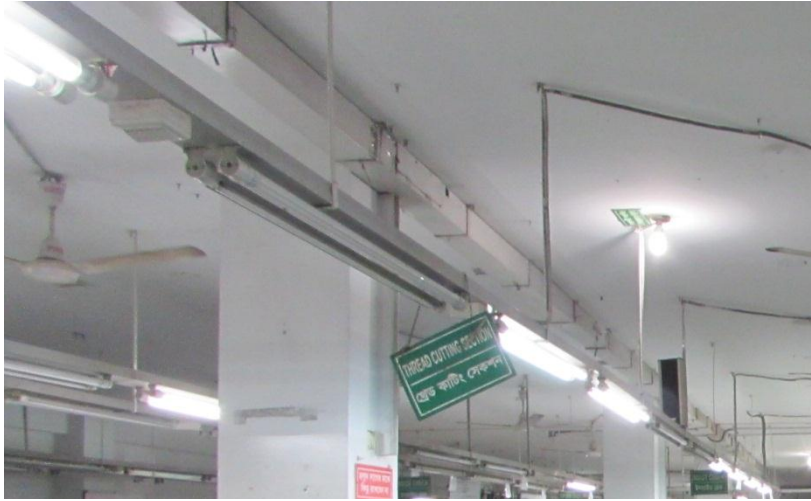
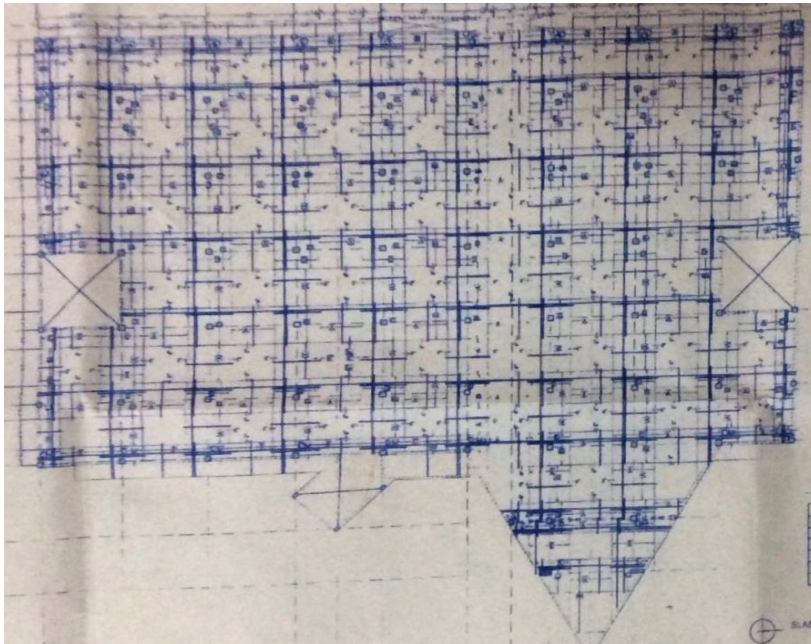
The span/depth ratio for flat slab which controls the limit of deflection for an RC element is defined apparently as  $L/30$ . The ratio for 7.62m span and 200mm thickness slab is 38 which was higher than ratio requirement.

Thinner flat slab will lead to increase the deflection in short-term and long-term and reduce the punching shear resistant as well.

The thin flat slab without drop panel and may be without shear reinforcement is not sufficiency to resist the punching shear load in seismic load which will cause the slab fall down suddenly and the building will collapse subsequently.

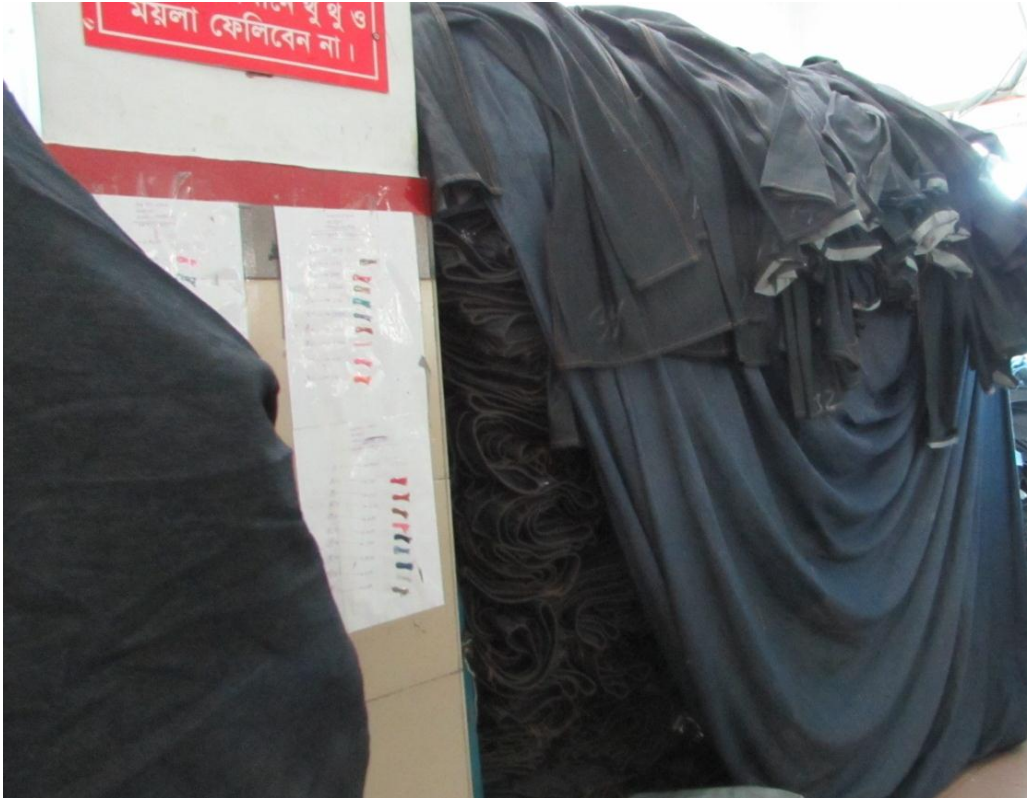
The storage of Jean trousers layers seem to be heavier than the allowable loading 1.5kPa (30psf), as per our estimated, the live load for this area is 3.09kPa which is higher than the allowable loading 1.5kPa (30psf).

The maximum number of layers allowable should be reduced to a maximum of 1.5kPa (30psf), and spread evenly around the storage area.

| Item No. | Observation | Recommended Action Plan | Recommended Timeline |
|---|---|---|---|
| 4 | 2nd Priority 1 - Loading intensity appears to be greater than the allowable load in some locations. | Immediately reduce stacking height of fabric bag to ensure total load does not exceed 1.5kPa (30 psf) | Immediate - Now |
| 5 | 2nd Priority 1 - Loading intensity appears to be greater than the allowable load in some locations. | Mark the maximum allowable height of fabric stacking to ensure full compliance | 6-weeks |
| 6 | 2nd Priority 1 - Loading intensity appears to be greater than the allowable load in some locations. | Ensure continued compliance to the loading intensity limitations on a long-term basis. | 6-months |

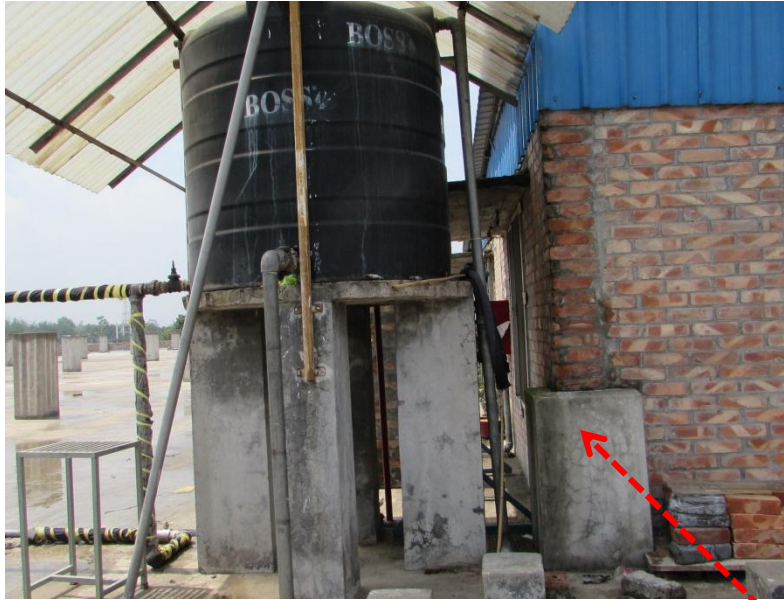
Main building

There is two water tanks 2m<sup>3</sup> per each tank which was put beside the column.

As the 2<sup>nd</sup> floor is the flat slab, so the tank put beside the column will cause the concentrate load to the slab, and this will potential increase the punching shear to the slab.

The tanks should be put directly on the main columns, that will help the load will transfer to the column, not to the slab.

| Item No. | Observation | Recommended Action Plan | Recommended Timeline |
|---|---|---|---|
| 8 | 2nd Priority 3 - The water tank was putted directly on the flat slab beside the column. | The tanks should be put directly on the main columns, that will help the load will transfer to the column, not to the flat slab. | 6-months |

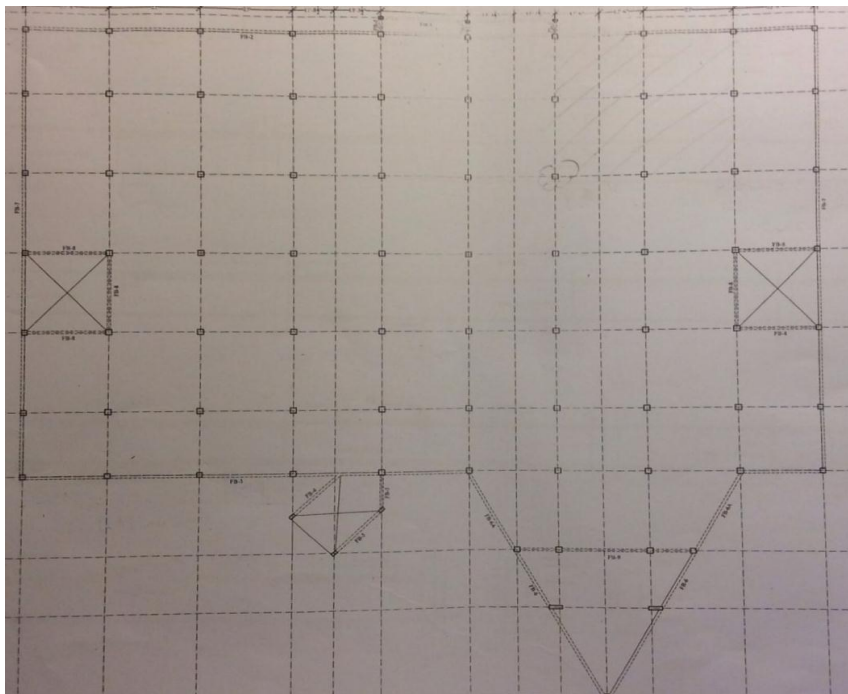
The overall structural arrangement does not appear to have any rational form of lateral stability system to resist the wind or earthquake loads. A lateral load analysis is required to be carried out. Together with the very low factor of safety to resist punching shear, the building is at a very high risk of collapse if a significant event occurs.

The design engineer need to check the deflection and storey drift under lateral wind and seismic load.

We require that these items be investigated in a Detail Engineering Assessment

| Item No. | Observation | Recommended Action Plan | Recommended Timeline |
|---|---|---|---|
| 9 | 3rd Priority 3 - No lateral load resistance system. | Building engineer to check and provide the solution for lateral resisting requirements of the structure | 6-weeks |
| 10 | 3rd Priority 3 - No lateral load resistance system. | As per the results of structural analysis, the building needs to be revised to accord with BNBC building codes with regard to lateral stability | 6-months |

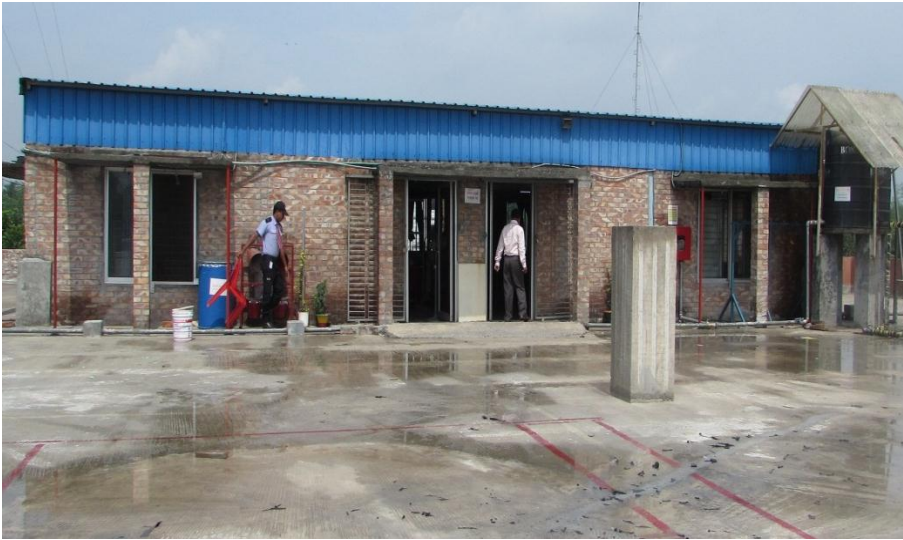
Because of the building is not constructed up to the permitted level, no waterproofing was seen during the survey. Consequently, any cracks or damage in the surface finishes on the roof will allow water to seep into the concrete slab beneath the finishes, and cause long-term soaking of the slab.

| Item No. | Observation | Recommended Action Plan | Recommended Timeline |
|---|---|---|---|
| 11 | 4th Priority 3 - There is no waterproofing provided on the existing roof of the main building. | Provide a proper waterproof layer on the roof level | 6-months |

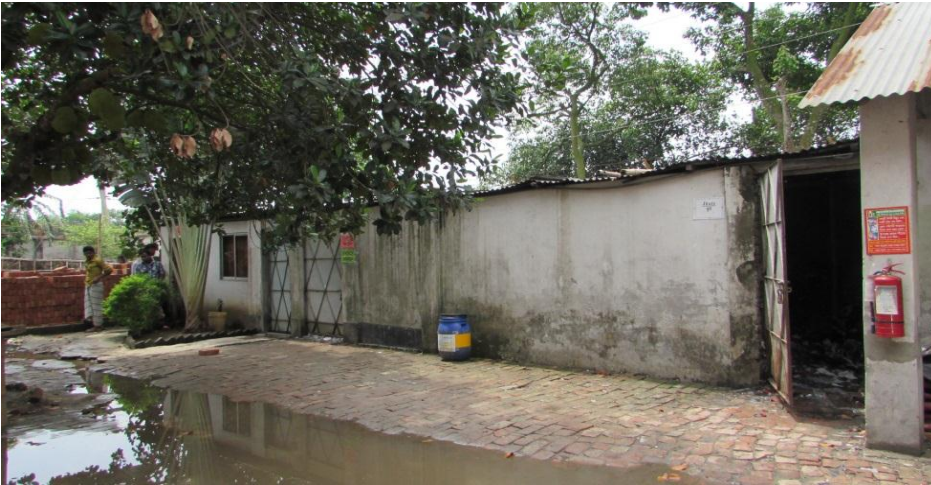
All the shed buildings seems to be a very simple structure, built without any calculation or design. There are no structural records to show the structural layout or connection details.

The steel truss and beams is not longitudinally braced and the steel connection needs to be reviewed and repaired properly according to the proper design.

We require that these items be investigated in a Detail Engineering Assessment

| Item No. | Observation | Recommended Action Plan | Recommended Timeline |
|---|---|---|---|
| 12 | 5th Priority 3 - Structural for the shed buildings need to be review and design for the longitudinal bracing and the connection of steel need to reviewed with proper detail design. | The detail design for the Shed building need be carry out to have the stability structural under wind load. The bracing system need to be provided in longitudinal direction | 6-months |
