# T.J. Sweater Ltd. (11352)

27.MAY.2014

## Identified Priority 1 Concerns

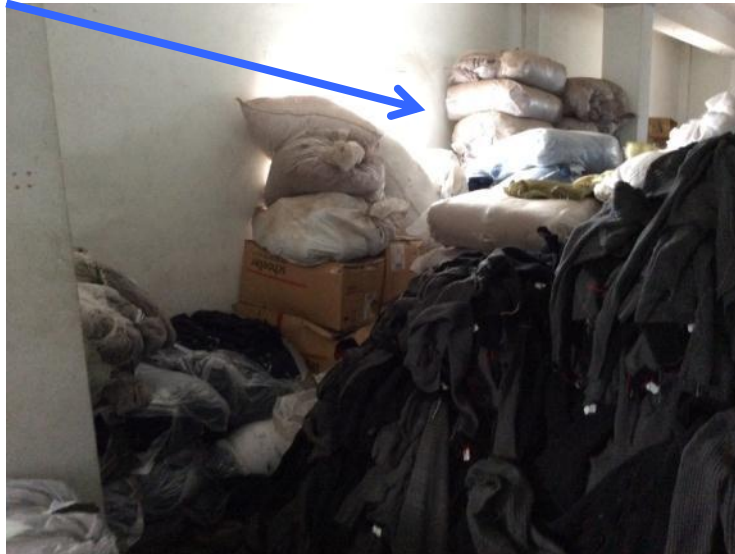
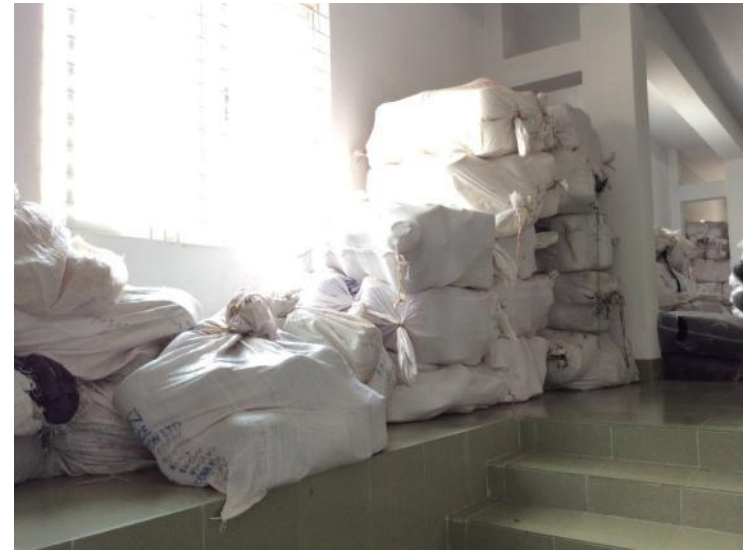
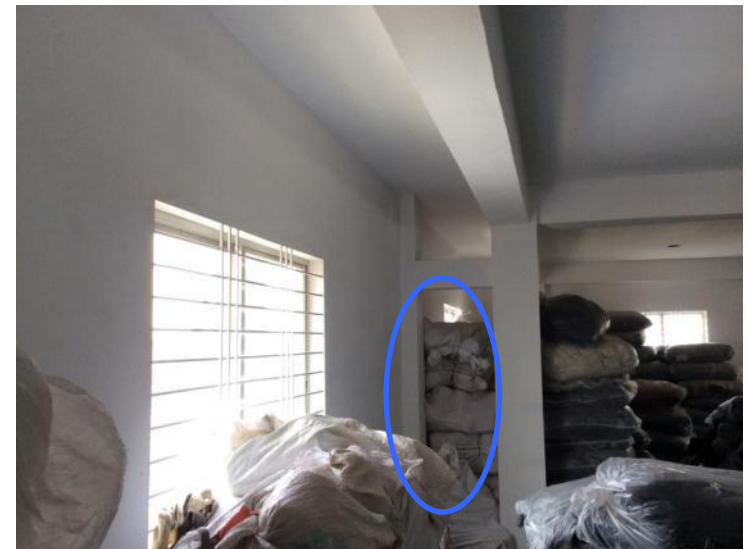
Uncontrolled heavy storage loading were found on cantilevered slabs at Building 2. The apparent live load is believed to be 5.0 kPa. Loading plan needs to be implemented.

| Item No. | Observation | Recommended Action Plan | Recommended Timeline |
|---|---|---|---|
| 1 | Uncontrolled heavy storage loading on cantilevered slab at Building 2. | Remove heavy storage loading in the area identified above.<br>Factory Engineer to review design and loads in the area identified above.<br>Factory Engineer to state the maximum weight that is allowed per square meter. Suggest that state the value on notice boards in this area. | Immediate - Now |
| 2 | Uncontrolled heavy storage loading on cantilevered slab at Building 2. | Adopt some sort of signage/staff guidance to ensure that the maximum weight of storage is not exceeded. (Loading Plans). | 6-weeks |
| 3 | Uncontrolled heavy storage loading on cantilevered slab at Building 2. | Maintain standards of quality control to ensure that storage procedures are correctly followed so that overloading problems do not arise in the future.<br>Implement Loading Plan. | 6-months |

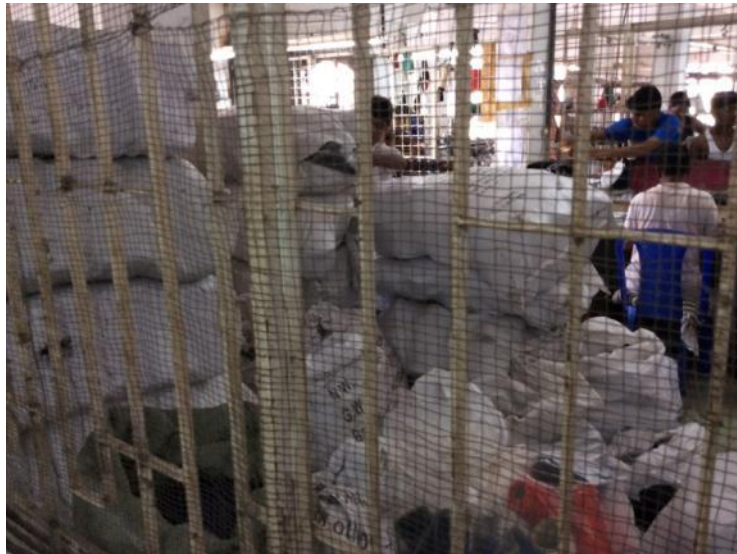
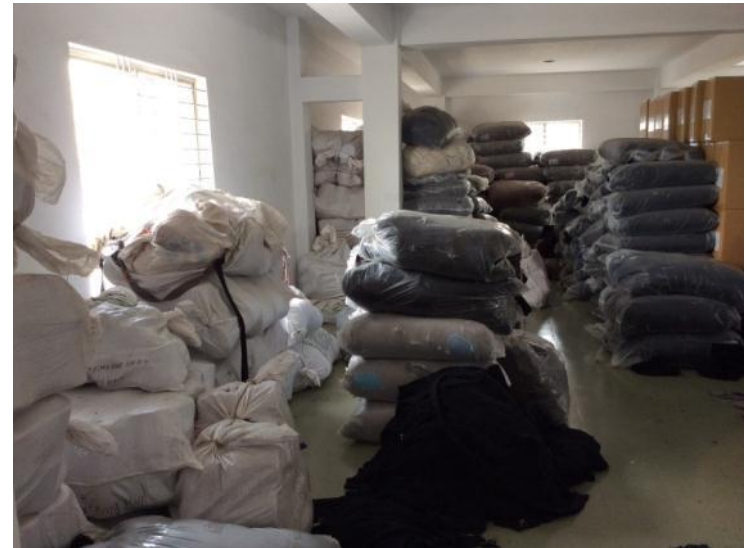
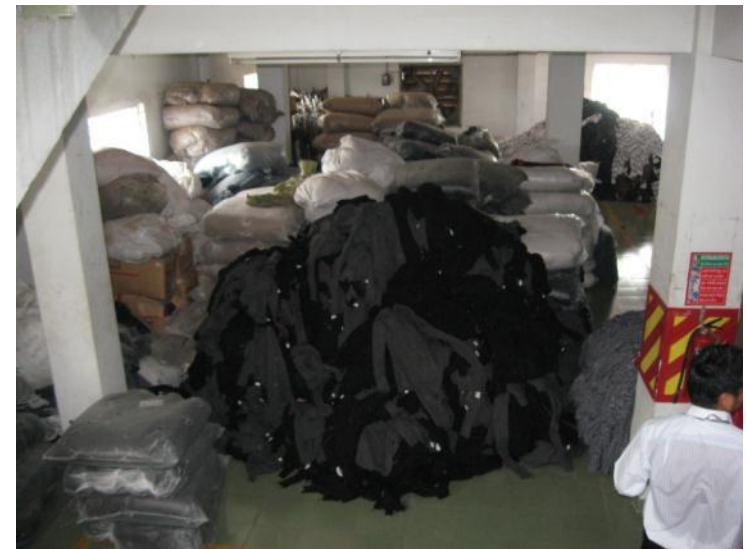
Uncontrolled Heavy storage loading was found on Building 1 and 2. The loading must be reduced to 3.0 kPa (4 bags of 50 kg or 6 bags of 35 kg). Loading plan needs to be implemented.

| Item No. | Observation | Recommended Action Plan | Recommended Timeline |
|---|---|---|---|
| 4 | Uncontrolled heavy storage loading at Building 1 and Building 2. | Reduce stacking height to ensure total load does not exceed 3 kPa.<br>Factory Engineer to review design and loads in area identified above.<br>Factory Engineer to state the maximum weight that is allowed per square meter. Suggest that state the value on notice boards in this area. | Immediate - Now |
| 5 | Uncontrolled heavy storage loading at Building 1 and Building 2. | Adopt some sort of signage/staff guidance to ensure that the maximum weight of storage is not exceeded. (Loading Plans). | 6-weeks |
| 6 | Uncontrolled heavy storage loading at Building 1 and Building 2. | Maintain standards of quality control to ensure that storage procedures are correctly followed so that overloading problems do not arise in the future.<br>Implement Loading Plan. | 6-months |

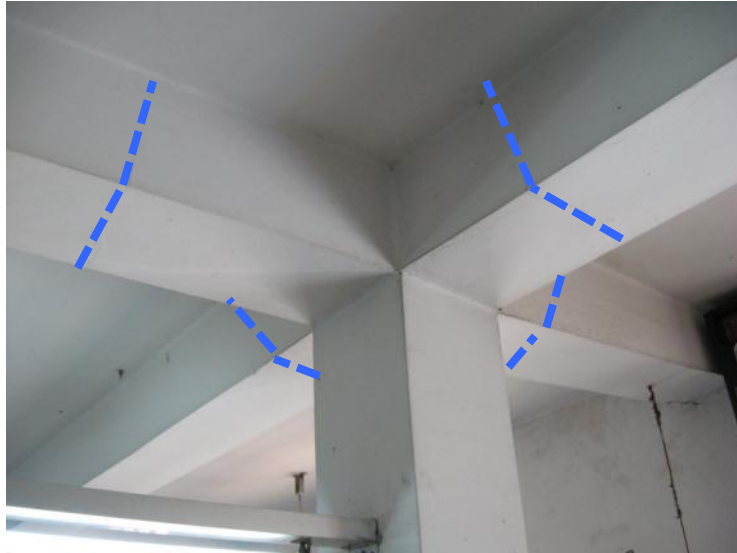
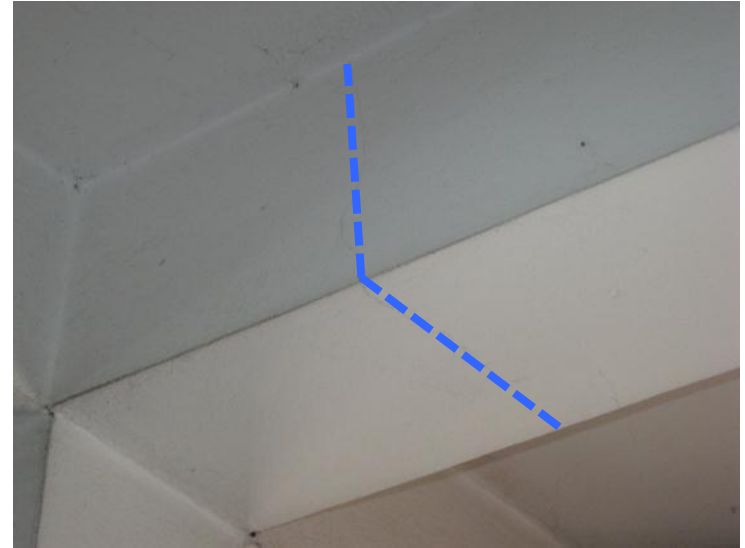
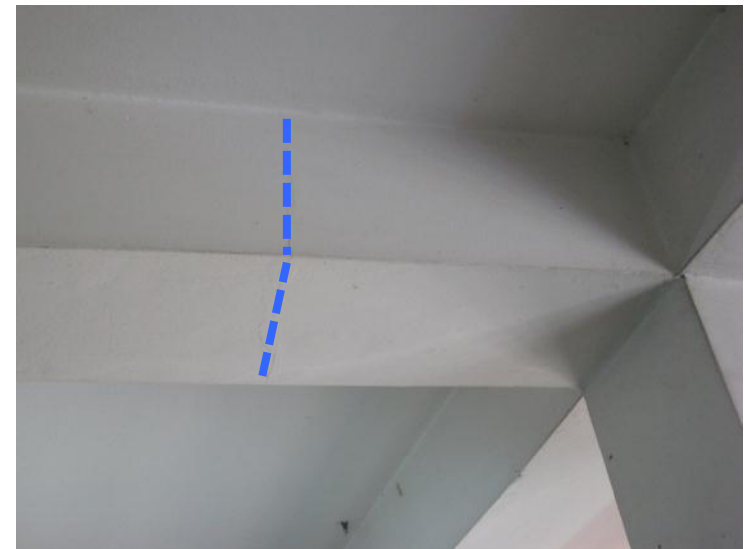
Cracks appeared underside beam on 1<sup>st</sup>, 2<sup>nd</sup> and 3<sup>rd</sup> floor. We require that these items be investigated in a Detail Engineering Assessment.

| Item No. | Observation | Recommended Action Plan | Recommended Timeline |
|---|---|---|---|
| 7 | Cracks appeared underside beam on 4th floor at Phase 2 of Building 1. | The Factory Engineer to investigate the cause of cracks by appropriate methods.<br>The distress found is to be suitably rectified and then repaired. | 6-weeks |
| 8 | Cracks appeared underside beam on 4th floor at Phase 2 of Building 1. | Create loading plans for each floor level.<br>Maintain standards of quality control to ensure that loading plan is correctly followed so that problems do not arise in the future.<br>Maintain and enforce the loading plans. | 6-months |

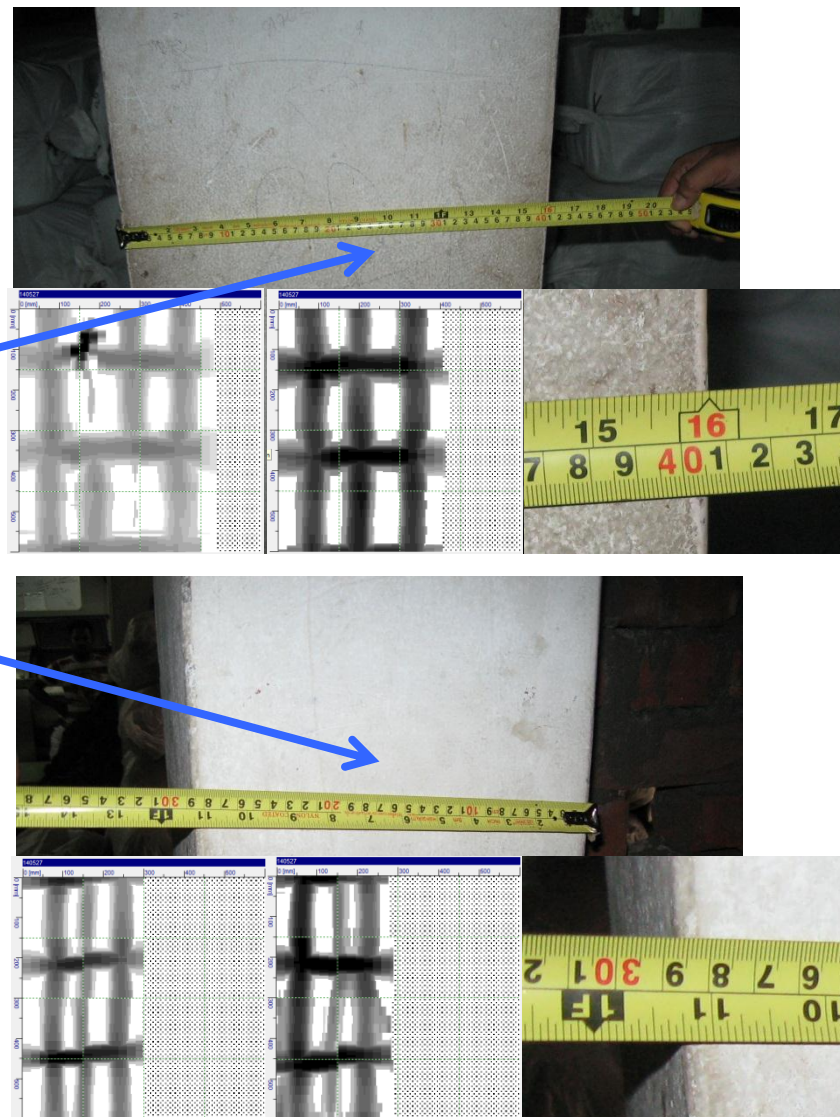
The actual conditions of column details of Building 1 do not match the details specified in the drawing.

| | C4 | | C5 | |
| | Drawing | In Situ | Drawing | In Situ |
| <b>Size</b> | 15"x 10" | 10" x 10" | 18" x 10" | 18" x 15" |
| <b>Vert. rebar</b> | 8-20mm $\phi$<br>2-16mm $\phi$ | 8-20mm $\phi$ | 10-20mm $\phi$ | 10-20mm $\phi$ |
| <b>Stirrups</b> | 10mm $\phi$ @7" | 10mm $\phi$ @8" | 10mm $\phi$ @7" | 10mm $\phi$ @8" |

**Remark:** Assumed rebar size in situ are the same size as shown in the drawing.

| Item No. | Observation | Recommended Action Plan | Recommended Timeline |
|---|---|---|---|
| 9 | Inconsistencies between the drawings of Building 1 and the actual as-built conditions. | Factory Engineer to survey the actual conditions and revise the drawings.<br>Factory Engineer to review design, loads and columns stresses to confirm suitability for loads applied.<br>Produce and actively manage a loading plan for all floor plates within this area giving consideration to floor capacity and column capacity. | 6-weeks |
| 10 | Inconsistencies between the drawings of Building 1 and the actual as-built conditions. | Continue to implement load plan | 6-months |

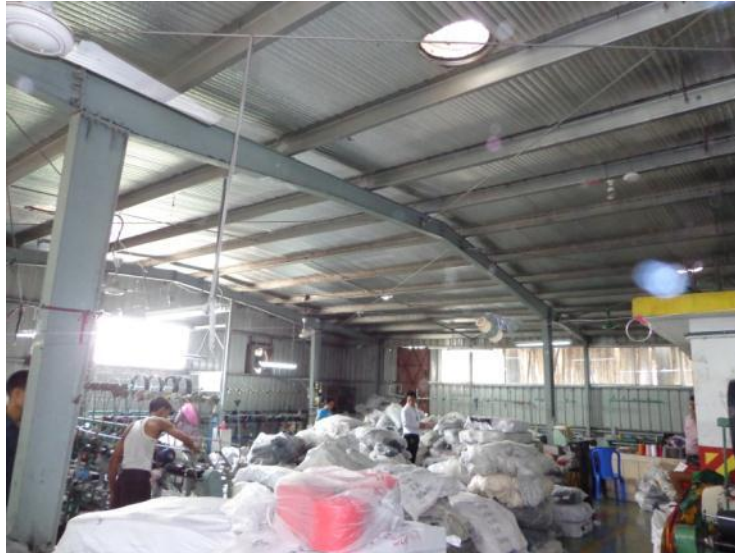
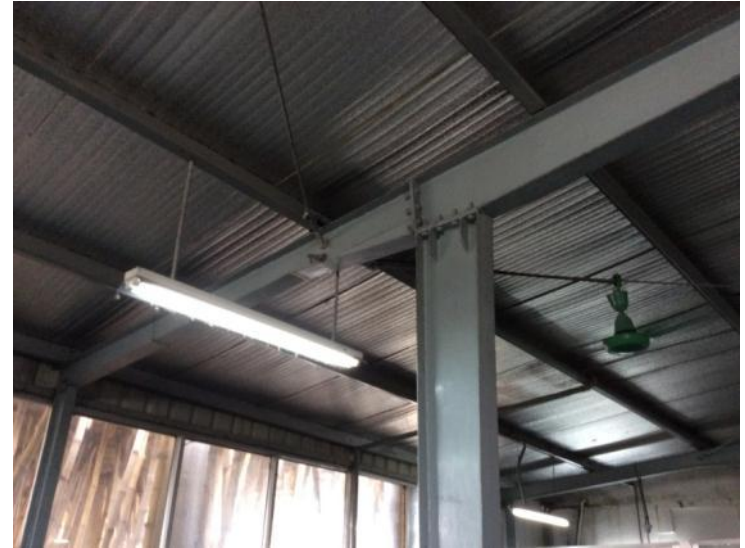
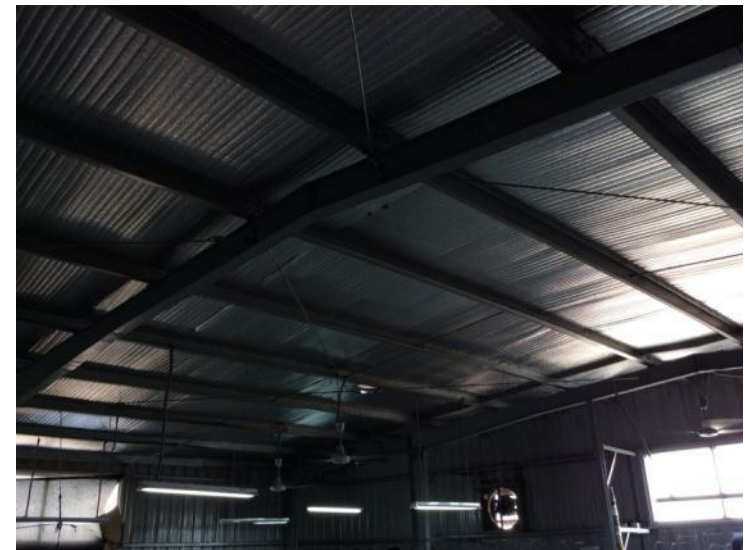
No fireproofing material applied for structural steel elements at Phase 1 of Building 1. It is unclear whether it is required by BNBC.

| Item No. | Observation | Recommended Action Plan | Recommended Timeline |
|---|---|---|---|
| 14 | No fireproofing material applied for structural steel elements at Phase 1 of Building 1 (if required). | Fireproofing material for structural steel element is recommended as suggested in BNBC Codes. | 6-weeks |
| 15 | No fireproofing material applied for structural steel elements at Phase 1 of Building 1 (if required). | Maintain standard of quality control. | 6-months |

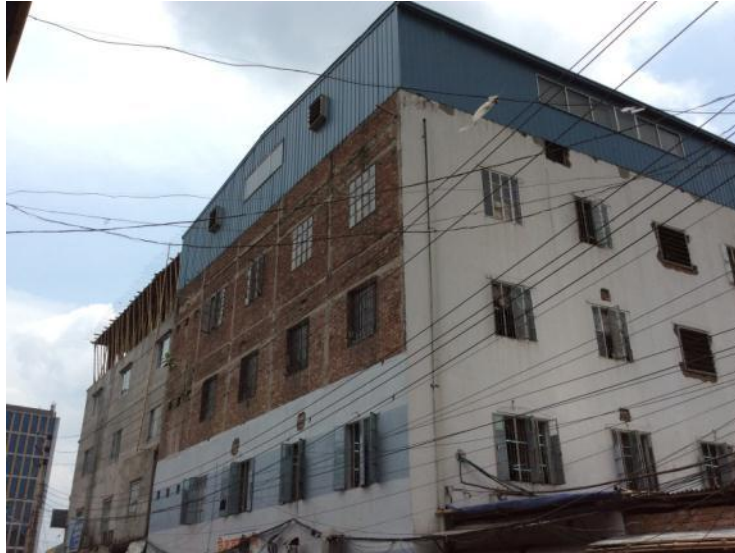
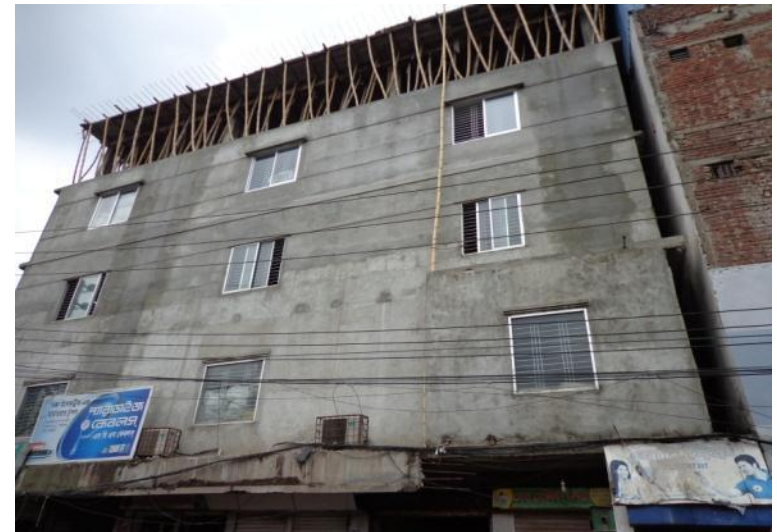
# Overall Stability System

Concerns on the stability system for lateral loading. Façade brickwork walls lack of moment capacity in the connections between columns and beams.

We require that these items be investigated in a Detail Engineering Assessment.

| Item No. | Observation | Recommended Action Plan | Recommended Timeline |
|---|---|---|---|
| 11 | Overall stability system. | Request that the Detail Engineering Assessment of the overall building to be carried out and in particular, stability and foundation aspects should be investigated in detail. | 6-weeks |

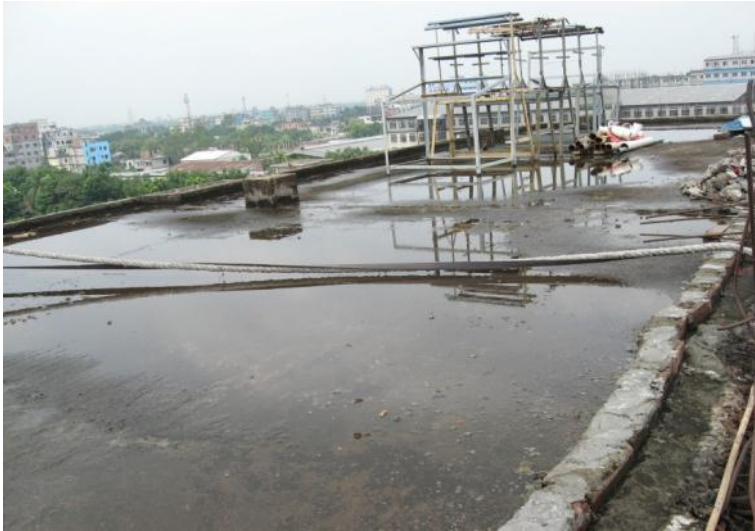
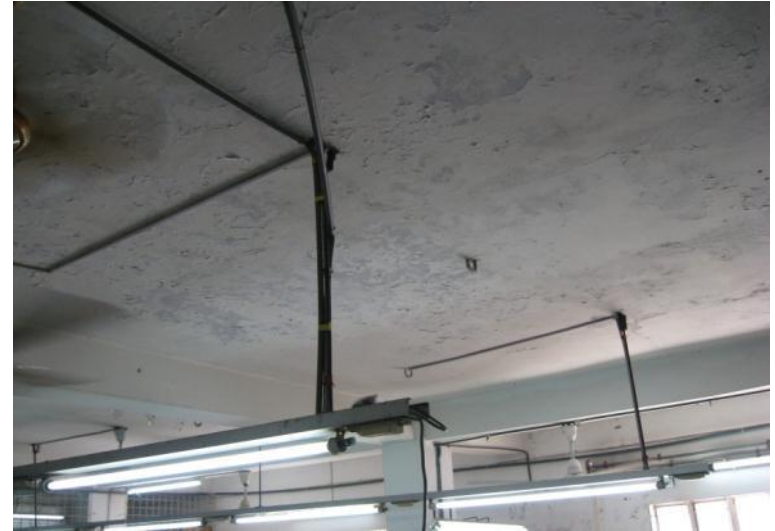
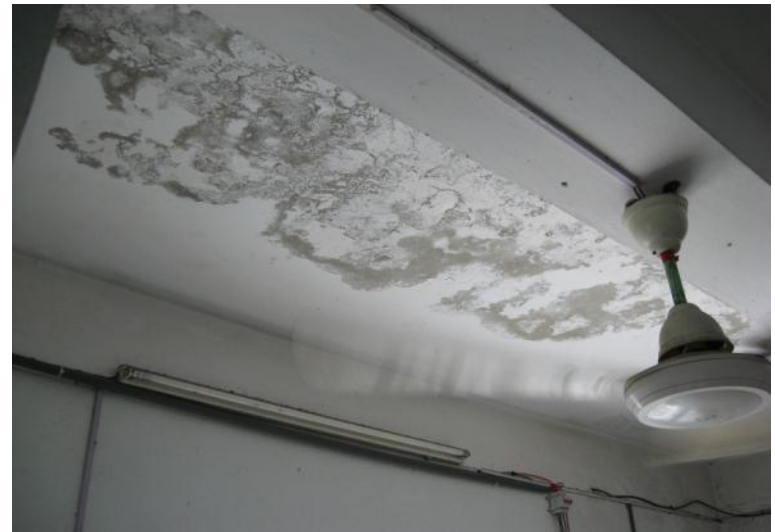
# Water Ingress

There are water ponding on the roof slab after the rain and distress due to water ingress noted on slabs, beams and walls.

| Item No. | Observation | Recommended Action Plan | Recommended Timeline |
|---|---|---|---|
| 12 | Distress due to water ingress. | Factory Engineer to inspect water damaged structures and repair with a suitable method. | 6-weeks |
| 13 | Distress due to water ingress. | Waterproofing on the roof slab is recommended. Moreover the slab drainage system should be investigated.<br>Maintain standard of quality control. | 6-months |

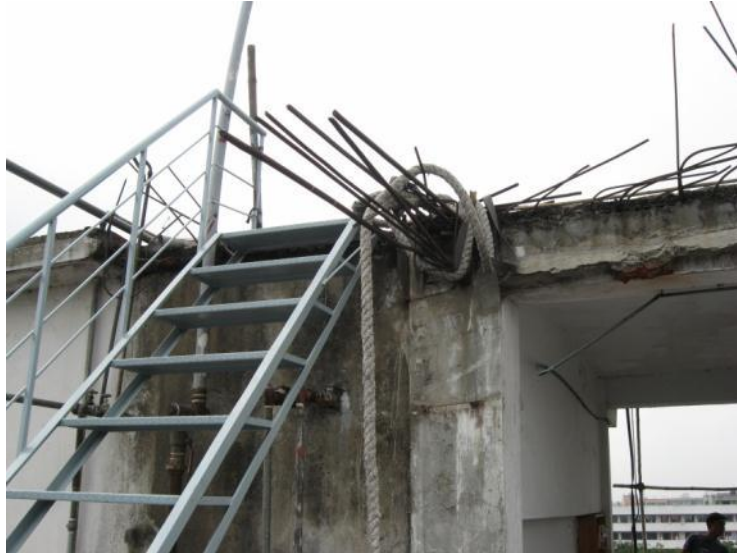
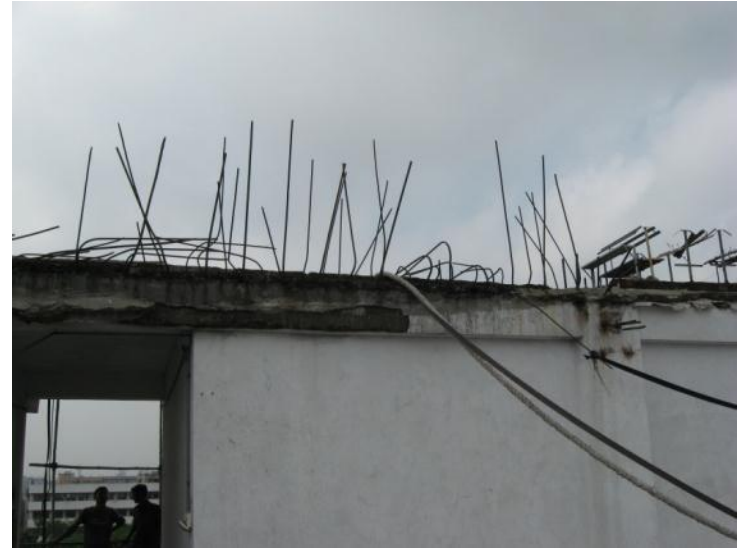
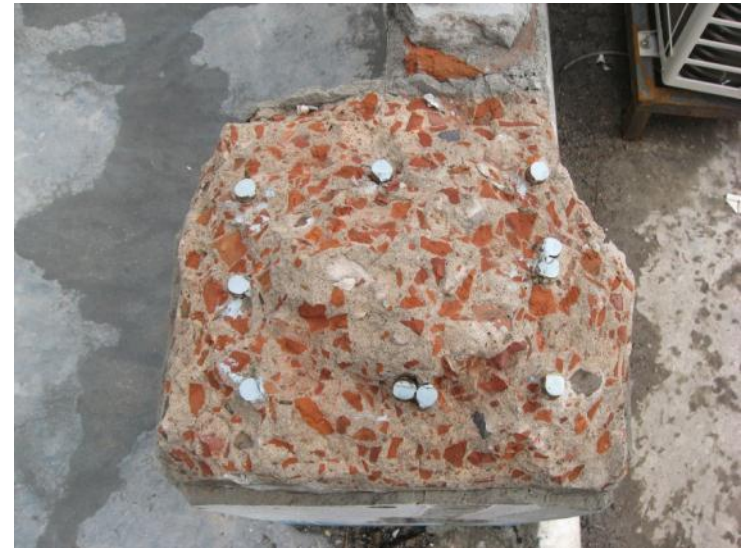
Reinforcement is left exposed at roof level.

| Item No. | Observation | Recommended Action Plan | Recommended Timeline |
|---|---|---|---|
| 16 | Reinforcement left exposed at roof level. | For both durability and serviceability, rust proof paint or any appropriate methods is recommended. | 6-months |
