# Pimkie Apparels Ltd. (9205)

Plot #328, Bloc #F, Tongi Industrial Area, Tongi

27.May.2014

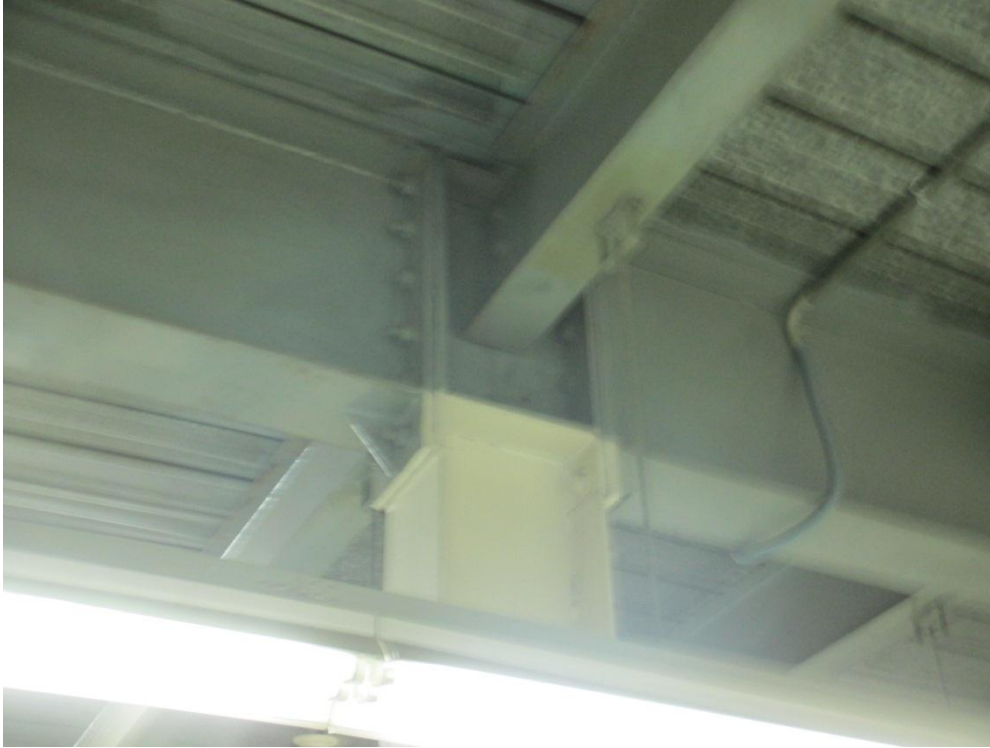
1<sup>st</sup> Priority 1 Concern

Garment Building – Steel columns

At the Garment Building, according to our verification of the steel columns , the loading of the 1<sup>st</sup> and 2<sup>nd</sup> floor are too high for the column sizes of the building. A design check of all of the steel columns must be included in the Detailed Engineering Assessment.

| Item No. | Observation | Recommended Action Plan | Recommended Timeline |
|---|---|---|---|
| 1 | Garment Building – Steel columns. | Verify steel columns: type of steel, plate thickness and weldings.<br>Detail Engineering Assessment of Factory to be commenced, see attached scope. | Immediate – Now |
| 2 | Garment Building – Steel columns. | If deemed necessary by Factory Engineer, carry out any remedial works recommended. | 6-weeks |

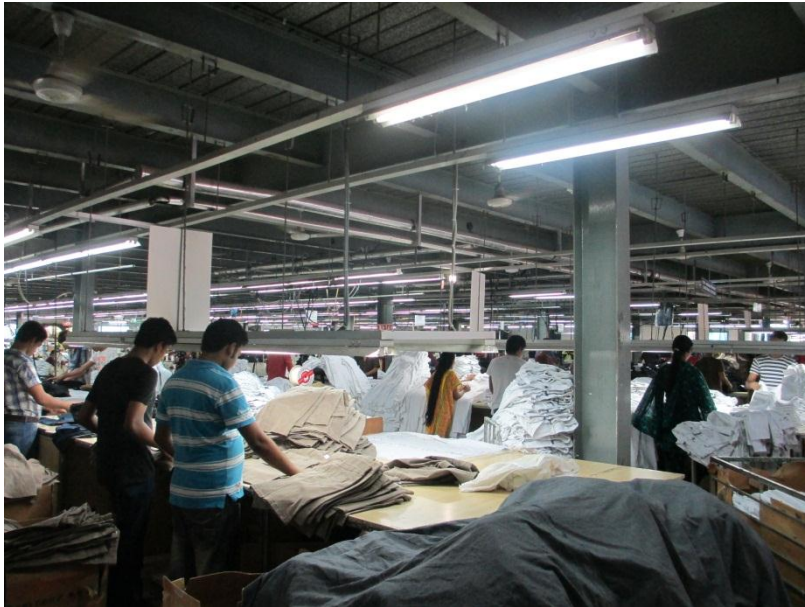
Garment Building – No Fireproofing of the structural steel.

At the garments building, no fireproofing material was noted on structural steel elements as suggested by BNBC 2006.

| Item No. | Observation | Recommended Action Plan | Recommended Timeline |
|---|---|---|---|
| 3 | Garment Building – No Fireproofing of the structural steel. | Fireproofing material for structural steel element is recommended as suggested in BNBC Codes. | 6-weeks |
| 4 | Garment Building – No Fireproofing of the structural steel. | Maintain standard of quality control and protection of the fire protection. | 6-months |

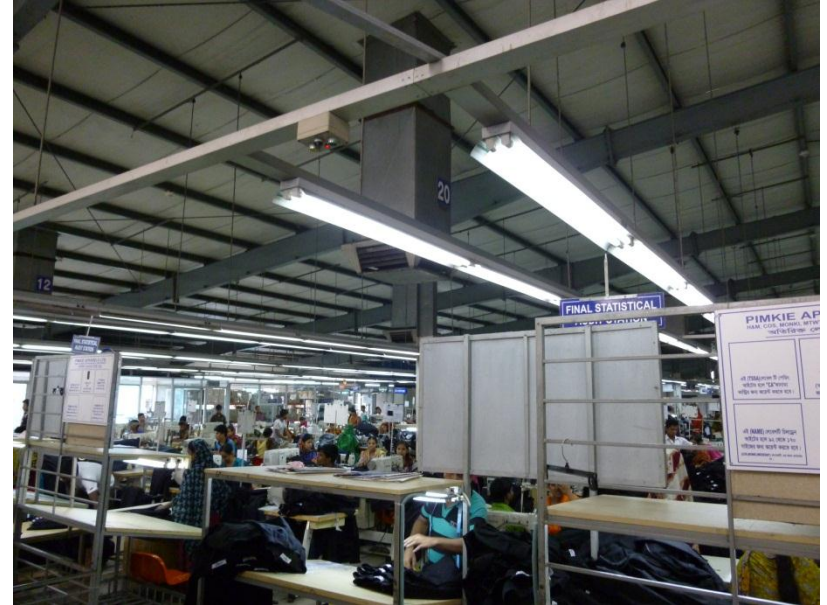
Existing welding  
at the gosset plate

Garment Building - Welds for braces

| Item No. | Observation | Recommended Action Plan | Recommended Timeline |
|---|---|---|---|
| 5 | Garment Building - Welds for braces. | The Factory Engineer is to carry out an assessment of the vertical (wall) bracing connexion at the column. | 6-weeks |
| 6 | Garment Building - Welds for braces. | If deemed necessary by Factory Engineer, carry out any remedial works recommended. | 6-months |

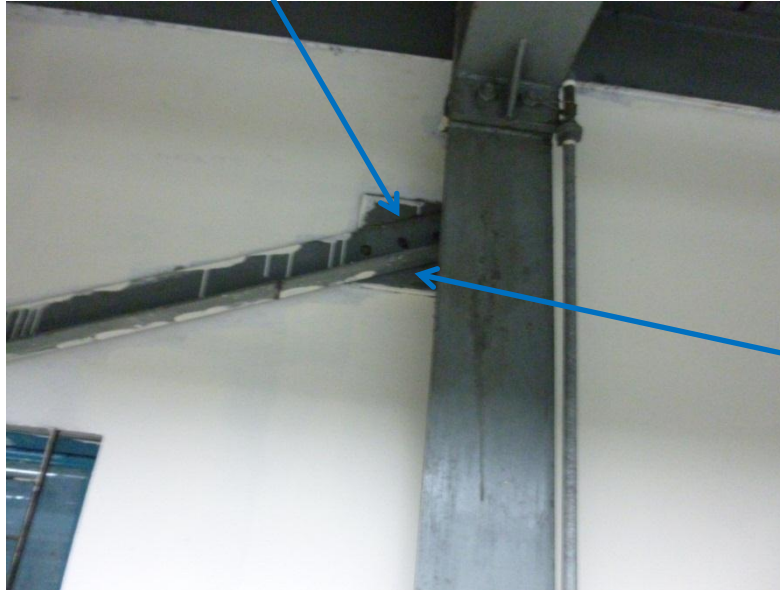
New welding  
at the gosset plate

At the Garment Building all of the bracing (made of an angle L75x75) connexion is done by welding fixed to a gosset plate at the column. For the member used for the bracing, the angle has to be welded on both side at the gosset plate. Also the neutral axis of the bracing, column and perpendicular beam aren't converging at the same point. This means that all the connexion of those members are capable to receive some moments. A design check of all of the bracing connexion structural must be included in the Detailed Engineering Assessment.

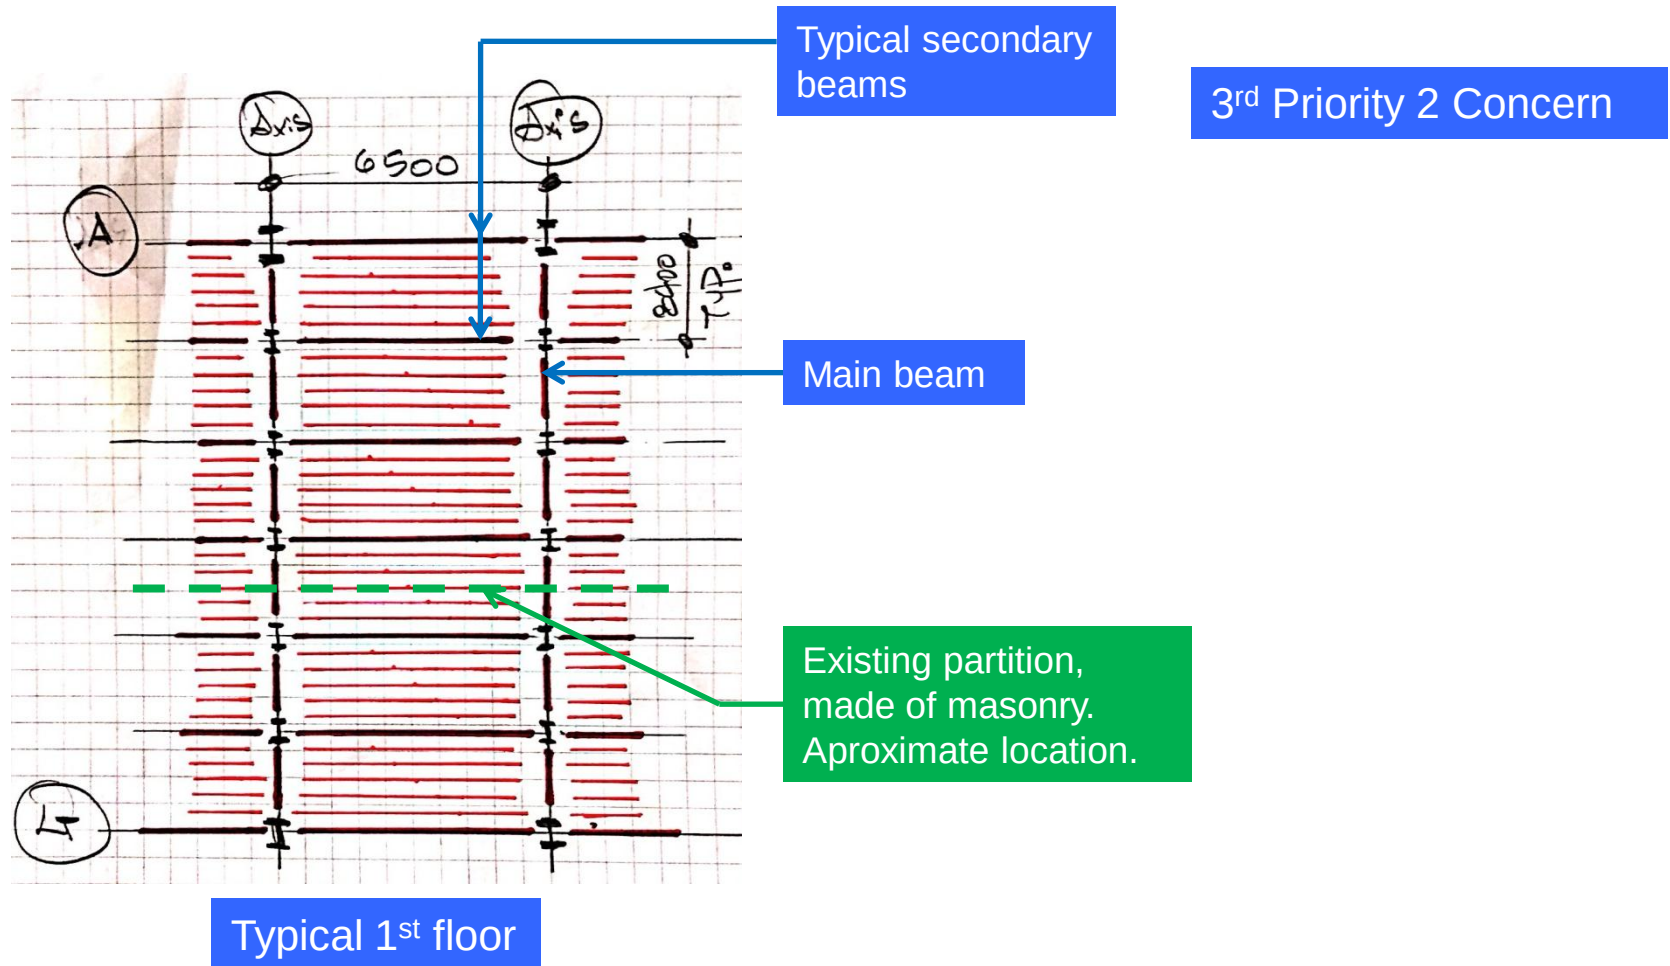
Garment Building - Heavy full height partition on typical size beam (1<sup>st</sup> floor)

At the Garment Building, some existing partitions are located in parallel to the typical secondary beams. The beams located under the partition are not loaded as the typical secondary beams. A design check of all the beams located under the partition must be included in the Detailed Engineering Assessment.

| Item No. | Observation | Recommended Action Plan | Recommended Timeline |
|---|---|---|---|
| 7 | Garment Building - Heavy full height partition on typical size beam (1st floor). | The Factory Engineer is to carry out an assessment of the wall supported by the typical beam of the 1st floor. | 6-weeks |
| 8 | Garment Building - Heavy full height partition on typical size beam (1st floor). | If deemed necessary by Factory Engineer, carry out any remedial works recommended. | 6-months |

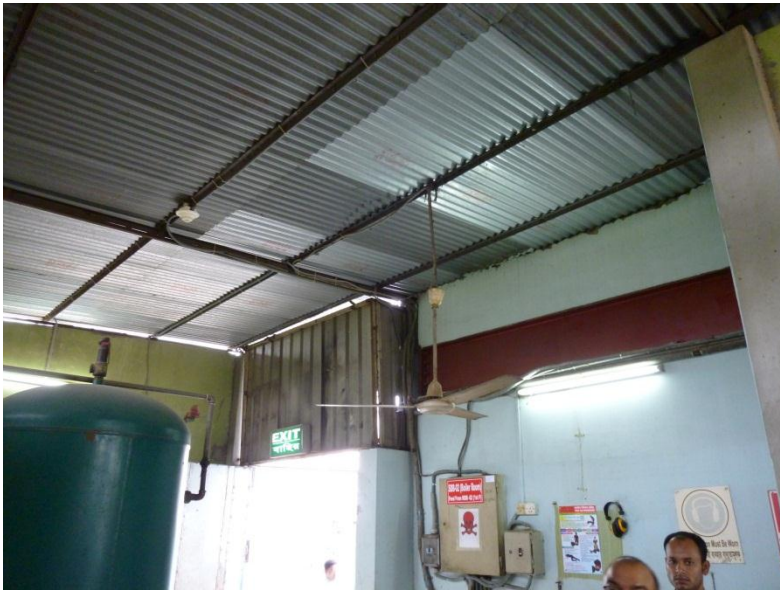
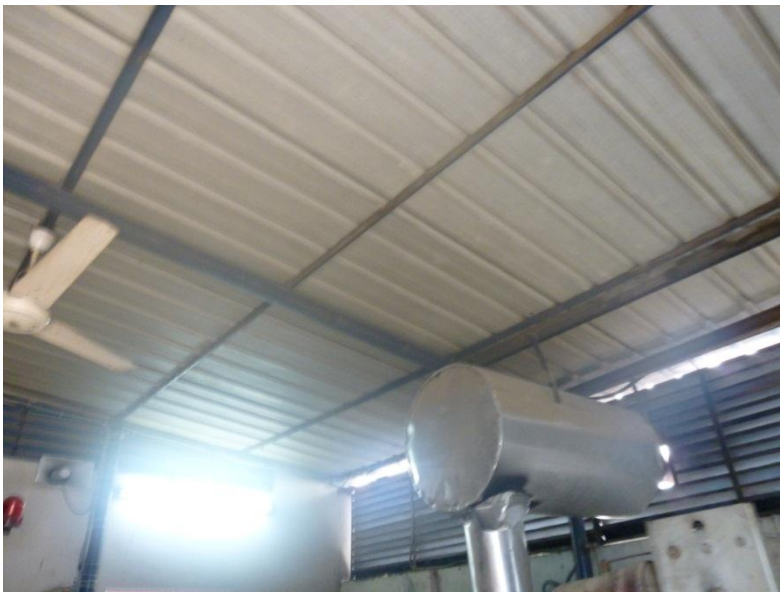
Sheds - Flimsy Roofs

At the roof of the Generator Shed, the Fire pump Shed and the Boiler Shed all the steel roof must be verified for the uplift of these roofs including the bearing of these roofs made of brick walls. A design check of all of these sheds must be included in the Detailed Engineering Assessment.

| Item No. | Observation | Recommended Action Plan | Recommended Timeline |
|---|---|---|---|
| 9 | All the 3 sheds - Flimsy Roofs for the sheds. | The Factory Engineer is to carry out an assessment of the lightweight steel located at the roof of the sheds. Also this assessment must be done for the masonry walls. | 6-weeks |
| 10 | All the 3 sheds - Flimsy Roofs for the sheds. | If deemed necessary by Factory Engineer, carry out any remedial works recommended. | 6-months |

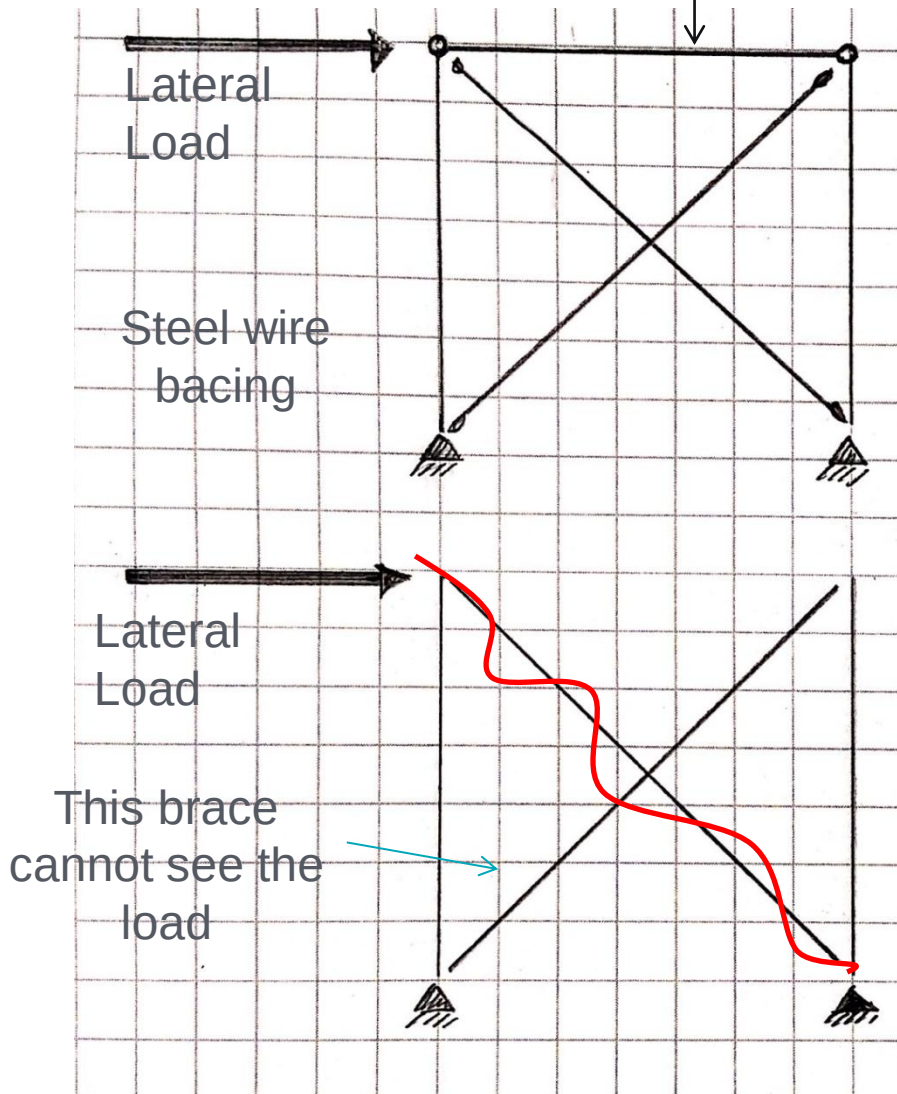
Compression element

At the Garments Building, the structure should be detailing for adequate lateral restraints for beams and purlins. The building also had horizontal steel bars bracing for the roof diaphragm. And for the vertical bracing, the elements are an angle 75x75.

Where we have a concern is that at the end of the horizontal bracing, the vertical bracing does not always have the collecting element at the top (compression element).

We require that this item be investigated in a Detail Engineering Assessment
