Renaissance Apparels Ltd. (10009)

C-S, Plot #659, 660, Mouza #93, Gazipur

27.MAY.2014

Identified Priority 1 Concerns

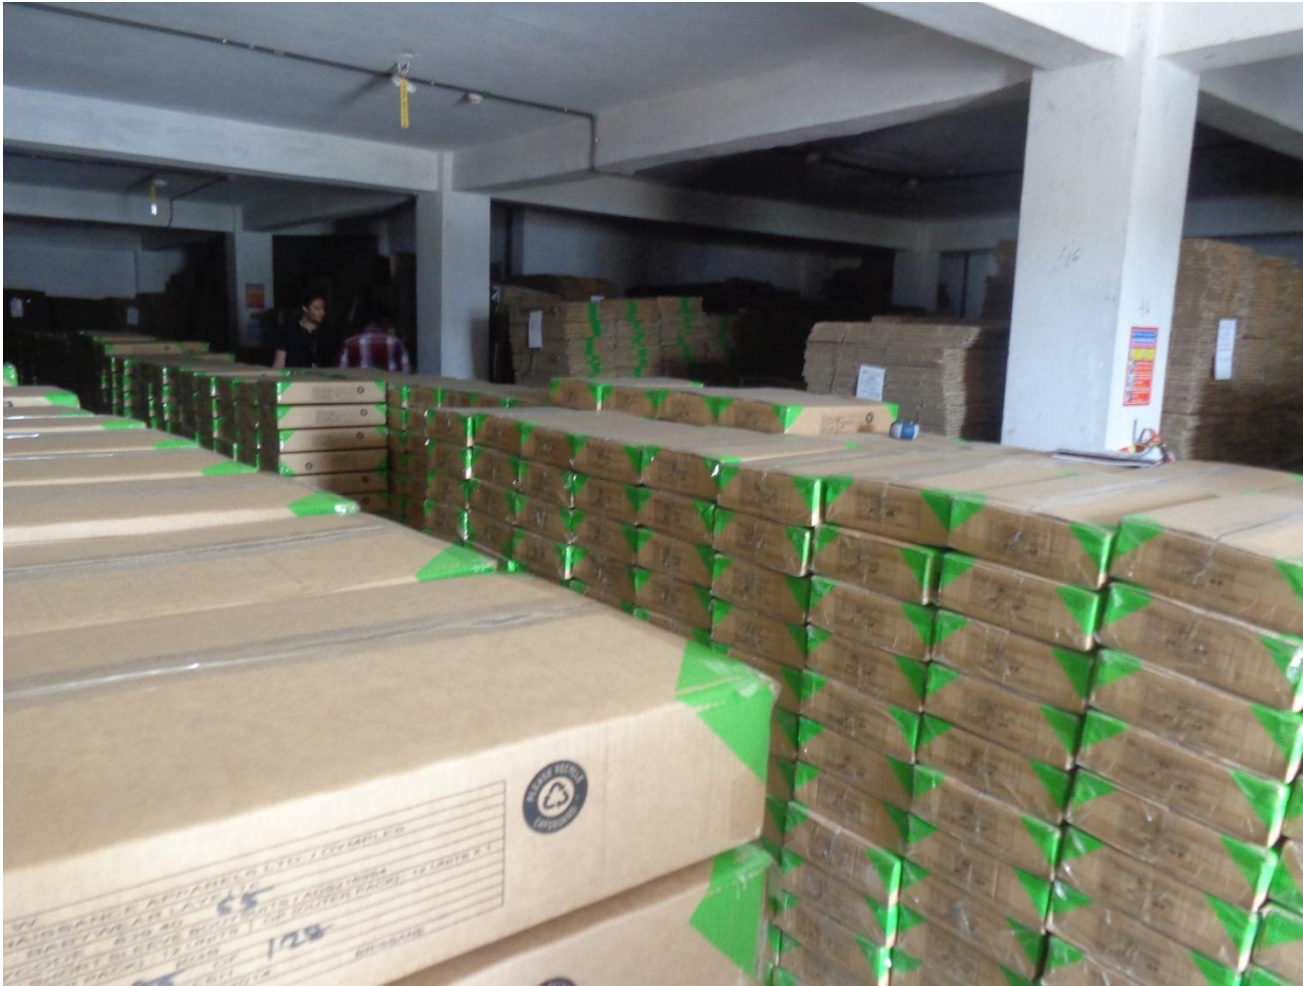
1st Priority 1 Concern

Critical columns of the office building are overstressed.

Item No.	Observation	Recommended Action Plan	Recommended Timeline
1	Critical columns of the office building are overstressed.	Remove storage on 1st floor of office building down to a maximum of 2.0 kPa (40 psf). Design Engineer to review design, loads and columns stresses in area identified above.	Immediate - Now
2	Critical columns of the office building are overstressed.	Verify insitu concrete stresses by laboratory testing. A Detailed Engineering Assessment is required to determine the load carrying capacity of the structure.	6-weeks
3	Critical columns of the office building are overstressed.	Implement recommendations from DEA.	6-months
4	Loadings plans were posted but overloading was observed on 1st floor of office building.	As mentioned earlier, remove all loading on all floors of the office building down to a maximum of 2.0 kPa (40 psf), and no materials or fabrics should be stacked higher than 3'. Adhere to posted loading plans.	Immediate - Now

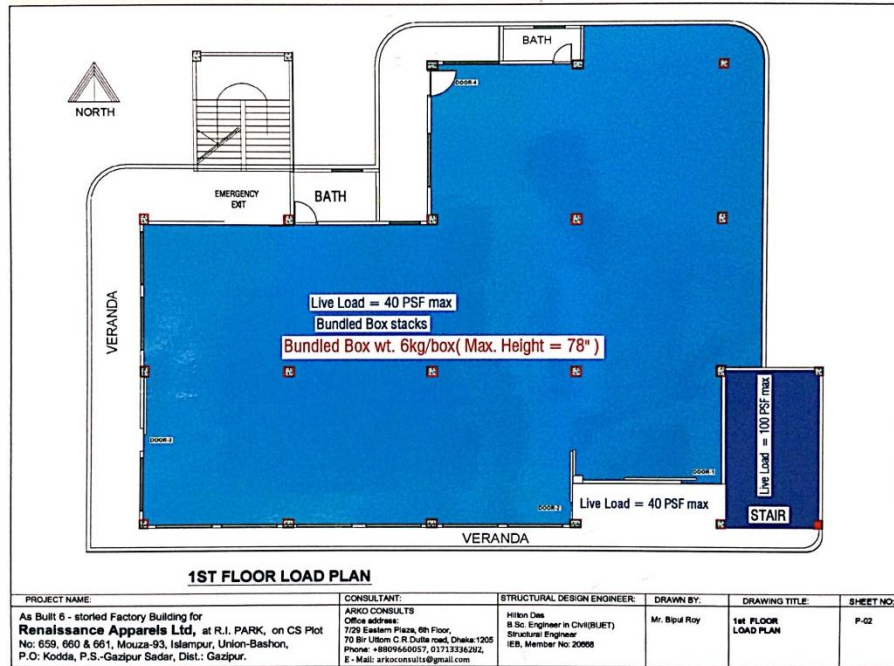
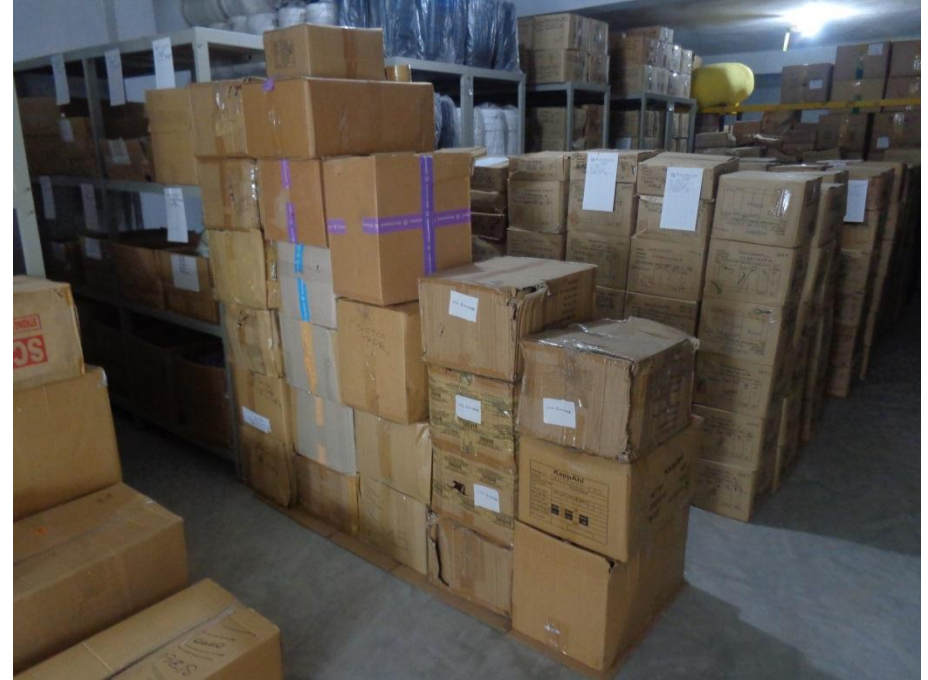
2nd Priority 1 Concern

Loadings plans were posted but overloading was observed on 1st floor of office building.

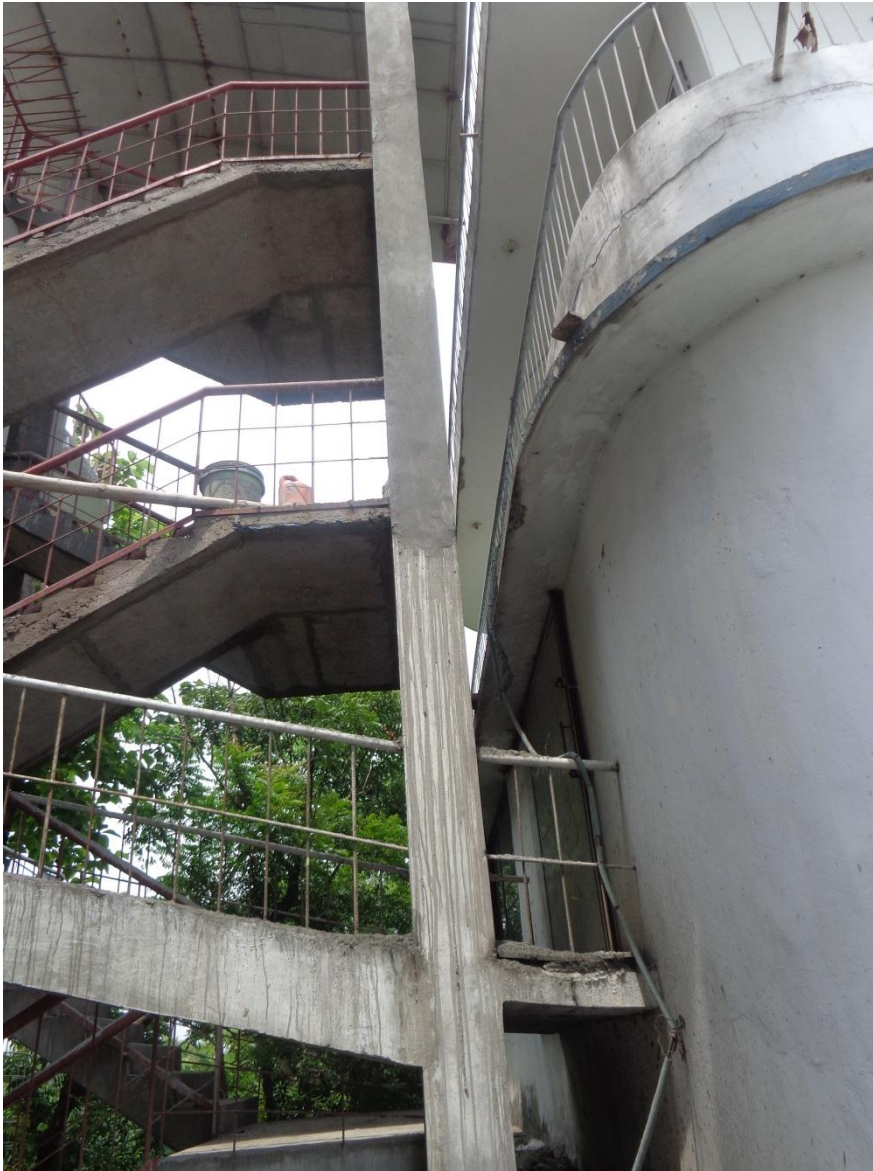
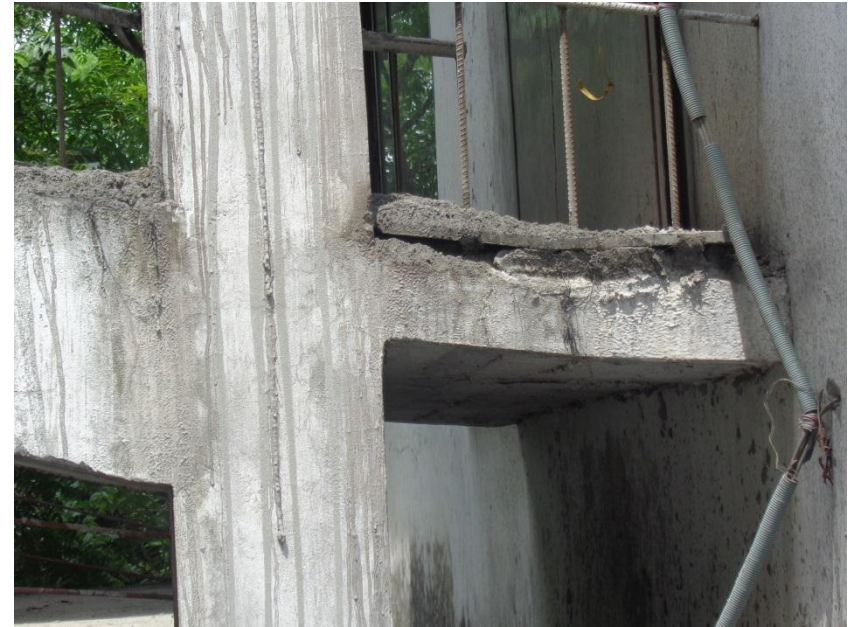
1st Priority 2 Concern

North concrete stairs of office building are connected to an adjacent concrete building. No expansion joint was visible between the two structures, and the link appears insufficient to brace buildings in case of seismic activity.

5	The structural drawings for the office building and production building do not match existing conditions. In addition, no drawings were made available for the remaining ancillary buildings.	Design Engineer to review existing conditions of office building and production building and revise drawings.	Immediate - Now
6	The structural drawings for the office building and production building do not match existing conditions. In addition, no drawings were made available for the remaining ancillary buildings.	Produce structural as-built drawings for all ancillary buildings.	6-weeks
7	North concrete stairs of office building are connected to an adjacent concrete building.	Detailed Engineering Assessment is required for concrete link between the two buildings.	6-weeks
8	North concrete stairs of office building are connected to an adjacent concrete building.	Implement any recommendations from DEA.	6-months

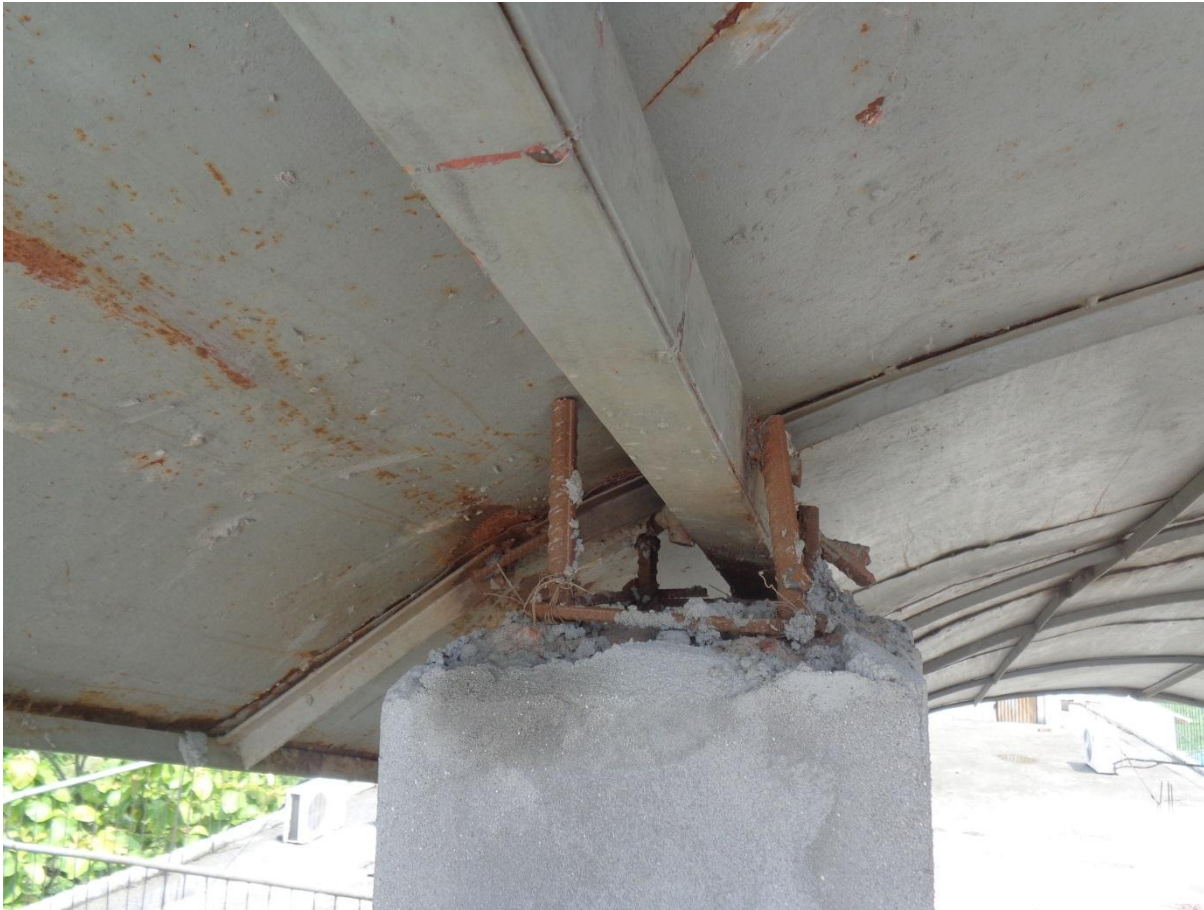
2nd Priority 2 Concern

Poor steel detailing was observed for the roof above the north stairs of the office building at the 5th floor. Poor connections between the steel angles and the concrete columns were observed.

Item No.	Observation	Recommended Action Plan	Recommended Timeline
9	Poor steel detailing was observed for the roof above the north stairs of the office building at the 5th floor.	A Detailed Engineering Assessment is required for steel roof above north stairs.	6-weeks
10	Poor steel detailing was observed for the roof above the north stairs of the office building at the 5th floor.	Implement any recommendations from DEA.	6-months
11	Water tank structure appears inadequately designed.	A Detailed Engineering Assessment is required for the water tank structure.	6-weeks
12	Water tank structure appears inadequately designed.	Implement any recommendations from DEA.	6-months
13	Overall Stability.	Request that the Detail Engineering Assessment of the overall building to be carried out and in particular, stability and foundation aspects should be investigated in detail.	6-weeks
14	Water Ingress.	Factory Engineer to inspect water damaged structures and repair with a suitable method. Waterproofing on the roof slab is recommended. Moreover the slab drainage system should be investigated. Maintain standard of quality control.	6-months

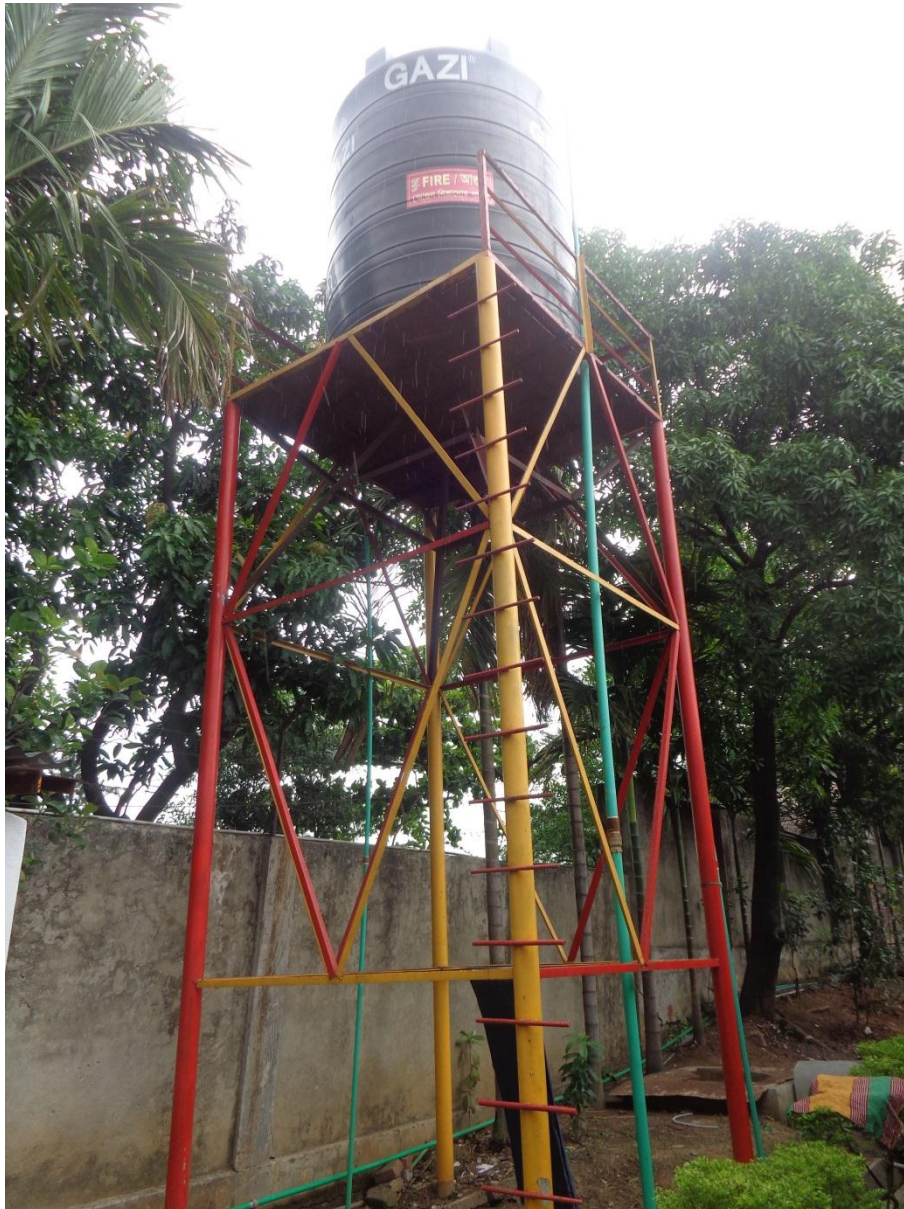
3rd Priority 2 Concern

Water tank structure appears inadequately designed. The steel plate floor supporting the water tank, as well as the steel angle braces in compression, appear under designed.

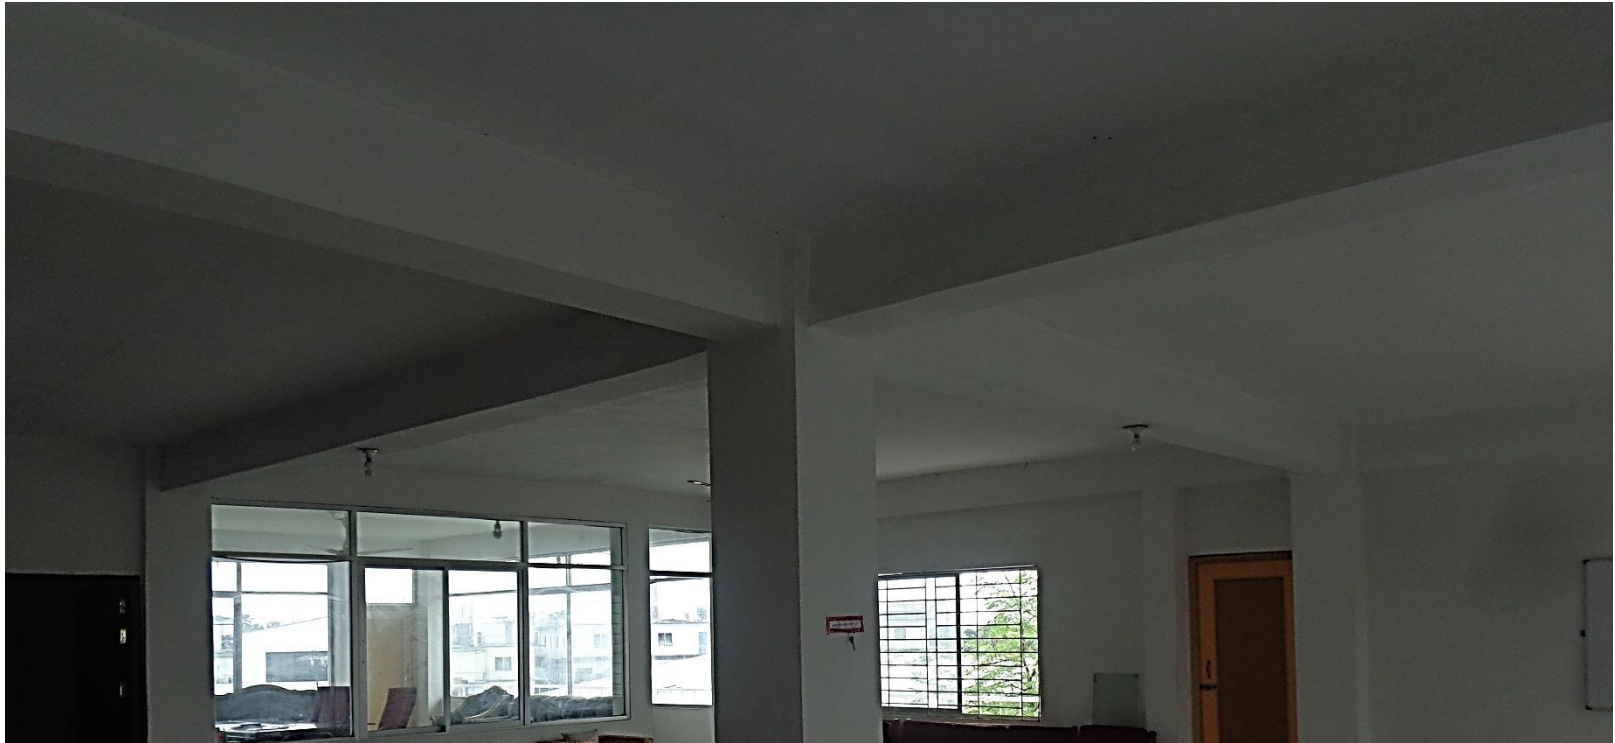
Overall Stability System

The building did not feature any core or shear walls. Stability was achieved through sway action between beams and columns and masonry infill walls.

We require that these items be investigated in a Detail Engineering Assessment

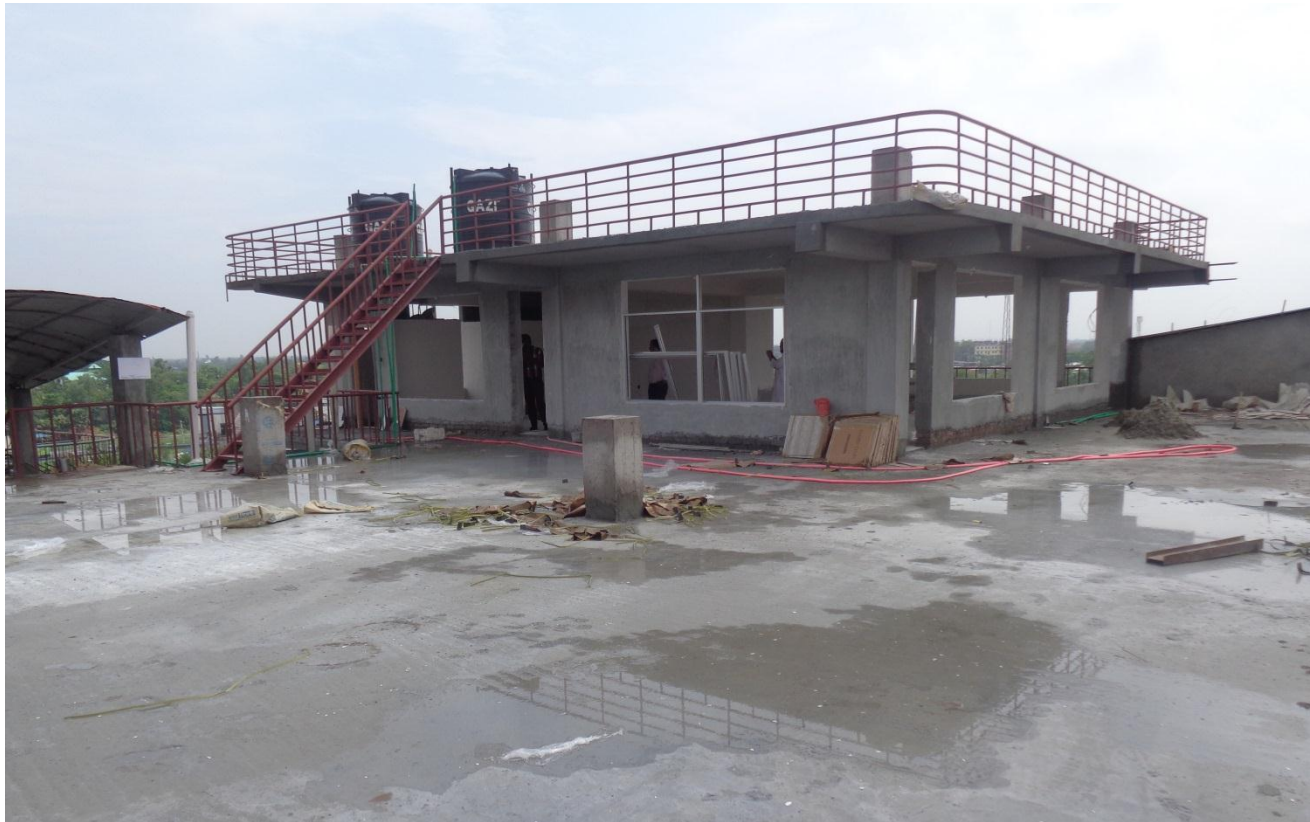
Water Ingress at Roof Level

No waterproofing membrane was visible on the roof of the building. This means that any cracks in the surface finishes on the roof will allow water to seep into the concrete slab beneath the finishes, and cause corrosion of the reinforcing steel.
