**Valmont Fashions Ltd. (9390)**  
**Valmont Sweaters Ltd., Meek Knit Ltd.,**  
**M.N.S. Printing Ltd**

Plot#928,923 AZIZ Complex, Vogra, Joydepur, Garzipur  
(+ 23.981214N,90.380281E)

28.MAY.2014

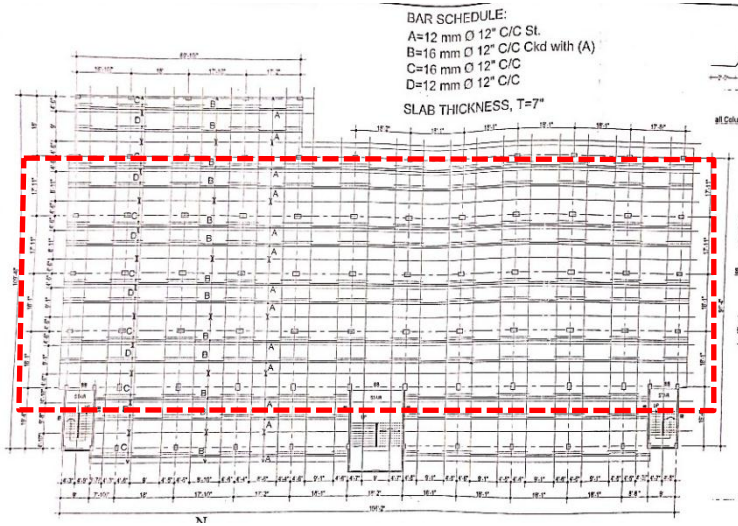
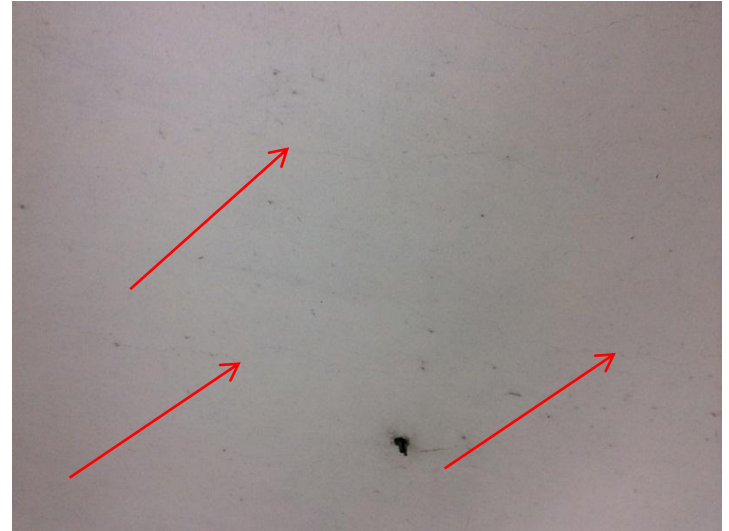
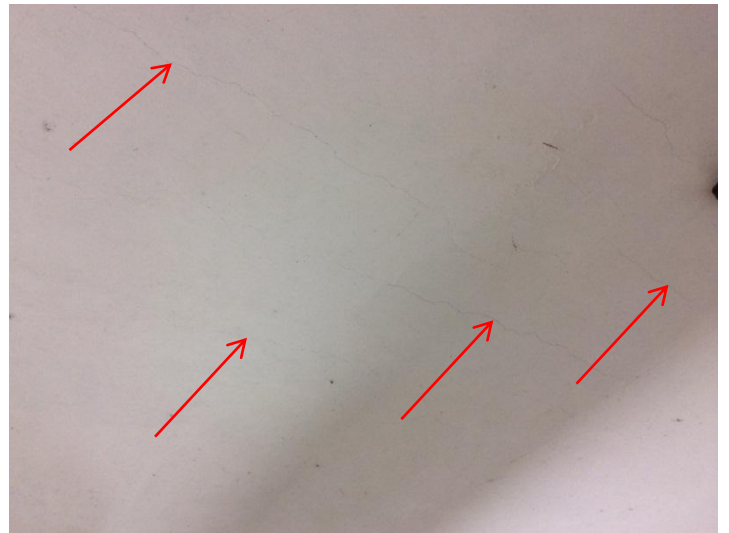
Cracks appeared underside slab on 4<sup>th</sup> - 6<sup>th</sup> floor level, capacity check is required prior to repairing.

| Item No. | Observation | Recommended Action Plan | Recommended Timeline |
|---|---|---|---|
| 1 | Cracks appeared underside slab on building 1, capacity check is required prior to repairing. | A Detailed Engineering Assessment of the factory is to be carried out. The distress found is to be suitably repaired. Simply plastering over is not allowed. | 6-weeks |

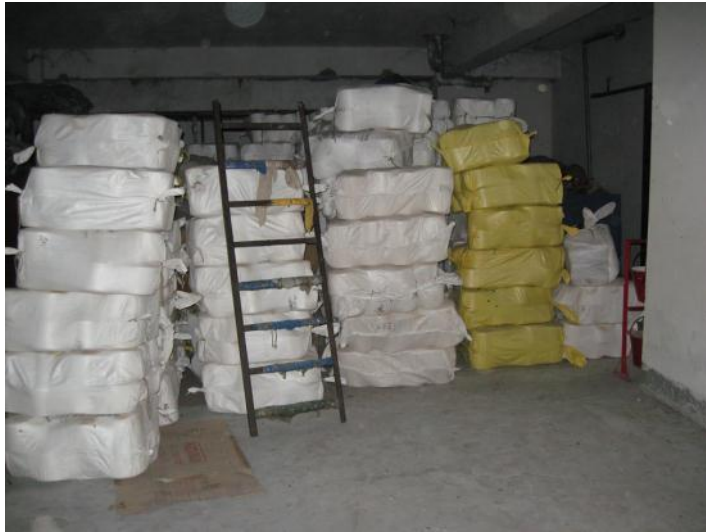
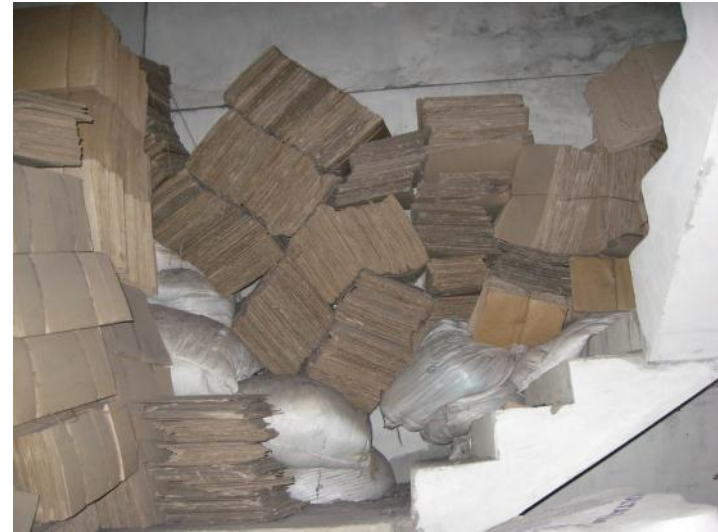
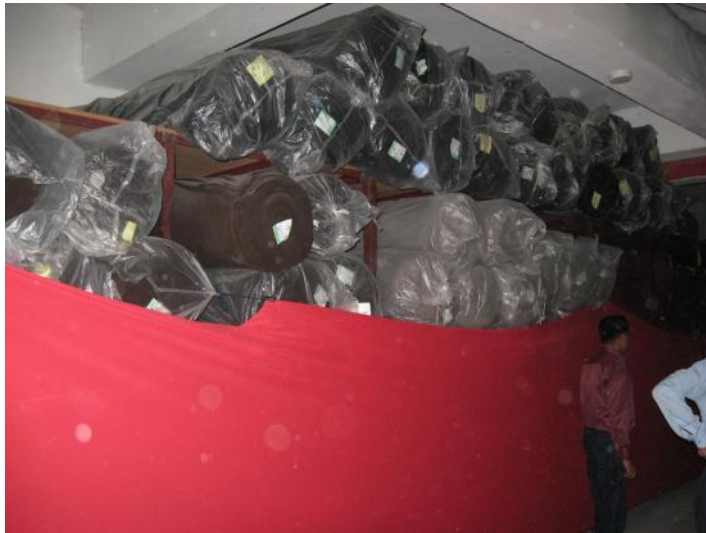
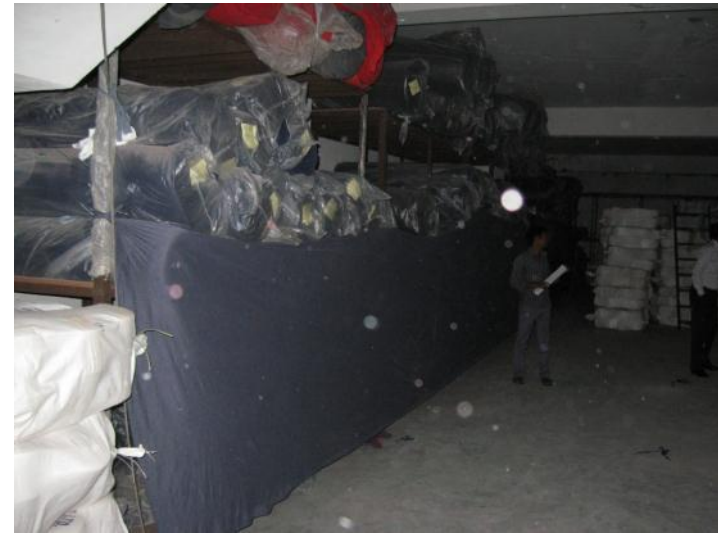
Uncontrolled heavy storage on ground floor. .  
The apparent live load is believed to be 5.0 kPa.  
Loading plan needs to be implemented.

| Item No. | Observation | Recommended Action Plan | Recommended Timeline |
|---|---|---|---|
| 3 | Uncontrolled heavy storage loading on building 2. | Reduce stacking height of fabric rolls to ensure total load does not exceed 3.0kPa.<br>Adopt some sort of signage/staff guidance to ensure that the maximum weight of storage is not exceeded. | 6-weeks |

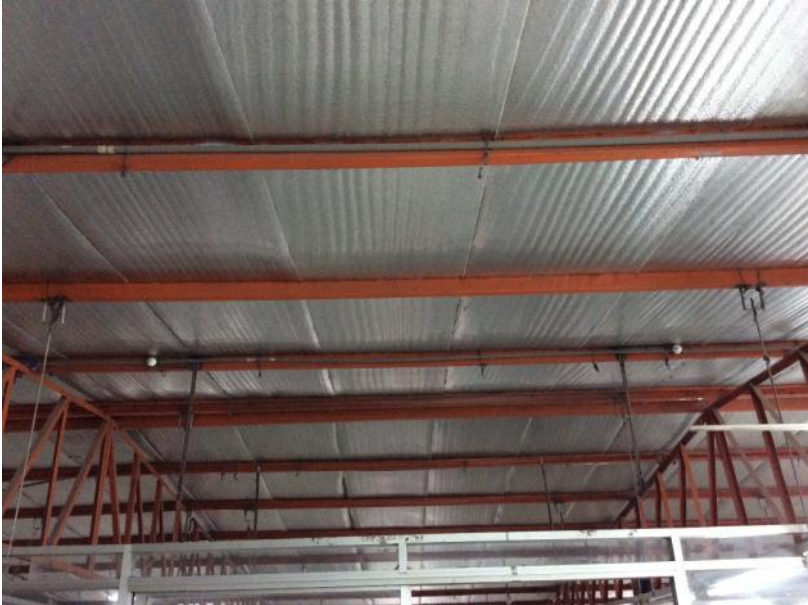
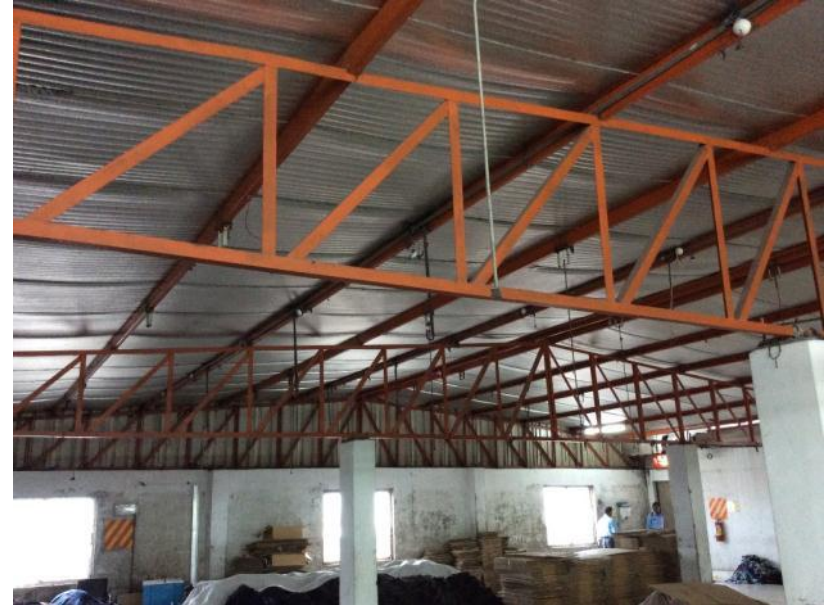
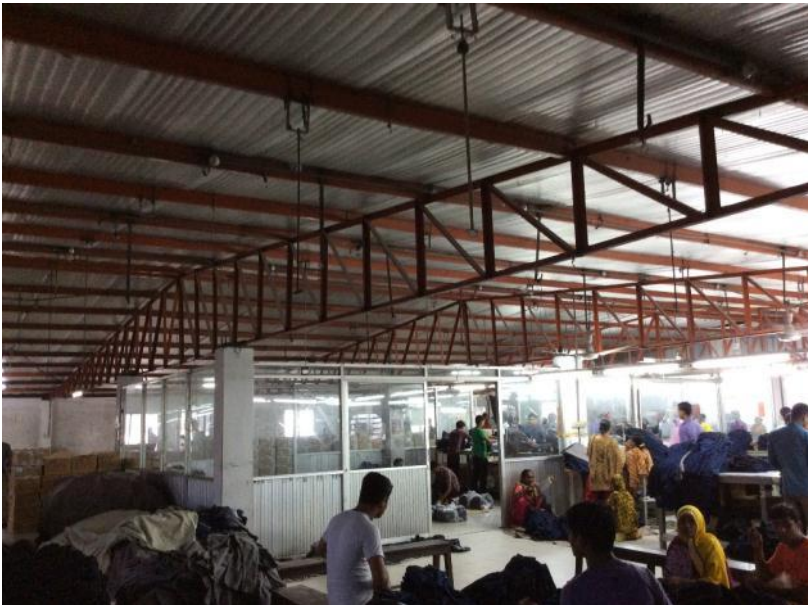
There is no structural drawings provided and insufficient lateral steel bracing. Capacity check is required.

| Item No. | Observation | Recommended Action Plan | Recommended Timeline |
|---|---|---|---|
| 5 | No structural drawings for steel roof and insufficient lateral steel bracing on building 1, capacity check is required. | Factory Engineer to review design and Detailed Engineering Assessment to be completed. | 6-weeks |

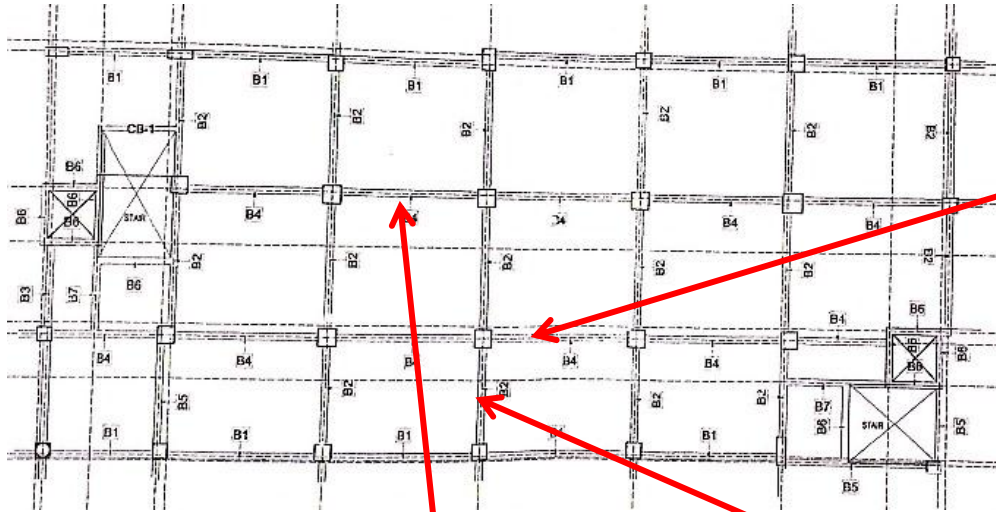
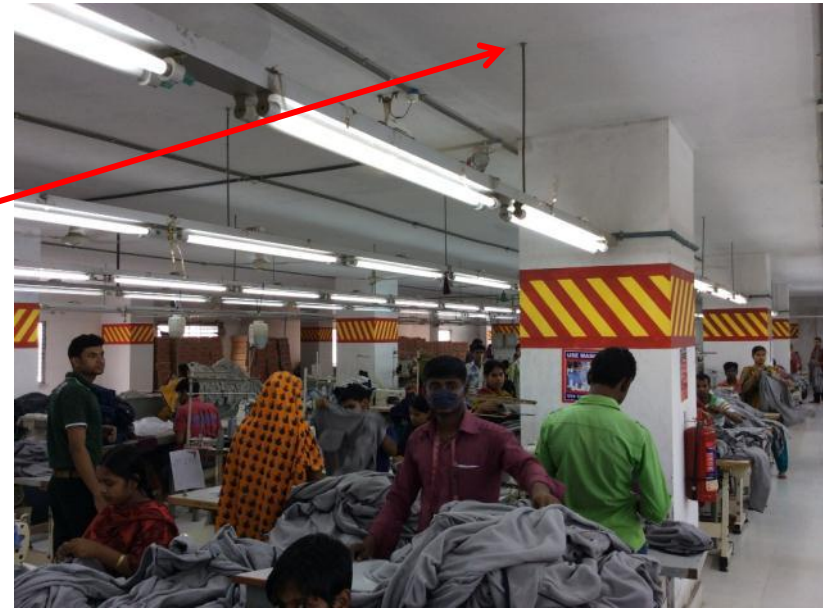
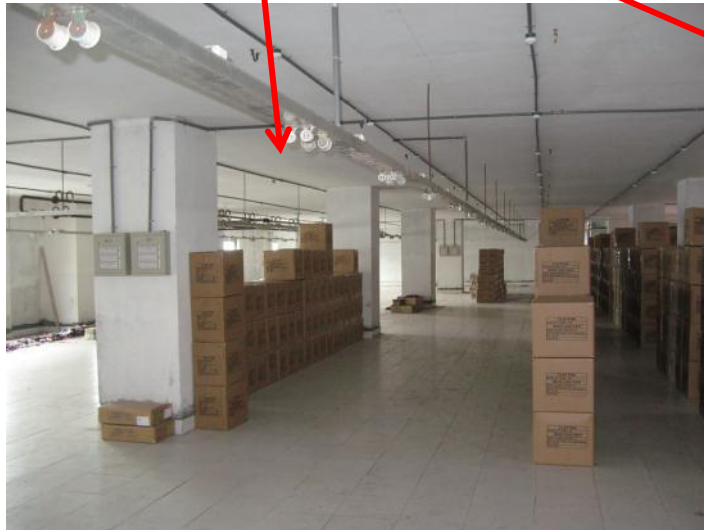
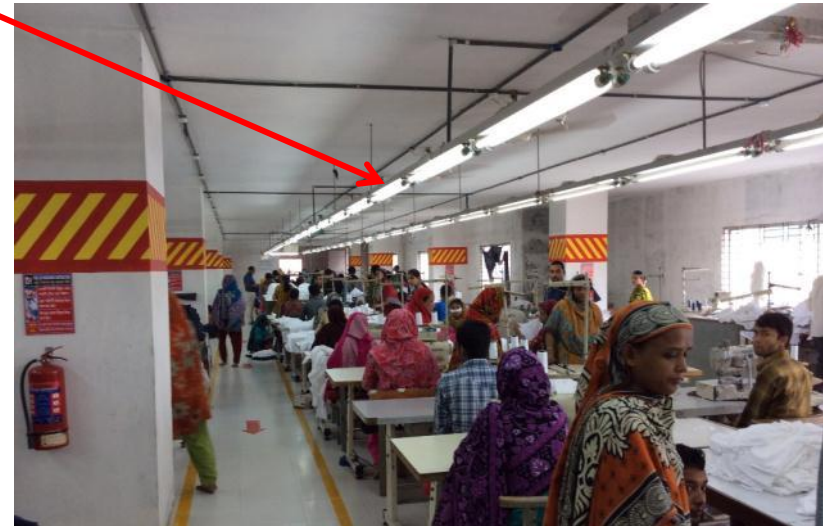
There are no R.C. beam on 1st to 4th floor levels and these do not match structural drawings. Capacity check is required.

| Item No. | Observation | Recommended Action Plan | Recommended Timeline |
|---|---|---|---|
| 6 | Existing structural system of building 2 does not match the construction documentations. | Factory Engineer to review design and Detailed Engineering Assessment to be completed. | 6-weeks |

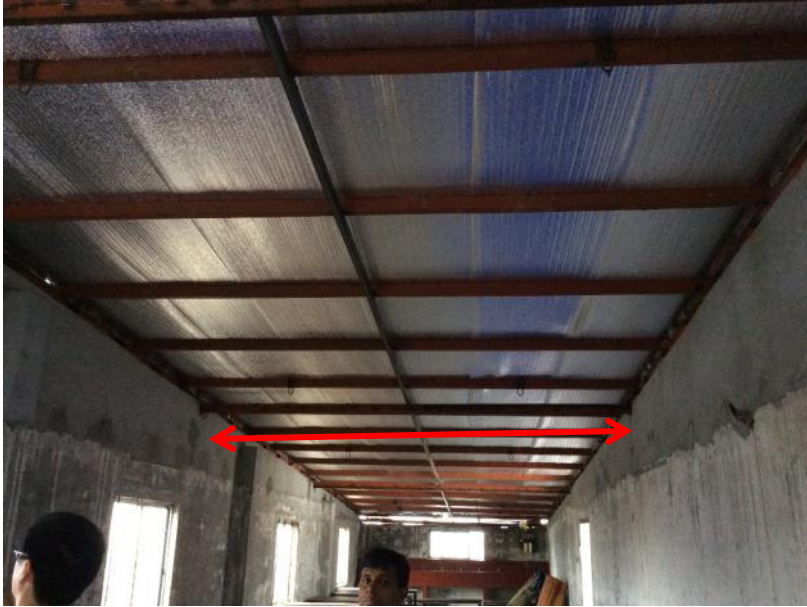
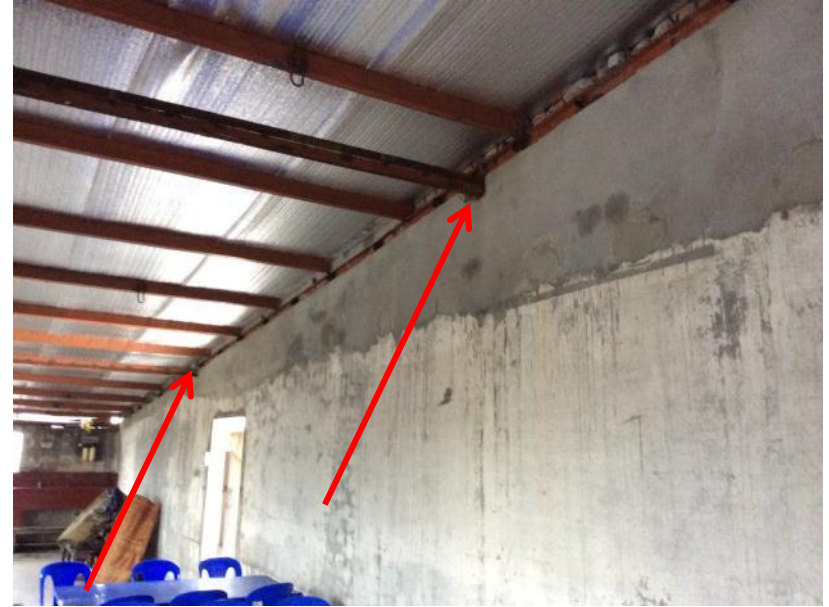
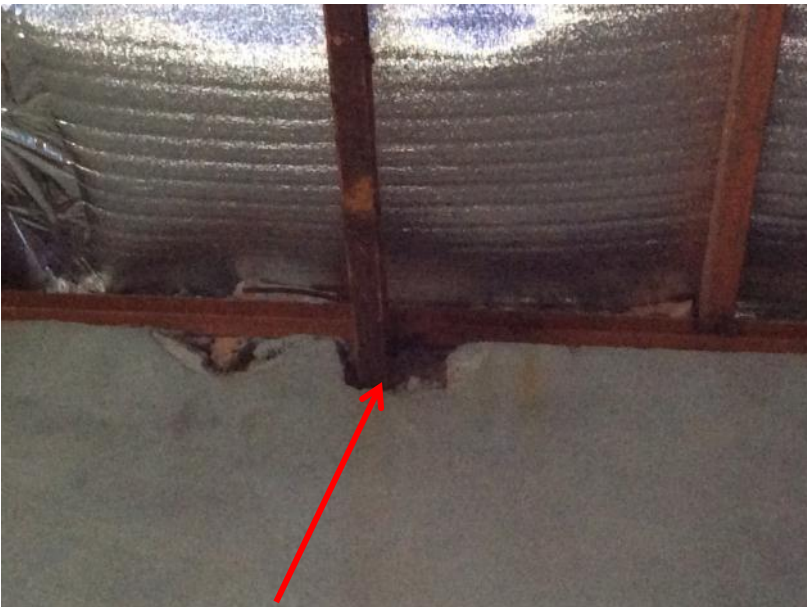
There are no structural support for steel roof. Capacity check is required.

| Item No. | Observation | Recommended Action Plan | Recommended Timeline |
|---|---|---|---|
| 7 | No structural support for steel roof on building 1. | Factory Engineer to review design and Detailed Engineering Assessment to be completed. | 6-weeks |

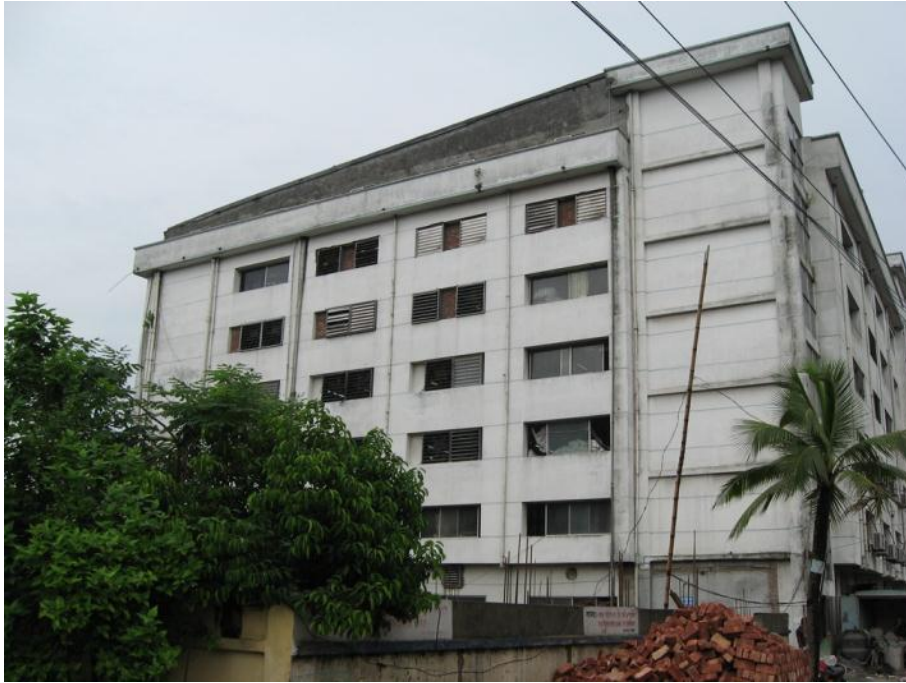
Concerns on the stability system for lateral loading. Façade brickwork walls lack of moment capacity in connection between columns and flat slab.

We require that these items be investigated as part of a Detailed Engineering Assessment and design review.

| Item No. | Observation | Recommended Action Plan | Recommended Timeline |
|---|---|---|---|
| 8 | Overall stability system on building 1 and 2. | Request that the Detail Engineering Assessment of the overall building to be carried out and in particular, stability and foundation aspects should be investigated in detail. | 6-weeks |

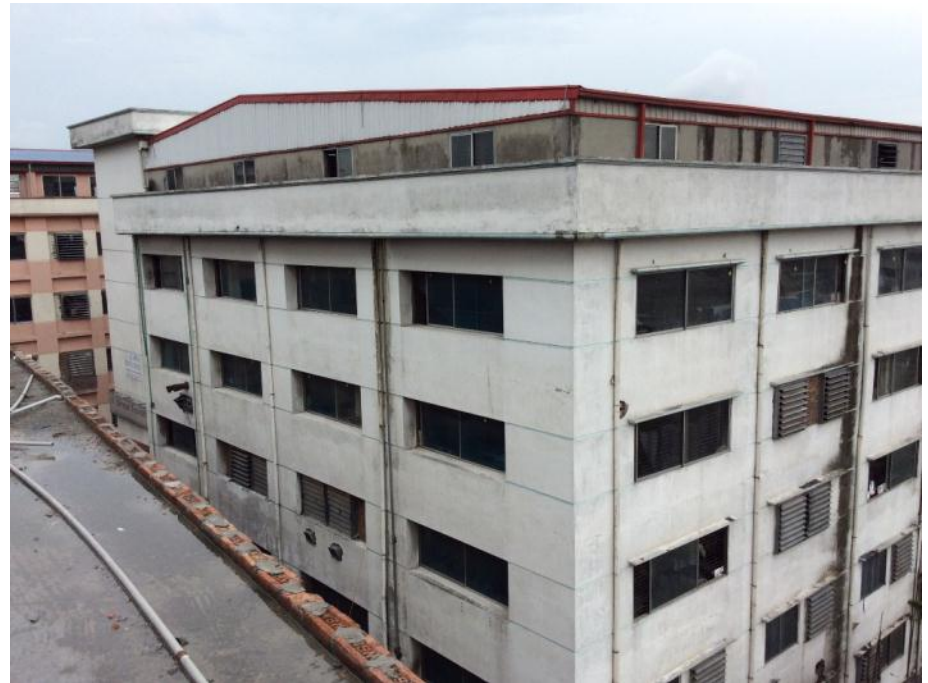
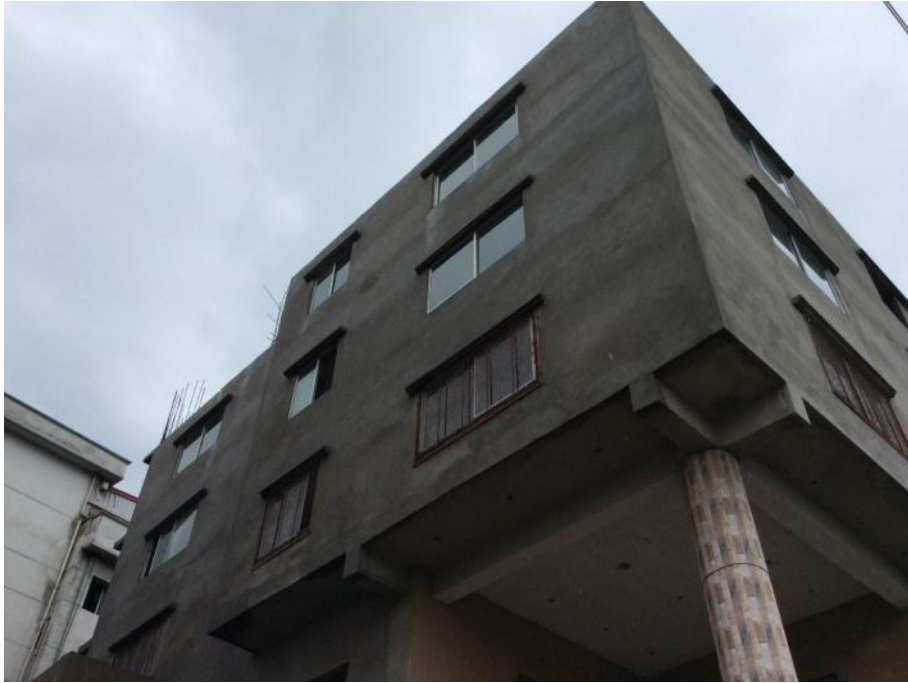
Concerns on the stability system for lateral loading. Façade brickwork walls lack of moment capacity in connection between shear wall, columns and flat slab.

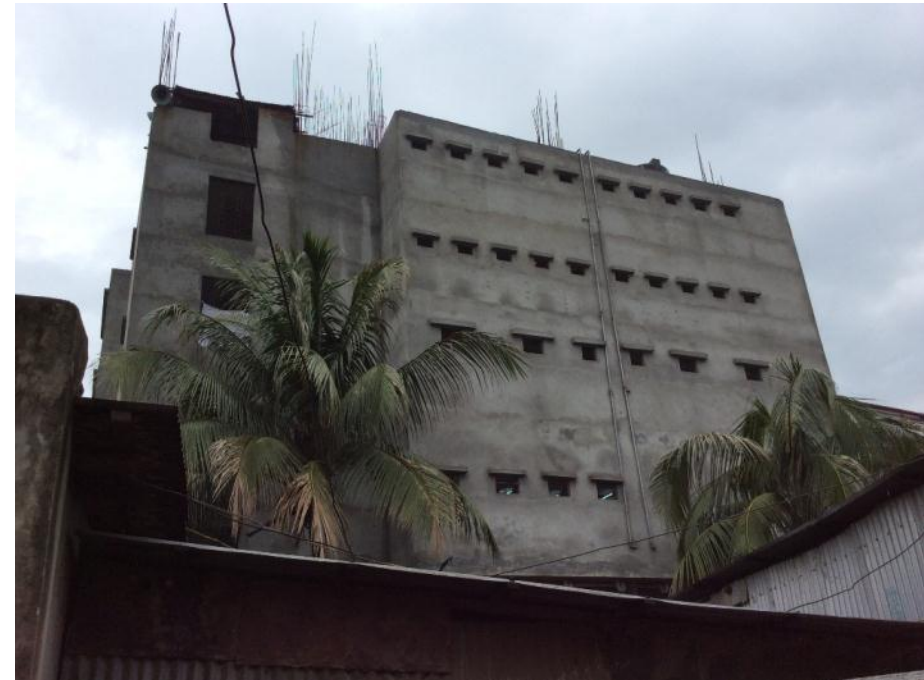
Although, the building have been used shear wall and moment frame for stability but the existing slab and beam structure have been changed to flat slab. We require that these items be investigated as part of a Detailed Engineering Assessment and design review.

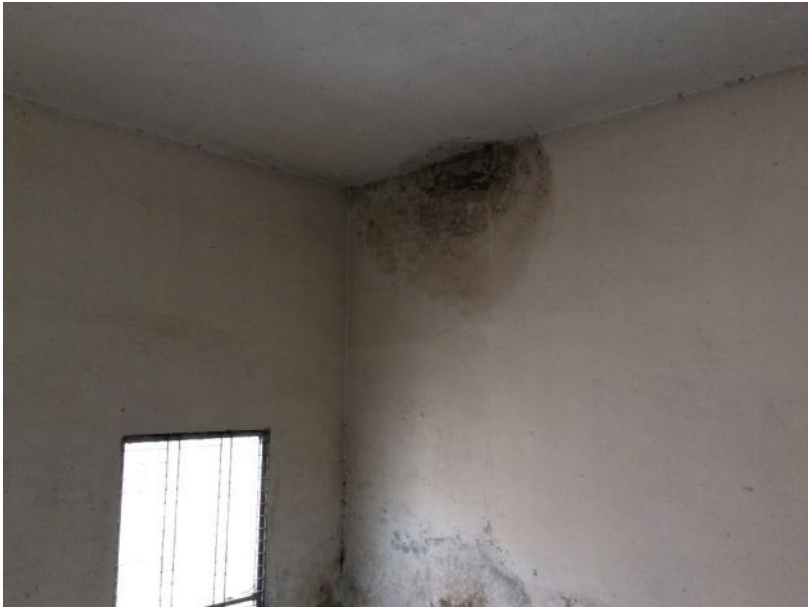
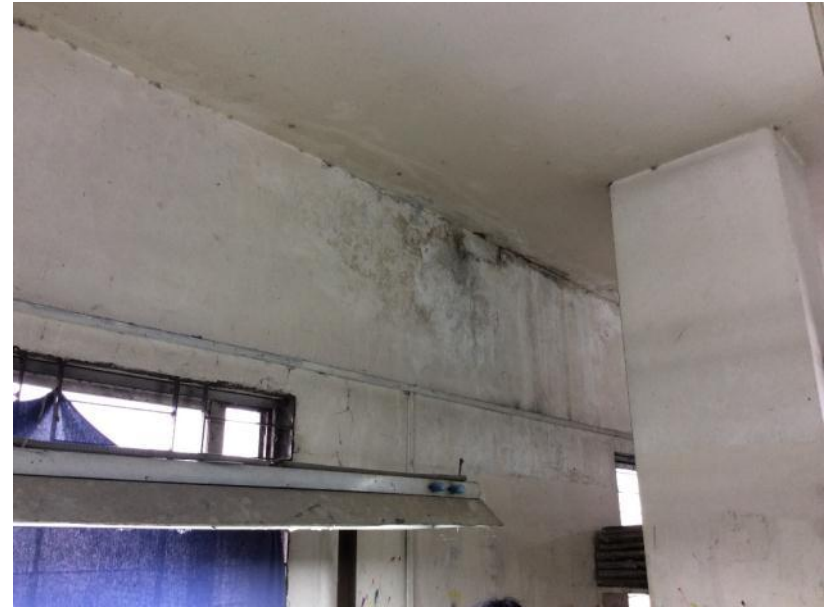
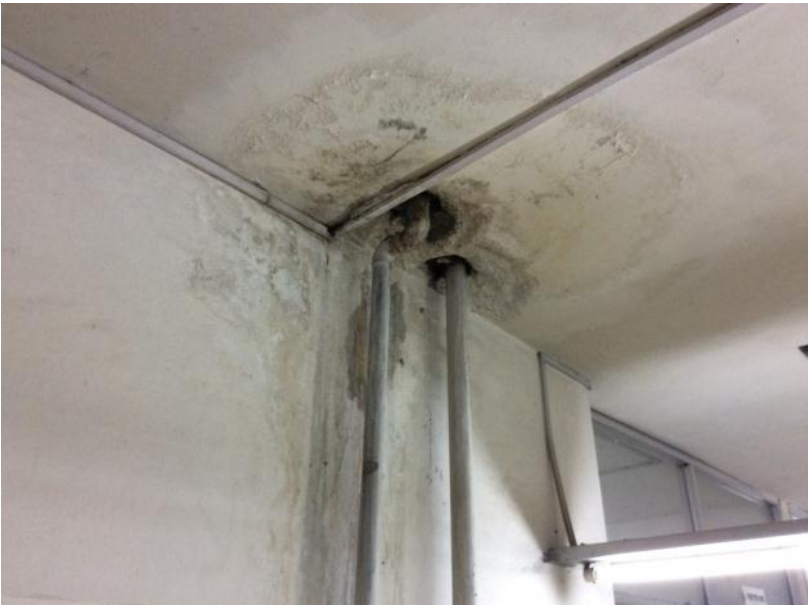
There are water ponding on the roof slab after the rain and distress due to water ingress noted on slabs and walls.

| Item No. | Observation | Recommended Action Plan | Recommended Timeline |
|---|---|---|---|
| 9 | Distress due to water ingress on building 1 and 2. | Factory Engineer to inspect water damaged structures and repair with a suitable method. | 6-weeks |
| 10 | Distress due to water ingress on building 1 and 2. | Waterproofing is recommended. Moreover the slab drainage system should be investigated.<br>Maintain standard of quality control. | 6-months |

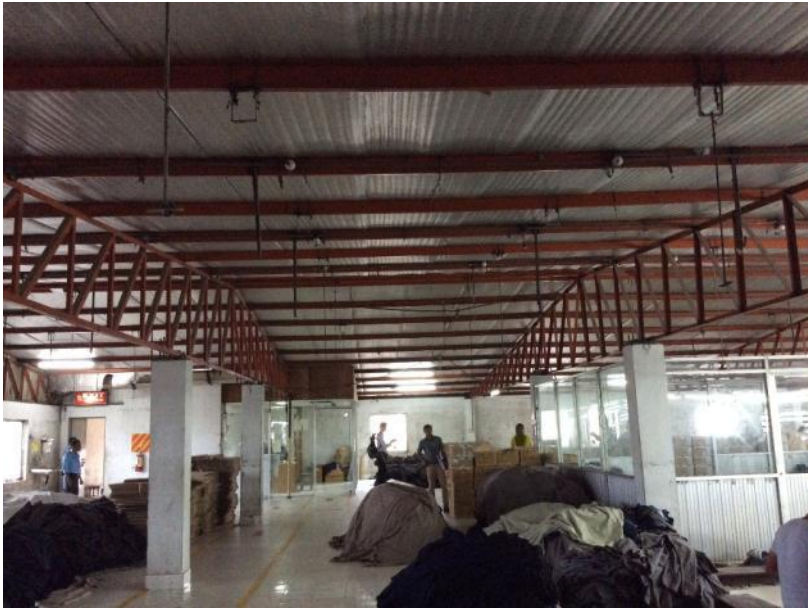
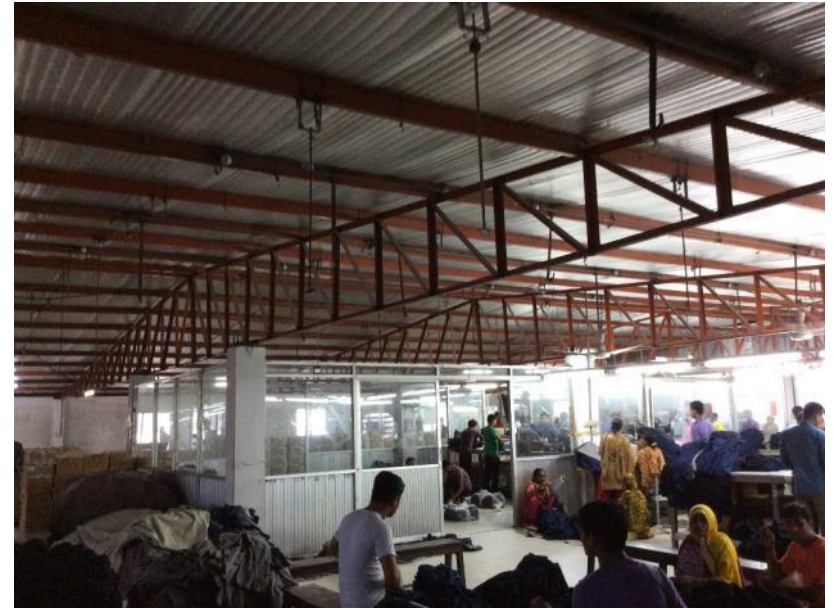
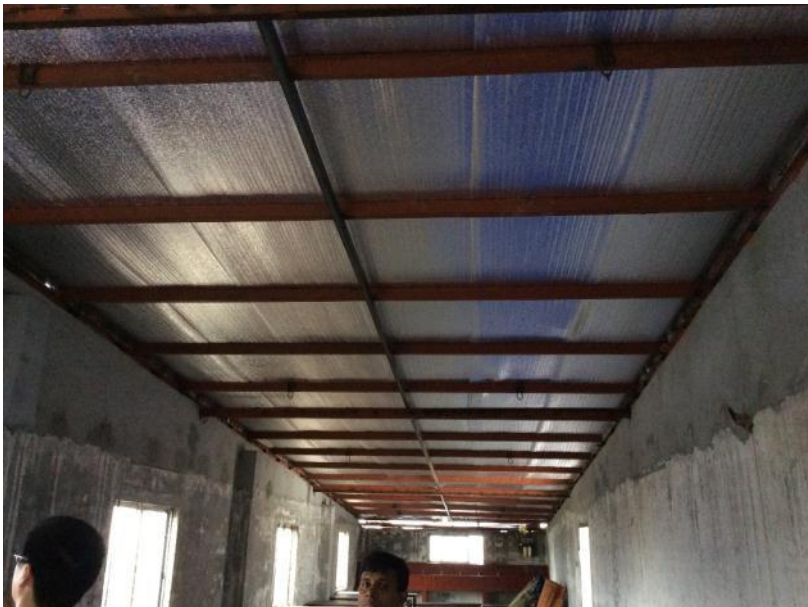
There are no fireproofing material applied for structural steel elements. It is unclear whether it is required by BNBC.

| Item No. | Observation | Recommended Action Plan | Recommended Timeline |
|---|---|---|---|
| 11 | No fireproofing material applied for structural steel elements on building 1 (if required). | Fireproofing material for structural steel element is recommended as suggested in BNBC Codes.<br>Maintain standard of quality control. | 6-months |

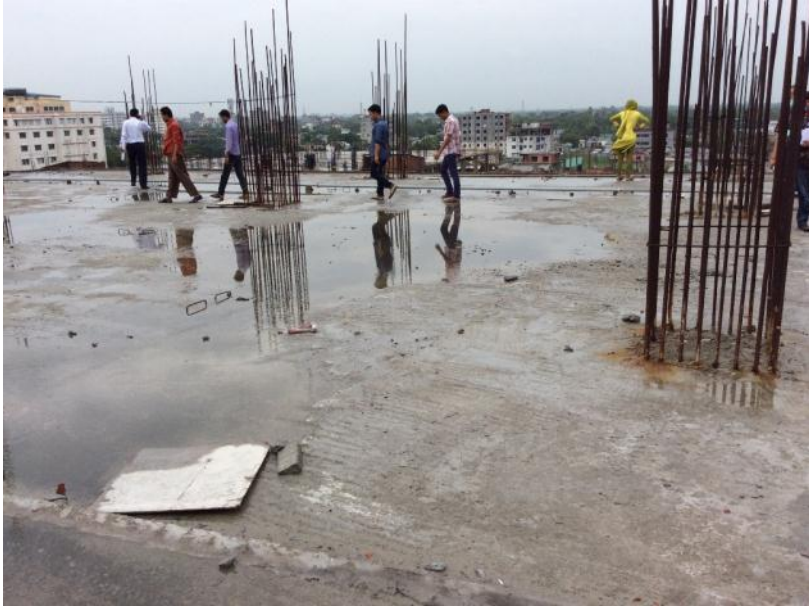
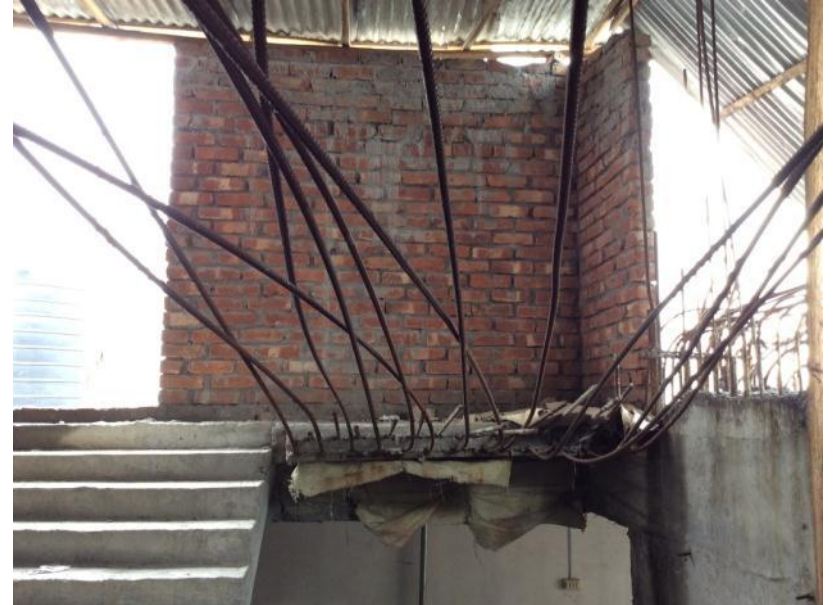
Reinforcement is left exposed, anti-rust paint is required.

| Item No. | Observation | Recommended Action Plan | Recommended Timeline |
|---|---|---|---|
| 12 | Reinforcement left exposed on building 2. | For both durability and serviceability, rust proof paint or any appropriate methods is recommended. | 6-months |

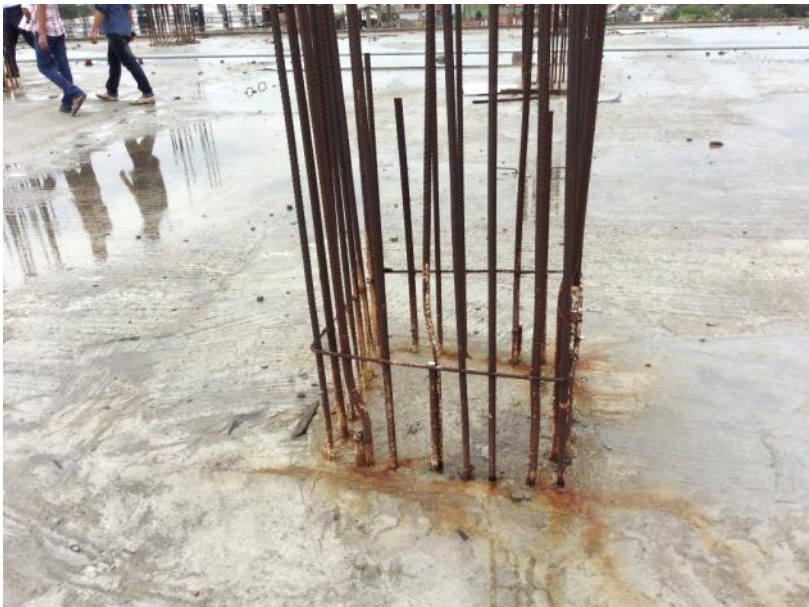
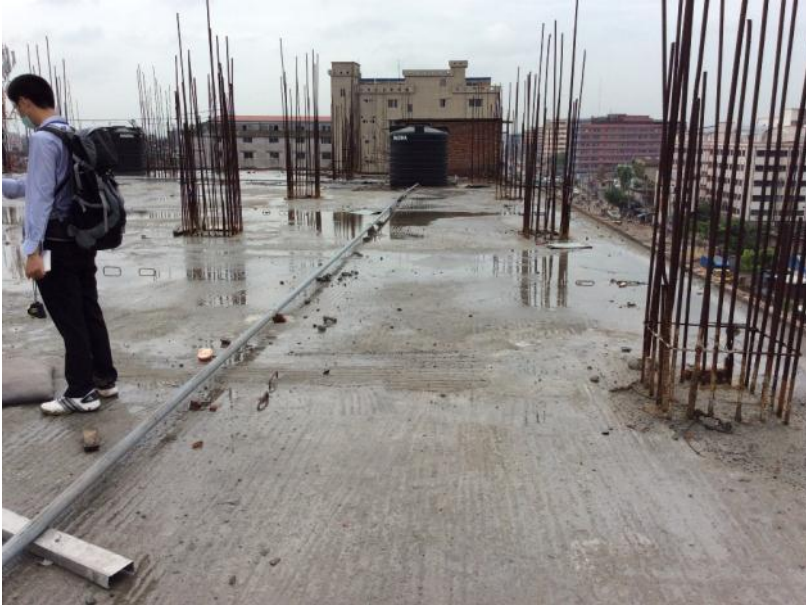
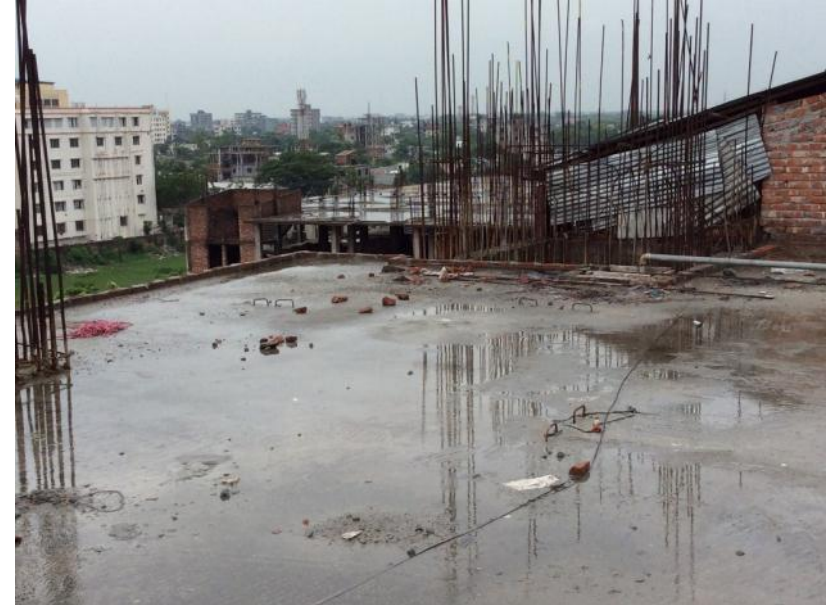
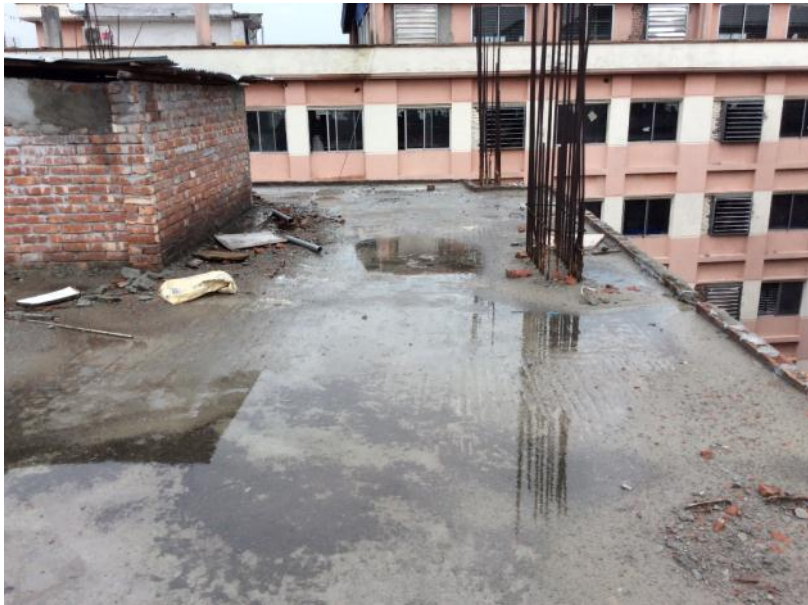
There is no parapet wall around the perimeter of the building. Whilst not a structural issue, this is a significant health and safety risk and should be rectified.

| Item No. | Observation | Recommended Action Plan | Recommended Timeline |
|---|---|---|---|
| 13 | No parapet wall present on top floor for building 2. | A suitable perimeter fence or wall should be constructed along the building envelope. Standard parapet is capable of resisting horizontal loads. | 6-months |
