# Saiham Knit Composite Ltd (9520)

Saiham Nagar, Noyapara, Madhabpur, Hobigonj

28.May.2014

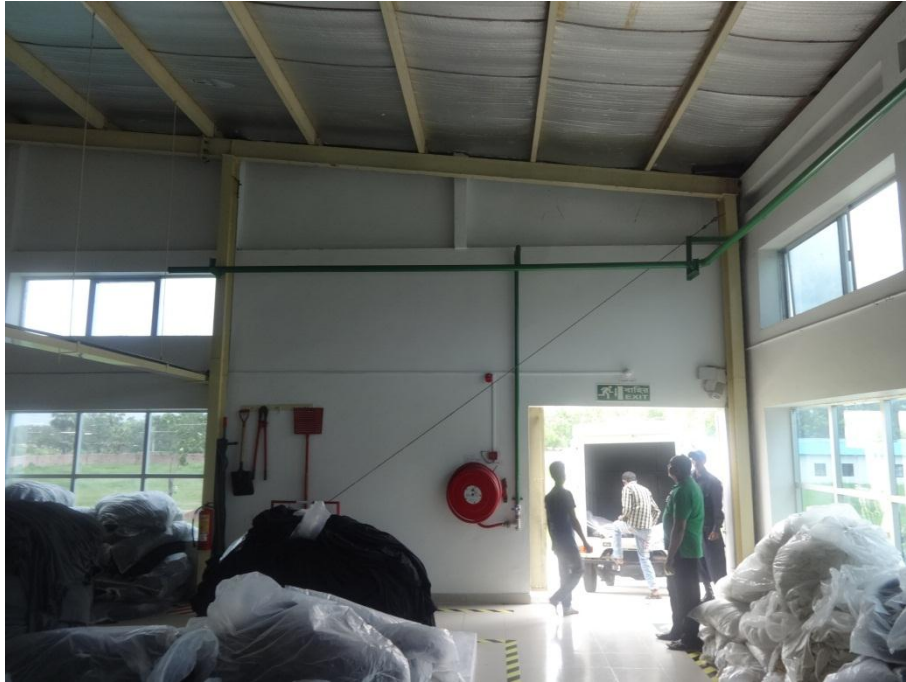
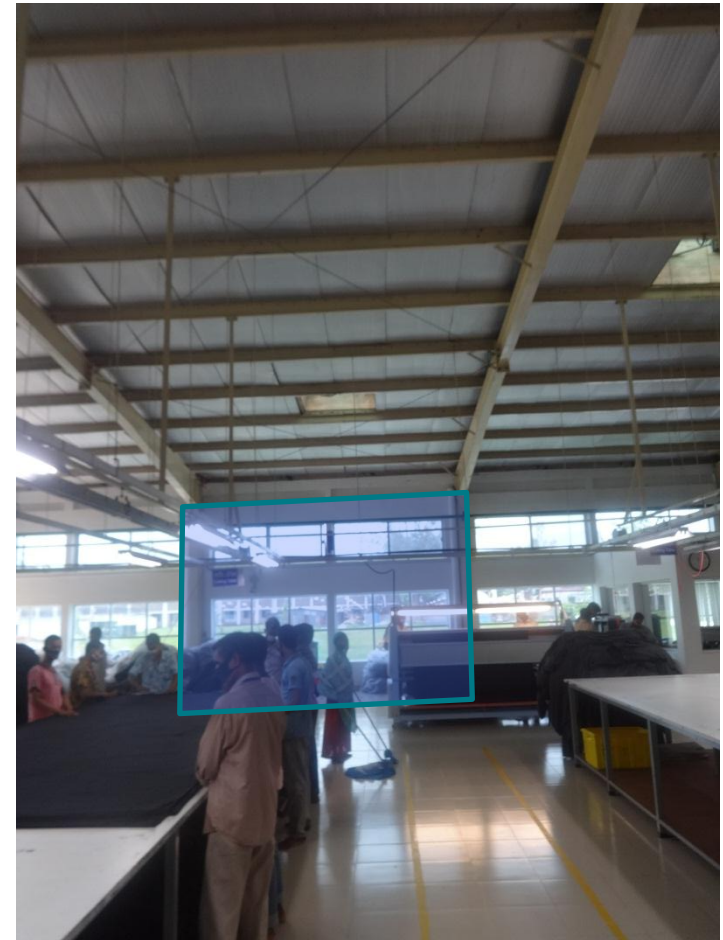
These images show two separate locations in the 'Green Floor' where the bracing system has either been modified from its original design or incorrectly detailed originally. In both cases the resulting stability gained from the bracing is insufficient.

Above, one of the cables from a cross-brace has been removed to allow for a doorway; and right, the horizontal bracing expressed along one bay is not continued into the vertical plane.

Bracing inadequacies such as these were visible in numerous locations around this building.

| Item No. | Observation | Recommended Action Plan | Recommended Timeline |
|---|---|---|---|
| 1 | Lateral stability of several buildings is questionable, particularly where modified to remove designed bays of bracing. | Detailed Engineering Assessment to be carried out to determine lateral stability of buildings across the site, particularly those where existing bracing has been modified. | 6-weeks |
| 2 | Lateral stability of several buildings is questionable, particularly where modified to remove designed bays of bracing. | Implement any structural changes deemed necessary by the DEA, including reinstatement of cross bracing and stiffening of portal frames/roof diaphragms if required. | 6-months |

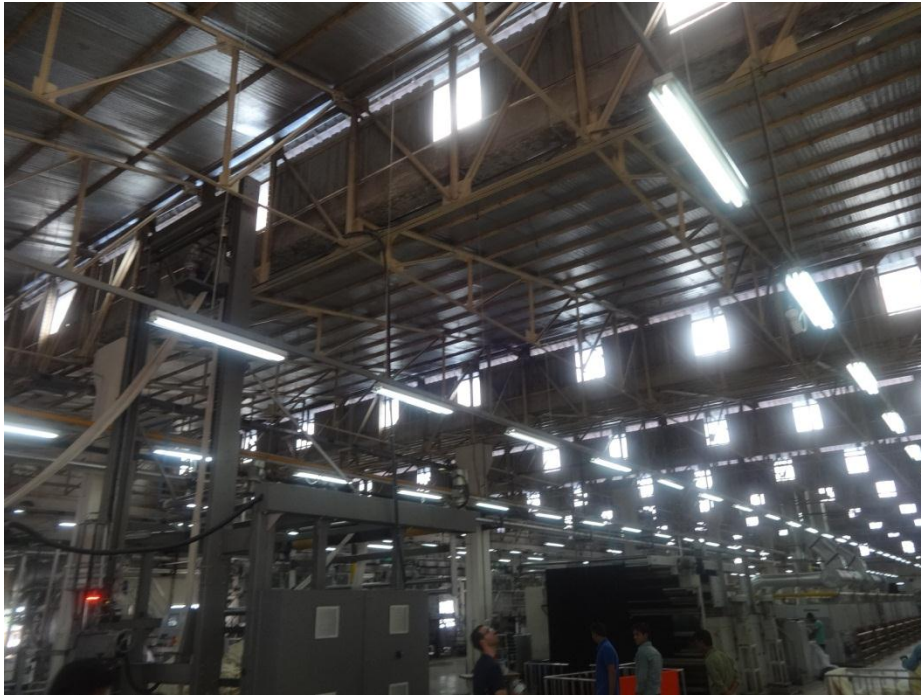
Left, the truss system supporting the roof of the '10 ton Building'. The trusses were very lightweight, and supported by 5m tall cantilever concrete columns. The anchorages to these as well as perimeter columns did not appear sufficient to transfer lateral loads.

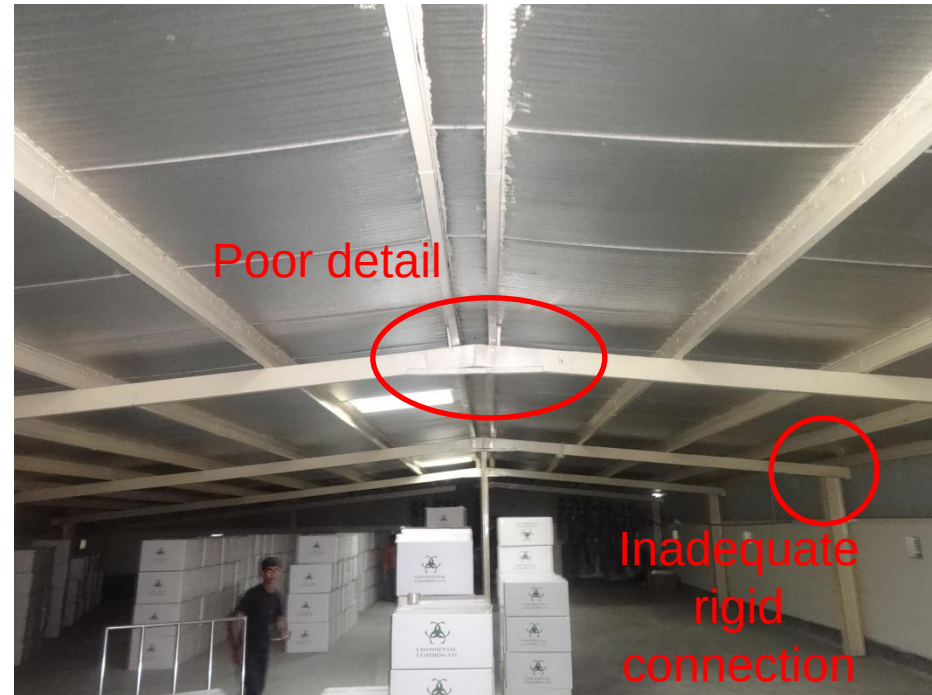
Right, a portal frame detail utilised in several different buildings across the site, in this case the storage building adjacent to the office building. The detail is an arbitrary attempt to increase inertia of the main rafter, but uses very lightweight members. Furthermore, the connection does not appear stiff enough to provide lateral stability. In addition to this, the lightweight roof build-up is very unlikely to provide diaphragm action.

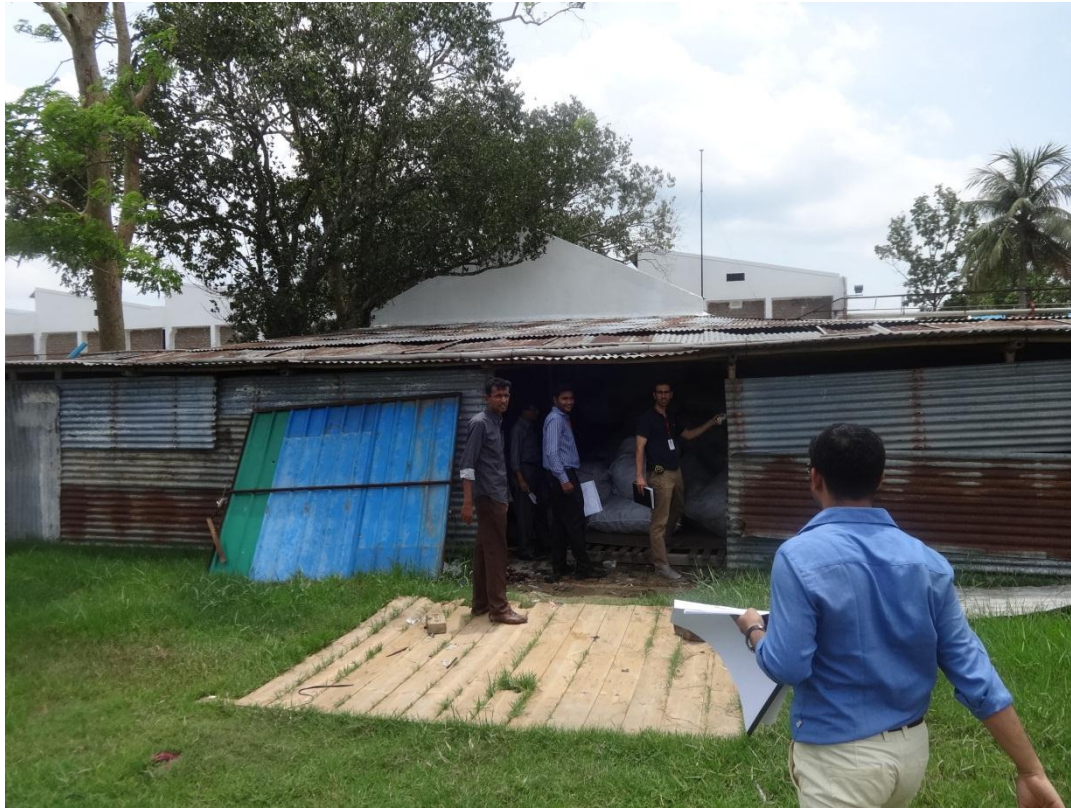
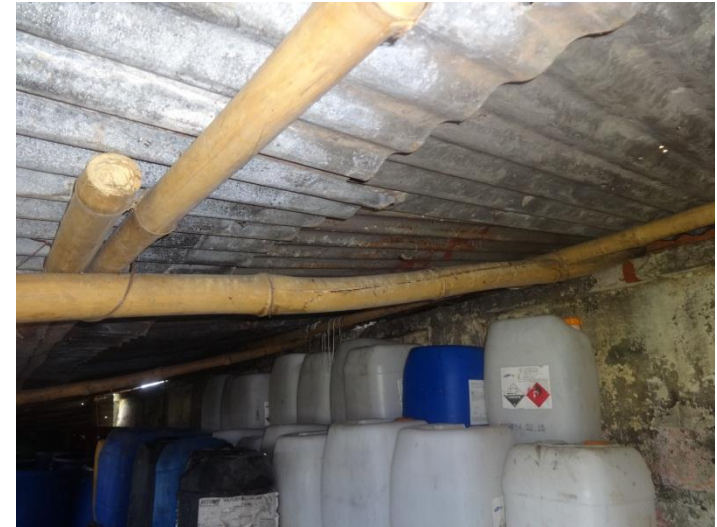
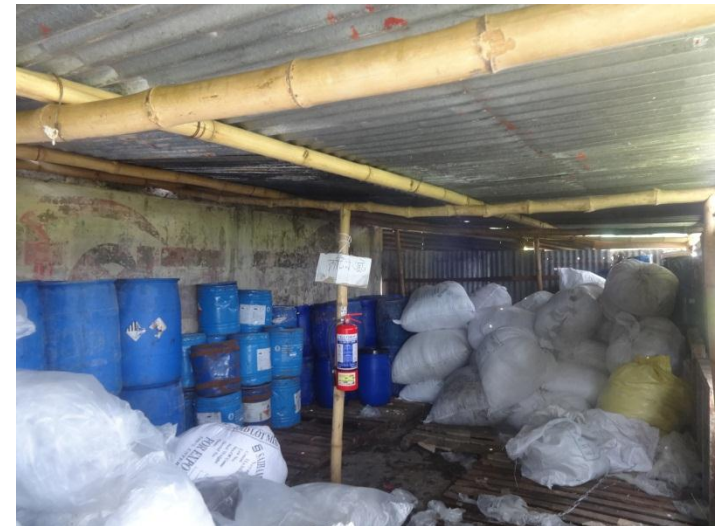
Above, external view of a bamboo-framed shed structure, with evidence of damage and excessive deflection shown above right and right. Note also the fire extinguisher, contradicting the claims that this is only a temporary structure.

This building does not house any permanent staff, and therefore does not pose a major threat to life, however its instability is liable to cause injury if not amended.

| Item No. | Observation | Recommended Action Plan | Recommended Timeline |
|---|---|---|---|
| 3 | Inadequate construction of some unlicensed buildings around the site, particularly the storage space of bamboo construction. | Structural Engineer to review construction of un-designed buildings, and carry out calculations to analyse existing capacity. Design remedial strengthening where required. | 6-weeks |
| 4 | Inadequate construction of some unlicensed buildings around the site, particularly the storage space of bamboo construction. | Implement any strengthening works deemed necessary by the Structural Engineer. | 6-months |

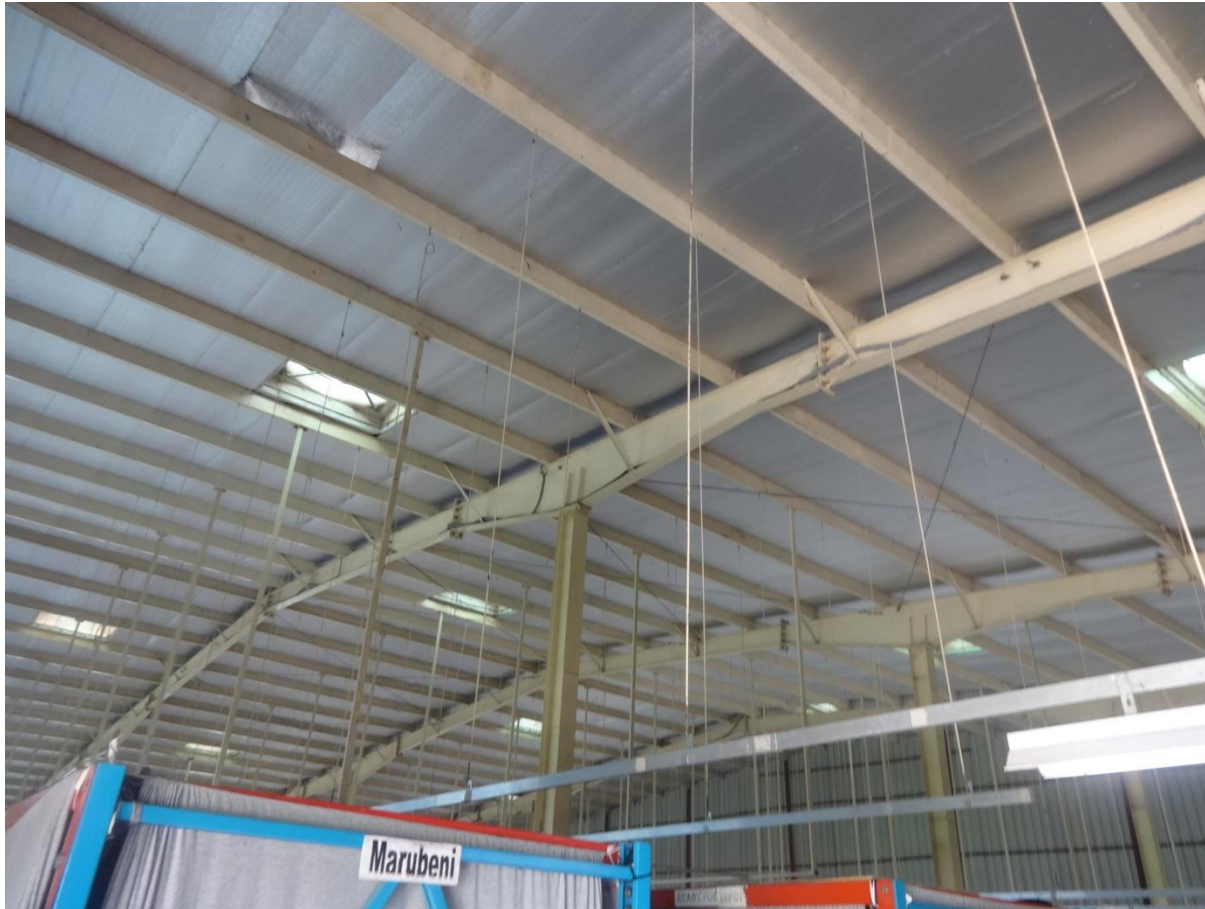
As indicated below, the vast majority of the roof steelwork, as well as that for floors and walls, was exposed and not protected against fire.

The appropriate local building codes should be consulted to ensure a sufficient level of fire resistance is implemented.

| Item No. | Observation | Recommended Action Plan | Recommended Timeline |
|---|---|---|---|
| 5 | Lack of fire-proofing to exposed structural steel members. | Factory Engineer to review BNBC requirements for fire protection. Investigate current arrangement to confirm compliance with code in this regard. | 6-weeks |
| 6 | Lack of fire-proofing to exposed structural steel members. | If existing structure does not provide sufficient fire protection, suitable fire-proofing system to be designed and implemented under the supervision of a competent Structural Engineer and Fire Engineer. | 6-months |

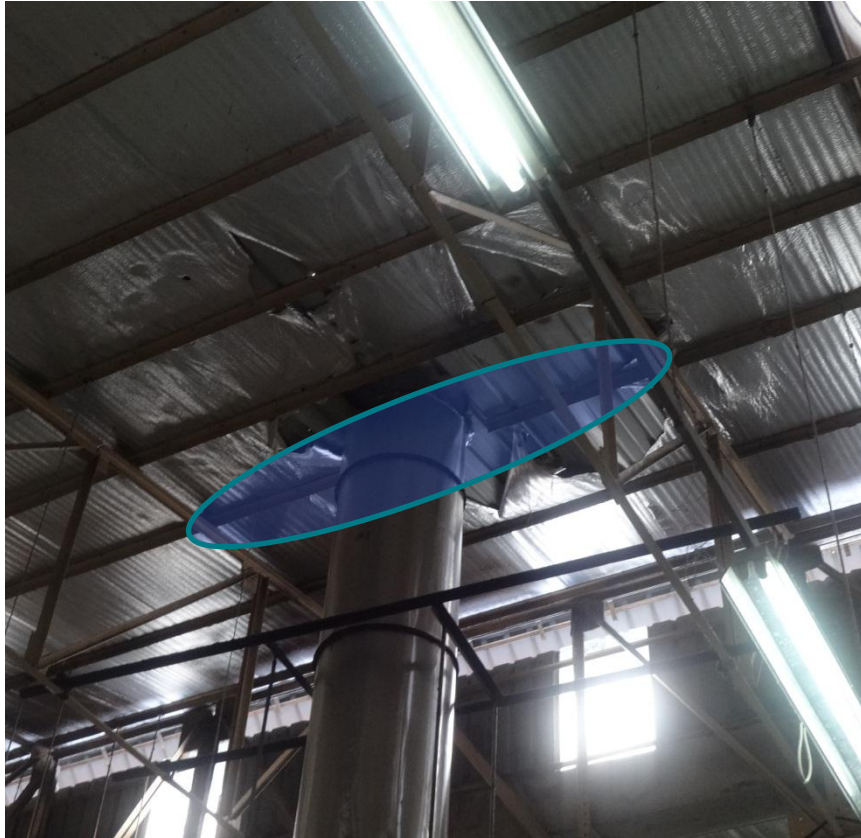
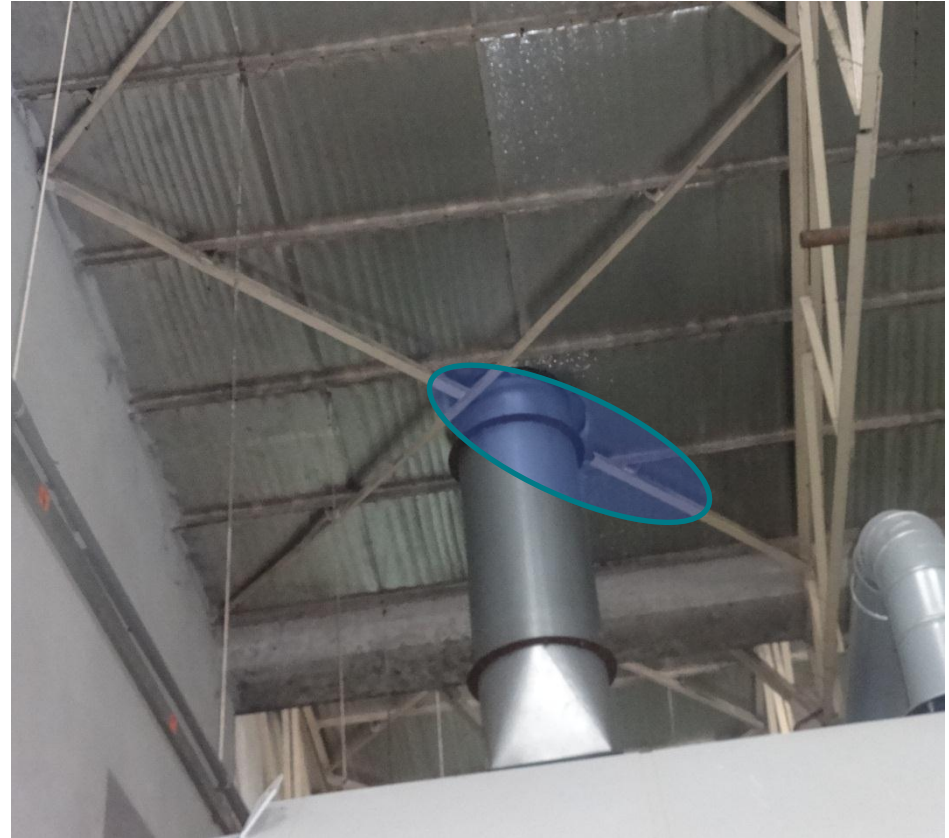
Both of these images show locations where a structural member has been cut to allow for the passage of a duct. Left, a purlin has been dismantled; while right, one angle from a section of cross bracing has been cut, rendering it useless.

| Item No. | Observation | Recommended Action Plan | Recommended Timeline |
|---|---|---|---|
| 7 | Damaged secondary structural members in '10 ton Building' following modifications to allow passage of ductwork. | Structural Engineer to design remedial repairs where elements have been modified. Repair work to be completed under Engineer's supervision. | 6-months |

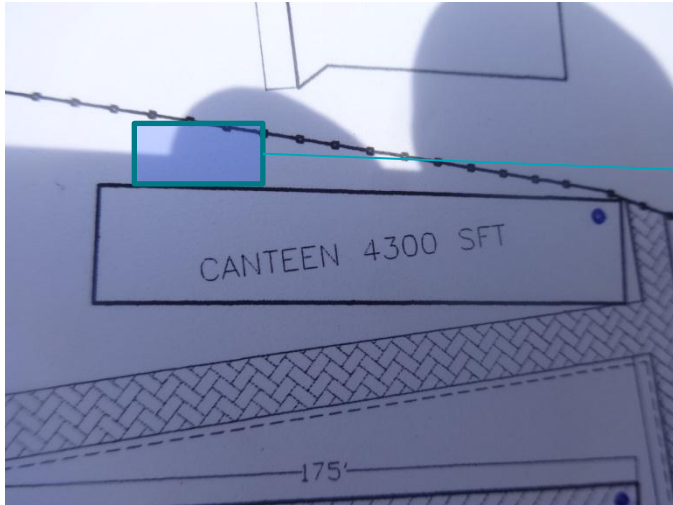
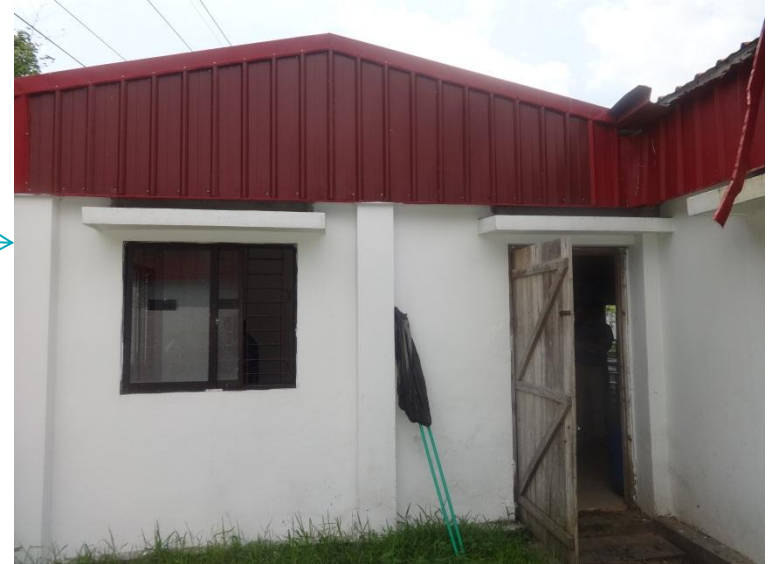
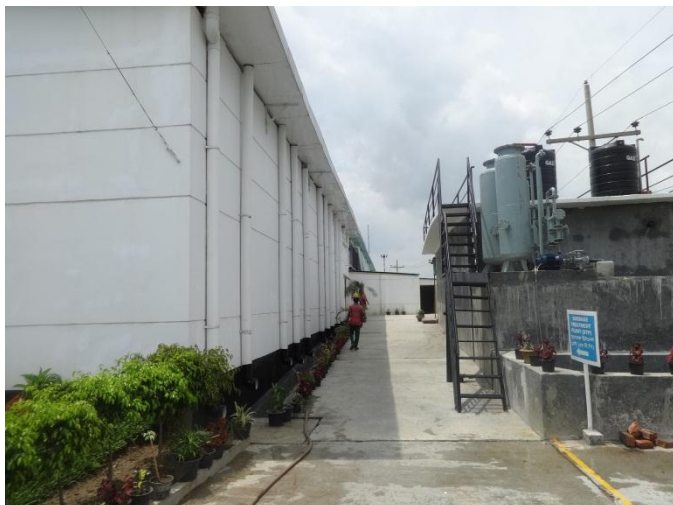
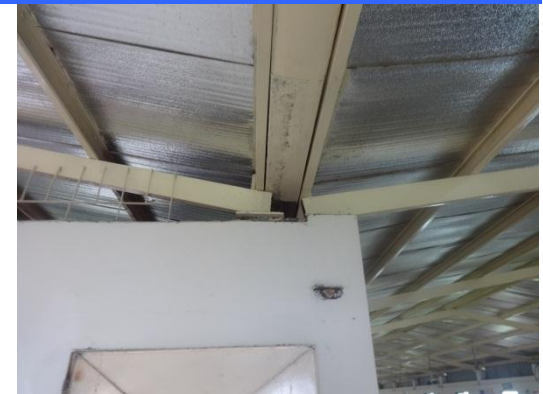
Above, layout drawing of the canteen (left) and an extension that was not indicated on this drawing, containing some insufficiently designed connections between this and the main building (right). Below right is an example of the poor connection details between the two phases of construction, and below left is an STP not indicated on the layout drawings.

None of these concerns present an immediate threat to safety, but it is important for future stages of work or inspections that drawings are updated to match reality.

| Item No. | Observation | Recommended Action Plan | Recommended Timeline |
|---|---|---|---|
| 8 | Incomplete or inaccurate structural and architectural drawings. | Factory Engineer to survey the actual site conditions. Structural and architectural drawings to be amended/updated to accurately reflect site conditions. | 6-months |

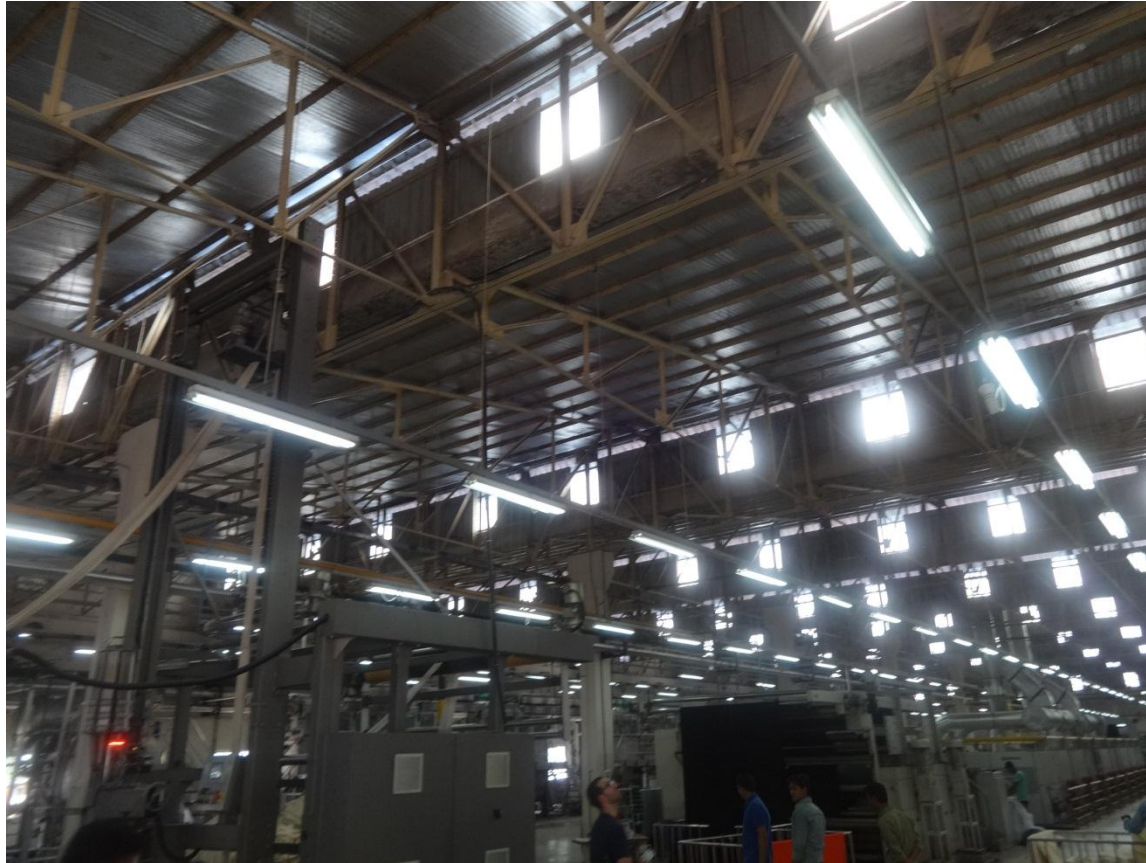
The cantilever concrete columns supporting the steel trusses in the '10 ton Building' were found to have a highly variable number of reinforcing bars, following Ferros scanning. As well as inaccuracies in the drawings, this also reaffirms the requirement for further structural assessment of lateral stability systems across the site.

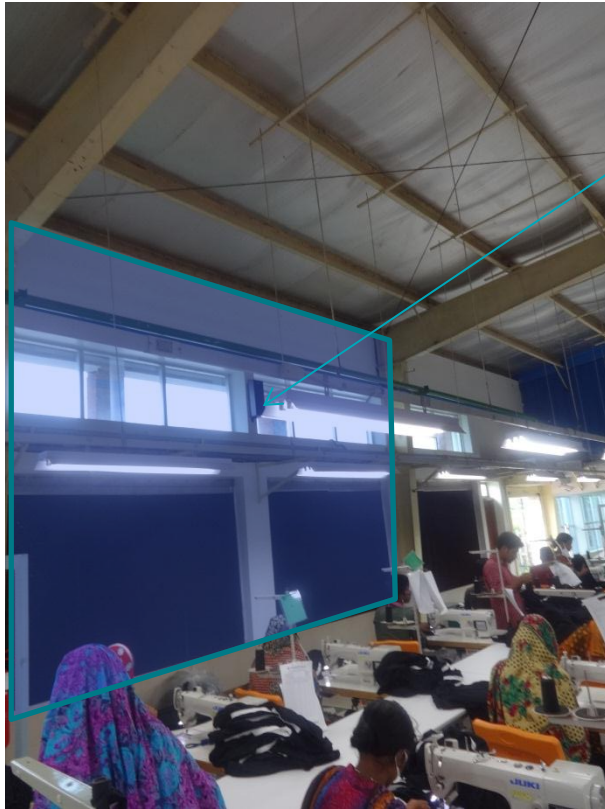
The first is the modified or removed sections of bracing from the 'Green Floor' building (below left), and the second is the apparent insufficiency in stiffness visible in several supposed portal-frame structures (below right). These portal frames are also generally poorly anchored and not supplemented by a rigid diaphragm roof.

Horizontal bracing not extended into vertical bracing in the same bay.

We require that these items be investigated in a Detail Engineering Assessment

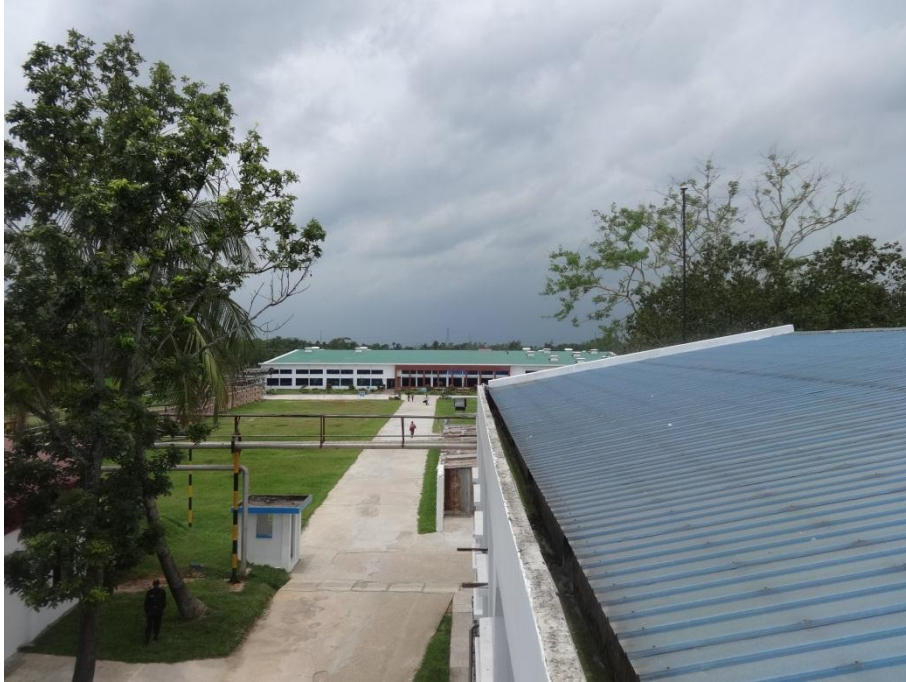
As is represented in these images of the '10 ton Building', the many structures on the site are all covered by pitched steel roofs. No signs of damage sufficient to allow water ingress were observed, and indeed no signs of water ingress internally were visible.

View from the perimeter of the '10 ton Building', where the roof of the 'Green Floor' building is also visible in the distance.

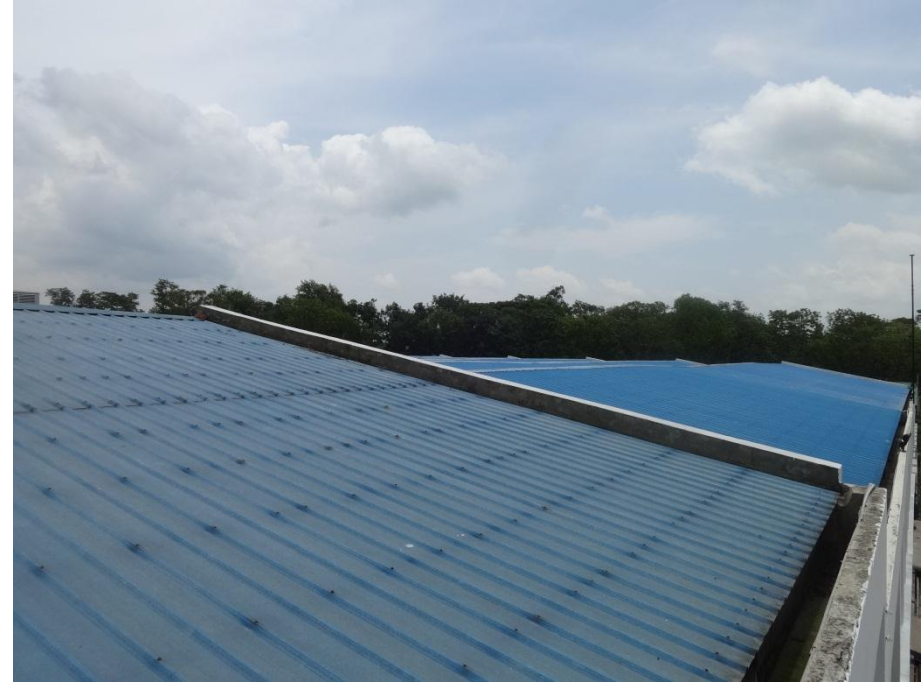
Roof of the '10 ton Building', looking East from the top of the external steel staircase.
