# M.A.C.K Shirts Ltd (9649)

## Basic Apparels Ltd (9791)

Plot #135-138, Abdullahpur, Uttara  
(+23.880716N, +90.401497E)

06.April.2014

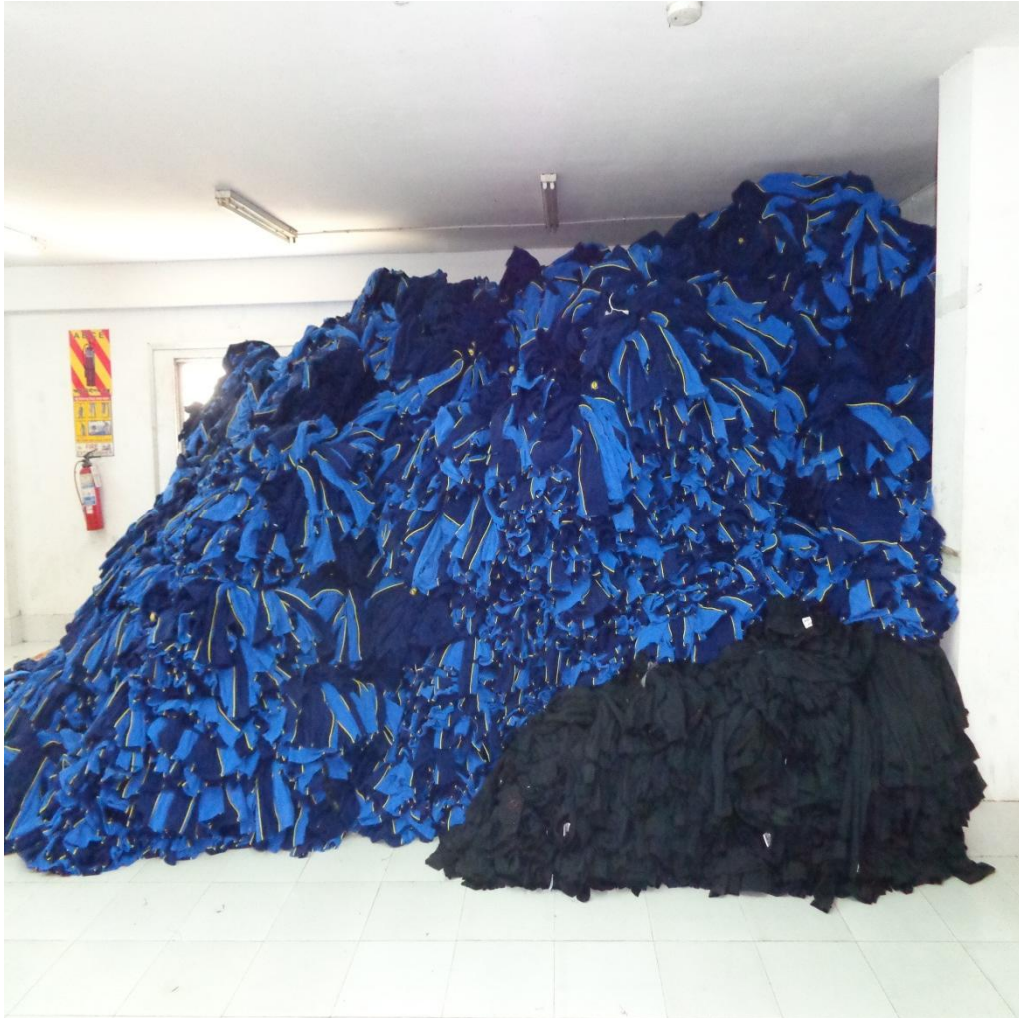
No loading plan in place on the upper floors to insure full compliance with specified design loads.

**No loading plan in place**

**ITEM 1: 1<sup>st</sup> priority 2 – No loading plan currently being used.**

- Factory Engineer to produce and actively monitor a loading plan for all floor plates within the factory, with consideration given to slab, column and foundation capacities.

- Maintain and enforce the loading plans.

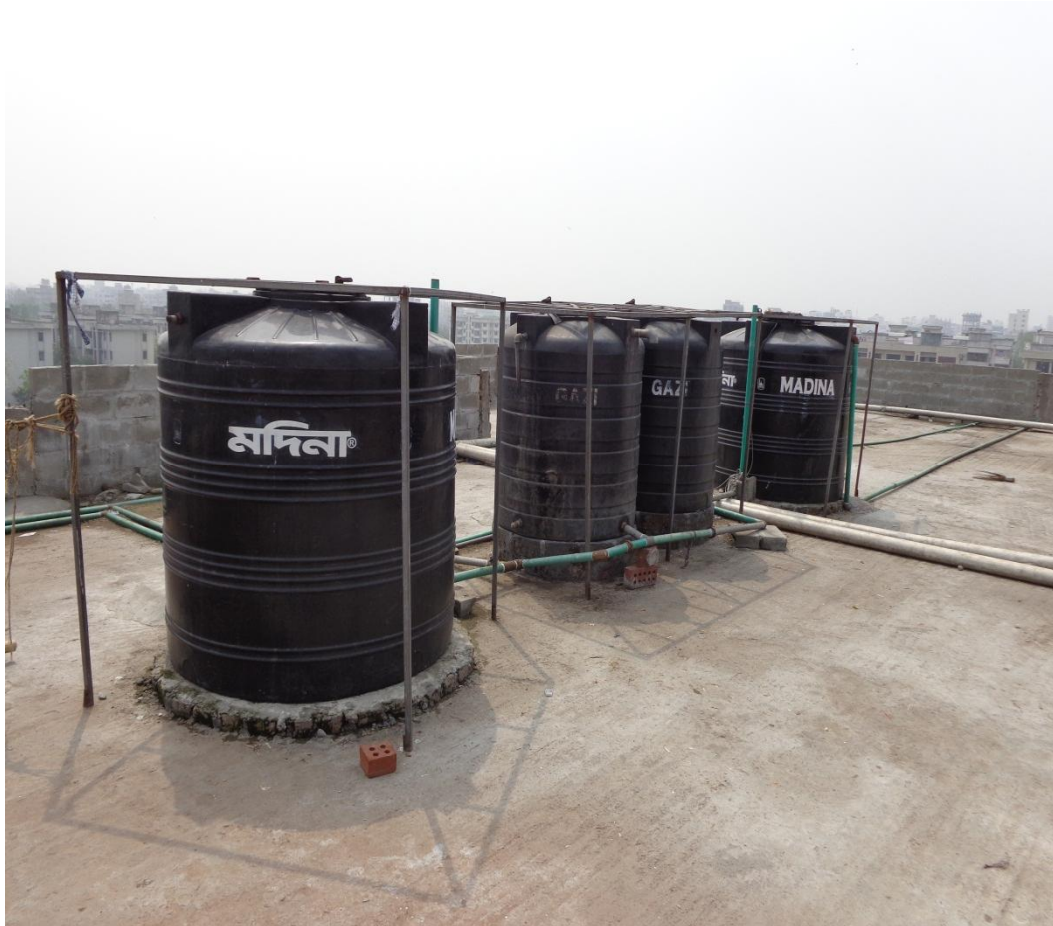
Capacity of the roof slab with regards to the quantity of water tanks in small area. These should be spread out ensure that the load is not carried out by same structural elements

**Multiple water tanks on the roof**

**ITEM 2: 2<sup>nd</sup> priority 2 – Capacity assessment of slabs below roof water tanks is required.**

- Verify the capacity of the slabs, beams and columns beneath the water tanks.

- This item can be managed by the loading plan mentioned in the item 1.

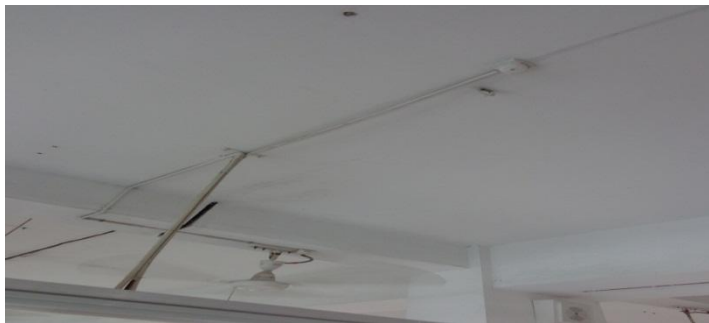
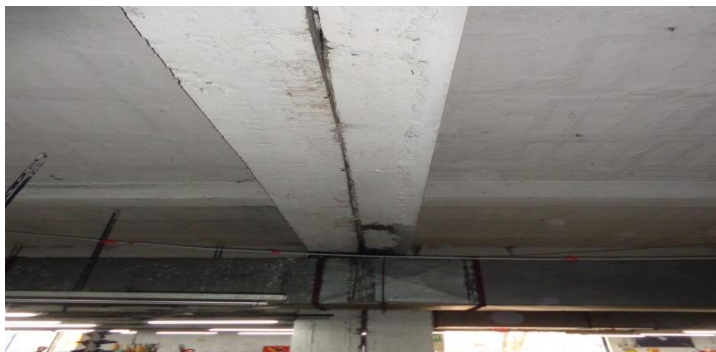
Multiple changes in the arrangement and location of the same movement joint at each floor level. The plans received do not detail the resulting cantilevered sections and the joint variations.

**Movement joint at each floor**

**ITEM 3: 3<sup>rd</sup> priority 2 – An Engineering Assessment of the cantilevered sections at the movement joint at each floor level is required.**

- At the joint at each floor level, verify the cantilevered sections of slabs and beams.
- Produce an assessment by the Factory Engineer.

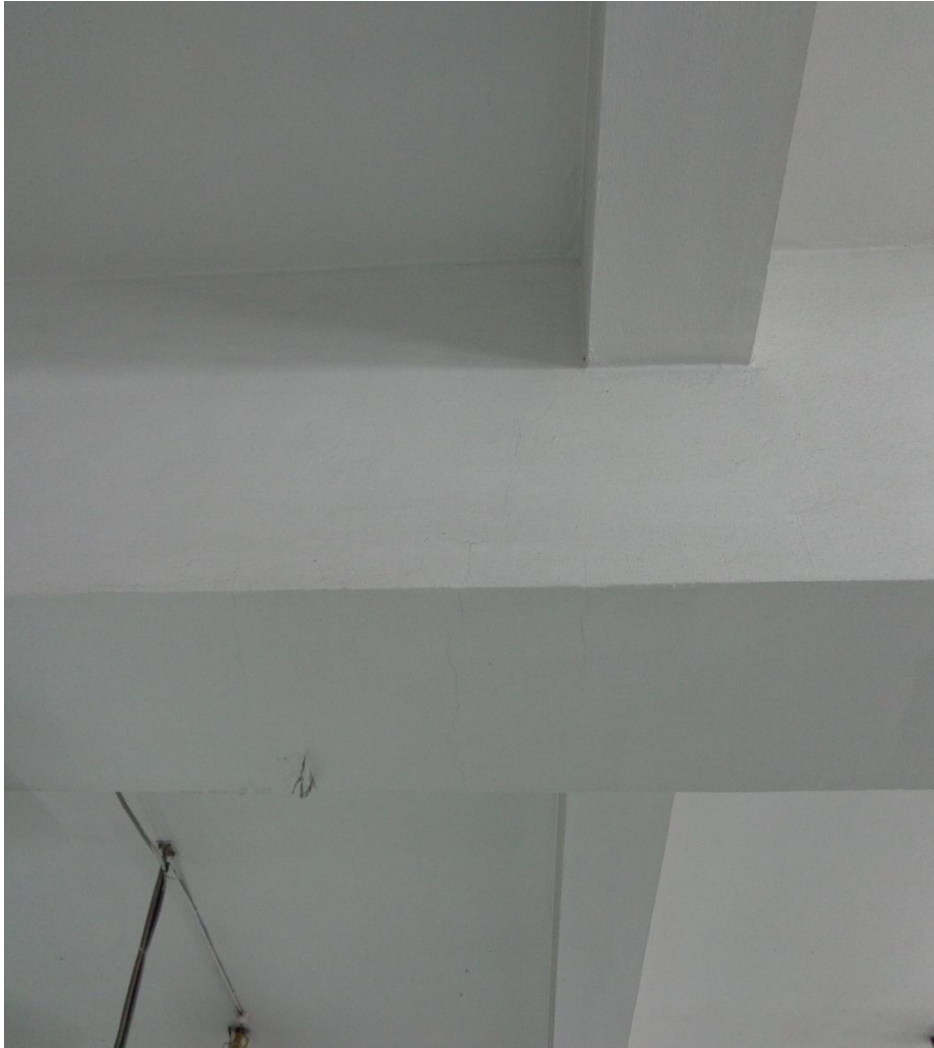
Many shear cracks at the intersection of the secondary and main (axis) beams located at the 4th floor. This is usually a sign that there are no additional shear link stirrups for the punching load/shear.

**Shear Cracks**

**ITEM 4: 4<sup>th</sup> priority 2 – Numerous cracks located at the intersection of secondary and main beams.**

- Produce an assessment by the Factory Engineer for the validation for the shear design of the beams.

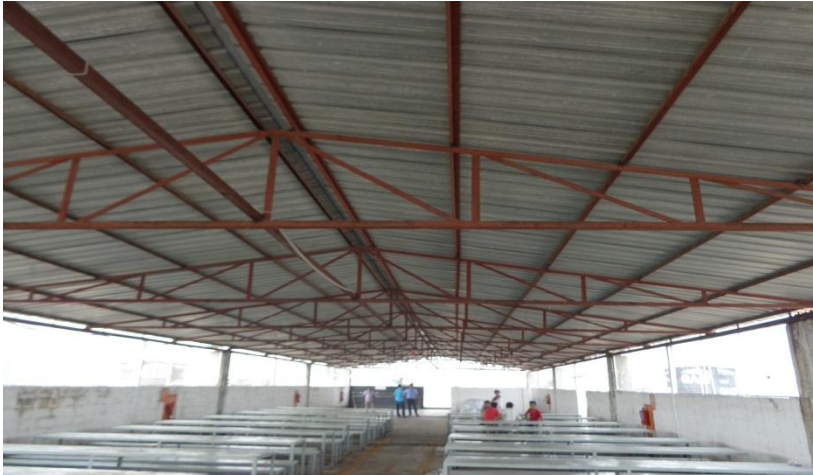
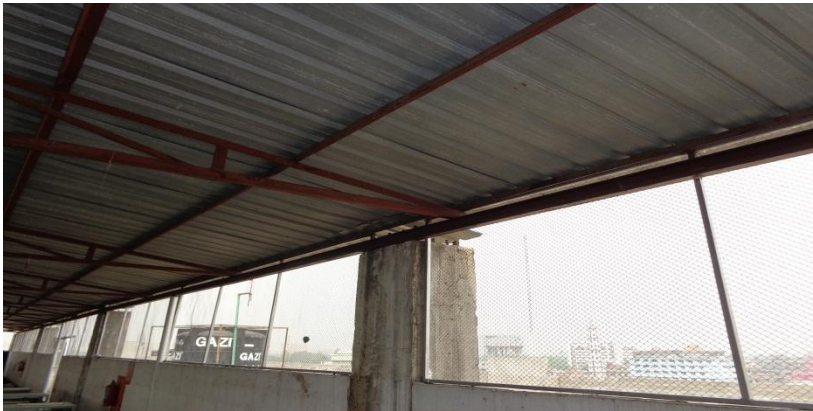
**Roof made of structural steel.**

The roof is made of structural steel, there are many concerns with members and their connections.

There are no lateral restraints against uplift forces on the bottom chords of trusses.

**ITEM 5: 1<sup>st</sup> priority 3 – A Detailed Engineering Assessment of the steel roof structure is required.**

We require a Detailed Engineering Assessment of this steel shed.

- Produce a Detailed Engineering Assessment of the steel shed at roof level.

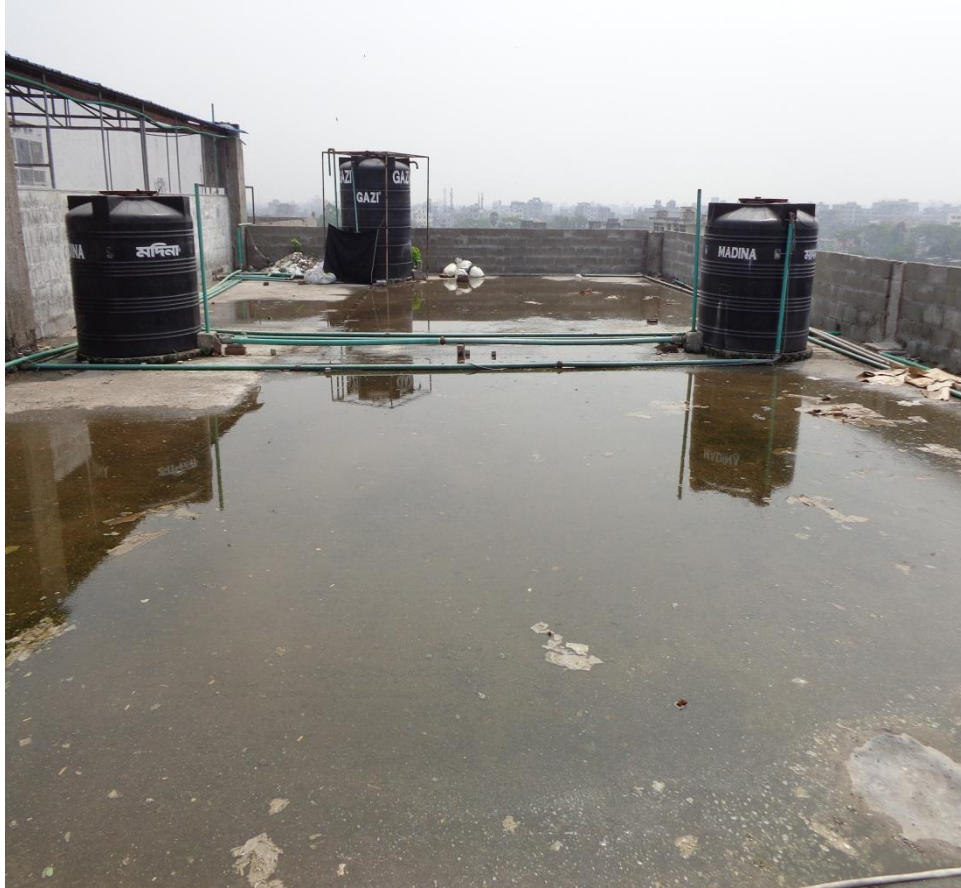
No waterproofing membrane was visible on the roof of the building. This means that any cracks in the surface finishes on the roof will allow water to seep into the concrete slab beneath the finishes, and cause long-term soaking of the slab.

**Roof floor does not appear to have any waterproof membrane to protect the structure from water damage**

**ITEM 6: 2<sup>nd</sup> priority 3 – Lack of roof waterproofing.**

- Apply a new waterproofing membrane.
