# FIRE SAFETY INSPECTION REPORT

ISLAM KNIT DESIGNS LTD (UNIT 2)

ACCORD ID: 12806

Inspected By: Shabbir Hossain and Mahfuza Khanom  
Date: 23 May, 2017

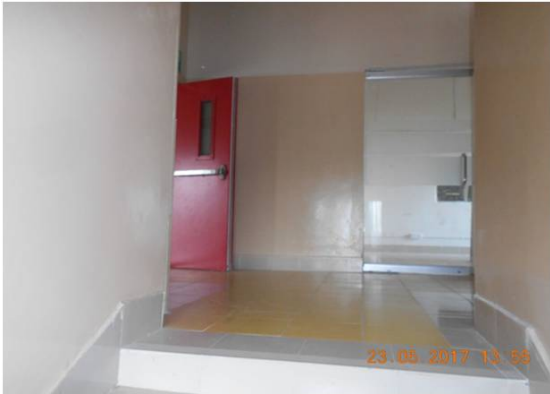
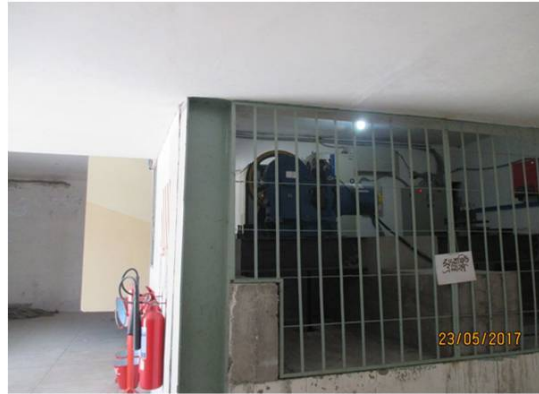
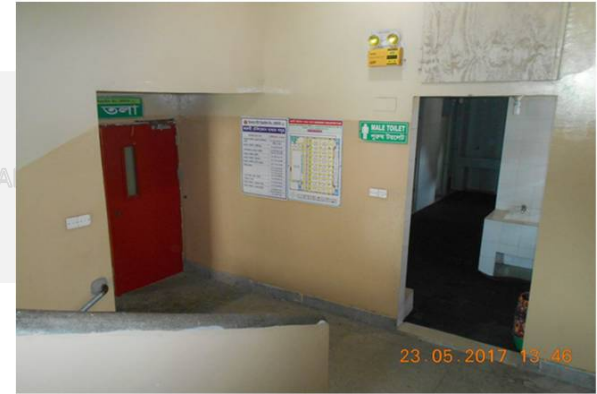
SI No.	Category	Findings	Required Action	Remediation Time Frame
1	Fire Rated Construction	The exit stairs enclosures are not separated from work areas and other spaces on each floor by fire-rated construction(Non rated doors, unsealed penetrations and openings etc.). Lift machine room, toilets are also not separated by fire rated separation. Fire doors have been found damaged in few location.	Provide minimum 1-hr rated doors for buildings with 3 or fewer stories and 1.5-hr fire rated doors for buildings that are 4 or more stories. Seal all unprotected openings to separate the exit stairs from work areas and other building spaces such as toilets, lift machine room etc. on all floor levels. Ensure that the fire doors are self-closing and positive latching and that they are provided with fire exit (panic) hardware where serving production floors. If fire doors are required to be held open for functional reasons, provide automatic closing devices tied to the fire alarm system. Once fire doors are installed, every door in a stair enclosure serving more than 5 stories shall be provided with re-entry unless it meets.	Within 3 months

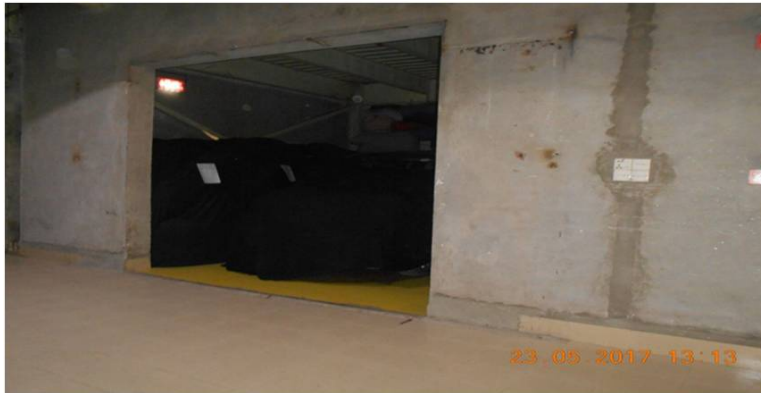
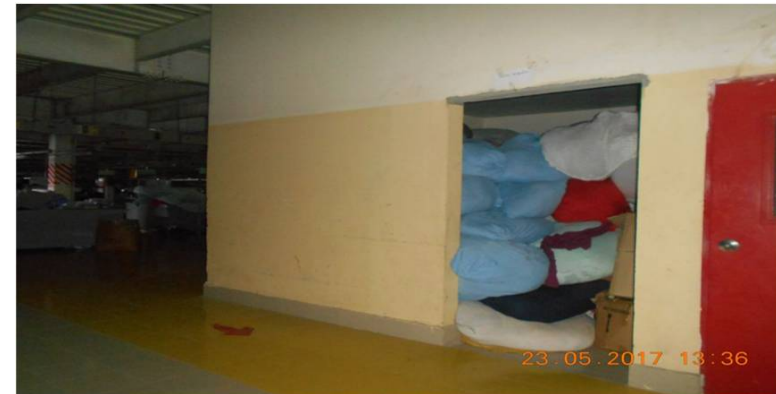
2	Fire Rated Construction	Rooms used for combustible storage are not separated by fire rated construction properly. Location: Fabric store in Ground floor and wastage room in first floor.	Provide dedicated storage room separated by minimum 1-hr fire-rated construction.	Within 3 months
---	-------------------------	--	---	-----------------

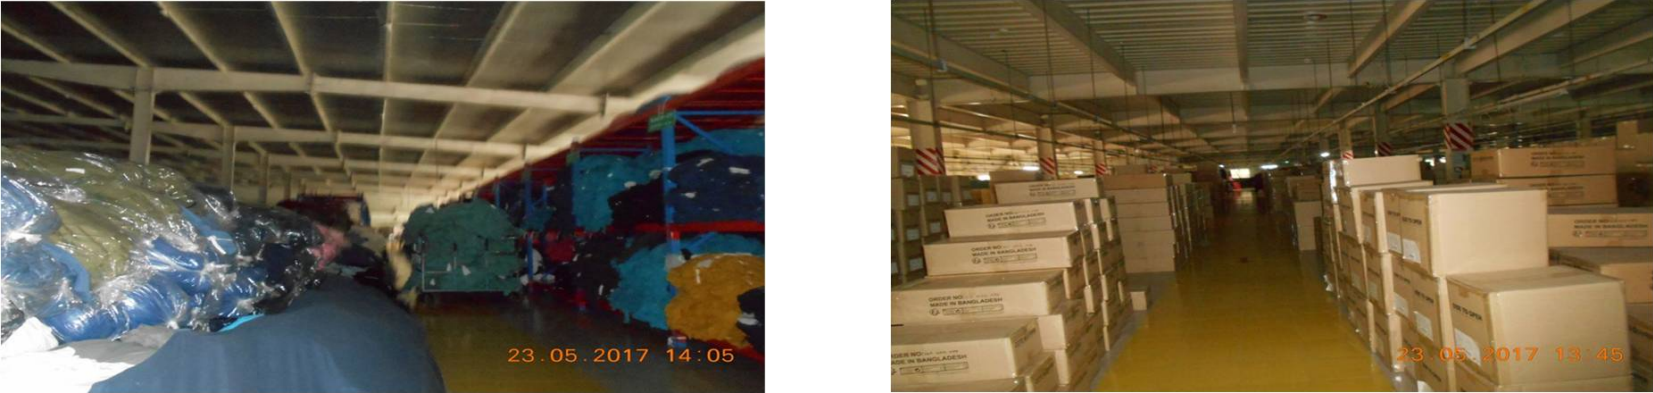
3	Fire Rated Construction	Areas used for combustible storage are not separated by fire rated construction. Location: Second floor and fifth floor.	<p>Provide dedicated storage rooms separated by minimum 1-hr fire-rated construction.</p> <p>Where separate storage rooms are not feasible, provide defined storage areas and limit the storage arrangement as follows:</p> <ul style="list-style-type: none"> <li>- Maximum height of 2.4m and maximum area of 23m<sup>2</sup></li> <li>- If sprinkler protected: maximum height of 3.66m and maximum area of 93m<sup>2</sup></li> </ul> <p>Separate areas of unenclosed combustible storage by a minimum clear distance of 3m.</p>	Within 3 months

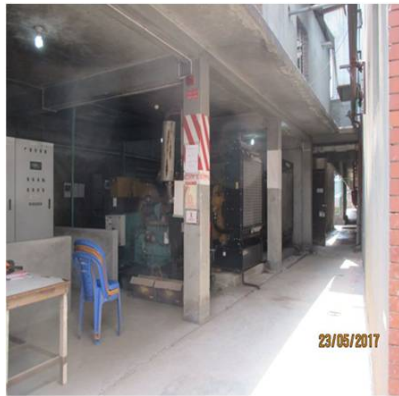
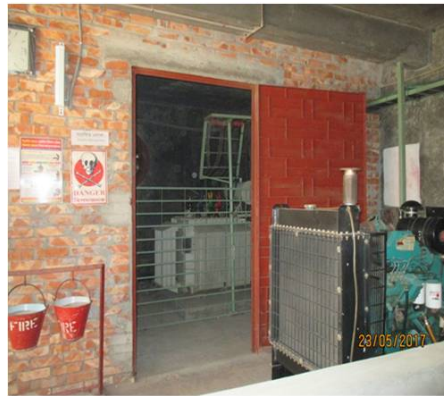
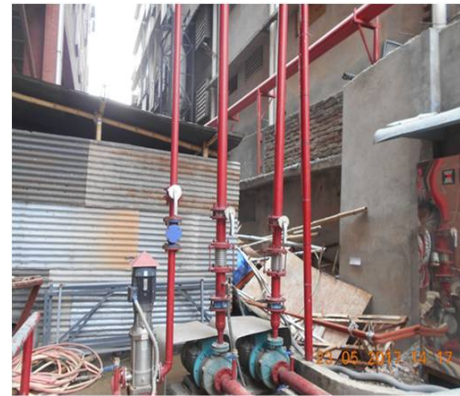
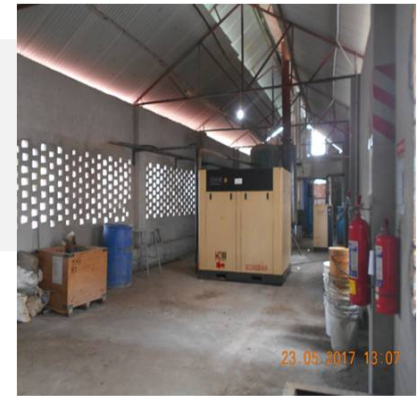
4	Fire Rated Construction	The generator, boiler, transformer, LT panel, compressor room, fire pump room is not separated by fire rated construction (openings, non-rated doors, penetrations). Location: Utility shed in South-East side.	Separate the generator, boiler, transformer, LT panel, compressor room by a minimum 2-hr fire rated construction. Seal and/or protected all openings to maintain fire separations.	Within 3 months

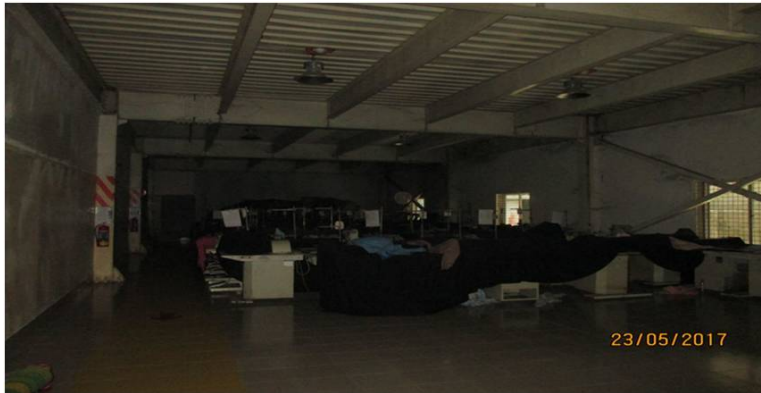
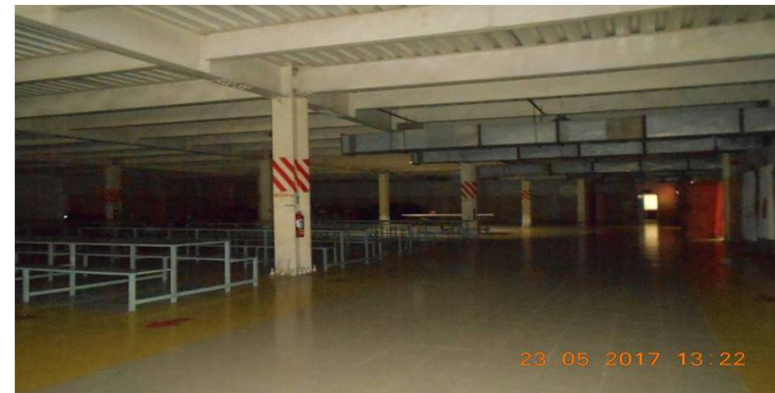
5	Fire Rated Construction	Dining area is not properly separated from machine store and other occupancies by fire rated construction. Location: Ground floor	Provide proper fire rated separation for dining area with other occupancies.	Within 3 months
---	-------------------------	--	--	-----------------

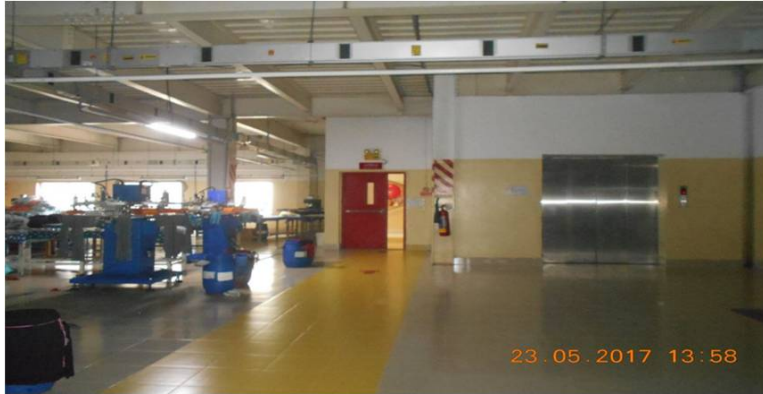
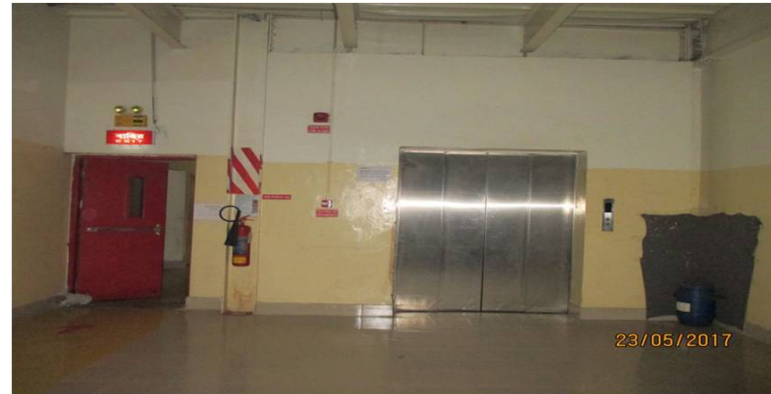
6	Fire Rated Construction	The elevator (South-East side) discharges inside the production floor	Provide a minimum 2-hr fire rated construction to separate the elevator shaft from each floor level. Seal all penetrations and openings in floors/ceiling assemblies to maintain the fire separation.	Within 3 months
---	-------------------------	---	---	-----------------

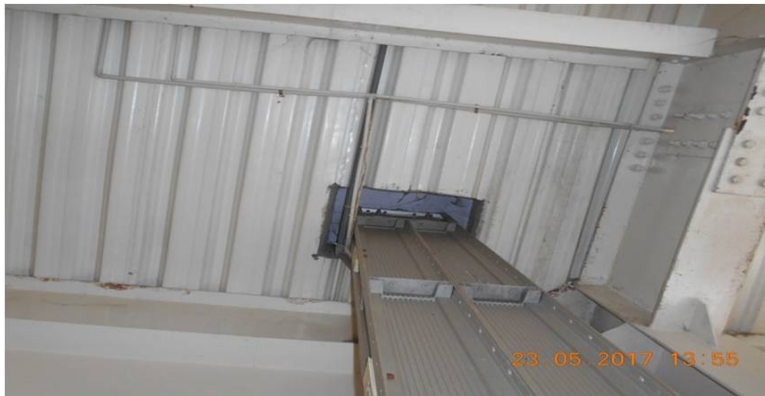
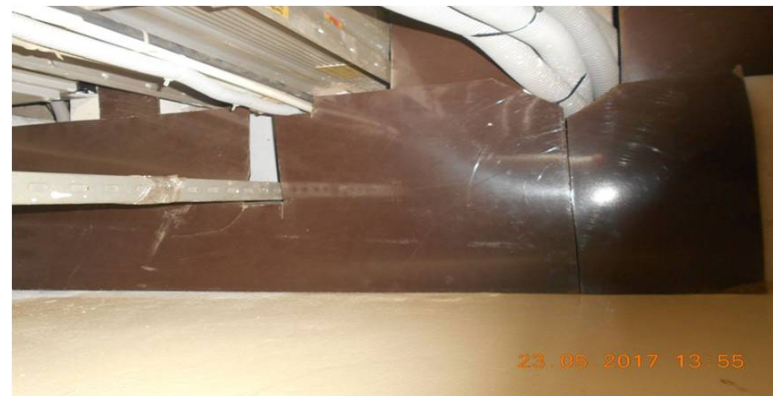
7	Fire Rated Construction	Unsealed penetrations and openings are located in the fire rated floor/ceiling assemblies. Location: South-East BBT riser for all floor.	Seal all penetrations and openings in floors/ceiling assemblies to maintain the fire separation.	Within 3 months
---	-------------------------	--	--	-----------------

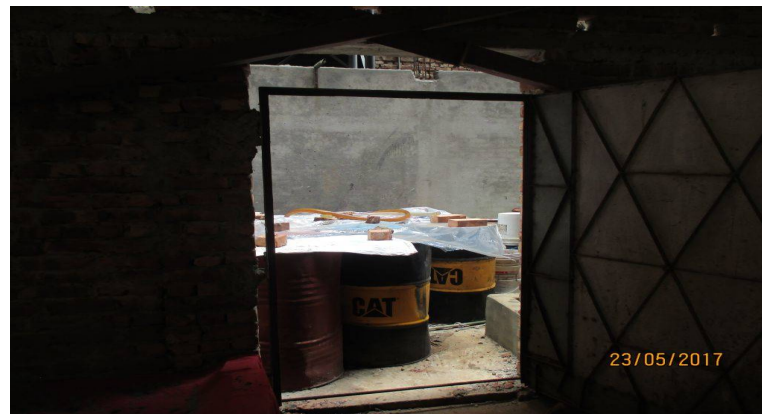
8	Fire Rated Construction	Hazardous materials / flammable liquid storage area is not separated by fire-rated construction. Location: East egress path.	Separate the hazardous materials / flammable liquid storage room by a minimum 2-hr fire-rated construction. Seal and/or protect all openings to maintain the required fire separations.	Within 3 months
---	-------------------------	--	---	-----------------

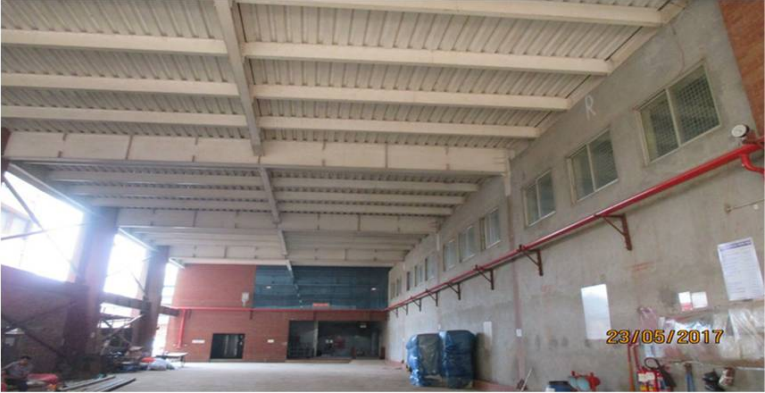
9	Fire Rated Construction	Exit discharge path is not separated by fire rated construction. Location: East discharge path.	Seal all penetrations and openings to the interior of the building along the discharge path to provide a minimum 1-hr fire separation.	Within 3 months

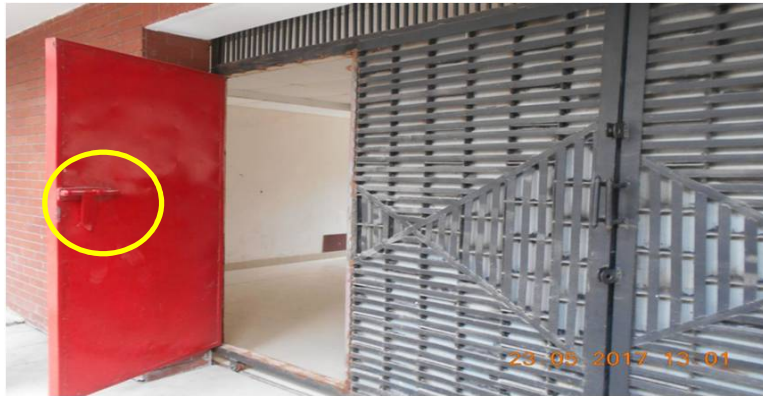
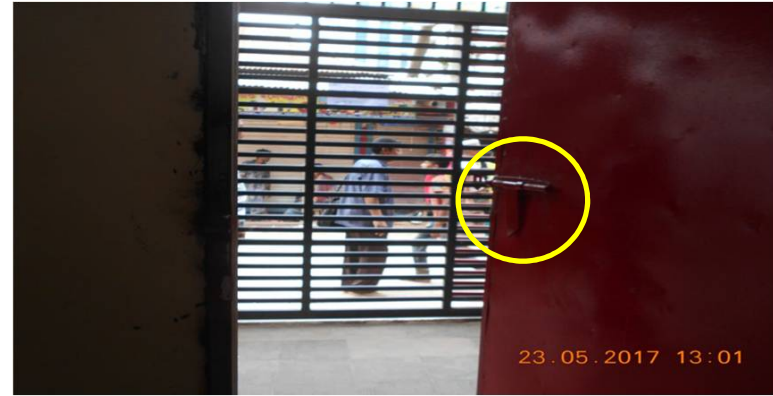
10	Egress	Egress doors/gates with locking features not complying with NFPA101 are provided at building. Location: Ground floor building main exit gates.	Remove locking features from all egress doors/gates. If locks are required for security reasons, utilize specialized door locking features complying with NFPA101.	Immediate

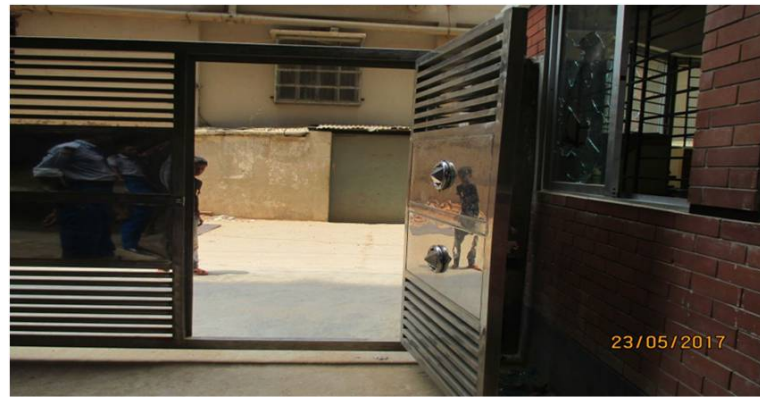
11	Egress	Egress door serving 50 or more occupants does not swing in the direction of egress travel. Location: Ground floor	Modify the egress door to swing in the direction of egress travel.	Within 1 month
----	--------	--	--	----------------

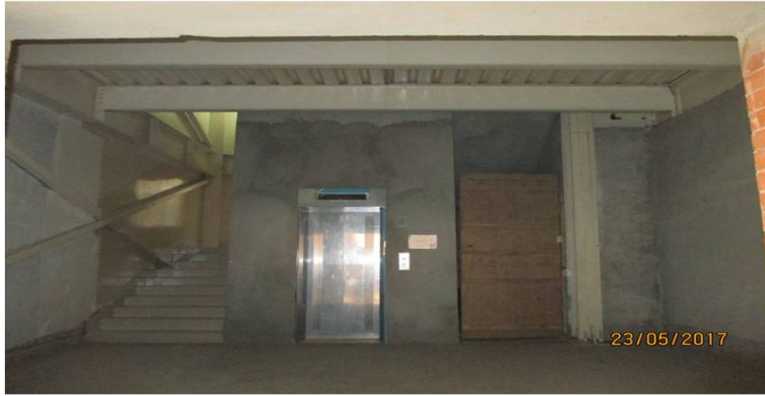
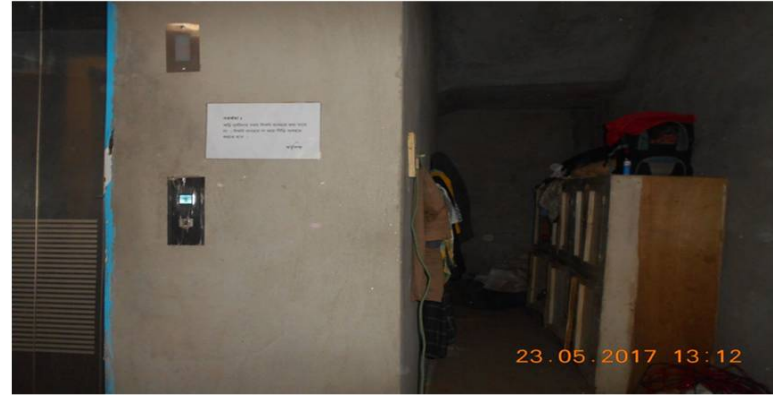
12	Egress	Storage was located in the exit stair. Location: South-East exit stair	Remove all storage from exit stairs.	Immediate
----	--------	---	--------------------------------------	-----------

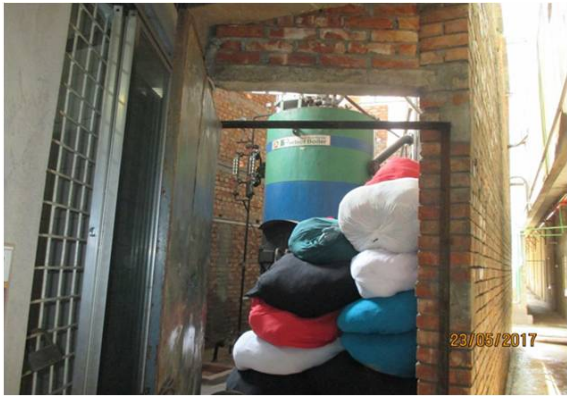
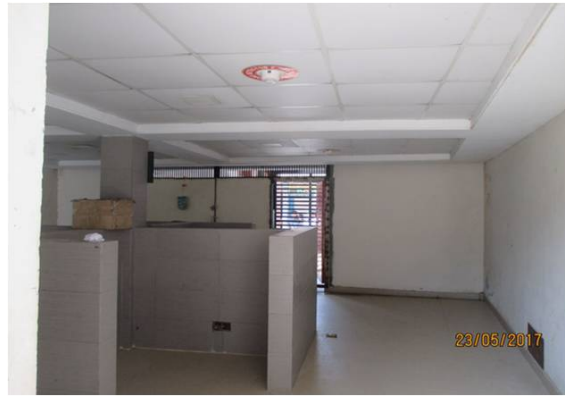
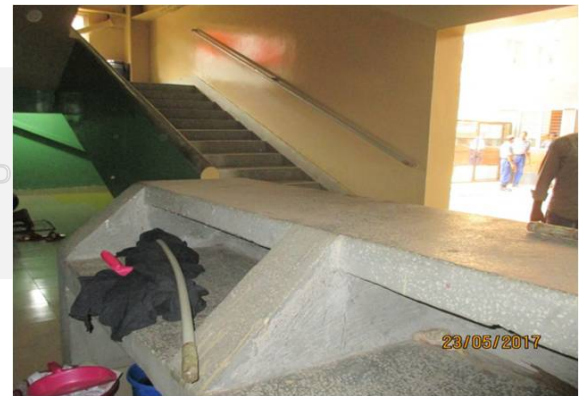
13	Egress	<p>The egress path along means of egress has interrupted by obstruction/storage.          Location: Storage on the egress path of jut boiler and reception located in North-East &amp; North-West exit in Ground floor</p>	<p>Means of egress shall be maintained continuously free and clear of all obstructions/storage.</p>	<p>Immediate</p>
----	--------	--	---	------------------

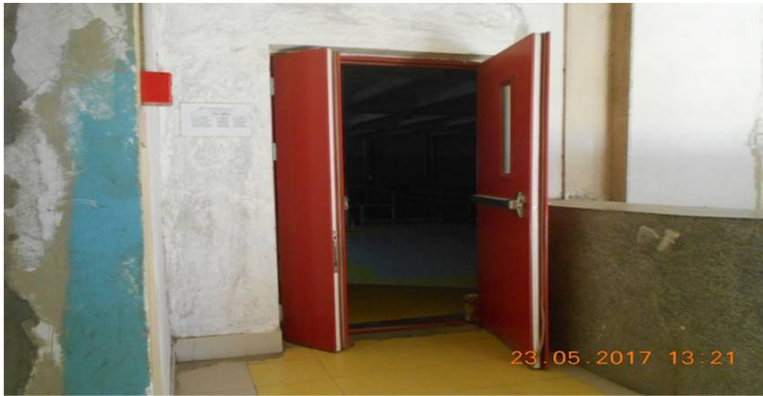
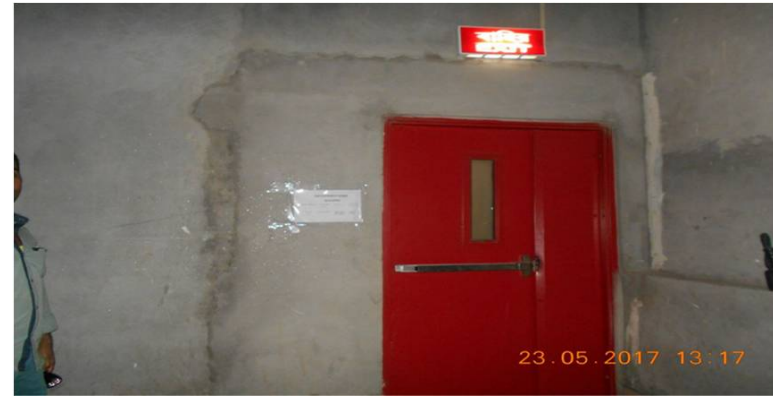
14	Egress	Exit capacity (381) is not adequate for the occupant load (500) in Ground floor (Dining area).	Reduce occupant load to not more than available exit capacity. Or Provide additional exits to increase exit capacity.	Immediate
15	Egress	Doors have widths less than the required minimum width . Location: South-East exit stair doors and Dining and storage doors in Ground floor.	Doors in a means of egress shall have a minimum width of 0.8 m (32 in.).	Within 3 months

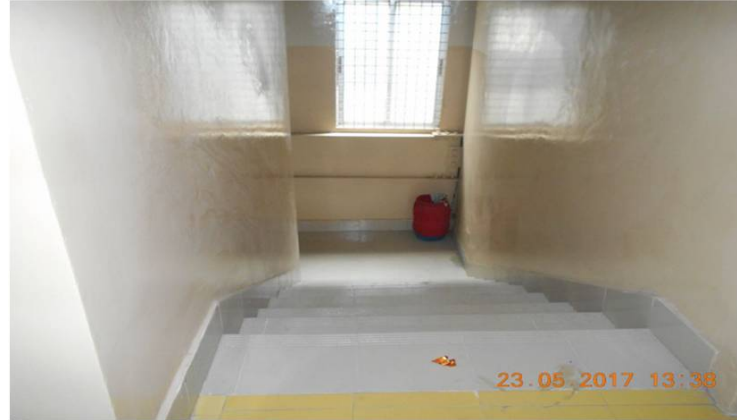
16	Egress	Handrails are not provided in the exit stair. Location: South-East exit stair	Provide handrails on both sides of the exit stair. New handrails shall have a minimum height of 865 mm (34 in.) and a maximum height of 965 mm (38 in.) as measured from the leading edge of the tread. Intermediate handrails shall be provided when the stair width exceeds 2.2 m (87 in.).	Within 3 months
----	--------	--	---	-----------------

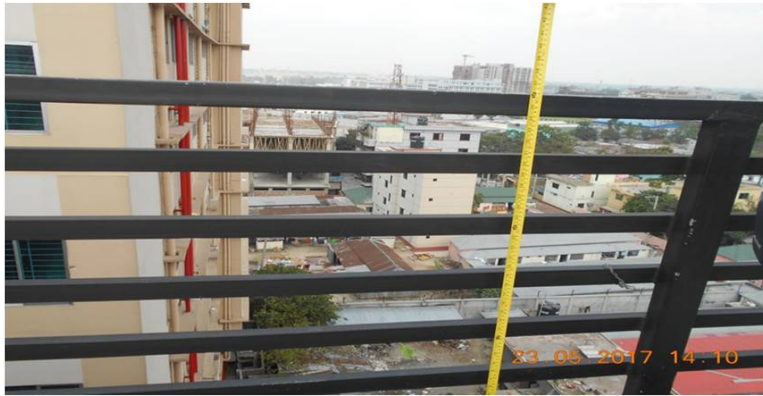
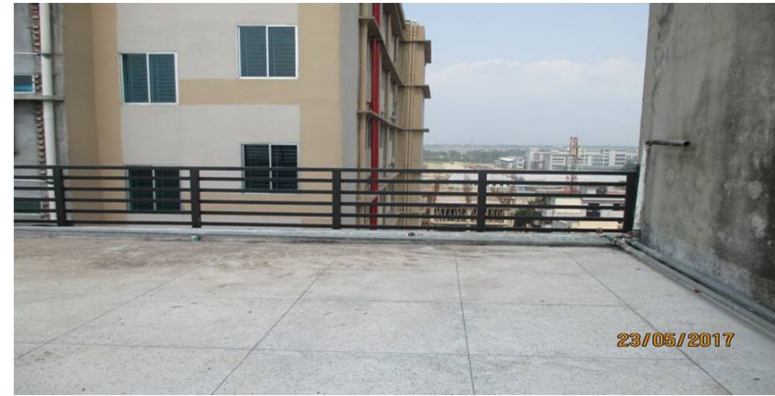
17	Egress	Building did not have stair designation signs and occupant load signs at the required locations.	Provide stair designation signs and occupant load signs at the required locations.	Immediate
18	Egress	Parapets or guards are provided in occupied roof which is less than 1067mm (42 inch.).	Provide parapets or guards with a minimum height of 1067mm (42 inch.).	Within 3 months

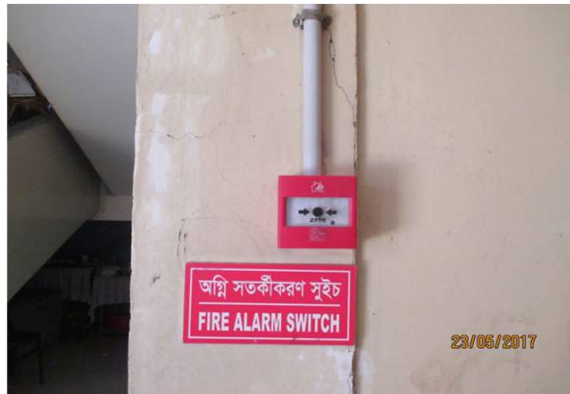
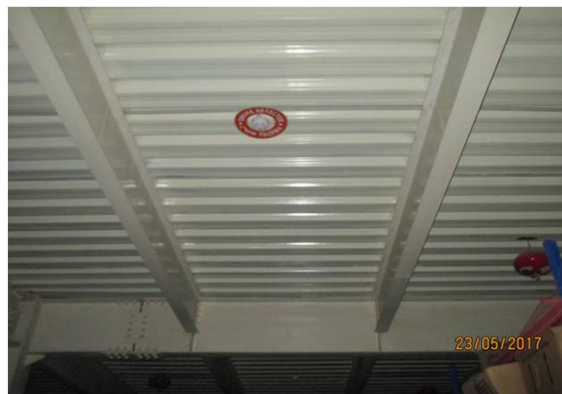
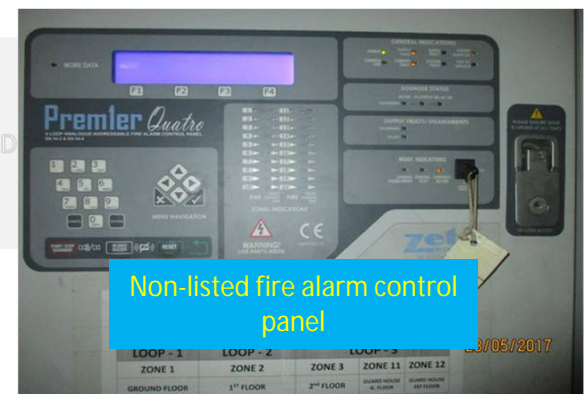
19	Fire Detection and Alarm System	The fire detection system is antiquated, not a listed system, and does not provide alarm and notification features consistent with acceptable standards.	Replace the fire detection system with a new, listed addressable fire detection system and modify the installation of existing system in accordance with NFPA 72.	Design within 4 months, Install within 9 months
----	---------------------------------	--	---	---

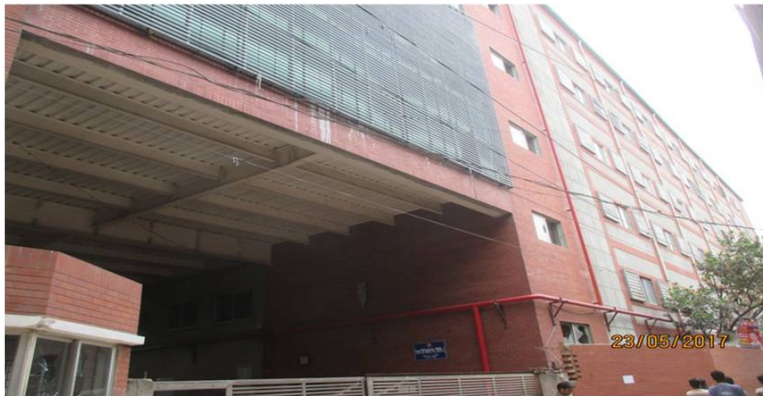
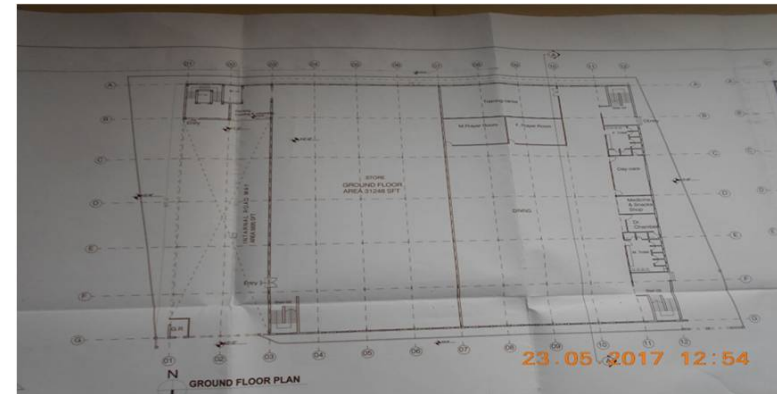
20	Fire Detection and Alarm System (ITM)	Inspection, testing, and maintenance for the fire alarm system is not in accordance with NFPA 72.	Inspect, test and maintain the fire alarm system, and keep written records on-site, in accordance with NFPA 72 or as per Accord standard.	Within 3 months
21	Fire Protection System	The existing building greater than 2 stories and per floor area exceeding 2000 sqm (22000 sqft) is not provided with automatic sprinkler protection.	Provide automatic sprinkler protection throughout the building in accordance with NFPA 13. or Confirm the fire resistance of structural members accordance with BNBC Part 3 Chapter 3 and Table 3.3.1.	Design within 6 months, install within 12 months

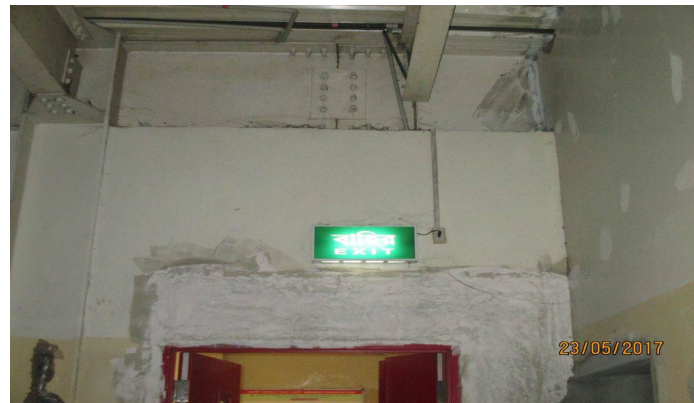
24	Egress Lighting	Manual on-off switch facility available for emergency lights/exit signs.	Remove manual on/off switches from emergency lighting units/ exit signs to prevent them from being switched off.	Within 1 month
----	-----------------	--	--	----------------

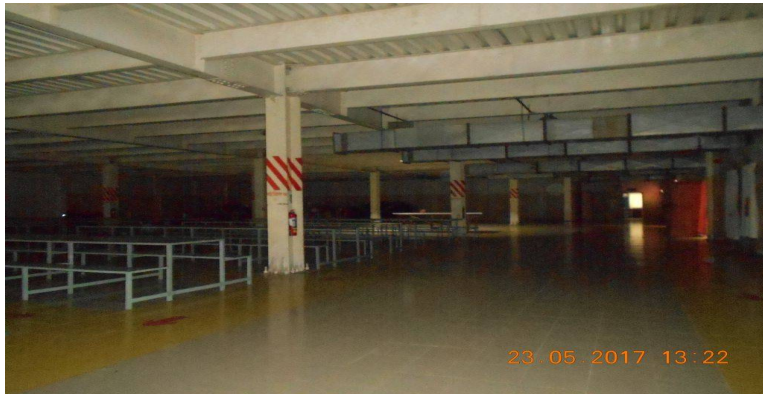
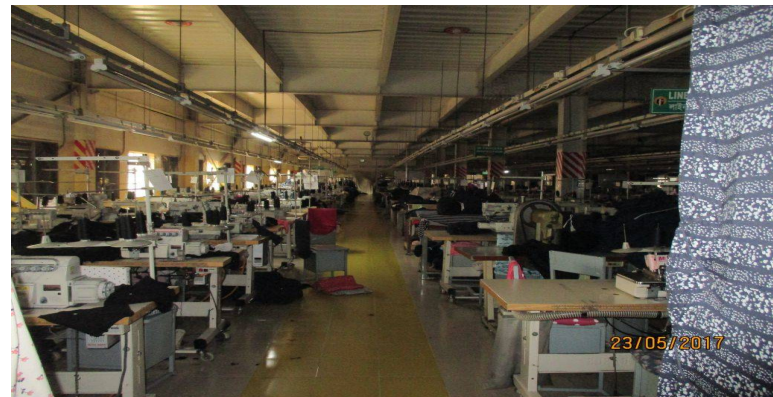
27	Egress Lighting	Based on the number and location of emergency lights/exit signs observed, adequate illumination levels are not anticipated along egress routes. Location: All through the building.	Test the emergency lighting system on each floor and provide additional emergency fixtures to provide adequate illumination along the means of egress. Provide a minimum illumination of 10 lux at the floor level within exit stairs and exit discharge paths and minimum 2.5 lux along exit access aisles.	Within 3 months
----	-----------------	--	--	-----------------
