FIRE SAFETY INSPECTION REPORT

Factory Name: Leaf Grade Casualwear Limited.

ACCORD ID: 12864

Date: 14th June, 2017

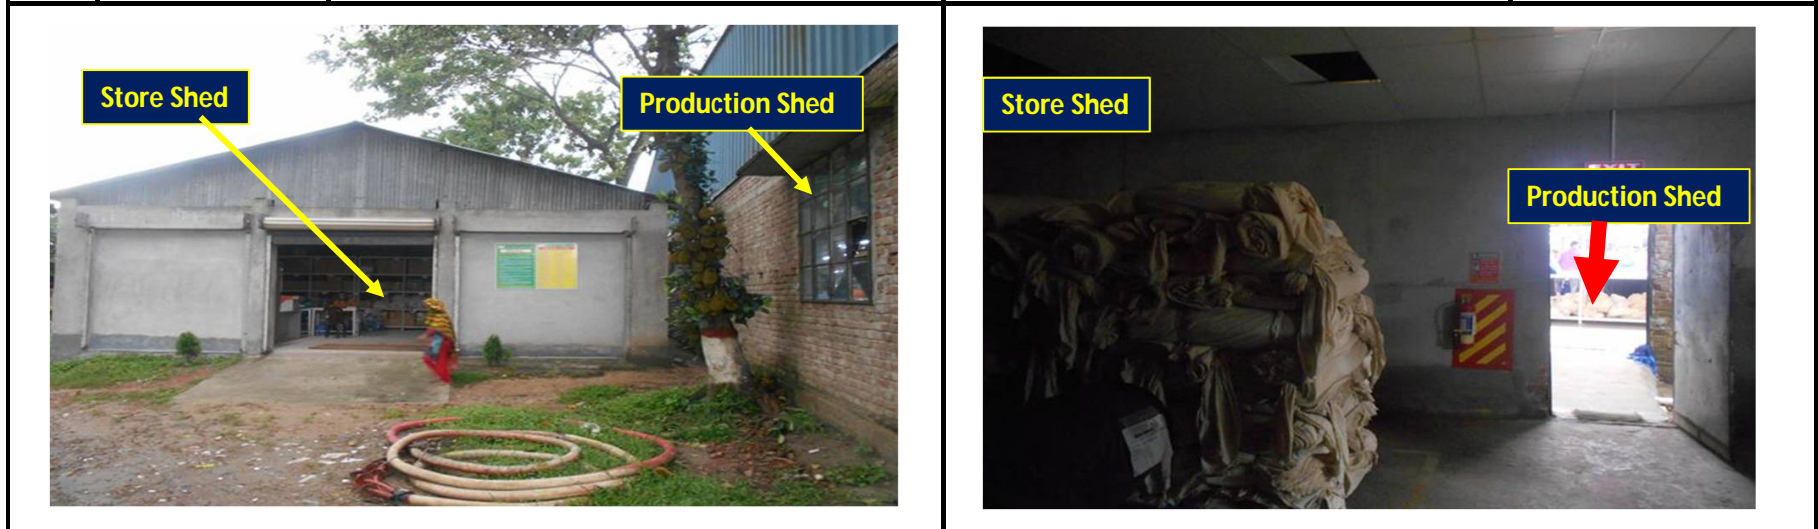
SI No.	Category	Findings	Required Action	Remediation Time Frame
1	Fire Rated Construction	The West exit of production building and east exit of store shed is not separated from each other. Note-The spatial distance between the two exit is 5 ft. and 8 inch.	Rooms used for storage of combustible materials shall be separated from the surrounding occupancy with a minimum 1 hour construction.	Within 3 months

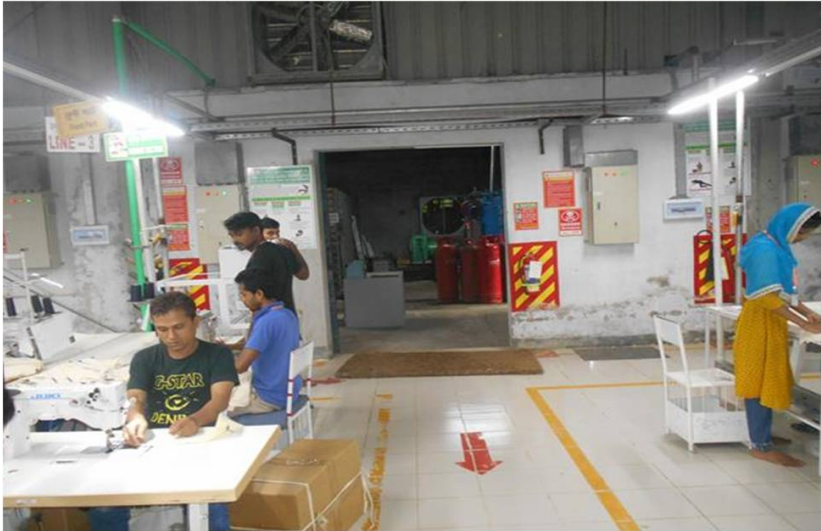
SI No.	Category	Findings	Required Action	Remediation Time Frame
2	Fire Rated Construction	<p>Utility shed is not separated from production shed with proper fire rated separation.</p> <p>Note- Unsealed opening is located on the north side of the production shed that directly goes into Utility shed.</p>	Provide minimum 2-hr fire rated construction to separate Utility shed from Production shed.	Within 3 months

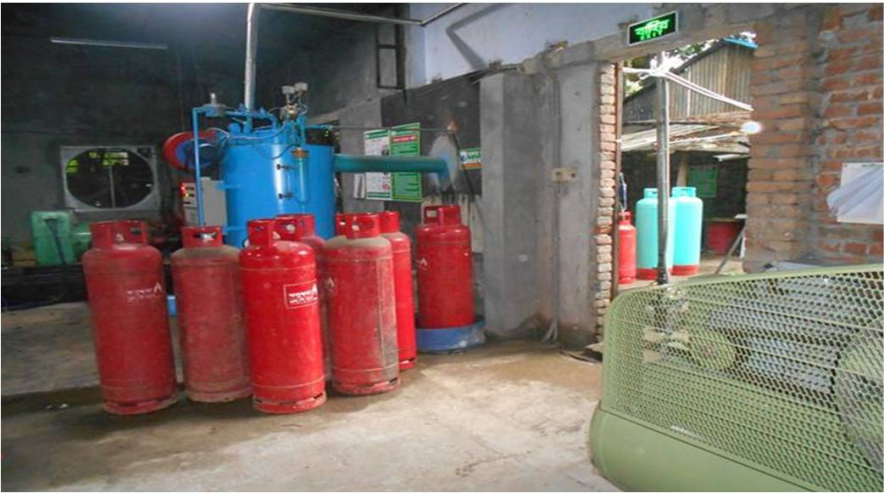
SI No.	Category	Findings	Required Action	Remediation Time Frame
3	Fire Rated Construction	Boiler, Generator, Compressor and transformers are not separated from each other with fire rated construction. Location: Utility Shed	Provide minimum 2-hr fire rated construction between each component and Separate Utility shed from Production shed with minimum 2-hr rated fire construction.	Within 3 months

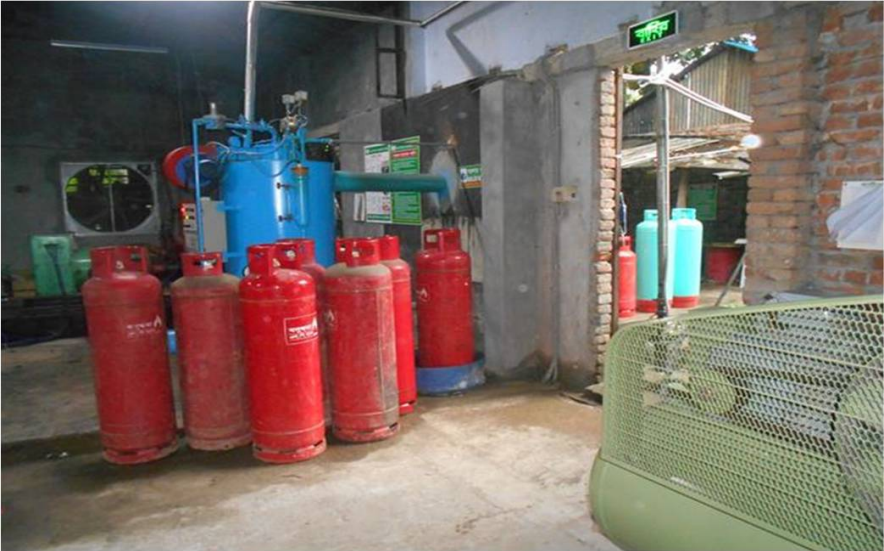
SI No.	Category	Findings	Required Action	Remediation Time Frame
4	Fire Rated Construction	The factory is using/storing liquified gas cylinders without proper separations. Location: Utility shed	Remove them from the factory premises. or Provide 2-hr rated room for using/storing liquefied gas cylinders and ensure proper ventilation of that room. Source of fire such as electrical connection shall be prohibited.	Within 3 months

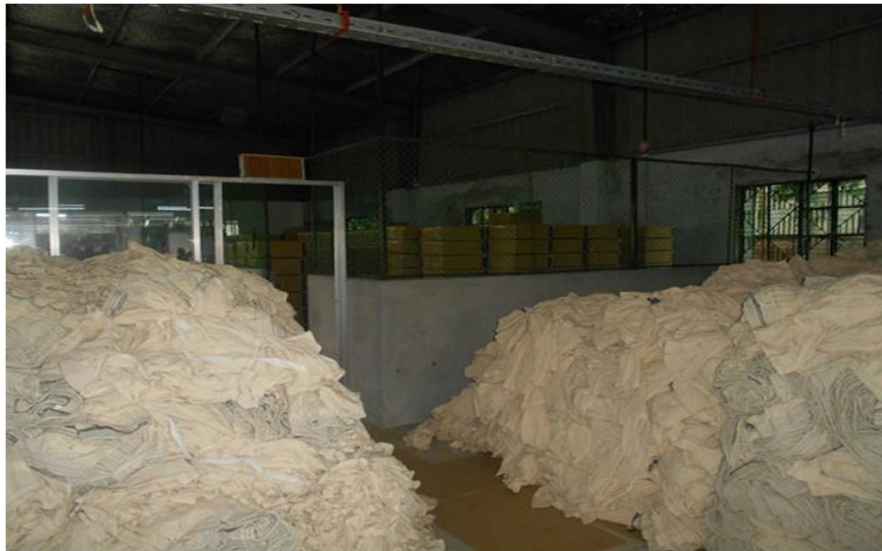
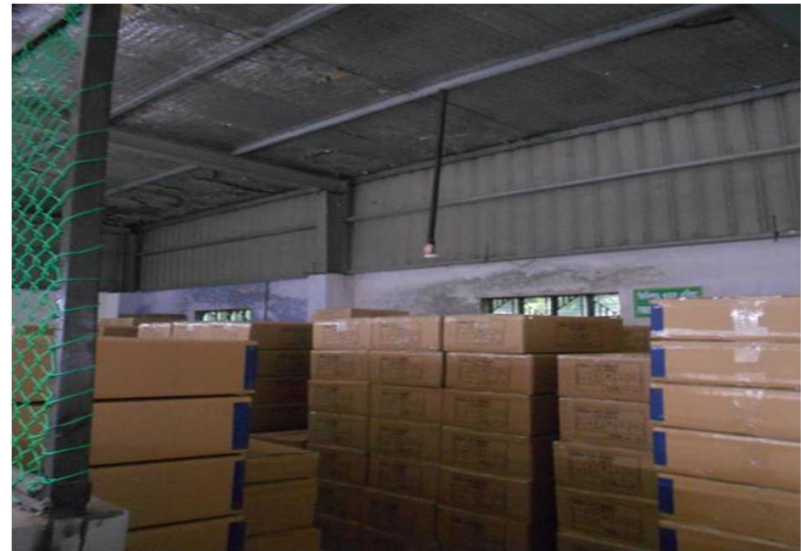
SI No.	Category	Findings	Required Action	Remediation Time Frame
5	Fire Rated Construction	Areas used for in-process storage of combustible materials are open to the surrounding occupancy. Location: South-East corner of the production shed.	Provide defined storage areas and limit the storage arrangement as follows:- Maximum height of 2.4m and maximum area of 23m ² . Separate areas of unenclosed combustible storage by a minimum clear distance of 3m. or Enclose the storage area from the surrounding occupancy with a minimum 1 hour construction.	Within 3 months

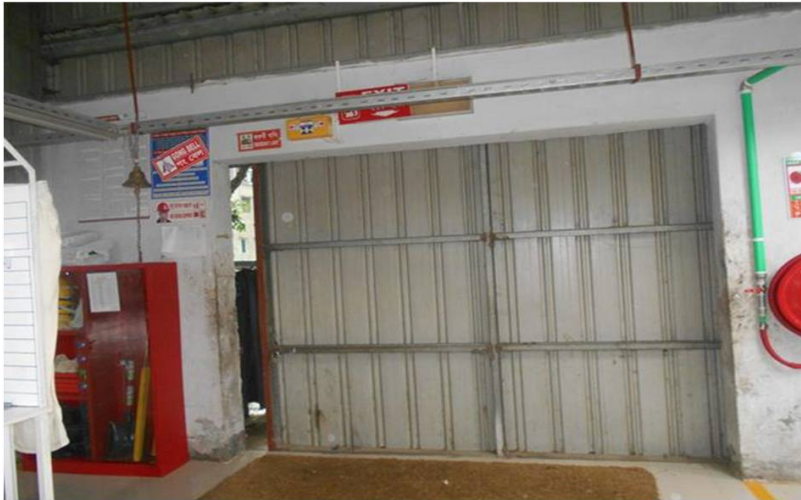
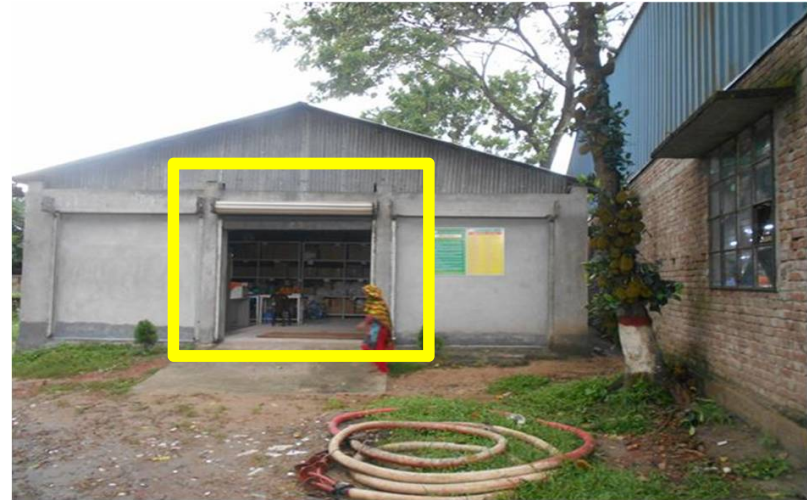
SI No.	Category	Findings	Required Action	Remediation Time Frame
6	Egress	Sliding/Rolling type doors have provided along means of egress. Location: Observed through out the production shed, Store shed.	Replace all collapsible/sliding/shutter type doors & gates by the side-hinged swinging type doors.	Within 1 month

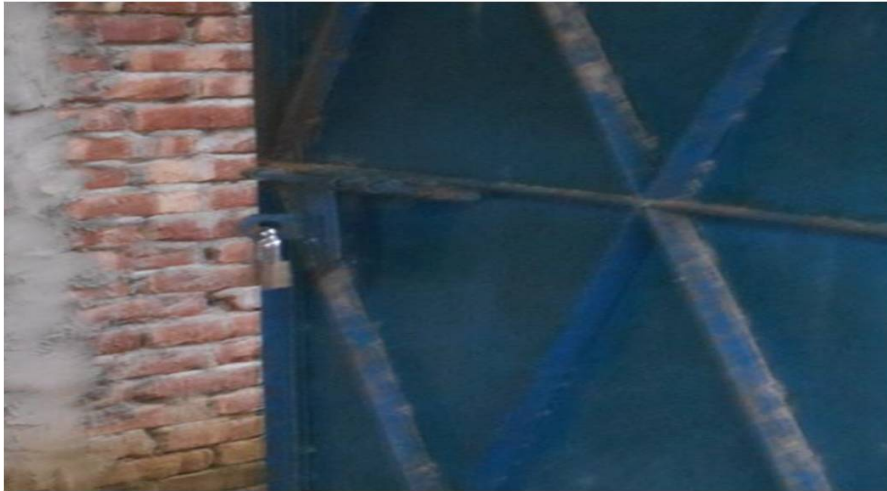
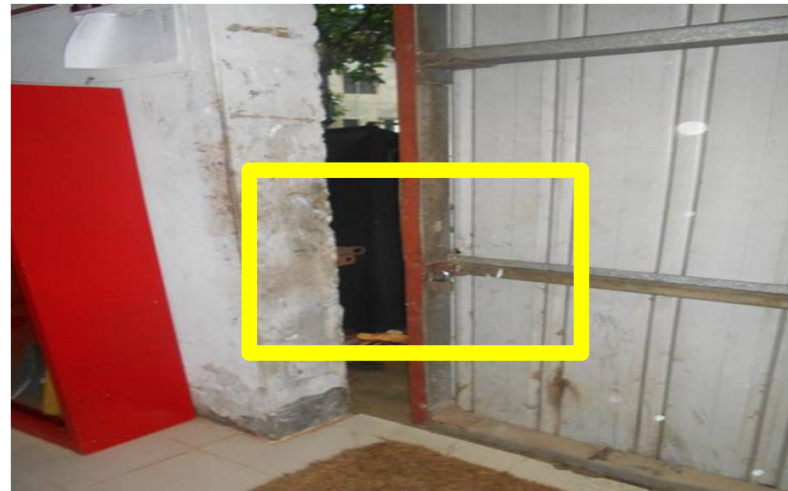
SI No.	Category	Findings	Required Action	Remediation Time Frame
7	Egress	Doors along means of egress are provided with non compliant locking system. Location: Observed through out the production shed and store shed.	<ol style="list-style-type: none"> 1. Remove all non compliant locking features from egress doors. 2. If locks are required for security reasons, utilize special door locking features complying with NFPA 101. 3. Doors may be locked where the latch and lock are disengaged with one motion where the occupant load does not exceed 49 persons. 4. Doors may be provided with locking hardware from the ingress side provided that a panic bar is installed on any door with an occupant load exceeding 49 persons. 	Immediate

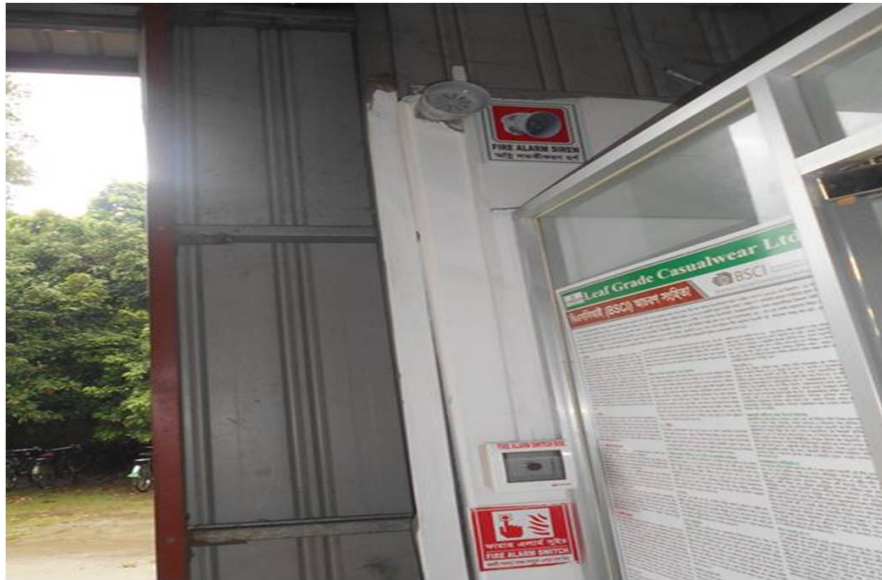
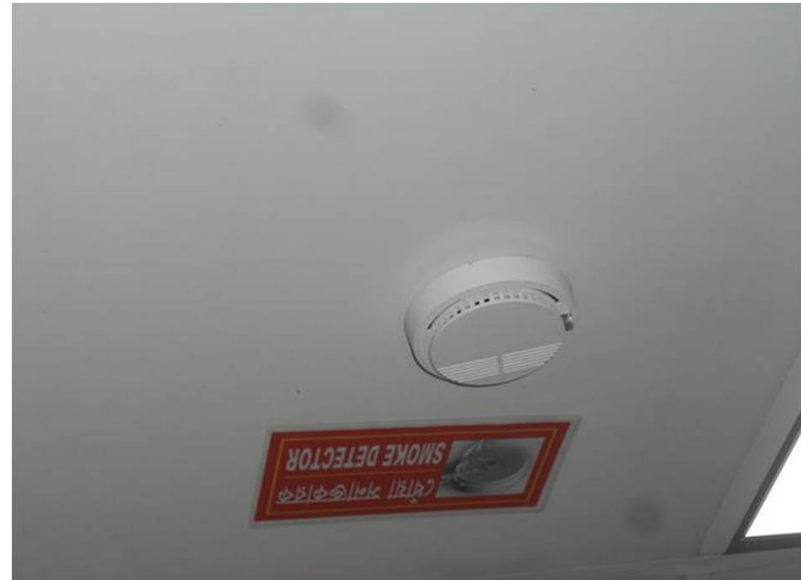
SI No.	Category	Findings	Required Action	Remediation Time Frame
8	Fire Protection	The existing fire alarm system is not a listed system and does not provide automatic alarm and notification features consistent with acceptable standards.	Replace the fire alarm system with a new, listed addressable fire alarm system in accordance with NFPA 72.	Within 9 months

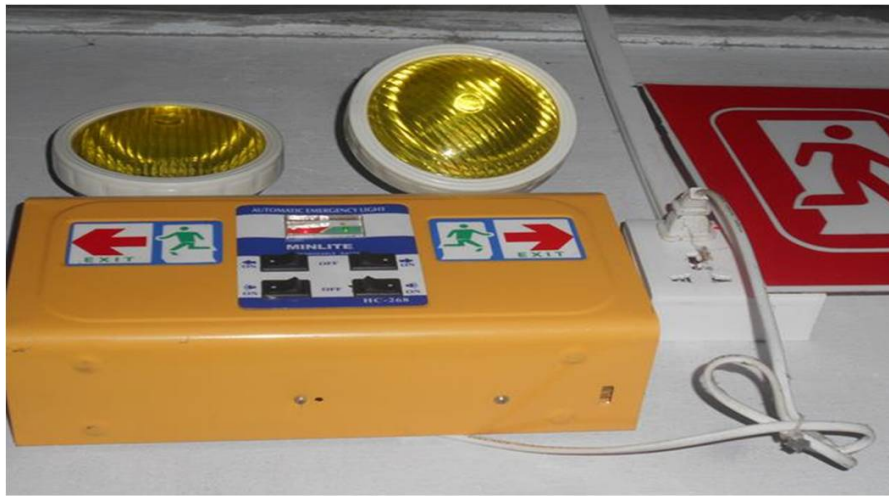
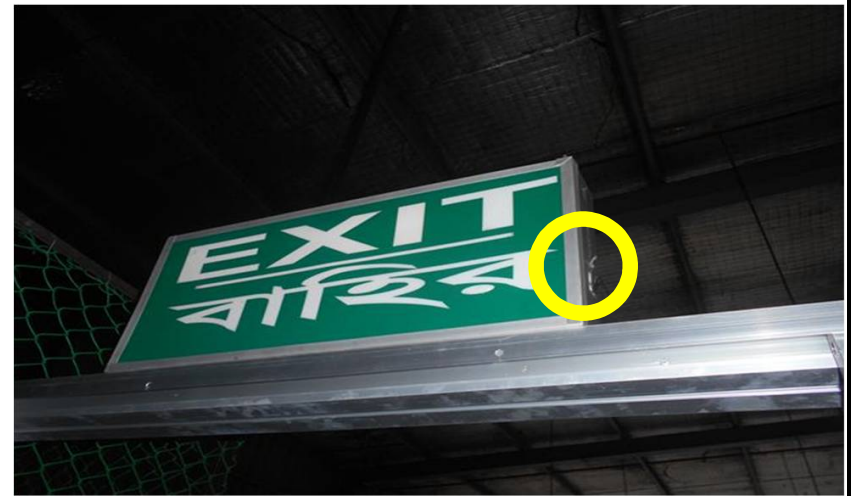
SI No.	Category	Findings	Required Action	Remediation Time Frame
13	Egress Lighting	Manual on-off switch is provided for [emergency lighting / exit signage] units. Location: Battery Back-up emergency light.	Remove manual on/off switches from emergency lighting / exit signage units to prevent them from being switched off.	Within 3 months

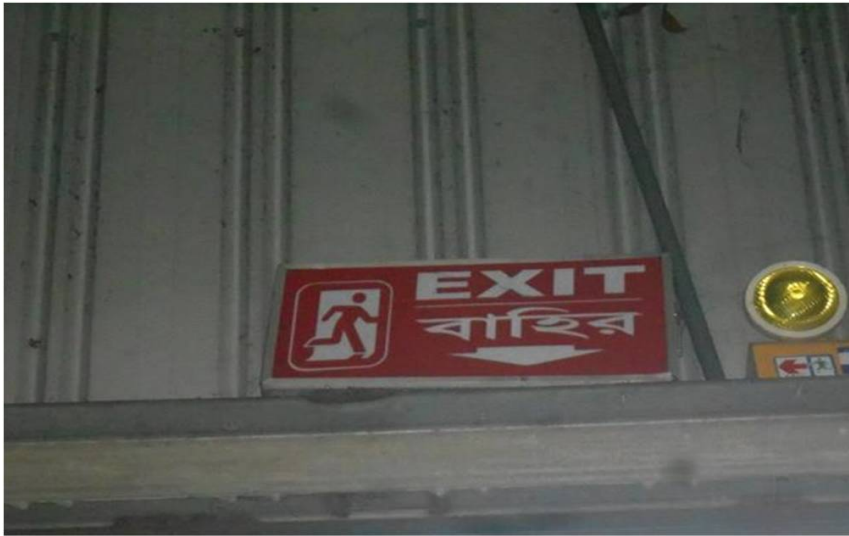
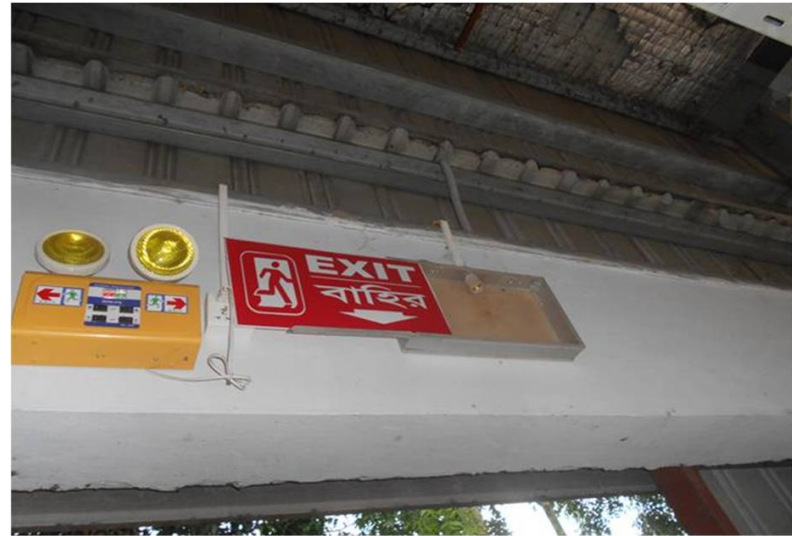
SI No.	Category	Findings	Required Action	Remediation Time Frame
16	Egress Lighting	Exit signage not illuminated during testing period (burned out, broken, etc.).	Regularly inspect all exit signage as per Accord standard and replace/install lights as needed to illuminate signs.	Within 3 months
