Nine 2 Nine Intimates Ltd

35/A –B, Kalurghat Heavy Industrial Area ,Chittagong 4208 , Bangladesh
(22.390795, 91.872791)

18 June 2017

Observations

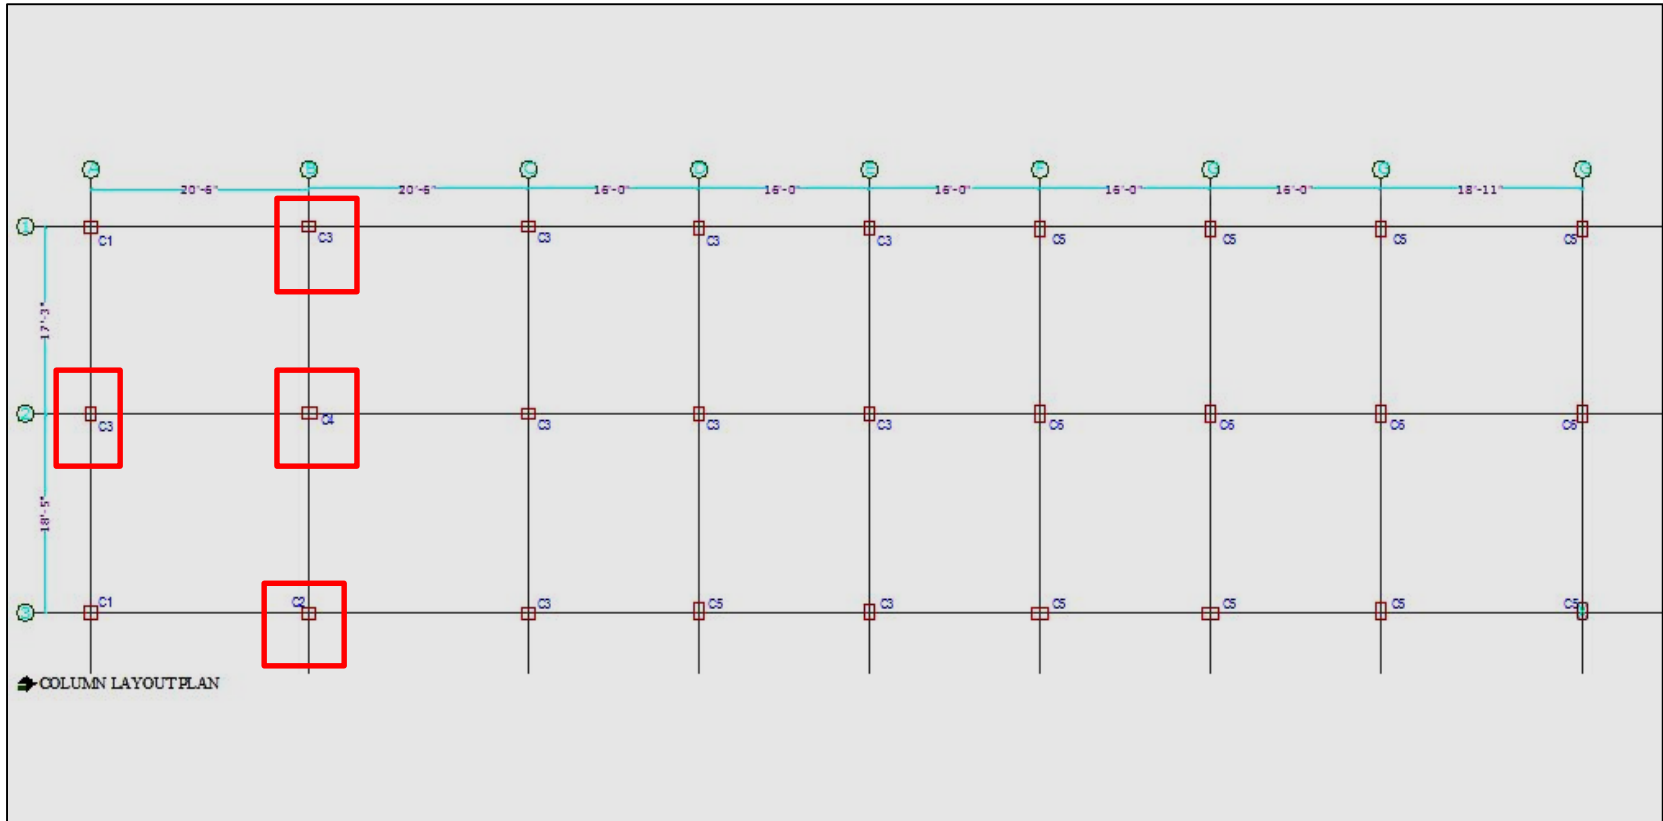
Inconsistency in the as built drawings

Mismatch was found in the column size in the marked location. Factory is required to update the structural drawing as per the as built condition.

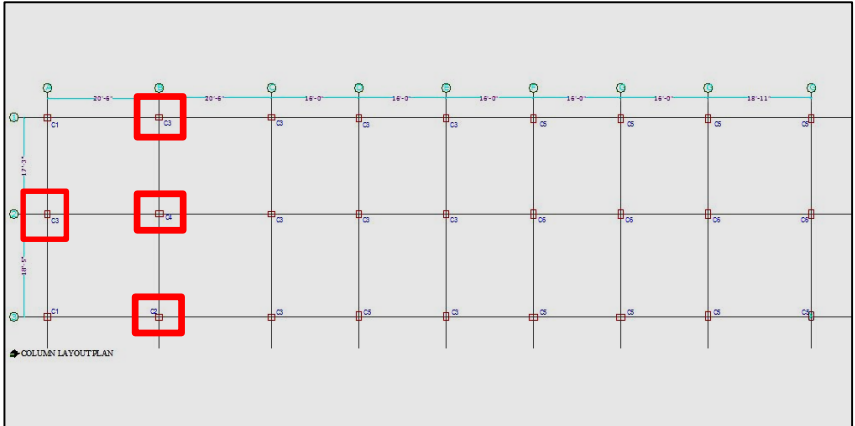
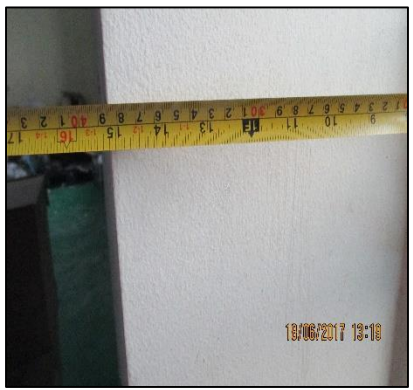
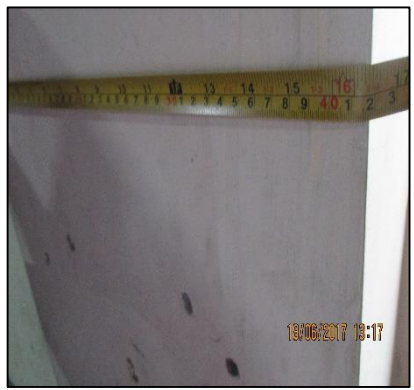
Generator Building

For example in the marked location (Grid A2) the column size was mentioned to have 300mmx375mm. In as built condition the section was found 350mmx375mm. Also in Grid B2 column size was found 300mmx 450mm instead of mentioned 325mmx 400mm . In Grid B1 size was found 300mmx450mm instead of 300mm x375mm and in Grid B3 the found size was 300mmx450mm instead of 300mmx375mm.

7	Inconsistency in the as built drawings of the Generator building	Check adequacy of the roof top truss.	6-weeks
8	Inconsistency in the as built drawings of the Generator building	Implement remedial action if required.	6-months

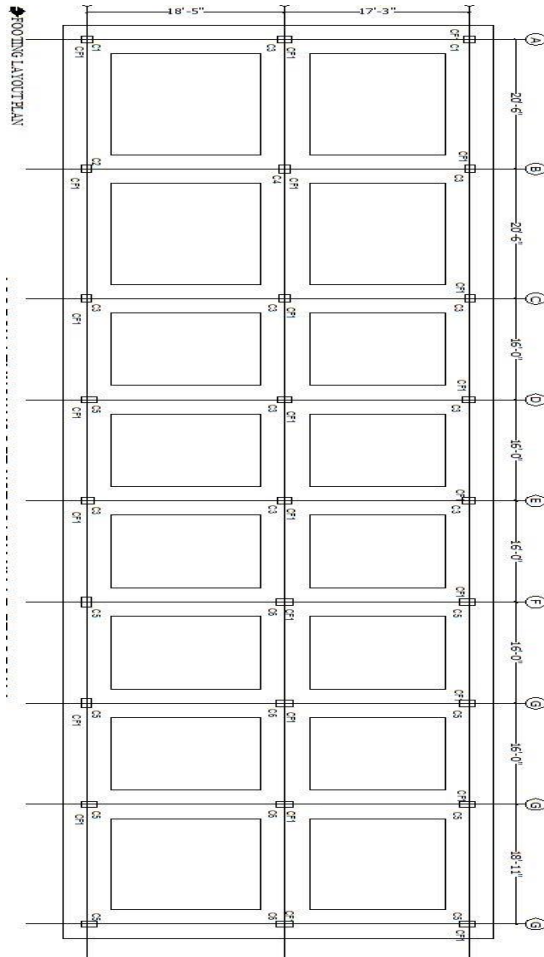
Foundation layout shows strip foundation

Mismatch between footing layout and section & footing plan has been found. Design report has also stated that the footing type is isolated column footing which leads to ambiguity regarding existing footing.

Factory engineer is required to investigate the foundation type of the building.

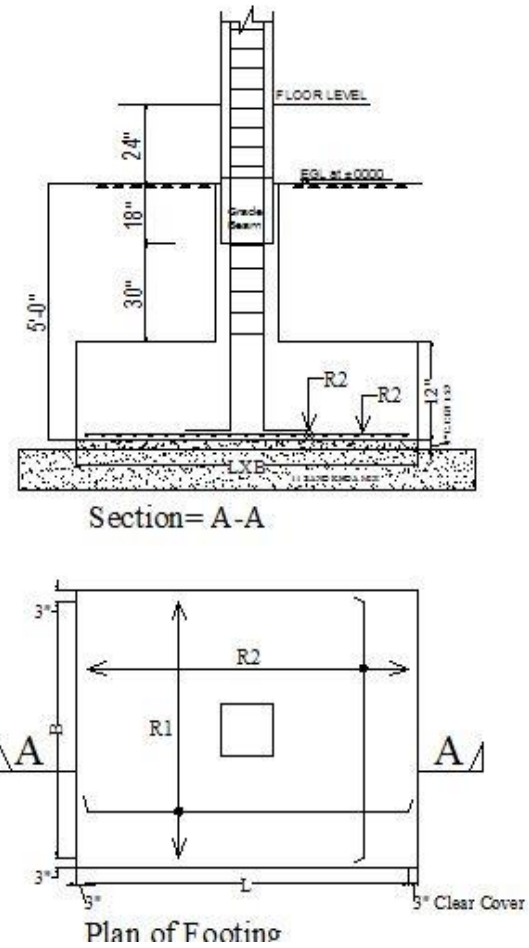
Section & plan of footing shows isolated column footing

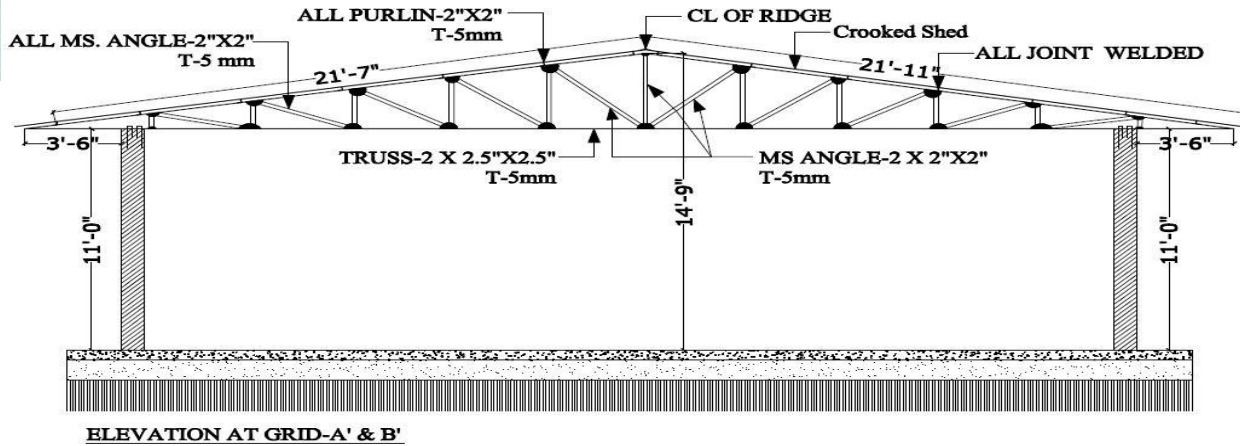
Provided Drawing of Truss: Number of vertical members are 11

Mismatch between existing Trusses of roof top Shed & provided drawing has been found.

Factory engineer is required to update the as built drawing . Also adequacy check is required to verify.

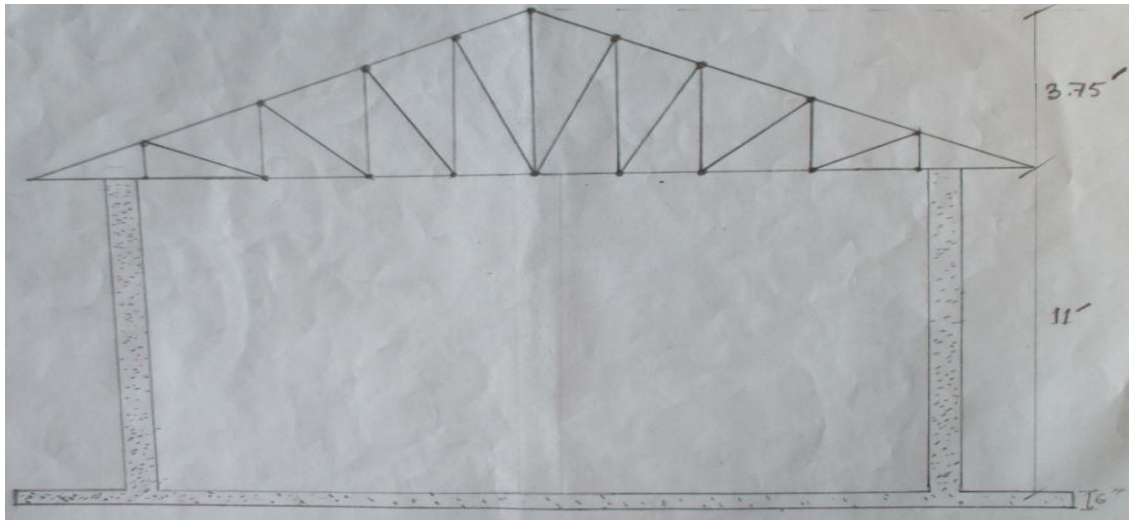
Existing Truss: Number of vertical members are 9

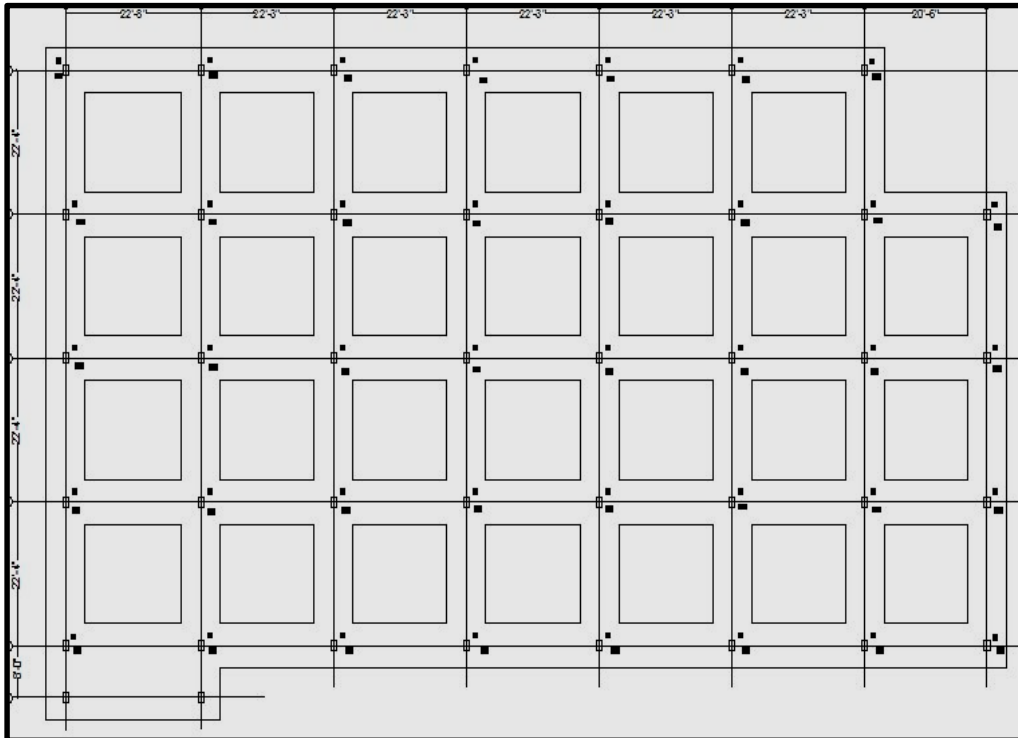
Mismatch between footing layout and section & footing plan has been found. Design report has also stated that the footing type is isolated column footing which leads to ambiguity regarding existing footing. Factory engineer is required to investigate the foundation type of the building.

Foundation layout shows strip foundation

Item No.	Observation	Recommended Action Plan	Recommended Timeline
9	Mismatch in Footing layout in the PFL Building	Factory Engineer is to investigate the footing type and Check the adequacy of the existing Footing as part of the Engineering Assessment.	6-weeks
10	Mismatch in Footing layout in the PFL Building	Produce Accurate drawing as per the as built condition.	6-weeks
11	Mismatch in Footing layout in the PFL Building	Implement remedial action if required.	6-months
12	Damage in steel stair in the PFL Building	Factory Engineer is to investigate the damage of the steel stair.	6-weeks
13	Damage in steel stair in the PFL Building	Apply remedial action if necessary.	6-months
14	Undocumented Steel Veranda in the PFL Building	Produce accurate as built drawings.	6-weeks
15	No proper drainage is provided at the roof top of the generator building and PFL building	Apply proper drainage system at the roof top.	6-months

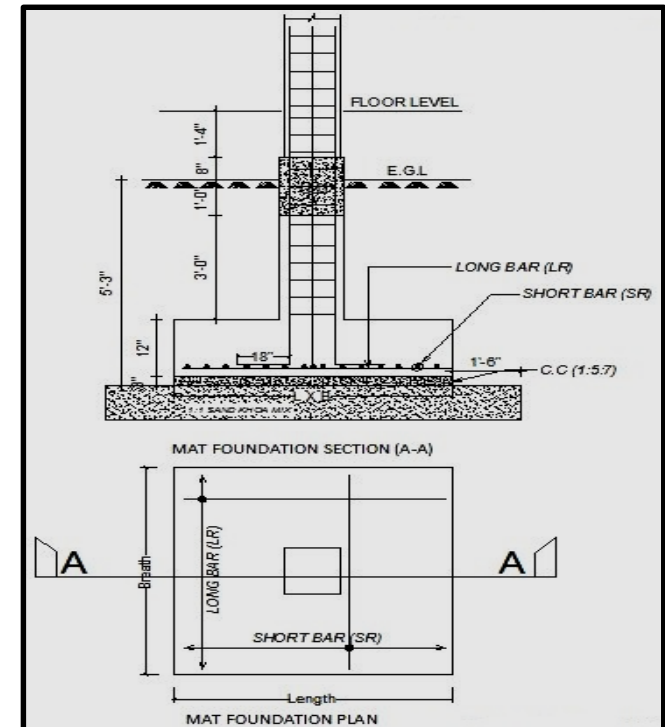
Section & plan of footing shows isolated column footing

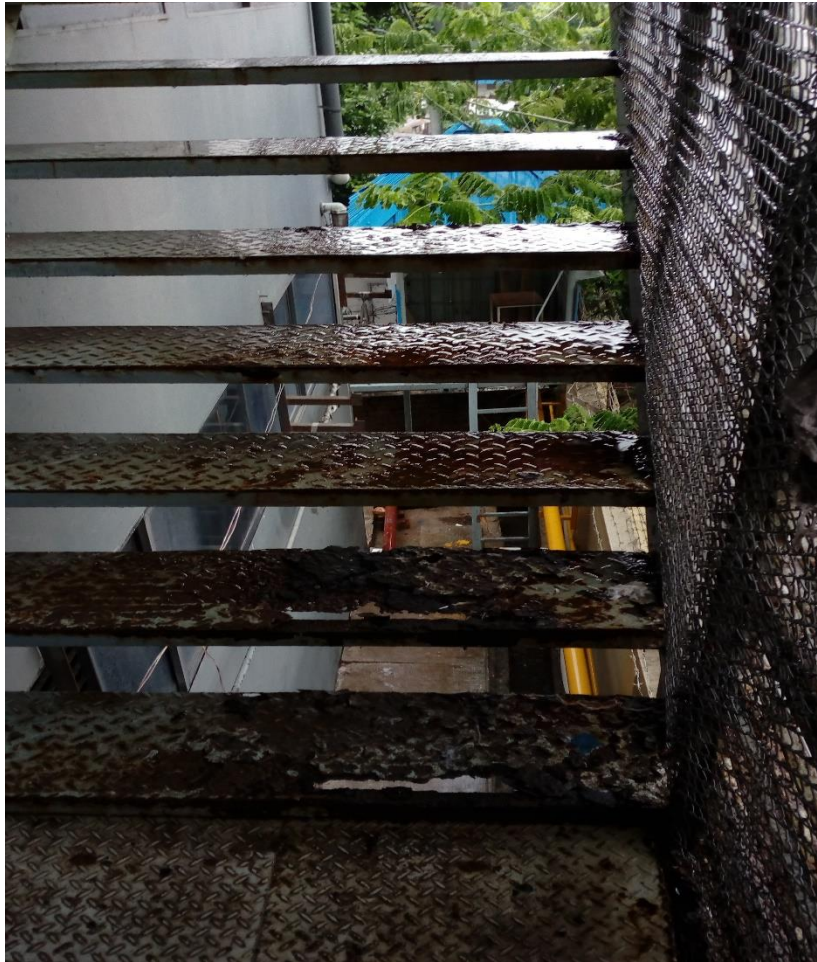
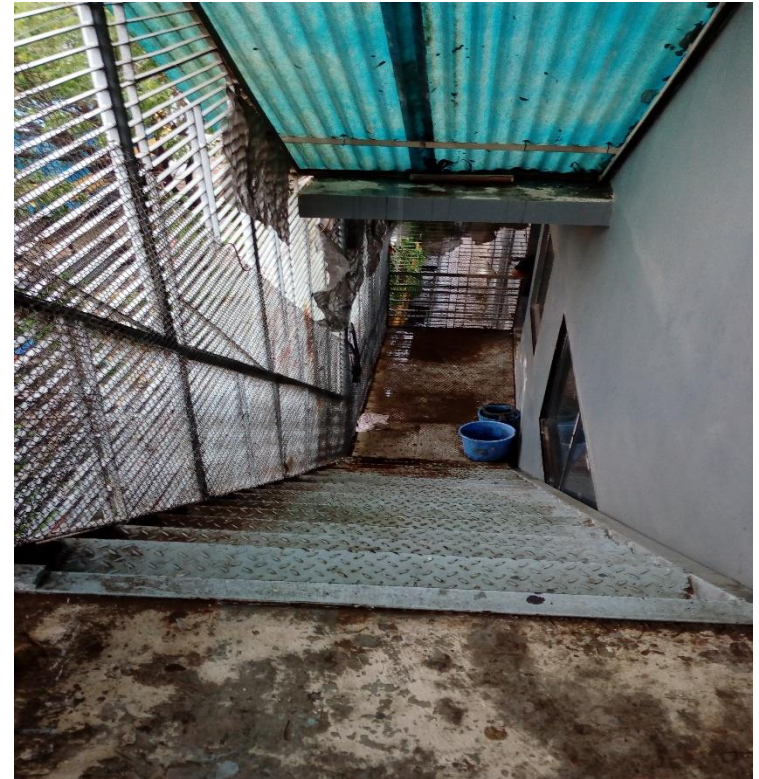
Damage in Steel Stair

The steel stair was found rusted. Landing was found damaged. It is required factory engineer implement proper remedial action for the rusted stair.

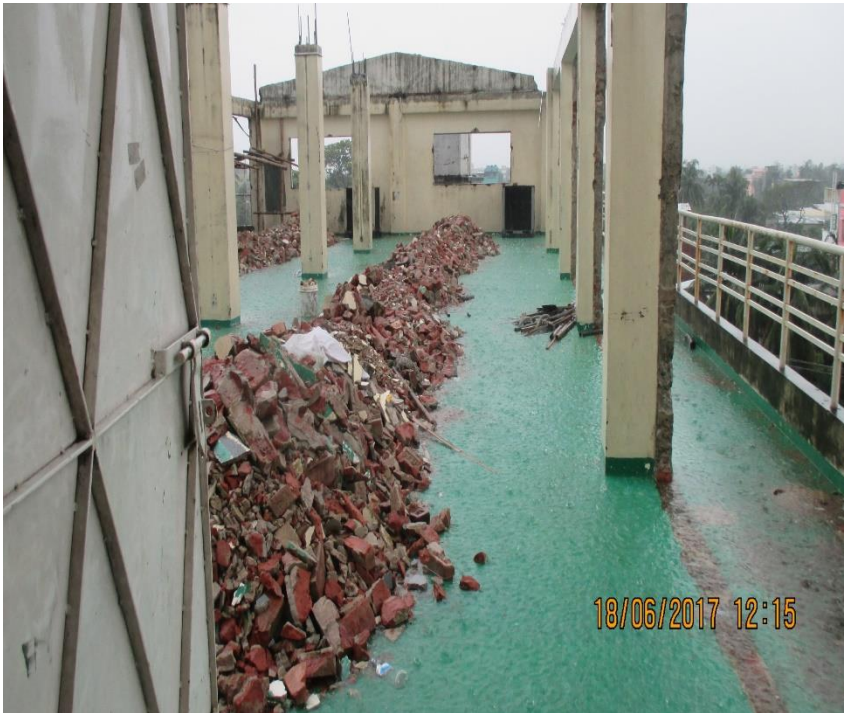
Generator Building

**No proper drainage is provided at the roof top
of the generator building and PFL building**

No drainage was visible at the roof top of the two buildings. Water accumulated at the roof tops . Proper drainage is required to be provided.

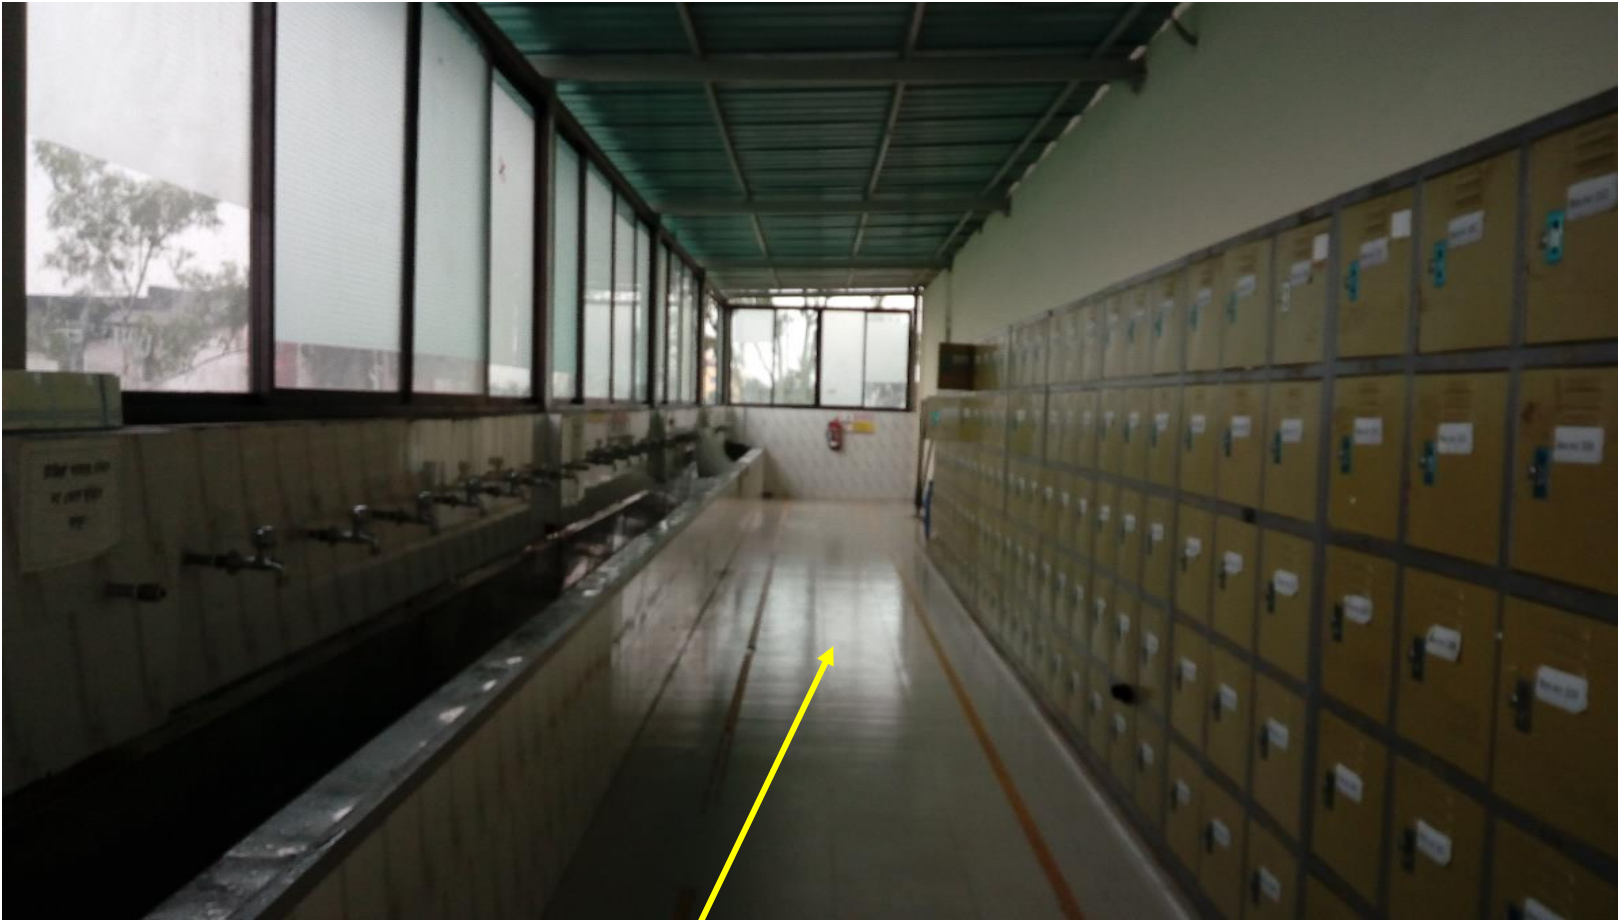
Undocumented Steel Veranda

No document was found for the steel veranda. Proper documentation is required for the veranda.
