# Aurum Sweater Ltd.

249/1,Teli Para,Gazipur Chowrasta,Gazipur.  
(23.996083, 90.382941)

6<sup>th</sup> July 2017

# Observations

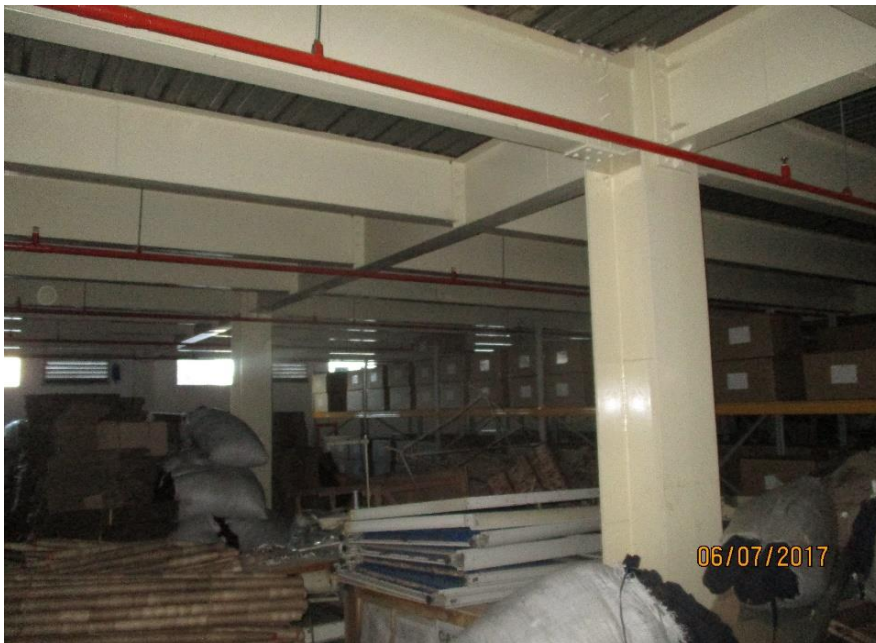
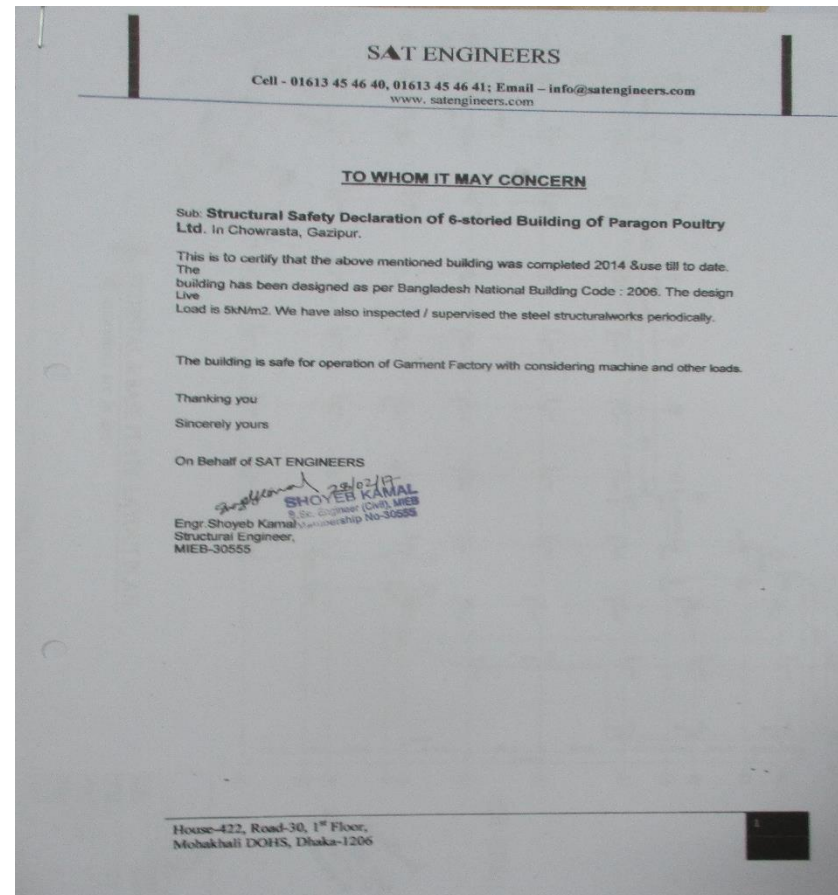
**Steel columns to be stressed above normal design limits as per load certificate**

Factory has provided a load certificate that the building has been designed as per BNBC 2006 and the design load is 5kpa. Design review is required if the factory management wants to implement the load plan according to BNBC.

Factory is required to maintain the floor live load 3kpa until further verification by design engineer.

During inspection no over loading was observed and FOS calculation for internal column was found satisfactory considering 3kpa allowable floor live loading.

| Item No. | Observation | Recommended Action Plan | Recommended Timeline |
|---|---|---|---|
| 1 | (Main Factory Building)<br>Steel columns to be stressed above normal design limits as per load certificate | Building engineer to review the design of the existing steel columns and recommend strengthening if necessary. | 6-weeks |
| 2 | (Main Factory Building)<br>Steel columns to be stressed above normal design limits as per load certificate | Produce and actively manage a loading plan for all floor plates within the factory, giving consideration to floor capacity and column capacity | 6-weeks |
| 3 | (Main Factory Building)<br>Steel columns to be stressed above normal design limits as per load certificate | Continue to implement load plan. | 6-months |
| 4 | (Main Factory Building)<br>Steel columns to be stressed above normal design limits as per load certificate | Carry out any remedial measures recommended by above mentioned engineering assessment . | 6-months |

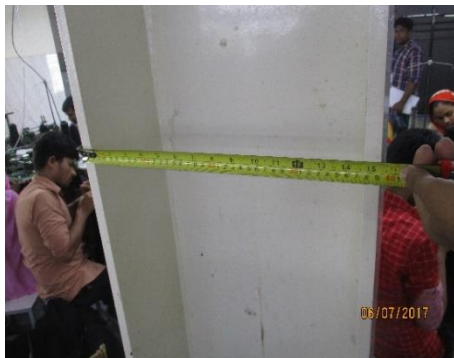
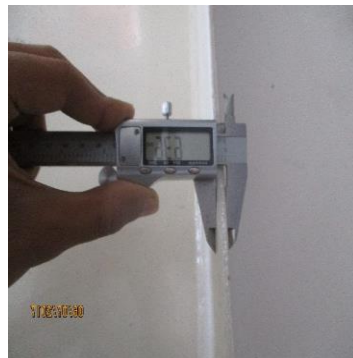
Column dimension

All Column & beam dimensions didn't match with provided drawings. Building engineer is required to produce an "as constructed" drawings which reflect the actual site dimensions with complete structural information.

| Item No. | Observation | Recommended Action Plan | Recommended Timeline |
|---|---|---|---|
| 5 | (Main Factory Building)<br>Discrepancies between drawings and on site condition. | Engage an Engineer to produce an “as constructed” drawings which reflect the actual site dimensions with complete structural information. | 6-weeks |

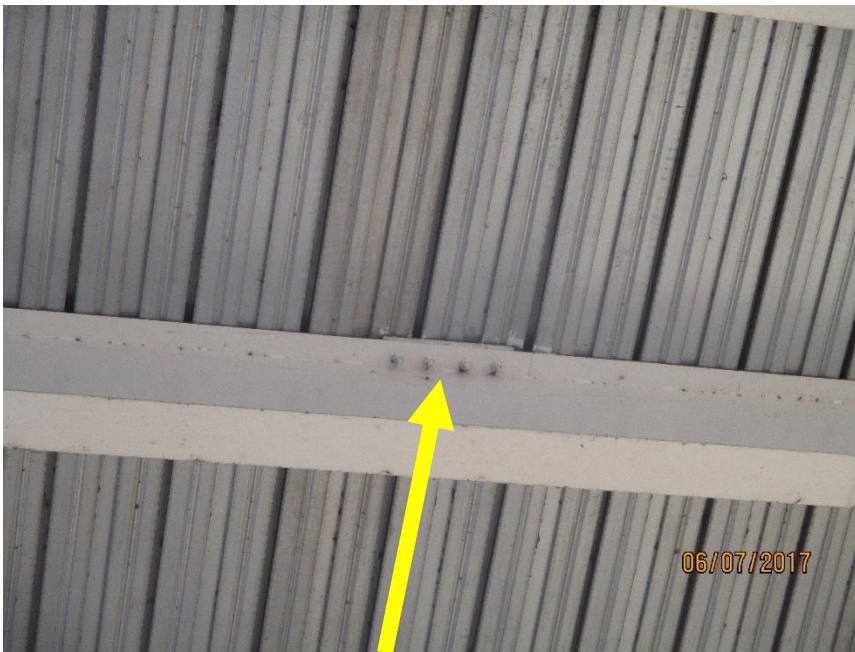
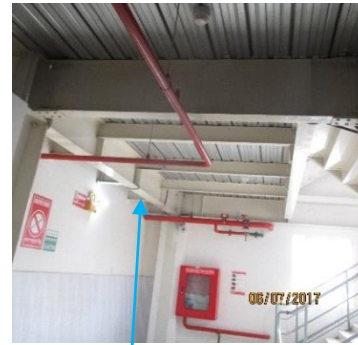
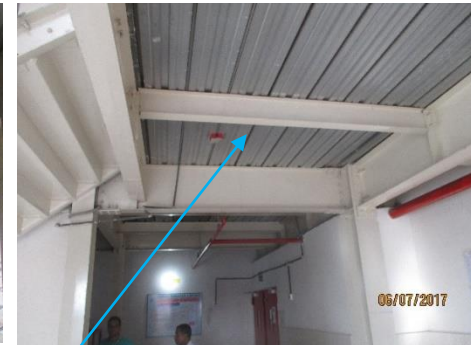
Extra Steel Column

Extra steel column was found which is starting from beam at 2<sup>nd</sup> floor near front stair. Few beams were not shown in beam-layout which actually exist.

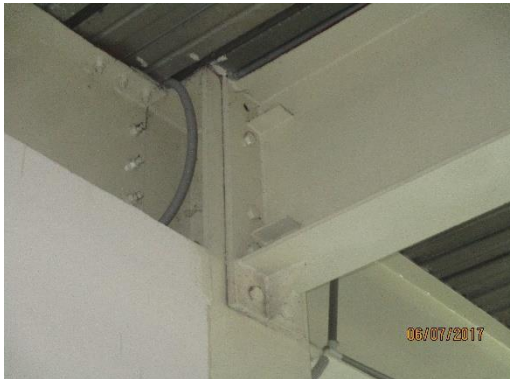
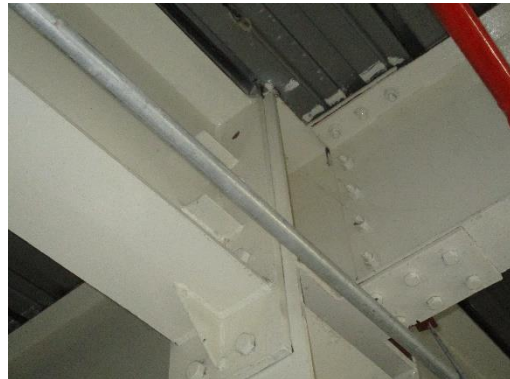
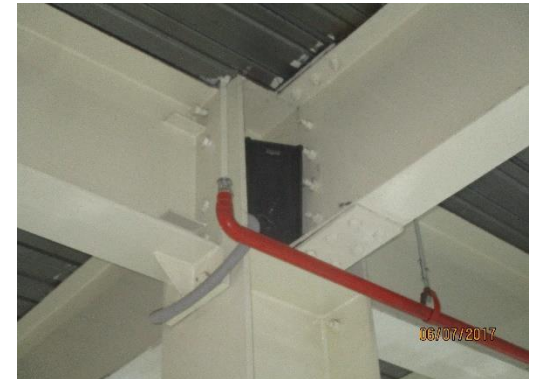
Missing and loose bolt found in several location.

| Item No. | Observation | Recommended Action Plan | Recommended Timeline |
|---|---|---|---|
| 6 | (Main Factory Building)<br>Bolt missing and light connection | Factory Engineer to check the member joints and install missing Bolts. | 6-weeks |

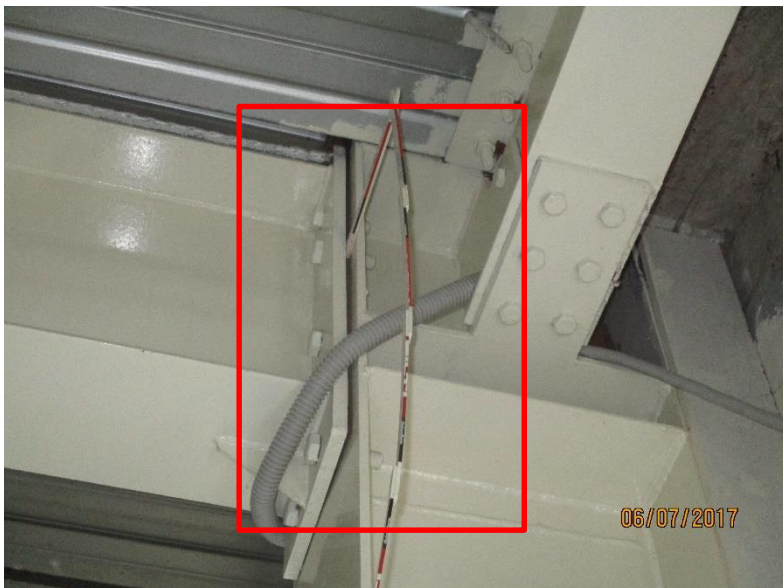
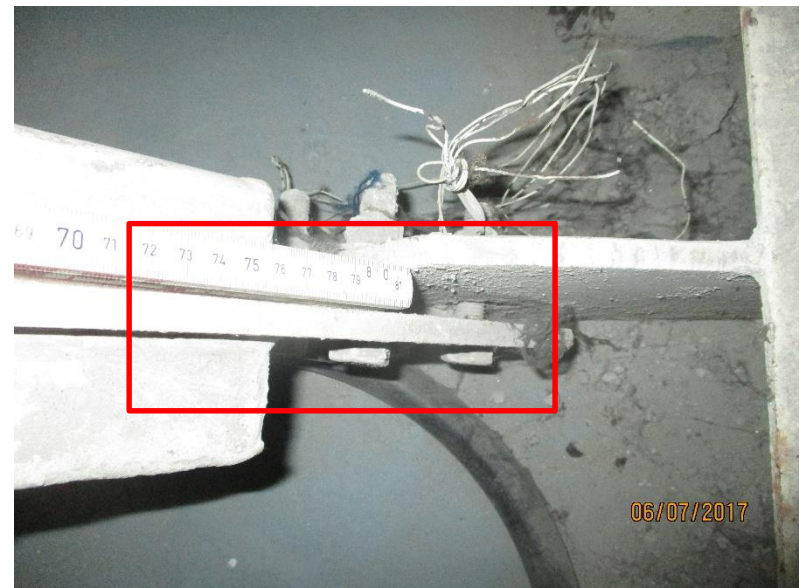
Improper connection found in beam-column joint and bracing joint.

| Item No. | Observation | Recommended Action Plan | Recommended Timeline |
|---|---|---|---|
| 7 | (Main Factory Building)<br>Bolt missing and light connection | Factory Engineer to snag all light connections and take remedial actions if required. | 6-weeks |

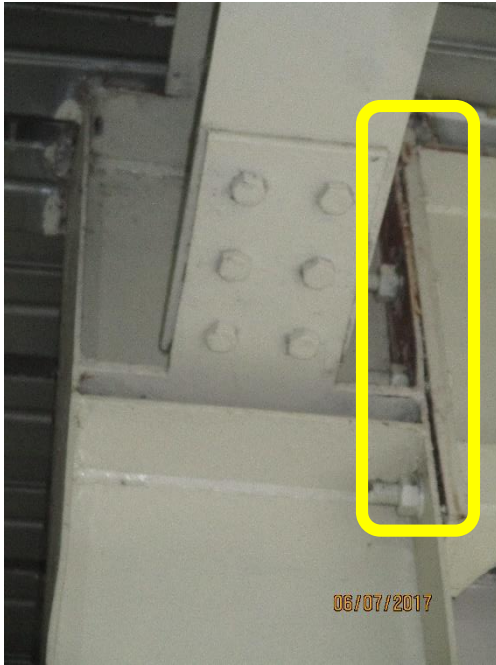
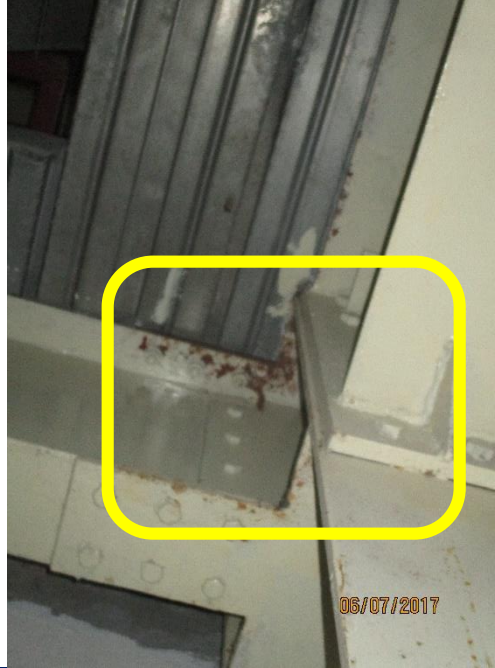
**Corrosion found in beam column connection and column base plate joint at toilet zone**

Corrosion at beam-column joint

| Item No. | Observation | Recommended Action Plan | Recommended Timeline |
|---|---|---|---|
| 8 | (Main Factory Building)<br>Corrosion found in beam column joint and column base plate at toilet zone | Apply suitable method to protect the steel members from corrosion. | 6-weeks |
| 9 | (Main Factory Building)<br>Corrosion found in beam column joint and column base plate at toilet zone | Complete further testing on areas of deterioration and have a structural engineer develop a remediation plan. | 6-months |

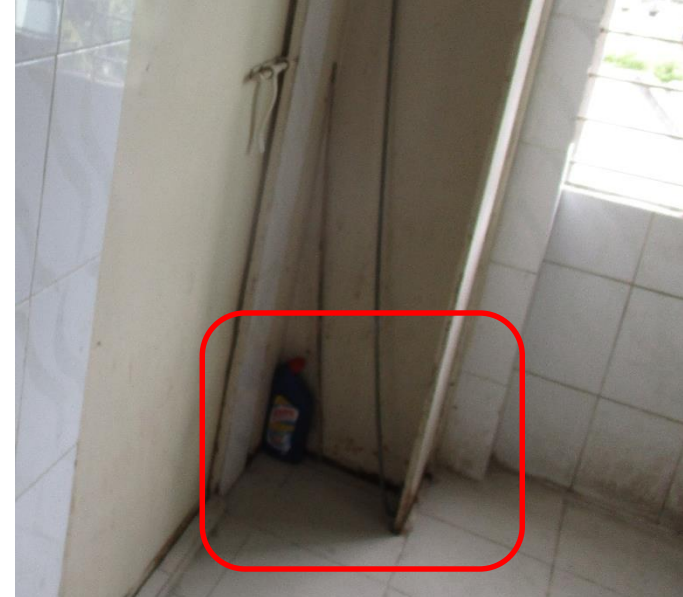
Corrosion at column base inside toilet zone

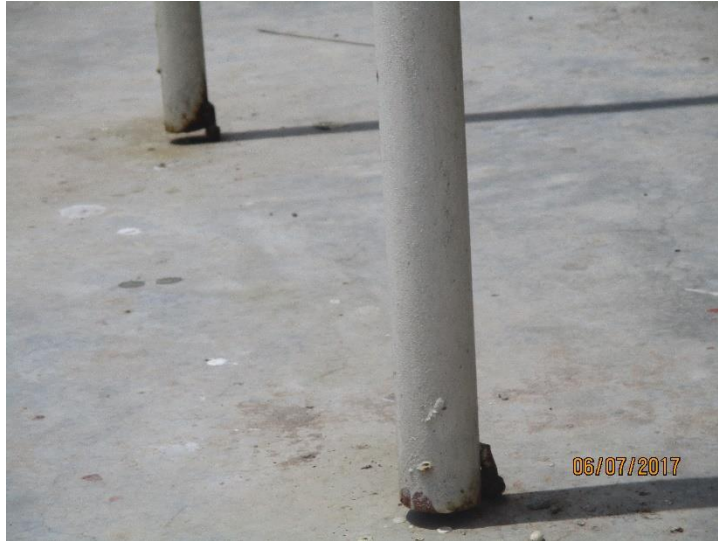
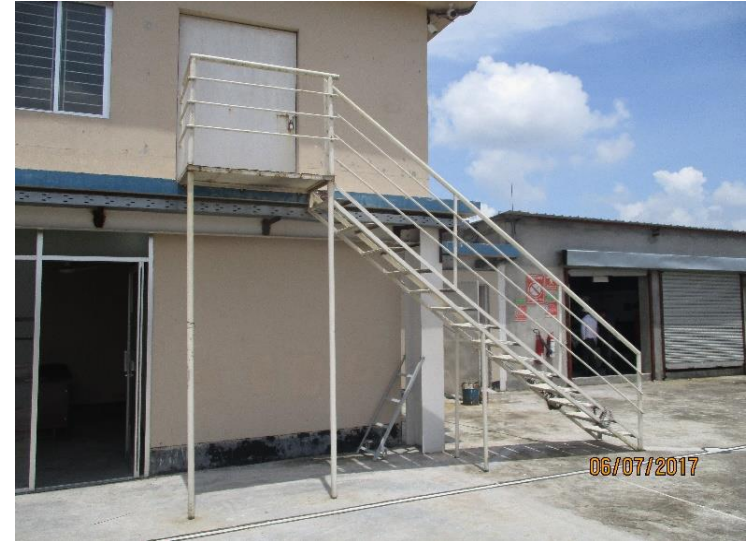
Apparently non-engineered steel stair on roof. Steel pipes are poorly welded with roof slab. The stair does not have adequate bracing and the connection to the building and it appears to be poor.

| Item No. | Observation | Recommended Action Plan | Recommended Timeline |
|---|---|---|---|
| 10 | (Main Factory Building)<br>Apparently non engineered stair with poor support condition | Factory Engineer to install adequate structural members to stable steel stair. | 6-weeks |

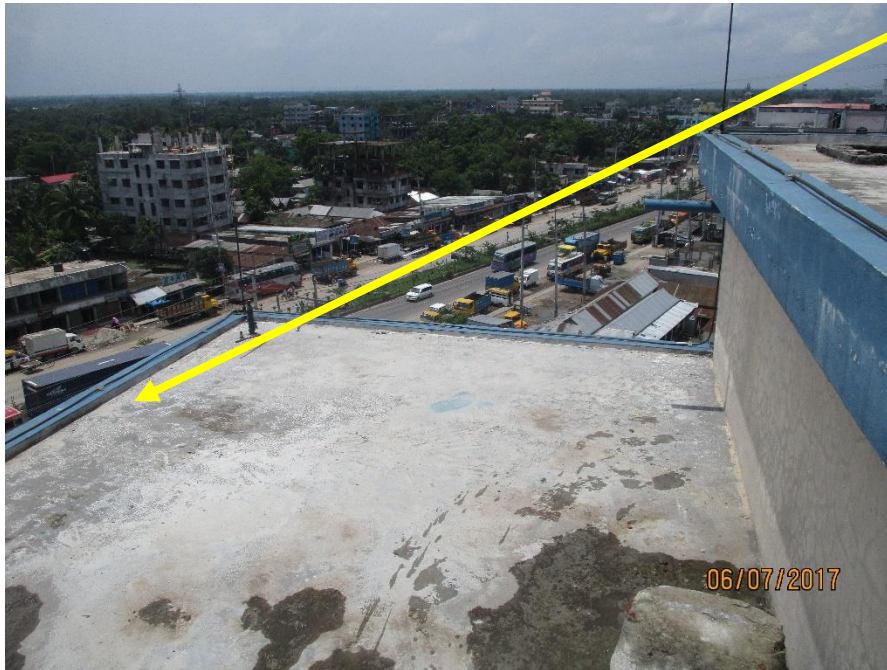
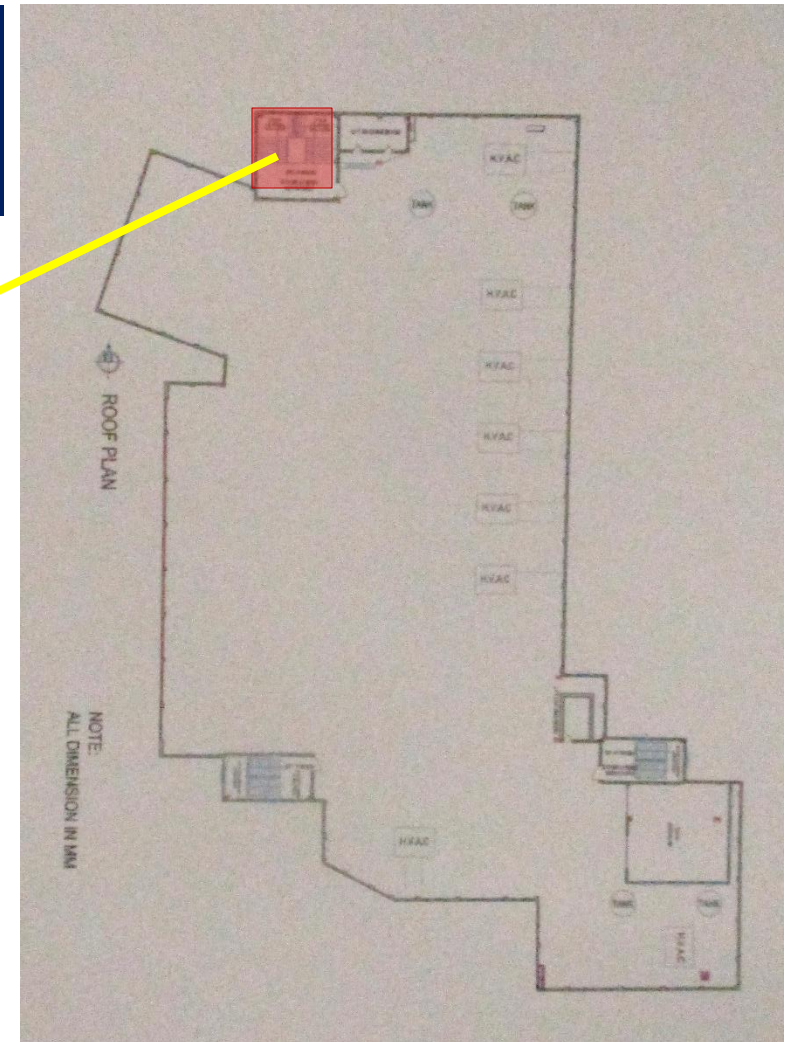
Roof Layout plan

No railing was found beside roof water tank at North-west corner of main production building.

| Item No. | Observation | Recommended Action Plan | Recommended Timeline |
|---|---|---|---|
| 11 | (Main Factory Building)<br>Falling hazard risk at roof | Provide proper edge protection at mentioned area on roof. | 6-weeks |

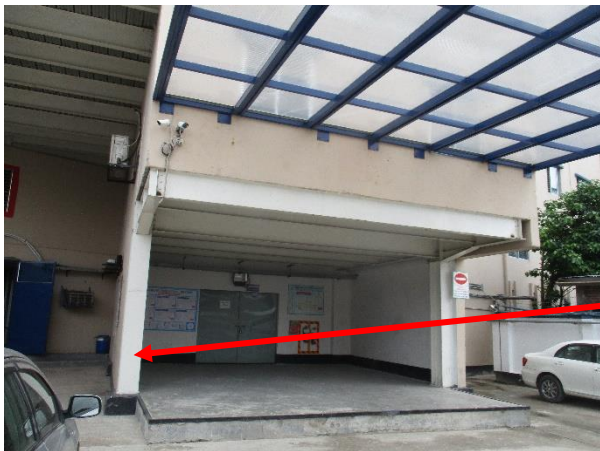
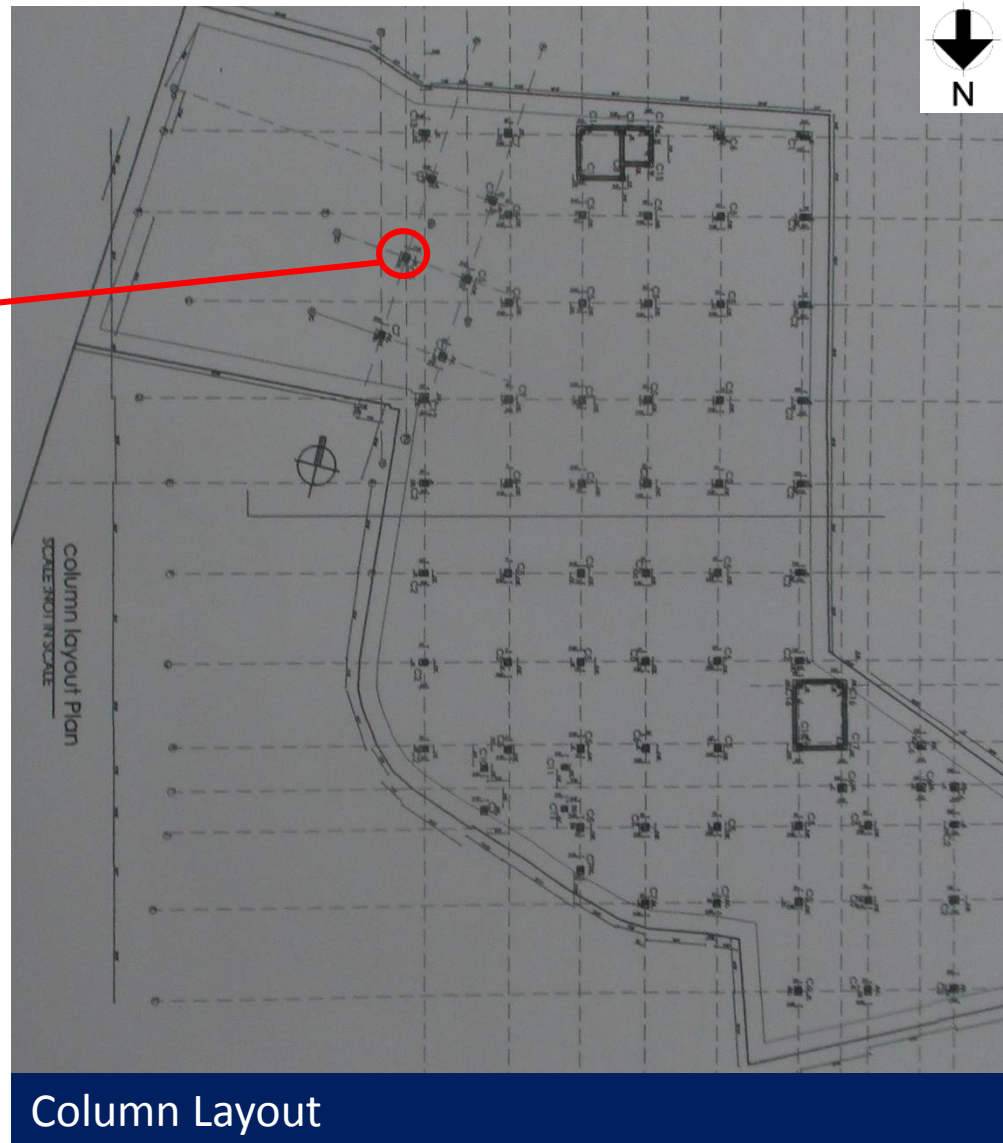
Impact protection not provided to columns at loading –unloading area. Columns are susceptible to impact loading from vehicles.

| Item No. | Observation | Recommended Action Plan | Recommended Timeline |
|---|---|---|---|
| 12 | (Main Factory Building)<br>Columns susceptible to vehicle impact | Install a barrier to prevent vehicle impact in column. | 6-weeks |

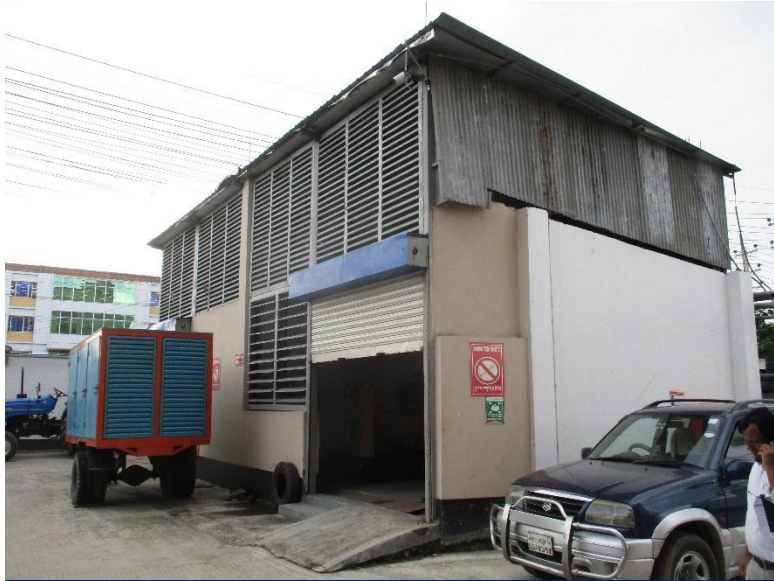
Generator room

Structural drawings were not available for all utility buildings during visit.

| Item No. | Observation | Recommended Action Plan | Recommended Timeline |
|---|---|---|---|
| 13 | (Utility Buildings)<br>In sufficient documents for Utility buildings. | Prepare up-to-date as-built documentation for all utility buildings. | 6-weeks |

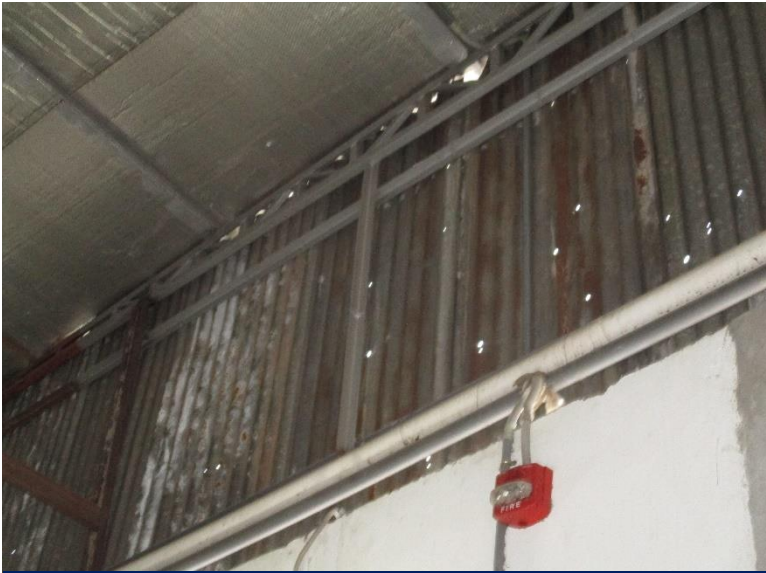
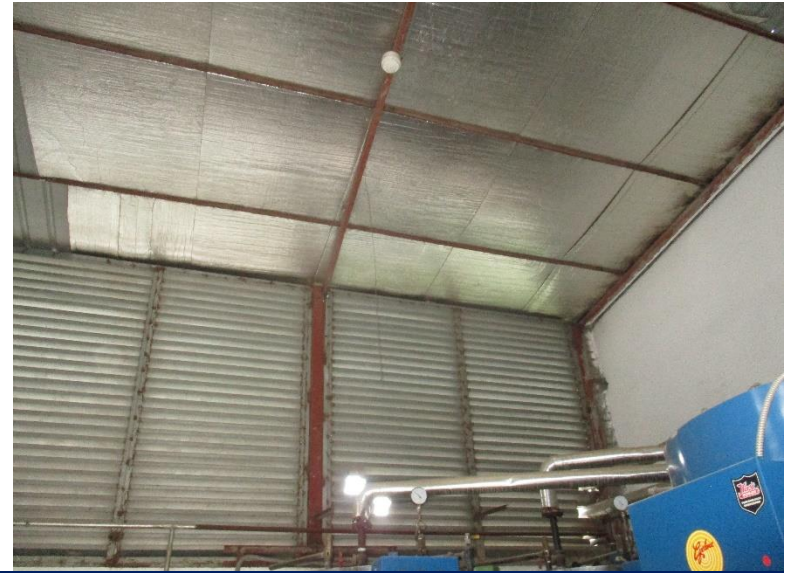
Generator & boiler room

Apparently non-engineered shed. There is no proper connection between support and truss and truss missing in some place. Building engineer to check the capacity of the lightweight steel roofs under lateral and vertical loading.

| Item No. | Observation | Recommended Action Plan | Recommended Timeline |
|---|---|---|---|
| 14 | (Utility Buildings)<br>Apparently non-engineered connection (Generator room & Pump house) | Building engineer to check the capacity of the lightweight steel roofs under lateral and vertical loading. | 6-weeks |
| 15 | (Utility Buildings)<br>Apparently non-engineered connection (Generator room & Pump house) | Carry out remedial works resulting from engineering assessment of building. | 6-months |
