# **FIRE SAFETY INSPECTION REPORT**

**MURAD APPARELS LTD.  
SOUTH GOURIPUR, ASHULIA, SAVAR, DHAKA**

**ACCORD**  
on Fire and Building Safety in Bangladesh

September 3, 2014

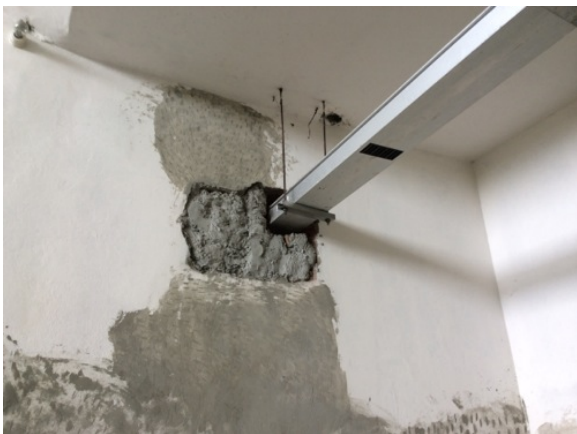
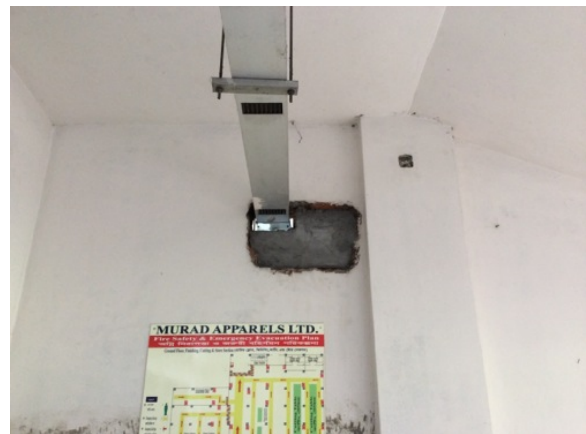
F-1	Fire Rated Construction	Two (2) unsealed penetrations from the utility room are located in the northeast exit stair enclosure on the ground floor.	Seal all penetrations and openings in exit stair enclosure walls to maintain the fire separation.	Within 3 months
-----	----------------------------	--	---	--------------------

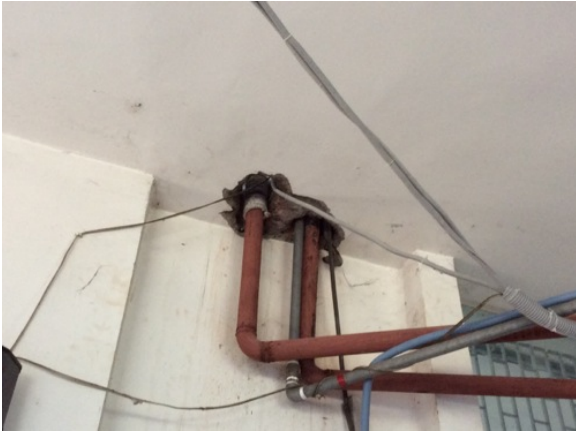
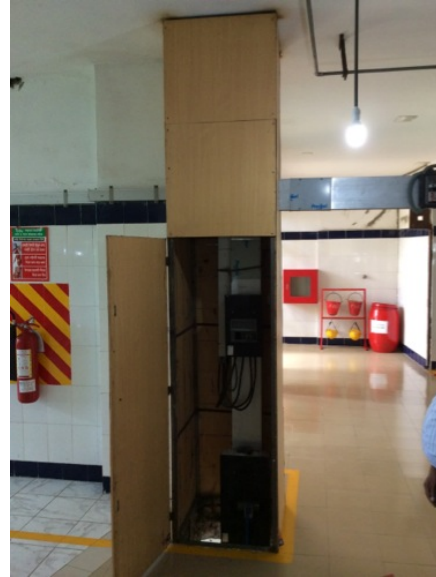
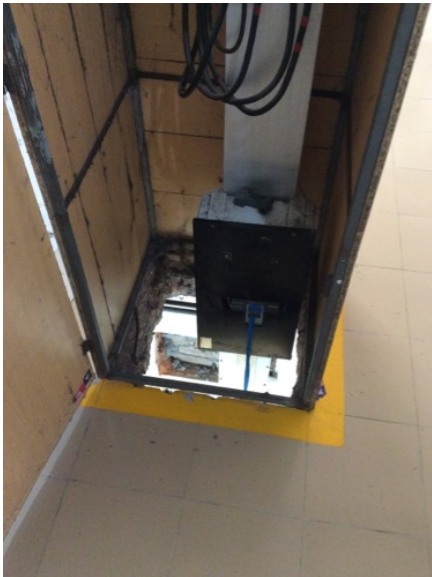
F-2	Fire Rated Construction	Unsealed penetrations are located in the fire-rated floor/ceiling assemblies. Specifically boiler piping from the utility room to the first floor, east office room and an electrical riser adjacent to the northeast exit stair.	Provide a minimum 2-hr fire-rated shaft for the electrical riser to separate the utility riser from each floor level.  Seal the boiler piping penetrations in the floor/ceiling assembly to maintain the fire separation.	Within 3 months
-----	----------------------------	---	---	--------------------

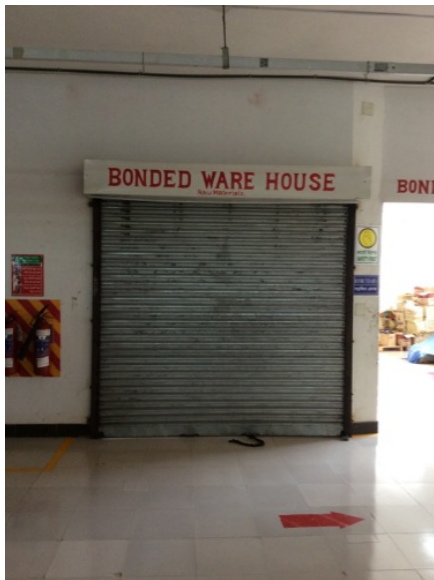
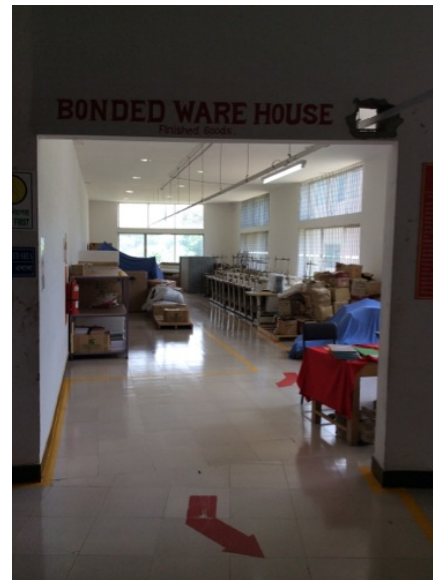
F-3	Fire Rated Construction	<p>Rooms used for combustible storage were not separated by fire-rated construction. Specifically, the building had dedicated storage rooms on the ground floor (bonded warehouse, finished goods storage).</p>	<p>Provide dedicated storage rooms separated by minimum 1-hr fire-rated construction.</p> <p>Where separate storage rooms are not feasible, provide defined storage areas and limit the storage arrangement as follows:</p> <ul style="list-style-type: none"> <li>- Maximum height of 2.4m and maximum area of 23m<sup>2</sup></li> <li>- If sprinkler protected: maximum height of 3.66m and maximum area of 93m<sup>2</sup></li> </ul> <p>Separate areas of unenclosed combustible storage by a minimum clear distance of 3m.</p>	Within 3 months
-----	-------------------------	---	--	-----------------

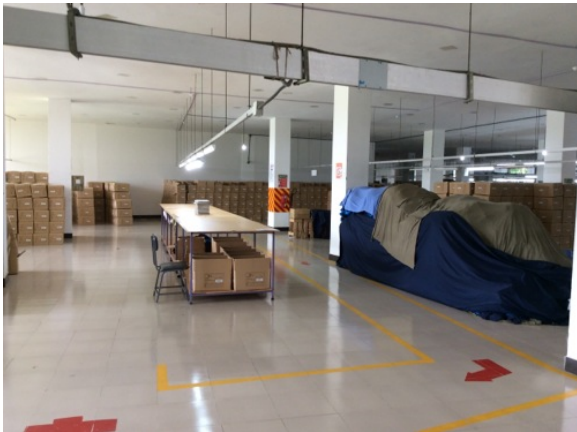
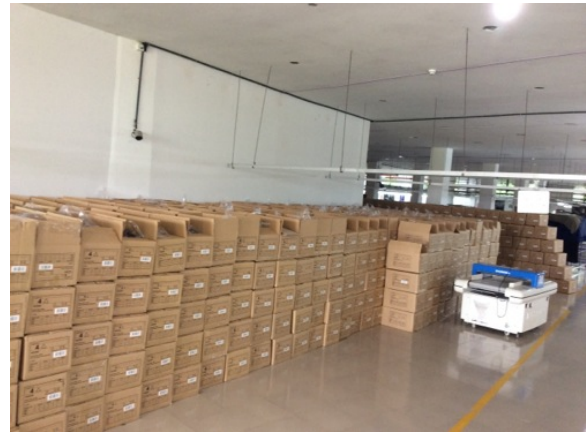
F-4	Fire Rated Construction	Areas used for combustible storage, open to the factory floor, were not separated by fire-rated construction. Specifically, storage was open to the factory floor on the ground floor.	<p>Provide dedicated storage rooms separated by minimum 1-hr fire-rated construction.</p> <p>Where separate storage rooms are not feasible, provide defined storage areas and limit the storage arrangement as follows:</p> <ul style="list-style-type: none"> <li>- Maximum height of 2.4m and maximum area of 23m<sup>2</sup></li> <li>- If sprinkler protected: maximum height of 3.66m and maximum area of 93m<sup>2</sup></li> </ul> <p>Separate areas of unenclosed combustible storage by a minimum clear distance of 3m.</p>	Within 3 months
-----	-------------------------	--	--	-----------------

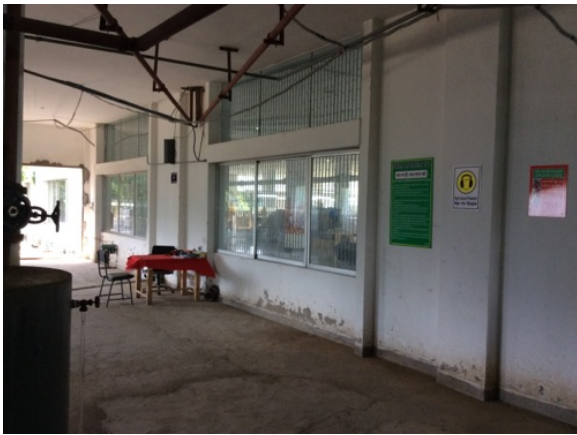
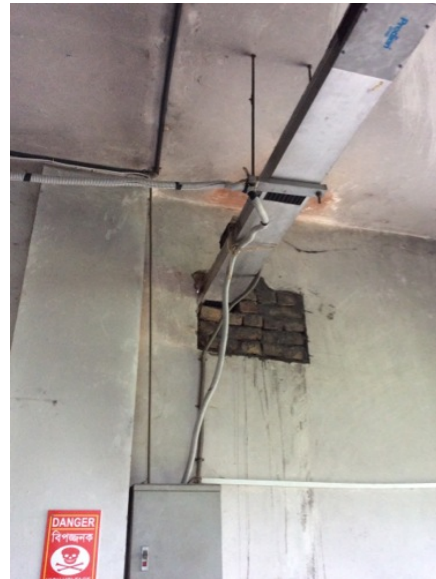
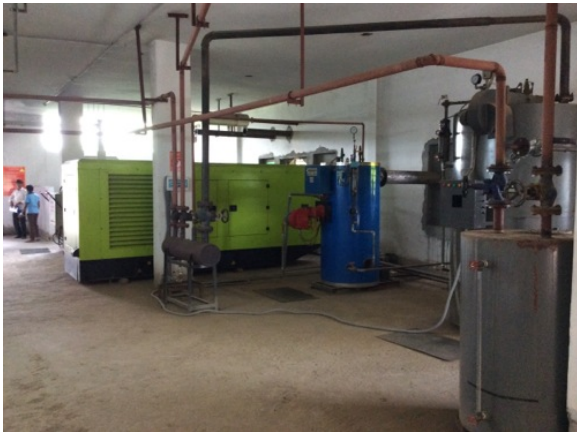
F-5	Fire Rated Construction	<p>The ground floor boiler, generator and transformer room (utility room) is not separated by fire-rated construction and open to the factory floor due to openings, a non-rated door and penetrations.</p> <p>The boilers, generators and transformer were not separated from each other.</p>	<p>Separate the utility room by a minimum 2-hr fire-rated construction. Seal and/or protected all openings to maintain the required fire separations.</p> <p>Separate all utilities from other utilities.</p>	Within 3 months
-----	-------------------------	--	---	-----------------

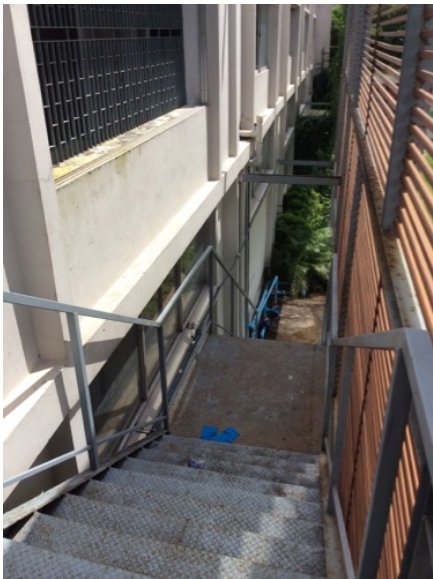
F-6	Fire Rated Construction	The south, exterior exit stair had unprotected openings to the building interior.	Seal the unprotected openings adjacent to and extending at a distance of up to 10 ft. beyond the ends of the south, exterior exit stair.	Within 3 months
-----	-------------------------	---	--	-----------------

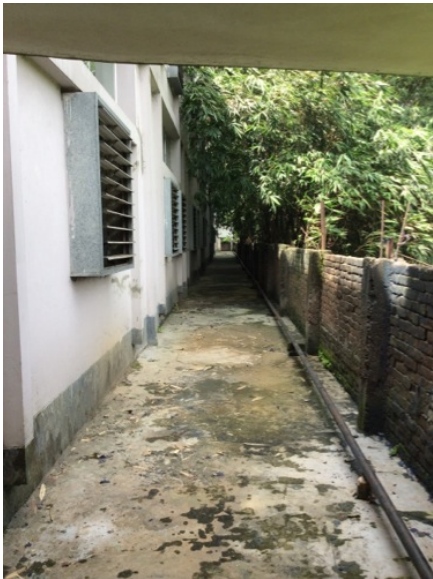
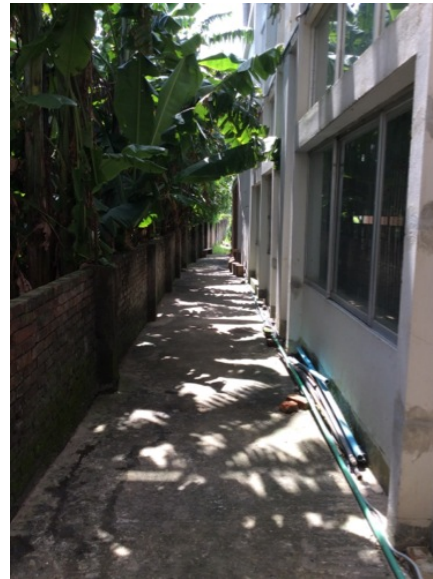
F-7	Fire Rated Construction	The exit discharge path serving the northeast exit stair (along the north side of the building) and the exit discharge path serving the south exit from the ground floor utility room (along the east side of the building) are less than 10 ft. wide, 7 ft. and 6 ft., respectively, and not separated from the building interior.	Seal all penetrations and openings to the interior of the building along the discharge paths, up to a height of 10 ft., to provide a minimum 1-hr fire separation.  For the northeast exit stair, alternatively provide a second remote discharge path to the public way.	Within 6 months
-----	-------------------------	---	---	-----------------

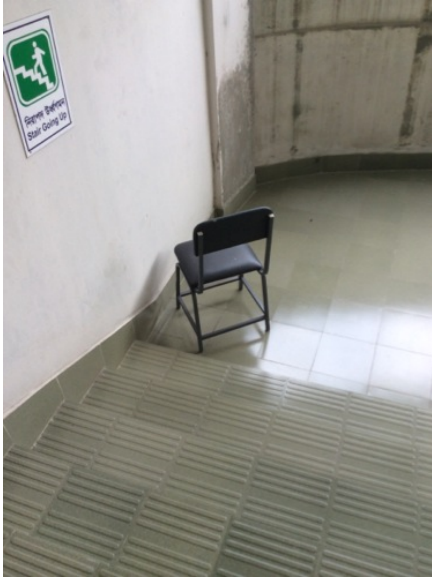
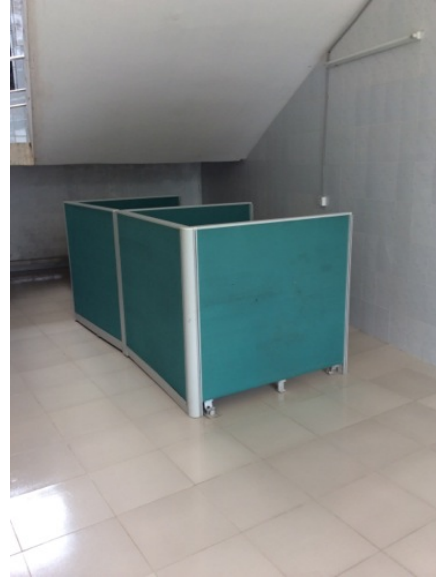
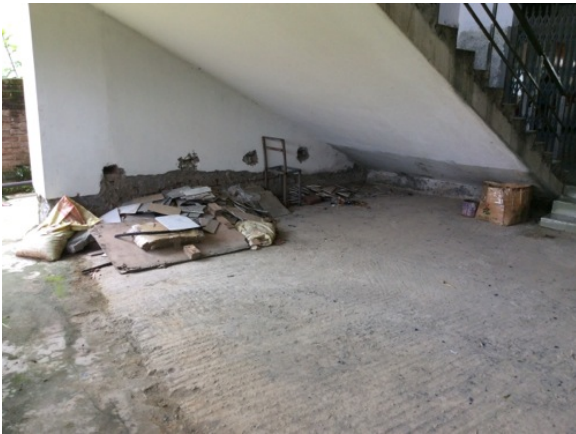
F-8	Egress	Storage was located in the west and northeast exit stairs on the ground floor and in the northeast exit stair on the first floor.	Remove all storage from exit stairs and egress paths.	Immediate
-----	--------	---	---	-----------

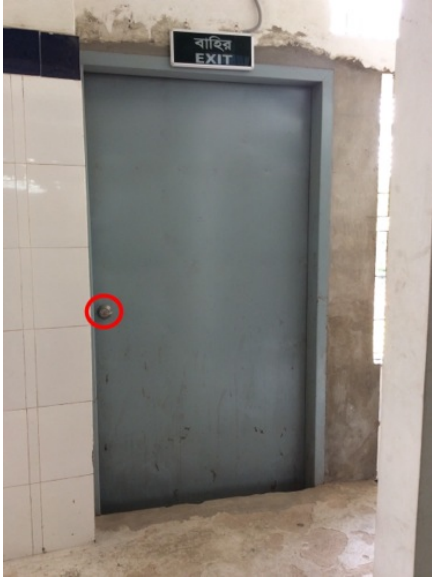
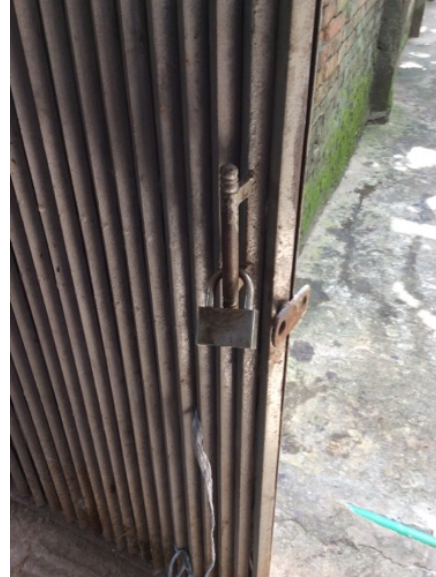
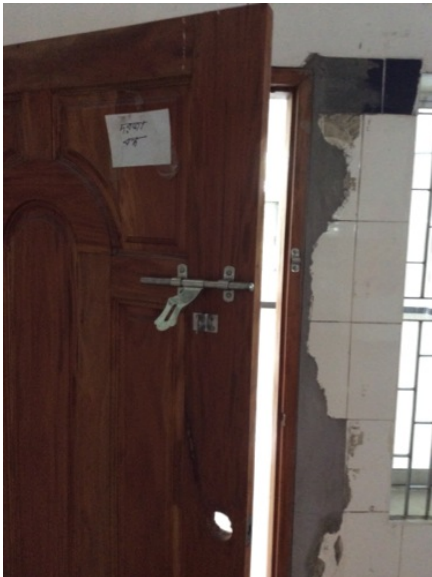
F-9	Egress	Egress doors and gates with locking features are provided at building exits, exit stairs and along egress routes. All gates and doors were open and unlocked during the inspection.	Remove locking features from all egress doors and gates.  If locks are required for security reasons, utilize special door locking features complying with NFPA 101.	Immediate
-----	--------	---	--	-----------

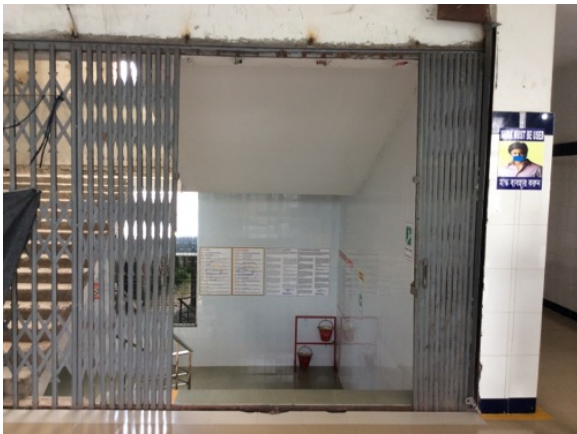
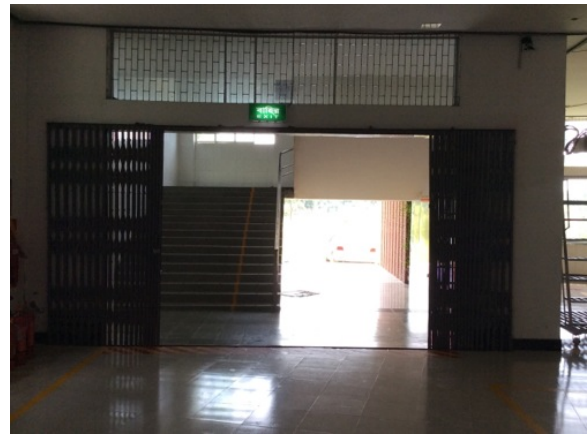
F-11	Egress	Collapsible gates are provided at building exits, exit stairs and along egress routes.	Replace all gates along the means of egress with side-hinged, swinging egress doors.  If locks are required for security reasons, utilize special door locking features complying with NFPA 101.	Within 1 month
------	--------	--	--	----------------

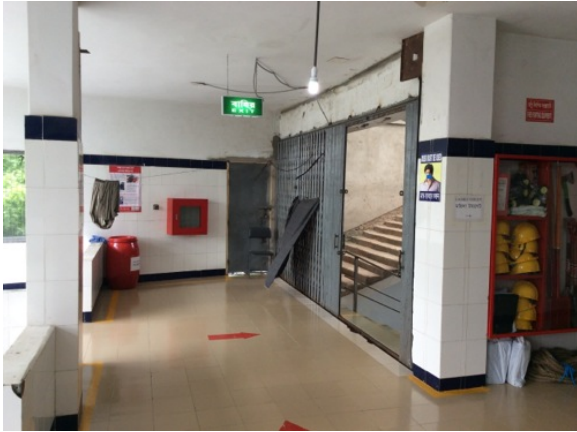
F-12	Egress	The west exit stair was unenclosed on the first floor and open to the factory floor.	Enclose all exit stairs in 2-hr fire-rated construction on all floors.	Within 3 months
------	--------	--	--	-----------------

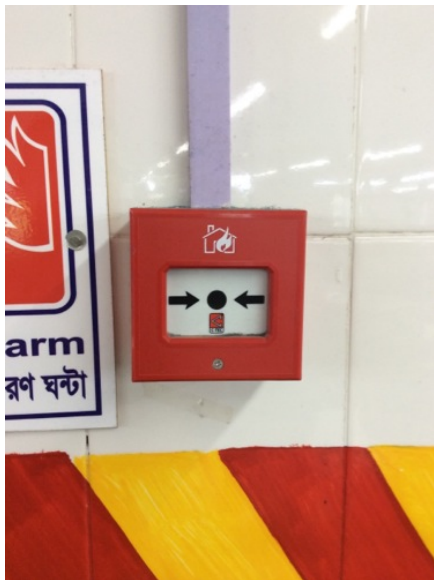
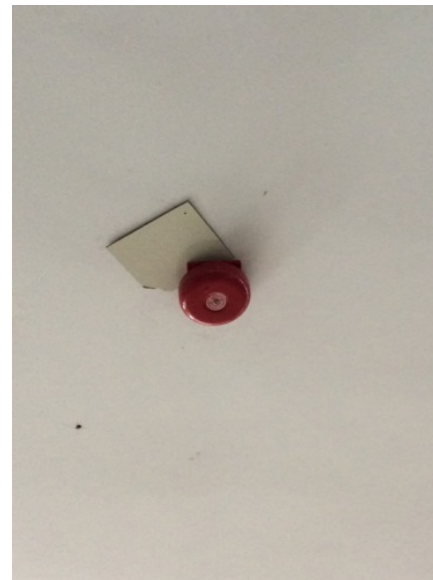
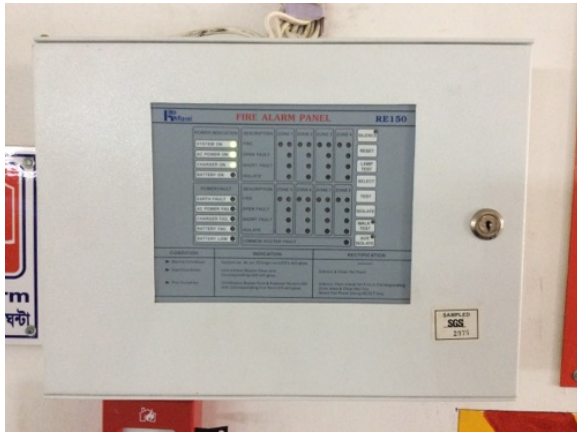
F-13	Fire Protection	The conventional fire alarm system is antiquated, not a listed system, and does not provide alarm and notification features consistent with acceptable standards.	Replace the fire alarm system with a new, listed addressable fire alarm system in accordance with NFPA 72.	Design within 4 months, install within 9 months
------	-----------------	---	--	---

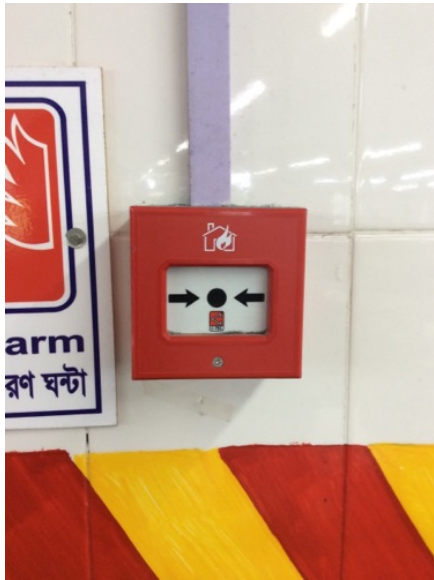
F-14	Fire Protection	No records of inspection, testing, and maintenance of the fire alarm system were provided during the inspection.	Inspect, test and maintain the fire alarm system, and keep written records on-site, in accordance with NFPA 72.	Within 3 months
F-15	Fire Protection	The fire alarm system manual activation points are located in the middle of the factory floor instead of adjacent to the exit stair entrances.	Relocate the fire alarm manual activation points adjacent to the exit stair entrances.	Within 6 months

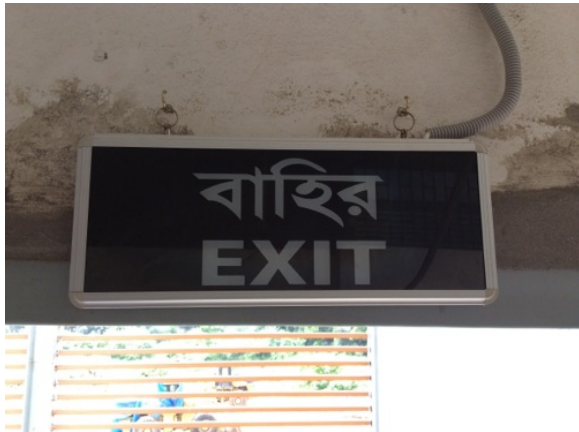
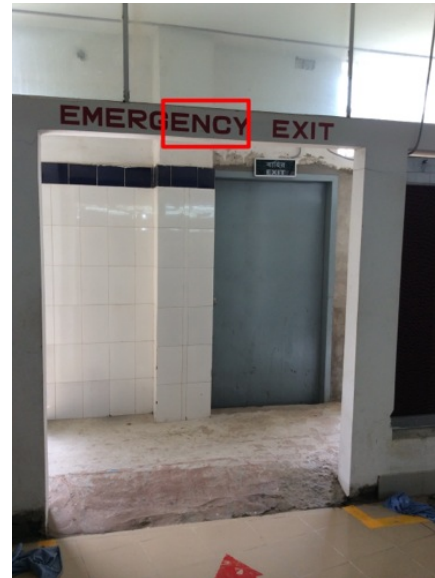
F-16	Fire Protection	<p>A functional test of the fire alarm system was performed during the inspection. The fire alarm was not audible in the utility room and based off observation, it does not appear to provide adequate audible notification coverage throughout other factory areas.</p>	<p>Provide additional notification appliances such that the fire alarm system is audible throughout the building in accordance with NFPA 72.</p>	<p>Within 6 months</p>
F-17	Egress Lighting	<p>The exit signage to the south exterior exit stair was not illuminated (burned out, broken, etc.).</p> <p>The placement of this sign was in a location such that it was not readily visible from the factory floor.</p>	<p>Regularly inspect all exit signage and replace/install lights as needed to illuminate signs.</p> <p>Relocate the exit signage such that it is readily visible from the factory floor.</p>	<p>Within 1 month</p>

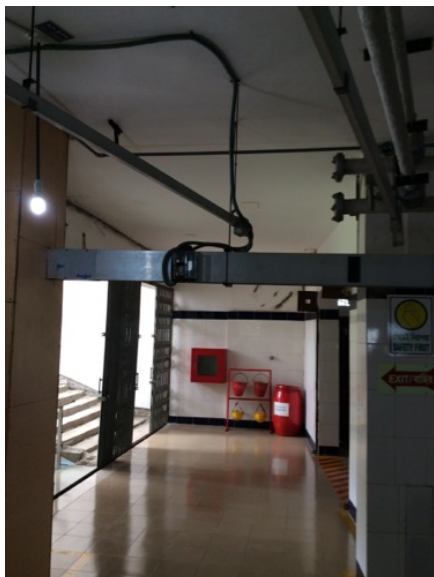
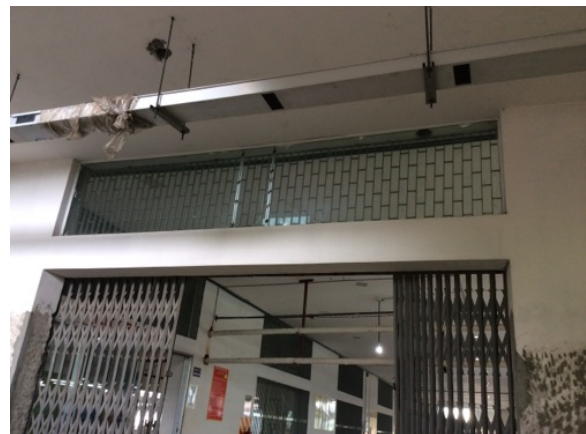
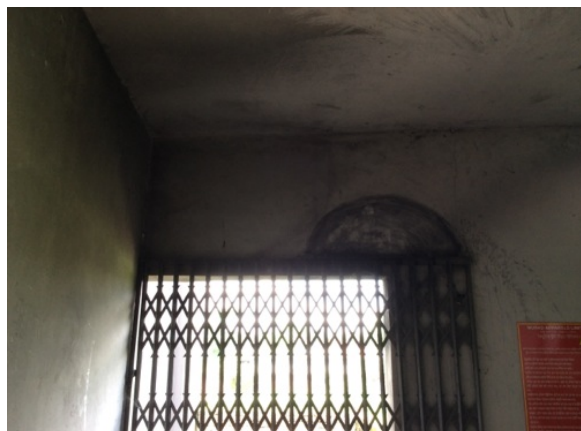
F-18 Egress Lighting

Exit signs were not provided at all exits. Specifically, one (1) to each of the first floor northeast and southeast exit stairs, two (2) from the east, first floor office room, one (1) from the ground floor bonded warehouse and two (2) from the east, ground floor utility room.

Provide exit signs above all exits to the exterior and all doors to the exit stairs.
