FIRE SAFETY INSPECTION REPORT

**TM FASHION LTD.
HAZI ISMAIL BHABAN, CHANDANA, CHOWRASTA,
GAZIPUR SADAR, GAZIPUR**

ACCORD
on Fire and Building Safety in Bangladesh

September 4, 2014

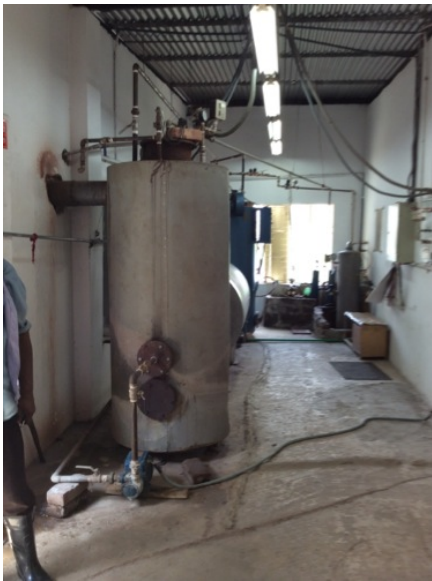
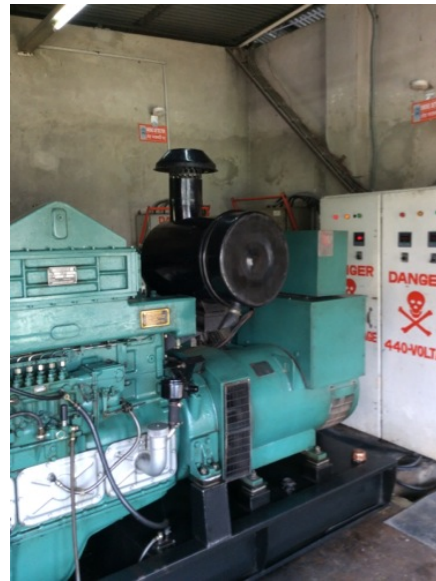
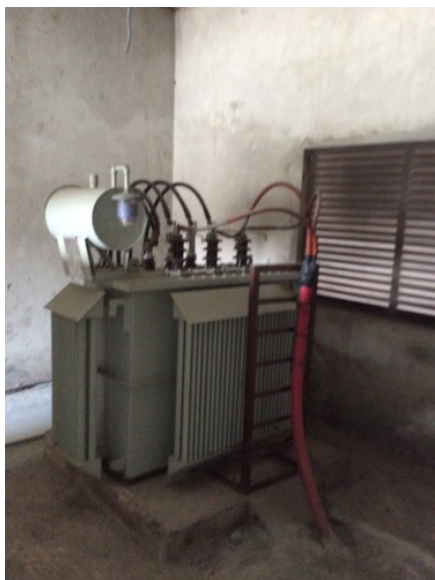
No.	Category	Finding	Recommendation	Remediation Timeframe
F-1	Fire Rated Construction	The boiler, generator and transformer rooms are not separated by fire-rated construction that is openings, non-rated doors and penetrations on ground and 2nd floors	Separate the boiler, generator and transformer room by a minimum 2-hr fire-rated construction. Seal and/or protected all openings to maintain the required fire separations	Within 3 months

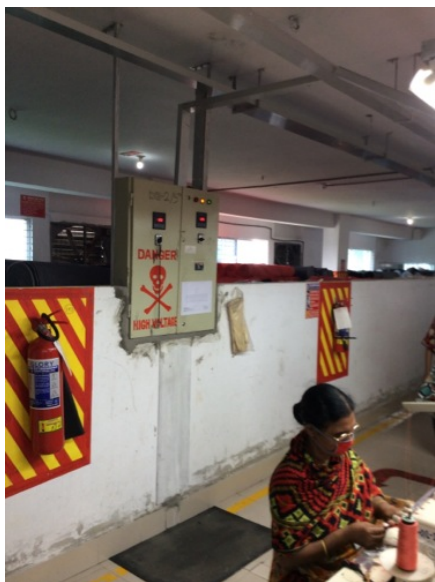
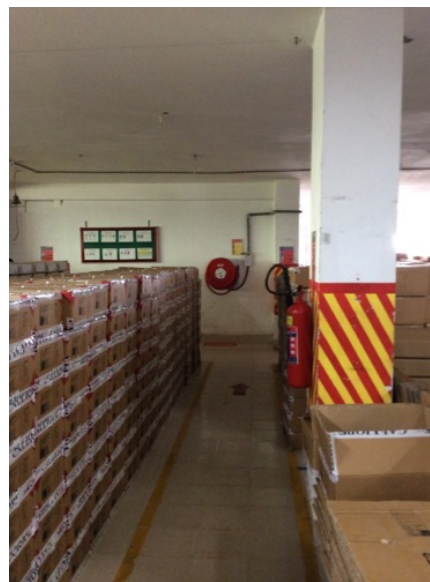
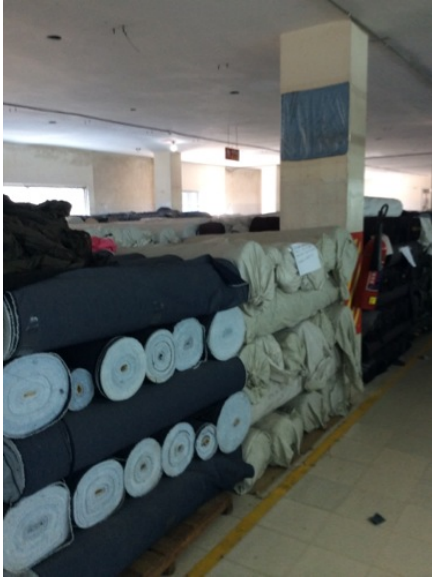
F-2	Fire Rated Construction	Rooms used for combustible storage are not separated by fire-rated construction on 1st, 2nd, 3rd, 4th and 5th floors.	Provide dedicated storage rooms separated by minimum 1-hr fire-rated construction.	Within 3 months
-----	-------------------------	---	--	-----------------

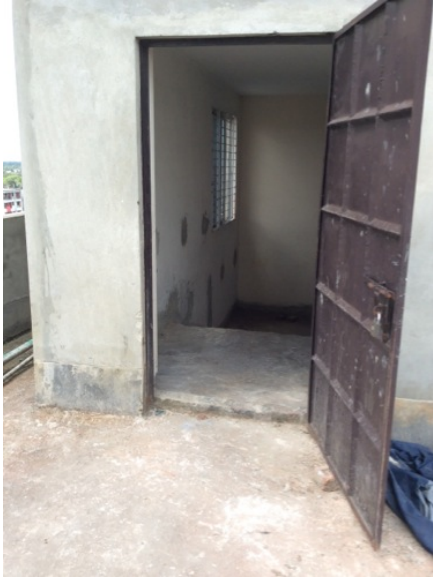
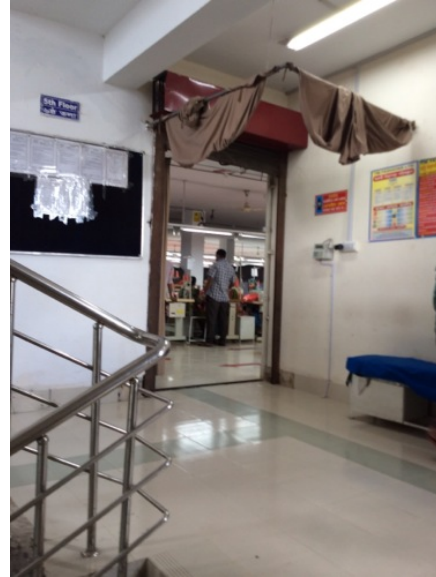
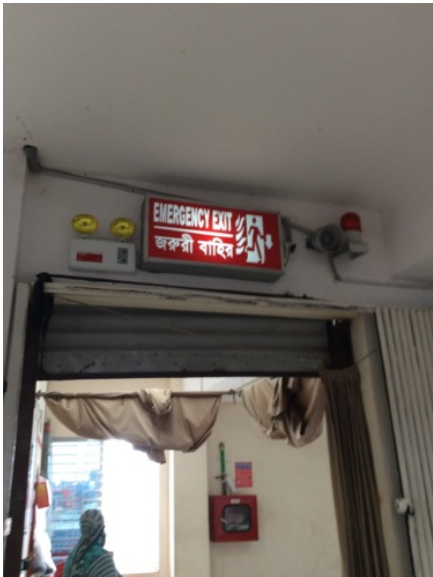
F-3	Fire Rated Construction	The exit stairs are not separated from work areas and other spaces on each floor by fire-rated construction.	Provide minimum 1.5-hr fire rated doors and seal all unprotected openings to separate the exit stairs from work areas and other building spaces on all floor levels. Ensure that the fire doors are self-closing and positive latching and that they are provided with fire exit (panic) hardware where serving production floors.	Within 3 months
			If fire doors are required to be held open for functional reasons, provide automatic-closing devices tied to the fire alarm system.

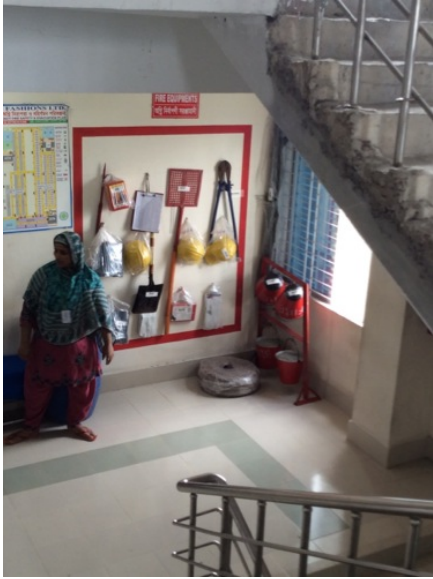
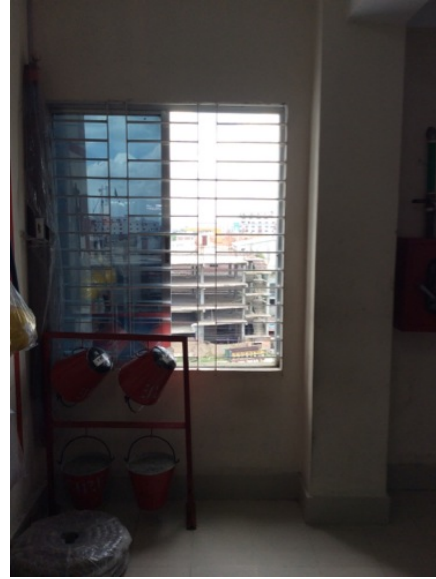
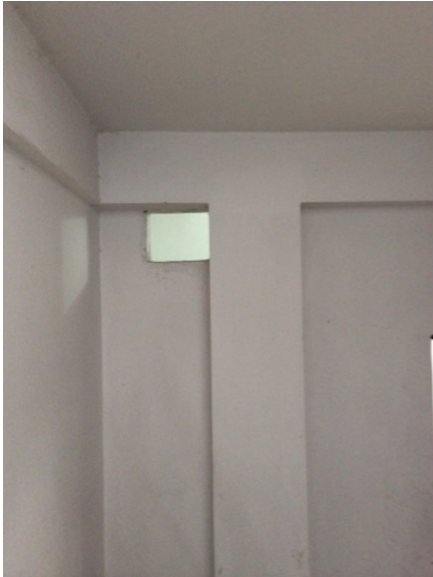
F-4	Fire Rated Construction	Unsealed penetrations and openings are located in exit stair enclosures.	Seal all penetrations and openings in exit stair enclosure walls to maintain the fire separation.	Within 3 months
-----	-------------------------	--	---	-----------------

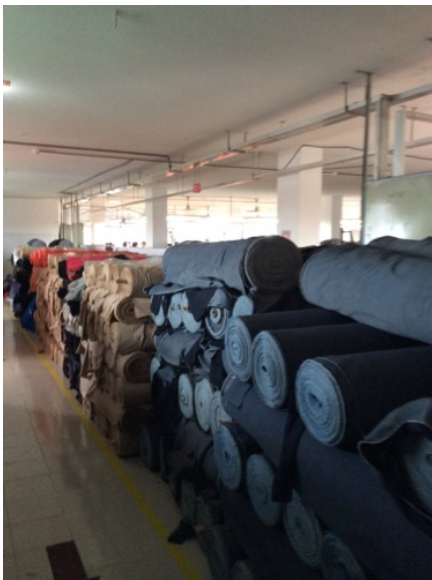
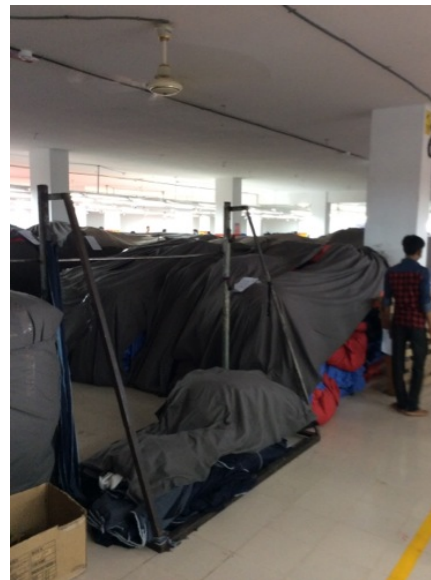
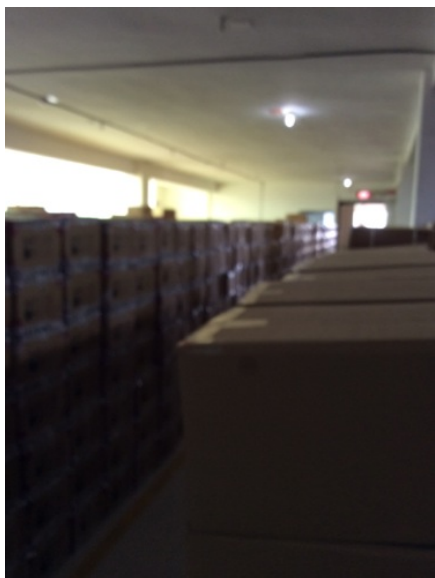
F-5	Fire Rated Construction	Areas used for combustible storage are not separated by fire-rated construction on 1st, 2nd, 3rd, 4th and 5th floors.	<p>Provide dedicated storage rooms separated by minimum 1-hr fire-rated construction.</p> <p>Where separate storage rooms are not feasible, provide defined storage areas and limit the storage arrangement as follows:</p> <ul style="list-style-type: none">- Maximum height of 2.4m and maximum area of 23m²- If sprinkler protected: maximum height of 3.66m and maximum area of 93m² <p>Separate areas of unenclosed combustible storage by a minimum clear distance of 3m.</p>	Within 3 months
-----	-------------------------	---	---	-----------------

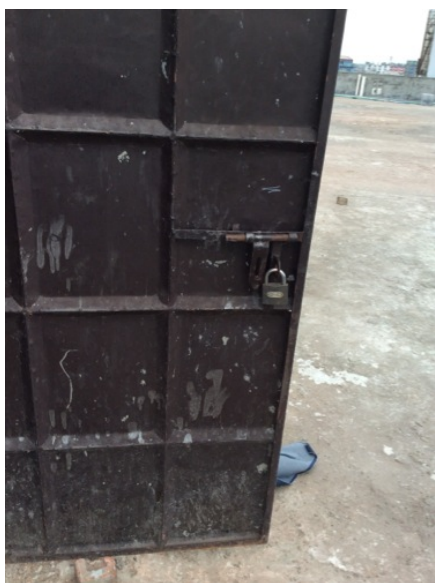
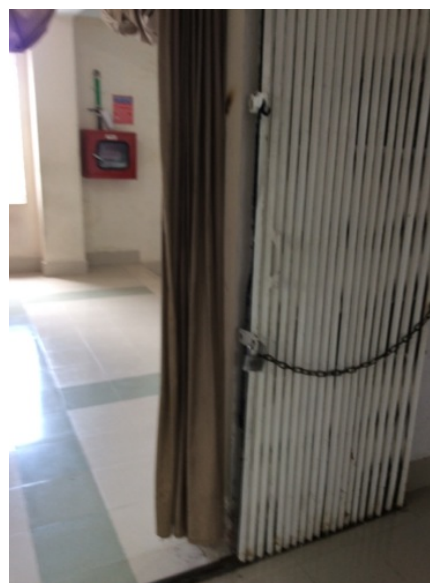
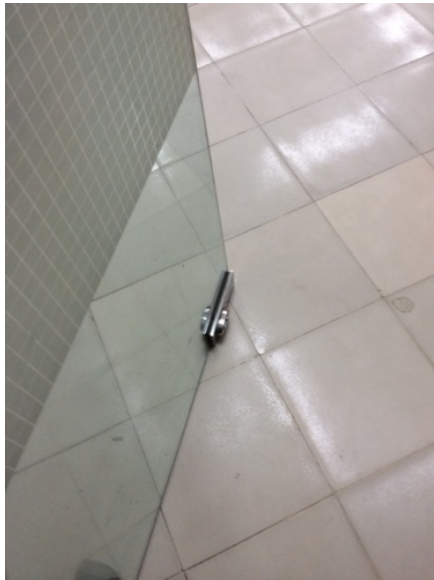
F-6	Egress	Egress doors / gates with locking features are provided at building exits, exit stairs, along egress route and exit discharge on all floors. All gates/doors were open and unlocked during the inspection.	Remove locking features from all egress doors / gates. If locks are required for security reasons, utilize special door locking features complying with NFPA 101.	Immediate
-----	--------	--	--	-----------

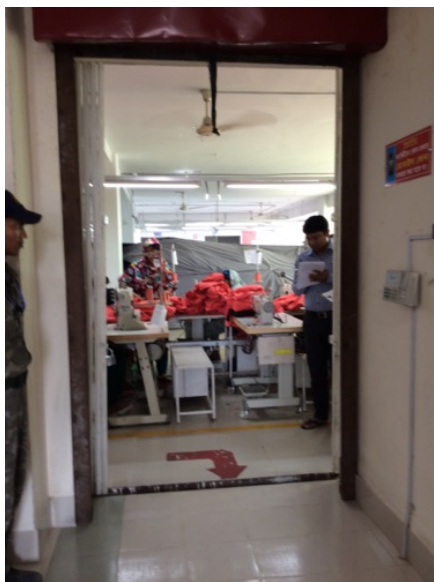
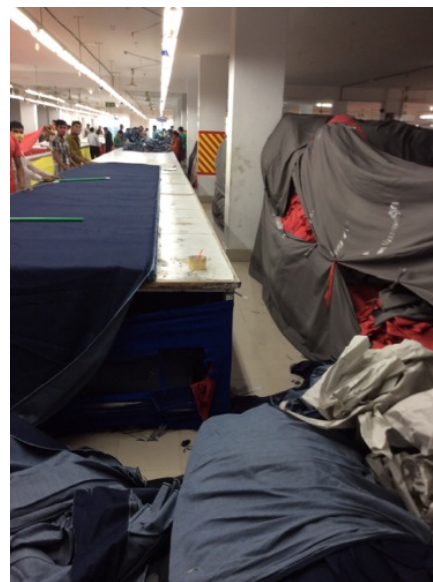
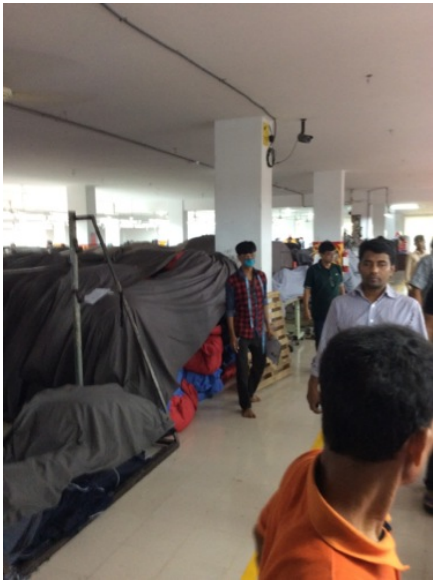
F-7	Egress	Storage was located in the egress path on 1st, 2nd, 3rd 4th and 5th floors.	Keep egress paths and stairs clear of storage.	Immediate
-----	--------	---	--	-----------

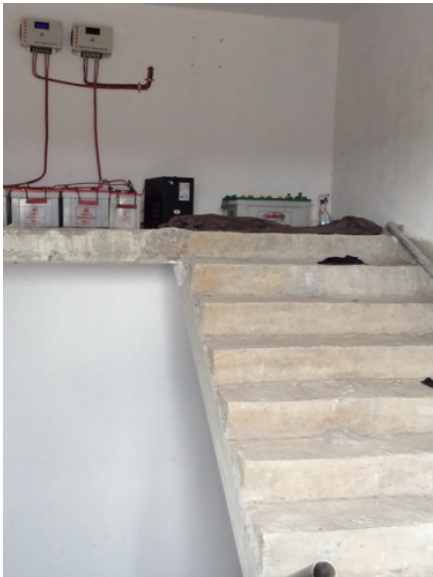
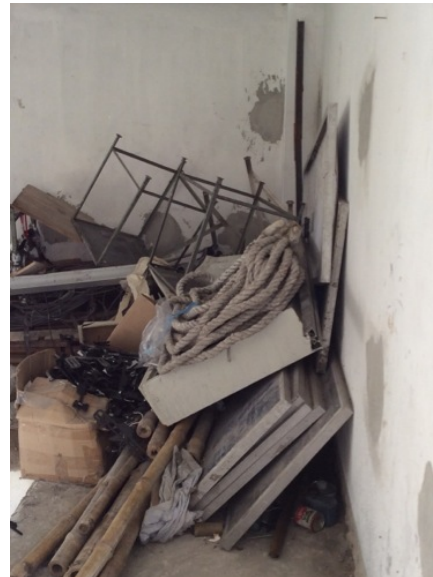
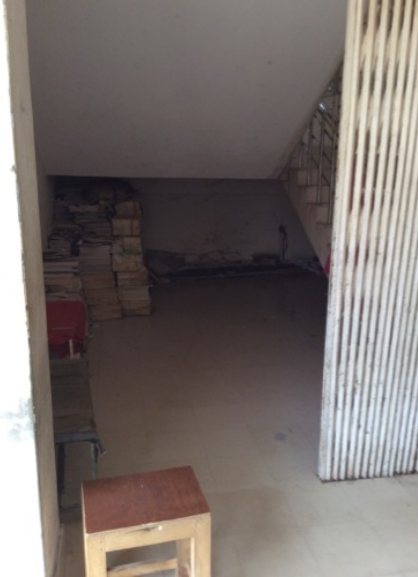
F-8 Egress

Storage was located in the exit stair on ground and roof floors.

Remove all storage from exit stairs and egress paths.

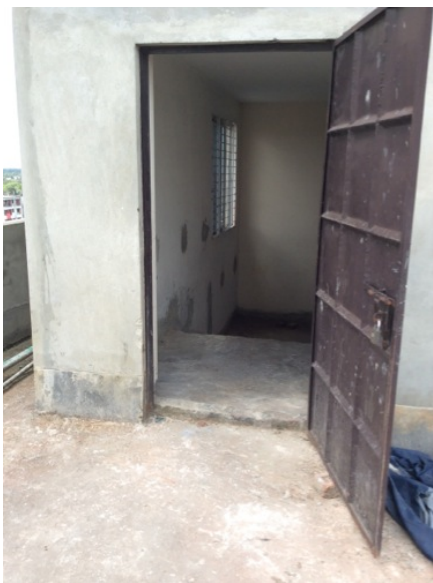
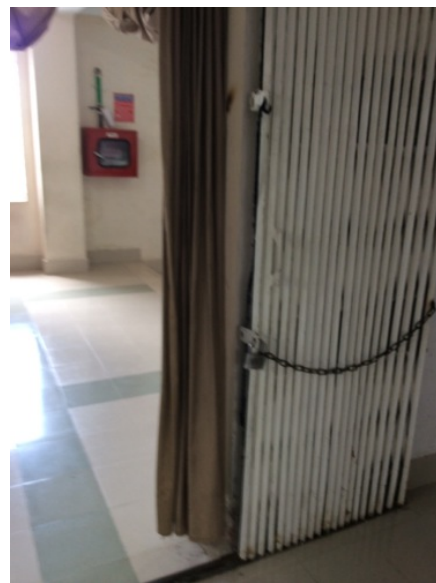
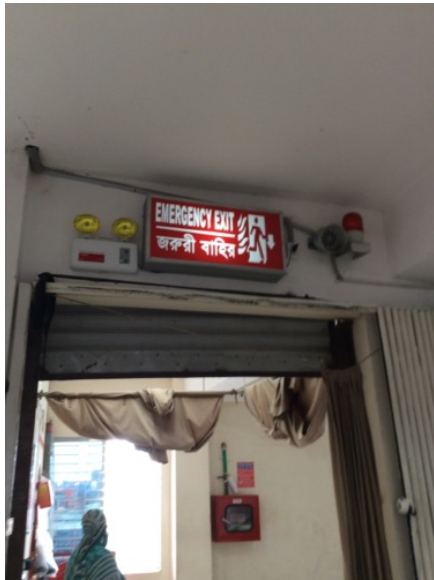
F-9	Egress	Collapsible gates / sliding doors are provided at building exits, exit stairs, along egress routes and exit discharge on all floors.	<p>Replace all gates / sliding doors along the means of egress with side-hinged, swinging egress doors.</p> <p>If locks are required for security reasons, utilize special door locking features complying with NFPA 101.</p>	Within 1 month
-----	--------	--	---	----------------

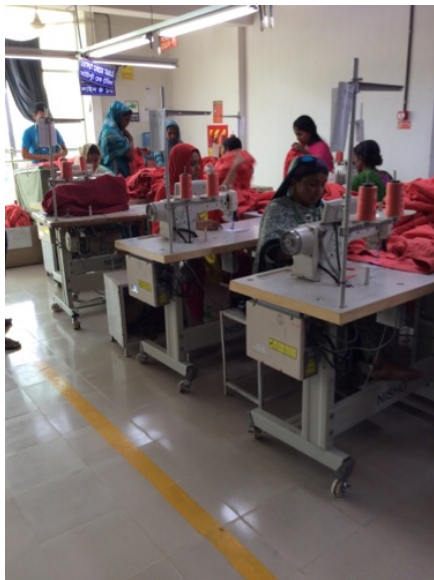
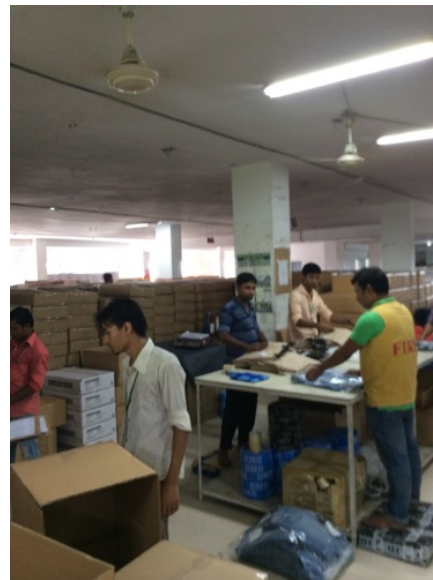
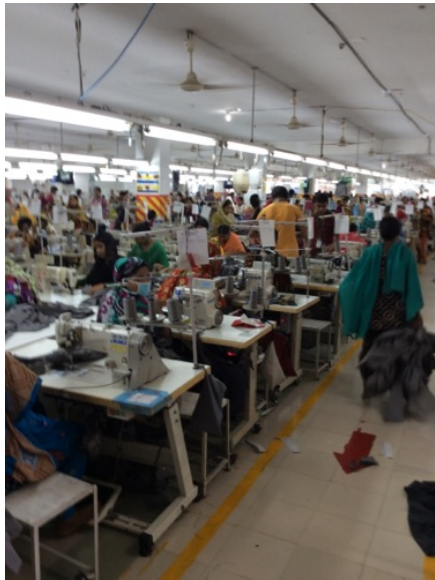
F-10 Egress

The width of egress aisles is less than 36-in. on 1st, 2nd, 3rd, 4th and 5th floors.

Provide minimum aisle widths of 36-in.

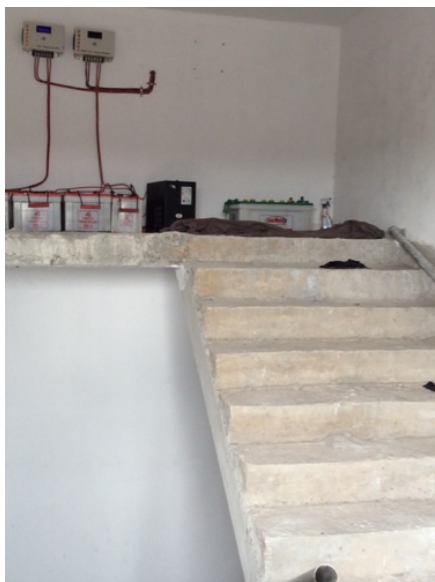
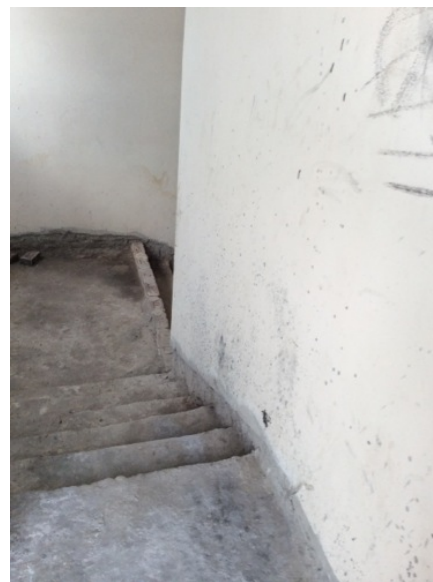
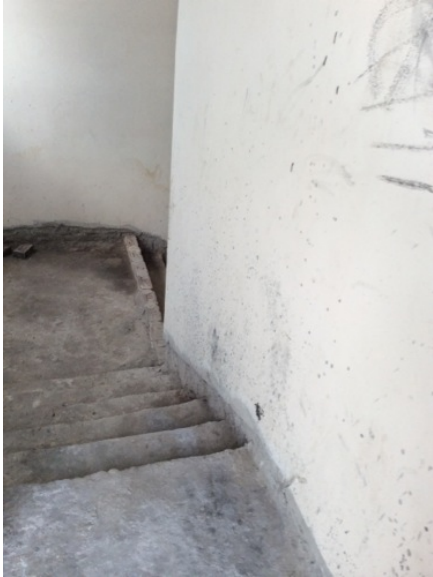
F-11 Egress

Handrails are not provided in the southeast exit stair on all floors.

Provide handrails on at least one side of exit stair.

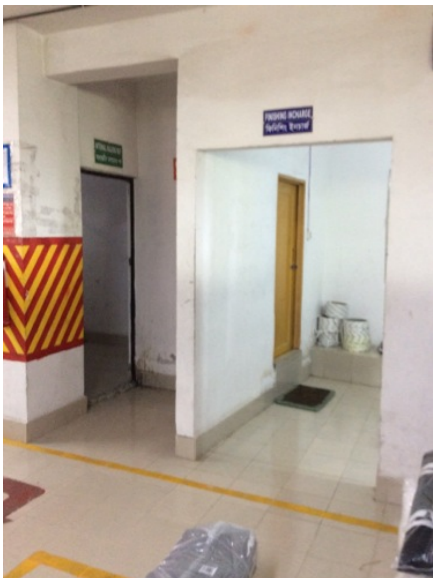
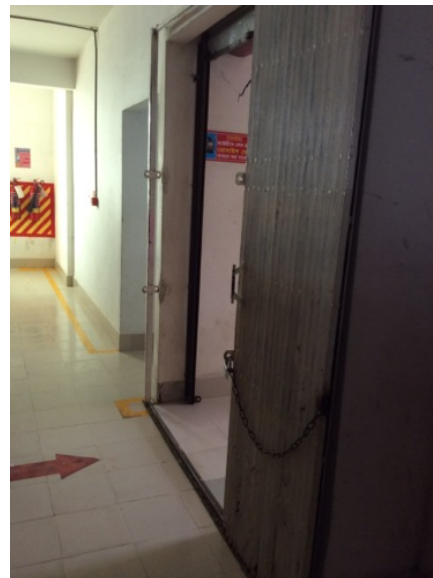
F-12	Egress	The southwest exits are not remotely located from each other such that a single fire event could compromise both exits on 1st, 2nd, 3rd, 4th and 5th floors.	Modify exit arrangement.	Within 6 months
------	--------	--	--------------------------	-----------------
