# Surma Garments Ltd. #10261

## Supasox Ltd. #9535

Aicha Noadda, Rajashon Road Savar, Dhaka  
(+23.8473927N, 90.265607E)  
06.MAY.2014

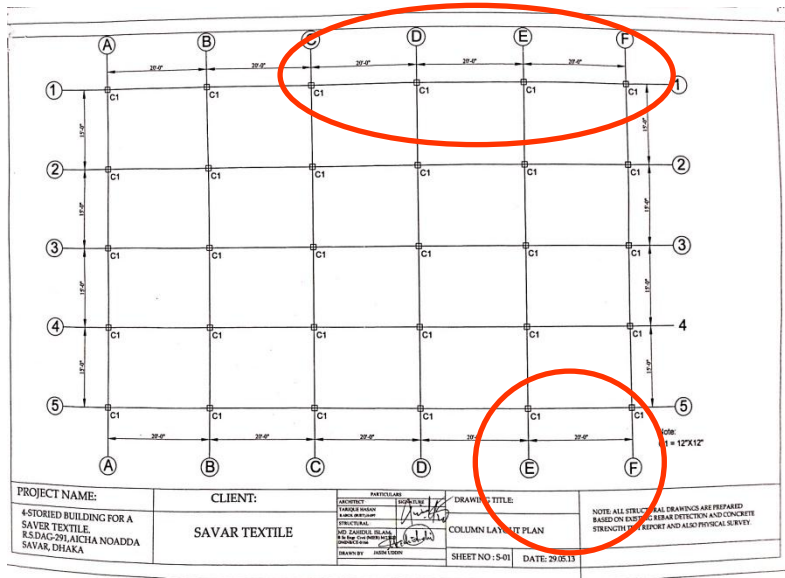
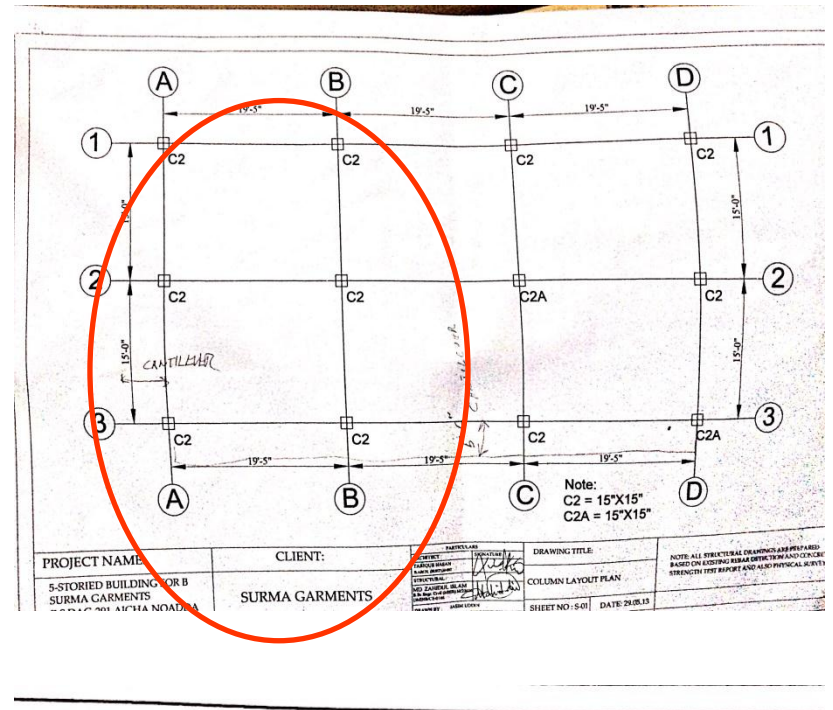
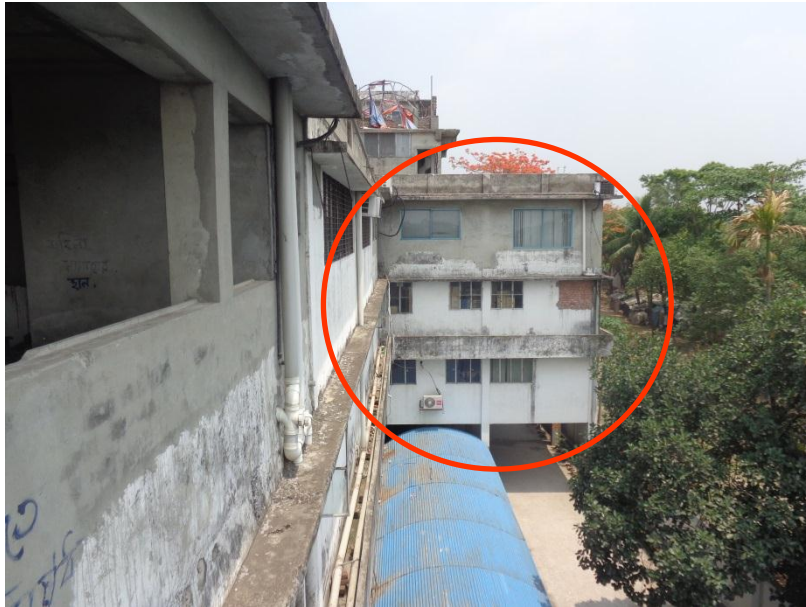
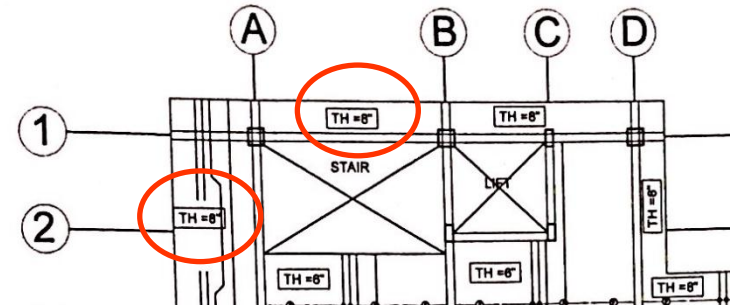
## 1<sup>st</sup> Priority 1 Concern

The structural drawings do not match the existing conditions for all buildings

The structural drawings do not match the existing conditions for all buildings. Extra bays were seen at the Est and West sides of building A. Concrete slabs between buildings A & B and B & C were not shown. Grid layout, number of columns and cantilevered slabs were incorrect for building B. Slab thickness and elevator beam depth were not accurately shown for building D. Finally, steel roofs were not shown on structural drawings for buildings A and C.

- Structural Engineer to survey existing conditions and update drawings to match actual condition.

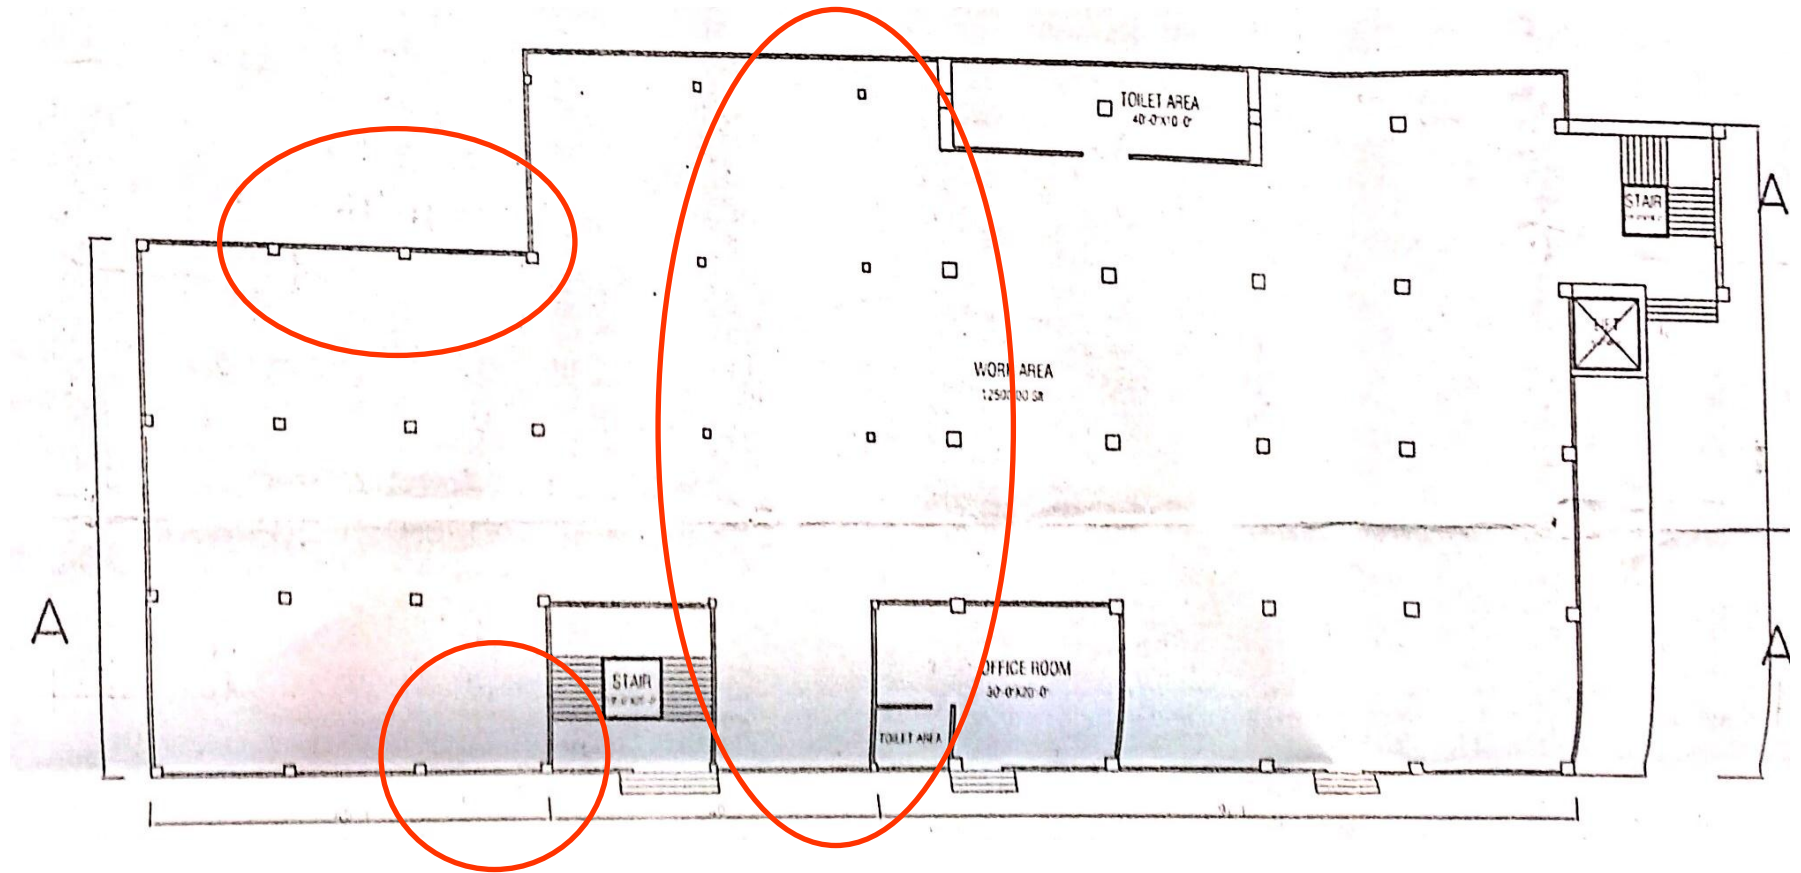
## 2<sup>nd</sup> Priority 1 Concern

The permit drawings do not match the structural drawings or the existing conditions for buildings A and B.

- Survey the existing conditions and produce new drawings for permit.
- Re-apply for permit with revised drawings.

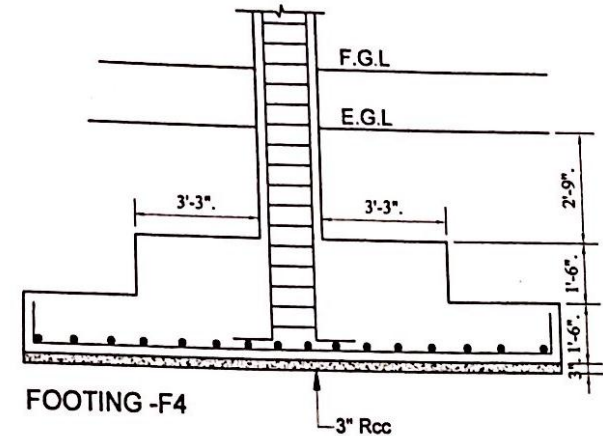
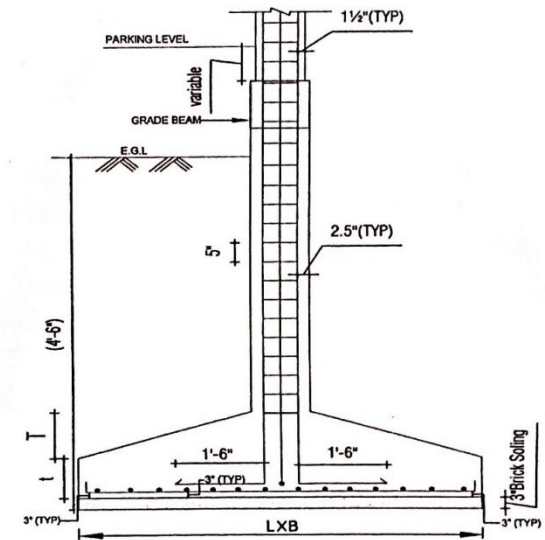
TYP. SEC. OF R.C.C. FOOTING & PEDASTAL.

The recommendations from the soils report were not executed. The footings were constructed between 3'6" and 4'9". The soils report recommended a footing depth of 9'.

The recommendations from the soils report were not executed. The footings for all four buildings varied between 3'6" and 4'9". The soils report recommended a footing depth of 9'. Based on conversation with the owners, however, it is believed the footings were poured deeper.

- We recommend a geotechnical investigation be completed to determine the exact footing depths of all buildings.

- A second geotechnical investigation be completed to ensure adequate bearing capacity for all buildings.

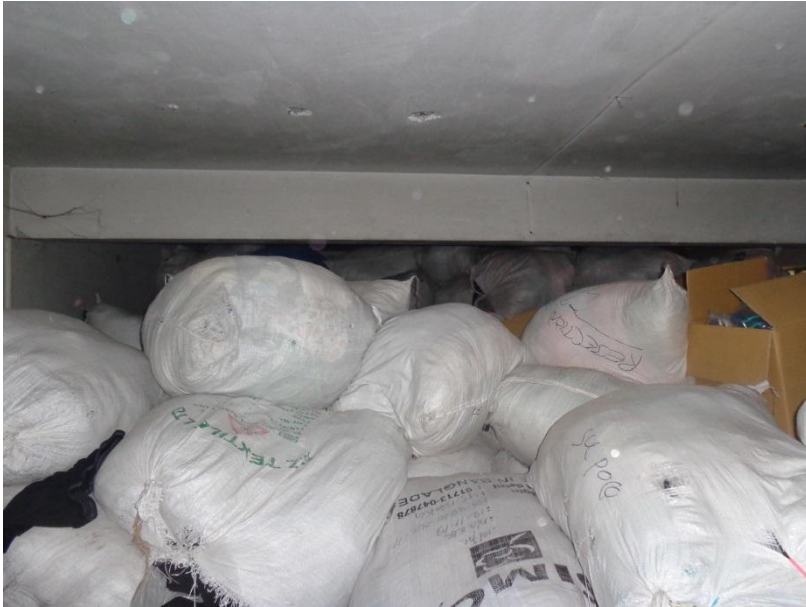
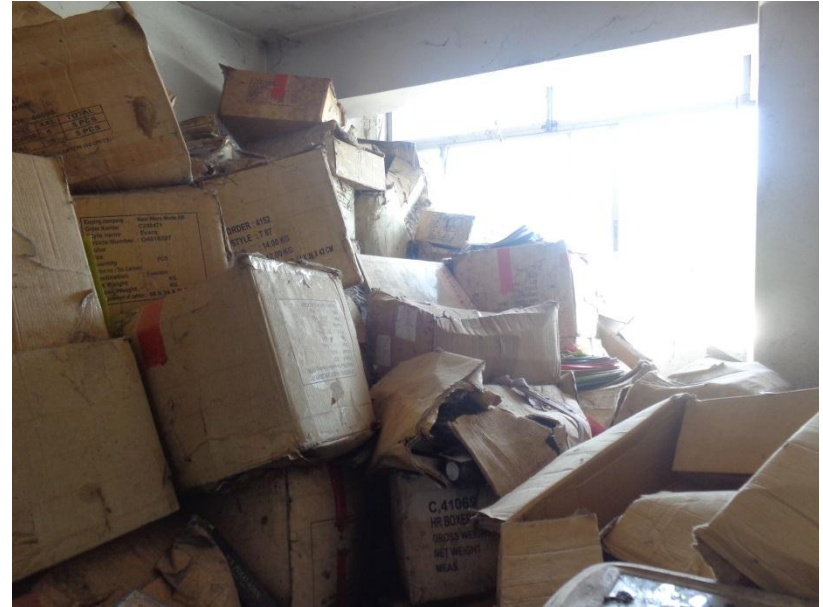
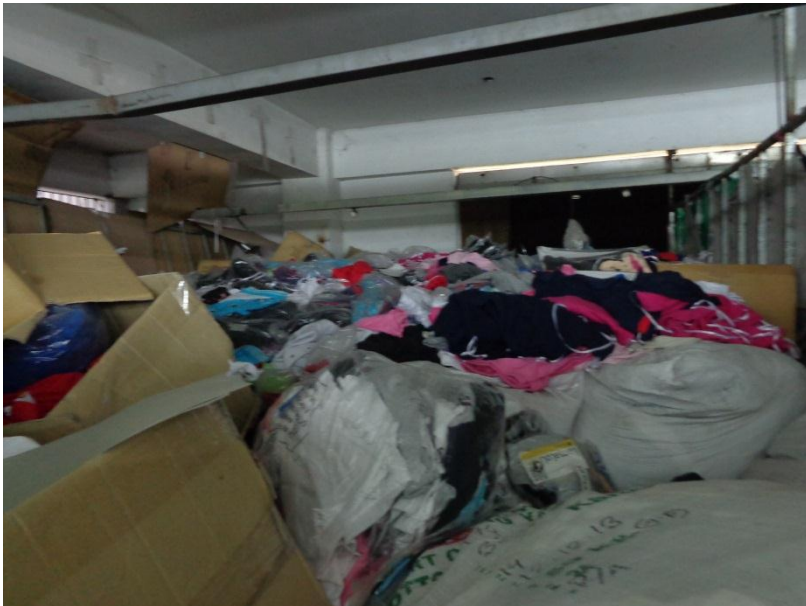
#### 4<sup>th</sup> Priority 1 Concern

High loading was observed in buildings A, B, and D with no loading plans made available.

High loading was observed in buildings A, B, and D and no loading plans were made available for any of the buildings. High loading was observed on floors 1 and 2 for building A, locally on floor 2 of building B, and locally on floor 1 of building D.

- Due to the lack of loading plans, the high local loading (up to 6.0 kPa) and the position of the loading (on cantilevered portion of slabs), all loading exceeding 2.0 kPa must be removed.

- Loading plans to be designed by Structural Engineer based on maximum capacity for each floor.

- Post loading plans at each level of all buildings and manage accordingly.

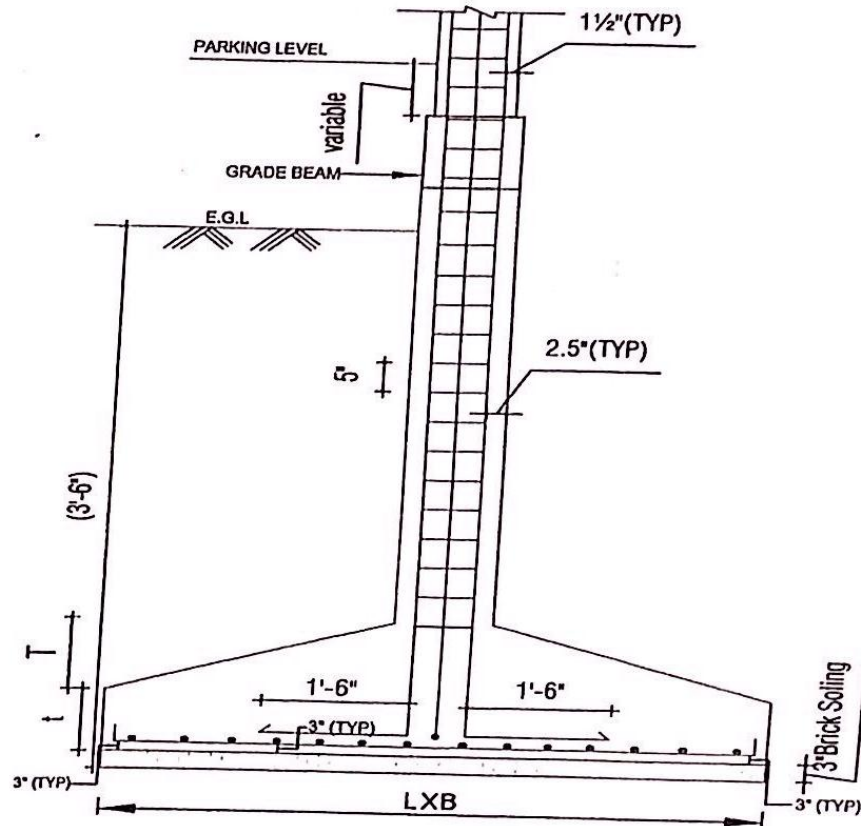
TYP. SEC. OF R.C.C FOOTING & PEDASTAL.

Footing size for critical column is 7' x 7'.

Load on critical column based on column rundown = 897 kN.

Pressure on soil = 197 kPa.

Allowable bearing capacity based on soils report = 150 kPa (FOS = 2.5).

Reduced FOS = 1.9.

Footing size at critical column appears too small for Building A.

- Detail Engineering Assessments are required for the above mentioned items.

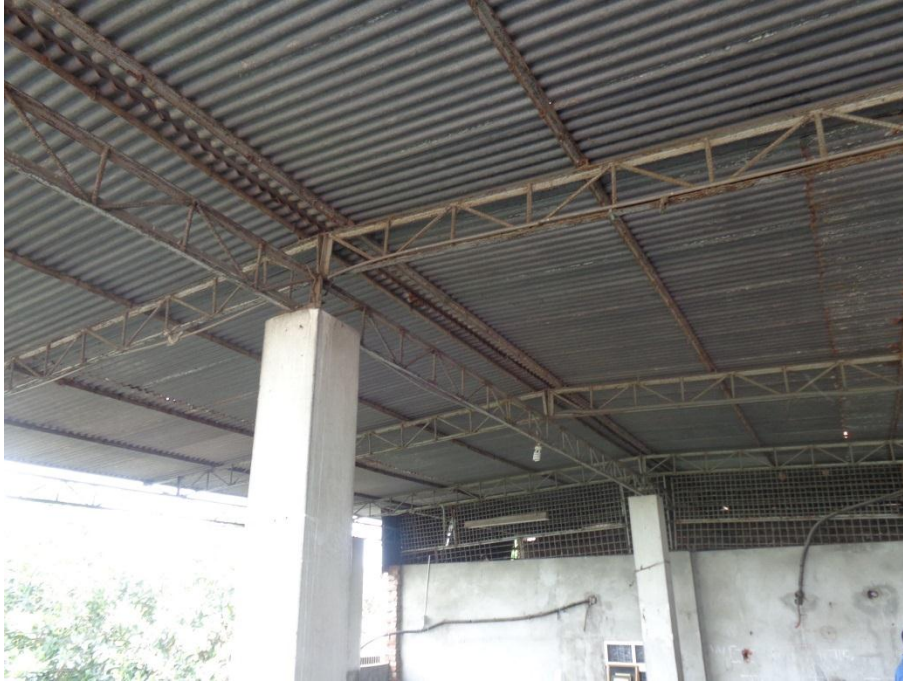
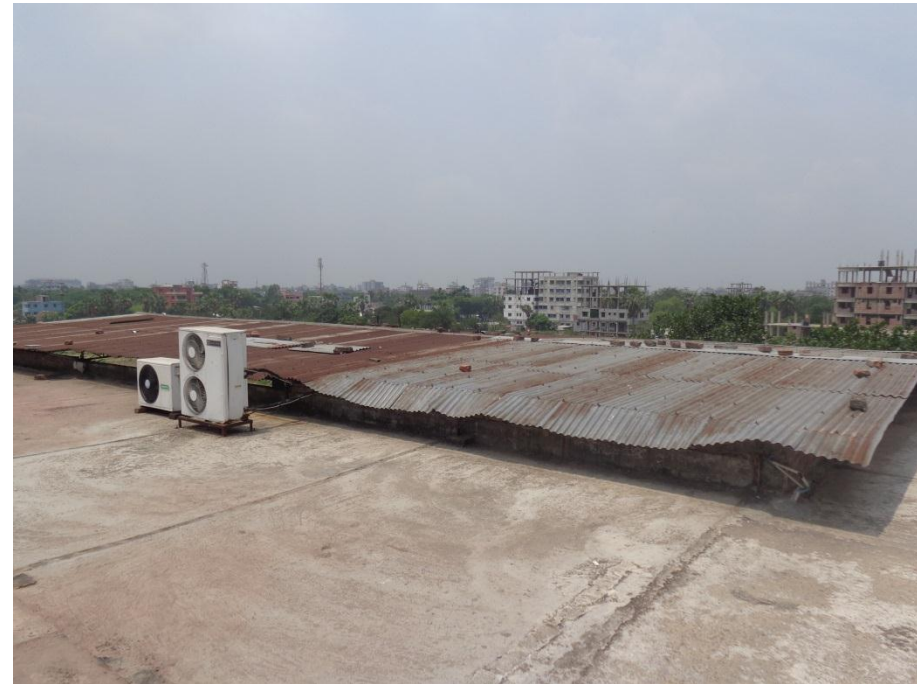
## 2<sup>nd</sup> Priority 2 Concern

Poor steel detailing observed at steel roof partially covering 3rd floor of Building A.

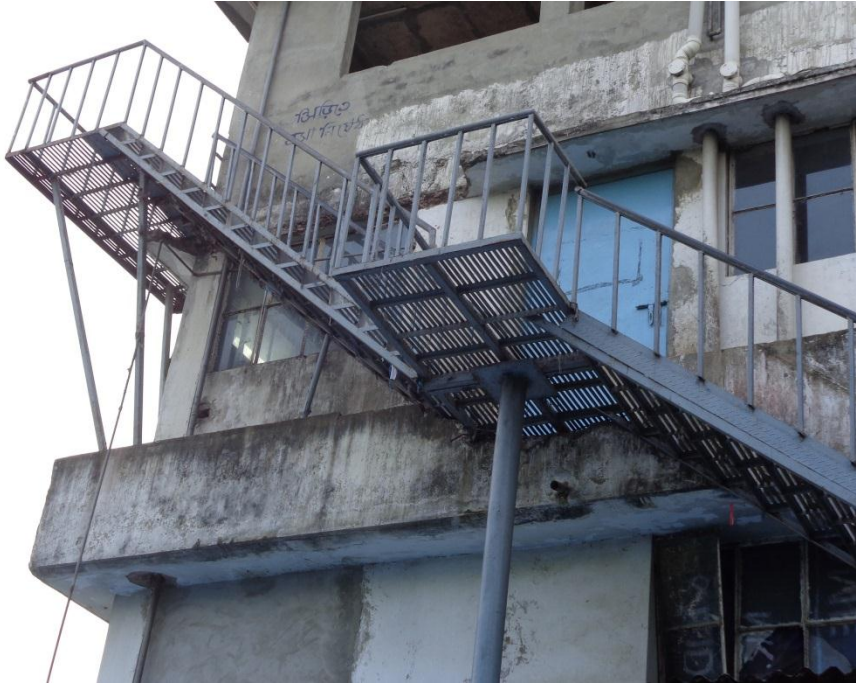
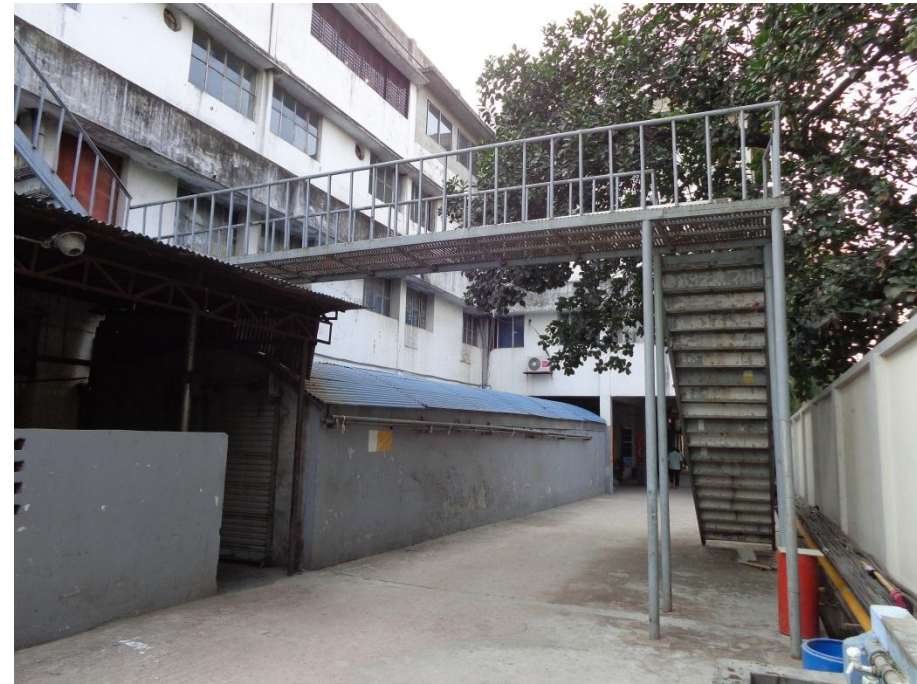
### 3<sup>rd</sup> Priority 2 Concern

Poor steel detailing observed at steel emergency staircase on East side of Building A.

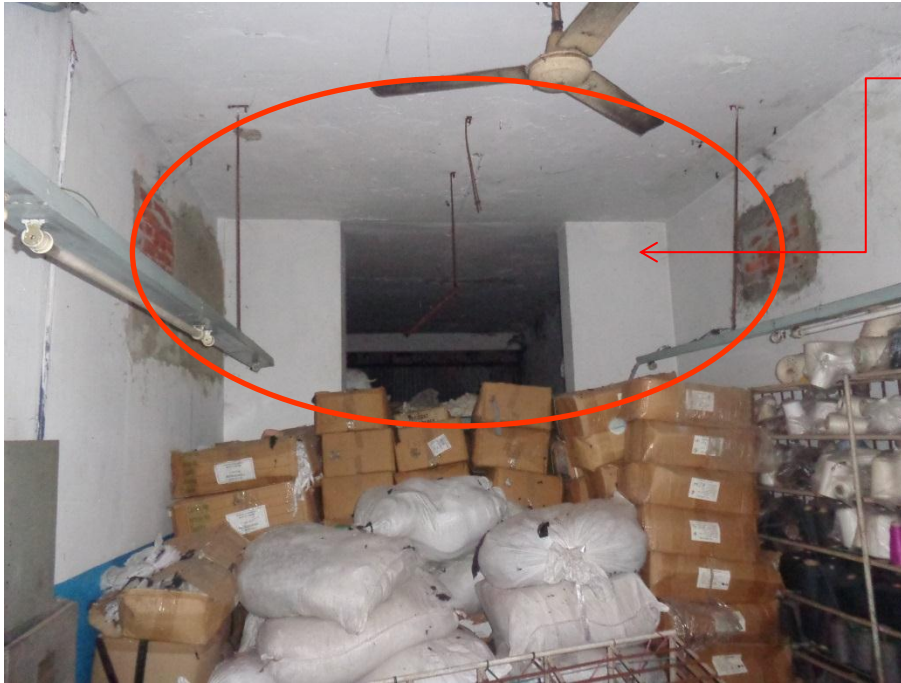
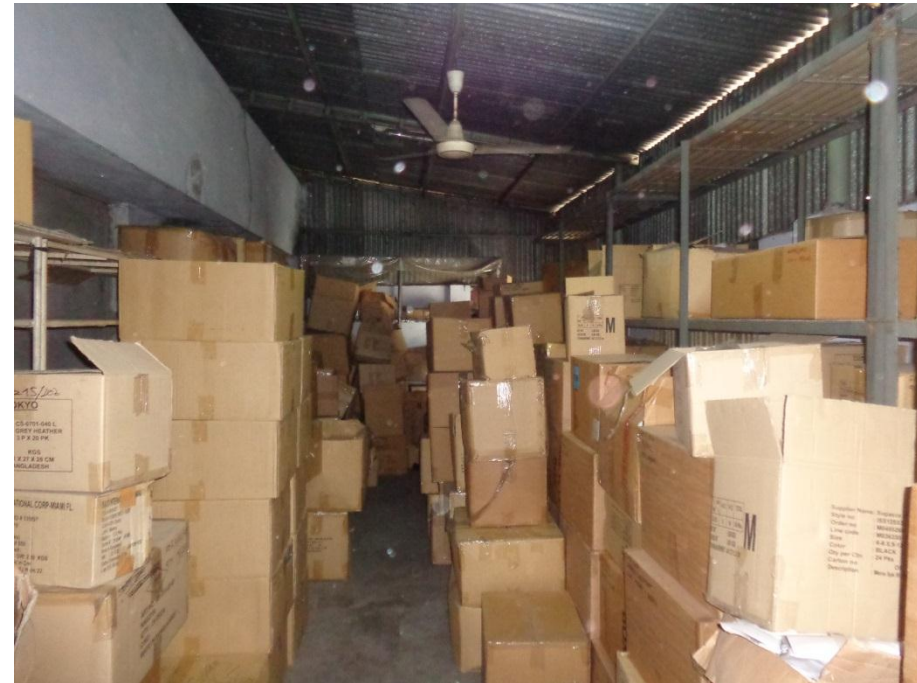
## 4<sup>th</sup> Priority 2 Concern

Portion of 1<sup>st</sup> floor concrete slab on West side supported by brick columns and walls at Building A. In addition, this portion is not shown on structural drawings.

Storage was also observed on the slab above.

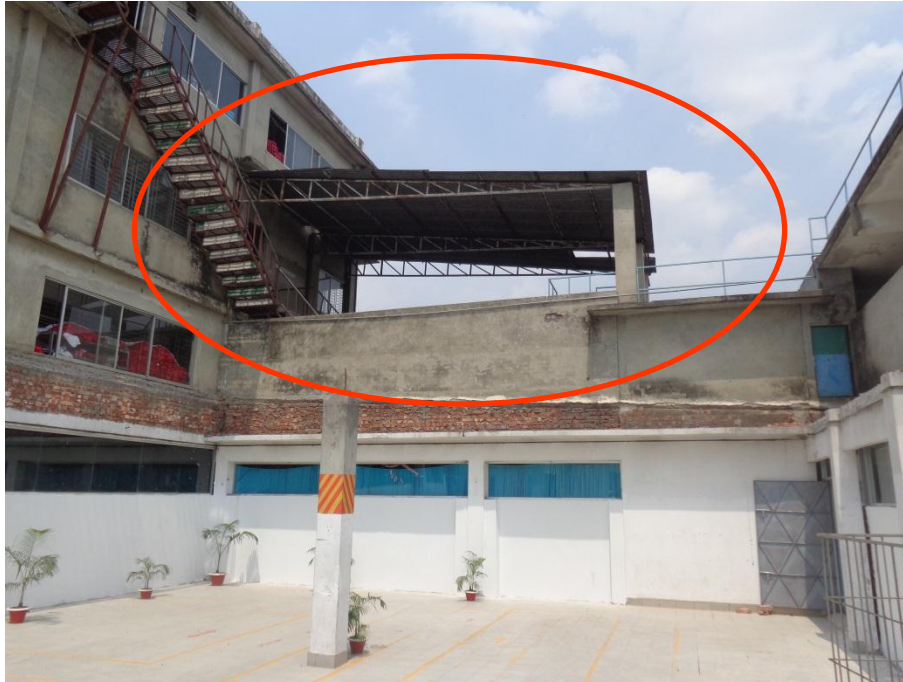
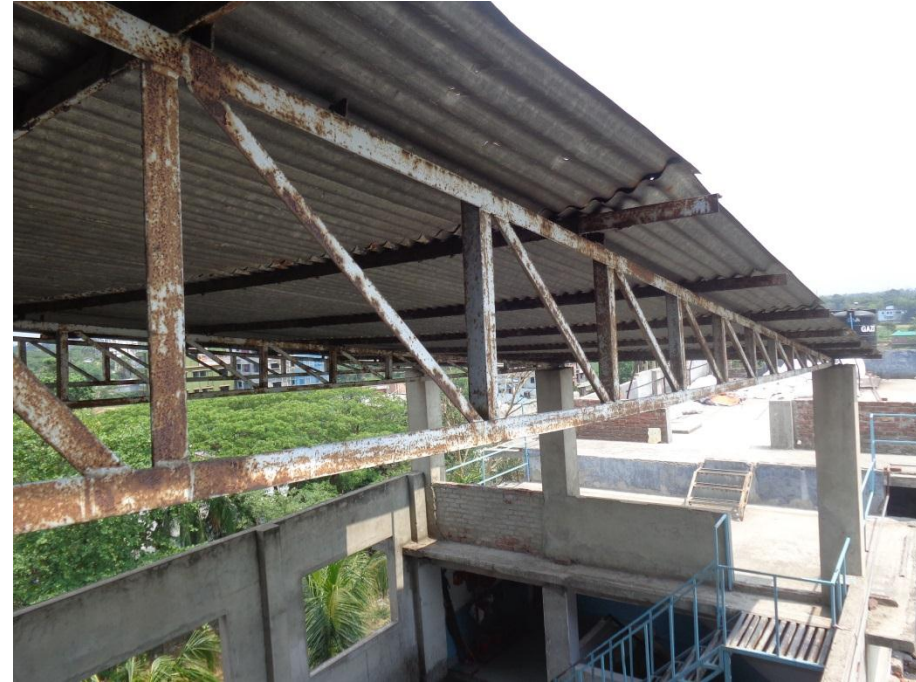
## 5<sup>th</sup> Priority 2 Concern

Poor steel detailing observed at the steel roof on the 4th floor of Building C.

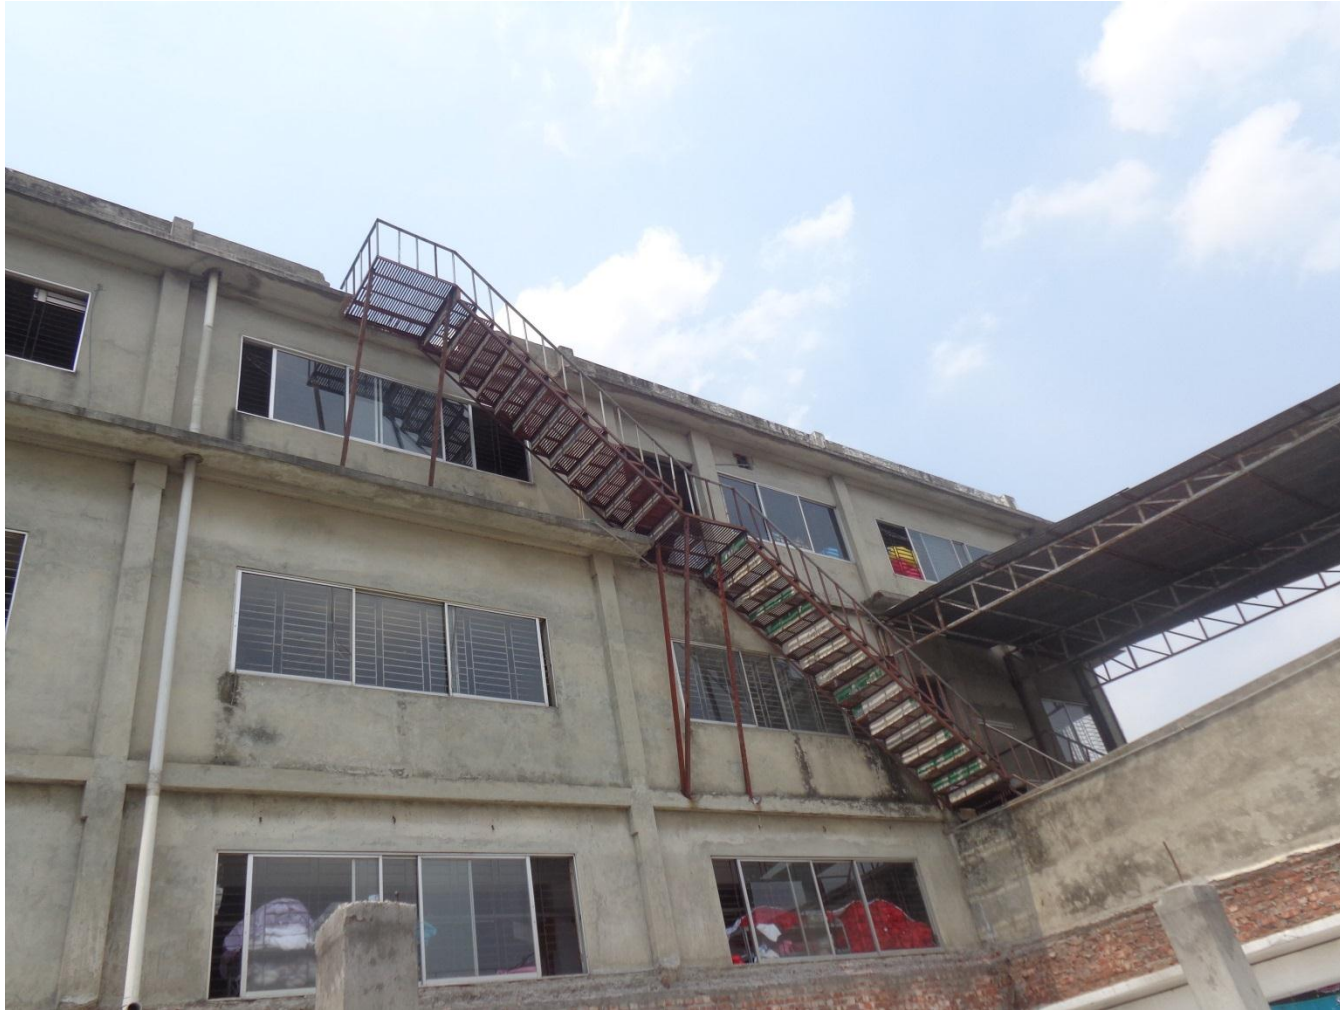
## 6<sup>th</sup> Priority 2 Concern

Poor steel detailing observed at the steel staircase on the South side of Building D.

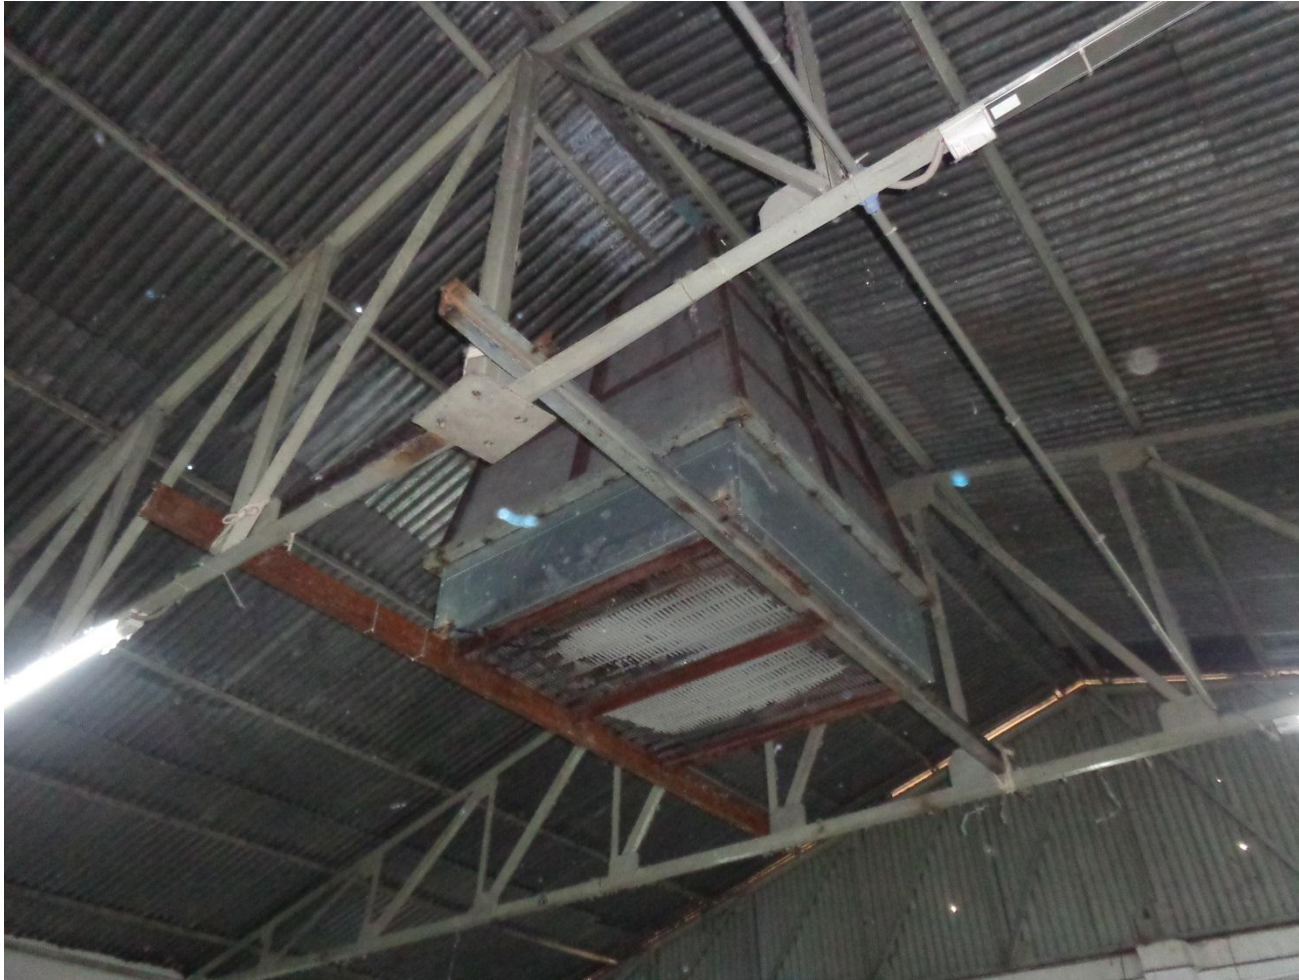
## 7<sup>th</sup> Priority 2 Concern

Poor steel detailing observed for the steel roof trusses and mechanical units of Sheds 1 and 2.

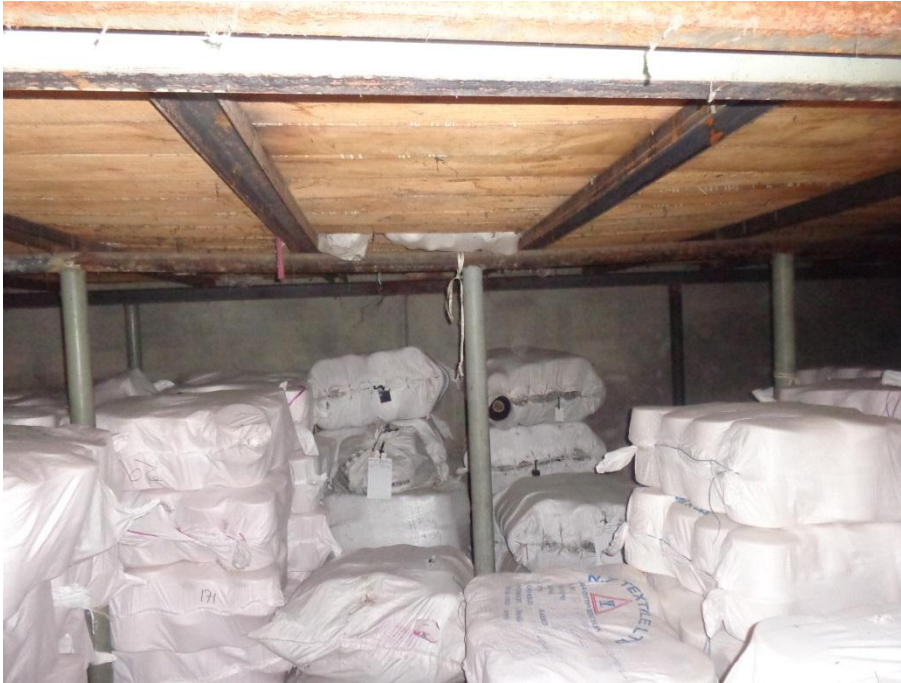
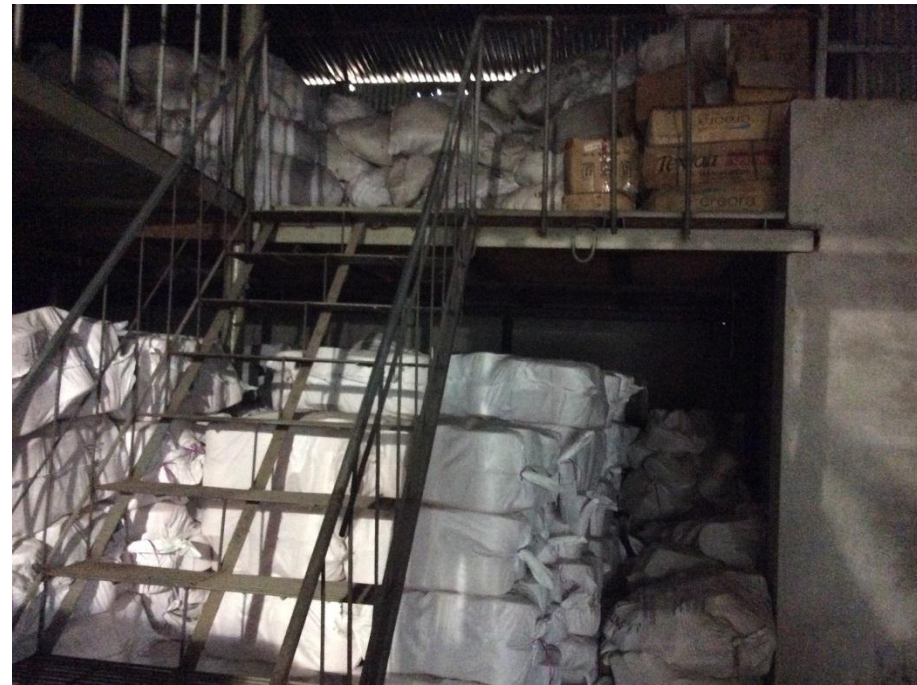
## 8<sup>th</sup> Priority 2 Concern

High storage loads were on the steel and timber plank mezzanine.

Excessive deflection was observed in the steel C-channel supporting the mezzanine in Shed 3. In addition poor steel detailing was observed.

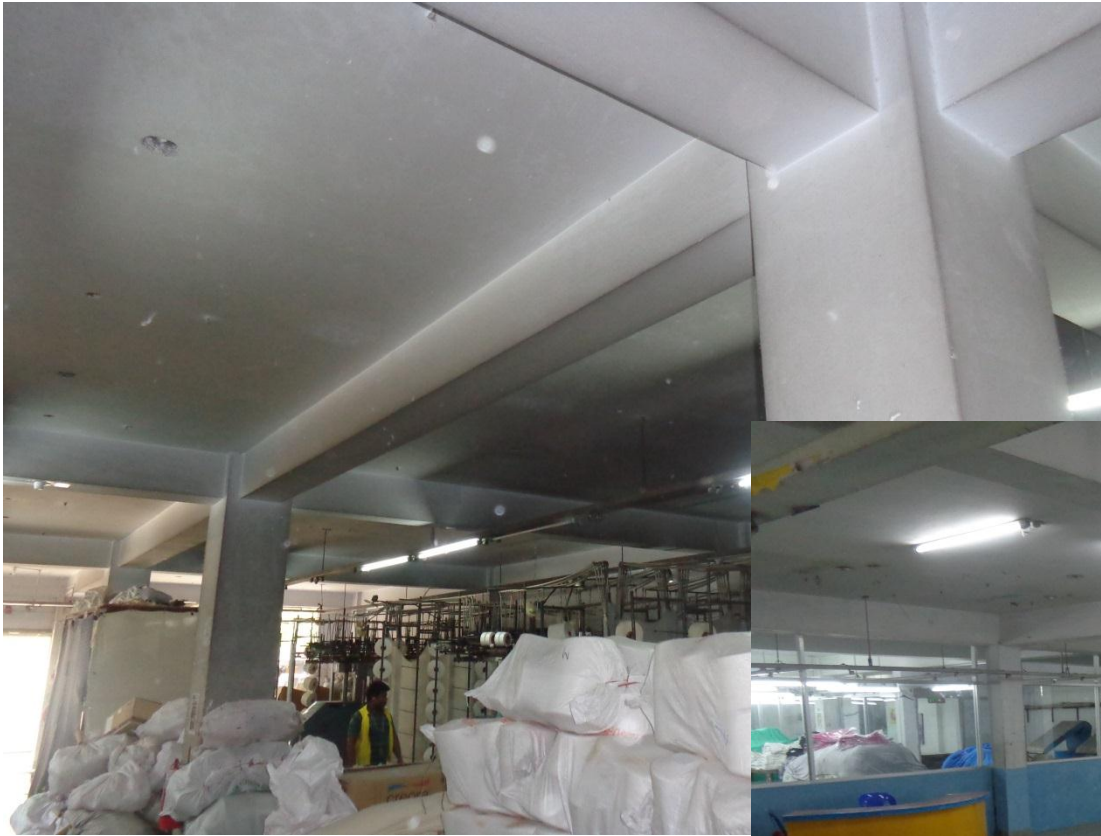
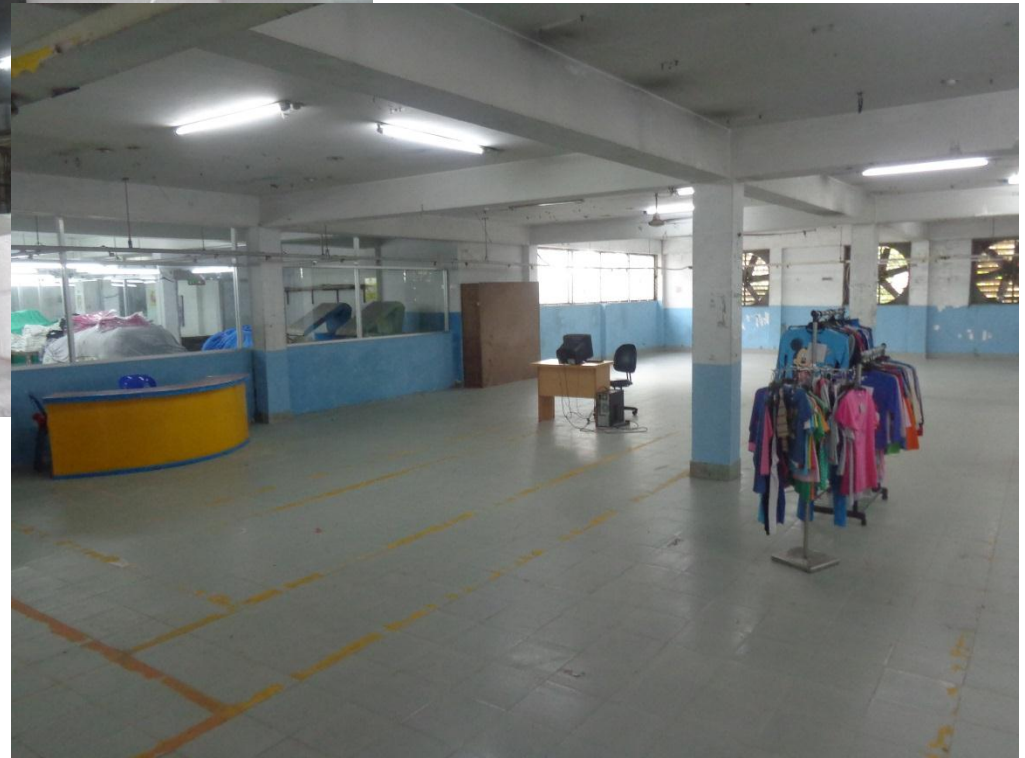
The building did not feature any core or shear walls. Stability was achieved through sway action between beams and columns and masonry infill walls.

We require that these items be investigated in a Detail Engineering Assessment.

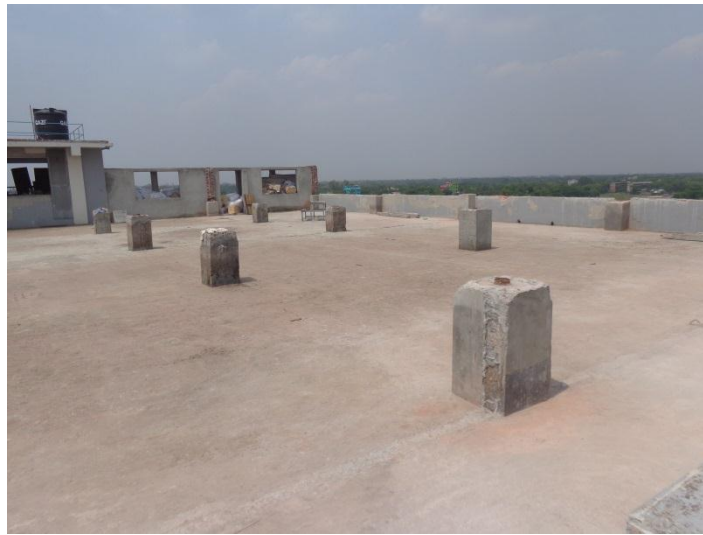
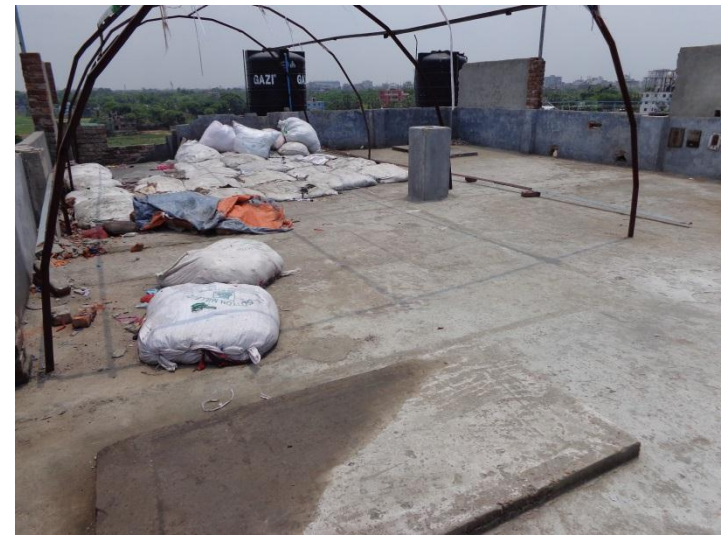
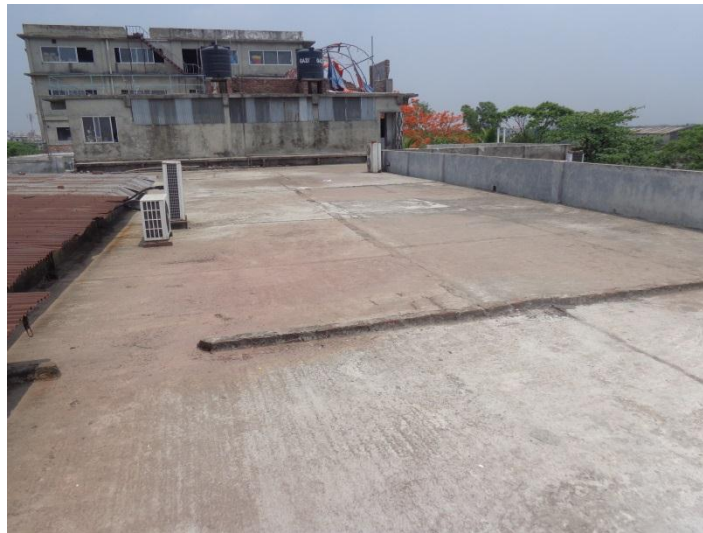
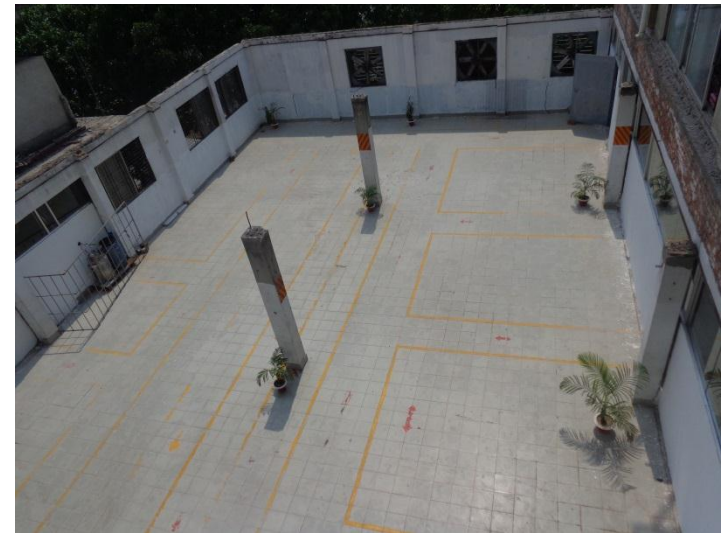
No waterproofing membrane was visible on the roof of any of the building. This means that any cracks in the surface finishes on the roof will allow water to seep into the concrete slab beneath the finishes.
