V-Knitwear & Composite Ltd. #10248

Mahana, Golakandail, Bhulta, Rupgonj, Narayanganj
(+23.805136N, 90.586609E)

07.MAY.2014

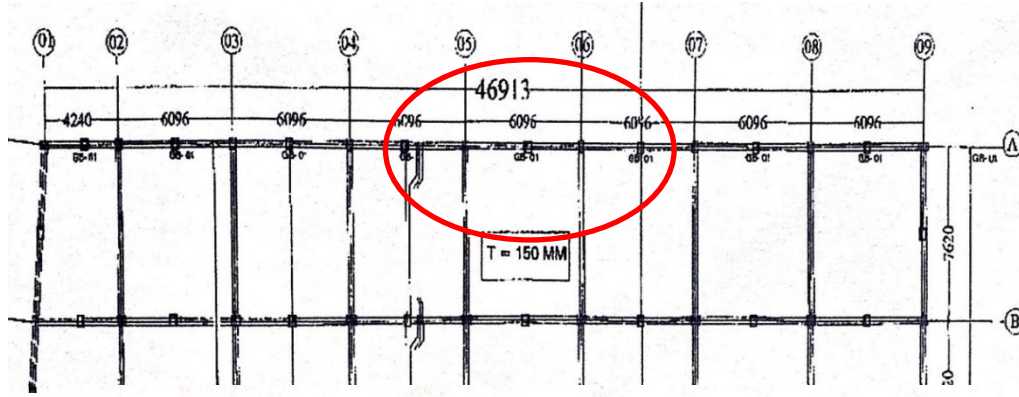
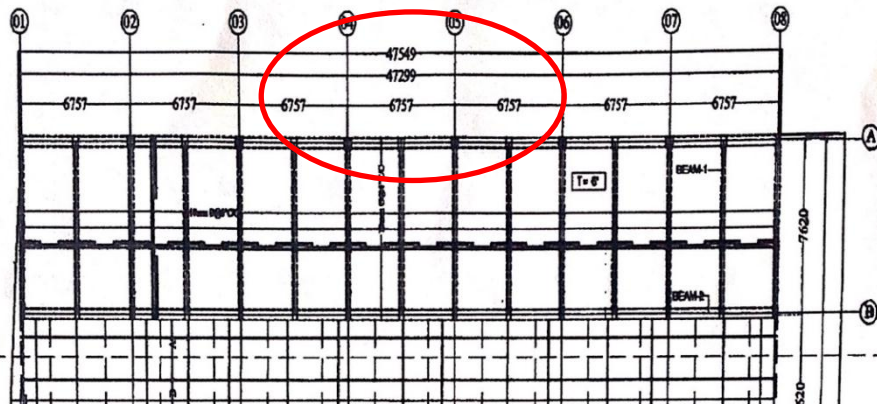
The structural drawings for the main building do not match the existing conditions:

The column grid layout does not match between the flat slab configuration and the slab with beam configuration for the main building.

The beams and columns size don't match the structural drawings for the main building.

An addition across two bays was seen but not shown on the drawings.

- Structural Engineer to review existing conditions and update drawings accordingly.

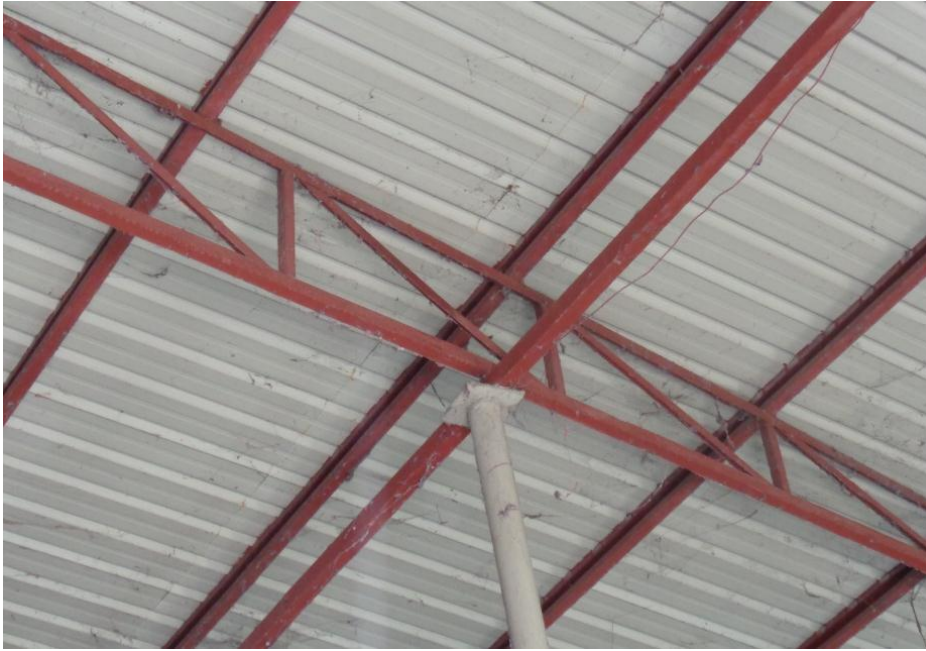
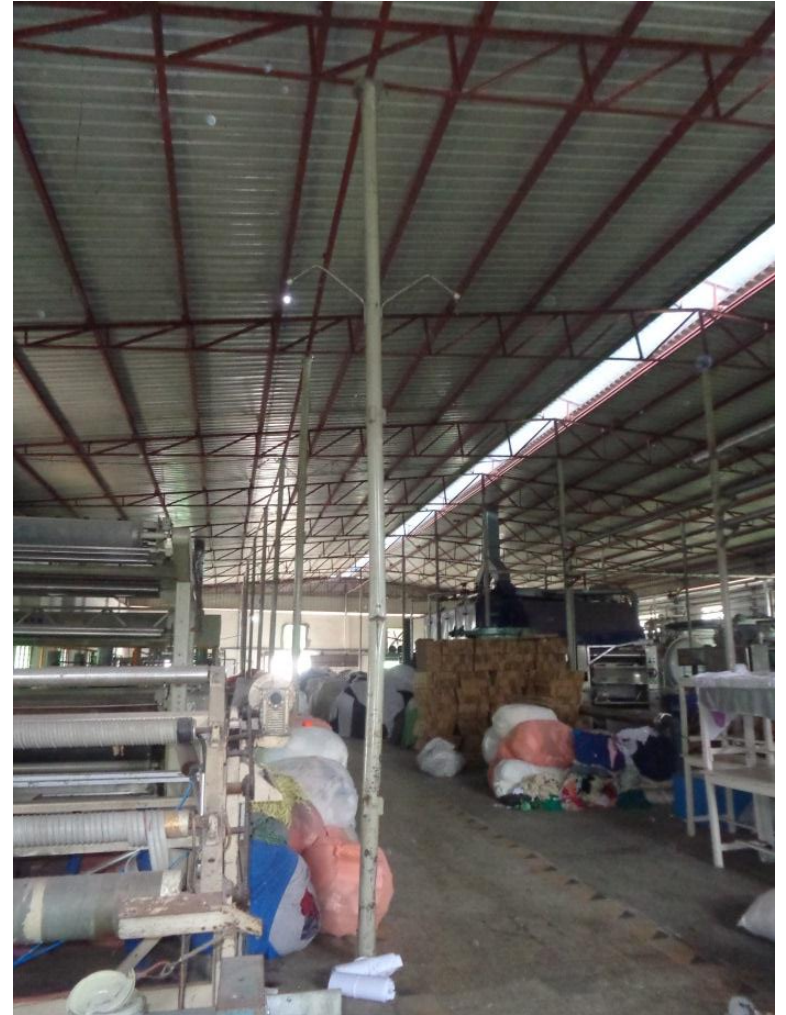
The steel roof of the dyeing shed is poorly detailed and one steel column is damaged.

- Damaged column to be replaced immediately
- Engineering assessment required for the steel roof and columns.

- Implement recommendations from engineering assessment.

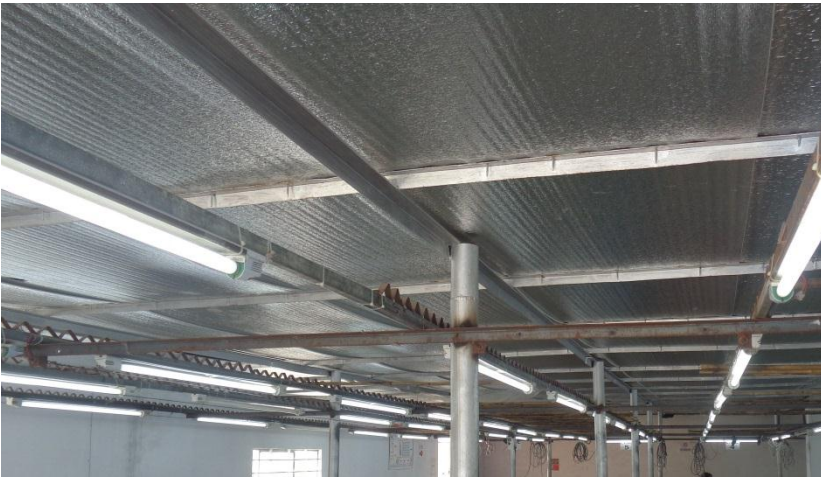
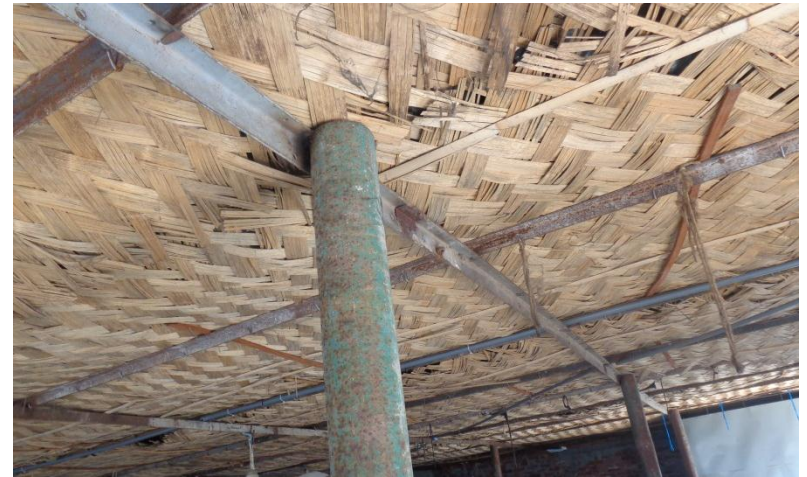
The temporary steel roof on the 3rd floor of the main building is poorly detailed.

- Engineering assessment required for the temporary steel roof.

- Implement recommendations from engineering assessment.

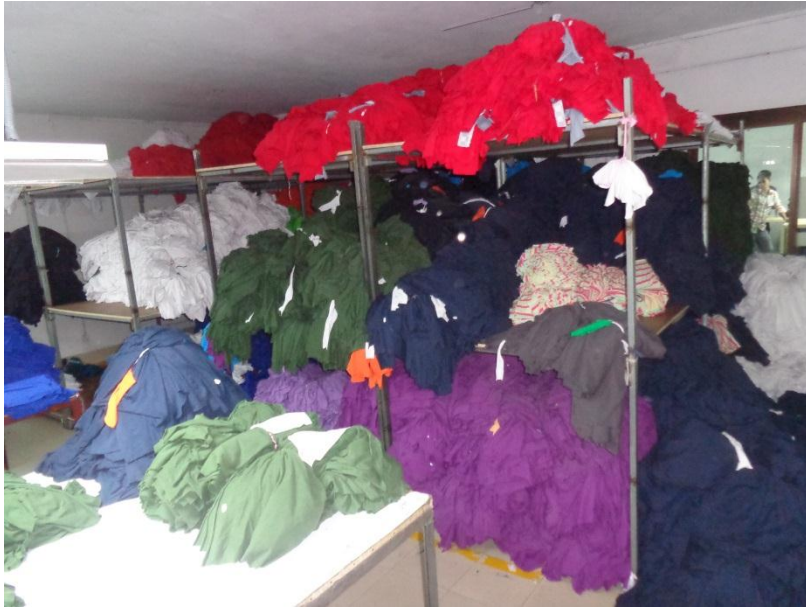
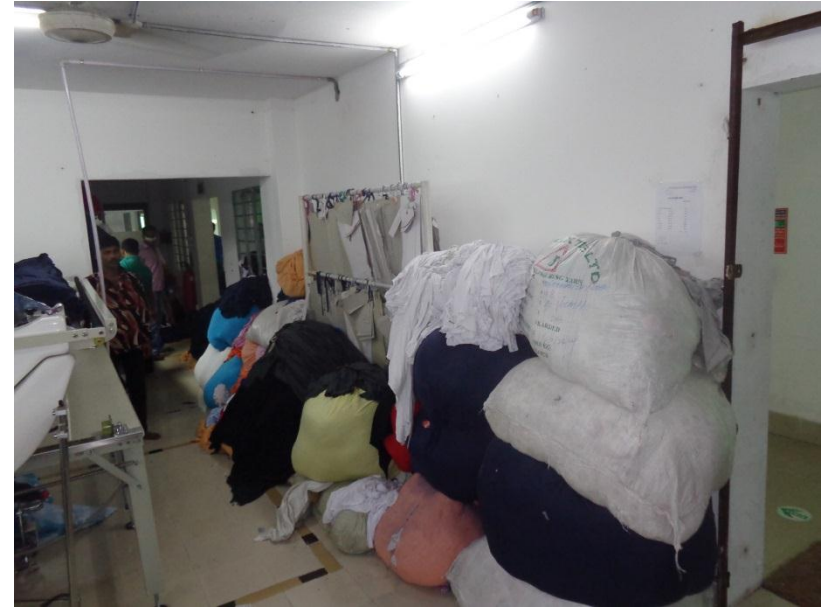
No loading plans were made available for the main building.

- Prepare loading plans based on the load carrying capacity of each floor, as specified by the original designer.

- Post load carrying capacity of each floor and manage loading.

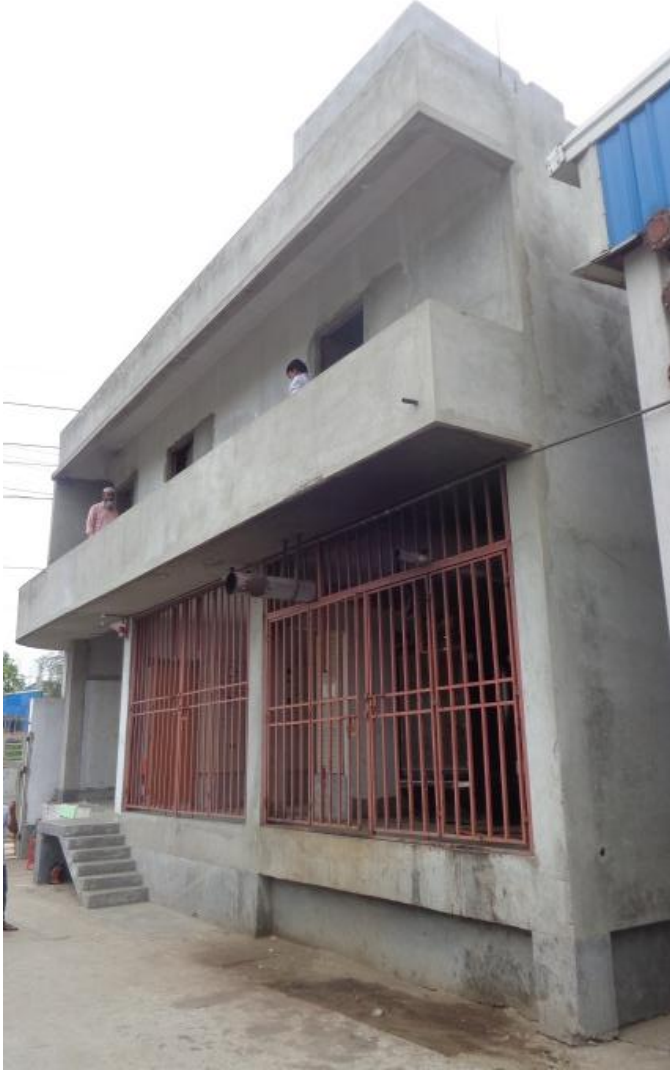
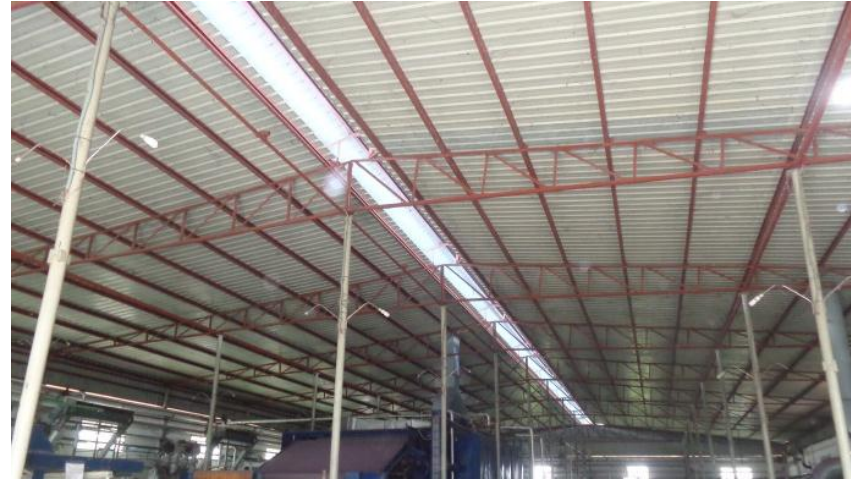
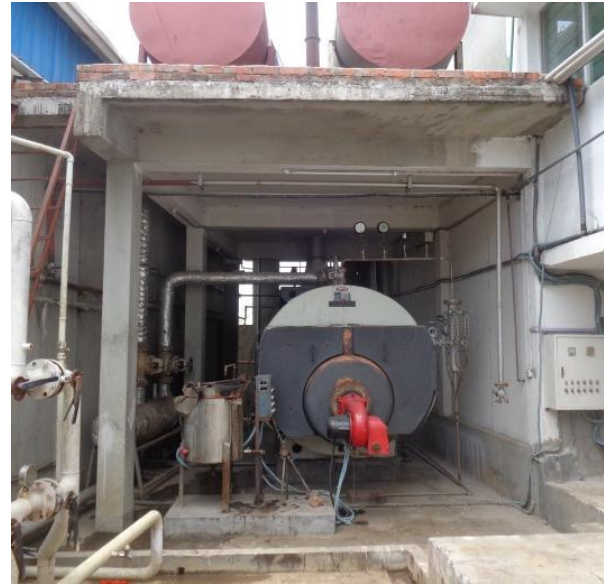
No structural drawings were made available for the generator building, the boiler structure and the dyeing shed.

- Produce structural drawings for the above listed buildings.

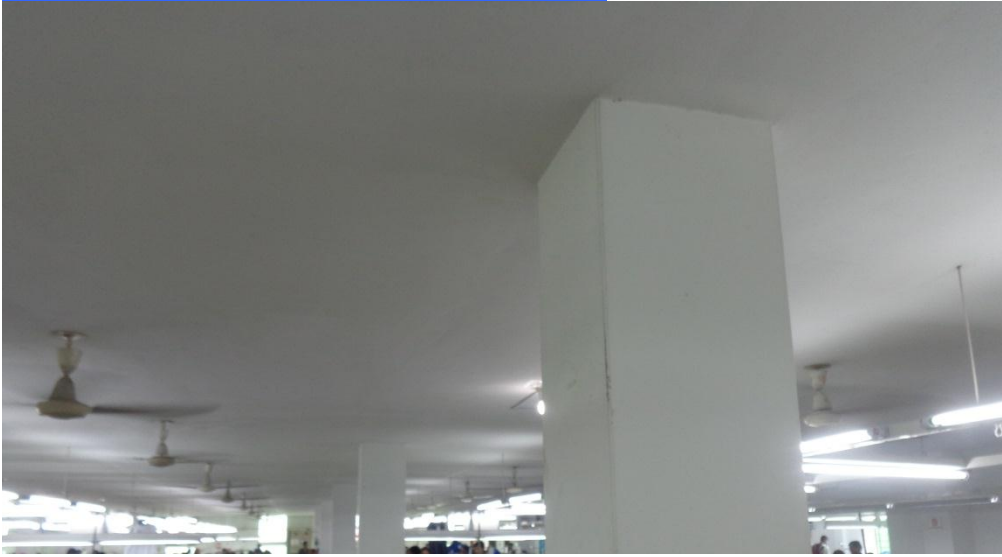
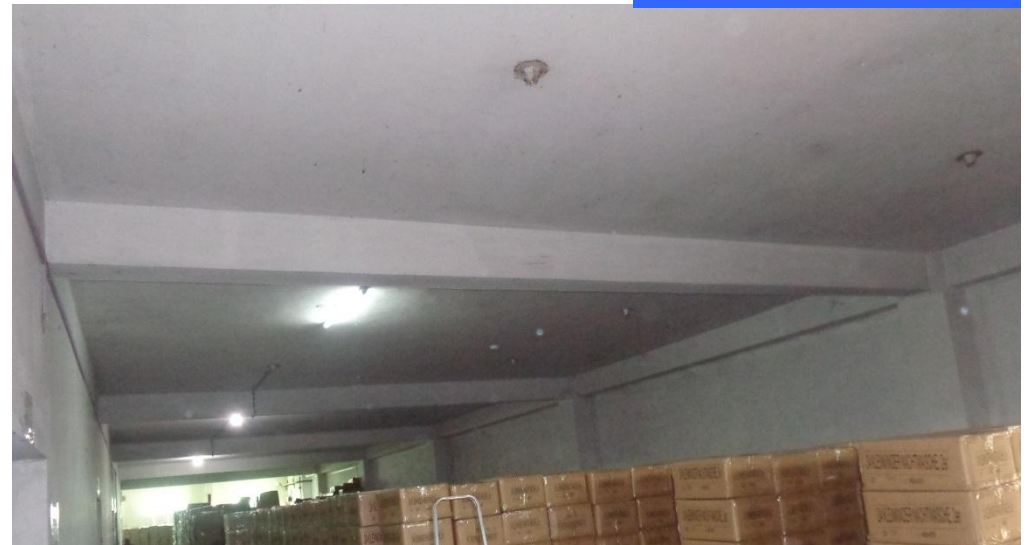
The building did not feature any core or shear walls. Stability was achieved through sway action between beams and columns and masonry infill walls.

We require that these items be investigated in a Detail Engineering Assessment

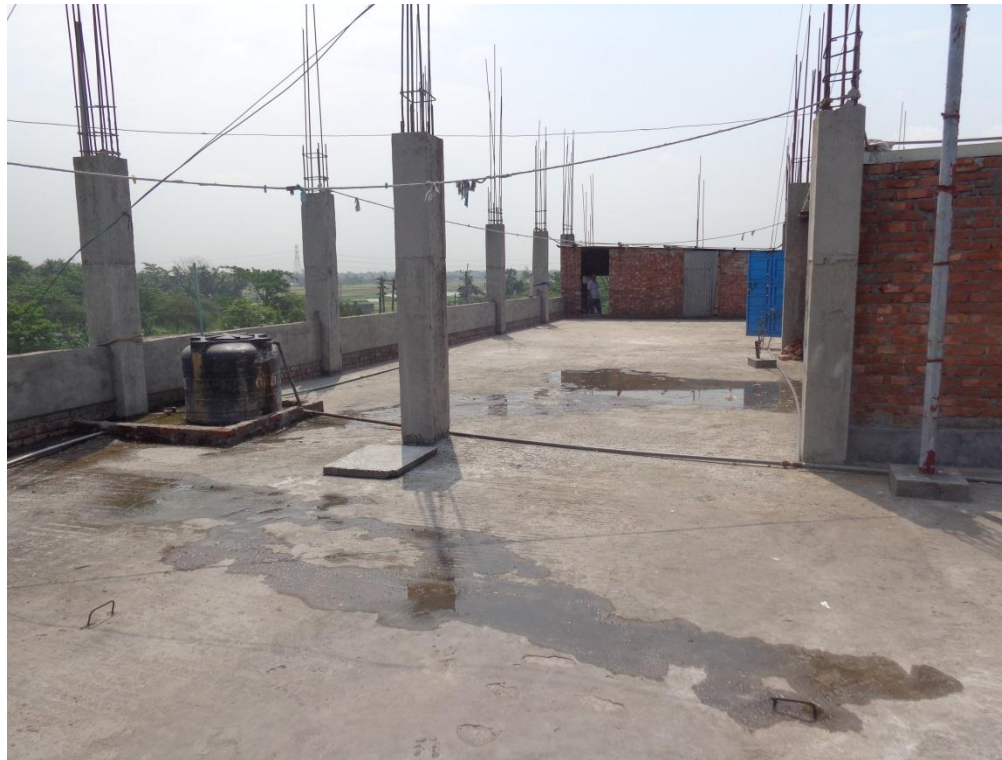
Water Ingress at Roof Level

No waterproofing membrane was visible on the roof of the building. This means that any cracks in the surface finishes on the roof will allow water to seep into the concrete slab beneath the finishes, and cause corrosion of the reinforcing steel.
