# SQ Birichina Ltd Unit 2

SQ Station, Jamirdia, Bhaluka, Mymensingh  
(24.283 N, 90.392 E)  
19 October 2015

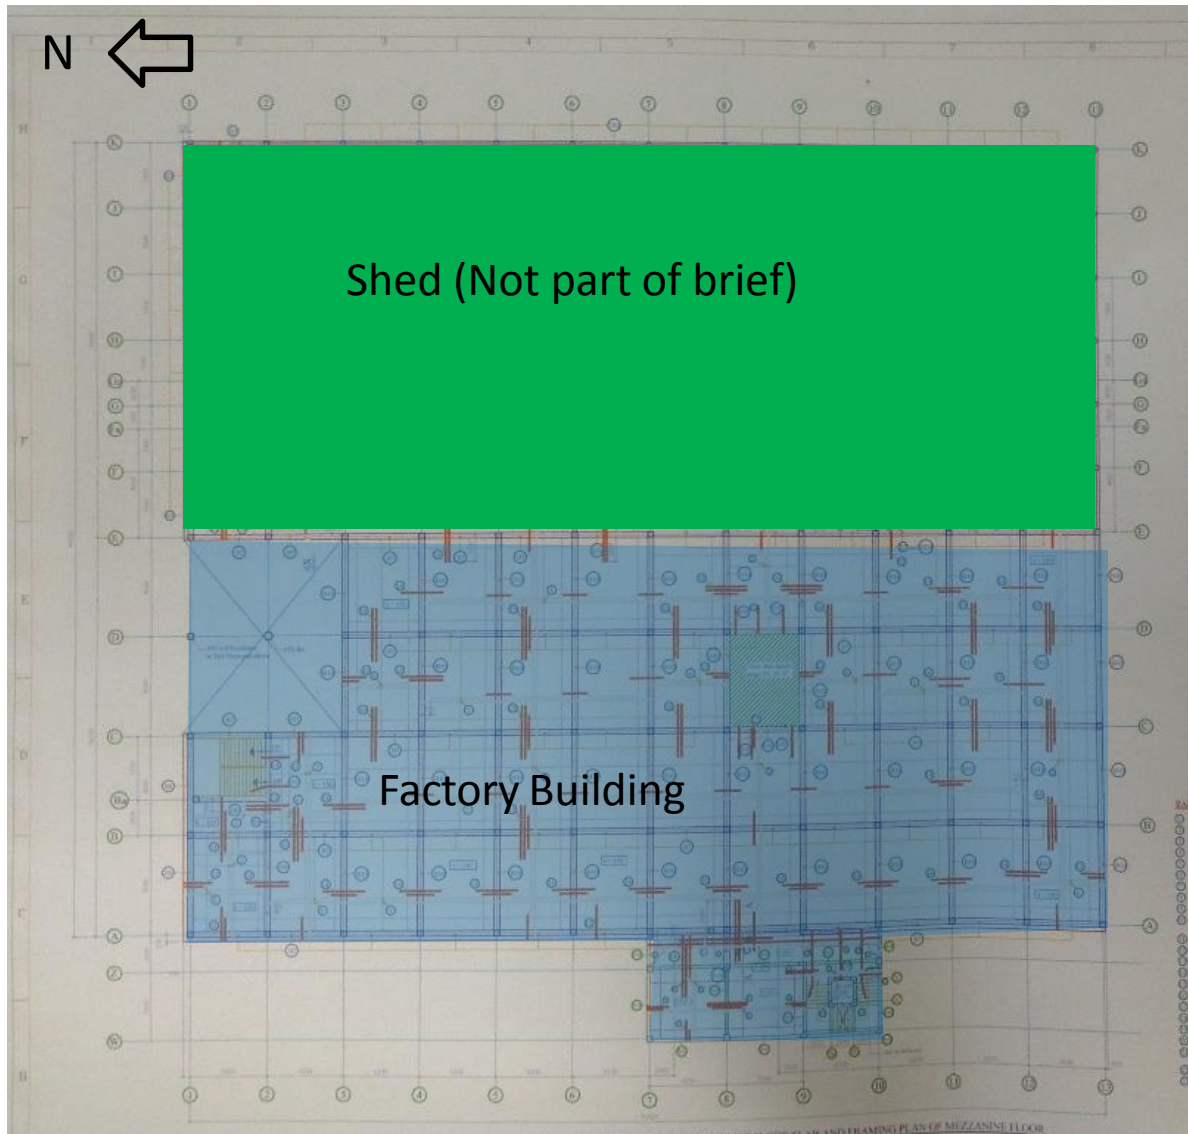
All columns are heavily loaded under current loading conditions at ground and first floors and should be reviewed immediately.

| Item No. | Observation | Recommended Action Plan | Recommended Timeline |
|---|---|---|---|
| 1 | Heavy loaded columns | Maintain current use of the floors and don't change use or increase occupation, either of which could increase loading. Restrict Crane loading to 2 tonne. | <b>Immediate - Now</b> |
| 2 | Heavy loaded columns | Factory Engineer to review design, loads and columns stresses in all columns at ground floor and first floor. | <b>Immediate - Now</b> |
| 3 | Heavy loaded columns | Verify in situ concrete strength either by taking 100mm diameter cores from a min of 4 columns in the original building or by using existing cylinder strength data. Verify grade of steel reinforcement. | <b>Immediate - Now</b> |
| 4 | Heavy loaded columns | A Detail Engineering Assessment of Factory to be commenced, see attached Scope. This should include an assessment of the as built pad foundations. | <b>Immediate - Now</b> |

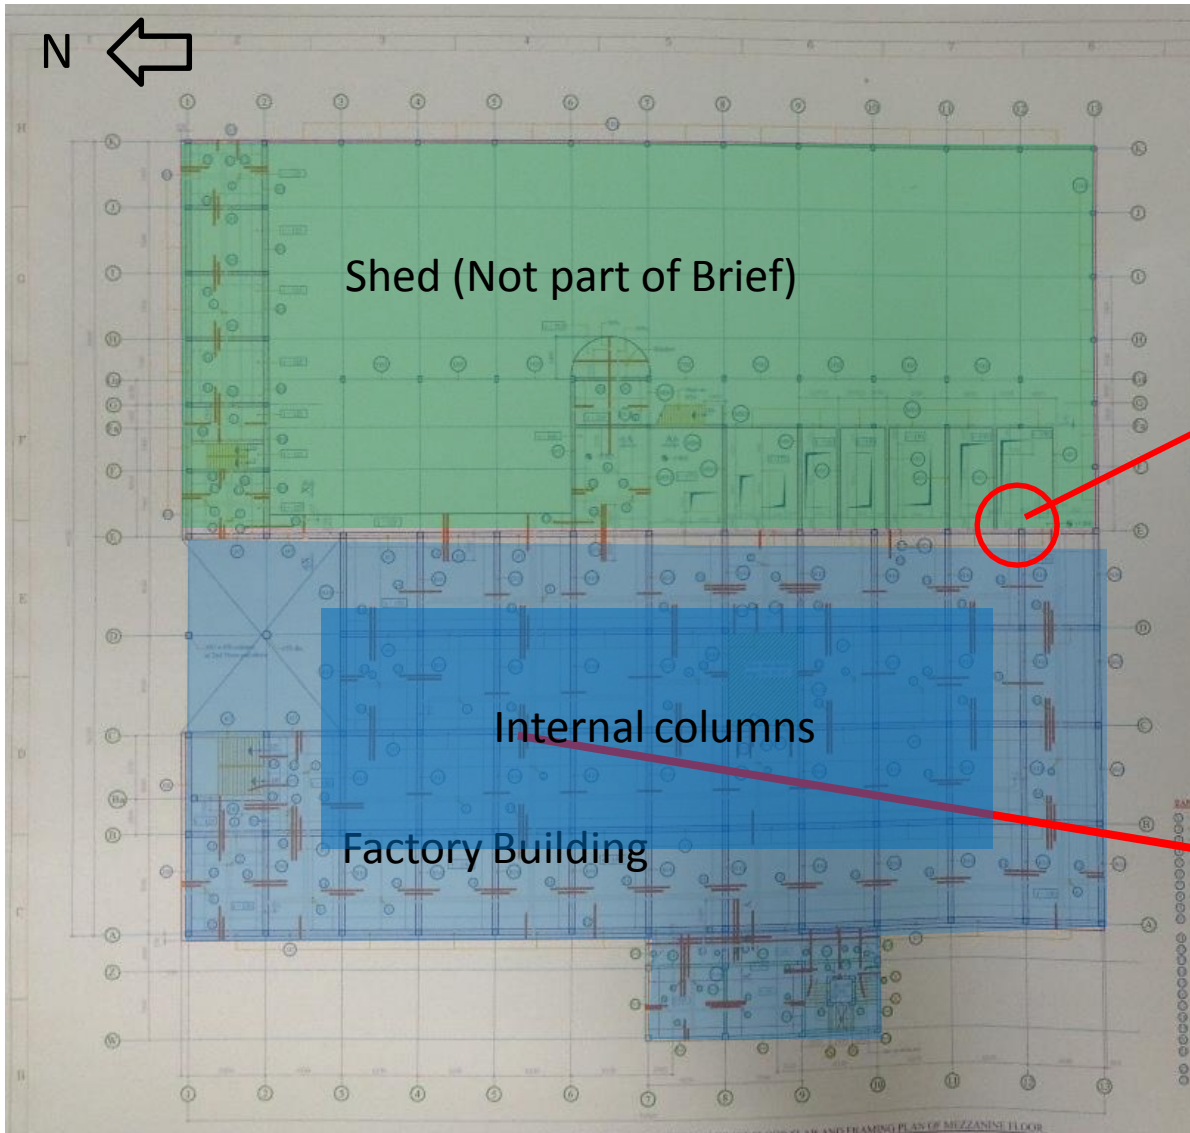
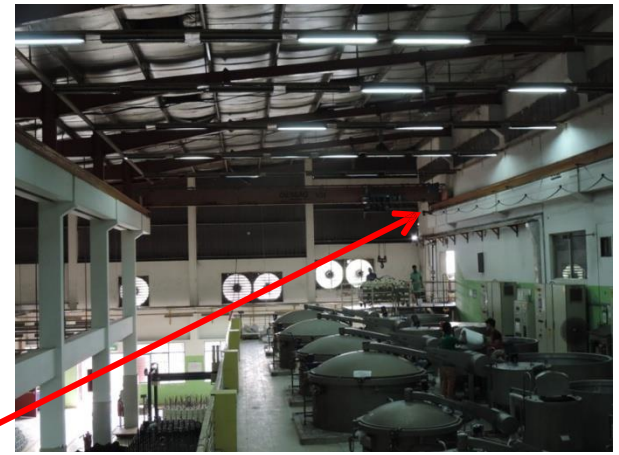
Heavily Loaded Columns (all columns)

Crane adds loading to some perimeter columns.

Water tank adds additional loads to some columns.

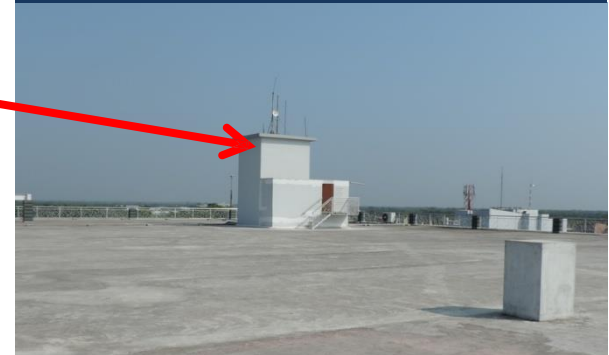
Water tank

Heavily loaded columns (all columns)

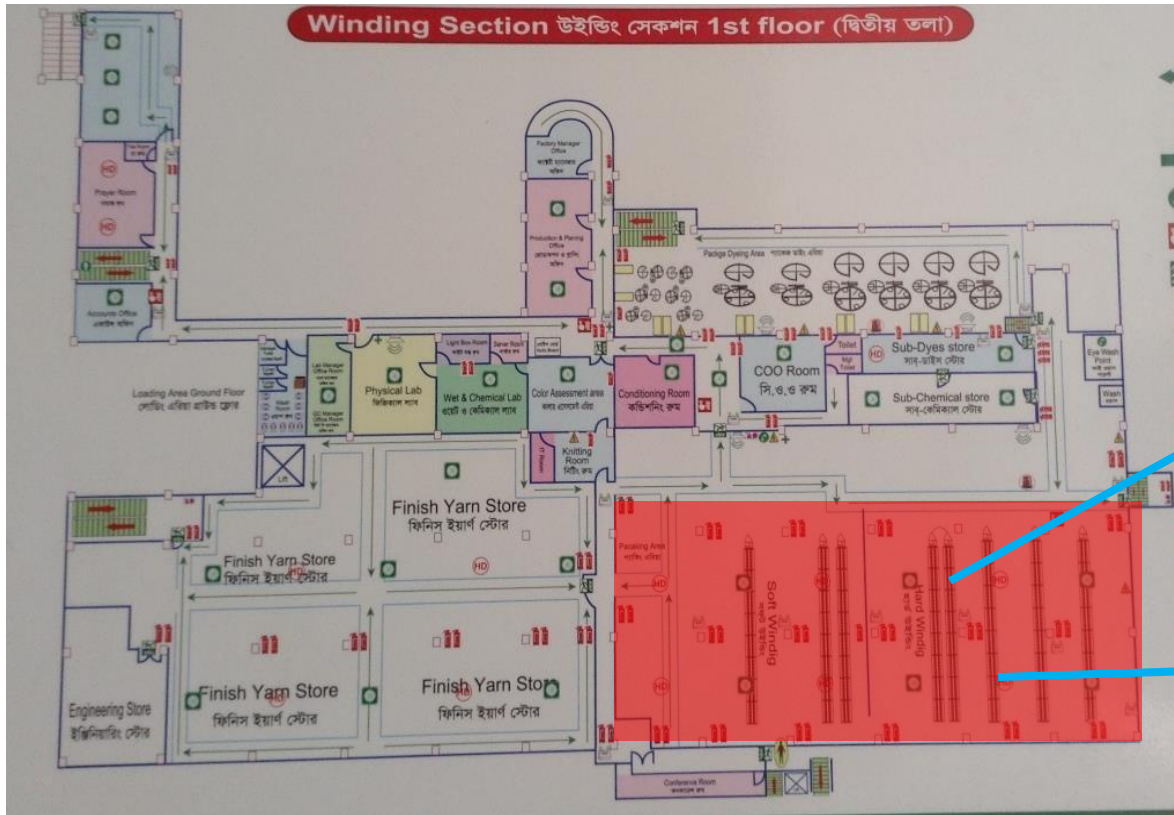
Heavy machinery on the 1<sup>st</sup> floor

| Item No. | Observation | Recommended Action Plan | Recommended Timeline |
|---|---|---|---|
| 12 | Machinery on the 1st floor. Heavy floor load | Building engineer to check the capacity of the floor slab to carry the machinery and storage on 1st floor level as part of the DEA noted at Item 1 above. | 6-weeks |
| 13 | Machinery on the 1st floor. Heavy floor load | Carry out any load reduction and maintain restriction based on recommendations made by the Building Engineer. | 6-months |

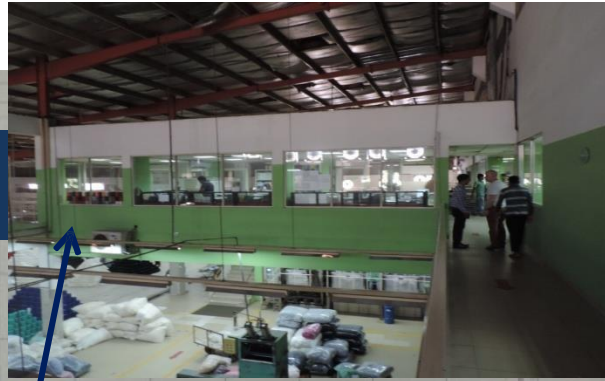
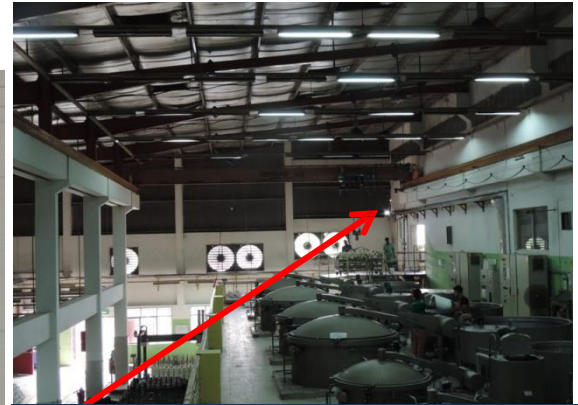
The shape of mezzanine is different on the drawings.

| Item No. | Observation | Recommended Action Plan | Recommended Timeline |
|---|---|---|---|
| 15 | Discrepancies between structural drawings and as constructed. | Building Engineer to carry out a full survey and update drawings as part of the DEA. | 6-weeks |

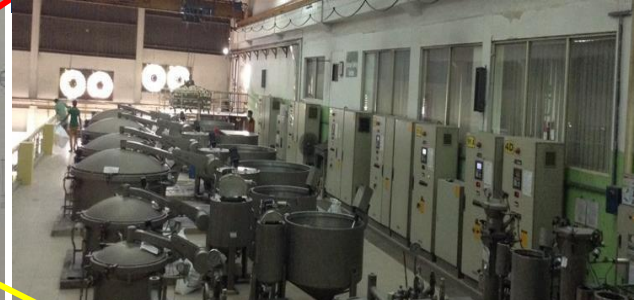
No gantry crane shown on drawings.

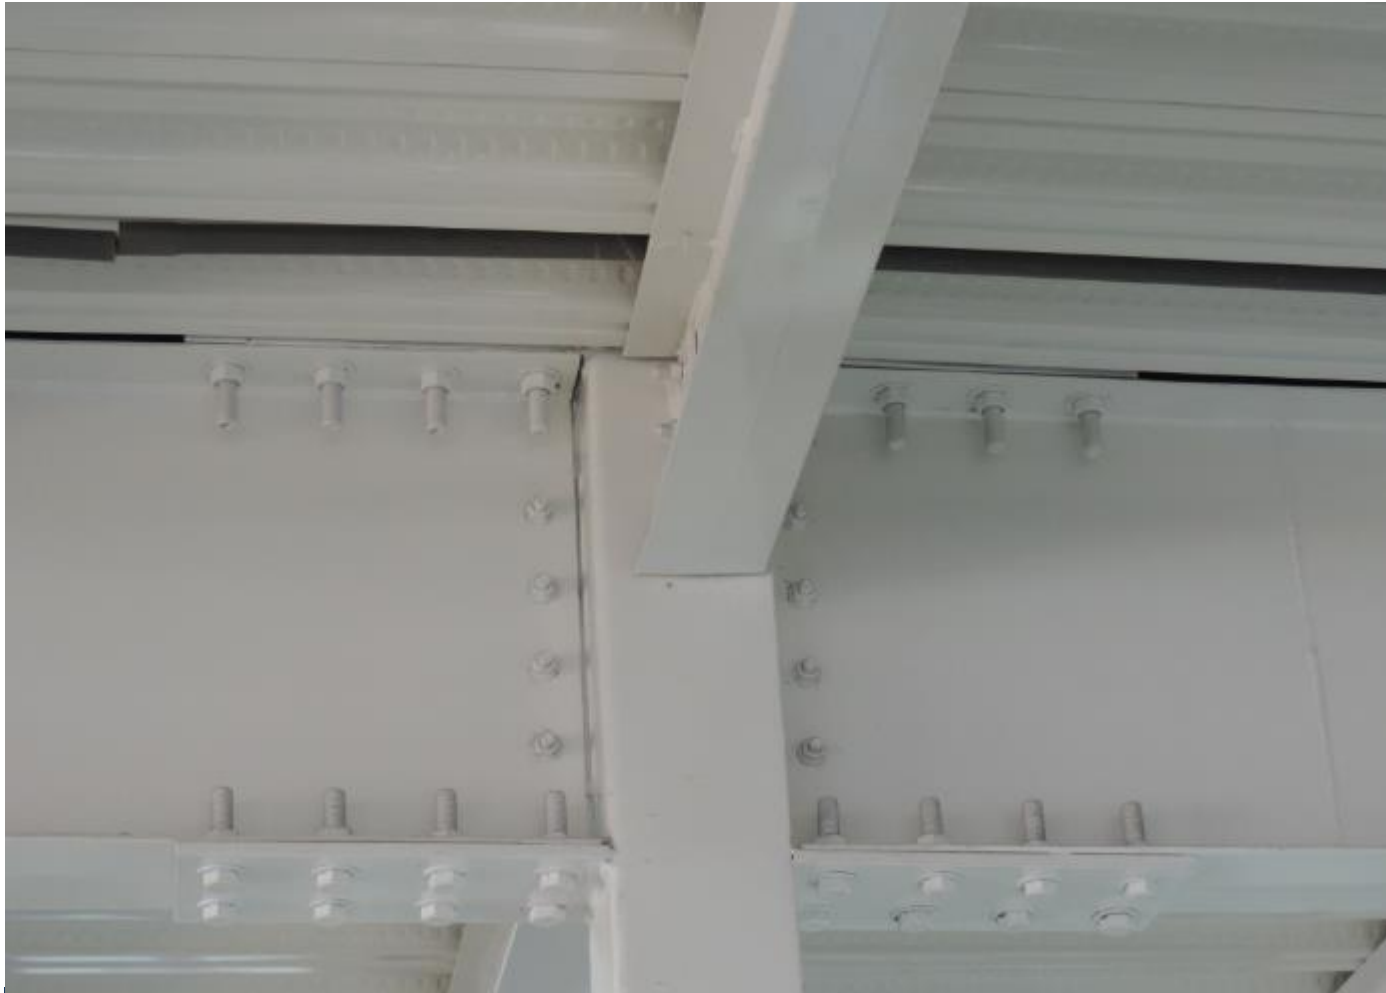
Composite beams appear under designed. Flange thickness circa 5mm.

| Item No. | Observation | Recommended Action Plan | Recommended Timeline |
|---|---|---|---|
| 18 | Composite beams appear to be under-designed | As part of the DEA the Engineer to verify the capacity of the composite beams at roof level | 6-weeks |
| 19 | Composite beams appear to be under-designed | Carry out any alterations as required by the DEA | 6-months |

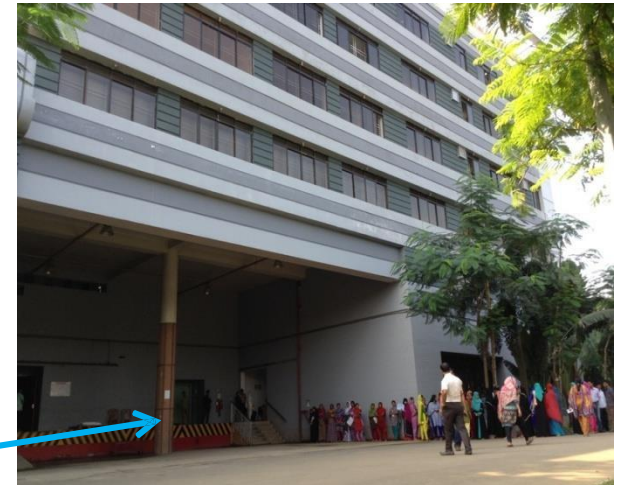
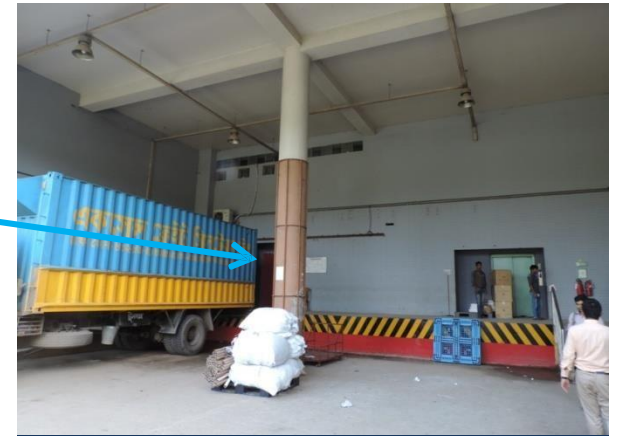
Unprotected column in front of loading bay at north . Signs of impact on side of column

| Item No. | Observation | Recommended Action Plan | Recommended Timeline |
|---|---|---|---|
| 21 | Column in loading bay unprotected from traffic (possible signs of previous collisions) | Design column protection to prevent traffic impact | 6-weeks |
| 22 | Column in loading bay unprotected from traffic (possible signs of previous collisions) | Install column protection | 6-months |

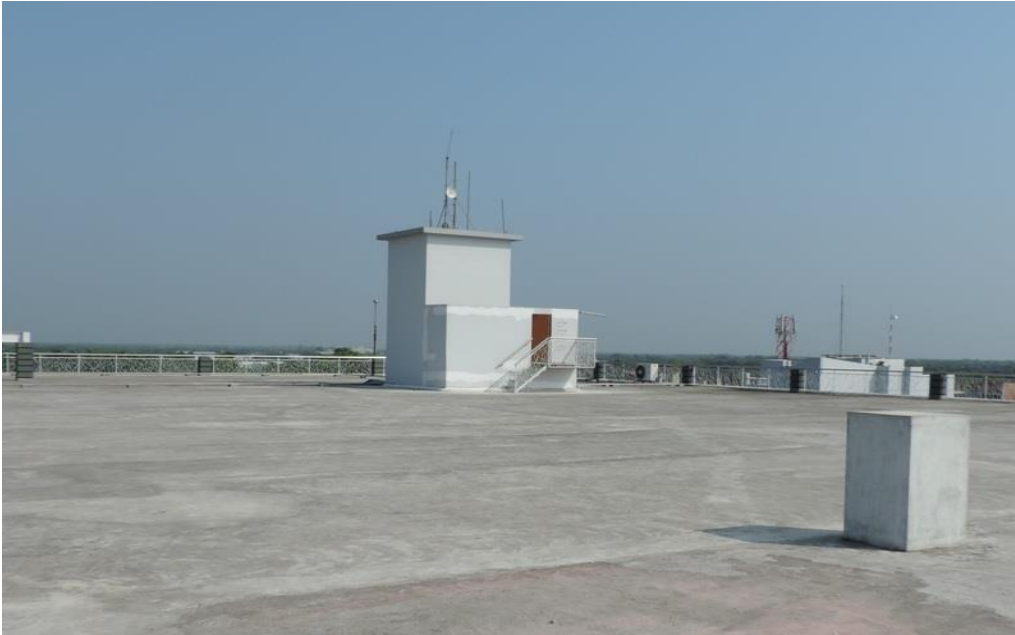
Water tank adjacent to lift room. Partially supported by lift core and partially supported on roof deck

| Item No. | Observation | Recommended Action Plan | Recommended Timeline |
|---|---|---|---|
| 24 | Water Tank on roof | As part of the DEA the composite deck to be checked for loading from tank/machinery room | 6-weeks |
| 25 | Water Tank on roof | Carry out alteration as per recommendations from DEA | 6-months |
